Development and Testing of an On-Line AE (Acoustic Emission)/Vibration Instrument

Technical Update, December 2006

Physical Acoustics Corporation

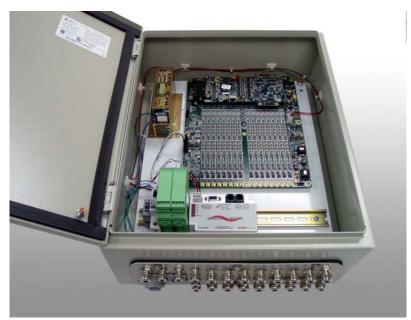
Figure 1-1 Internal view of Sensor Highway II

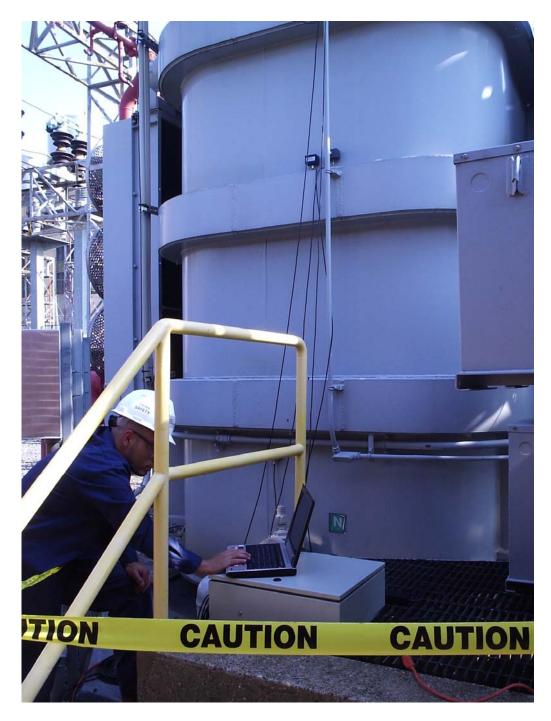
Figure 1-3 Plug in laptop computer

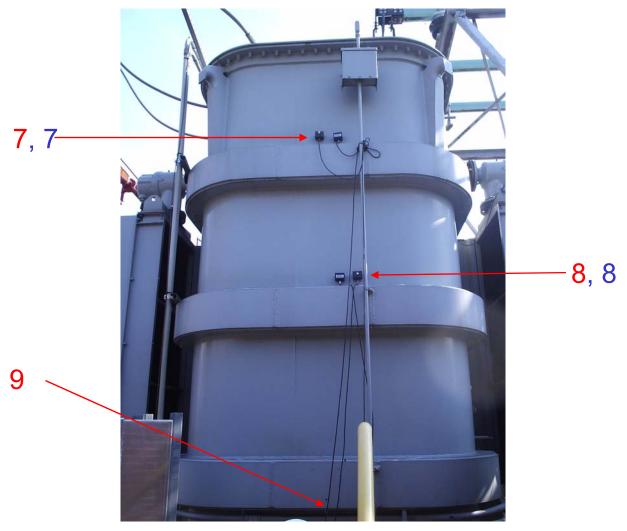
Figure 2-3 Right side

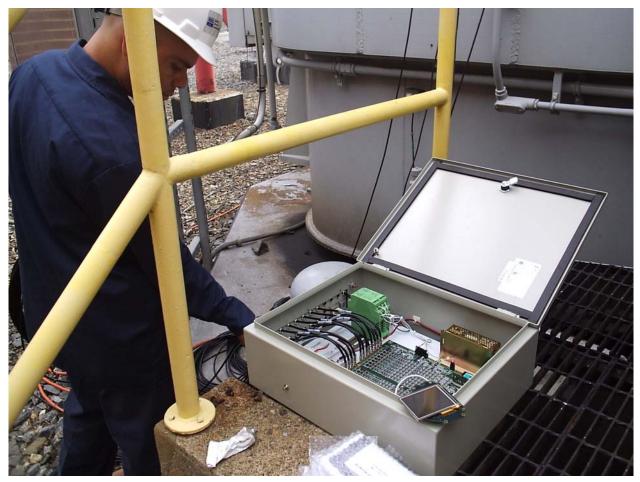
Figure 2-6 Installation on-site of the acoustic sensors and parametric channel

Also, one parametric channel was used to monitor the oil temperature on the transformer.

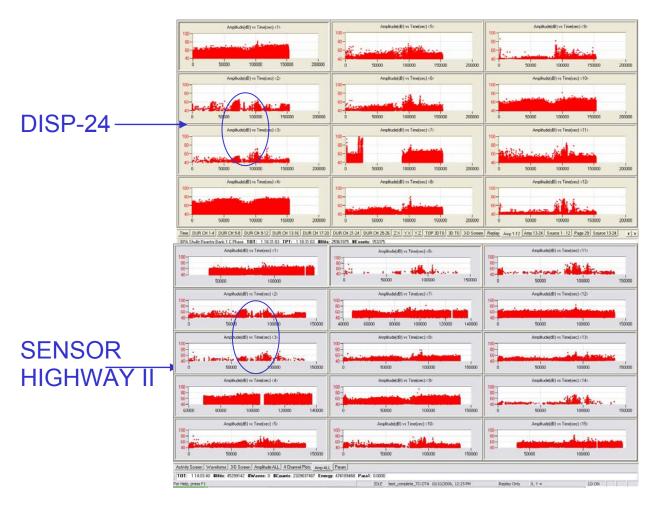
Figure 2-7 Comparison of data collected by Sensor Highway II and Standard instrumentation

Very similar responses were obtained for both systems as can be observed on figure 2-7.

Most of the data detected by both systems corresponds to pump operating noise, however, an increase in acoustic activity can be observed on sensors 2 & 3 as well as continuous activity on sensors 4, 5, 6, 7 & 8 (same numbers on both systems).

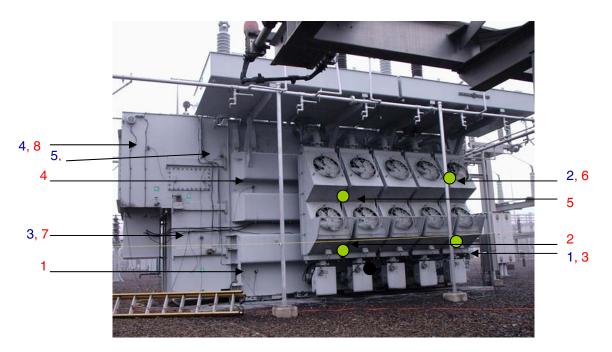
Figure 3-2 Location of acoustic sensors on HV side

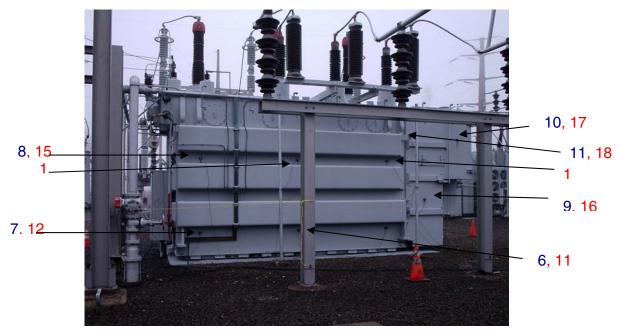
Figure 3-4 Location of acoustic sensors on LV side

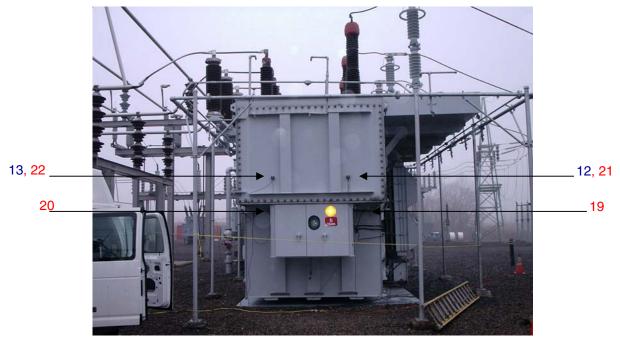
Figure 3-5 Location of acoustic sensors on Load Tap Changer compartment side

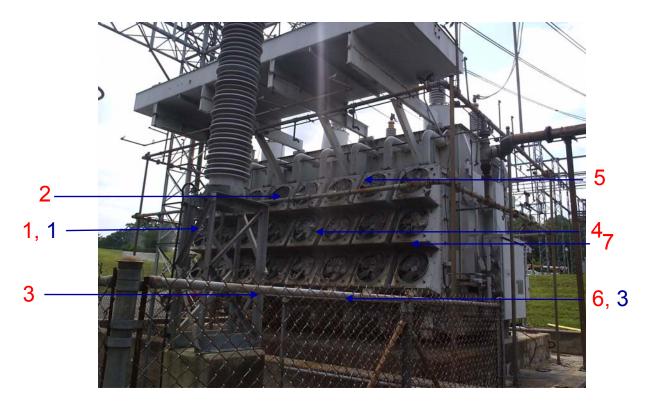
Figure 3-11 Sensor location HV side

During the June test, 23 acoustic sensors were used to monitor this unit, see figures 3-11 to 3-14 for sensor location. At the end of the test, two areas of acoustic activity were detected, one on the lower part of the Phase A coil and the other on the upper part of the Phase C coil, see figure 3-15

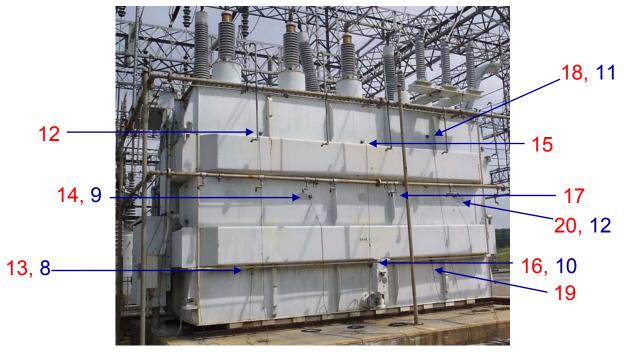
Figure 3-13 Sensor location Low Voltage Side
