Nuclear Maintenance Applications Center: Reactor Coolant Pump/Reactor Recirculation Pump Motor Lubrication Oil Systems Maintenance Guide

1013456

Technical Update, December 2006

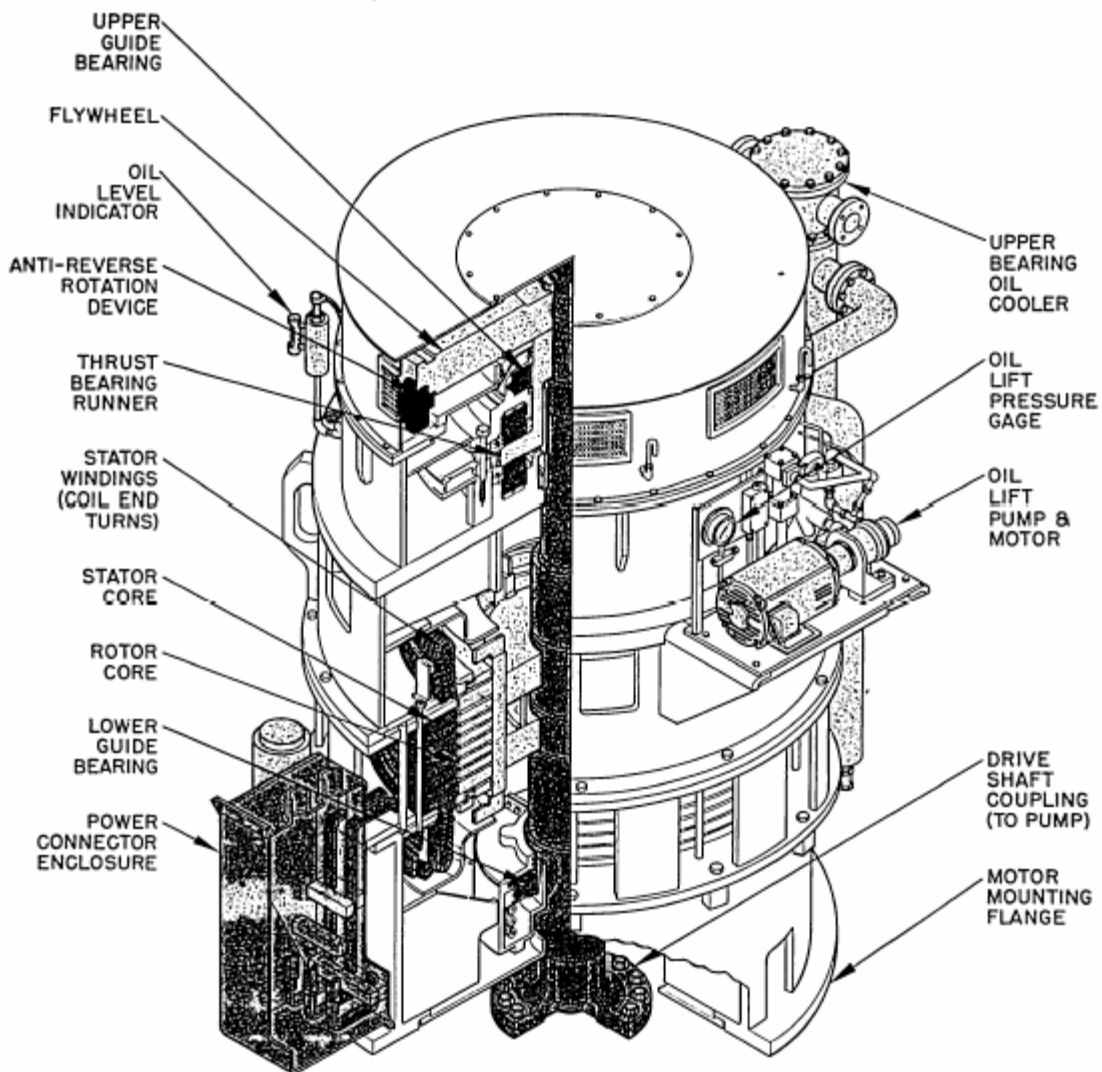
Figure 4-1 Typical Westinghouse RCP Motor

The motor for the reactor coolant pump is a drip-proof squirrel cage induction motor with two bearing assemblies, upper and lower. At the top of the motor are the pivoted-pad radial upper guide bearing, the flywheel, the anti-reverse rotation device, and one up-thrust and one down-thrust Kingsbury-type thrust bearing. A viscosity pump at the outer periphery of the thrust-bearing runner-circulates oil through an external oil-to-water heat exchanger to cool the upper bearing. This viscosity pump also pumps oil to the upper guide bearing which is located above normal oil level. An oil lift system applies an oil film to the thrust bearing shoes and upper guide bearing before startup and is also used for coast down of the motor. The lower radial guide bearing, a pivoted pad type is located below the rotor core. It is cooled by with an oil-to-water heat exchanger which is integral to the oil reservoir. Figure 4-1 shows a typical Westinghouse RCP motor.

Figure 4-7 is a drawing with shows the potential oil leak paths on the upper bearing oil cooler which is located on the outside of the motor (see figure 4-1). Oil is taken from the upper bearing oil reservoir and piped to the oil cooler and back. This piping can be the source of leakage at the flange joints. Particular attention should be placed on replacing the insulated flange joint gaskets whenever they are removed.

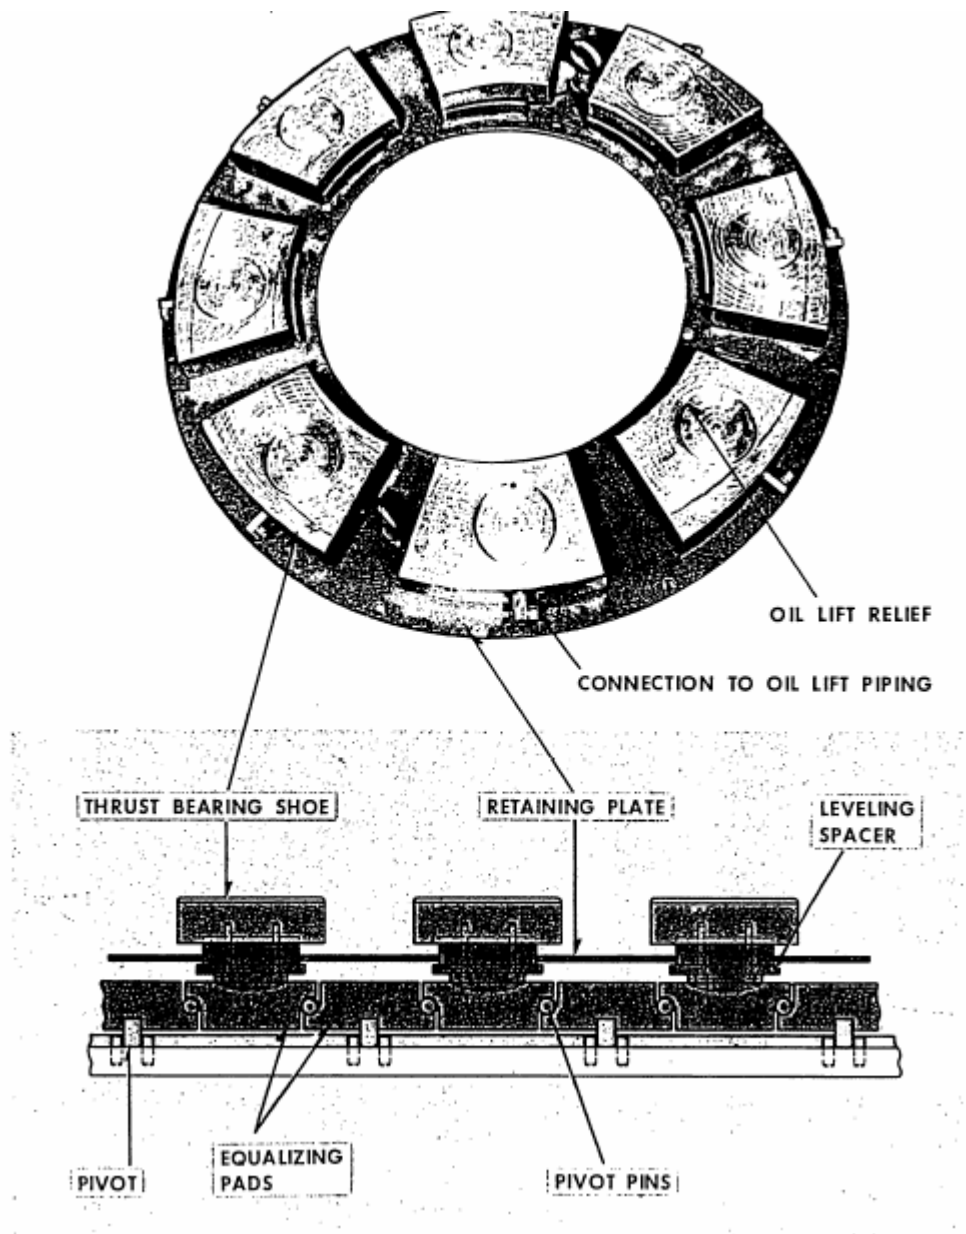
Figure 4-2 Thrust Bearing Assembly

The upper bearing assembly contains two eight-shoe thrust bearings (upper and lower thrust bearings) (see Figure 4-2) and a seven-pad radial guide bearing (upper guide bearing). Kingsbury-type thrust bearing shoes are used above and below a common runner to accommodate thrust in either direction. The babbitted-steel shoes are mounted on equalizing pads which distribute the thrust load equally to all shoes. The shoes tilt and allow the oil to form a thin wedge-shaped film between them and the shaft mounted runner. An oil lift system provides the initial oil film during startup. Cooling is provided by the upper bearing oil cooler. The upper radial guide bearing consists of oil-cooled pivoted pads similar to the lower guide bearing. The guide bearing runner is an integral portion of the thrust bearing runner. Typical oil capacity for the upper bearing assembly including the external oil cooler is around 250 gallons.

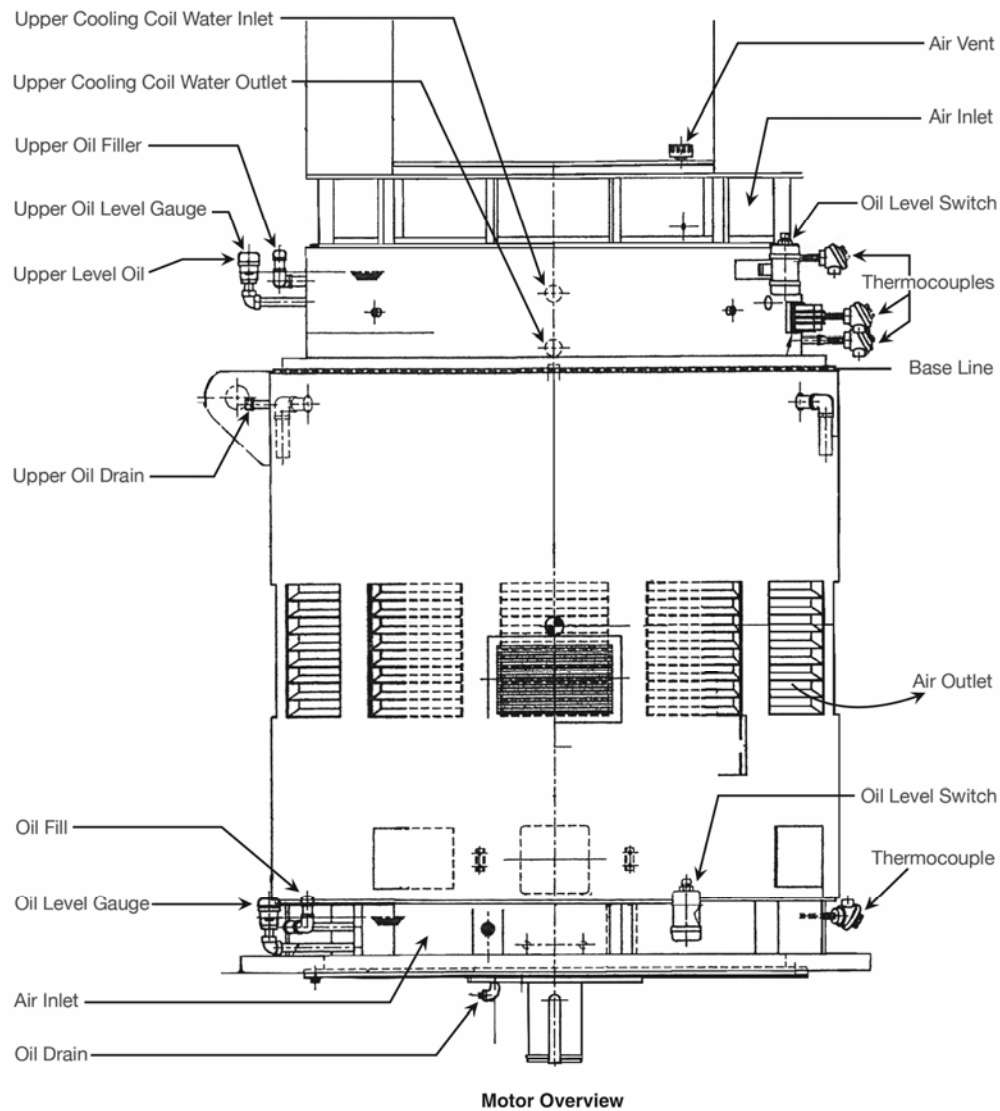
Figure 4-4

The motor for the RRP used in most GE BWRs (and a few RCP motors) are high horsepower variable speed induction motors (four pole, 1668 rpm at a frequency of 56 Hz). To accommodate axial thrust, the motors are equipped with one up-thrust and one down-thrust self-lubricating Kingsbury type thrust bearings. Self-lubricating guide bearings are also provided above and below the rotors. The motors have upper and lower oil reservoirs to supply oil to these bearings. Indication of high or low oil level is provided by annunciators in the Control Room. To check actual level in the reservoirs requires access to the motor in the drywell which is usually in an inert environment. The cooling of the motor oil is accomplished in two ways; the passing of cool air over the outside surface of the oil reservoirs and through the use of tube-in-tube heat exchangers that are an integral to the oil reservoirs. These coolers are cooled by the RBCCW System.

There is no oil lift system required with this design. The thrust bearings are immersed in oil and the radial guide bearings are half immersed in oil at standstill oil level. Lubrication circulation is provided by the rotation of the bearing journals and the oil grooves designed into the Babbitt of the radial guide bearings.

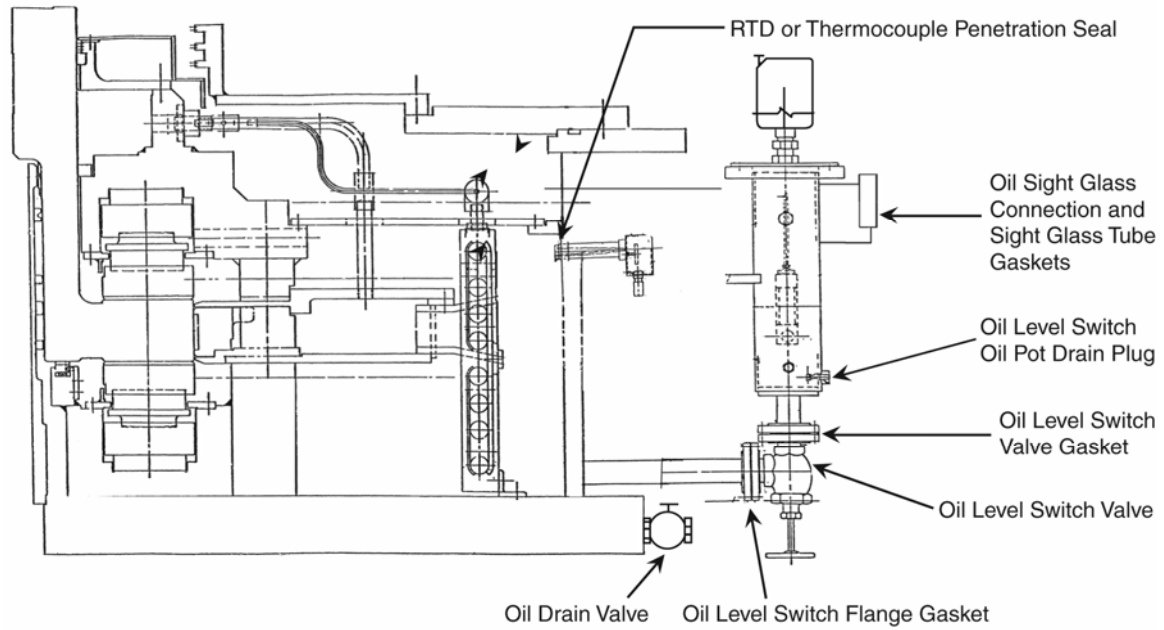
Figure 4-5 Upper Motor Bearing

The outline of the upper bearing area of the Westinghouse RCP motor is shown in Figure 4-5. The most probably potential leak paths that can result in a lubrication oil leak are shown.

Westinghouse Motor Upper Bearing

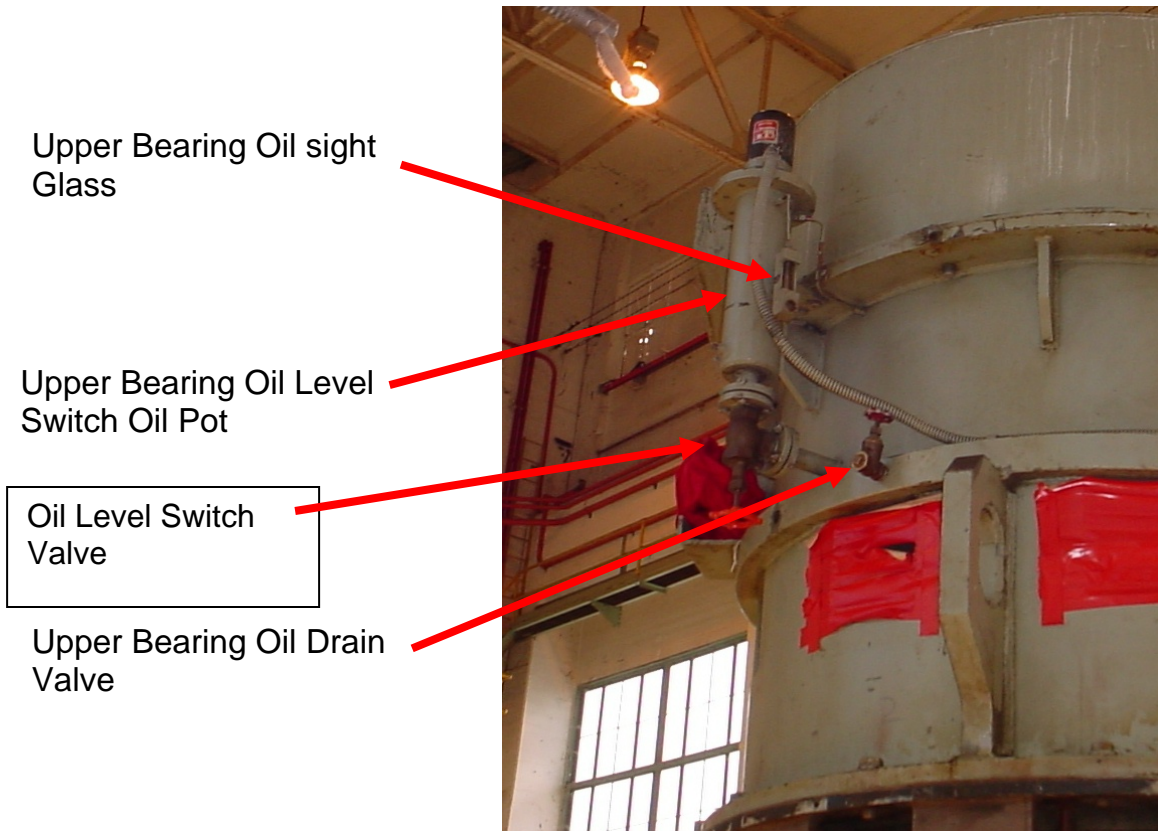
Figure 4-6 Upper Bearing Area

Figure 4-6 is a photograph which shows the upper bearing area including the oil sight glass, the oil level switch oil pot and the upper bearing oil drain valve.

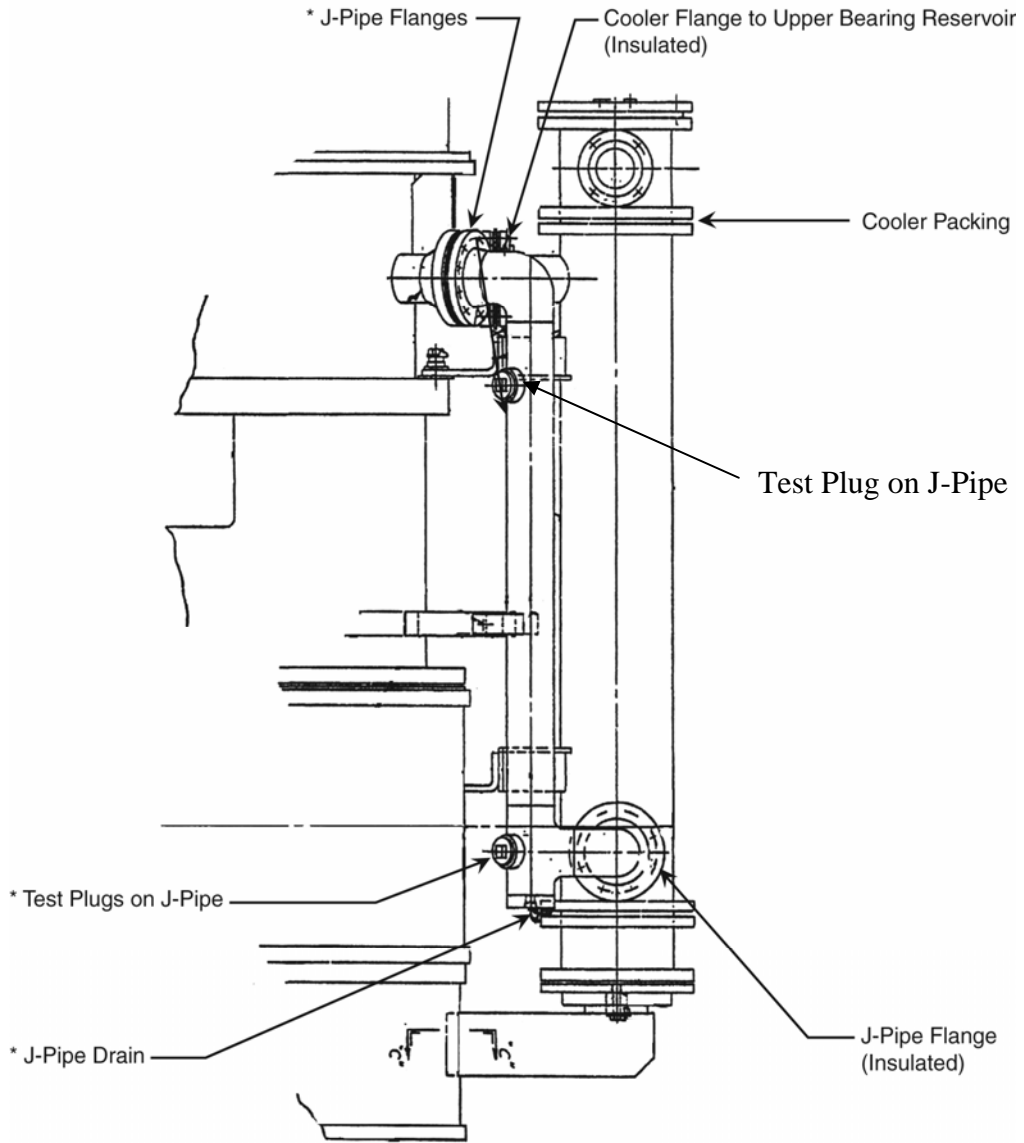
Westinghouse RCP Motor Upper Bearing External Oil Cooler

** Note: On this drawing, there is one test plug shown. The configuration varies from none to two test plugs. Other J-pipe plugs may be present.*

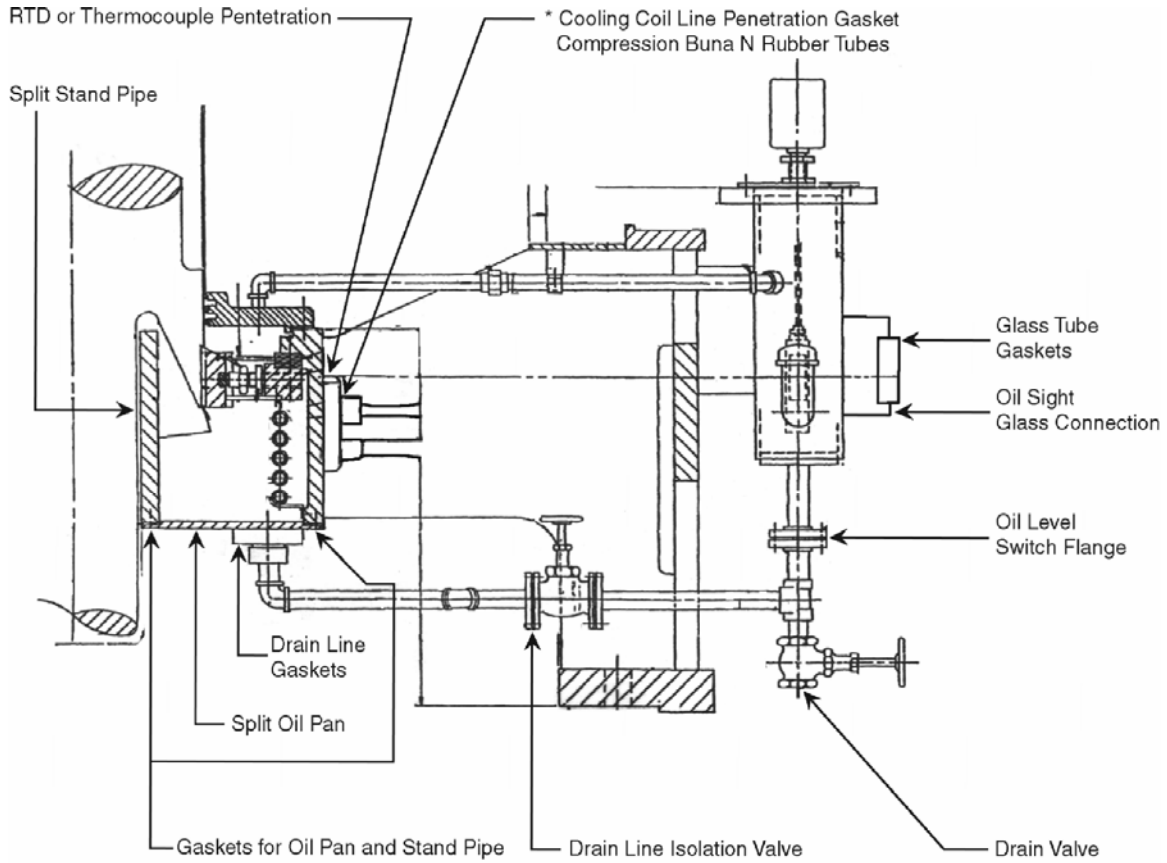
Figure 4-8 Lower Bearing Area Potential Leak Paths

The lower bearing area is quite complex and has many potential leak paths, including threaded connections, flanges and oil pan/(segmented oil pan)/standpipe gasket areas. Figure 4-8 shows a schematic drawing of the lower bearing areas:

Westinghouse RCP Motor Lower Bearing

** Note: On some models, these inlet and outlet waterlines are soldered in place.*

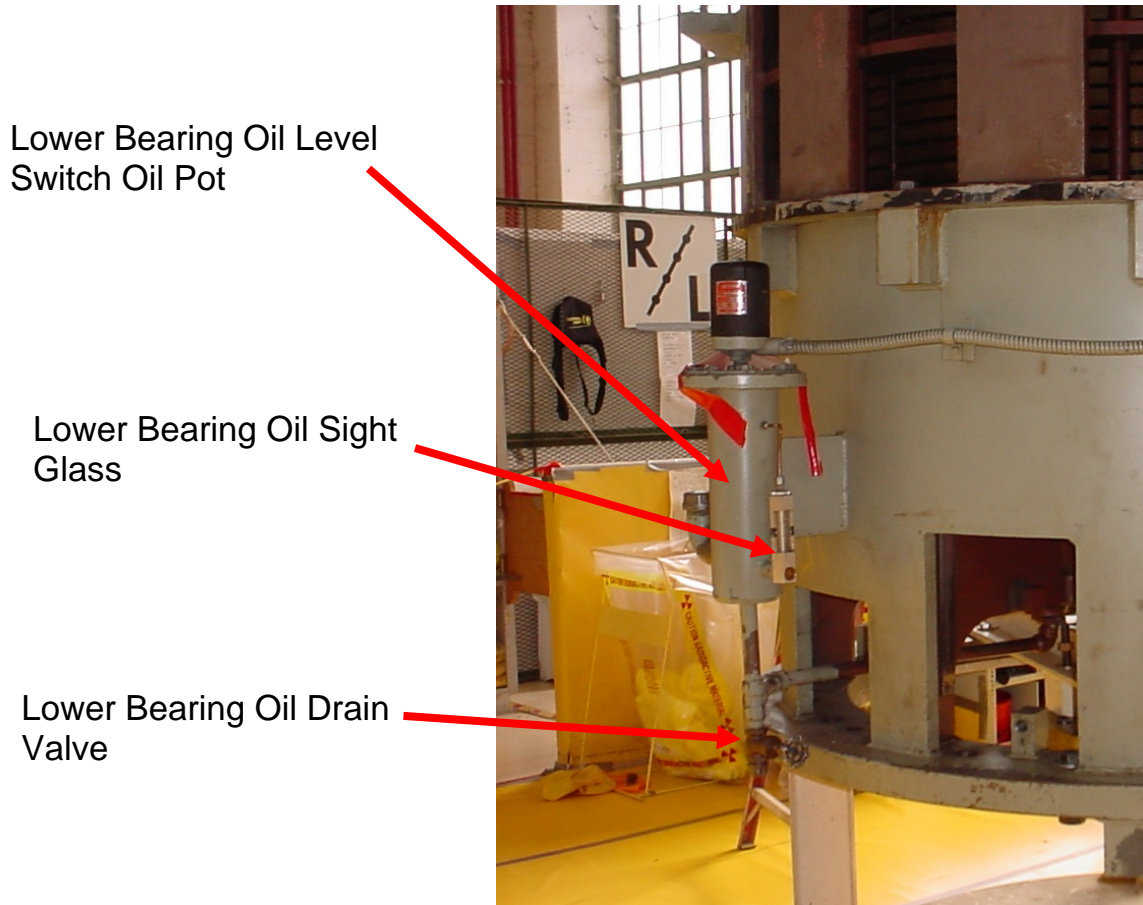
Figure 4-9 Lower Motor Bearing Area
(see also Figure 4-14)

Figure 4-9 shows a photograph of the lower motor bearing area showing the oil level switch oil pot, the oil sight glass and the oil drain valve, all potential leak paths.

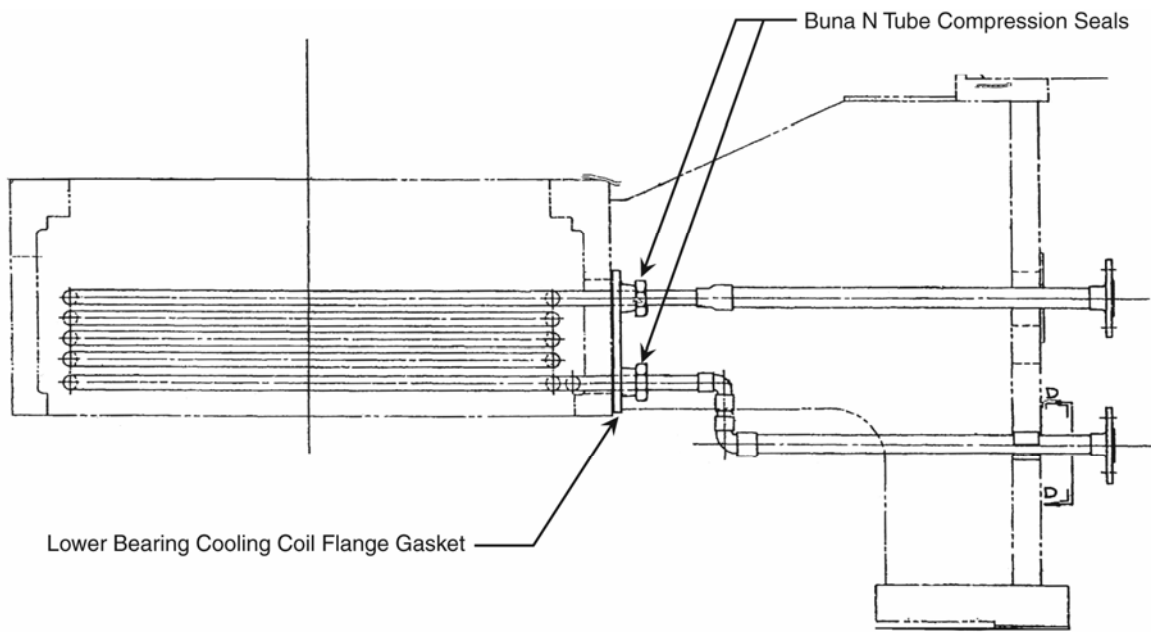
Figure 4-10 Lower Bearing Cooling Coil

Figure 4-10 and 4-11 shows the lower bearing cooling coil and in particular, how the cooling water lines penetrate the lower oil reservoir. Potential leak paths occur in the area of the flange where it bolts to the oil reservoir. Another common leakage area is where the cooling water line exits the flange and a Buna N compression seal (very similar to small valve packing) is used. Both of these areas should be replaced during the 10 year motor overhaul.

Lower Bearing Cooling Coil

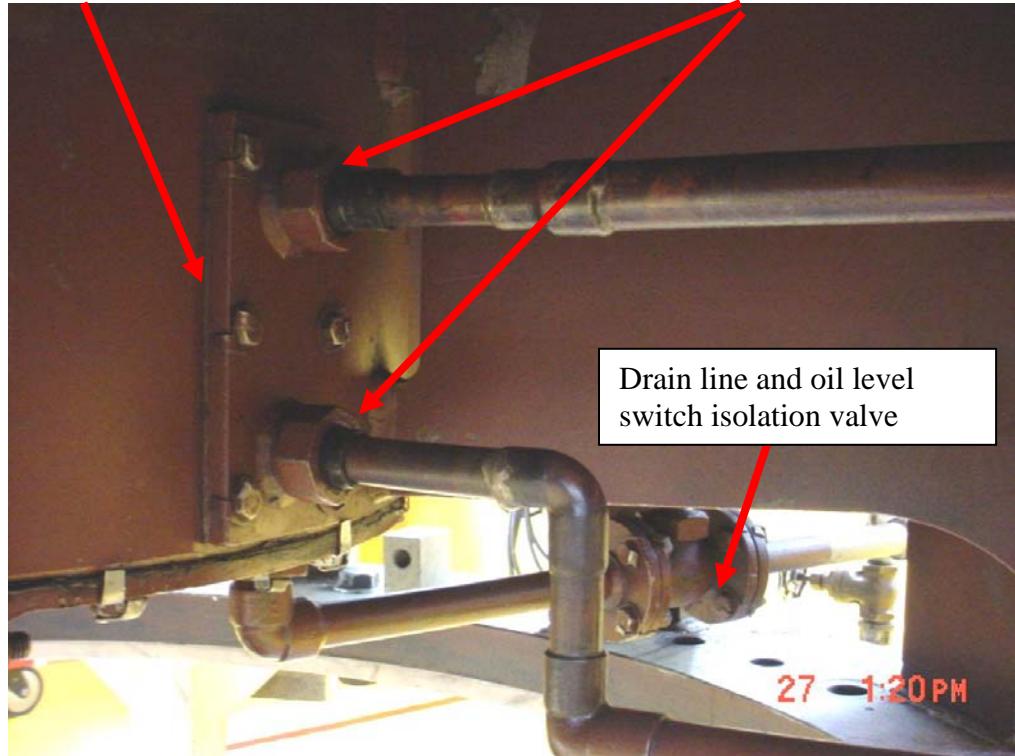
Figure 4-11 Photograph of the Oil Cooler Penetration Flange Area

Lower Bearing Oil Cooler
Flange Gasket

Lower Bearing Oil Cooler
Compression Tube Fittings

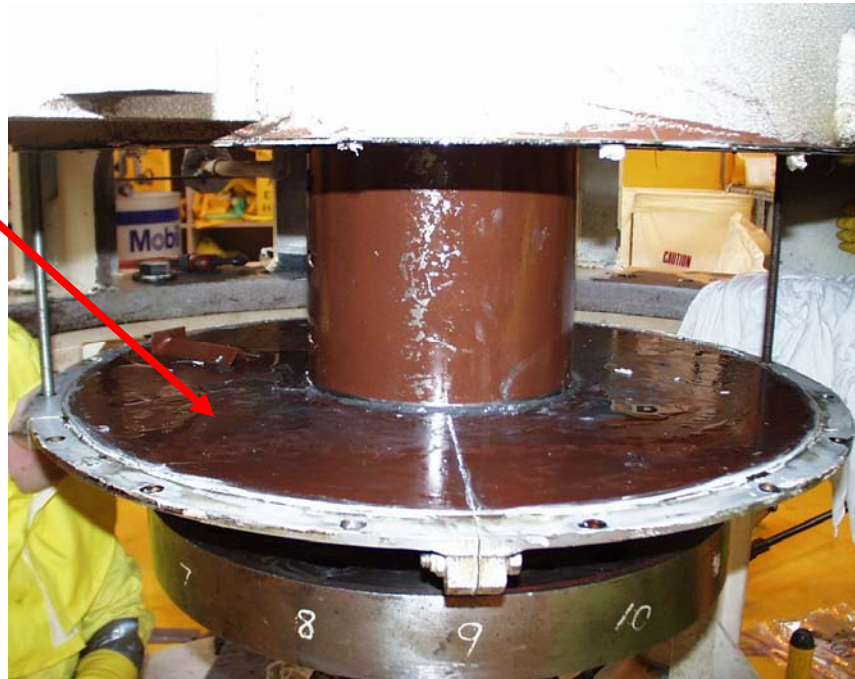
Figure 4-12 Lower Oil Pan

Figures 4-12, 4-13 and 4-14 show the various parts of the lower oil pan and standpipe. The flange connections on these are very crucial and can leak if not properly assembled. Some Westinghouse motors have been supplied with lower oil pans made of aluminum which have a tendency to warp and leak due to the high temperatures surrounding the motor. A replacement oil pan made of steel is available which is much stiffer and not subject as susceptible to these leakage problems. Additionally, the proper size oil pan and standpipe flange bolting (in particular, length) must be utilized to obtain a good seal. One area that needs particular attention is the bolting hardware on the splits on the lower bearing oil pan. Two bolts on each split are ream bolts which act as dowels for the split alignment. If these bolts are not installed, split misalignment can occur which will create a leak path. Figure 4-14 shows the lower pan drain line which has threaded pipe connections and flanged joints which can leak if not properly installed and sealed. Figure 4-15 is a picture of the lower oil pan installed and the flange has been 'battered' with sealant which can help prevent leaks.

Lower Oil Pan with
Standpipe attached
Dropped Down

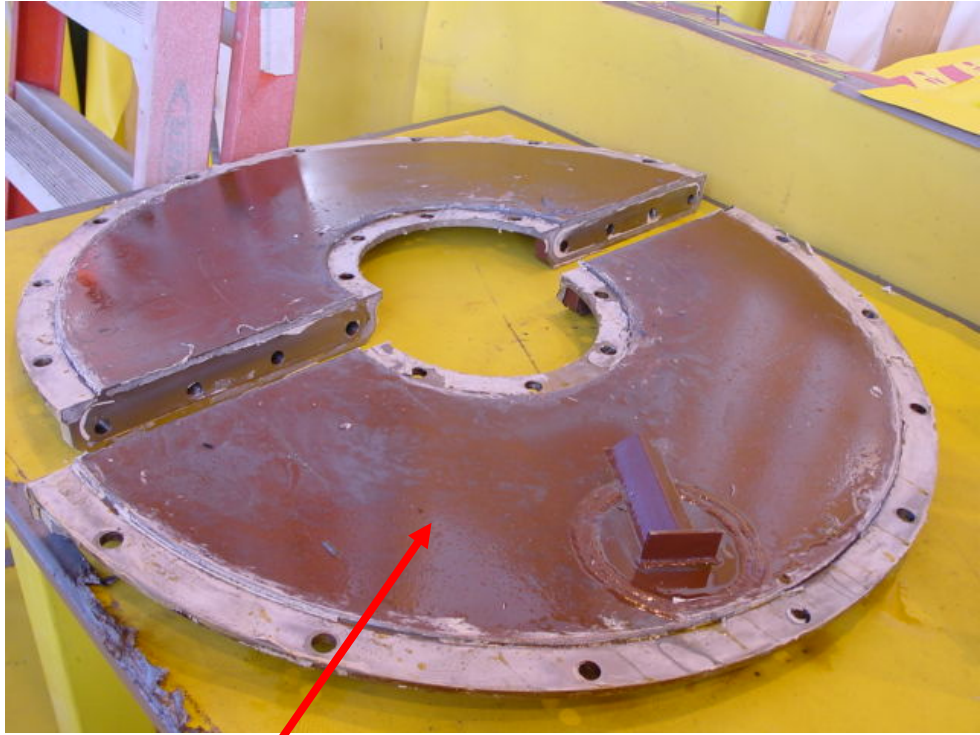
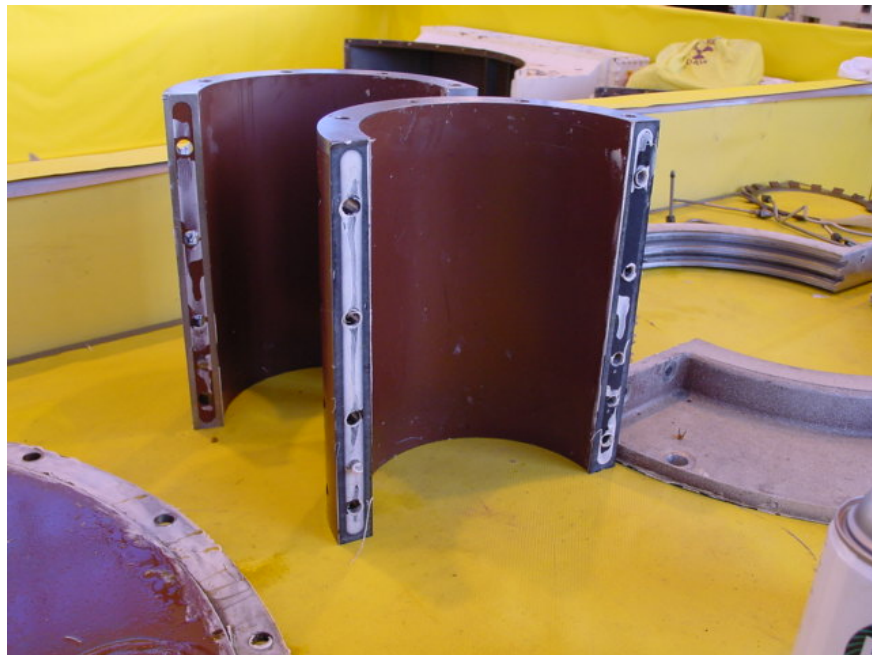
Split Oil Pan Halves
Figure 4-13 Lower Oil Pan Halves

Lower Bearing Split Oil Pan

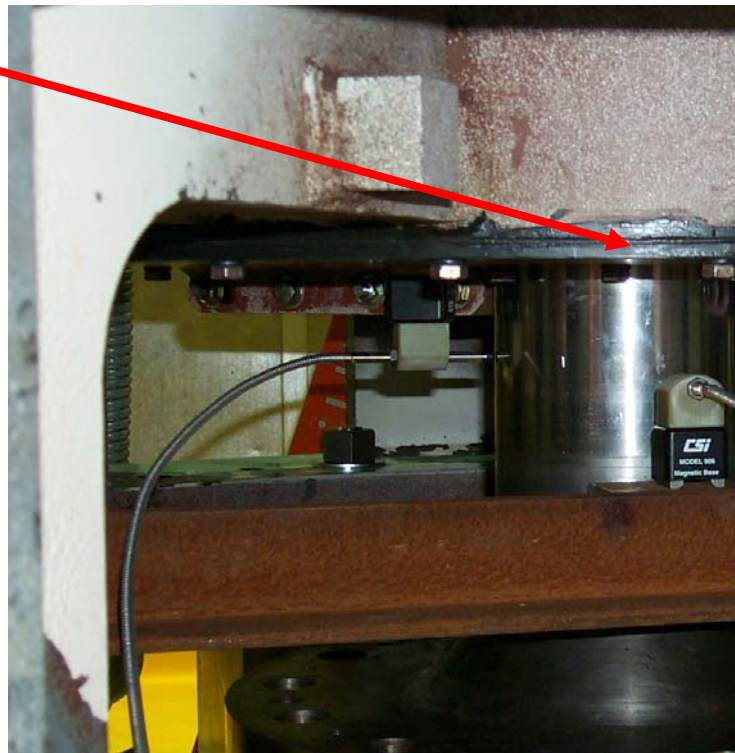
Figure 4-15 Lower Oil Pan Flange "Buttered"

Lower Bearing Oil Pan (showing sealant)

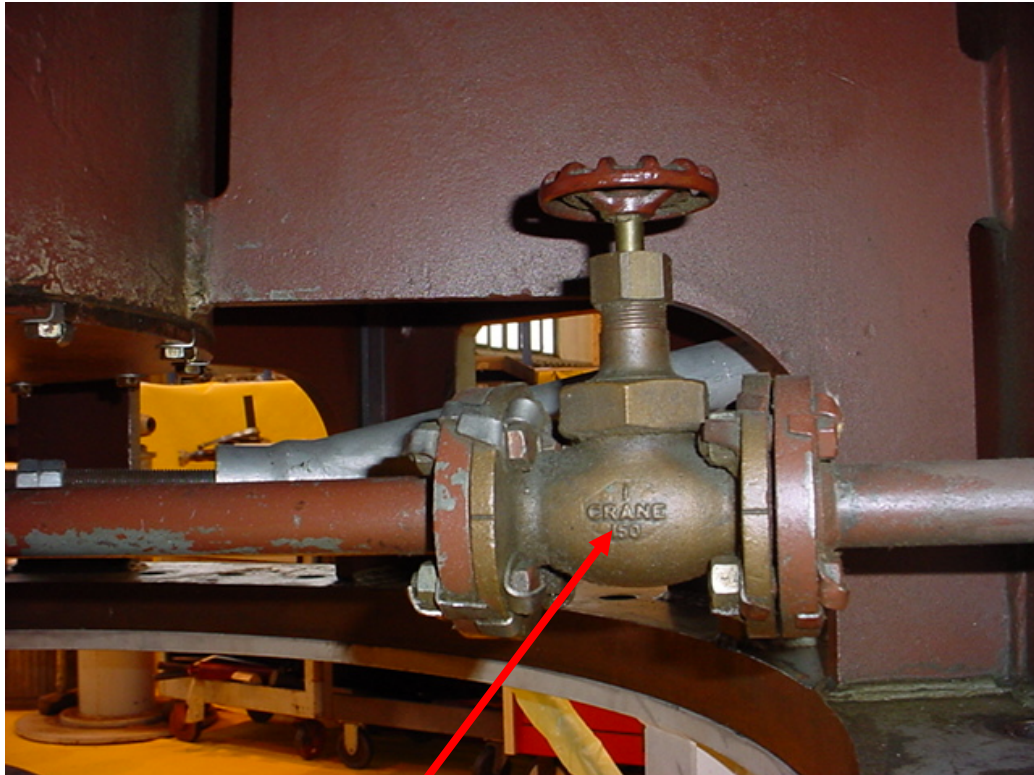
Figure 4-16 Lower Bearing Reservoir Drain Isolation Valve

Figure 4-16 shows the Lower Bearing Reservoir Drain Line Isolation Valve. Potential leak paths here are at the valve flanges and packing. These should also be refurbished during the recommended 10 year motor overhaul.

Lower Bearing Drain Line Isolation Valve
This line goes to the lower bearing oil level switch oil pot

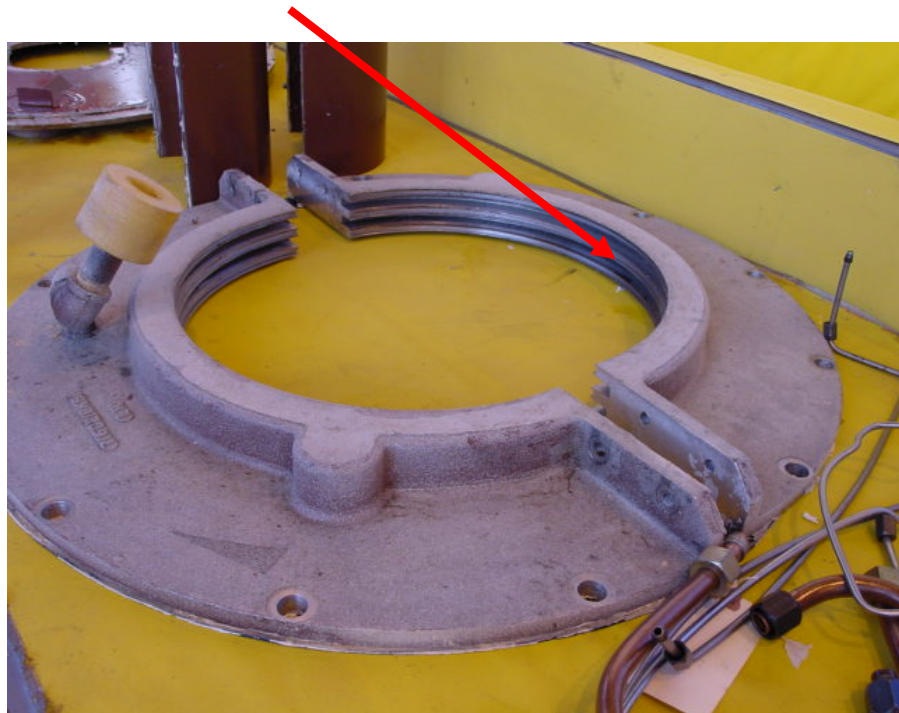
Figure 4-17 Lower Bearing Labyrinth Seal

The lower bearing oil reservoir is topped with a two piece labyrinth seal as shown in Figure 4-17. The flange on the seal are above the oil level and do not typically cause leakage problems. However, the seals themselves can become a source of oil misting should the clearances grow too large which can result in oil accumulating external to the oil reservoir. The motors were originally supplied with aluminum seals but now a more durable copper seal is available which provides longer seal life.

Lower Bearing Labyrinth Seal, can be aluminum or copper
Can cause oil misting inside the stator if seal clearances are too large,

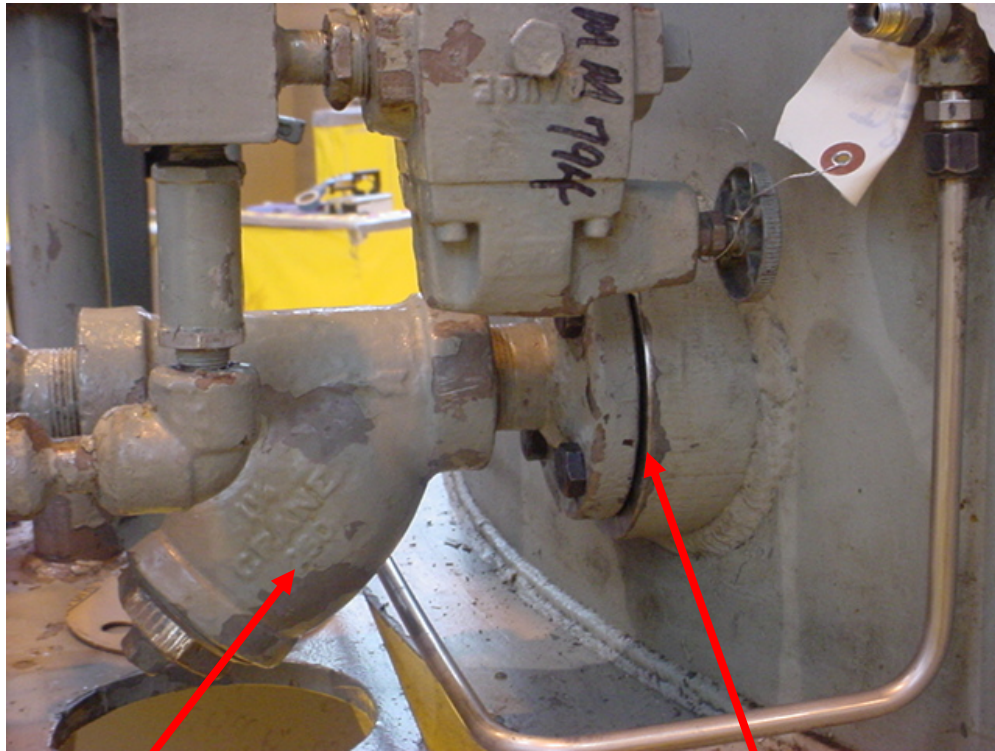
Figure 4-18 Common Leak Paths in the Oil Lift System

The oil lift system (shown schematically in Figure 4-3) consists of many threaded connections which can be the source of oil leakage, especially when removed for maintenance. EPRI Report TR-111413 provides excellent guidance on preventing leaks in lube oil piping systems and can be a resource for dealing with problems in this area (as well as all threaded connections in the lube oil system). Figure 4-18 shows two common leak areas, the flange on the suction line from the bearing oil reservoir and the suction strainer, care should be taken in the installation of these items.

It should be noted that some leak paths are only present during oil lift system operation when the high pressure is applied to the oil lift system piping. Typical operating pressure is around 1200 psi.

Oil Lift System Strainer on
Suction Line

Oil Lift System Suction Line
Flange Gasket to Oil Reservoir

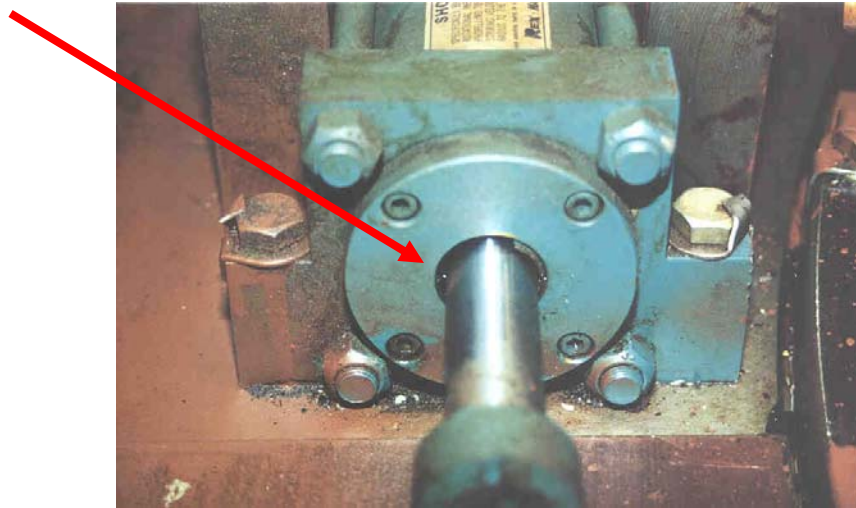
Figure 4-19 Ratchet Plate Shock Absorber

One area that is mistakenly diagnosed as indication of a lubrication system oil leak occurs in the area below the flywheel. The Anti-Rotation Ratchet Plate Shock Absorber can begin to leak oil due to o-ring aging as shown in Figure 4-19.

Ratchet Plate Shock Absorber
O-Ring Degradation
(Potential False Bearing Oil Leak)

These shock absorbers should be replaced during the 10 year refurbishment.

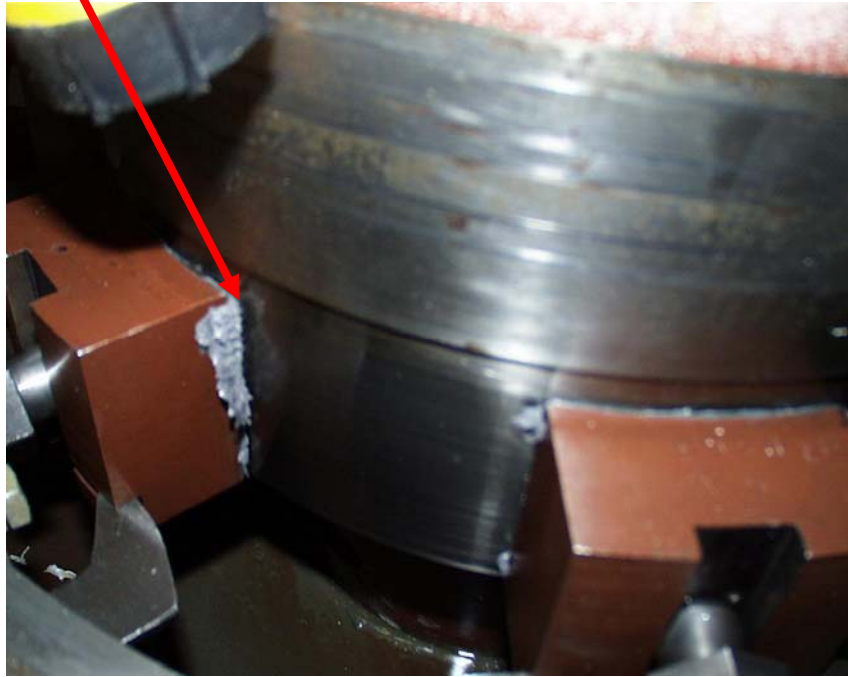
Figure 4-20 Lower Bearing Oil Damage from low oil level

Low oil level in the Lower Bearing Oil Reservoir can sometimes result in the ‘wiping’ of the lower bearing (shown in Figure 4-20). Often times this goes undetected and is discovered during inspection or teardown. Usually this damage is preceded by a bearing temperature spike and a sudden return to normal. Because the upper motor bearing and the hydrostatic bearing in the pump are still functioning, vibration levels remain normal as well. Inspection during a RFO should include the lower bearing if low oil levels have resulted in repetitive low oil level alarms.

Lower Bearing wiping
due to low oil level

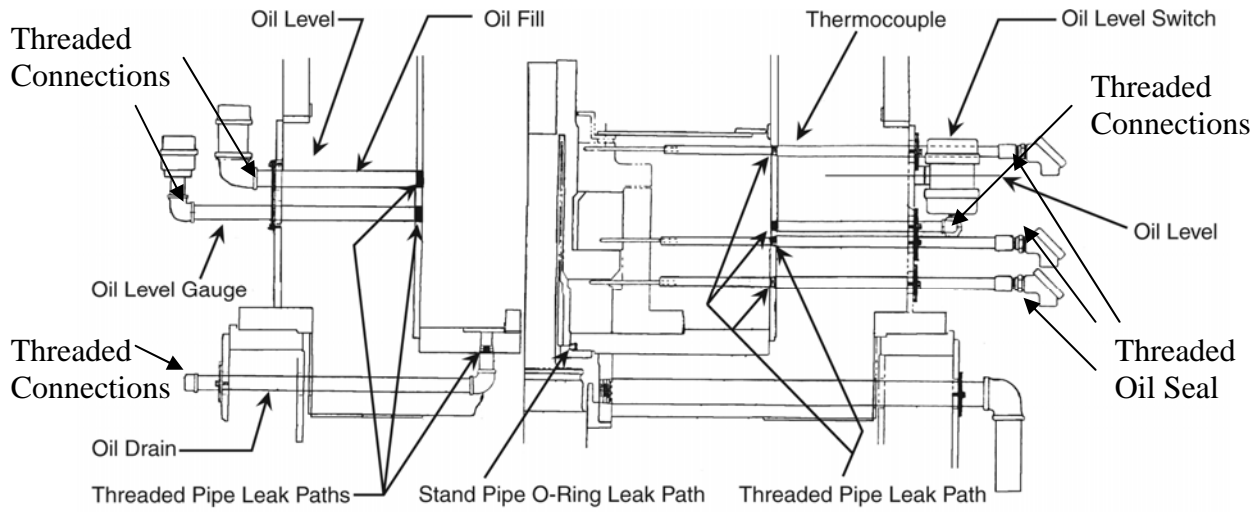
GE Recirc Motor Upper Bearing
 Figure 4-21 GE Motor Upper Bearing

The outline of the upper bearing area of the GE RRP motor is shown in Figure 4-21. The most probable potential leak paths that can result in a lubrication oil leak are shown. Photos of these leak paths are shown in Figures 4-22, 4-23 and 4-24. As can be seen, the majority of the leak paths involve threaded connections.

It should be noted that the threaded pipe connections that enter the oil reservoir are hidden from view due to the motor housing design for the air flow inlet path to the stator.

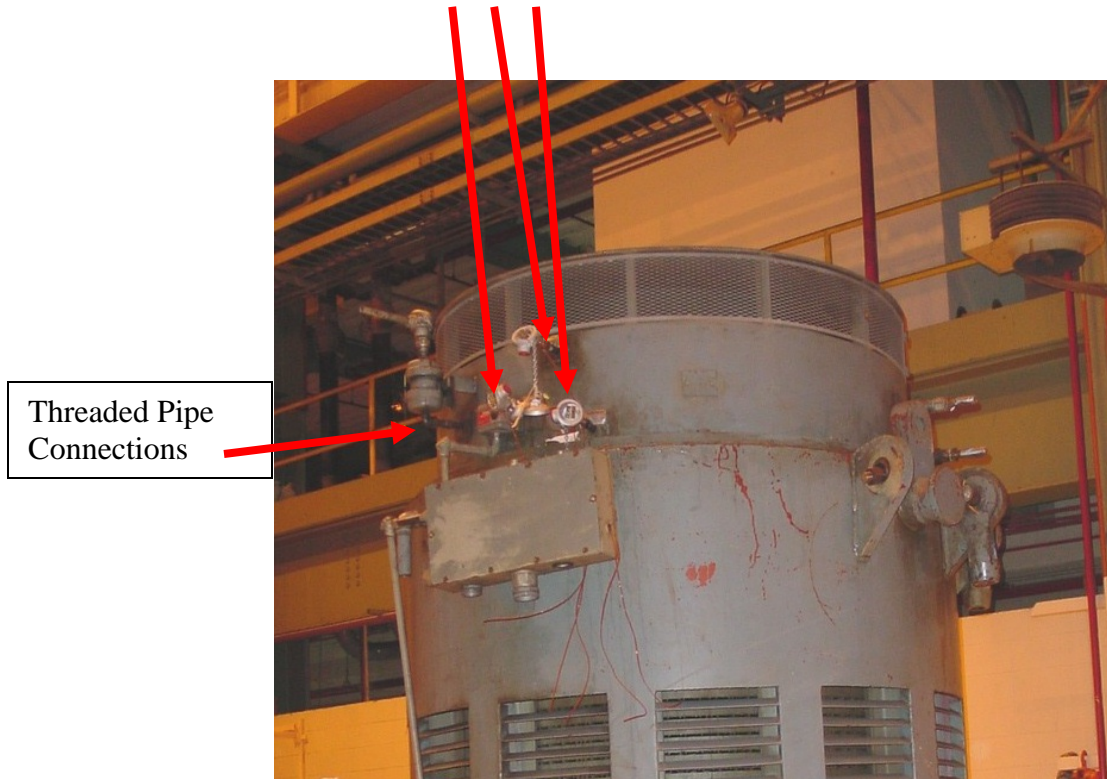
Figure 4-22 Upper Bearing Potential Leak Paths

Photos of these leak paths are shown in Figures 4-22, 4-23 and 4-24.

Upper Bearing Thermocouple
(threaded pipe into oil reservoir—potential leak path)

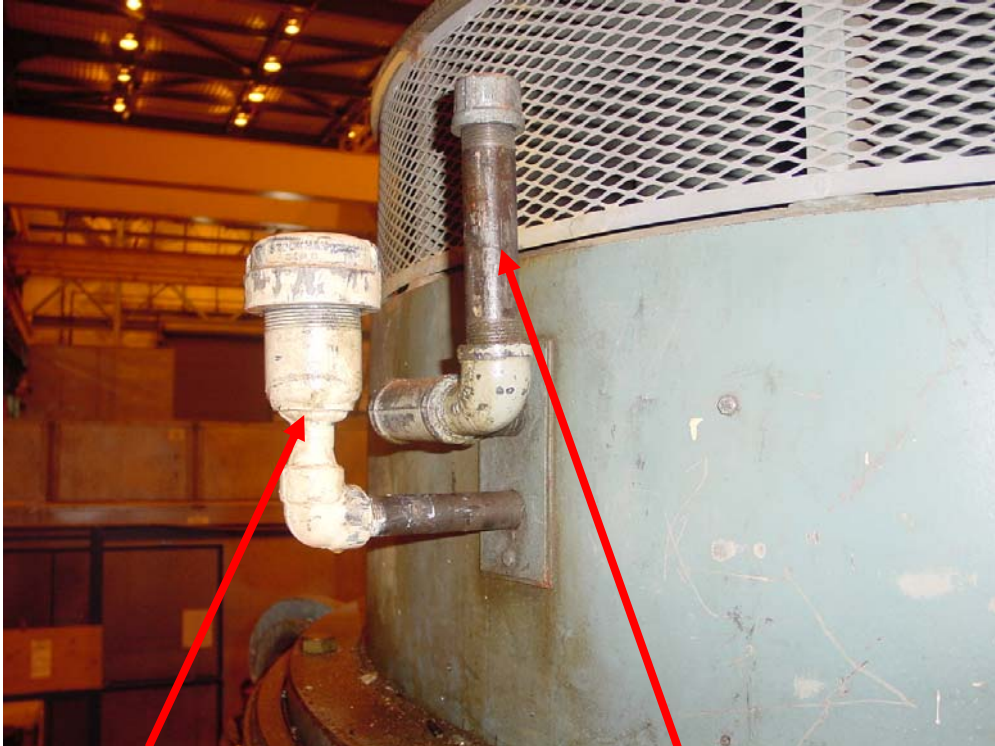
Figure 4-23 Upper Bearing Potential Leak Paths

Upper Bearing Oil Level Gauge
(some have sight glasses)

Upper Bearing Fill Line

(Both are potential leakage paths where they thread into oil reservoir and the external threaded connections)

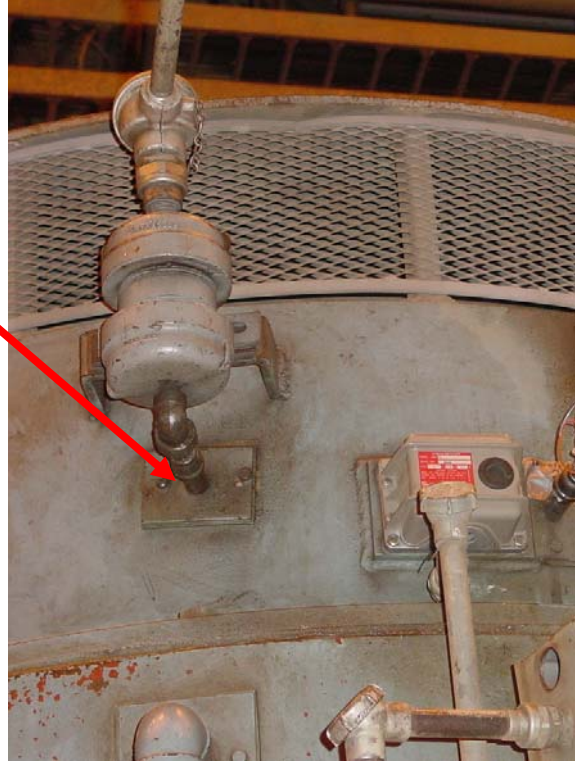
Figure 4-24 Upper Bearing Potential Leak Paths

Upper Bearing Level Switch
Threaded pipe in oil reservoir
Potential leak path where this pipe
threads into the oil reservoir and the
external threaded connection shown
here

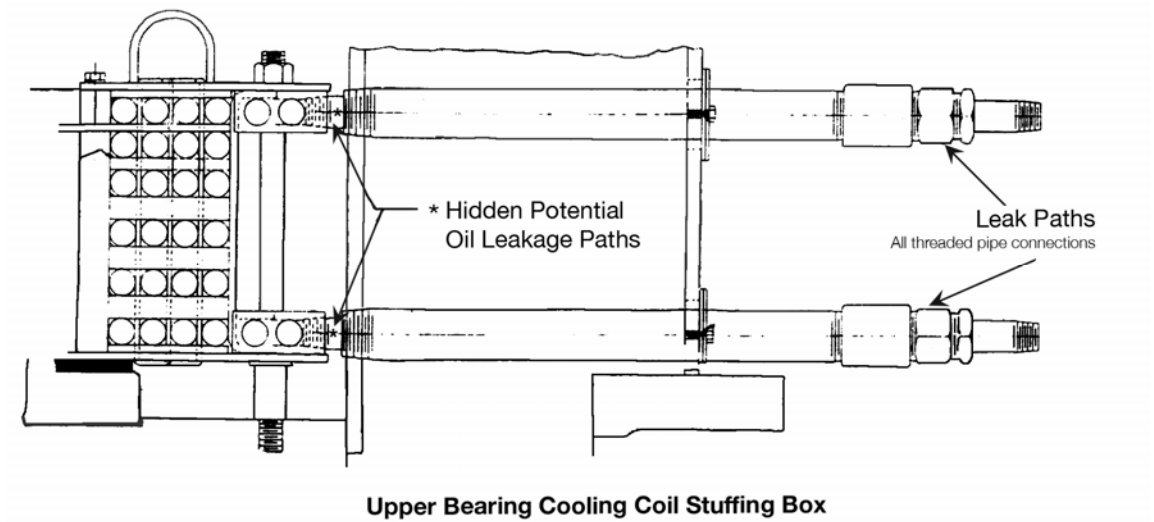
Figure 4-25 Upper Bearing Cooling Water Lines Oil Reservoir Penetrations

A leak path that requires careful attention is the area where the upper bearing cooling water lines penetrate the upper bearing oil reservoir. The seal must be properly installed and is very similar in design to a 'stuffing box' design. See Figure 4-25 and 4-26.

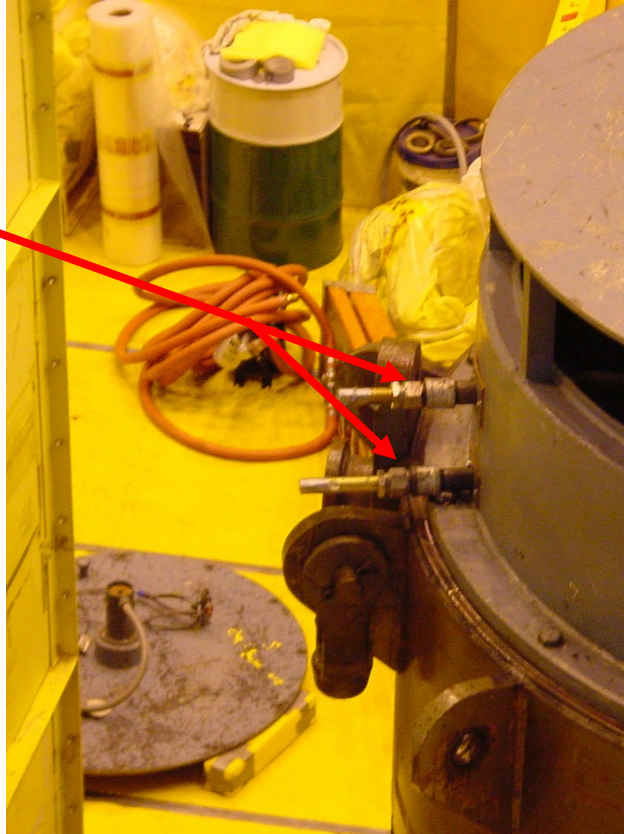
Figure 4-26 Upper Bearing Cooling Water Lines

Upper Bearing Cooler Water Line
Stuffing Box – Oil Seal
