Nuclear Maintenance Applications Center: Reactor Coolant Pump/Reactor Recirculation Pump Motor Lubrication Oil Systems Maintenance Guide

1013456

Technical Update, December 2006

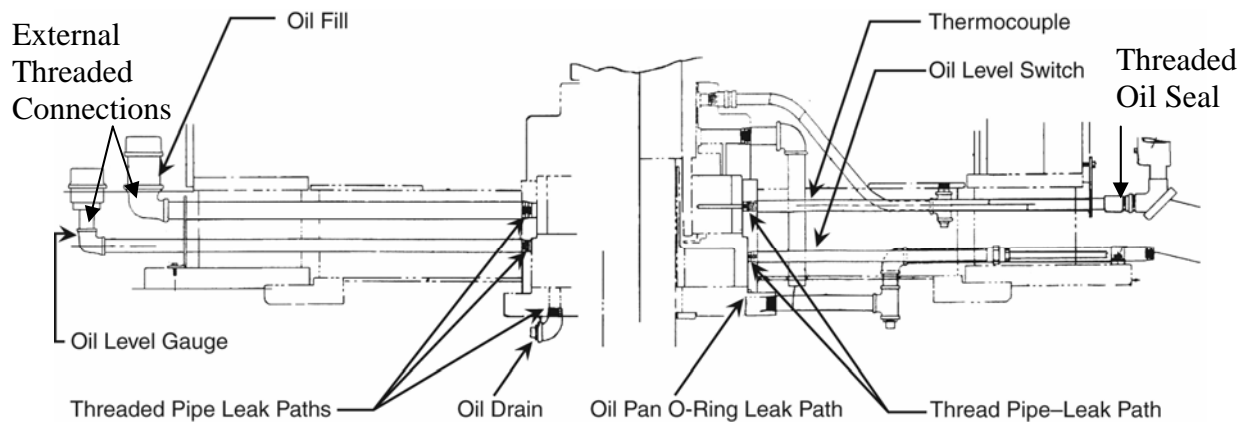
Figure 4-27 Lower Motor Bearing Area

The outline of the lower bearing area of the GE RRP motor is shown in Figure 4-27. The most probable potential leak paths that can result in a lubrication oil leak are shown. Photos of these leak paths are shown in Figures 4-28, 4-29. The majority of the leak paths also involve threaded connections

GE Recirc Lower Bearing

Another potential leak path is the lower bearing oil reservoir lower oil pan. This pan (Shown in Figure 4-27) is sealed with an O-ring and care must be taken for proper installation. One method of ensuring that a good seal is obtained is to use threaded rod to raise and lower the pan evenly in order to properly seal the lower oil pan as shown in Figure 4-30 and 4-31.

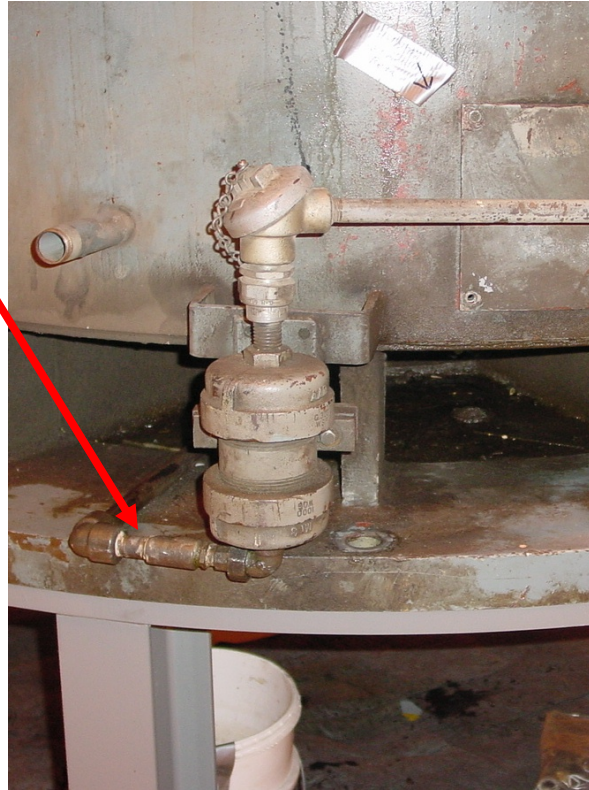
Figure 4-28 Lower Bearing Oil Level Switch

Lower Bearing Oil Level Switch-
Threaded pipe into oil reservoir
potential leakage path and external
threaded joints shown

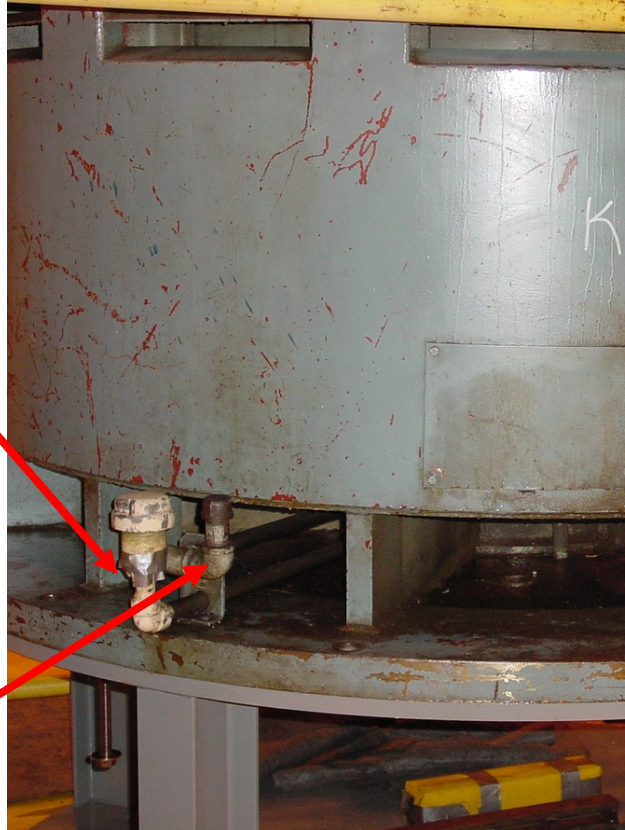
Figure 4-29 Lower Bearing Potential Leak Paths

Lower Bearing Oil Level Gauge
Threaded pipe into oil reservoir
leak path and external threaded
joints shown in this photo

Lower Bearing Oil Fill Line
Threaded pipe into oil reservoir
leak path and external threaded
joints shown in this photo

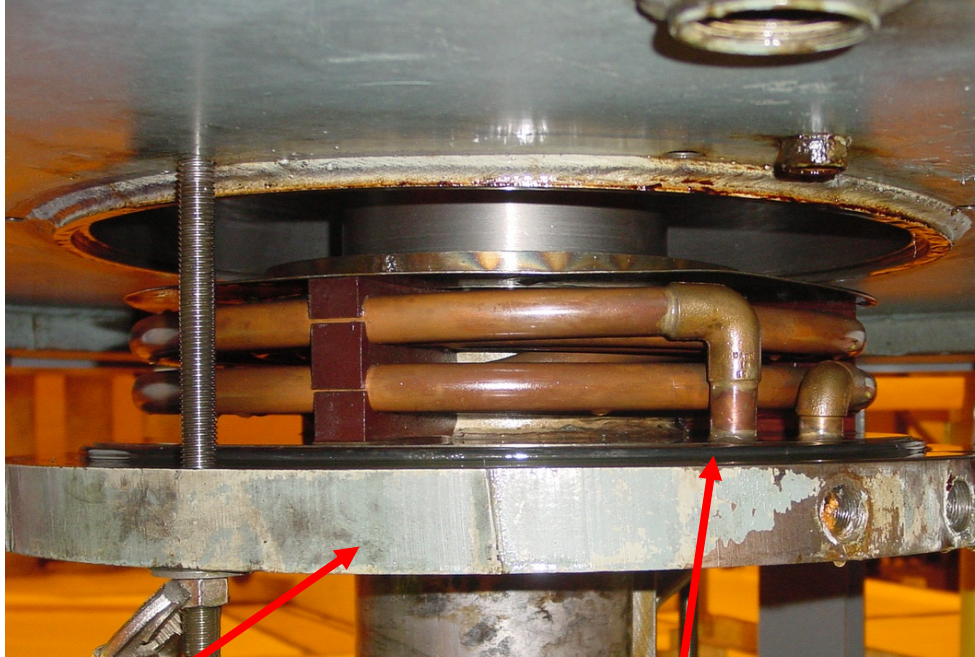
Figure 4-30 Lower Bearing Oil Pan Being Installed

Lower Bearing Oil Pan

Lower Bearing Oil Pan O Ring
Leak path

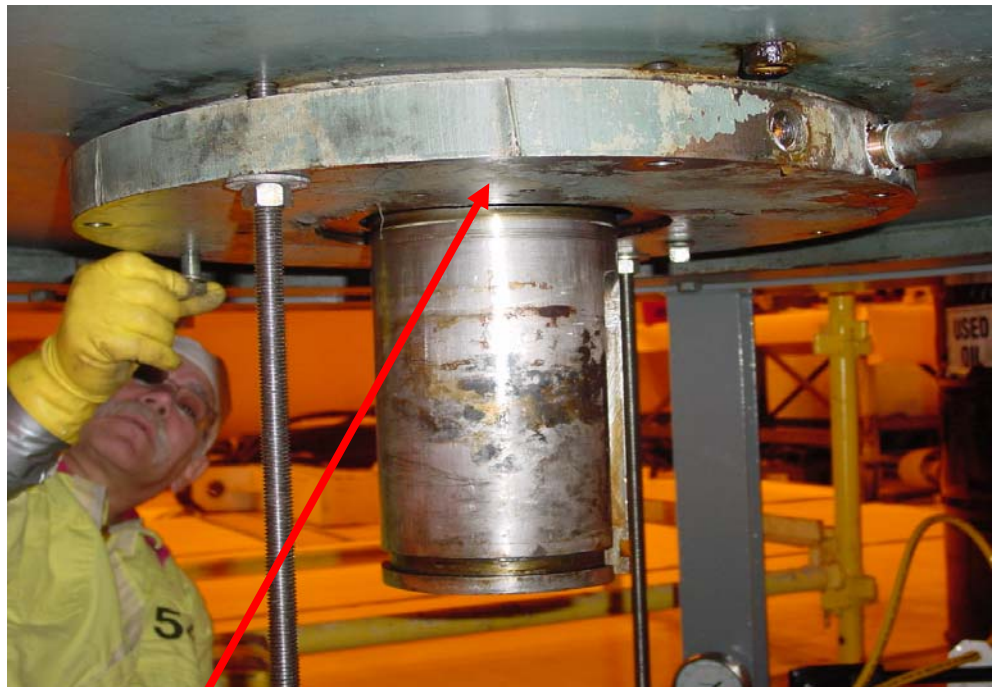
Figure 4-31 Lower Bearing Oil Pan Being Installed

Lower Bearing Oil Pan
