# **HRSG Repair Welding Technologies to Address FAC in Tube Bends**

1014301

Technical Update, March 2008

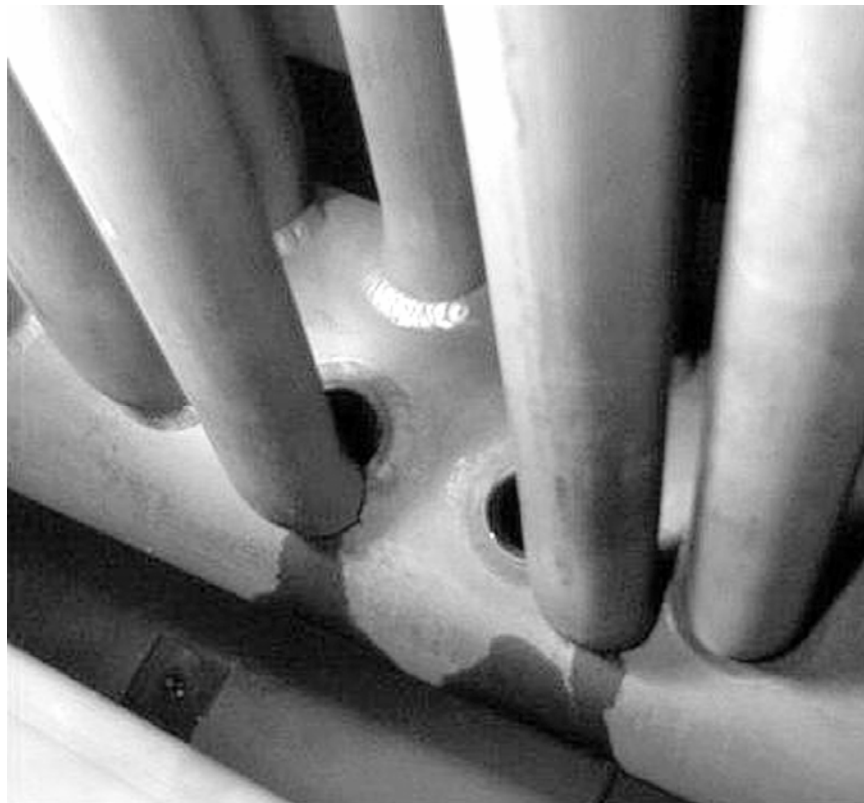
**Figure 3-1**  
**Failed HRSG Tube at the Header Location**

One form of repair identified during the preparation of the EPRI report, *HRSG Material Selection and Repair Guidelines* (1004875), was tube-to-header attachment repair (see tube failure at header location in Figure 3-1). Due to limited access, this form of repair is often more difficult to perform than conventional tube repairs. A photograph of several tube-to-header attachments, shown in Figure 3-2, reveals the complexity and limited access of such repairs, particularly those that may be buried deep within the bundle. As a result of access limitations, tube failures are often left in place and simply plugged. Figure 3-3 provides an example of a plug-weld configuration. Plugging requires 1) removing a window within the header 180 deg away from the stub tube attachment location, 2) machining and inserting a plug into the damaged tube bore, 3) welding the plug into place, and 4) reinstalling the window.

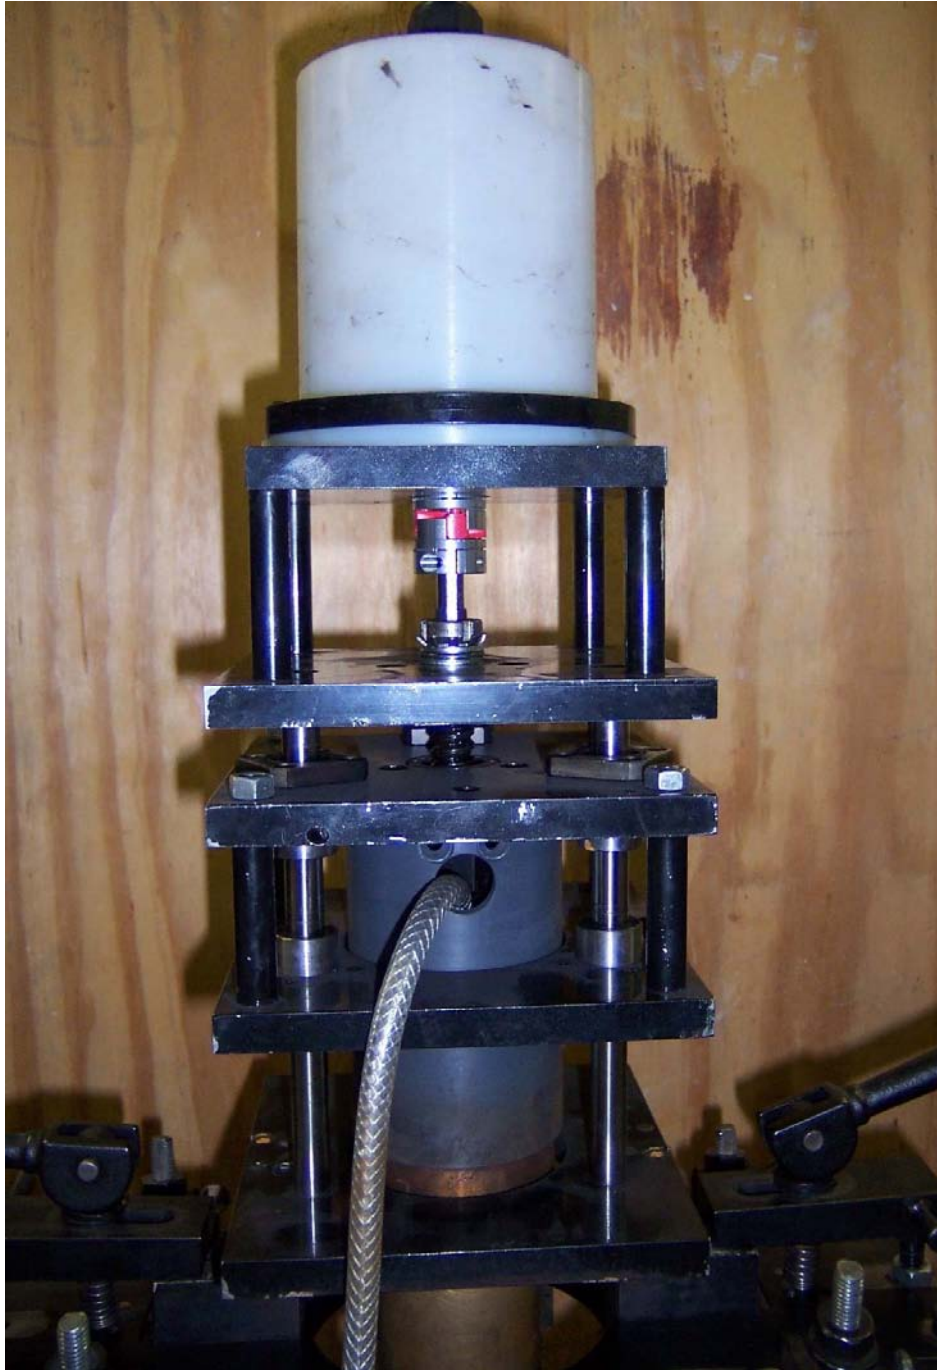
**Figure 3-6**  
**A contoured EDM profile device is used to remove the damaged header-to-existing weld.**

In the previous approach used for removal of the damaged header to weld attachment region, a machining device was employed (Report 1010441). The machining approach generated a considerable amount of machining chips and concerns about leaving chips inside the header or in the tube were expressed. To eliminate this concern, the EDM head developed for Step 1 is utilized to also remove the header-to-existing weld attachment and is positioned 180 degrees from the access hole. This is accomplished using a smaller profile device than was used for the “access hole” in Step 1. The device is shown in Figure 3-6.

The device creates a penetration in the header that is slightly oversized (0.125 inches) over the original tube size. This facilitates insertion of a slightly oversized stub tube later in Step 12 and removal of the elbow through the header ID in Step 7.

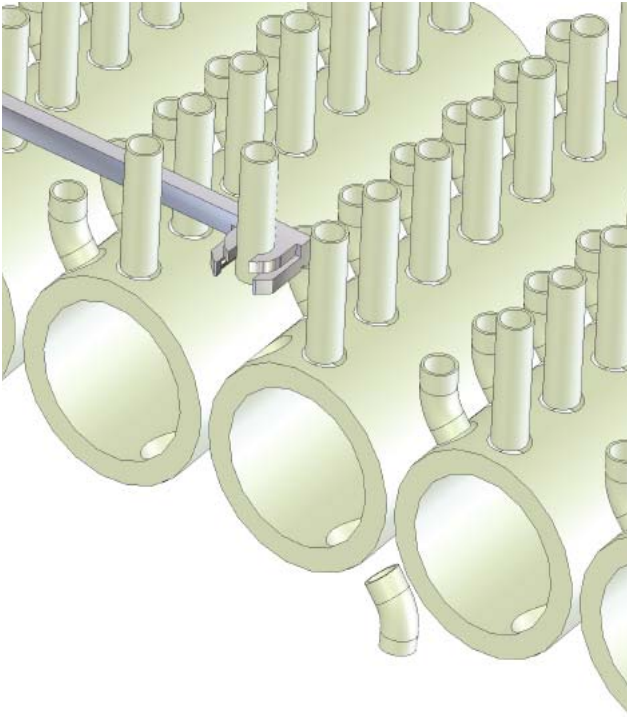
**Figure 3-13**  
The replacement elbow is inserted through the header access window.

Step 9 of the process involves insertion of a new replacement elbow. This is accomplished once again from the inside of the header. The tube can be inserted through the access hole and then through the “over-bored” hole wherein the stub tube will be inserted later in Step 12. Insertion of the new replacement elbow is shown in Figures 3-13 through 3-15.

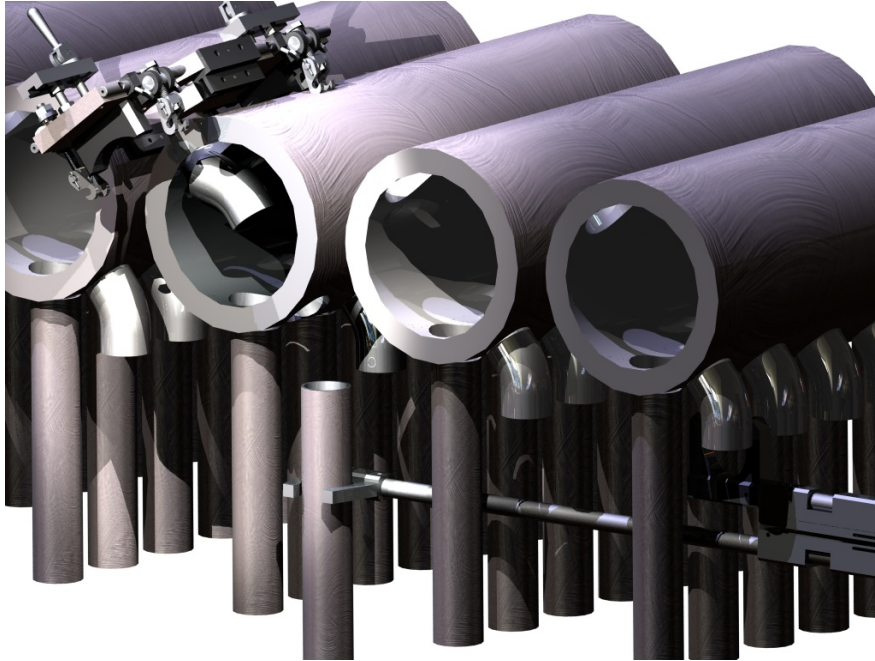
**Figure 3-15**

**Continuing on from Figures 3-13 and 3-14, the replacement elbow is inserted through the “over-bored” hole where the stub tub will be inserted in Step 12.**

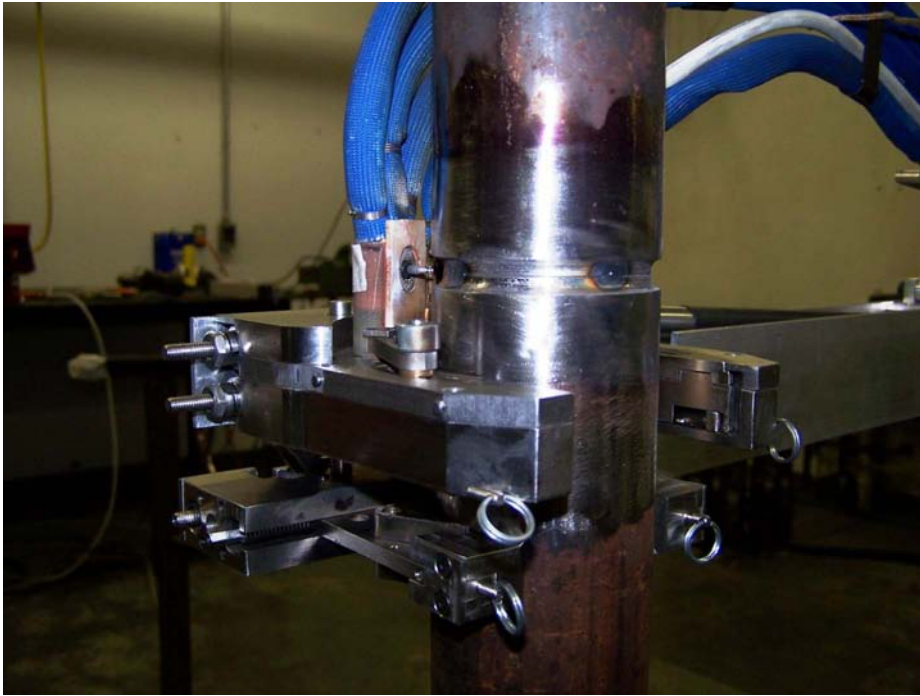
**Figure 3-19**  
**Another view of the C-Frame welding approach used for CANDU reactor tubing.**

The current equipment as shown in Figure 3-18 through 3-20 is being modified to address somewhat more confined spaces and smaller diameter tubing than was encountered for the CANDU tubing applications.

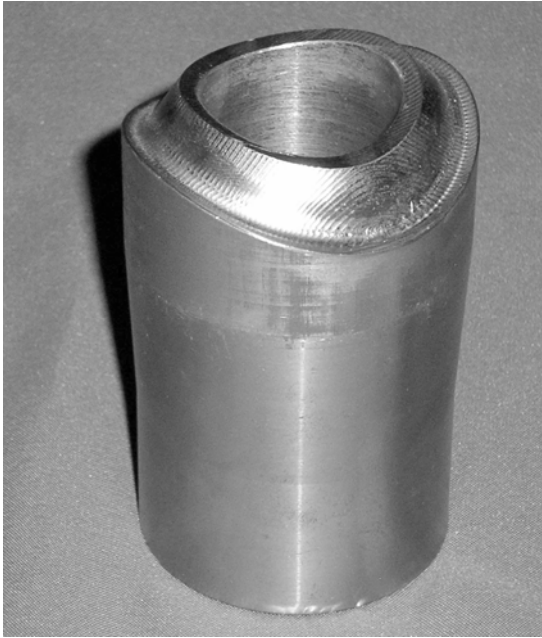
**Figure 3-22**  
**Upper Profile of Tube Fabricated to Match Contour of Header ID**

Step 12 involves insertion of the new, slightly larger, stub tube through the header (at the attachment location) until it contacts and is slid over the new elbow section. The stub tube is designed with a recess (or female) receptor on the tube end which acts similar to a backing strip during welding that occurs in Step 13 (Figure 3-21 and 3-22). The stub tube is identical to that described in Report 1010441 for straight tube. Figure 3-23 shows the insertion of the stub tube, while Figure 3-24 shows the tube being inserted over the elbow.

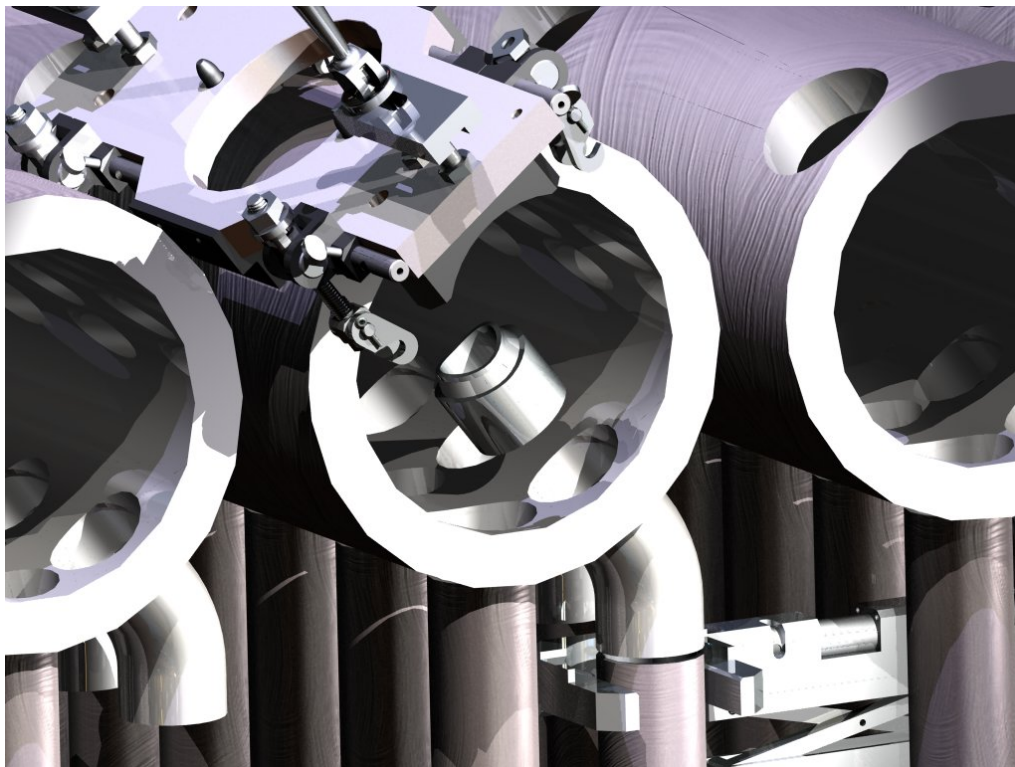
**Figure 3-23**  
**Insertion of the new oversized stub tube.**

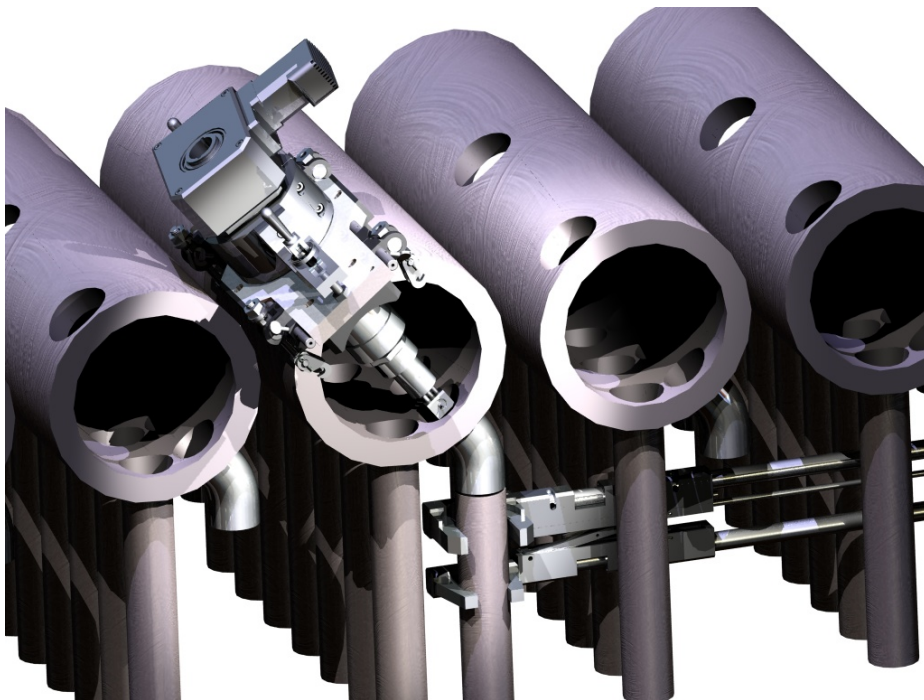
**Figure 3-26**

**A closer view of the schematic shown in Figure 3-25.**

The elbow-to-stub tube weld is accomplished using a new, more compact ID welding system compared with the one described in EPRI Report 1010441. The device can be used for either straight tube-to-tube welds or for elbow-to-stub tube welds. The device is shown schematically in Figures 3-25 and 3-26.

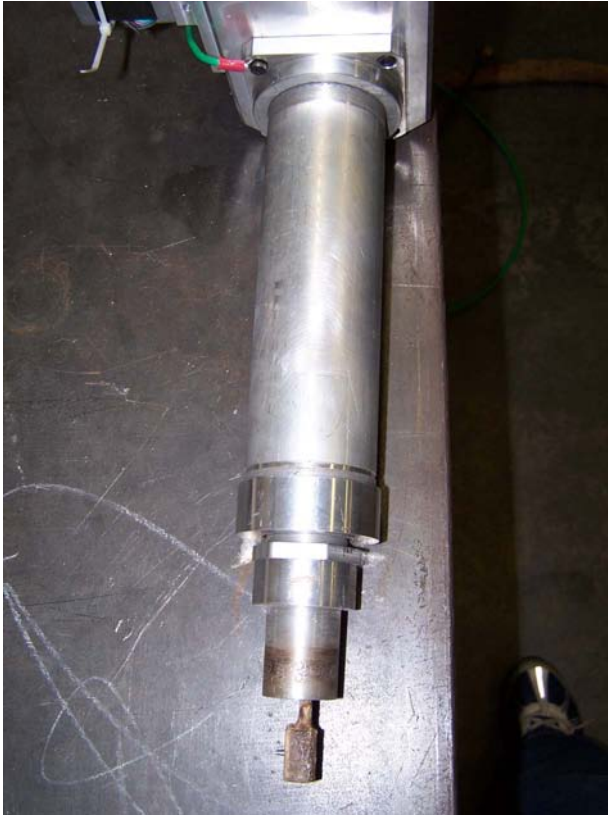
**Figure 3-27**

**ID Tube Welding Head.**

Two photographs of the actual ID welding device are shown in Figures 3-27 and 3-28. Figure 3-29 provides a cut-away view of a tube welded with the ID welding device. To date, >25 welds have been made with the ID welding device demonstrating its consistency.

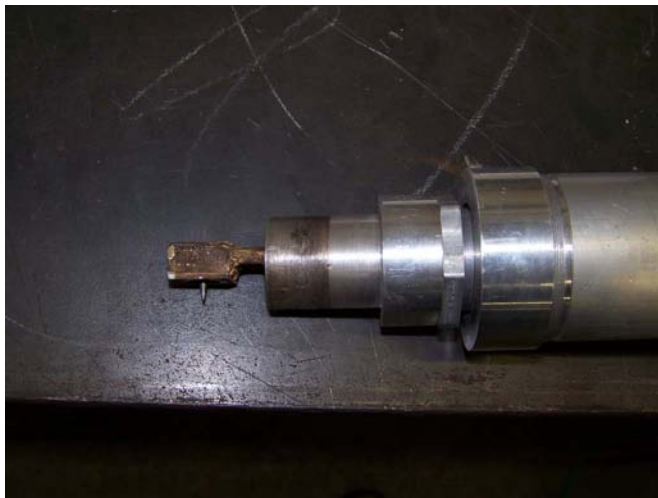
**Figure 3-28**

**A closer view of ID Tube Welding Head shown in Figure 3-27.**

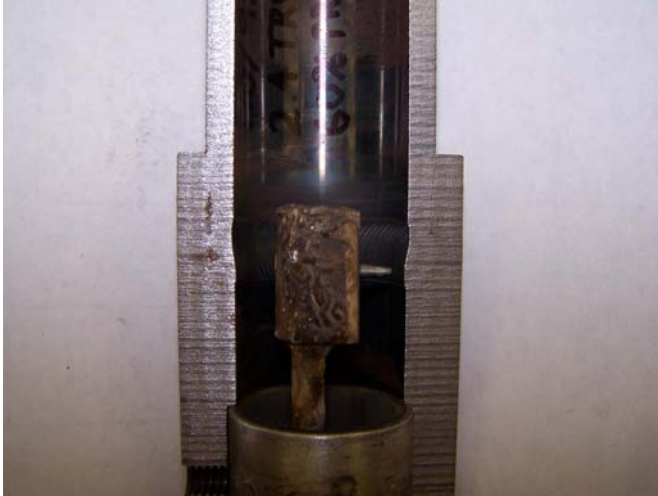
**Figure 3-29**

**The ID Tube Weld Head Is Shown Inserted Into a Cut-away of a Tube (top) to Stub Tube (bottom) Mockup. Tube Diameter is 1-1/4 inches.**

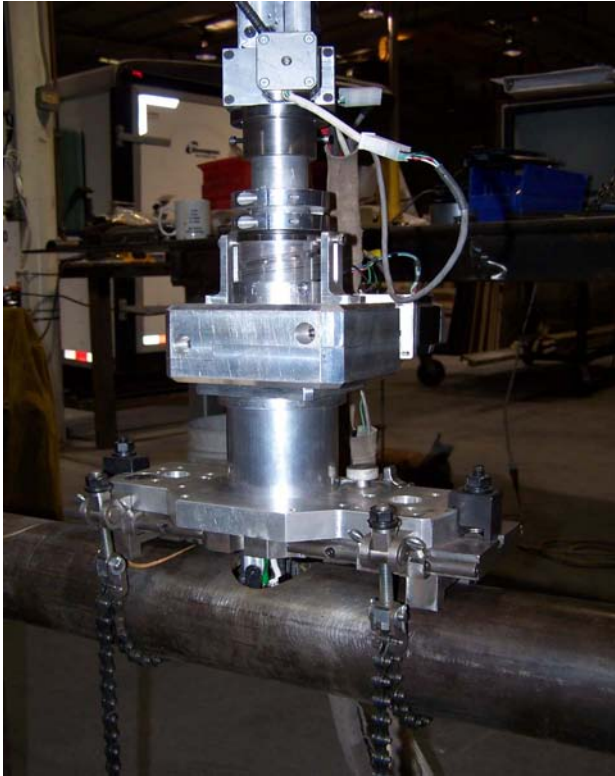
**Figure 3-32**  
**Header-to-stub tube welding device inserted into a header.**

The third welding step in the process utilizes the device shown schematically in Figure 3-31. The actual welding device is shown mounted onto a 4-inch diameter tube in the shop (Figure 3-32). The welding device is approximately 21 inches tall and mounts directly into the saddle fixture described earlier. A schematic of the weld head is shown in Figure 3-32.
