Evaluation of Medium-Voltage Cable Joints

New and Modified Single-Phase Cold Shrink and Separable Connector Cable Joints

Technical Report

Final Report, September 2006

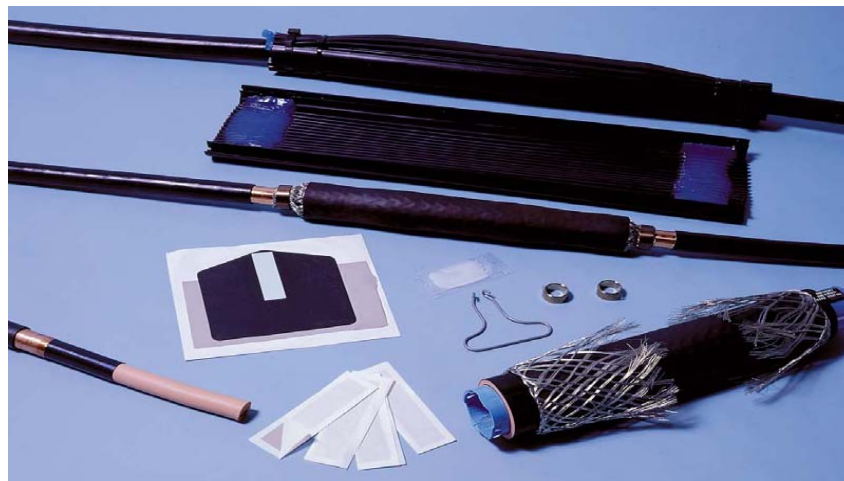
Components of the Tyco cold shrink joint are shown in Figure 5-1.

Figure 5-1
Components of Tyco Cold Shrink Joint

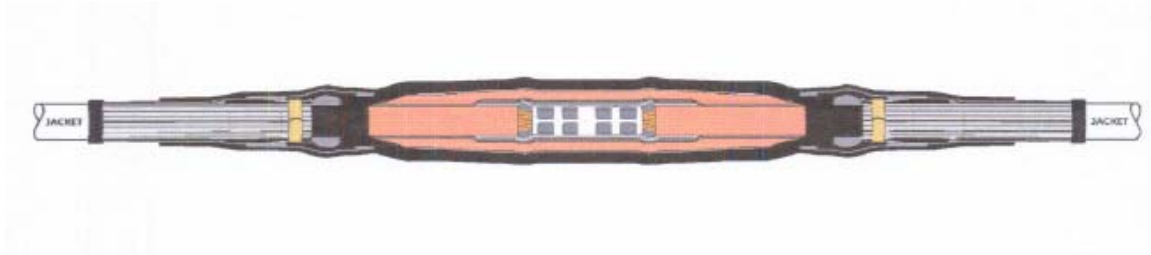
A cross-sectional diagram of the Pirelli cold shrink joint is shown in Figure 5-2.

Figure 5-2
Pirelli Cold Shrink Joint

The bond between the two carrier tubes that support the housing is broken by two wrenches turned in opposite direction. The short section of the carrier tube is expelled first and part of the joint sleeve is collapsed over the exposed cable. The distance of 1 inch between the edge of the sleeve and the cable jacket cutback is verified. As the blue straps are cut, the second (longer) section of the carrier tube is released and the joint sleeve is collapsed on the other end.

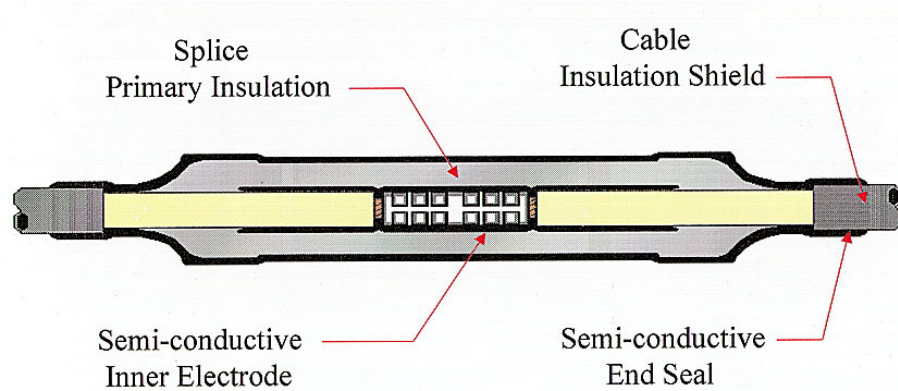
A cross-sectional diagram of the 3M cold shrink joint is shown in Figure 5-3.

Figure 5-3
3M Cold Shrink Joint

The cold shrink joint is positioned over the connector area, aligning its end at the center of a previously applied marker tape and installed by unwinding the loose core end. The joint body ends must overlap onto the insulation shield of each cable by at least 0.5 inches.

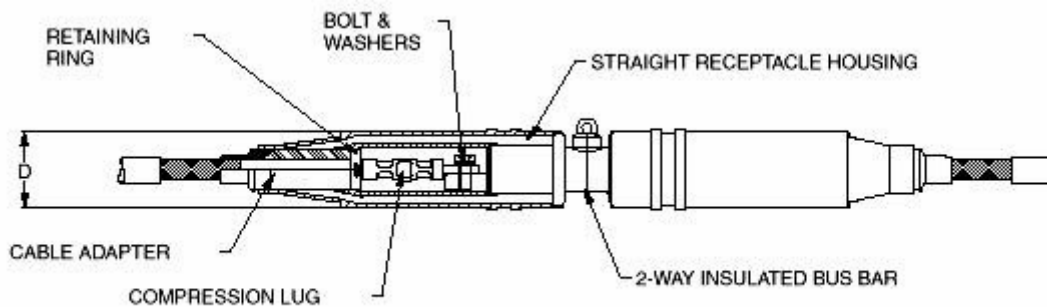
A cross-sectional diagram of the Elastimold separable connector joint is shown in Figure 5-4.

Figure 5-4
Elastimold "I"-Type Separable Connector Joint

The third sealing mastic strip is applied following the two layers of vinyl tape around the cable insulation shield, next to the receptacle housing ends. The cold shrinkable sealing tubes are installed at the ends by pulling and unwinding the loose core in clockwise direction. The tube must overlap the joint end at least 1 inch for a proper seal.

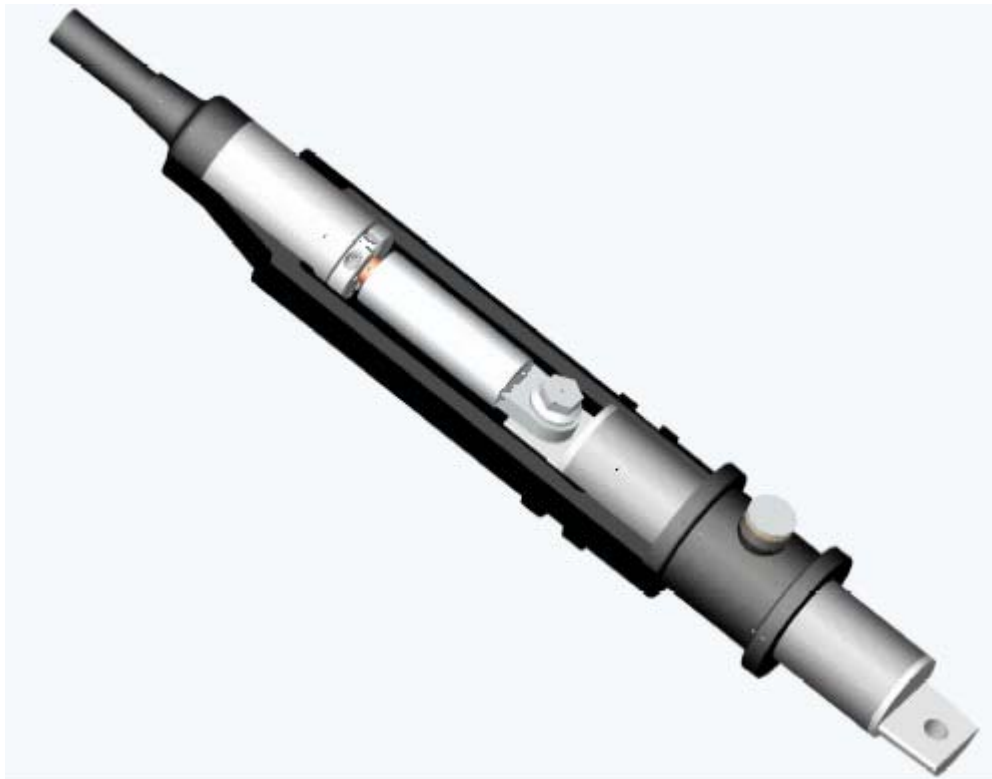
Figure 5-5
Richards “I”-Type Separable Connector Joint

The assembly aid is removed. An EPR tape bumper (replacement for the retaining ring) is installed in front of the cable adapter on each end.

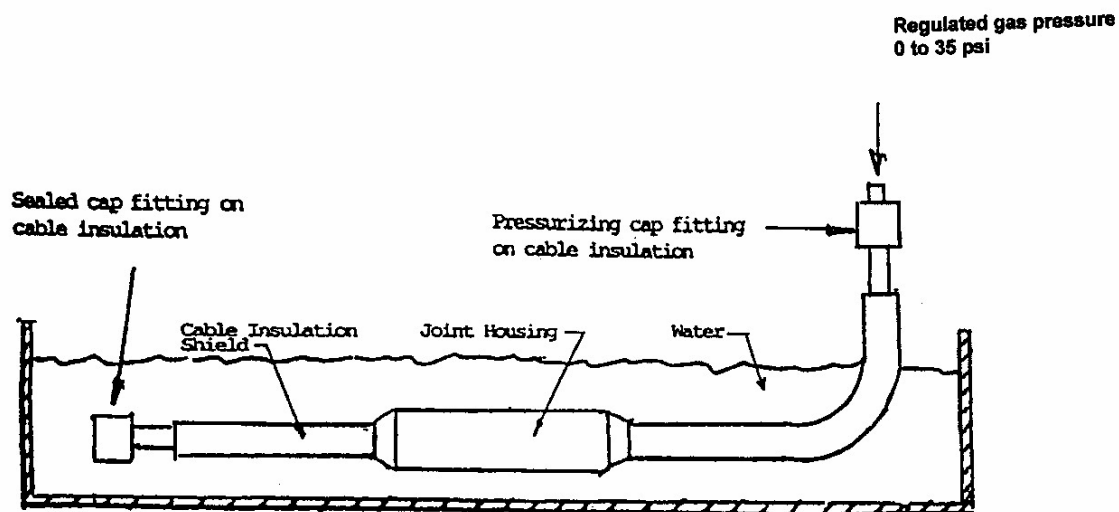
An interface gas pressure test was performed as shown in Figure 6-1 on cold shrink joints to determine the ability of the joints to withstand internal pressure without venting. If the joint vents at relatively low pressures, environmental water and contaminants could gain ingress to the cable/joint interface resulting in electrical failure. This test was performed initially and after heat cycling tests.

1. Seal far end of cable.
2. Immerse cable with joint in water.
3. Apply gas pressure in 5 psig increments up to 35 psig. At each increment hold pressure for five minutes.
4. Observe joint ends for gas leakage.

Figure 6-1
Interface Gas Pressure Venting Test

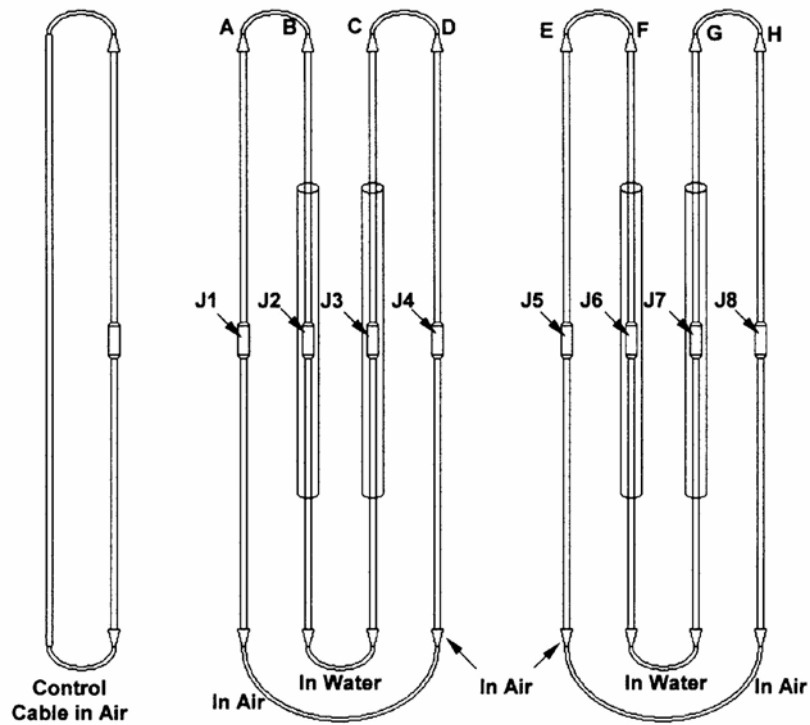
The eight joints and corresponding cables were set-up for heat cycling, as shown in Figures 6-2 and 6-3. They were divided into two groups, each constituting a separate heating circuit. Each circuit consisted of four joints and corresponding cables, two in air and two in water. In one of the circuits, one joint in air and one in water were installed misaligned to create a condition simulating displacement of the cable from the horizontal position of the joints. The four joints to be tested in water were installed in individual six inch diameter PVC pipes, having at the ends 90 degree elbows joined to the straight section with rubber reducers. They were submerged to a depth of one meter of water, measured from the top surface of the joint.

Figure 6-2
Heat Cycle – Conductor Connection for Circulating the Same Current Through all Joints.

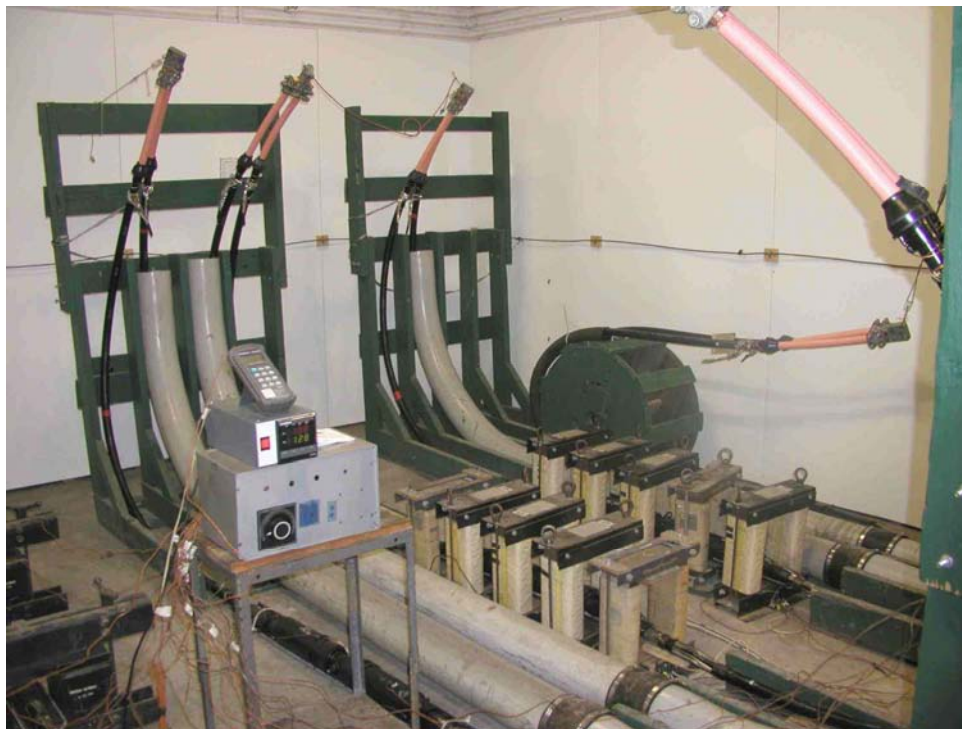
Figure 6-3
Laboratory Setup for Heat Cycling Tests.

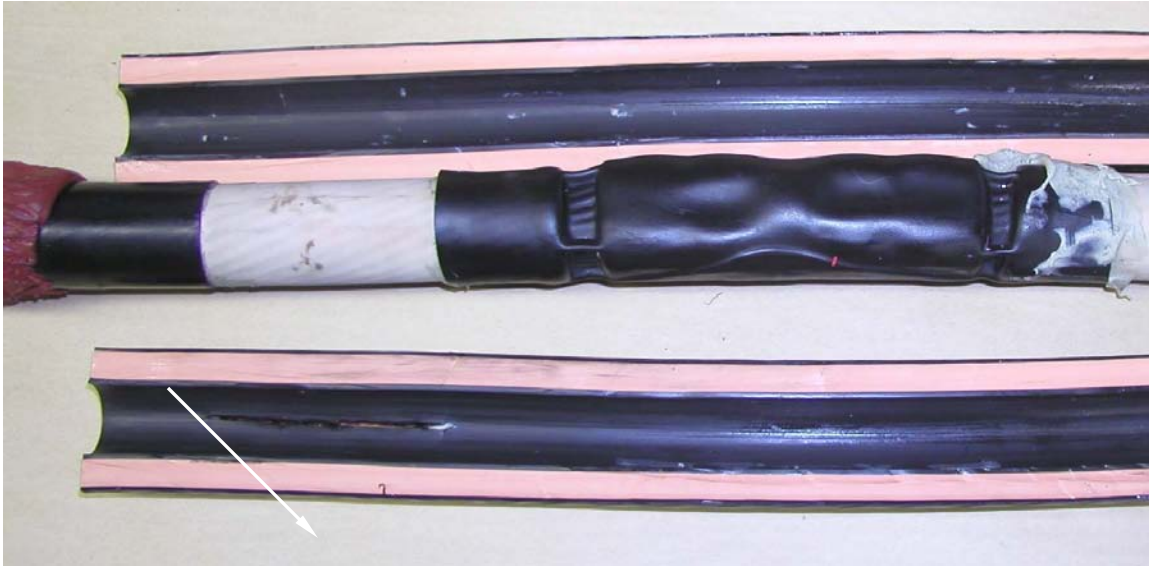
Table A-15 provides the results of dissection of the eight joints after tests. The four joints that had been aged in air broke down radially starting at or very close to the cutback insulation shield. In Joint T8, which failed at 56 kV, the failure originated from a cut into the insulation. Of the four joints aged in water one also failed radially, next to the edge of the insulation shield, while the other three broke down longitudinally at the interface between the cable insulation and the inner layer of the joint body.

Figure A-1
Longitudinal Failure in Joint T7.

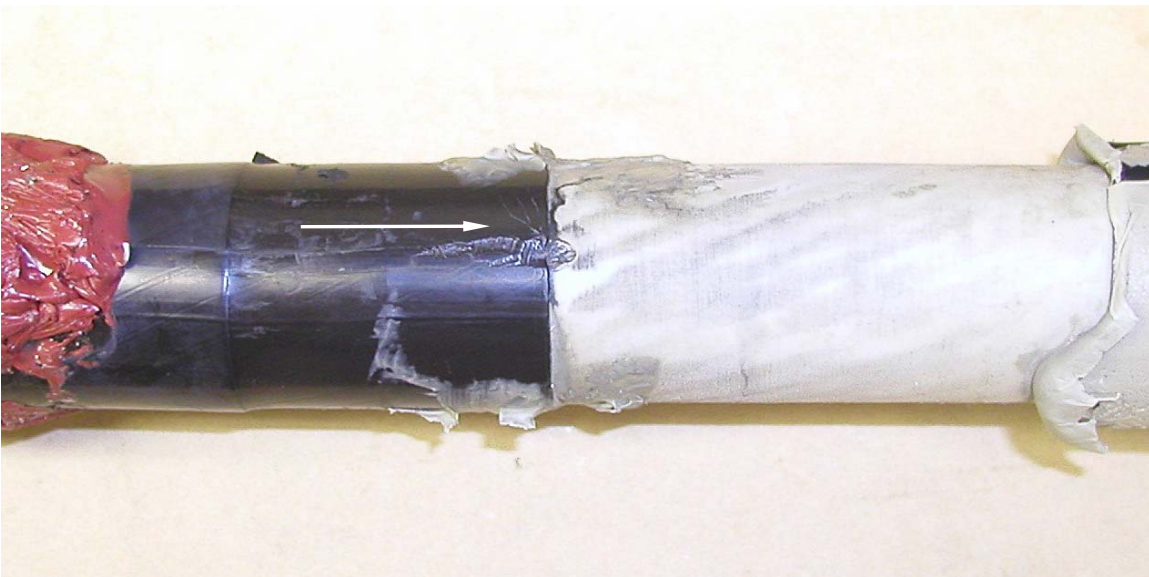
Figure A-2
Failure in Joint T4. Failure at the Edge of the Cable Insulation Shield.

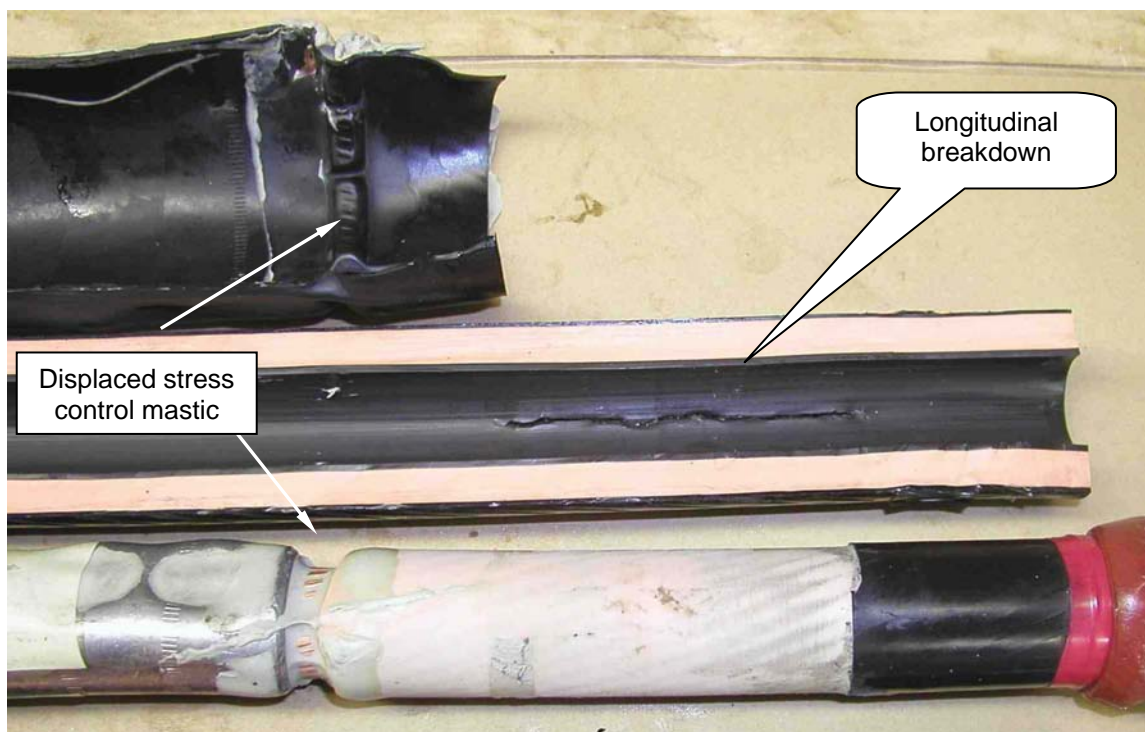
In several of the joints the field control mastic, applied at the end of the insulation shield and in the gaps at the connector (under the two-layer patch), had spread over the cable insulation surface. Apparently the high temperature, during heat cycling, softens the mastic causing its redistribution under the high radial hoop stresses generated in the insulation of the cold shrink sleeves. No negative effect of this redistribution was noted.

Figure A-3
Longitudinal Failure in Joint T6. Note Displaced Stress Control Mastic.

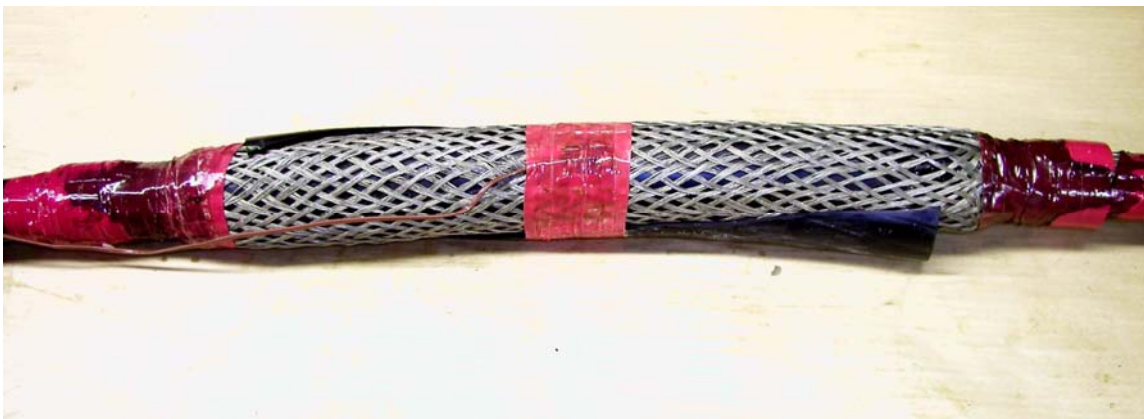
It was also found that in two of the joints heat cycled in air the outer non-conductive sleeve (over the metallic shield) had split longitudinally, apparently during heat cycling. When assembling the joints, a thermocouple attached to a thin copper plate (with sharp edges) was placed on the outside of this sleeve, on each joint. Taking into account the thermal expansion of the joint body under the elevated temperature conditions, it is possible that these sharp edges could have cut the sleeve. The joints aged in water had a better cooling and did not show the sleeve splitting.

Figure A-4
Split Outer Sleeve of Splice Body in Joint T1 (Heat Cycled in Air).

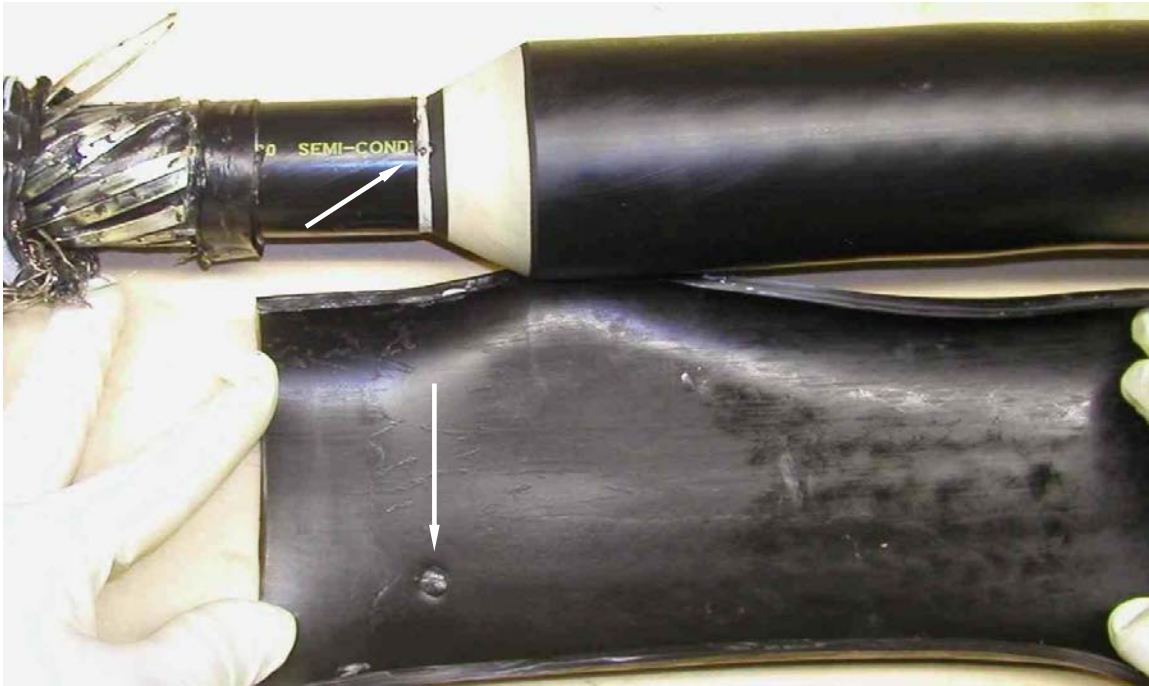
Table B-15 provides the results of dissection of the eight joints after tests. All failures consisted of radial breakdowns occurring very much in the same area, where the outer semiconducting sleeve bridges over the cable extruded insulation shield. Of the four joints aged in air three (Joints P1, P5 and P8) failed at or very close to the cutback insulation shield. In Joint P4, which failed at 36 kV, the failure originated from a cut into the insulation that, most likely, was made during cable preparation. In Joints P2, P6 and P7 (aged in water) breakdown took place between the edge of the inner high permittivity layer and the insulation shield cut back. Figures B-1 through B-3 illustrate the breakdown of these three joints.

Figure B-1
Joint P5. Radial Failure next to the End Step in Insulation Shield.

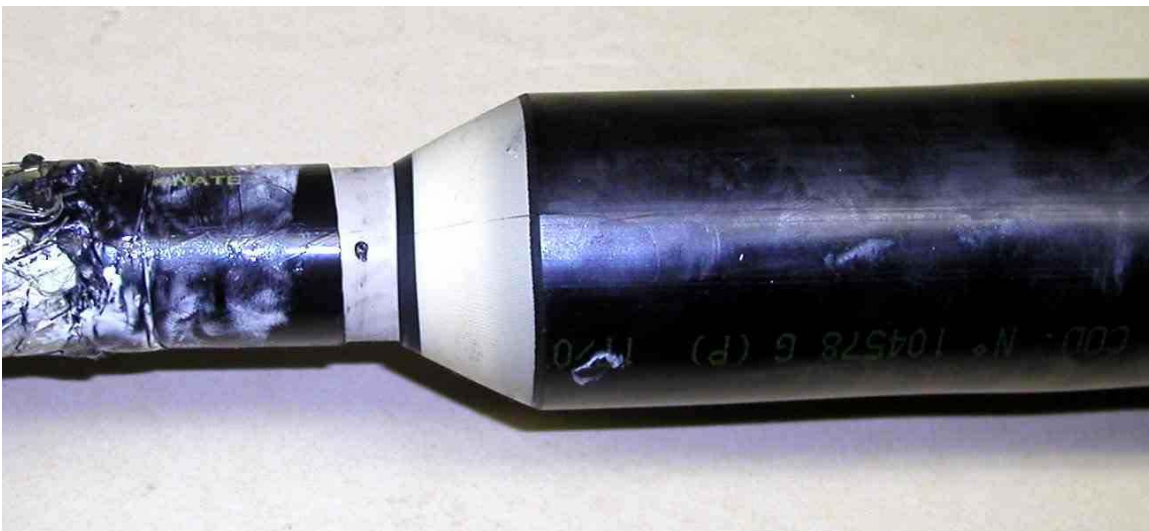
Figure B-2
Joint P2. Radial Failure at 150 Mils from End of Insulation Shield.

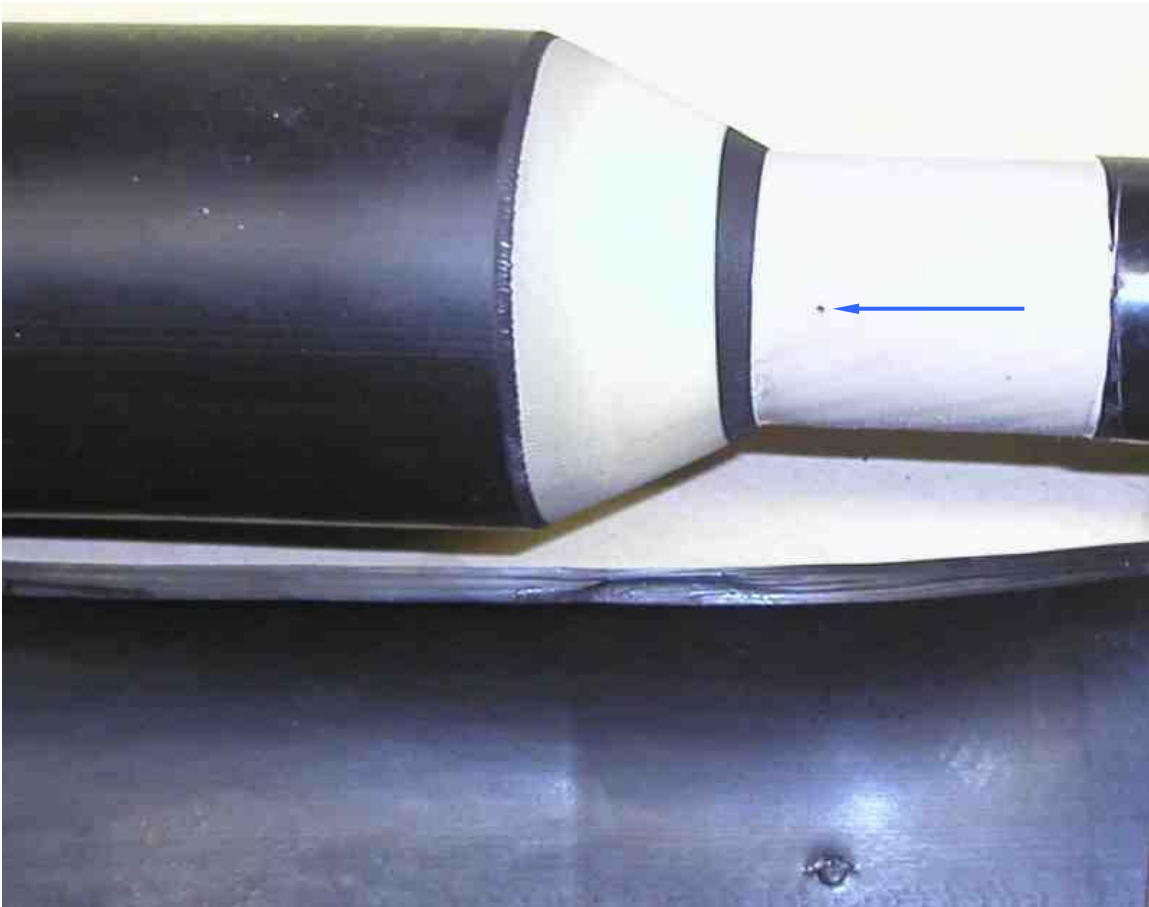
Figure B-3
Joint P6. Radial Failure at About 300 Mils from Inner Layer of Joint Body.

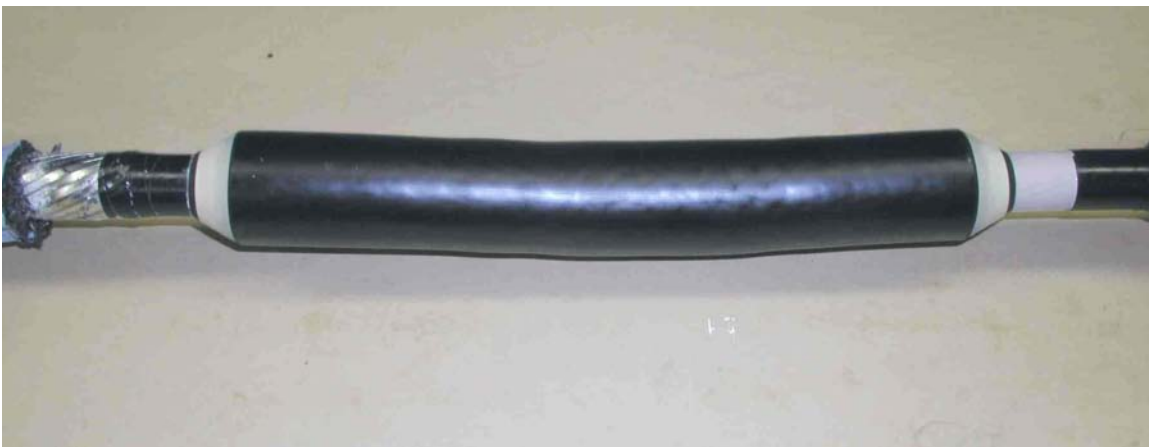
Most of the joint components are incorporated in one package.
High permittivity mastic pad and mastic strips are convenient to use.
Special care is required to assure tight contact between the outer semiconducting sleeve, that extends over joint body and cable insulation. This is achieved by applying a rubber tape (supplied) over the joint ends.
Some effort is required to unfold the joint jacket.
AC breakdown levels for joints heat cycled in air and in water are similar.
Dissection of the joints after test completion indicated that some of the joint bodies had not been properly centered.
The joint kit used in the tested joints may not have been the most suitable for the cable used in the project. This plus the relatively high effort to pull the joint jacket into place may have contributed to the displacement of the joint body.

Figure B-4
Joint P6. Joint Body Not Properly Centered

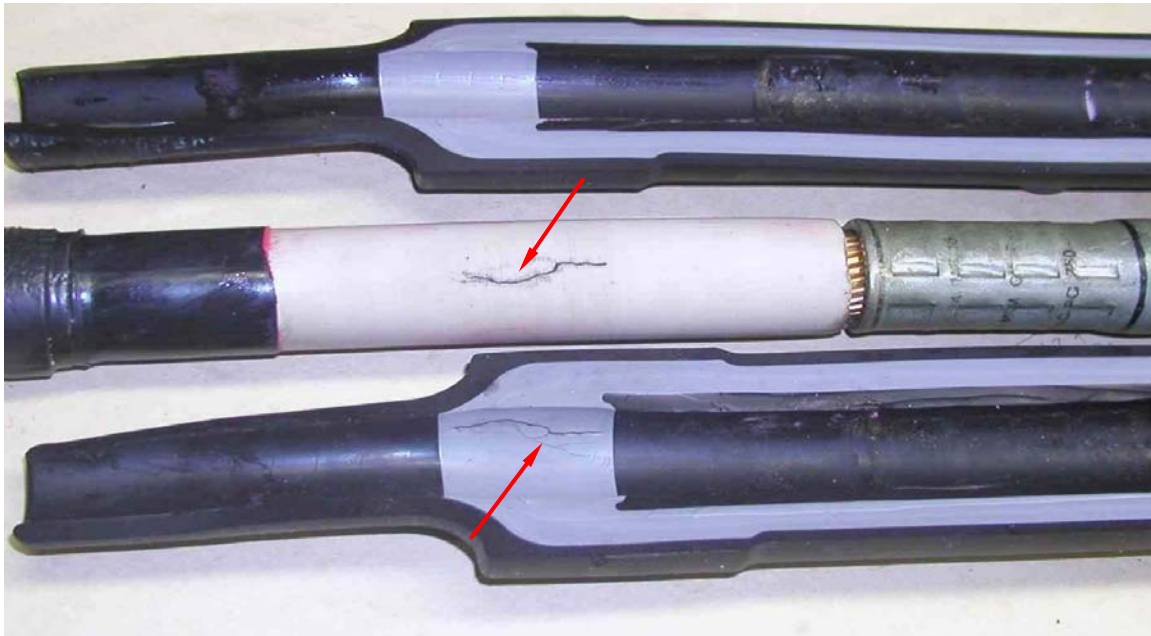
It was established that of the four joints aged in air one (3M1) failed longitudinally, at the interface between the joint and the cable. Two (3M5 and 3M8) failed at or very close to the cutback insulation shield. In Joint 3M4 the failure occurred at the center of the connector. Of the joints aged in water one breakdown took place at the middle of the connector (Joint 3M2), one at about 0.5 inches from the insulation shield cut back (Joint 3M3). In Joints 3M6 and 3M7 failures occurred next to the edge of the connector. Illustrations of some of these failures are provided in Figures C-1 through C-4.

Figure C-1
Joint 3M1. Longitudinal Failure at the Interface Between Joint and Cable.

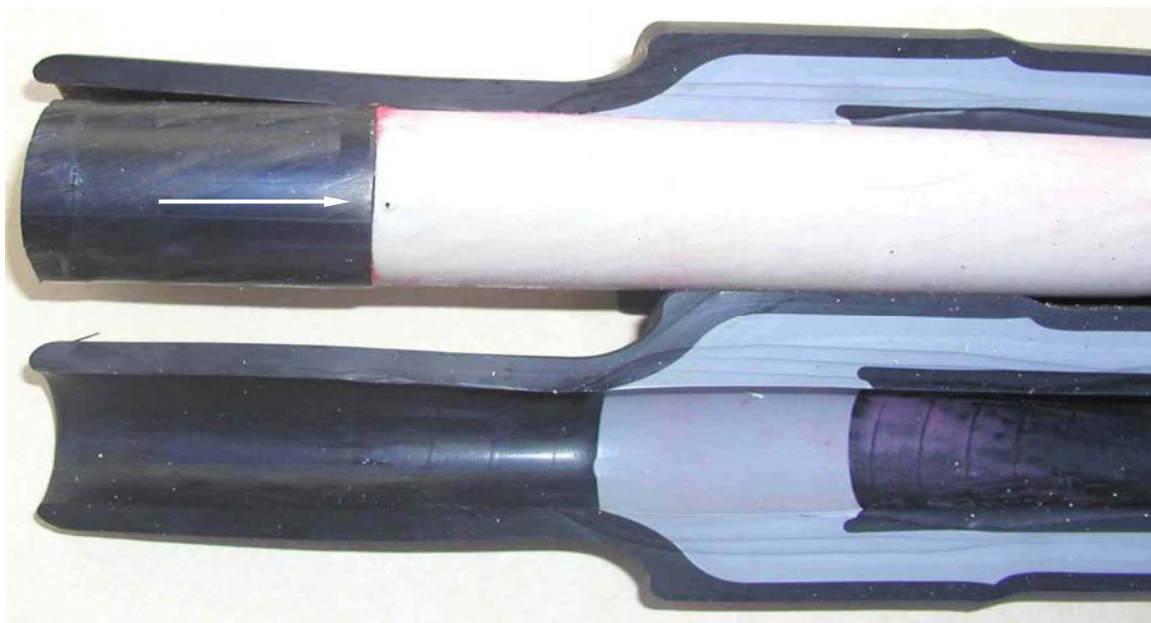
Figure C-2
Joint 3M5. Radial Failure next to the Insulation Shield Cut Back.

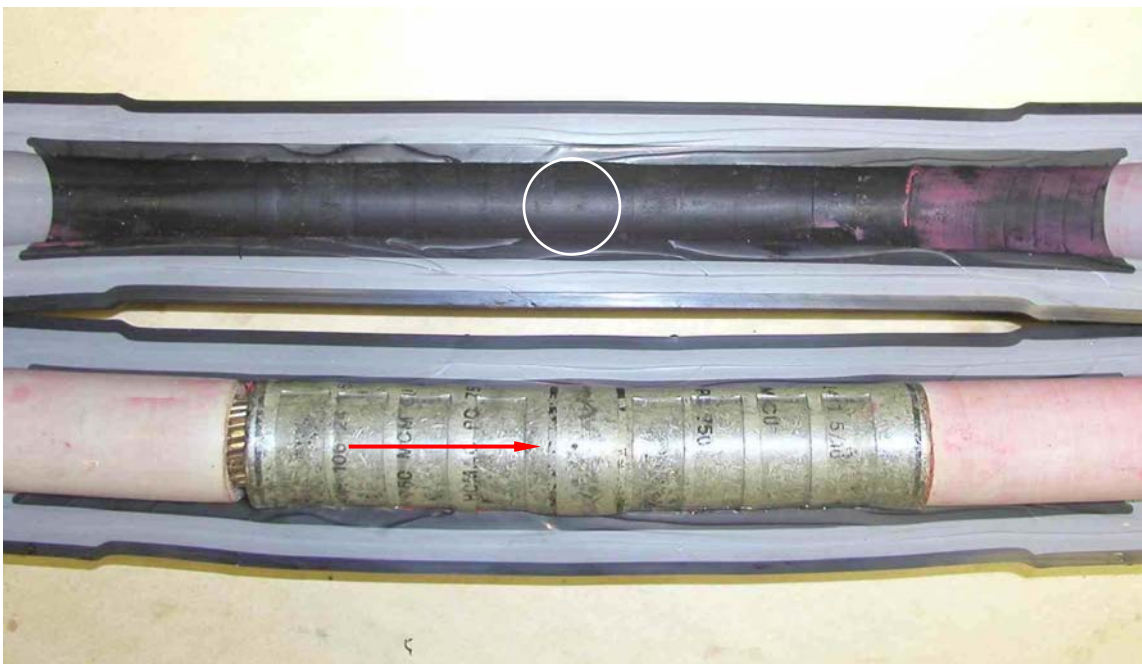
Figure C-3
Joint 3M4. Radial Failure at Center of the Connector.

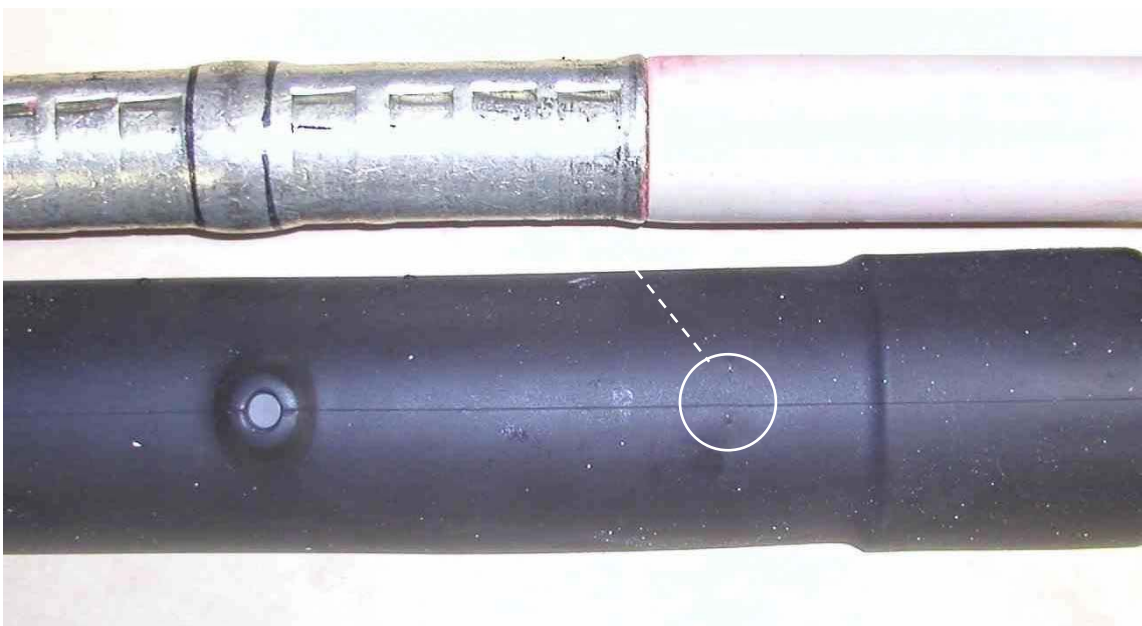
Figure C-4
Joint 3M7. Diagonal Failure next to the Edge of the Connector.

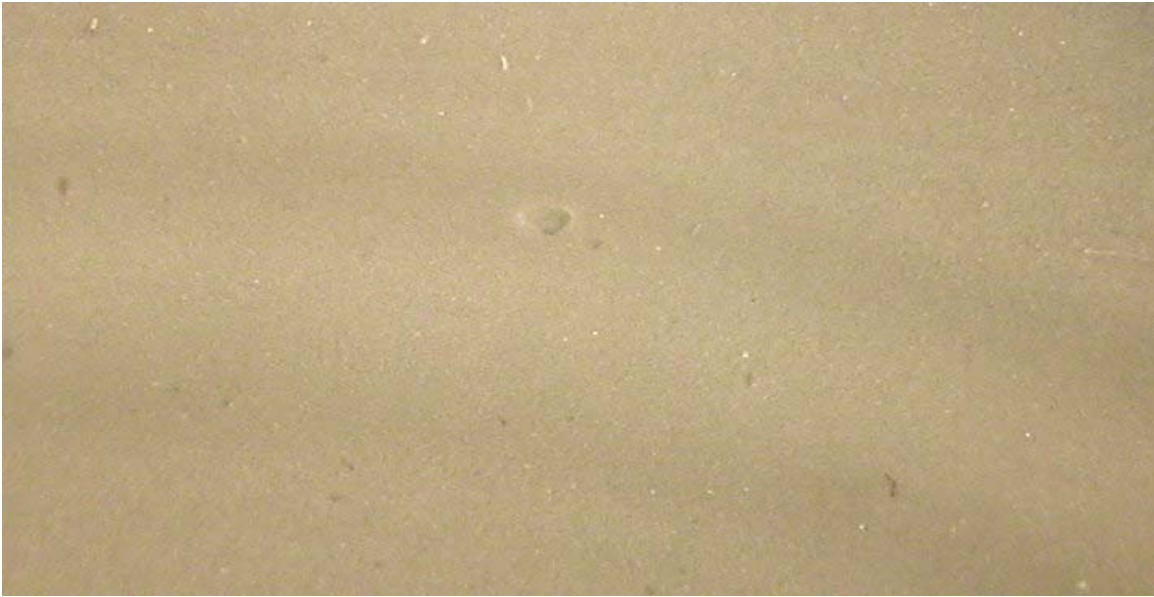
As previously mentioned Joints 3M6 and 3M7 had the lowest voltage breakdown levels. Slices containing the breakdown paths were examined with the aid of a microscope. During this examination voids were found in the insulation of both joints. The size of the largest voids ranged between 10 and 15 mils in the greatest dimension. Figure C-5 shows one of these voids. In addition, more voids were found away from the failure location.

Figure C-5
Joint 3M6. Fifteen Mils Void in Joint Insulation.

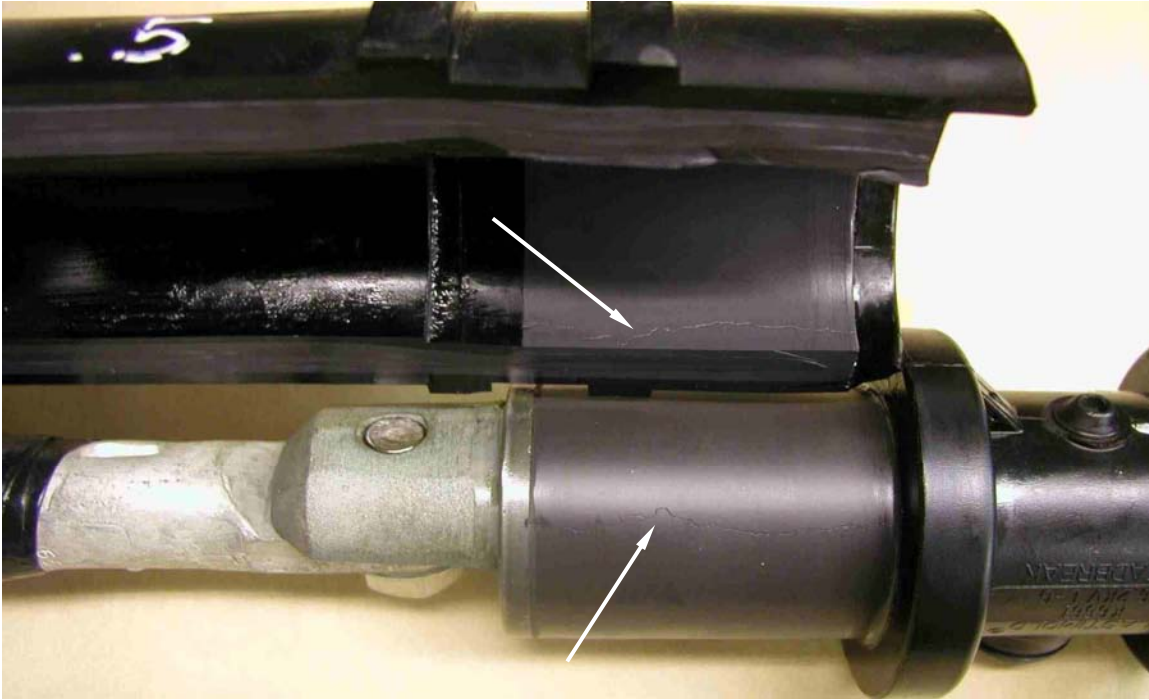
Of the four joints aged in air one (E5) failed longitudinally, at the interface between the insulating layers of the bus bar and the receptacle housing. Two joints (E1 and E8) failed at or close to the inner semi-conducting layer of the cable adapter. In Joint E4 the failure occurred at the cut back of the insulation shield. Of the joints aged in water three breakdowns (E2, E6 and E7) took place at the cable insulation shield cut back. One failure occurred at the location of the step in the semiconducting layer of the cable adapter (Joint E3).

Figure D-1
Joint E5 (with EPR Tape Bumper). Longitudinal Failure at the Interface Between Bus Bar and Receptacle Housing.

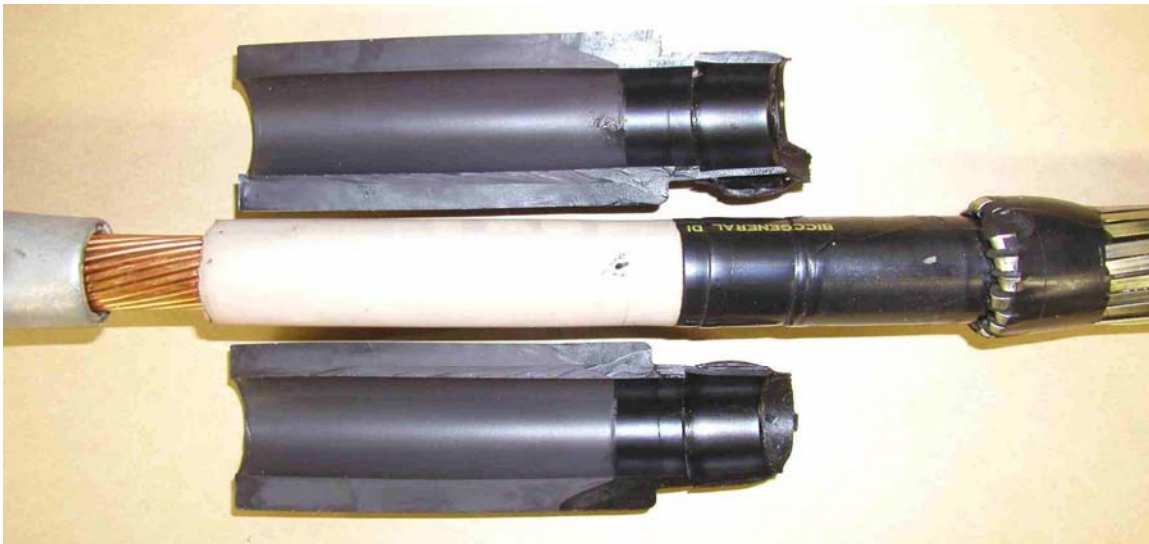
Figure D-2
Joint E1 (with Retaining Ring). Radial Failure at the Edge of Semiconducting Layer of Cable Adapter.

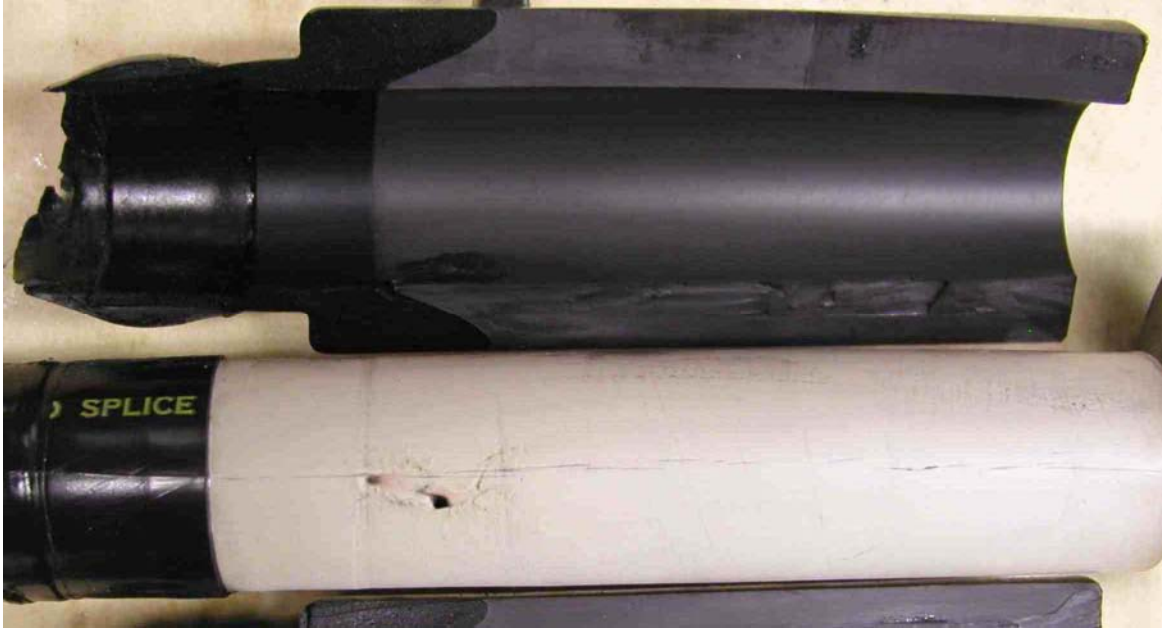
Figure D-3
Joint E8 (with Retaining Ring). Radial Failure at About 0.4 Inch from Semiconducting Layer of Cable Adapter.

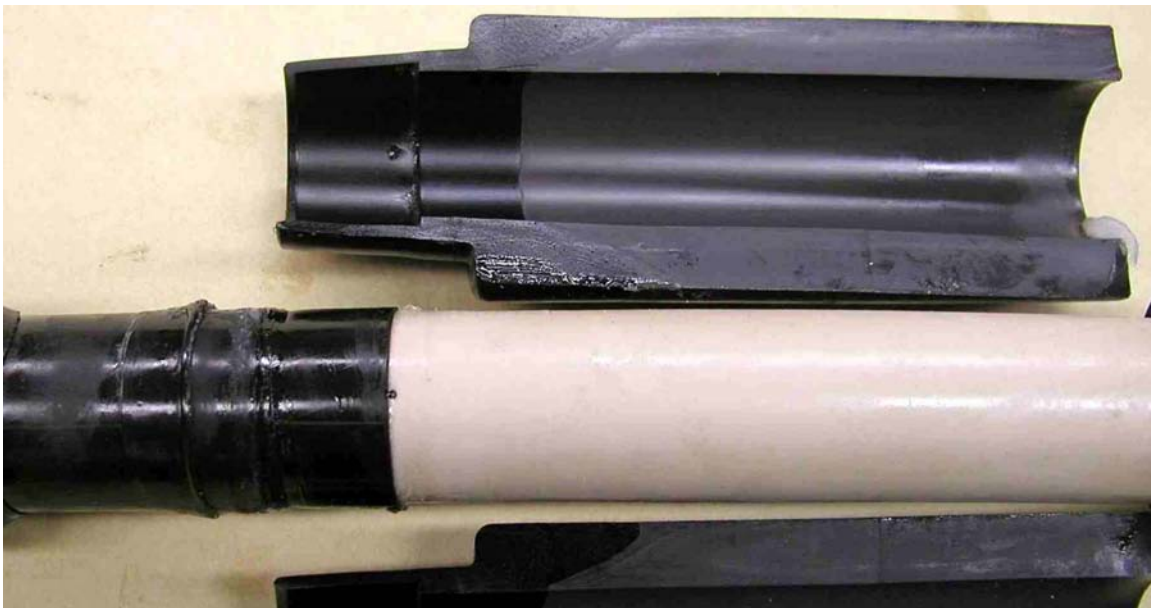
Figure D-4
Joint E6 (with EPR Tape Bumper). Radial Failure at the Cable Insulation Shield Cut Back.

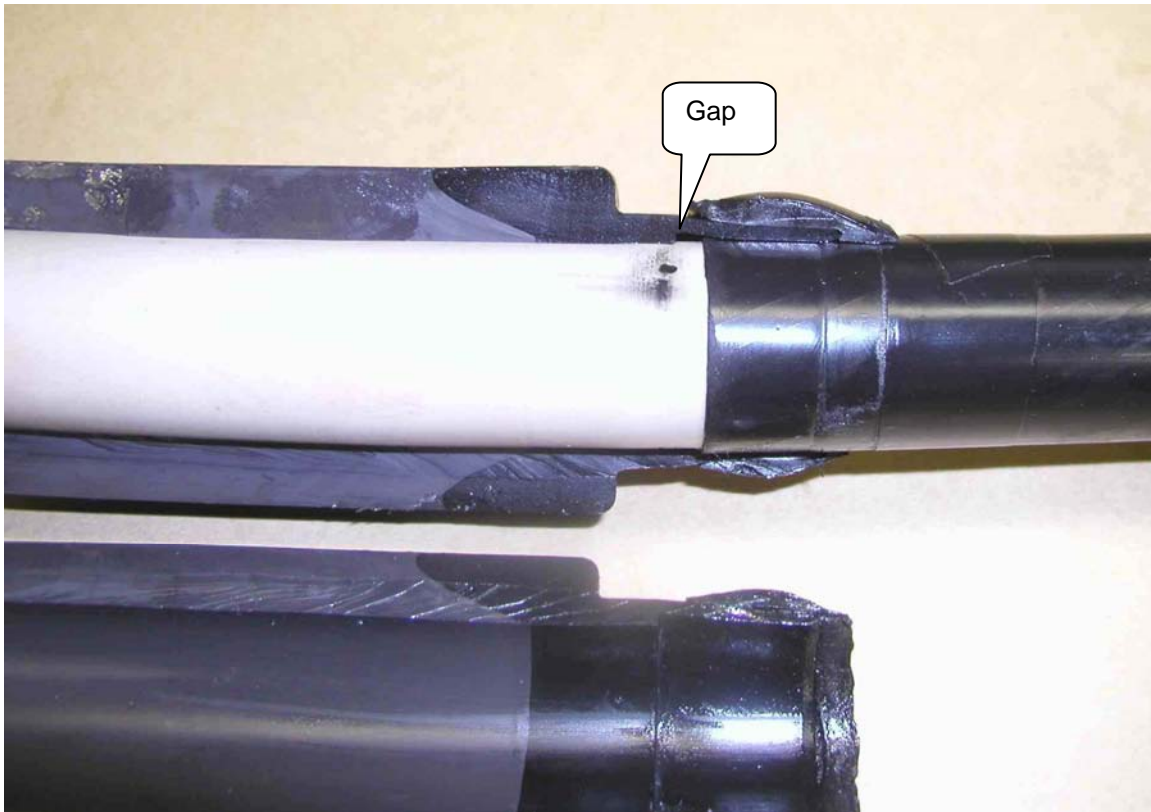
Figure D-5
Joint E3 (with EPR Tape Bumper). Radial Failure at the Step in the Semiconducting Layer of Cable Adapter. Note Gap in this Area.

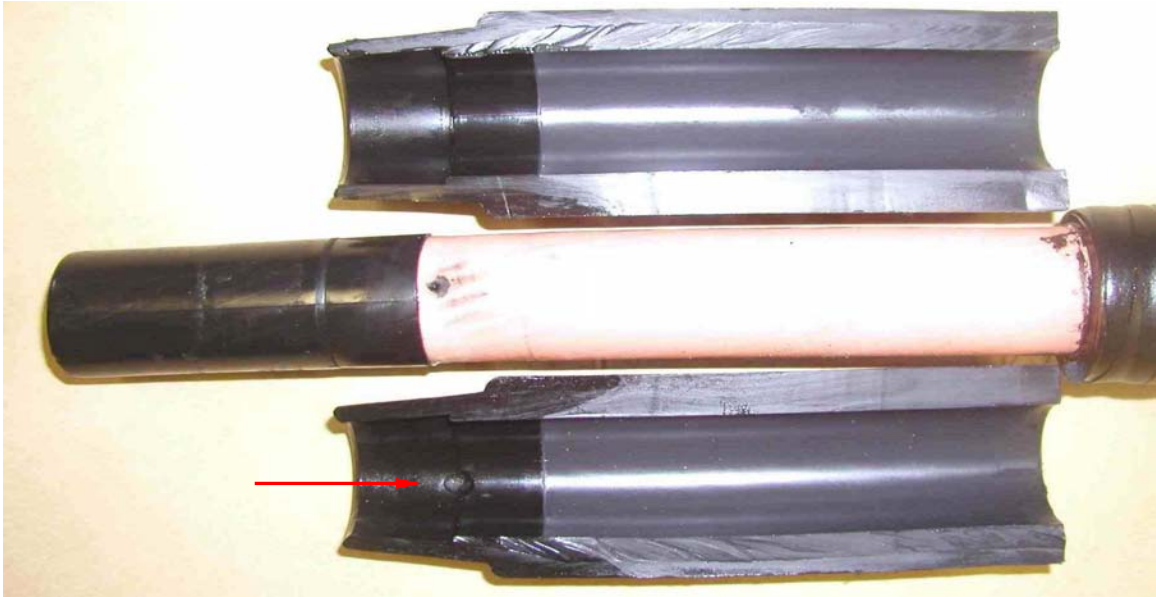
After completing the ac voltage breakdown tests, each of the eight joints were dissected and examined. Results of the dissection are provided in Table D-11. All four joints aged in air (R1, R4, R5 and R8) broke down at the location of the step in the semi-conducting layer of the cable adapter. Of the four joints aged in water one (R2) failed longitudinally, at the interface between the insulation of the cable adapter and the receptacle housing. Two joints (R3 and R6) failed at the location of the step in the cable adapter. In one joint (R7) the failure path was a combination of radial (through the cable insulation) and longitudinal (at the interface between the insulation of the cable and the adapter).

Figure E-1
Joint R8. Radial Failure at the Location of the Step in the Semiconducting Layer of Cable Adapter (120 Mils from the Cable Insulation Shield Cut Back).

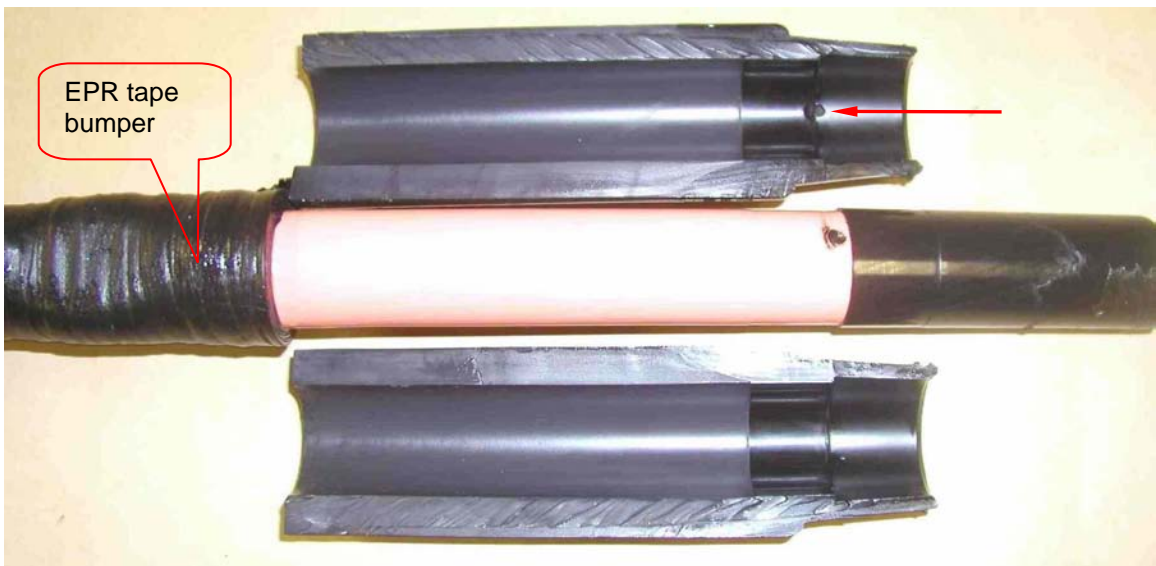
Figure E-2
Joint R6. Radial Failure at the Location of the Step in the Semiconducting Layer of Cable Adapter (90 Mils from the Cable Insulation Shield Cut Back).

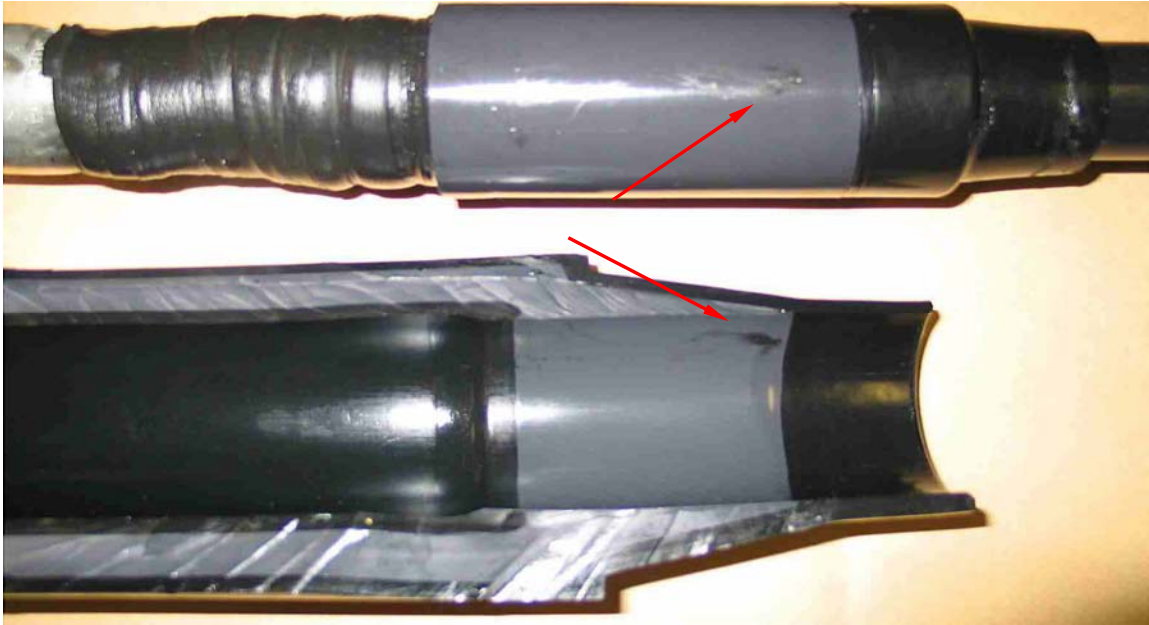
Figure E-3
Joint R2. Longitudinal Failure at the Interface Between the Insulation of the Cable Adapter and Receptacle Housing.

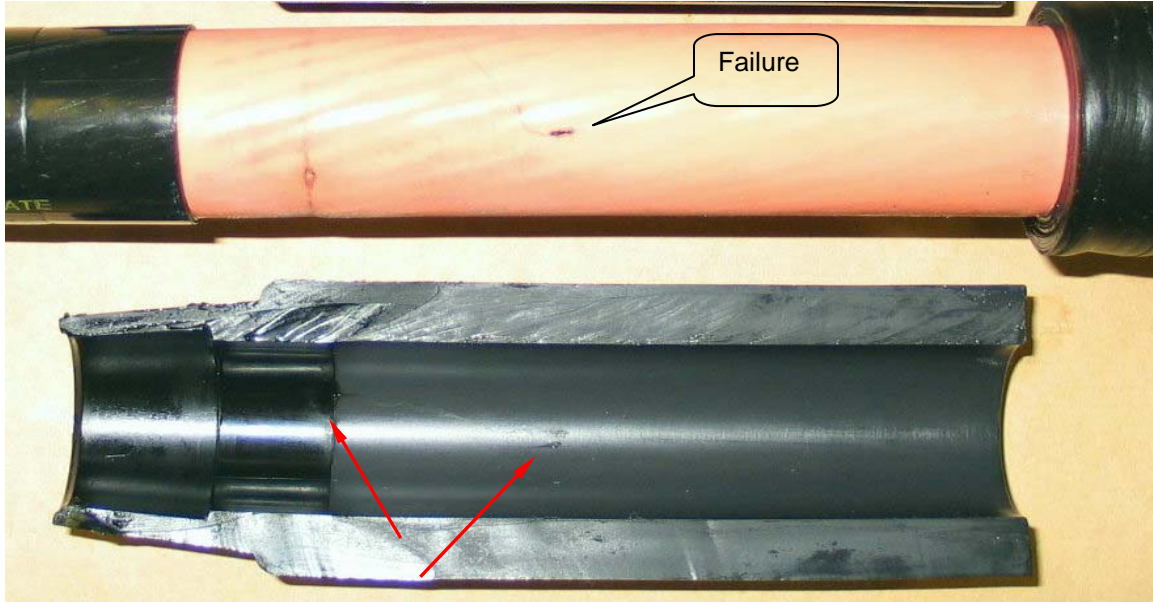
Figure E-4
Joint R7. Failure Follows the Interface Between Insulation of the Cable and the Cable Adapter and Radially Through the Cable Insulation.
