Evaluation of Medium-Voltage Cable Joints

New and Modified Single-Phase Cold Shrink and Separable Connector Cable Joints

Technical Report

Final Report, September 2006

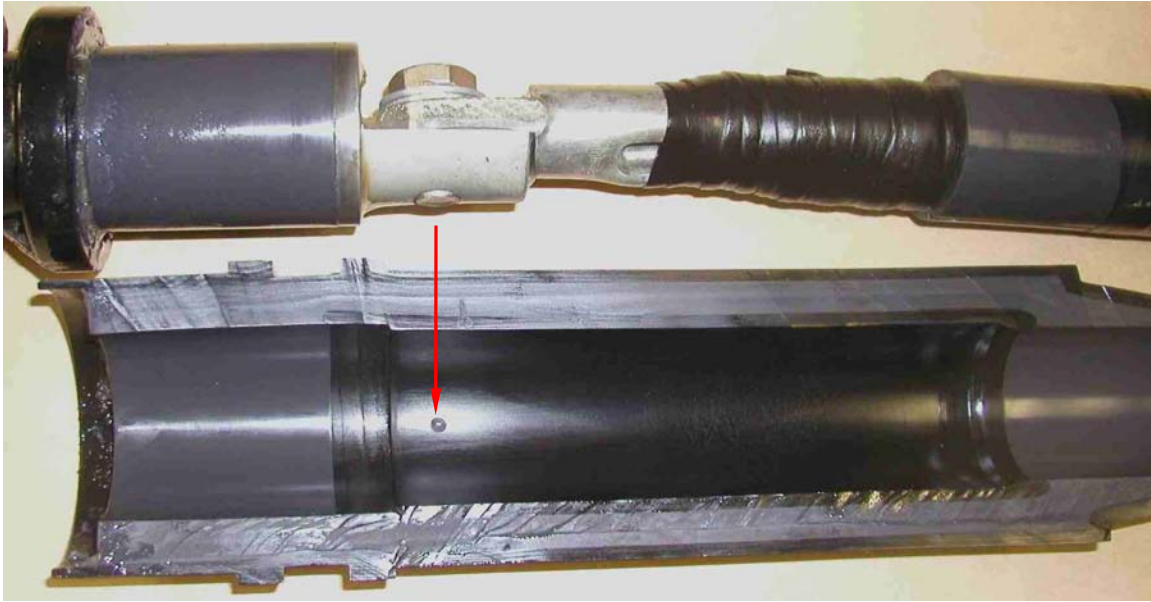
Figure E-5

During dissection it was noted that in several joints the inner semiconducting layer of the receptacle housing exhibited signs of partial melting and pitting in the area corresponding to the location of the hex bolt (Figures E-5 and E-6).

The erosion on the inner semiconducting layer surface of the receptacle housing (Figures E-5 and E-6) apparently was caused by impulse voltages to which the assemblies were subjected. The test impulses had a standard shape of $1.2 \times 50 \mu\text{s}$. At this fast transient the semiconducting material can acquire a substantially different potential than the cable conductor (connector) depending on volume resistivity of the semiconducting component¹. This difference in potential

could result in sparking through the air gap between the exposed sharp edge of the hex bolt and the semi-conducting layer causing the observed damage.

Joint R8. Eroded Area in the Inner Semiconducting Layer of the Receptacle Housing at the Location of the Exposed Edge of the Hex-Head Bolt. A Similar Condition was Observed in Several Other Joints.

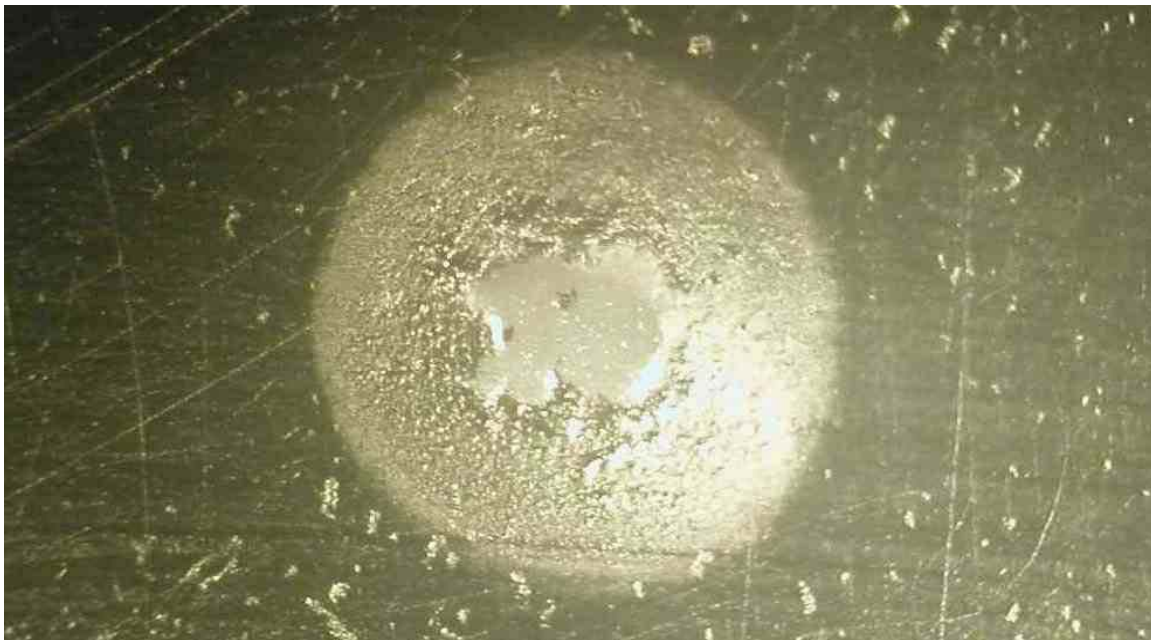
Figure E-6

Joint R8. Microscopic View of Erosion Caused by Sparking Through the Air Gap Between the Inner Semiconducting Layer of the Receptacle Housing and the Hex-Head Bolt.

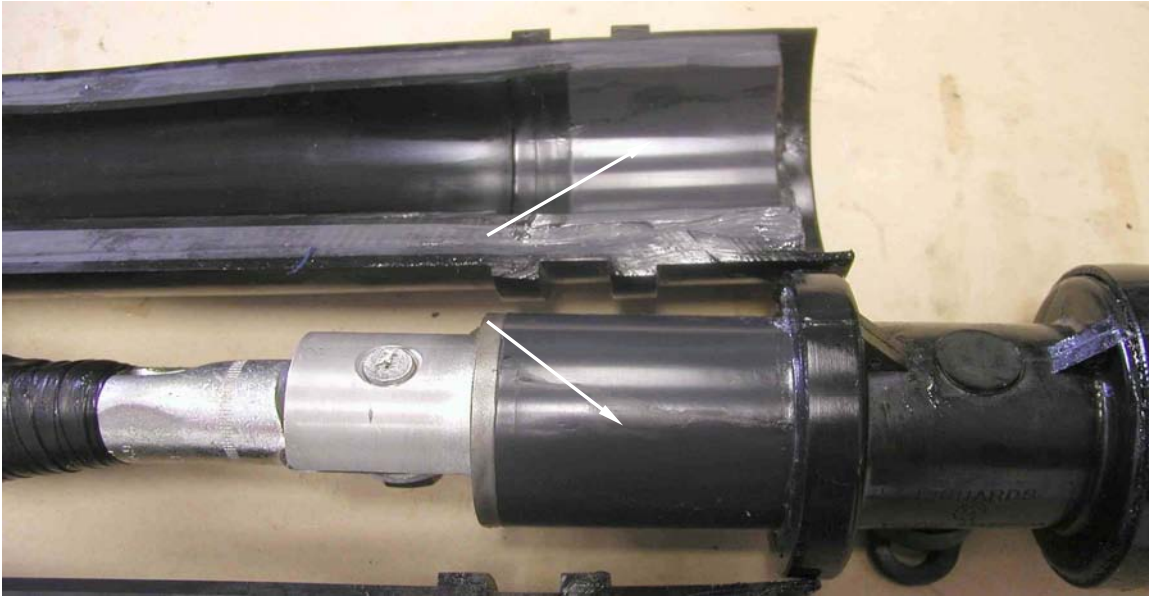
Figure F-1
Joint R4. Longitudinal Failure at the Interface Between the Insulation of the Bus Bar and Receptacle Housing.

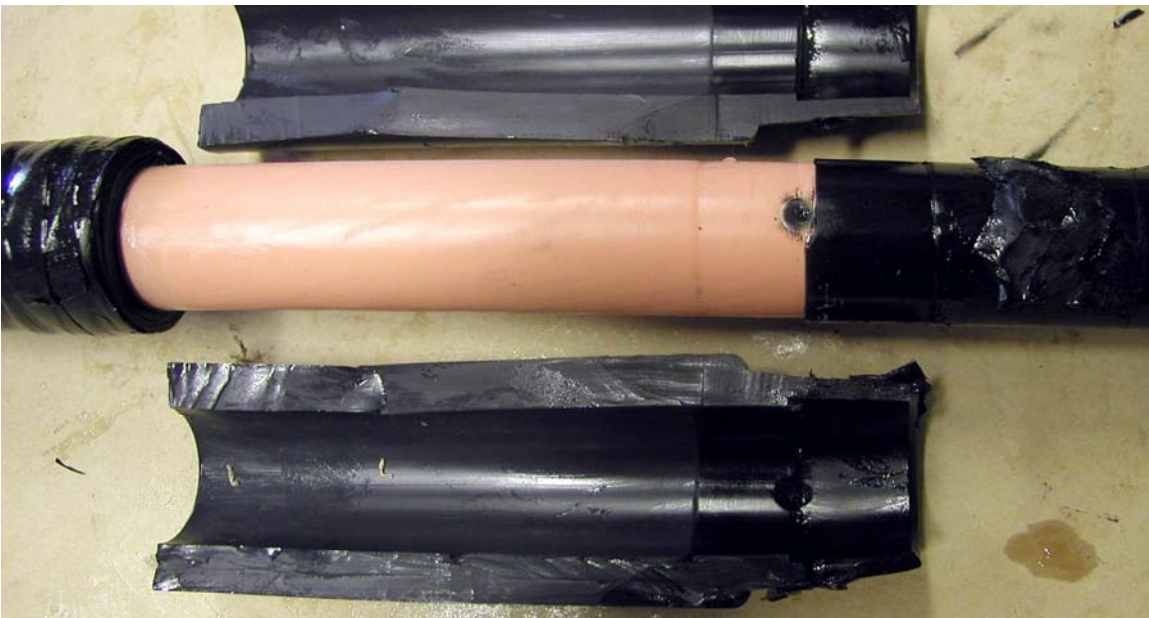
Figure F-2
Joint R8. Radial Failure at the Cable Insulation Shield Cut Back.

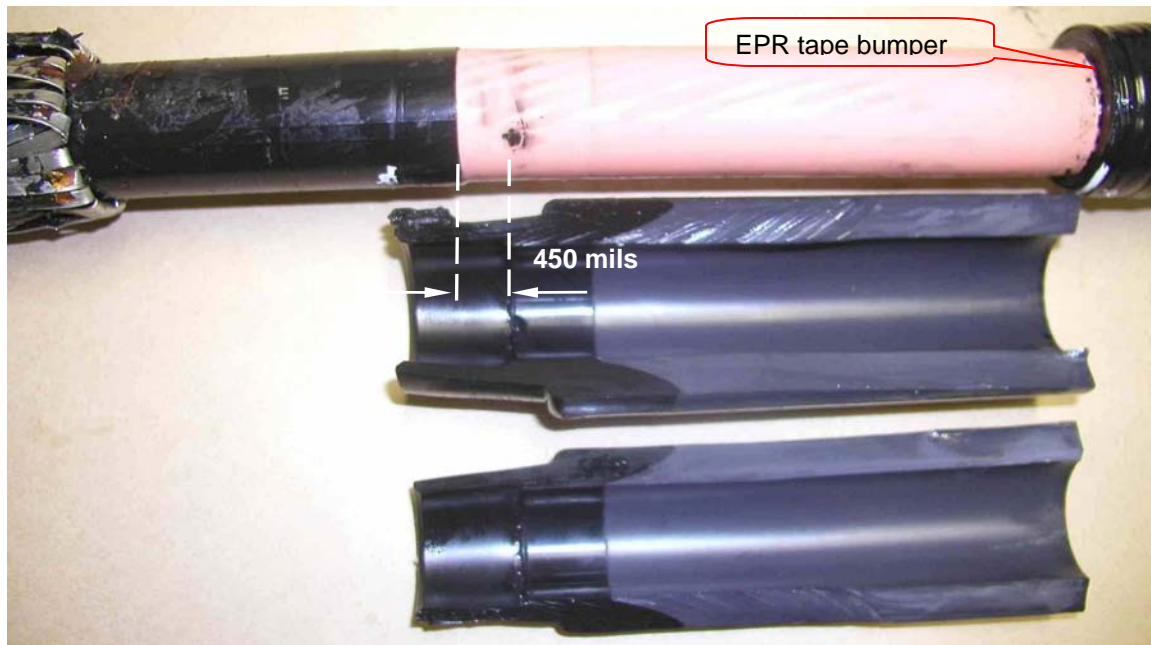
Figure F-3
Joint R5. Radial Failure in Coincidence with the Step in the Semiconducting Layer of the Cable Adapter (About 450 Mils from the Cable Insulation Shield Cut Back).

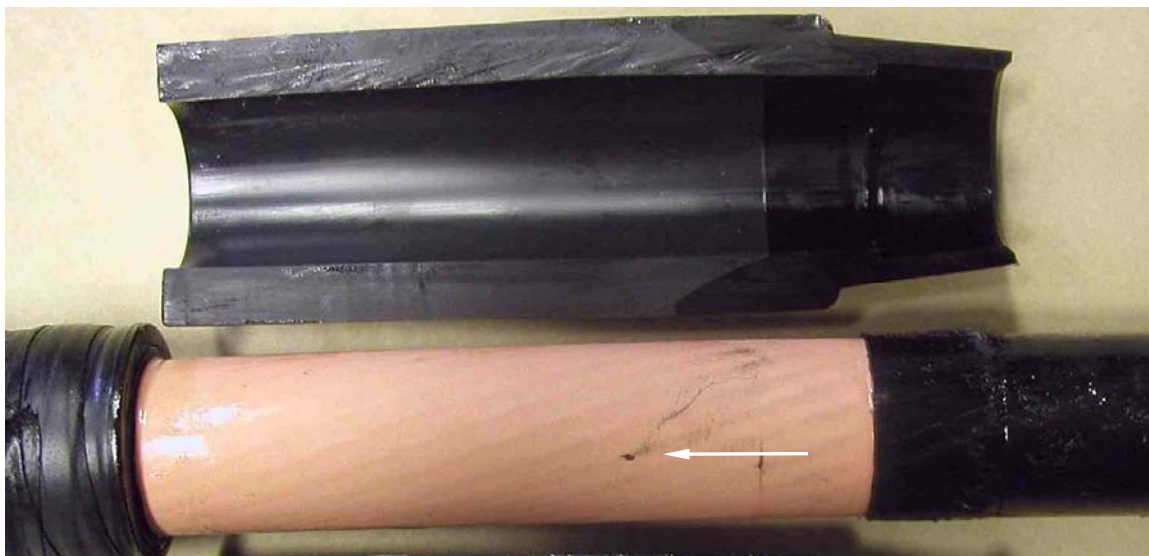
Figure F-4
Joint R3. Radial Failure in the Cable Insulation After Following Longitudinally Along the Interface Between the Insulation of the Cable and the Cable Adapter.

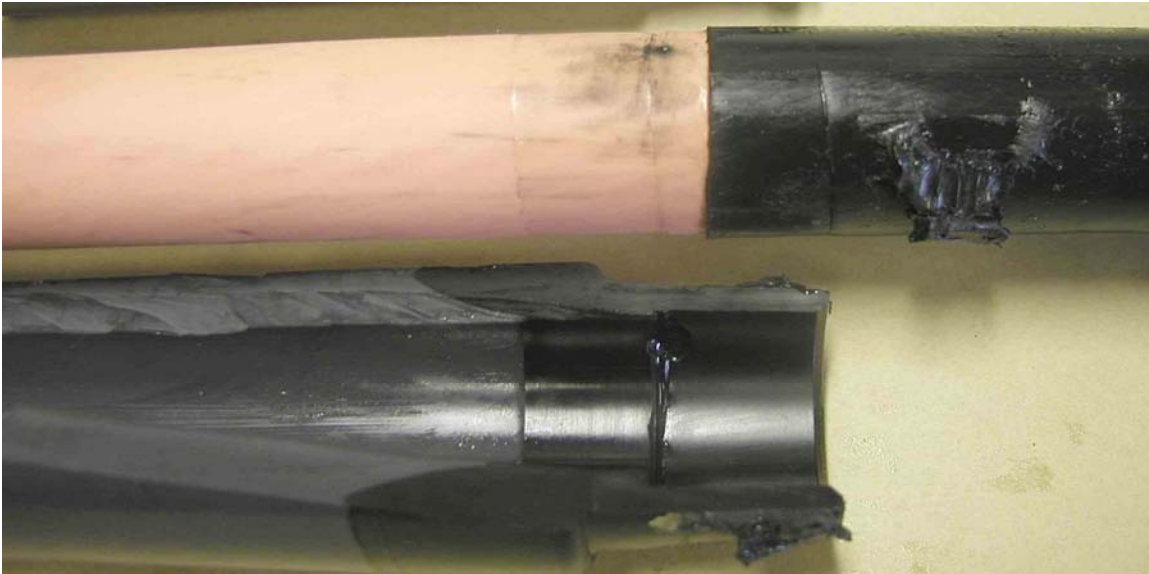
Figure F-5
Joint R6. Radial Failure in Coincidence with the Step in the Semiconducting Layer of the Cable Adapter (About 250 Mils from the Cable Insulation Shield Cut Back).

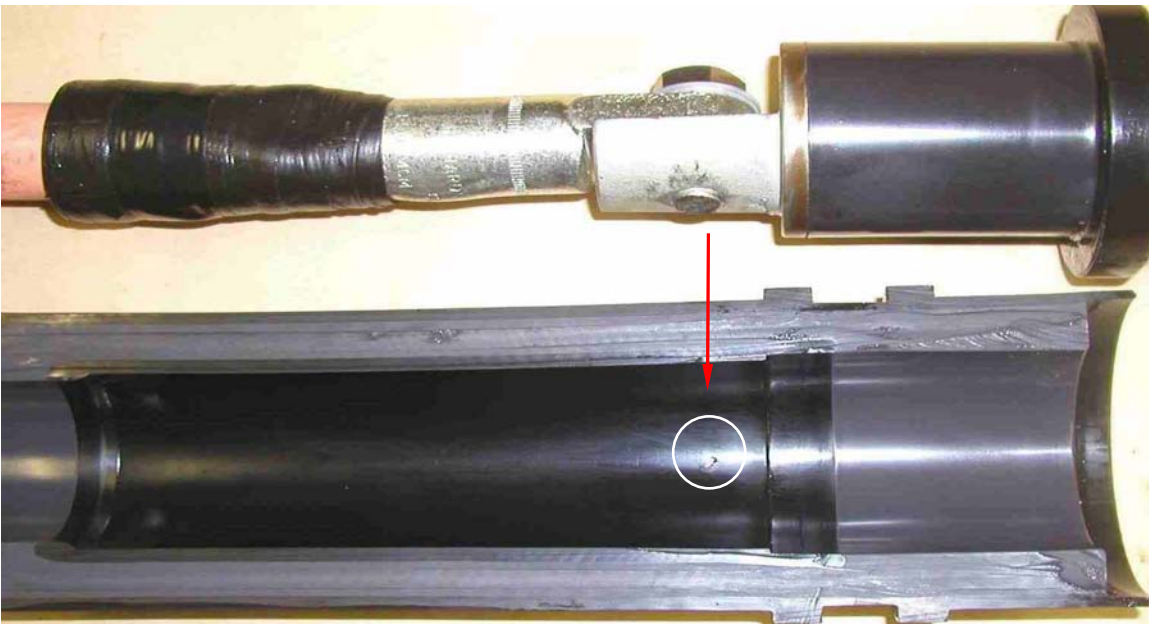
Figure F-6
Joint R1. Eroded Area in the Inner Semiconducting Layer of the Receptacle Housing, at the Location of the Exposed Edge of the Hex-Head Bolt. A Similar Condition was Observed in Several Other Joints.
