Nuclear Maintenance Applications Center: Isolated Phase Bus Maintenance Guide

Update to TR-112784

1015057

Final Report, December 2007

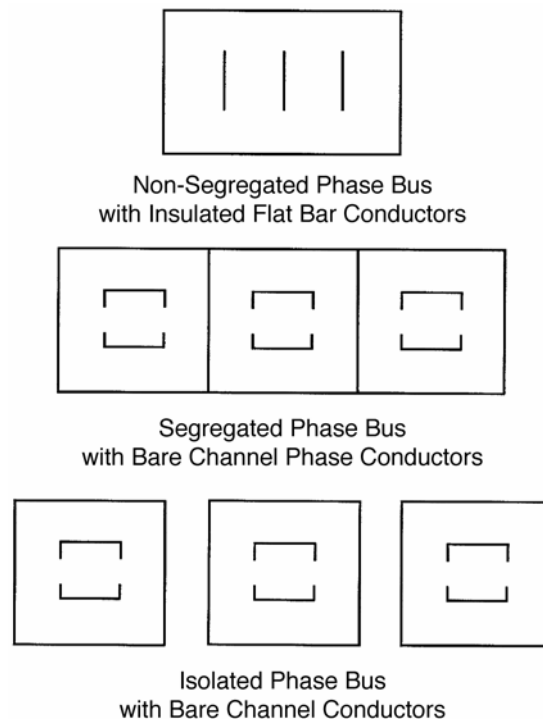
Figure 1-1
Types of Isolated Phase Buses

- Non-segregated phase
- Segregated phase
- Isolated phase

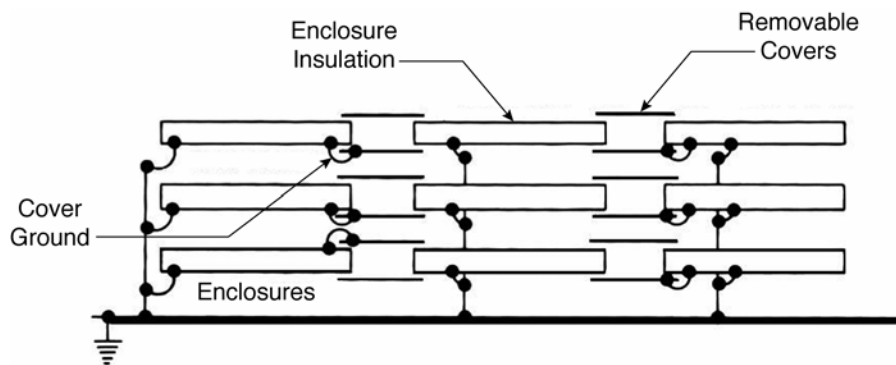
Figure 3-1
Circulating Currents Design for Non-Continuous Bus Enclosures

With the isolated phase bus, non-continuous enclosure design, the enclosures are electrically non-continuous throughout their length. Succeeding enclosure sections are insulated from each other. This insulation is required to prevent circulating currents from flowing through the high-resistance joints at interfaces between enclosures and between the enclosure and supporting steel beams. The resistive heating losses (I^2R) loss at these joints could raise temperatures to unacceptable levels. The three enclosures of each three-phase group are insulated from each other, except at one end where they are connected together and grounded, as shown in Figure 3-1.

One important advantage to this design is that these enclosures have internal circulating currents in them that greatly reduce the mechanical stress that develops on support insulators during fault conditions. Because large generators usually have the capacity for very high bus fault currents, this is an important benefit. Because of eddy currents in the enclosure, fault current forces on insulators can be reduced by as much as 90% of the value that would result if an enclosure were not present. The result is that only single cantilever, widely spaced insulators are required for conductor support [1].

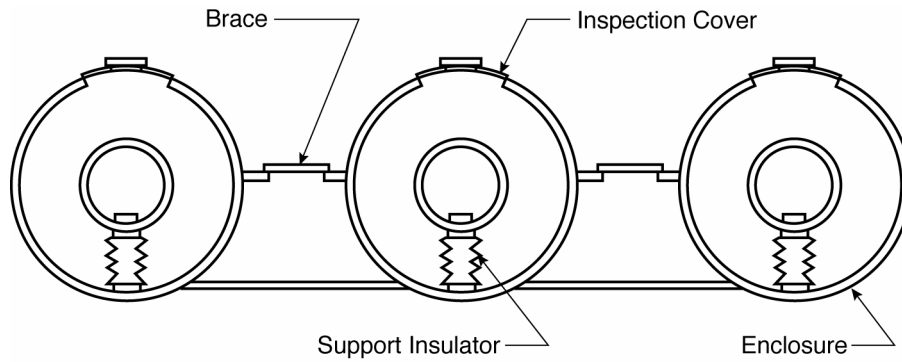
Figure 4-2
Cross-Section of Isolated Phase Bus

Quantitatively, this means that for an isolated phase bus with a nominal rating of 20,000 amperes, the external magnetic field of the non-continuous enclosure bus would be equivalent to $0.3 \times 20,000 = 6000$ amperes for an open bus. Support beams would usually require protection against excessive inductive heating. No such protection is required with the continuous enclosure design. Here, the external field would be the same as a $0.05 \times 20,000 = 1000$ -ampere bus. The fact that no enclosure insulation is required ensures that voltages generated in the continuous enclosures and appearing between enclosure and ground will be low, and, in practice, they are usually less than 1 V. The voltage drop along an enclosure will mainly be the resistive voltage drop due to I^2R losses. Because of the low resistance of the enclosure, voltage drop will also be low. Dangerous voltages that can develop with the non-continuous enclosure are nonexistent with the continuous enclosure bus. An additional benefit of this principle is a further reduction of at least 25% of the forces on the insulators during fault conditions. An illustration of the circulating currents in continuous enclosures is provided in Figure 4-1. A cross-section of an isolated phase bus is shown in Figure 4-2.

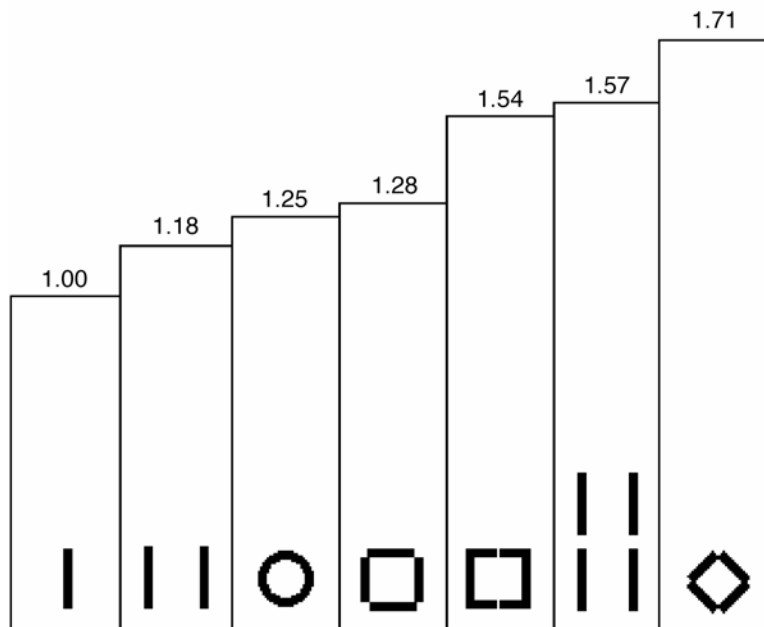
Figure 5-1
Comparison of Ampacity and Conductor Shape

Each shape has a total cross-section area of 4 sq. in. (26 sq. cm).
Relative 60-Hz current ampacity is given for a fixed temperature rise.

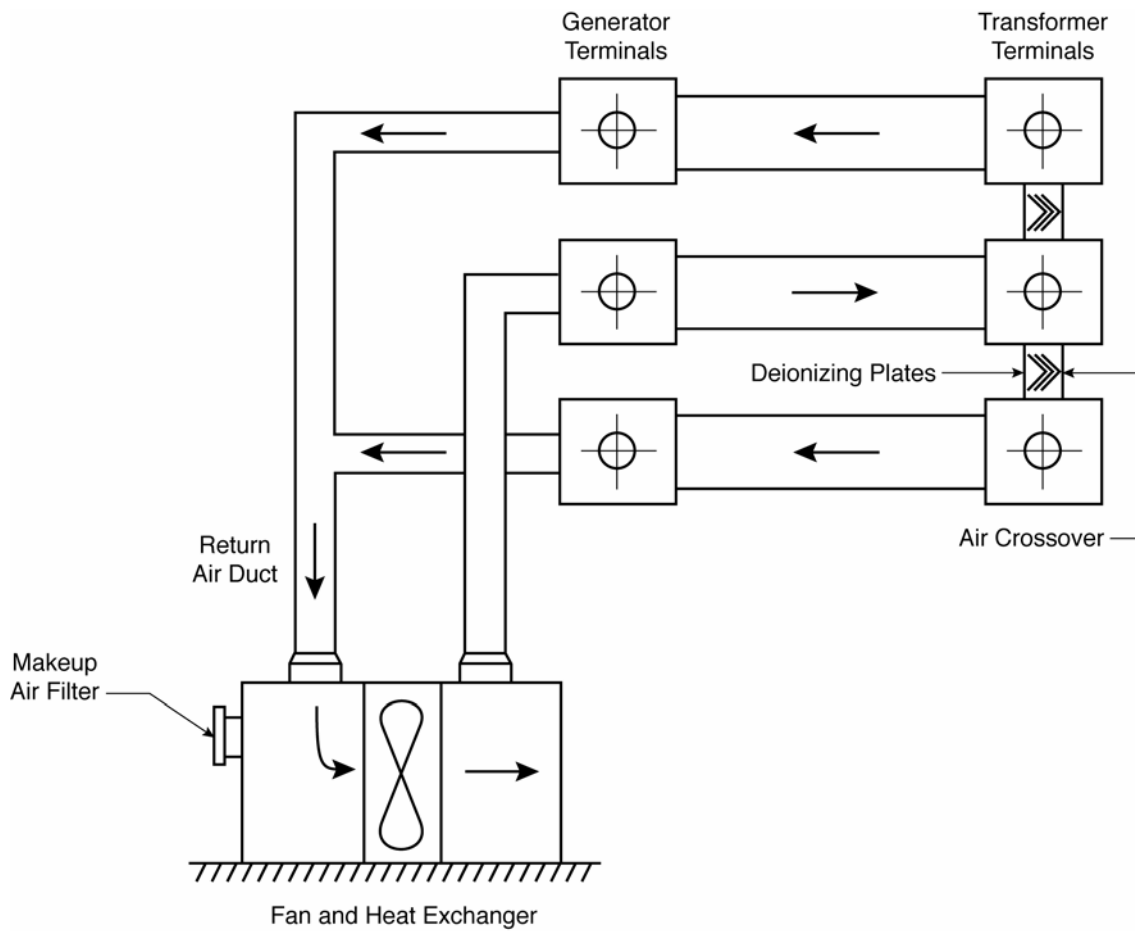
Figure 7-1
Typical Isophase Bus Forced Air Flow Cooling System

In most systems, all air enters the center phase enclosure, usually near the generator. It flows to the main transformer, passes through air crossover ducts, and returns through the two outside phases. Some ventilation around the generator bushings and transformer bushings is usually provided. Excessive pressure drop will result if air velocity in the center phase is high. A typical isophase bus forced air flow cooling system is illustrated in Figure 7-1.

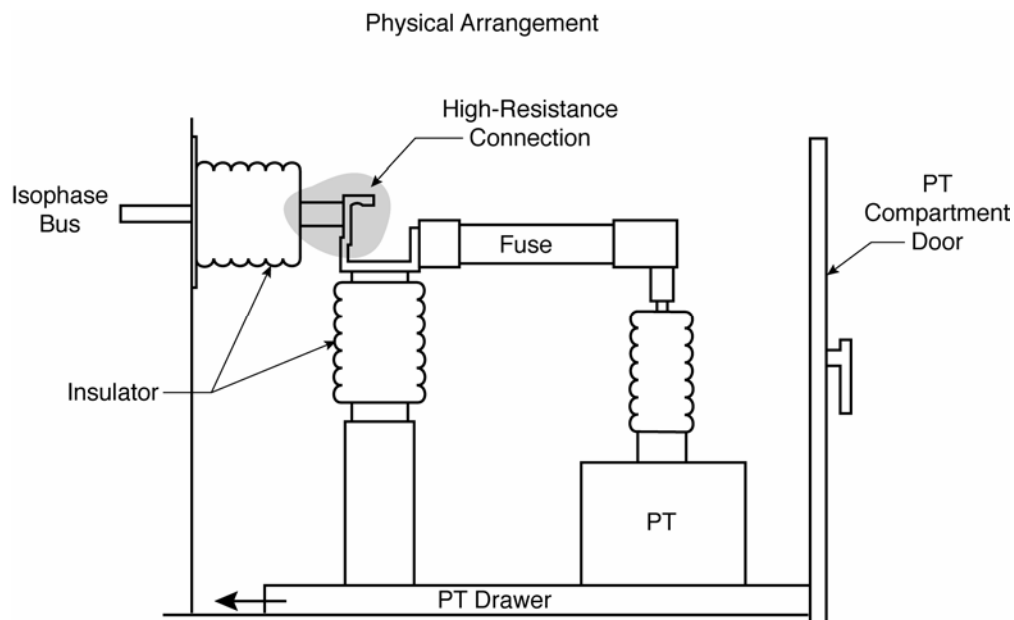
Figure 9-1
Typical PT-to-Isophase Bus Connection

The metering and regulation PT banks are generally located in housing directly below the generator prior to the isophase fan housing. The PTs are in locked cabinets with sliding rack-out drawers. The connection point to the isophase bus is on the backside of the PT drawer as shown in Figure 9-1. The PT, its secondary wiring, fuses, insulators, and high-voltage or low-voltage sliding contact connections to the isophase bus can all lead to shutdowns or extended outages if not properly maintained. Improper operation or generator over-excitation may result from poor contact between PT fuses and fuse holders.

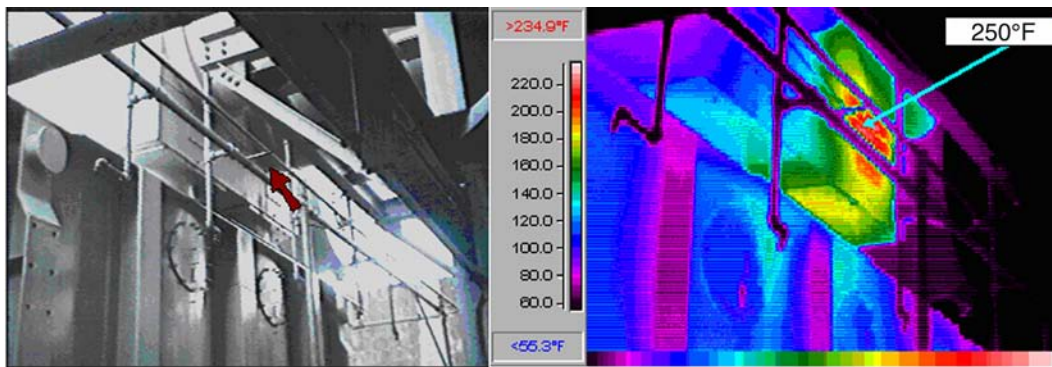
Figure 11-1 shows a thermal image of a GSU transformer that highlights an area of the transformer surface where a temperature of 250°F (121°C) is measured. The corresponding visual image is shown. This specific area is where the isolated phase bus duct enters the low-voltage bushing compartment of the transformer. The 250°F (121°C) temperature is excessive, especially considering the ambient air temperature of 45°F (7.2°C). Another thermal image of the same location, taken from a different angle, is presented in Figure 11-2. This image was taken from directly below the isophase. A careful inspection of the visual image reveals oil stains on the flanges of the compartment that are probably caused by oil leakage from within. The low-side transformer bushing would have to be generating a significant amount of heat in order to cause the compartment surface to reach this extreme temperature on such a cool day.

Figure 11-1
Visual and Thermal IR Images of the Isophase/GSU Transformer Connection Area

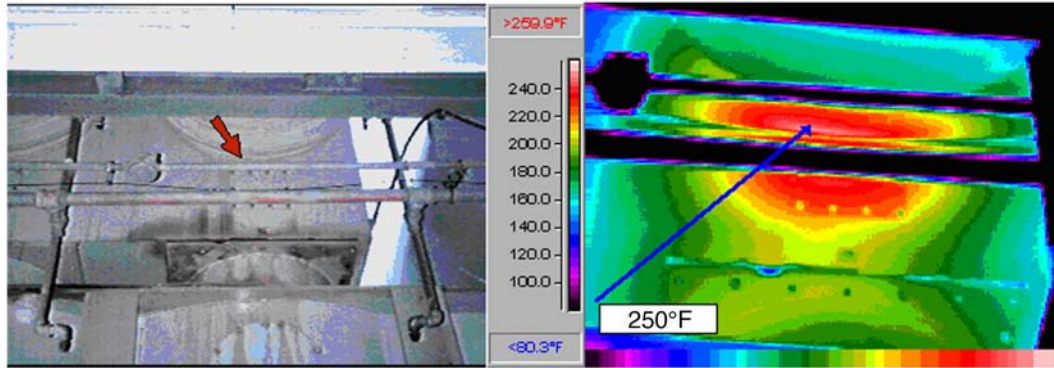
Figure 11-2
Images Captured from Directly Below the Anomaly (Note the oil leakage in the visual image.)

A decision was made to remove the unit from service in an effort to avoid a catastrophic failure of the transformer. An investigation of the bushing compartment revealed that the bushing and the surrounding components had sustained significant damage. Temperatures within the compartment had been hot enough to cause the component to begin to melt. Pictures of pieces of the damaged components are shown in Figure 11-3.

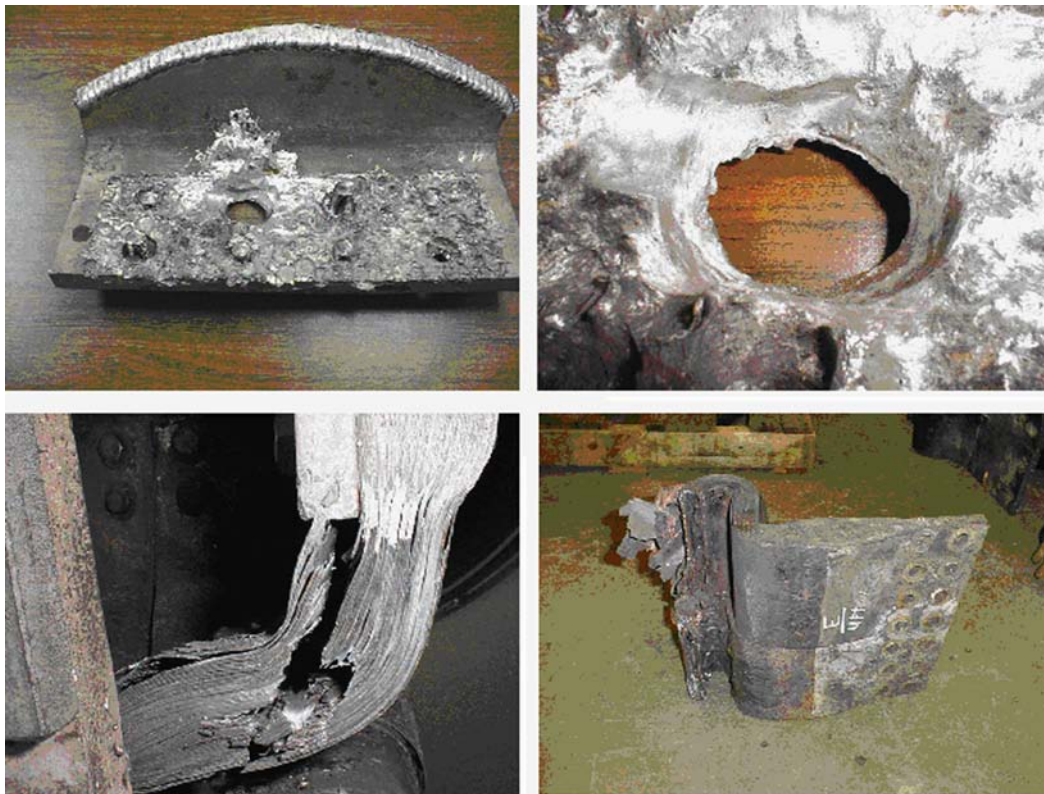
Figure 11-3
Damage to Connections Between the Isophase Bus and Low-Voltage Bushing

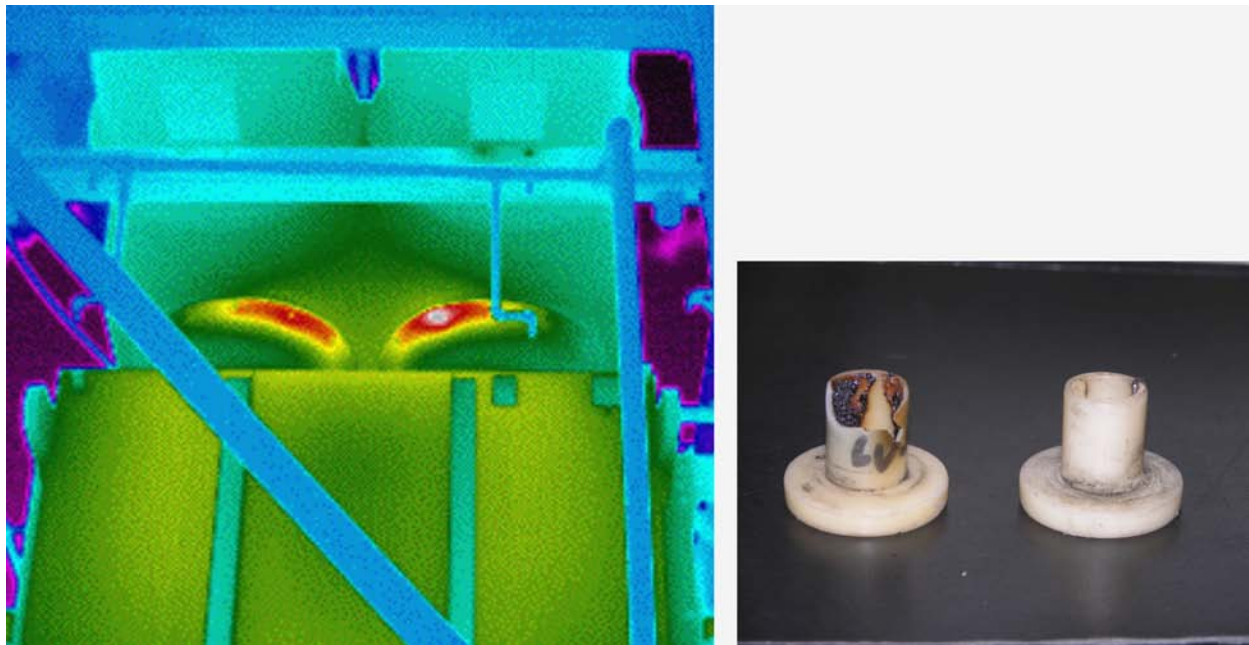
Many connection and insulation issues can be readily identified using IR thermography (see Figures 11-4 through 11-6).

Figure 11-4
Inductive Heating Between Low-Voltage Bushings on One Phase of the GSU Transformer
(Note the bolt heating on the right side of the enclosure and damaged insulator found during the next outage.)

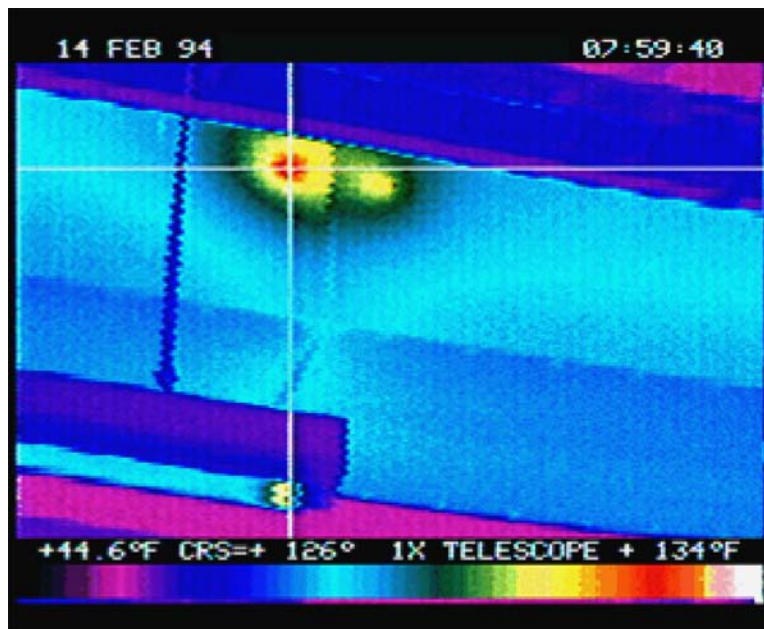
Figure 11-5
Overheating Caused by a Loose Ground Strap

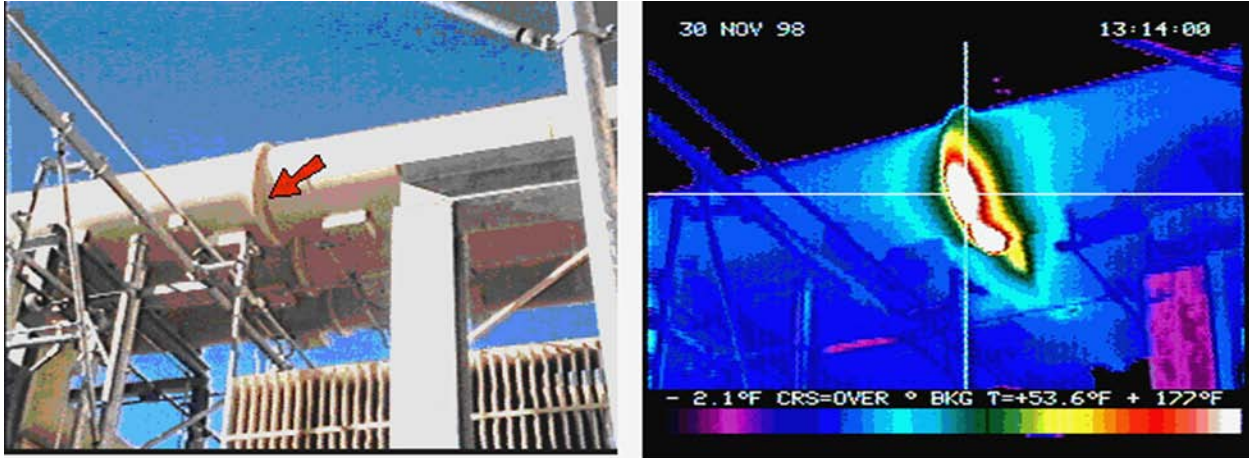
Figure 11-6
Overheating at the Bus Section Joint

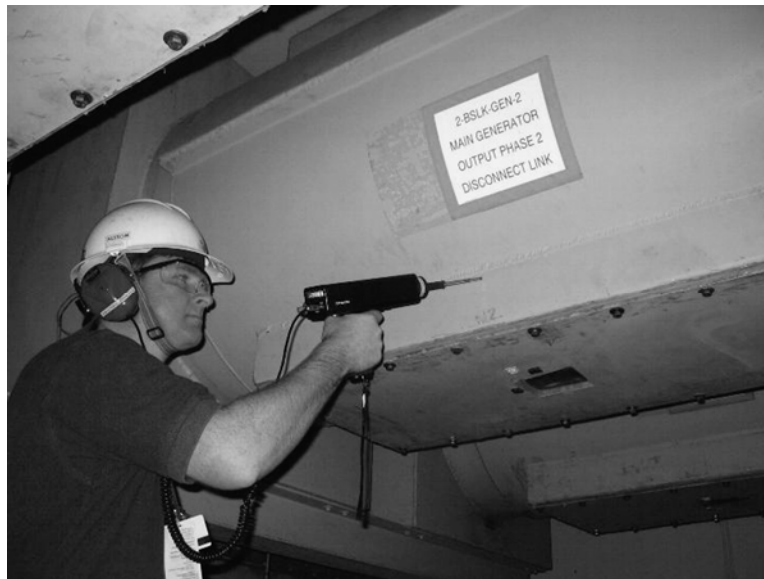
Acoustics has been used primarily as a troubleshooting tool, but it can also be used for periodic monitoring. In regard to the isophase bus, acoustics can be used to locate tracking or arcing that is occurring. Filtering for frequencies greater than 25 MHz is recommended for this type of discharge. Due to the thickness of the bus enclosure, it is likely that the contact probe will be required; thus some locations may be inaccessible without a scaffold, ladder, or man-lift of some type. Of course, proper grounding and other safety precautions must be considered when placing conductive materials in proximity to the bus. Figure 11-7 shows the proper technique for acoustic monitoring on the bus.

Figure 11-7
Proper Technique for Monitoring Isophase Bus with an Acoustic Contact Probe

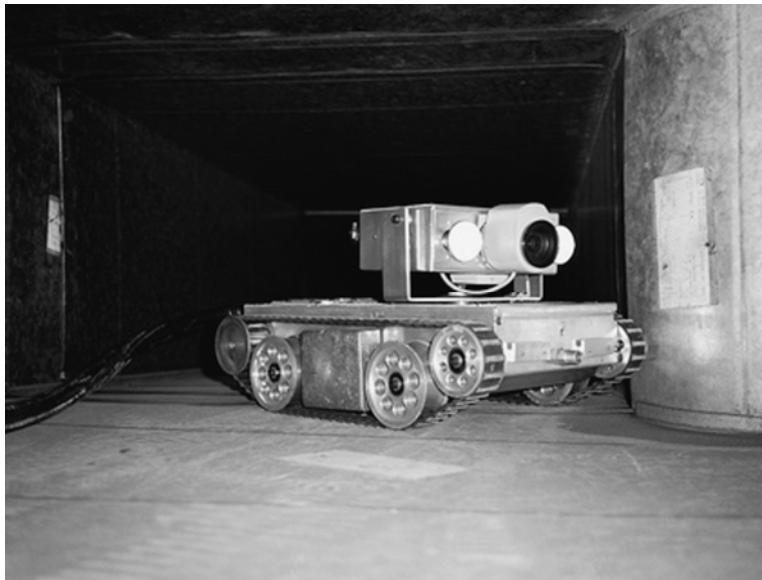
Poor access to the internal bus duct to perform adequate visual inspections has been problematic. Access covers are often too small to allow for direct visual observation of a given bus section. The current state of small robotic roving devices, as shown in Figure 11-8, with high-quality optics provides a means to perform much better visual inspections than are possible by use of direct observation, telescopic mirrors, or flexible borescopes. It is also possible to record the inspection to allow review at a later date if needed.

Figure 11-8
Robotic Walkers Are Ideal for Performing and Recording Visual Inspections in Isophase Buses with Limited-Sized Inspection Covers

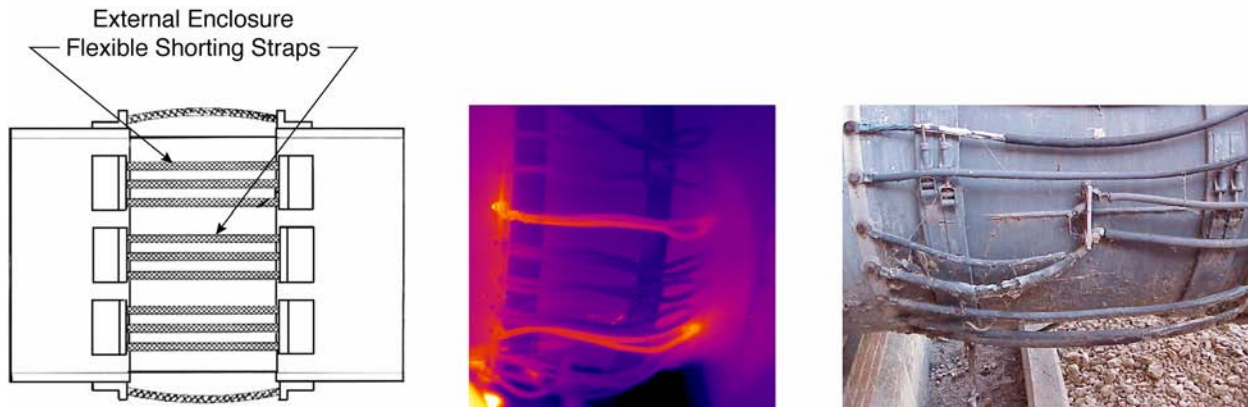
With a minimum flux design, phase current is present in the continuous enclosures. One major bus supplier welded all external joints between the enclosure tubes and shorting plates. Another major manufacturer chose to use an array of bolted jumpers from one enclosure to the next. These jumpers are prone to overheating, as shown in Figures 12-1 and 12-2, if the original design is marginal or not properly maintained.

Figure 12-1
Bus Duct with Bolted Jumpers, Thermography Showing a High-Resistance Joint, and a Visual Image of Jumper Cables

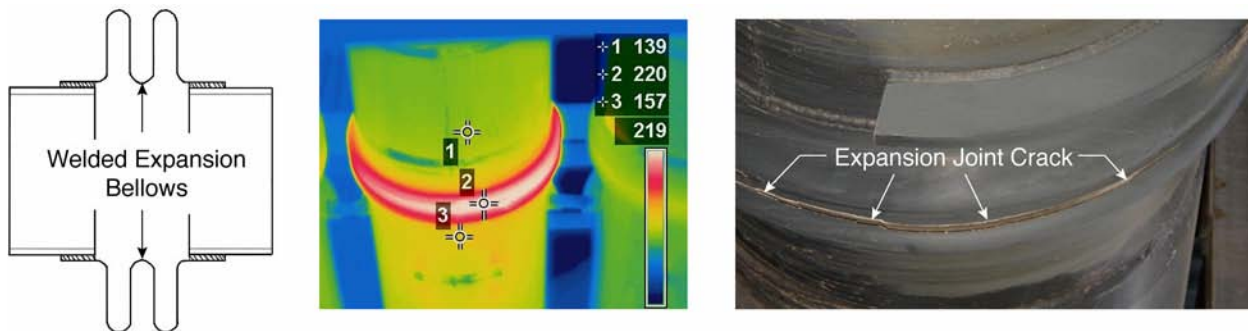
Figure 12-2
Bus Duct with Welded Expansion Bellows, Thermography Indicating a Problem, and a Visual Image of the Cracked Joint

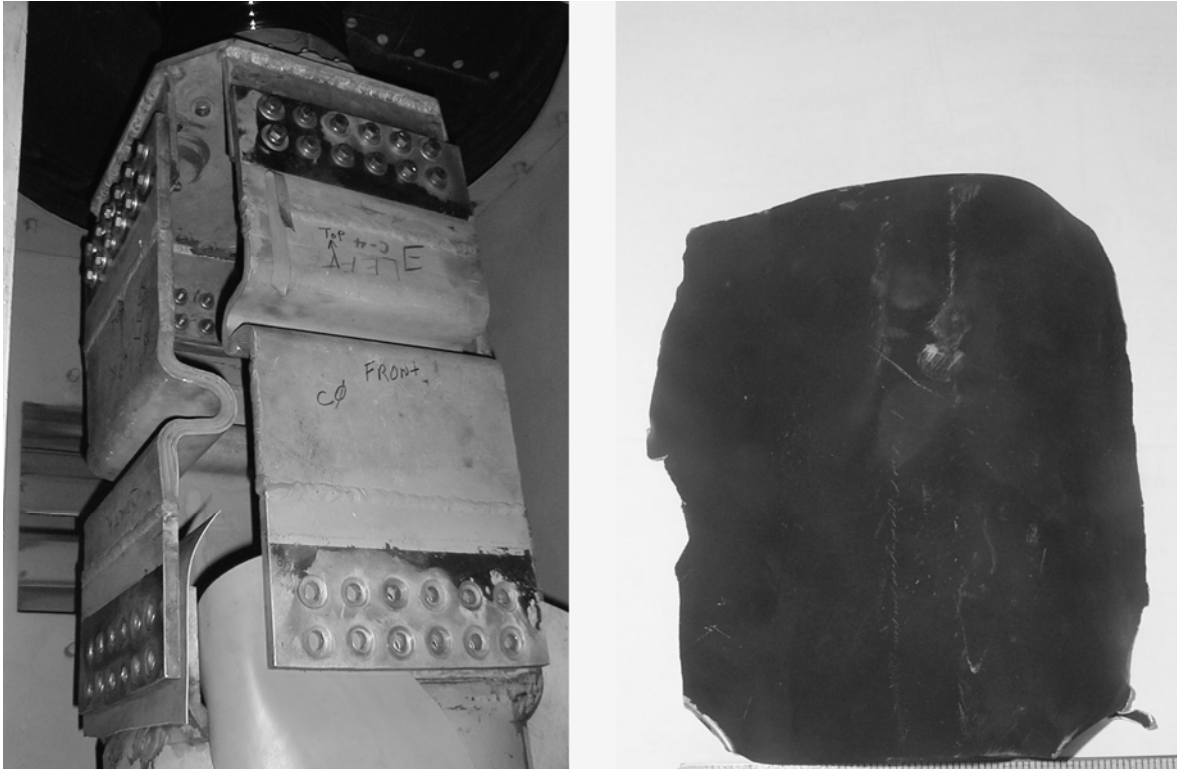
The use of the laminar-style flexible links connecting the bus sections, bus to bushing, and neutral bus have been problematic. Cyclic vibration, increased air flow, and/or age-related thermal cycling has resulted in cracking of laminations, as shown in Figure 12-3. Cracked laminations have been found to be the cause of unit trips on neutral/ground overcurrent relay actuation.

Figure 12-3
Main Generator Flexible Link Lamination Style and Delaminated Piece That Caused a Unit Trip

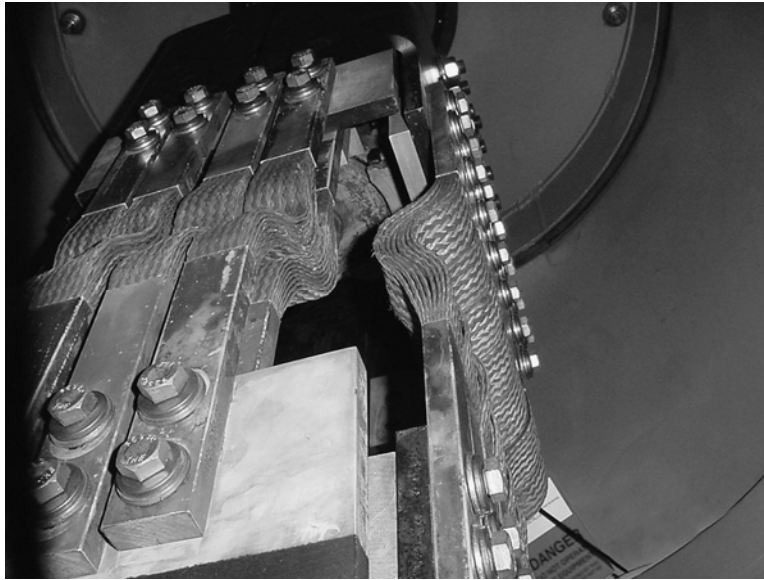
The recommended replacement for the laminar-style links is the use of a flexible braid-style link. Flexible braid-style links can also be damaged by improper maintenance techniques. Electricians need to be careful not to overstress the braids by bending them backward during removal and installation. Repeated flexing or bending, as illustrated in Figures 12-4 and 12-5, could result in breaking of strands and greatly reduced life.

Figure 12-4
Flexible Braid-Style Main Generator Links

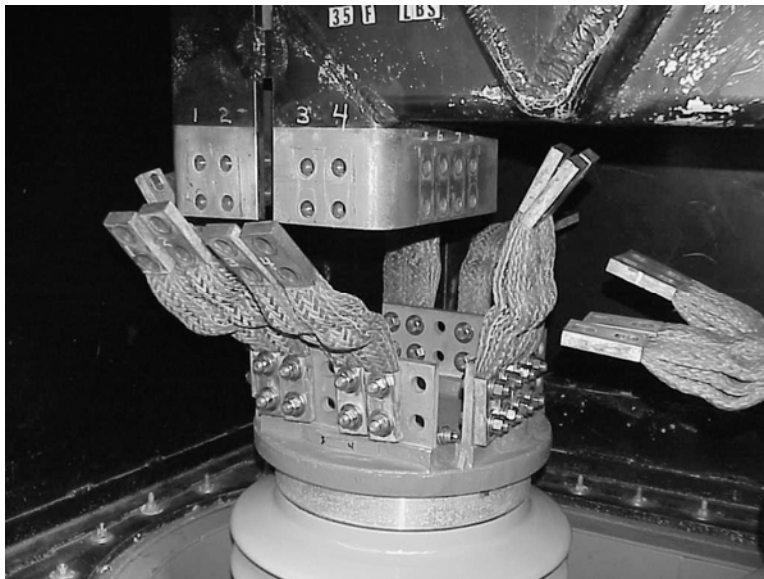
Figure 12-5
Flexible Links at Transformer End Improperly Bent Back (This practice could lead to broken strands and shortened link life.)

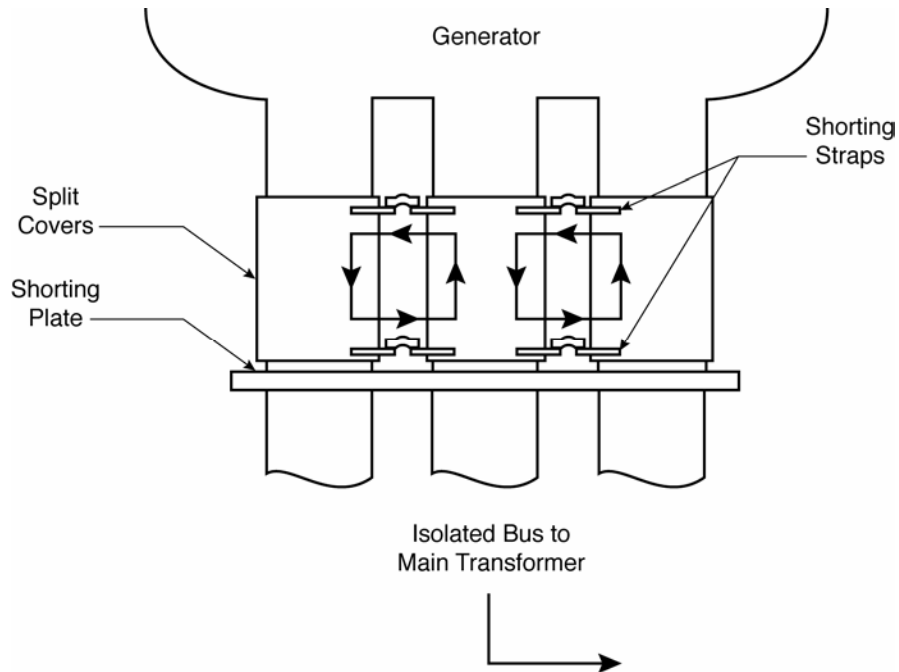
The ends of continuous enclosure bus are fitted with thick shorting plates welded to two or all three of the outer tubes. Beyond this shorting plate, a very strong magnetic field exists. This is often the case at transformers; however, near the generator bushings, split covers are sometimes used (as shown in Figure 12-6) to eliminate the external magnetic field and reduce mechanical forces on the generator bushings during a bus fault. This assembly has all of the features of the main bus except that it is insulated from adjacent structures and grounded at only one location. Failure of this thin insulation gasket is a common problem. Secondary grounds can result in unwanted circulating currents and overheating of adjacent structures or the split covers.

Figure 12-6
Typical Arrangement of Split Covers

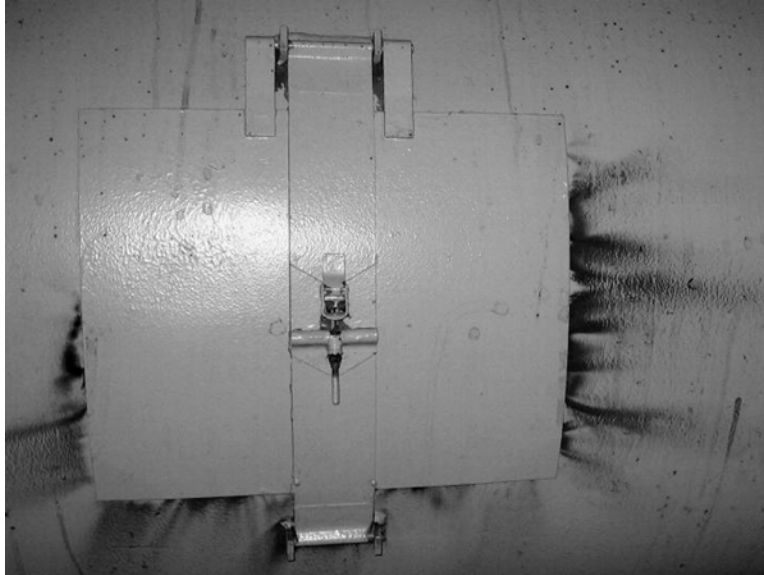
Removable hatches or inspection covers are often provided along the enclosure to permit access to center conductor support insulators, expansion joints, and other internal components. These covers should be both air- and water-tight to keep contamination out of the bus. Gasket material often hardens and cracks, as shown in Figure 12-7, because of fluctuation in operating temperatures. Replacement can be expected. The use of closed-cell silicone rubber sponge per aerospace material specification (AMS) 3195, medium or soft, has been found to be a long-term solution to inspection cover gasket deterioration.

Figure 12-7
Inspection Cover with Failed Gasket, Noting Evidence of Gasket Breakdown on the Surface of the Bus Duct

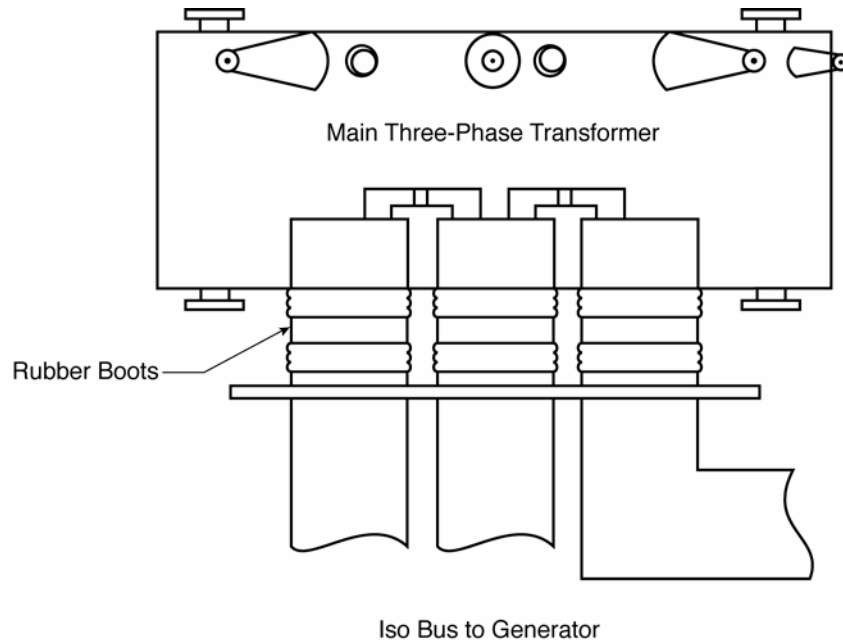
With many designs, each enclosure is fitted with a rubber expansion joint between the end shorting plate and transformer bushing, as illustrated in Figure 12-8. These “boots” keep rain and dirt out and keep bus-cooling air in. An insulating material is necessary to eliminate stray currents in this non-shielded area. Usually, the original material deteriorates from heat and sunlight in 15–20 years. Replacements can be ordered from the original supplier or fabricated by a ventilation contractor. If non-OEM boots are installed, no wire-reinforced material can be used and only high-temperature (Thermal Class F, 311°F [155°C]) components will provide long life. Low-temperature material was the downfall of many OEM designs.

Figure 12-8
Typical Location of Enclosure Boots

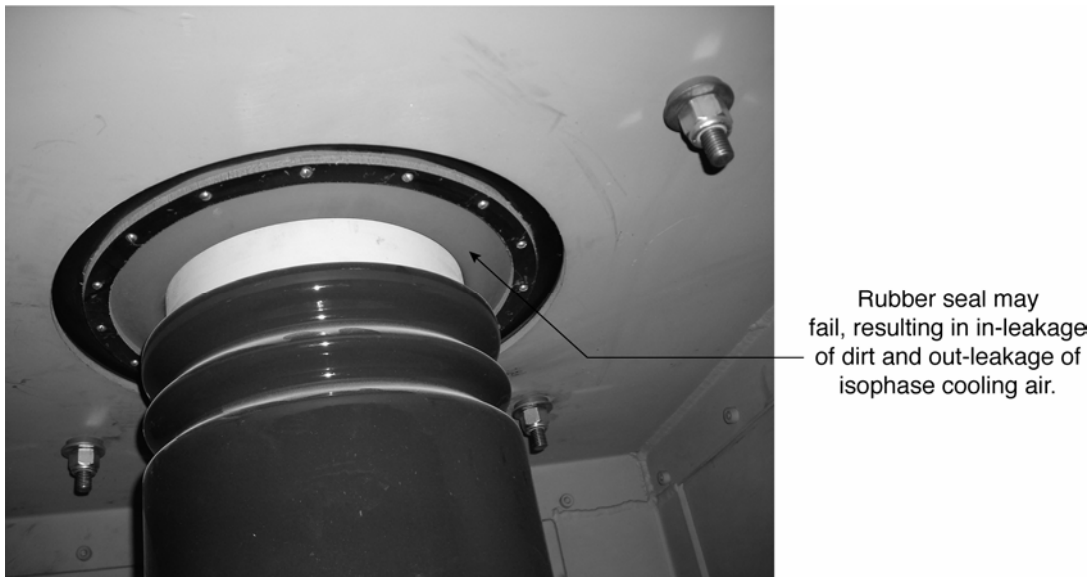
Many generators also have a rubber seal or boot, as shown in Figure 12-9, between the bushings and the neutral or high-voltage bushing box penetrations. These seals serve a similar function in keeping dirt out and cooling air in on forced-air isophase systems. These seals may fail from thermal degradation over time and must be replaced.

Figure 12-9
24-kV Generator Bushing with a Rubber Seal

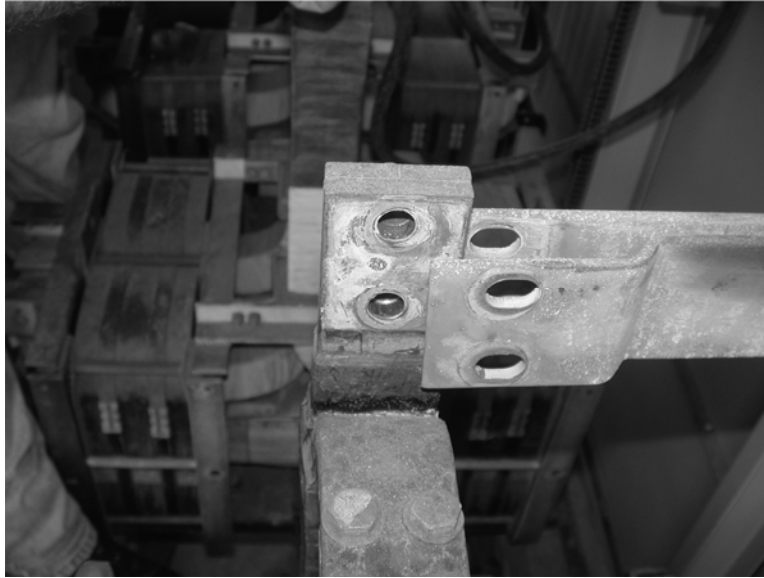
Figure A-1
Typical Neutral Connection Point on the 13.8-kV Segregated Bus

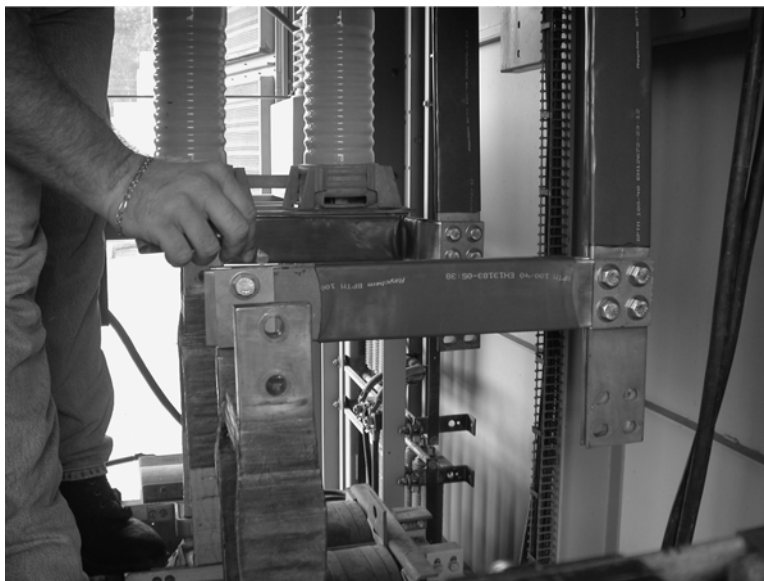
Figure A-2
Improved Neutral Connection Using Stainless Steel Plates on Both Sides of the Bus Bar, Stainless Steel Bolting, and Belleville Washers (The electrician is making a cursory examination of the connection point with a 0.002-in. [0.051-mm] feeler gauge.)

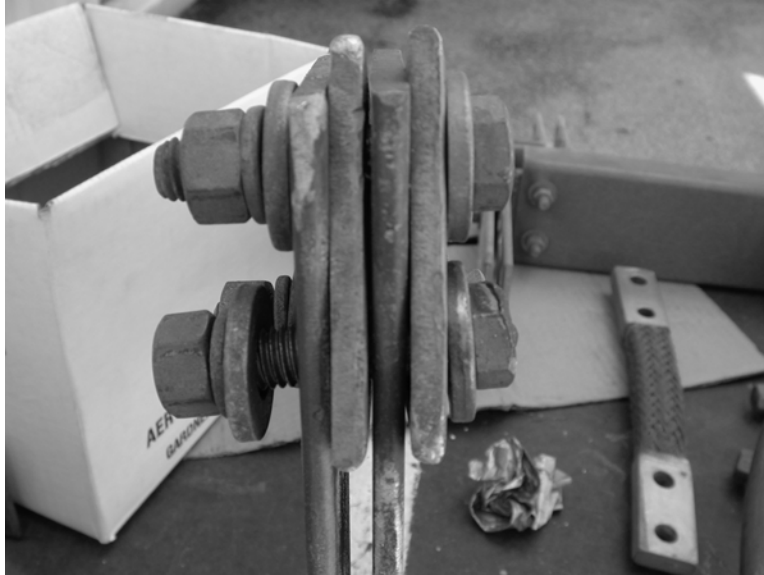
Figure A-3
Typical As-Found Bolted Bus Bar Connection Using Steel Bolts and Flat Washers

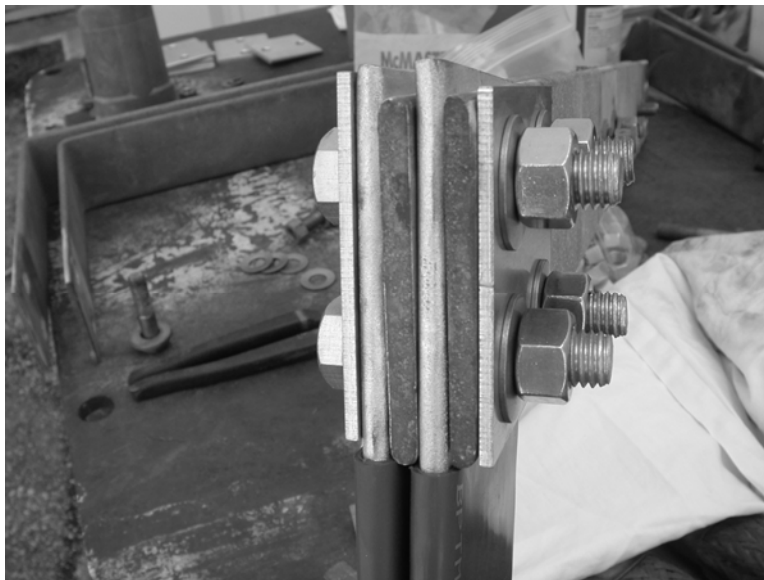
Figure A-4
Improved Connection with Stainless Steel Plates on the Outside of the Bus Bars to Spread the Compressive Load of the Bolts, Stainless Steel Bolts, and Belleville Washers

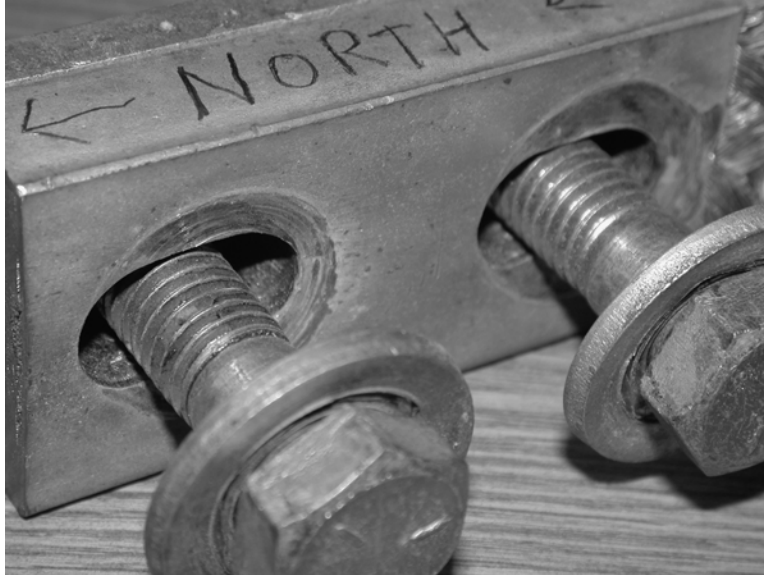
Figure A-5
Flexible Strap Ends That Have Been Overtorqued into Concave Condition

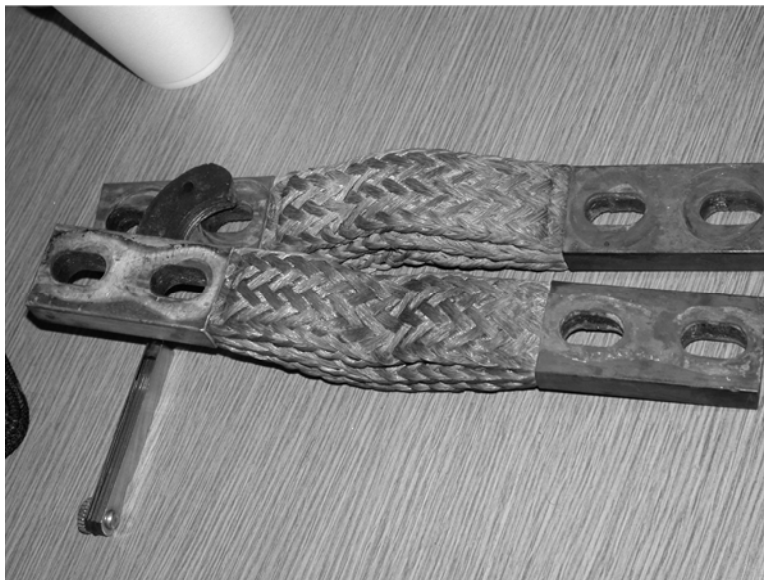
Figure A-6
Typical Electrical Connection Pattern on Flexible Strap Ends; Design Is for the Entire Surface to Be in Contact with the Bus or Neutral Bus Segment (Poor electrical connections have caused the bus and the strap ends to be heated.)

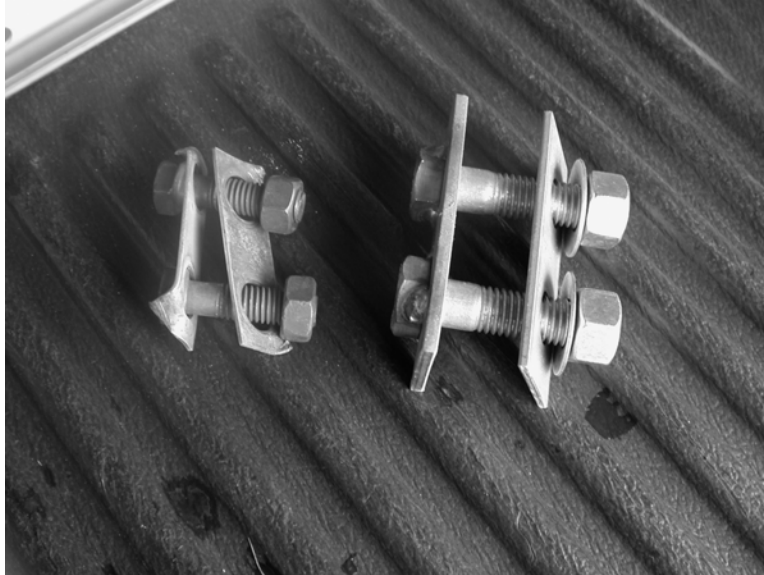
Figure A-7
Before and After Flexible Strap End Bolting (The plate with the stainless steel bolts tack-welded in place provides technicians with a much easier to use bolting configuration.)

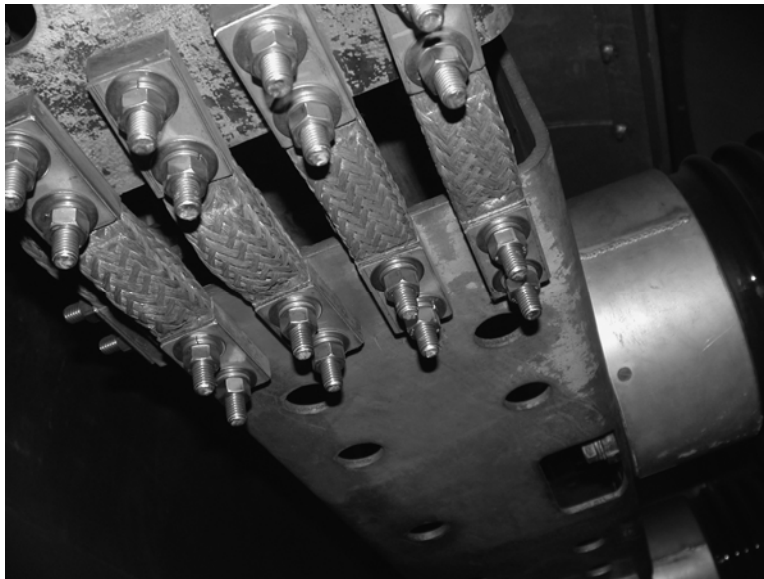
Figure A-8
Flexible Straps Between Neutral Bus Segments with Improved Stainless Steel Plates, Bolting, and Belleville Washers (The bracket with two bolts tack-welded in place drops into the holes in the bus segments. Tightening the nuts on the outside does not require holding the bolt head on the inside.)

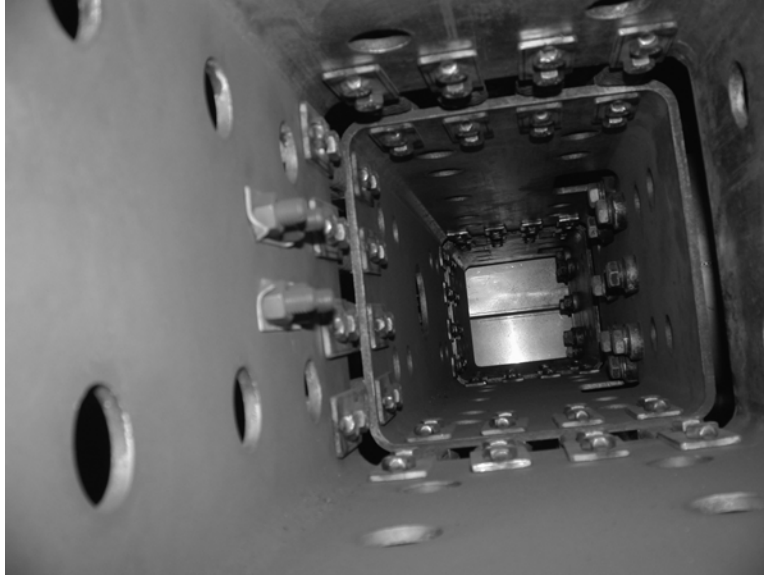
Figure A-9
Neutral Bus Segments from the Inside (The plates with the bolts tack-welded in place make assembly much easier. The four silicone-bronze bolts and existing bend-up tabs on the left are the neutral grounding transformer connection point. They were changed to stainless steel bolts and Belleville washers after this picture was taken.)

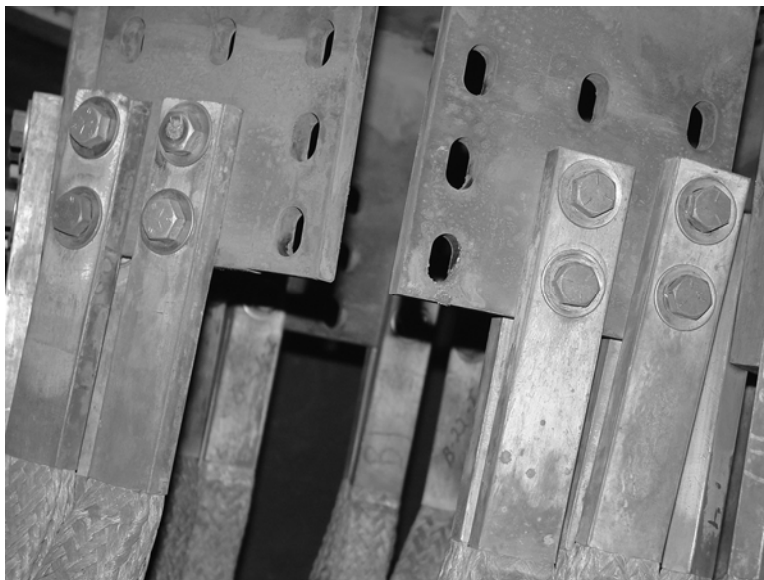
Figure A-10
Typical Main Lead Connection Plate to Isophase Bus Work Flexible Links

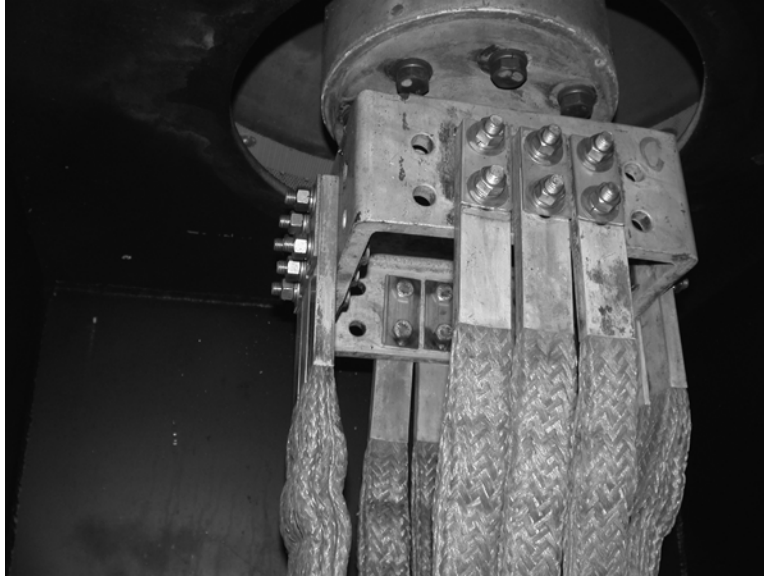
Figure A-11
Improved Main Lead Connection Plate to Isophase Bus Work Flexible Links (The plates with the bolts tack-welded in place are on the inside. Stainless steel plates, Belleville washers, and nuts are on the outside. Again, this arrangement is easy to work while significantly improving the electrical connections.)

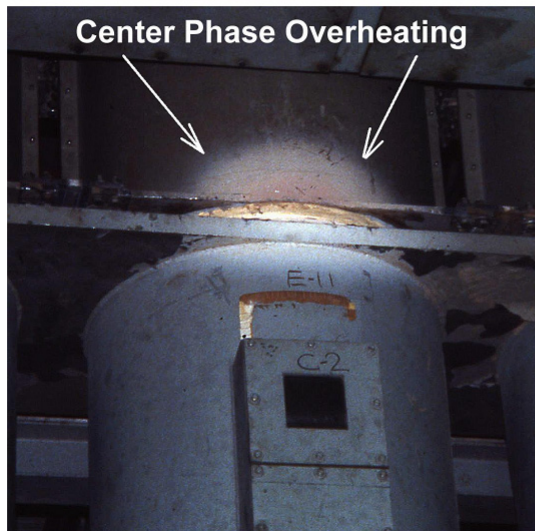
In some cases, heating is extreme.

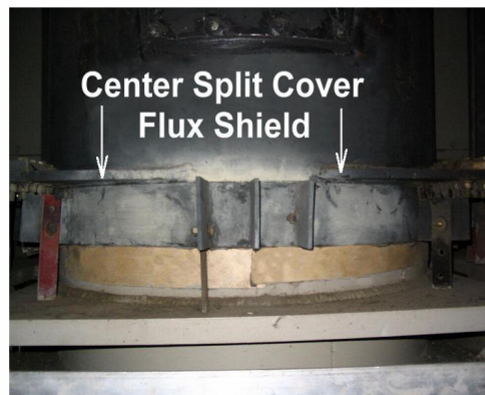
This common problem results from stray flux heating, thin material, and inadequate cooling. A supplemental external flux shield is usually required to reduce center phase split cover temperatures.

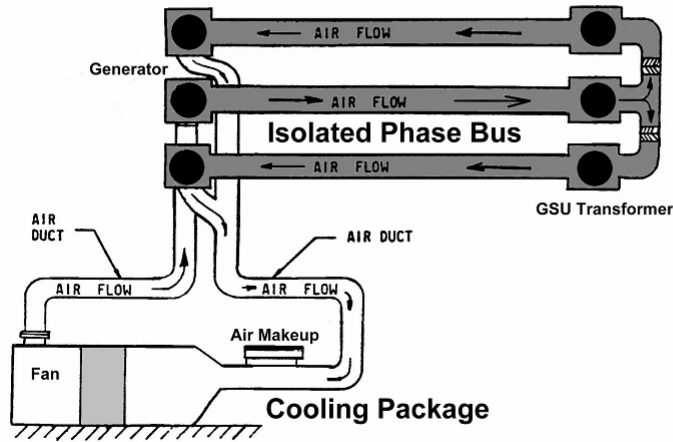
Cooling is critical to the reliable operation of the isophase bus. Loss of cooling requires quick operator response.

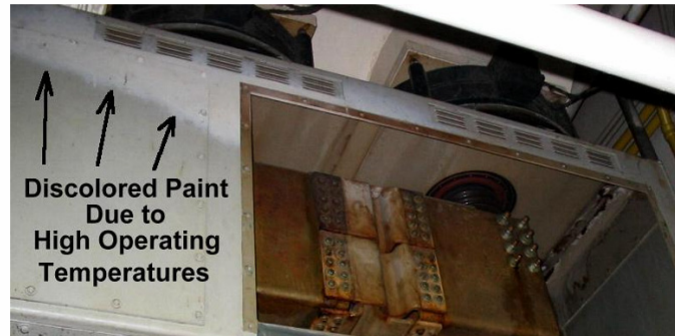
Visual inspection found chalked paint resulting from overheating of this neutral enclosure. New ventilation holes were added to improve cooling.

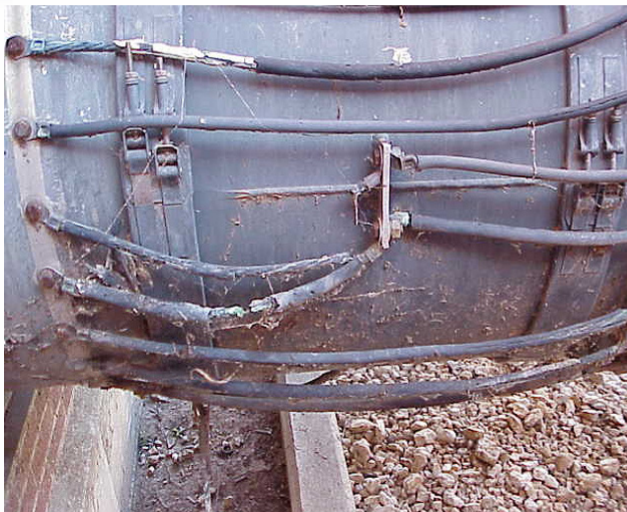
A visual inspection will easily identify some types of deterioration.
