Nuclear Maintenance Applications Center: Isolated Phase Bus Maintenance Guide

Update to TR-112784

1015057

Final Report, December 2007

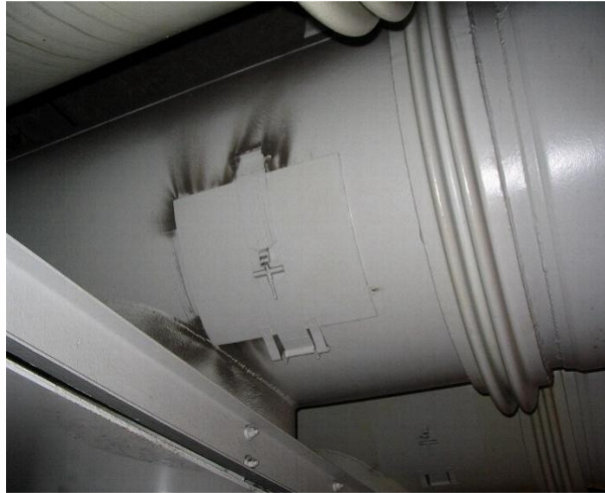
Forced air-cooled systems often develop air leaks around the inspection hatches due to hardening of the original gasket material.

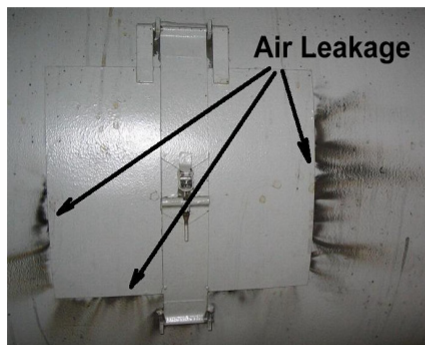
Enclosure gaskets that harden and leak air or allow water to enter are a common problem.

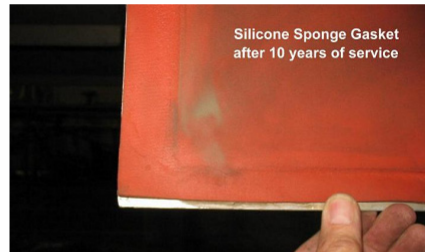
Replacement with improved new material may be warranted.

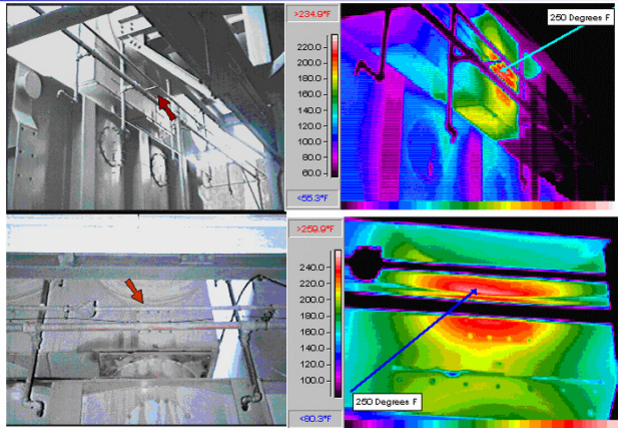
IR image of indirect heating of low-voltage connection to isophase bus

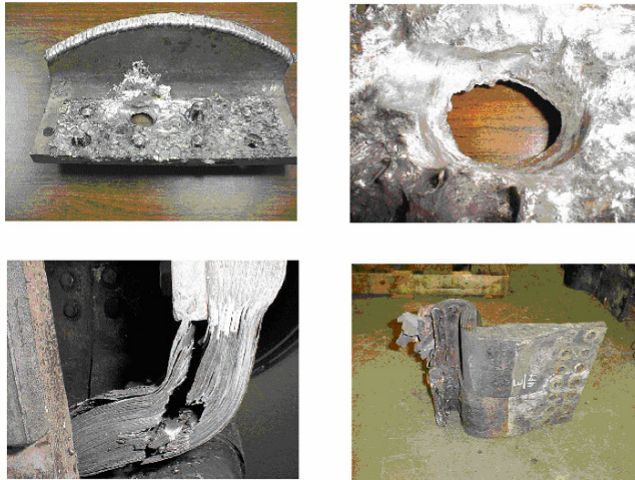
Damage found when doghouse opened and inspected

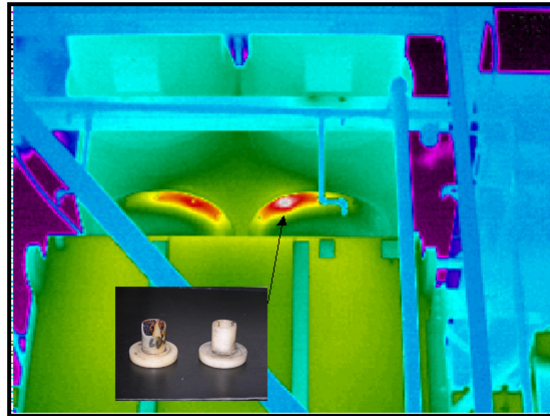
Induced heating at isophase to GSU doghouse

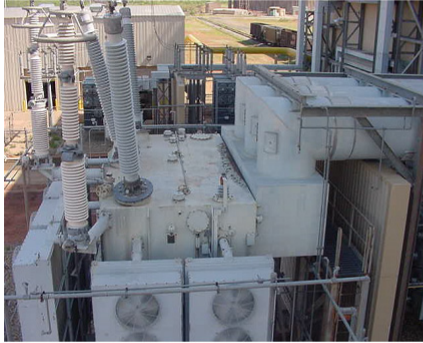
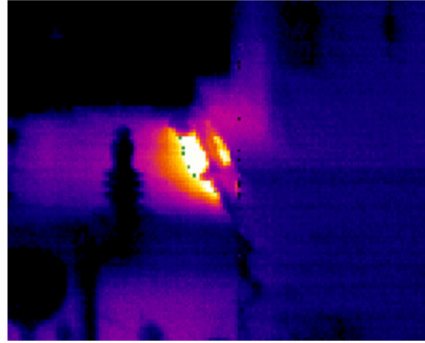
Flux shields are often required to solve high stray flux heating problems as shown here on a transformer tank lid.

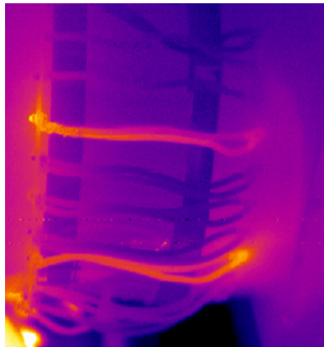
Overloaded jumpers

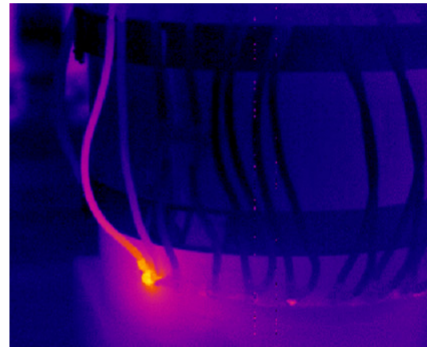
Loose connections

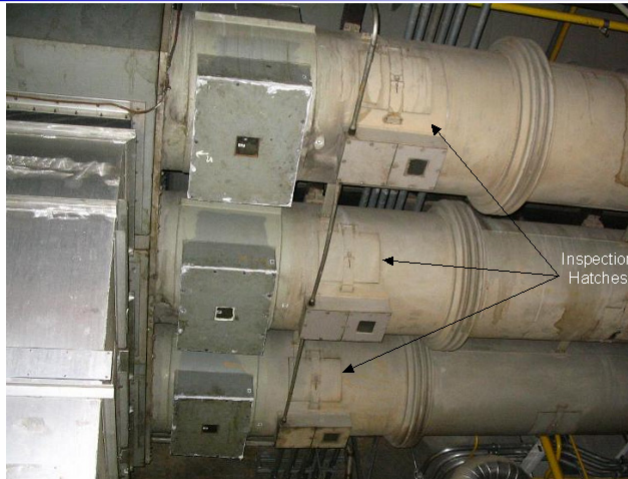
Most designs have inspection covers at each support insulator and near the internal conductor removable links.

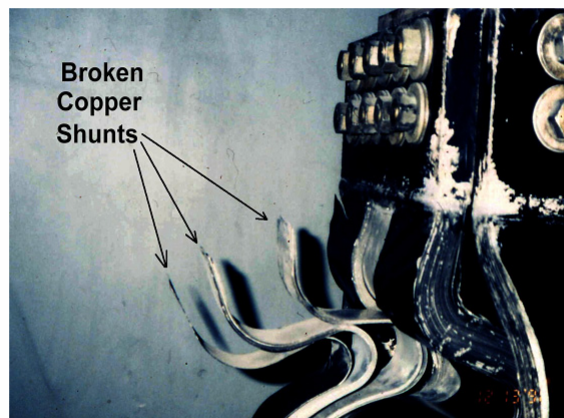
Broken conductor shunts will develop. Periodic visual inspection will locate them (EMI detection can also be used).

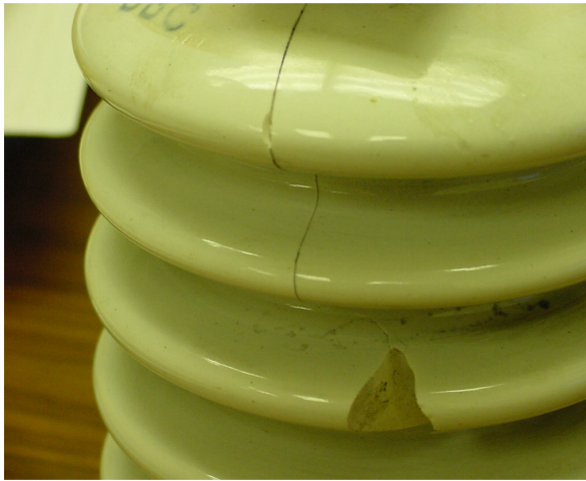
High vibration can result in broken support insulators.

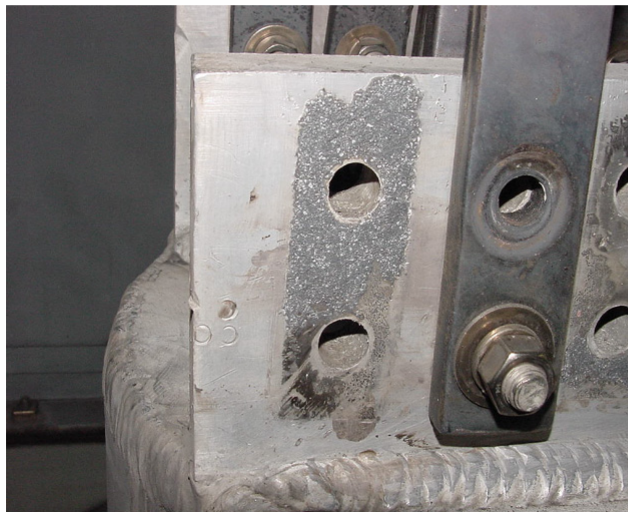
Bolted connections can deteriorate.

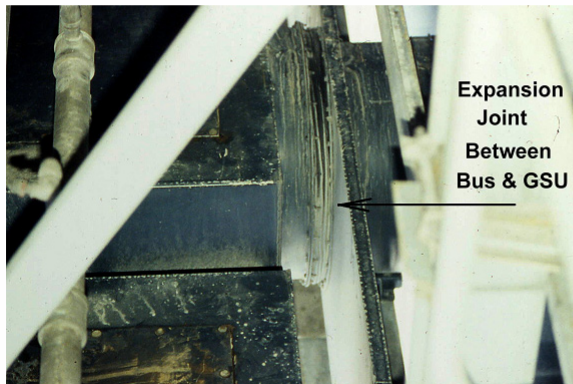
Some designs have an insulated expansion “bellows” between the bus enclosures and GSU. This must remain airtight and insulated.

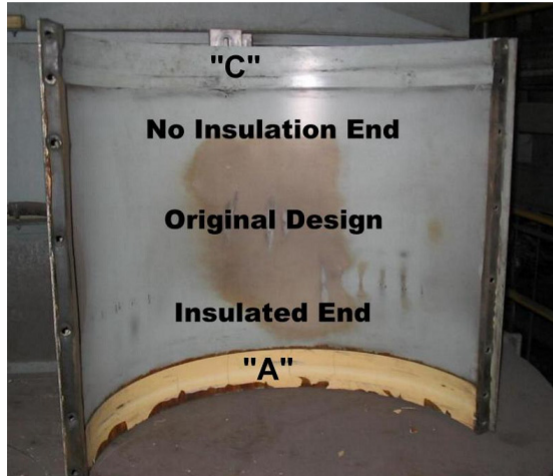
Split cover insulating gaskets and air seals deteriorate. Enclosure-to-split cover sparking resulted.

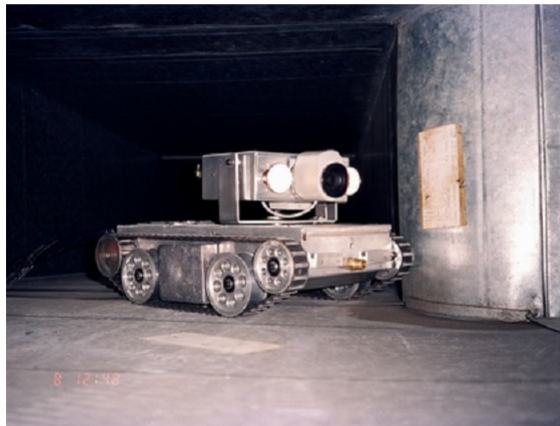
Visual inspections can be hampered by poor access. Robotic walkers with video recording can improve results.

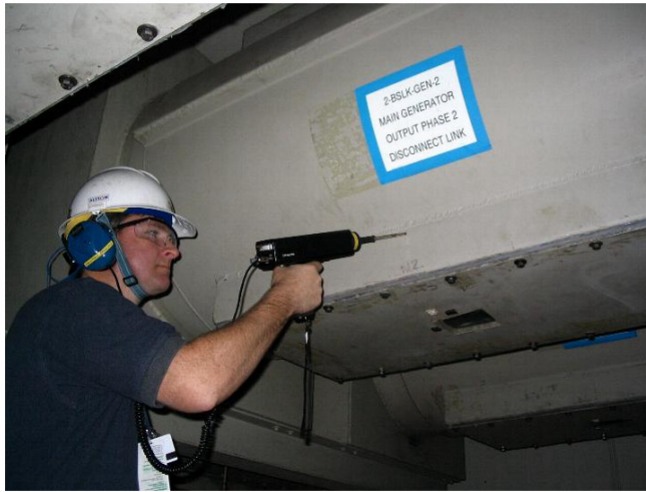
Ultrasonic probes have proven to be useful in detecting localized defects.
