Harmonic Impacts Due to Induction Furnaces on a Distribution System

Section 1.1: Introduction

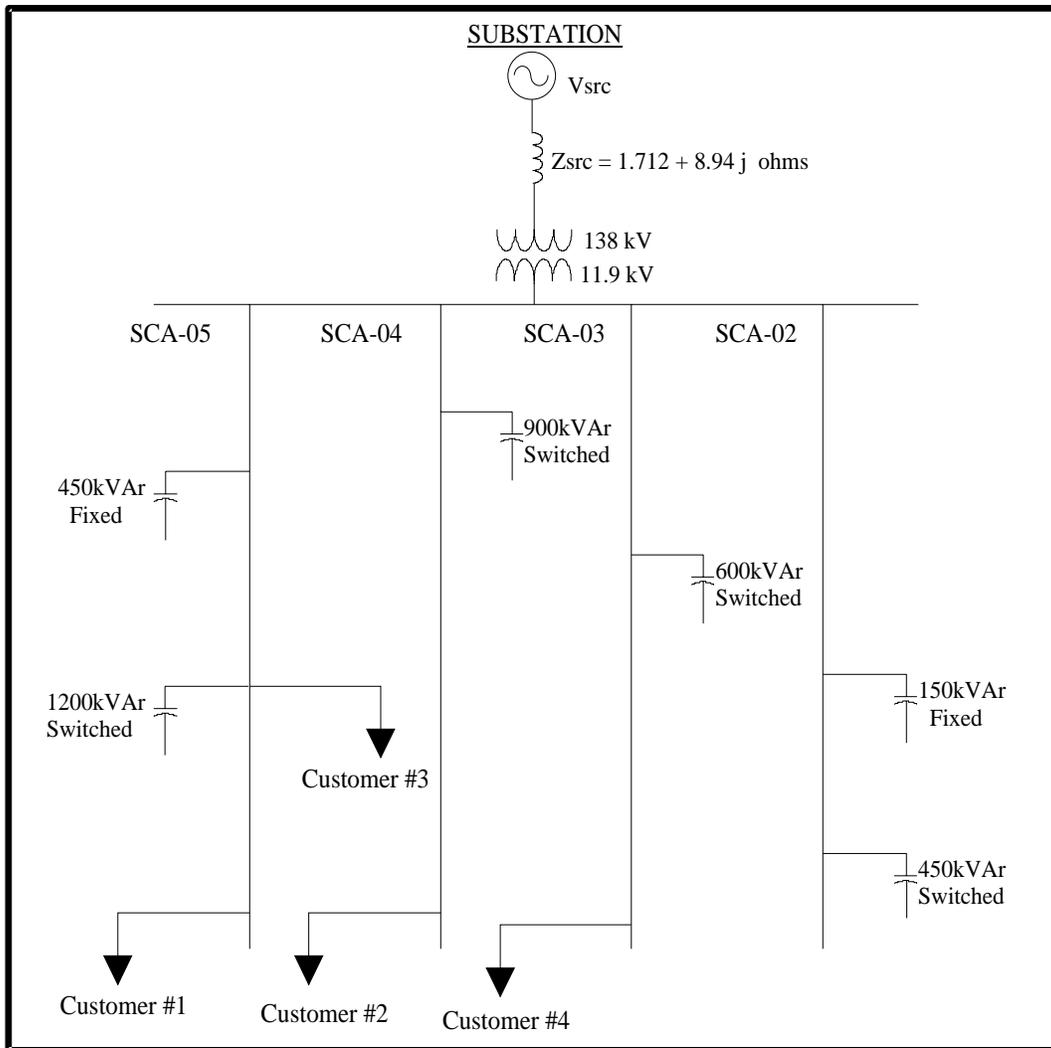
An industrial customer, customer #1, has been experiencing a number of problems with the power converters used in their induction furnace loads. Harmonic distortion levels were measured on this system and found to be very high throughout the distribution system. The harmonics are being caused by the induction furnaces at the plant and at other industrial customers (including other induction furnace loads) on the same distribution system. There are also a number of capacitor banks located on the primary distribution systems which are aggravating the harmonic problem by causing resonance conditions. A one-line diagram of the system is illustrated in Figure 1.1.

Figure 1.1: One-Line Diagram of System

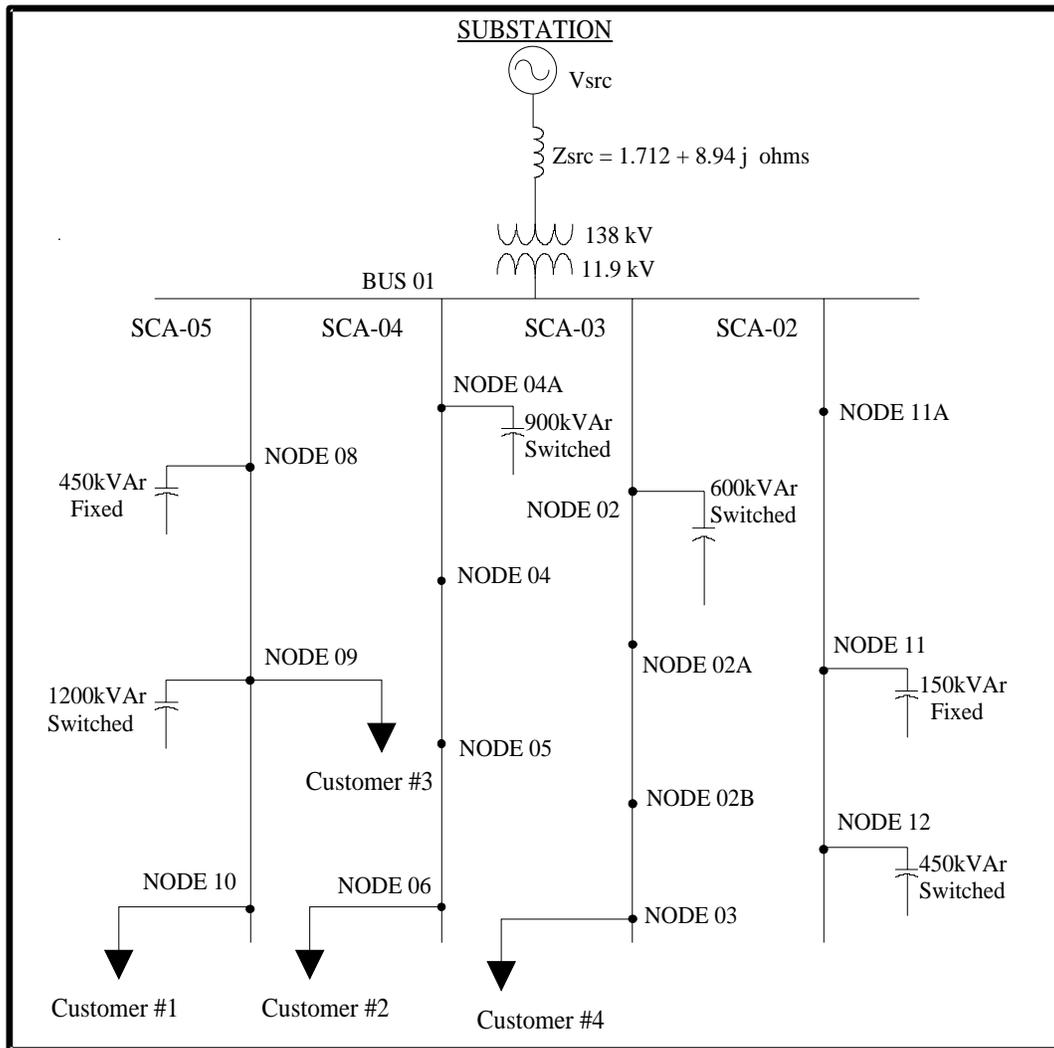
The power system investigated is shown in Figure 2.1. There are four customers which have a high percentage of nonlinear loads; customer #1, #2, #3 and #4. The substation transformer is a 15 MVA delta-wye connected transformer with an impedance of 8%. The capacitor banks in the one-line diagram are all ungrounded wye connected and the branches shown in the diagram were modeled with pi equivalents.

Figure 2.1: One-Line Diagram

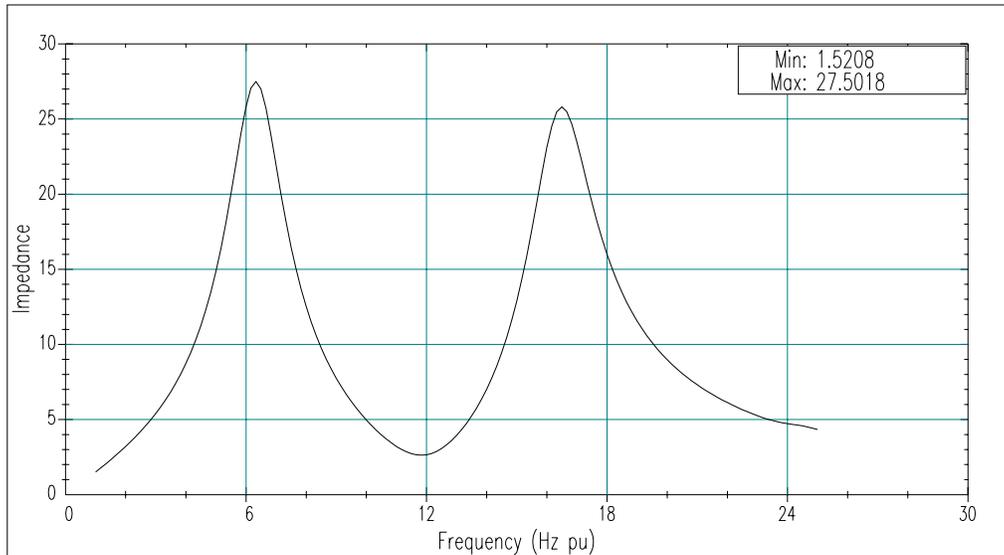
The system described in Section 2 was simulated using a harmonic analysis program. Figure 4.1 shows the frequency scan of the base case simulation at customer #1. This case modeled the system before the installation of the filters but with all distribution capacitor banks in. It is evident in this figure that there exists a potential resonance problem due to the capacitor banks located throughout the power system. The figure shows that the impedances at characteristic harmonic frequencies (5th and 7th) are high which results in a high level of voltage distortion. The actual system resonance is between the sixth and seventh harmonic.

Figure 4.1: Frequency Scan at Customer #1

The verification of the proposed filter designs commenced with simulations of the filters for the primary side at customer #1 and #2. The proposed filters were added to the system model. As was noted in Figure 4.1, the capacitors in the system contribute to the resonance conditions observed at higher harmonics, therefore, the other capacitor banks were removed from the system. Figure 5.1 compares the frequency scans at customer #1 with and without filters.

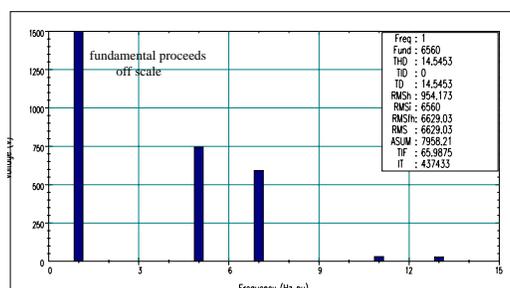
The harmonic voltage spectrum can be seen in Figure 4.2 at customer #1. The distortion is particularly evident at the 5th and 7th harmonics, contributing to a total harmonic distortion of 14.55% on the high side of the transformer.

Figure 4.2: Harmonic Voltage Spectrum at Customer #1 (High Side)

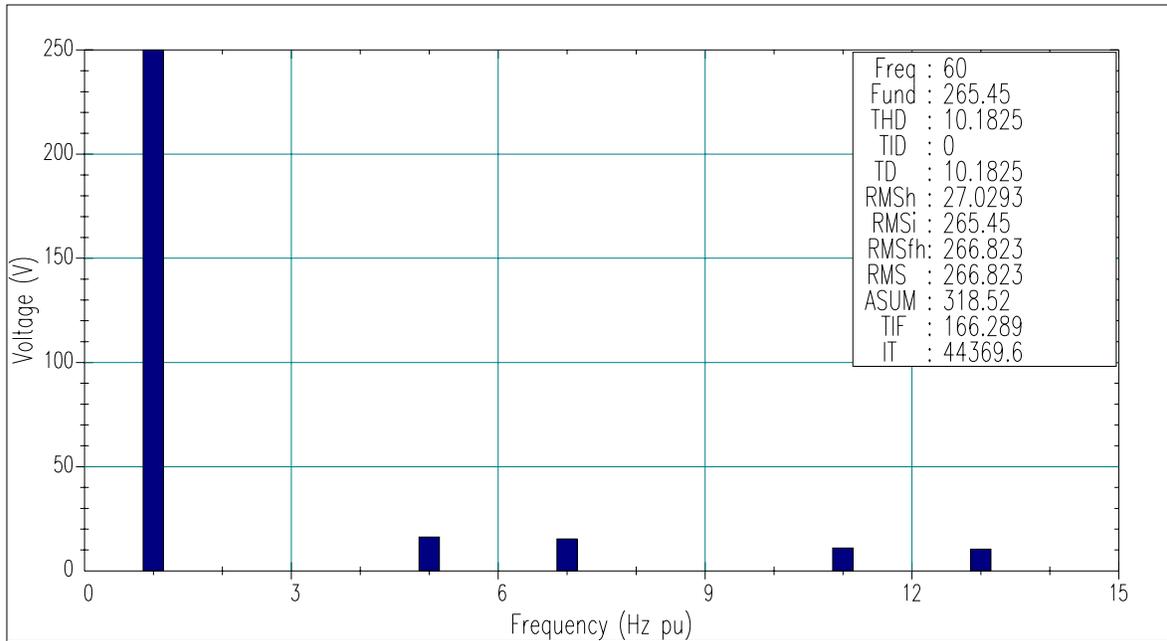
It can be seen in Table 4.3 that the simulated values compare favorably with the measurements at both locations. It is likely that at least the fixed capacitor banks were in service during the measurements. Figure 4.3 is an example of the harmonic spectrum at customer #1 for the case with the fixed capacitor banks in service.

Figure 4.3: Simulated Harmonic Voltage Spectrum at Customer #1 (Low Side)

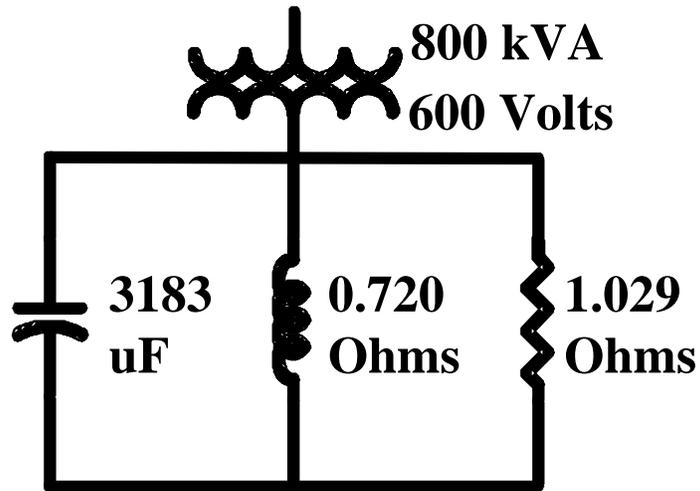
The 60 Hz furnaces are of concern because they can presently only be run at 60% of full power. Plant engineers at customer #1 would like to increase production with this furnace. The 60 Hz furnace was modeled using an equivalent parallel RLC circuit as shown in Figure 4.4. This furnace is very difficult to model because three different parameters can vary. These parameters include the tap changing autotransformer, furnace coil, and furnace power factor correction capacitors. The furnace parameters modeled in Figure 4.4 represent one estimated operating condition. This condition resulted in severe voltage distortion at the 600 V bus (about 27%). A series resonance draws harmonic currents down from the high voltage bus at customer #1 as shown in Figure 4.5. A parallel resonance causes magnified voltage distortion as shown in Figure 4.6. This bus is very important and should be monitored.

Figure 4.4: Equivalent Furnace Model

- The 60 Hz furnace monitoring device is very important. This furnace was modeled using an equivalent parallel RLC circuit. The furnace is very difficult to model because three different parameters can vary. These parameters include the tap changing

autotransformer, furnace coil, and furnace power factor correction capacitors. The furnace parameters modeled represent one estimated operating condition. This condition resulted in severe voltage distortion at the furnace 600 V bus. A series resonance draws harmonic currents down from the high voltage bus at customer #1, and a parallel resonance causes magnified voltage distortion. The simulations also showed that with the filters at customer #1 installed, the harmonic currents are directed into the filters and not into the 60 Hz furnaces. This reduces the low side voltage distortion to acceptable levels, which should allow the 60 Hz furnaces to run at a higher power rating. The monitoring device will be used to verify the harmonic levels and furnace operating conditions.

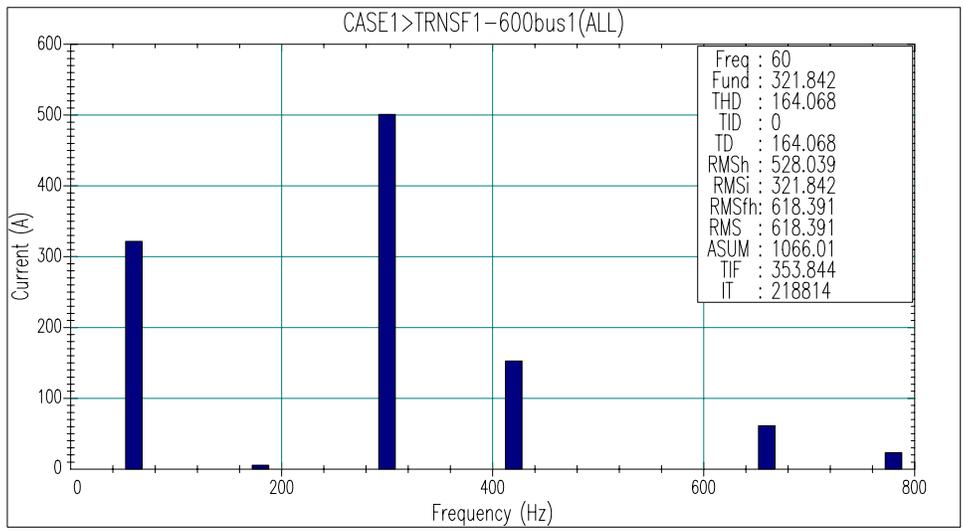
Figure 4.5: 60 Hz Furnace Current

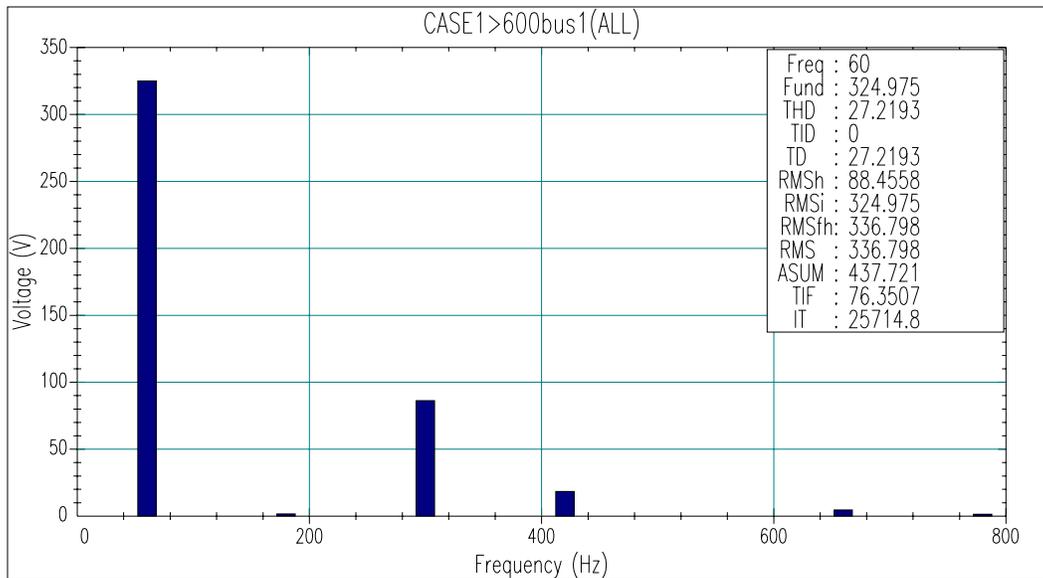
Figure 4.6: 60 Hz Furnace Low Side Voltage Distortion

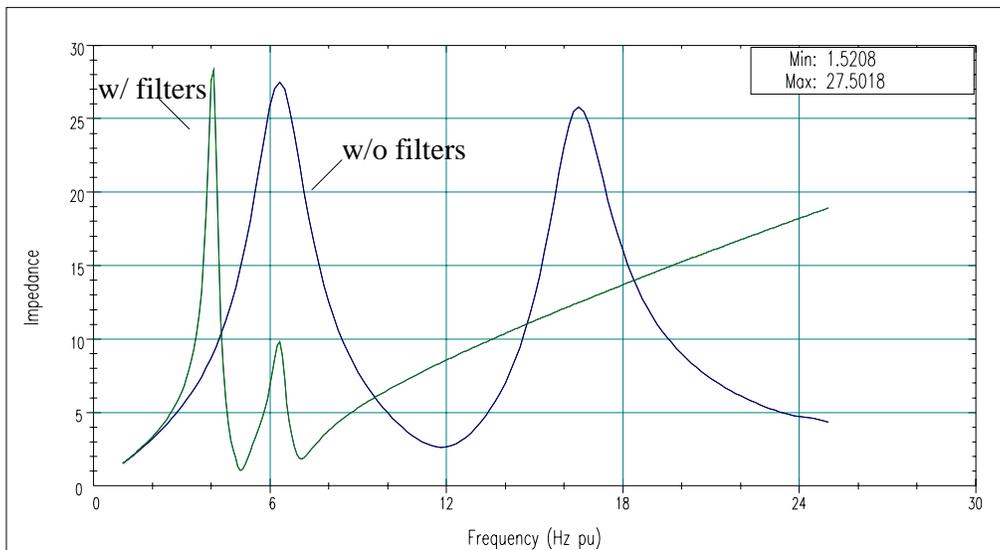
Figure 5.1: Frequency Scan at Customer #1

The frequency scan with filters shows an expected parallel resonance before a reduction in the impedance at characteristic harmonic frequencies. As desired, the fifth and seventh harmonic filters have effectively lowered the impedance at these frequencies. The effect of the filters on the voltage distortion levels can be observed in Figure 5.2. The addition of the filters reduced the total harmonic voltage distortion at customer #1 to 1.56%. Table 5.1 compares the voltage THD values at the other locations. These values are significantly less than the distortion evident before the installation of the filters.

The initial peak observed in Figure 5.1 occurs at the fourth harmonic with an impedance of 28 ohms. The uncharacteristic injection of a third harmonic current of 1.5% was cause for some concern due to this high impedance. The addition of this non-characteristic harmonic showed a voltage distortion of only 30 V at the third harmonic. This satisfies the concern of high third harmonic voltage levels and verifies the primary filter design.

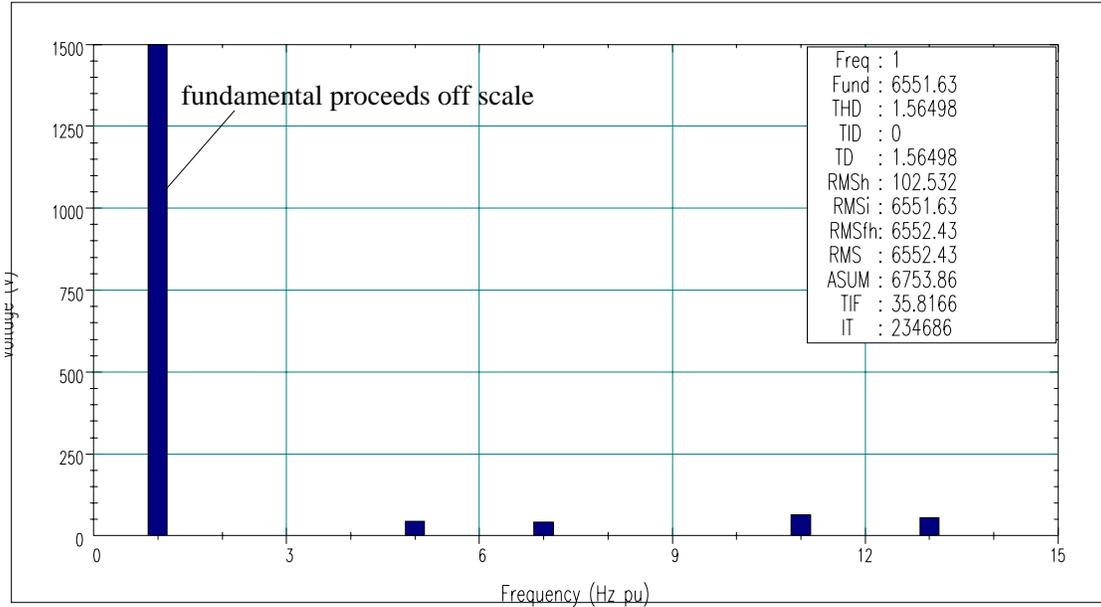
Figure 5.2: Harmonic Spectrum with Filters at Customer #1 (High Side)

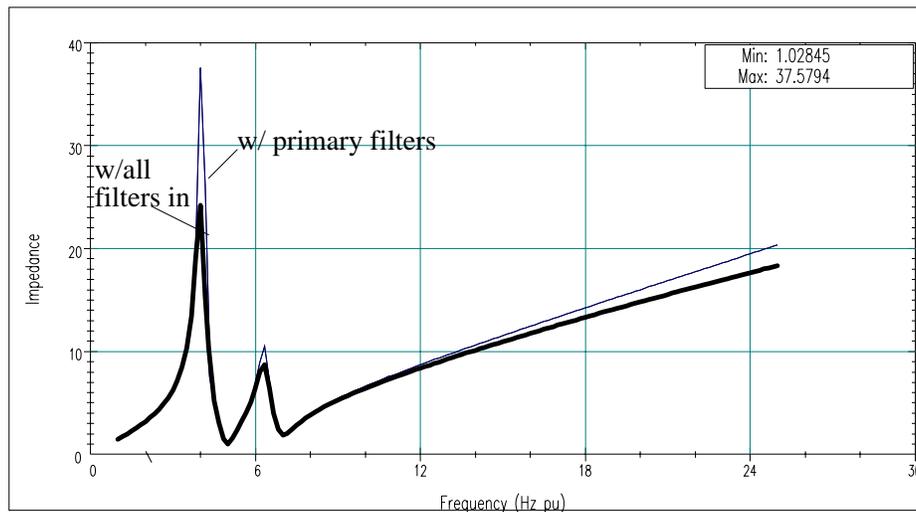
It can be seen from the values in Table 5.2 that the addition of the filters at customer #3 and #4 do not significantly change the THD values. The distortion evident with only the filters at customer #1 and #2 are within acceptable percentages. The effect on harmonic levels with the addition of the secondary filters can be seen in the frequency scans in Figure 5.3. The frequency scans were done on the high side of the transformer at customer #3. These filters succeeded in reducing the maximum harmonic resonance peak by 35%, yet the 5th and 7th harmonic notches remain at the same values. This accounts for the small decrease in the harmonic distortion.

Figure 5.3: Frequency Scans at Customer #3

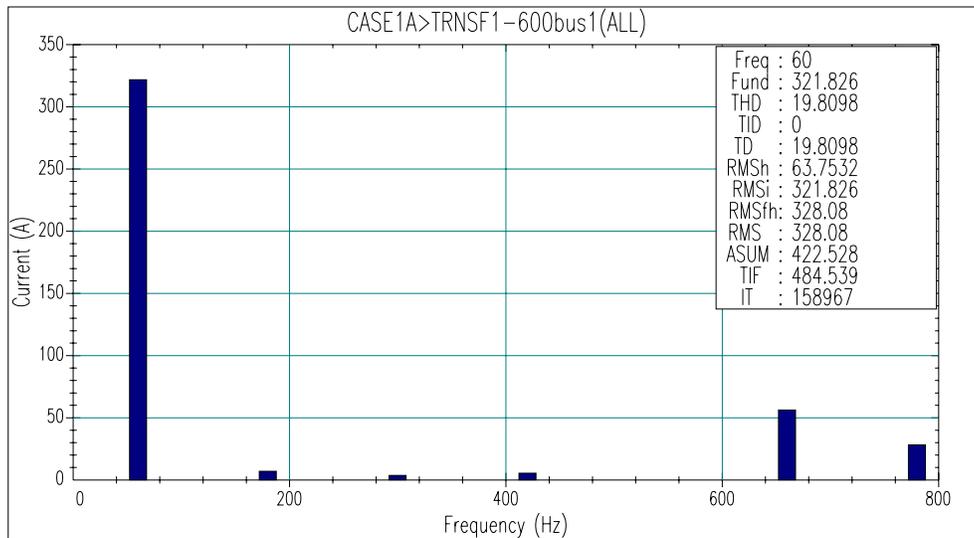
With the filters installed at the high voltage bus at customer #1, the harmonic currents are directed into the filters and not into the 60 Hz furnaces as shown in Figure 5.4. This reduces the low side voltage distortion to acceptable levels as shown in Figure 5.5. This should allow the 60 Hz furnaces to run at higher power ratings. The monitoring device will be used to verify the harmonic current and voltage levels and furnace operating conditions.

Figure 5.4: 60 Hz Furnace Current with Filters Installed at Customer #1

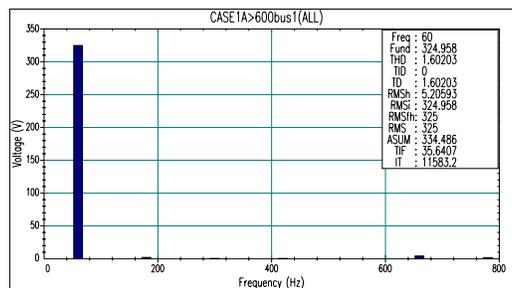
Figure 5.5: 60 Hz Furnace Low Side Voltage Distortion with Filters Installed at Customer #1
