Demonstration of Ultrasonic Guided Wave Examination Capability for FAC Damage and Circumferential Cracking

1019285

Technical Update, May 2009

Structural Integrity Associates, Inc.

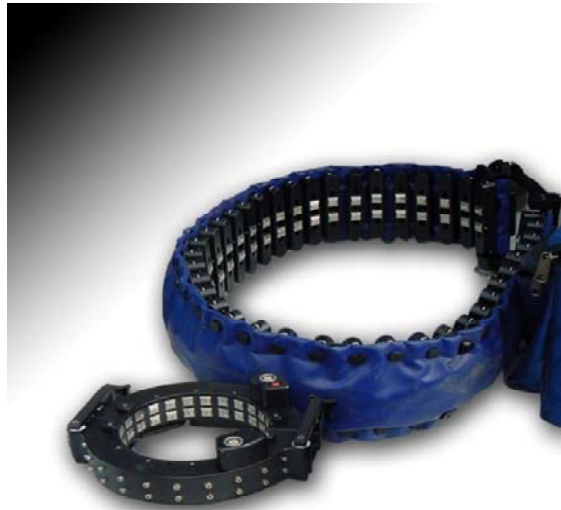
Figure 2-2
Guided Ultrasonics Ltd. Transducer Collars. Hard Collar is Black, Inflatable Collar is Blue.

Transducer collars are used to introduce the guided waves into the pipe and to detect reflected waves from features and wall loss. Figure 2-2 shows the two basic types of transducer collars; rigid or hard collar used on smaller diameter pipes up to 10 inches (250 mm) in diameter and inflatable collars used on larger diameter pipes typically up to 36 inches (900 mm) in diameter¹.

Typically, the collars have two rows of piezoelectric transducers. The collars are designed to be dry-coupled to the pipe and usually only take minutes to install. Minimal surface preparation is typically required to remove loose scale². The collars can be installed on pipes up to 300°F (150°C). Due to heat restraints for the piezoelectric transducers and the plastic transducer modules the transducer collars cannot be used on hotter pipes.

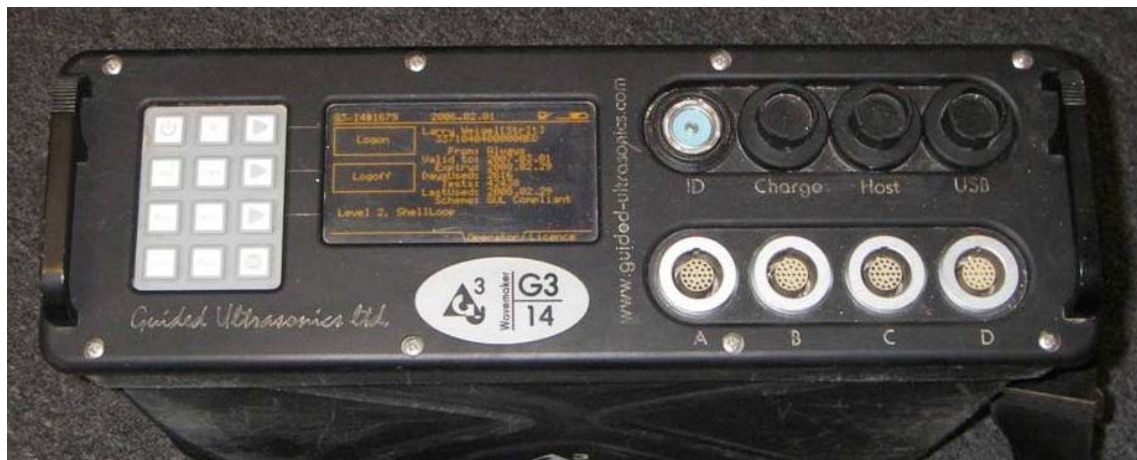
Figure 2-3
GUL G3 Guided Wave Ultrasonic Pulser

Figure 2-3 shows the GUL G3 pulser. This unit is the third generation of the GUL pulsars and includes a significant improvement in frequency interpolation. The pulser unit provides signal and energy to the transducer collar and does much of the signal processing. During each examination, it performs a series of diagnostic checks on the pulser, the transducer collar, and the cables. The unit is battery operated and portable.

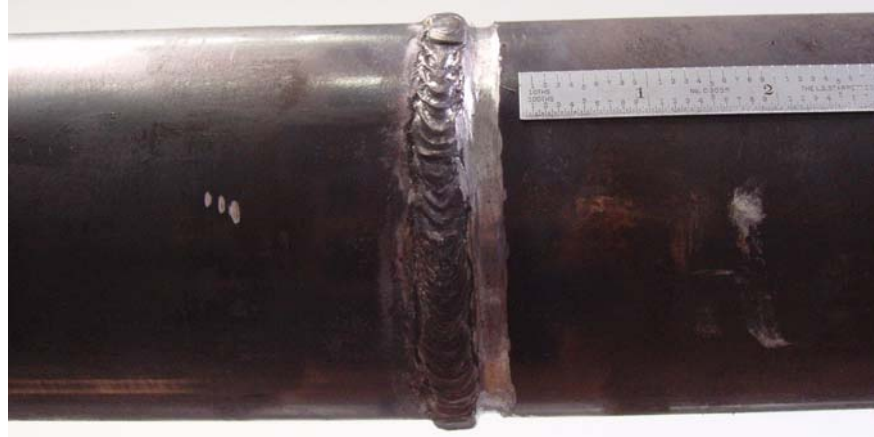
Figure 3-2
Flaw #1, 360° Groove Adjacent to Girth Weld

Flaw #1 was intended to simulate circumferential wall loss at a girth weld. A 360° groove was placed around a weld as shown in Figure 3-2. Examinations were performed when the groove was 30% and 60% of the wall thickness.

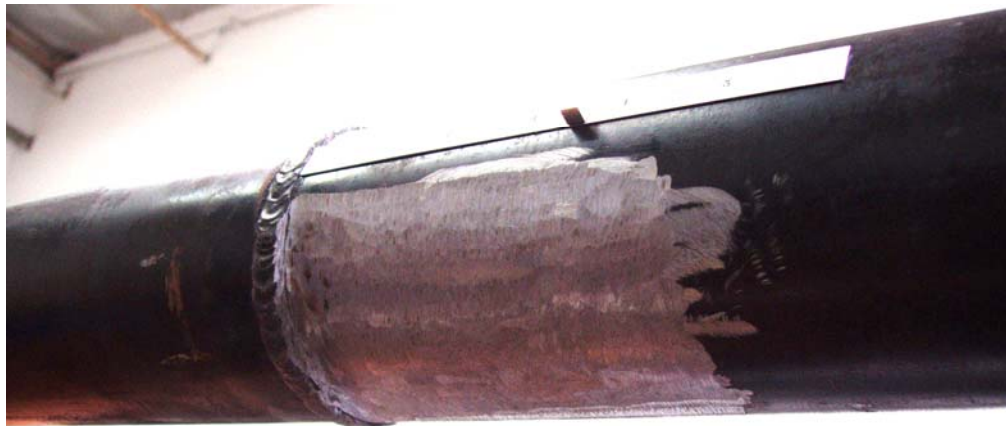
Figure 3-3
Flaw #2 Simulated Axial Wall Loss Associated with a Girth Weld

Flaw #2 simulates axial wall loss associated with a girth weld. This wall loss was greatest next to the girth weld and tapered off downstream of the weld. Figure 3-3 shows Flaw #2 that was 40% wall loss at the girth weld, 25% of the circumference and tapered from 40% to 0% over a 4-inch (102-mm) axial length.

Figure 4-4 shows a comparison of the response of Girth Weld #2 without a flaw (baseline case) to the weld with Flaw #2 which is shown in Figure 3-3. Flaw #2 represents 40% wall loss around 25% of the circumference, tapering back to the original wall thickness within 4 inches (100 mm).

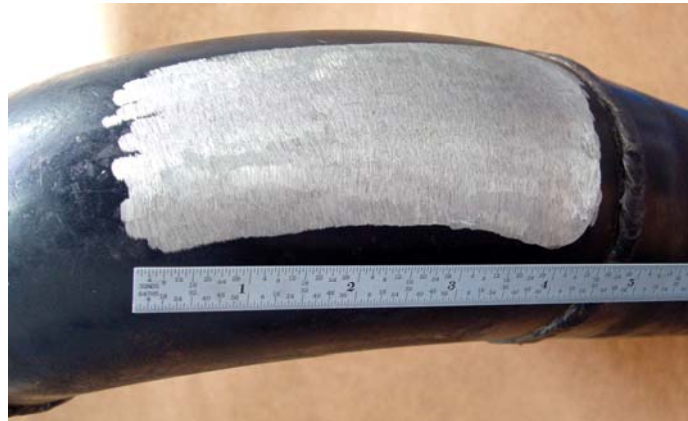
Figure 3-4
Flaw #3, Simulated Wall Loss in an Elbow

Flaw #3 simulates wall loss in an elbow associated with a girth weld. Figure 3-4 shows the simulated wall loss at the elbow with similar dimensions as Flaw #2; 40% wall loss at the girth weld, 25% of the circumference and tapered from 40% to 0% over a 4-inch (102-mm) axial length.

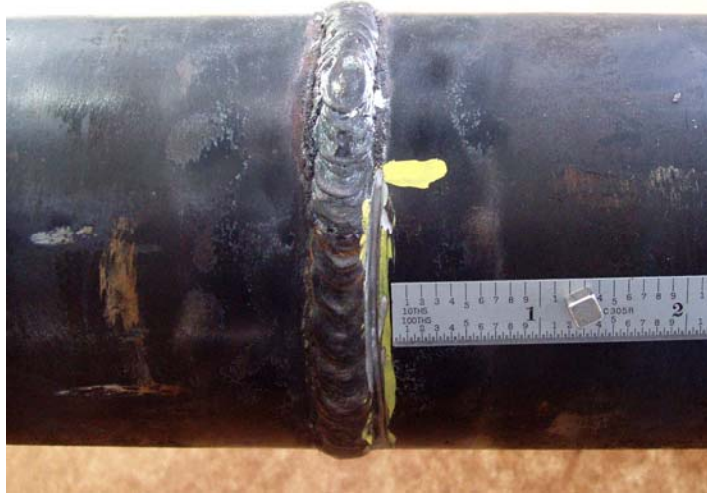
Figure 3-6
Flaw #4, 30% around the Circumference and 30% Through Wall

Circumferential radial cracking is a form of degradation that can occur in or near girth welds on high temperature piping systems as shown in Figure 3-5. Two circumferential radial slits were introduced into the test loop. Flaw #4, shown in Figure 3-6, is a slit that is 30% of the circumference and 30% of the wall thickness.

Figure 4-7 compares the response of the girth weld without a flaw (baseline case) to the girth weld with Flaw #4 as shown in Figure 3-6 which is a slit 30% wall loss and 30% around the circumference.

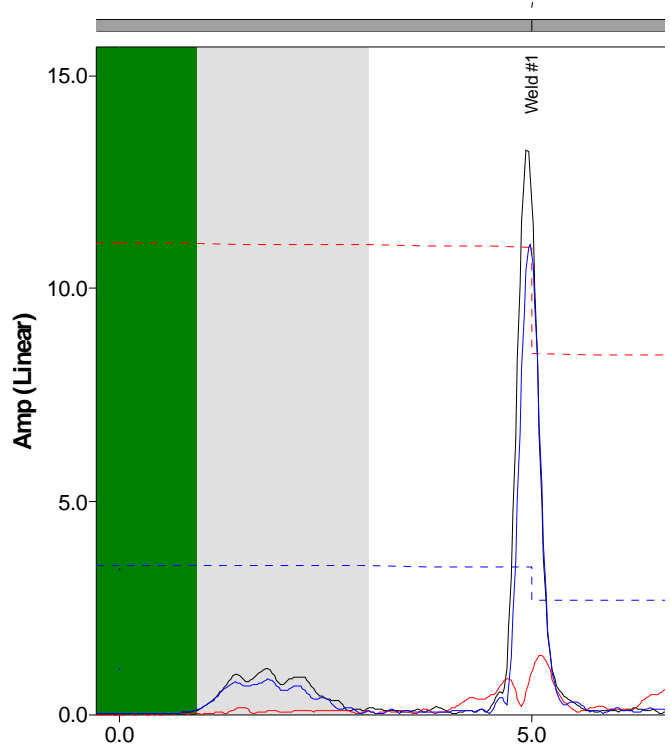
Figure 4-2
Response from Flaw #1 at 30% Wall Loss. Blue Line is Baseline Trace

Table 4-3 provides the S/B ratios for Flaw #1. The change for the 30% deep flaw was a 2.12 dB increase and the change for the 60% flaw was an 8.04 dB increase. Both changes in dB are detectable. Detectability of the 30% flaw would require accurate setting of the DAC and not a lot of variation from weld to weld sizes. The detectability, based on amplitude alone, is low. The 60% through-wall depth is easily detectable from the increase in amplitude of the signal. The detectability of the flaw from amplitude alone is high.

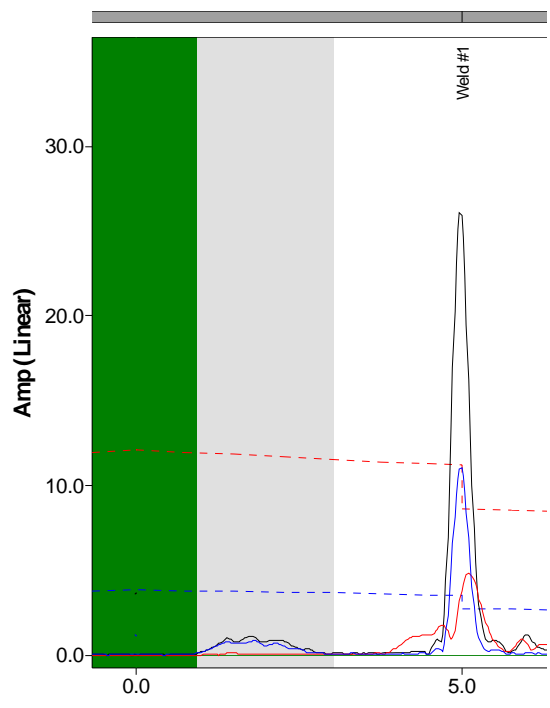
Figure 4-3
Response from Flaw #1 at 60% Wall Loss. Blue Line is Baseline Trace

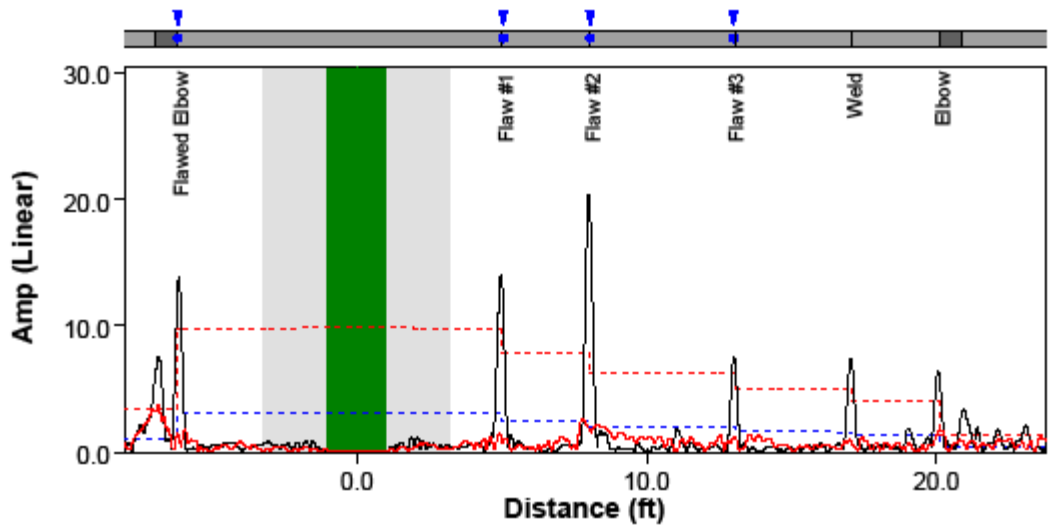
5375.wg3

General Notes: Shot take after the induced flaws and S-4 location

Feature	Location	Size (mV)	ECL	Extent	Class	Notes
Flawed Elbow	-8'2"	13.8	-	90	1D Bend	
	-8'2"	13.8	70	90	Medium	
	4'12"	14	30	90	Weld	
Flaw #1	5'0"	14	40	90	Medium	
Flaw #2	8'0"	20.3	60	90	Medium	
Flaw #3	12'12"	7.56	25	80	Medium	
Weld	17'1"	7.42	35	90	Weld	
Elbow	20'1"	6.37	-	70	1D Bend
