# **Hydrogen Fuel Cell Buses for Urban Transport in Brazil: Functional Test Results**

Technical Update, January 2010

**Netz Automotiva Engenheiros Associados Ltda.**

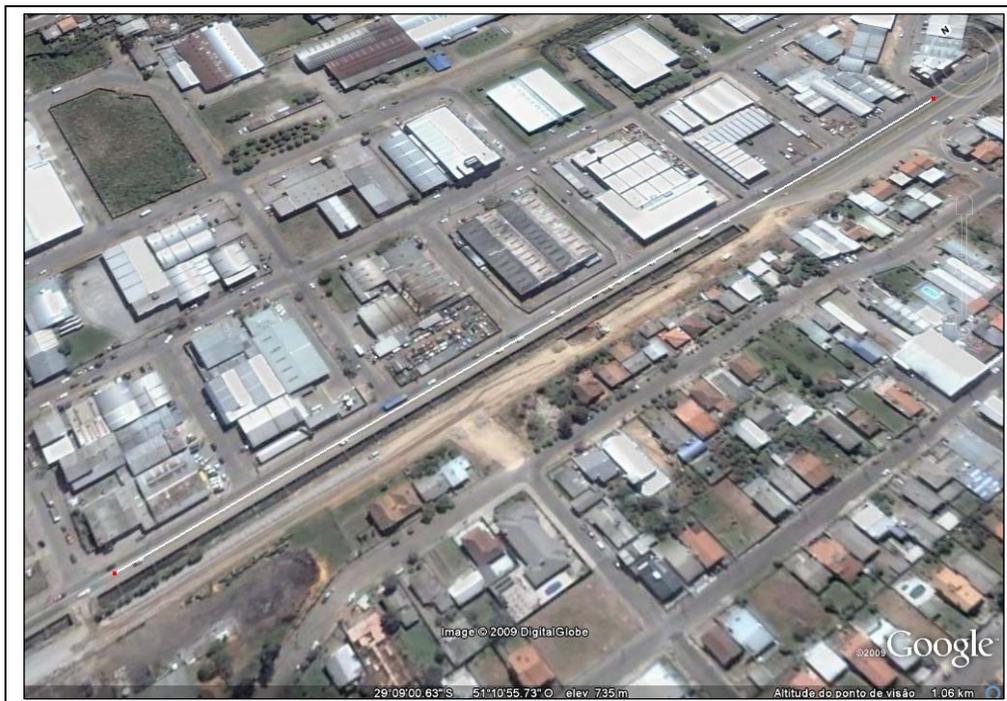
**Figure 2-1**  
**Performance test track**

To ensure minimum safety conditions, the measurements were performed after 10 p.m. on west direction route, which was closed by the Caxias do Sul Transit Department.

Measurements were done in dry track, with temperature between 15 and 20°C.

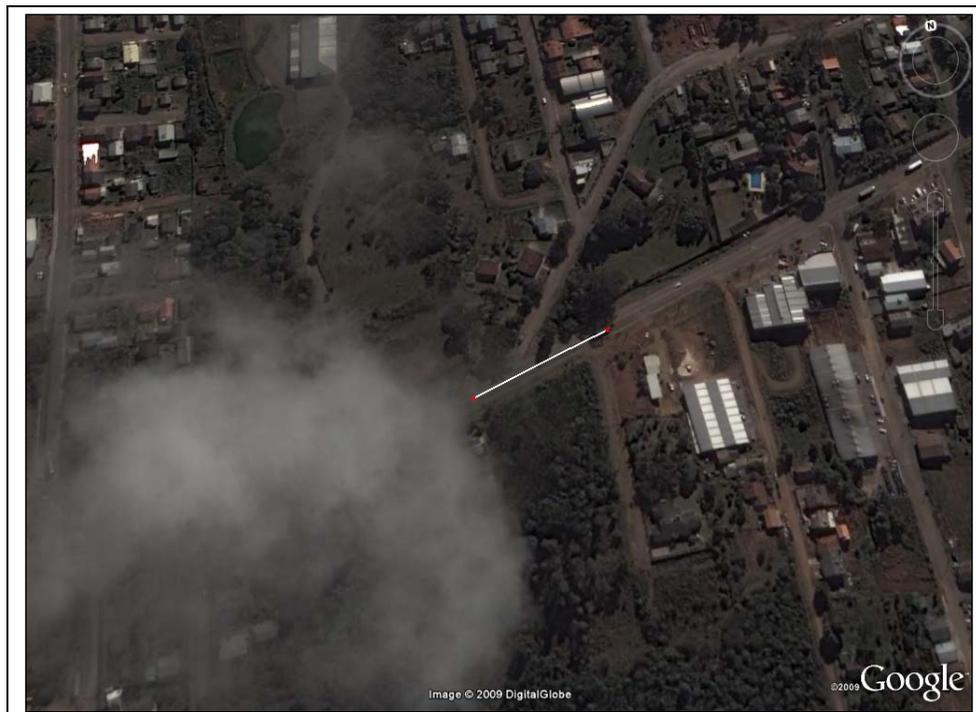
**Figure 2-2**  
**Brake test track**

As with the acceleration test, the measurements were performed after 10 p.m. with support of the Caxias do Sul Transit Department.

Measurements were done in dry track and temperature between 15 and 20°C.

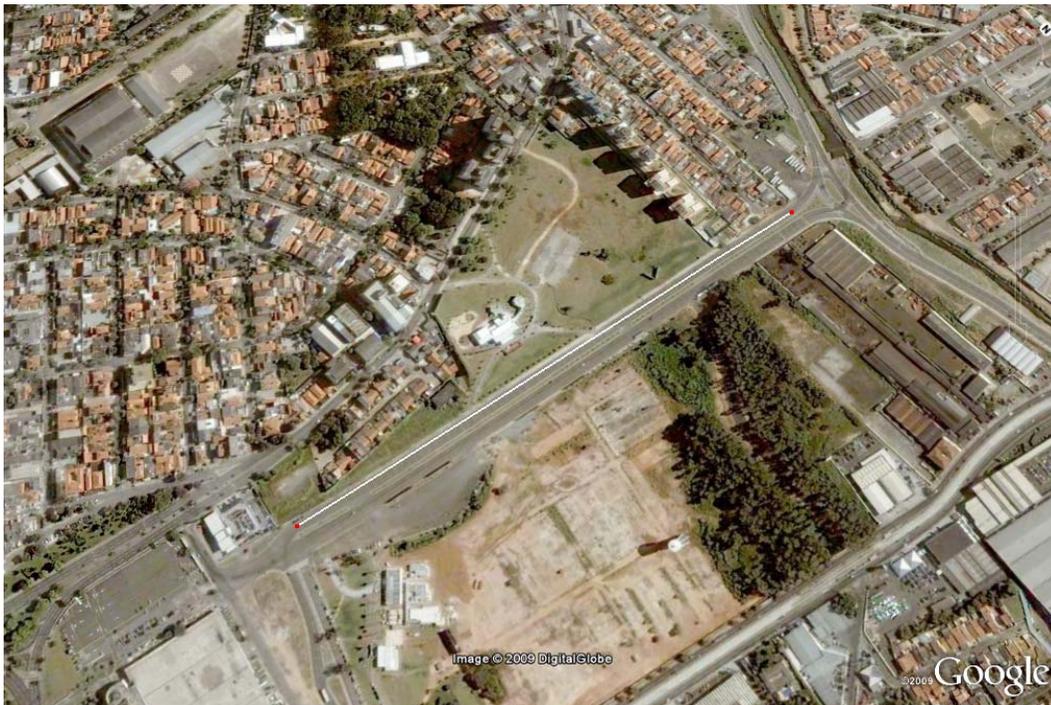
**Figure 3-1**  
**Fading brake test track**

The fading and auxiliary brake system measurements were repeated at Av. Aldino Pinotti in São Bernardo do Campo.

Measurements were done in dry track and temperature between 15 and 20°C.

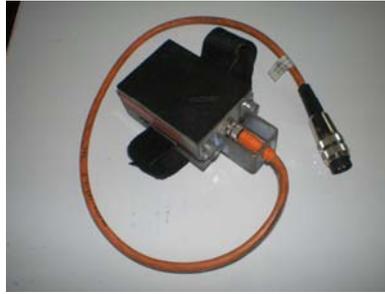
**Figure 3-2**  
**Brake pedal load cell**

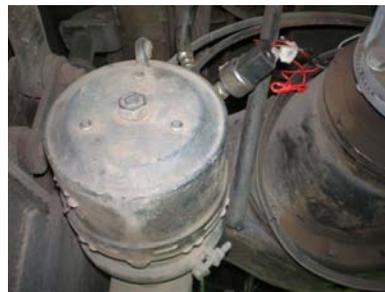
**Figure 3-3**  
**Pressure Transducer, Rear Axle Bringer BRPT 030**

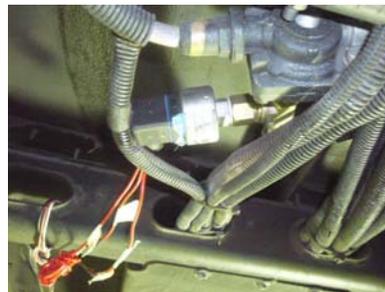
**Figure 3-4**  
**Pressure transducer, front axle Bringer BRPT 030**

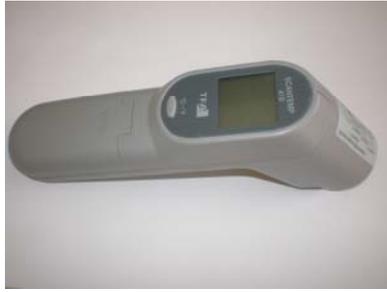
**Figure 3-5**  
**Thermometer TFA scantemp 410**

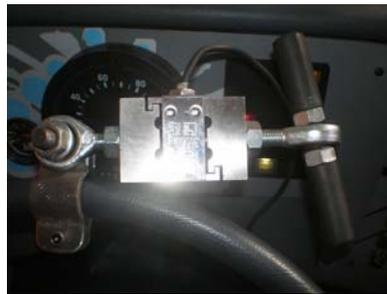
**Figure 3-6**  
**Steering system load cell HBM S40**  
**HBM S40**

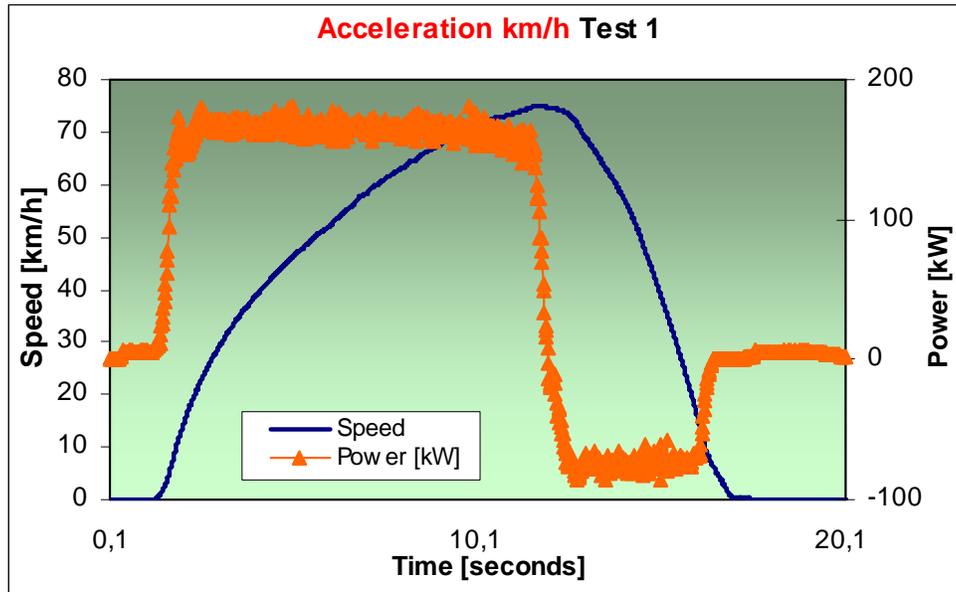
Figure A-1  
Acceleration 0% Slope - Test 1 (Caxias do Sul)

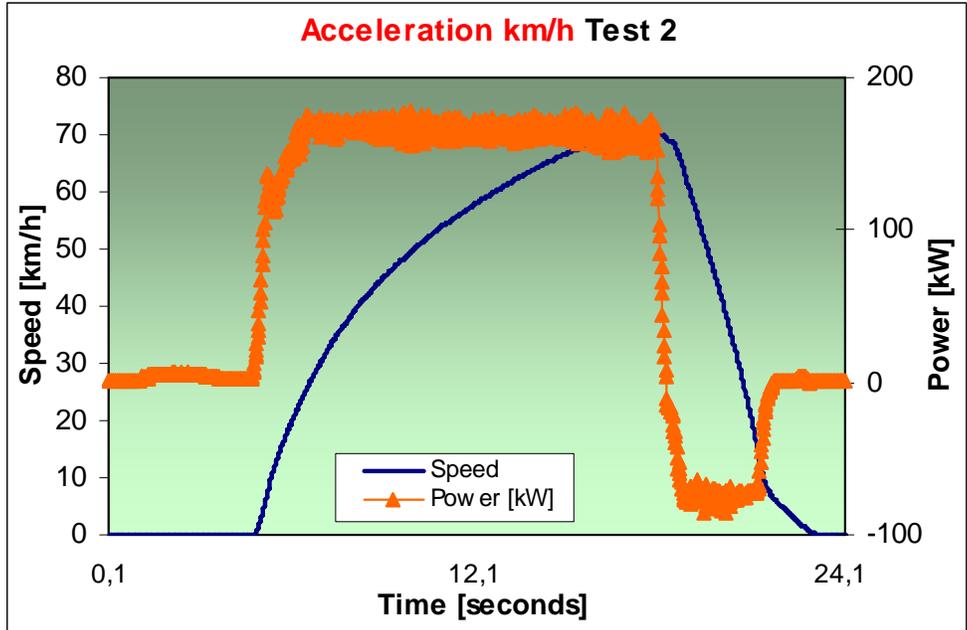
**Figure A-2**  
Acceleration 0% Slope - Test 2 (Caxias do Sul)

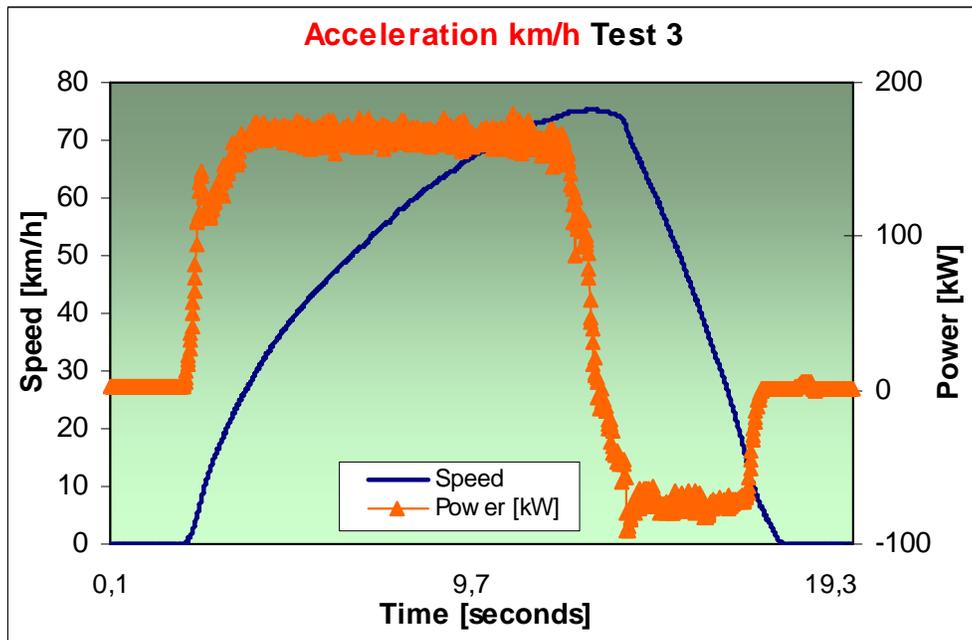
**Figure A-3**  
Acceleration 0% Slope - Test 3 (Caxias do Sul)

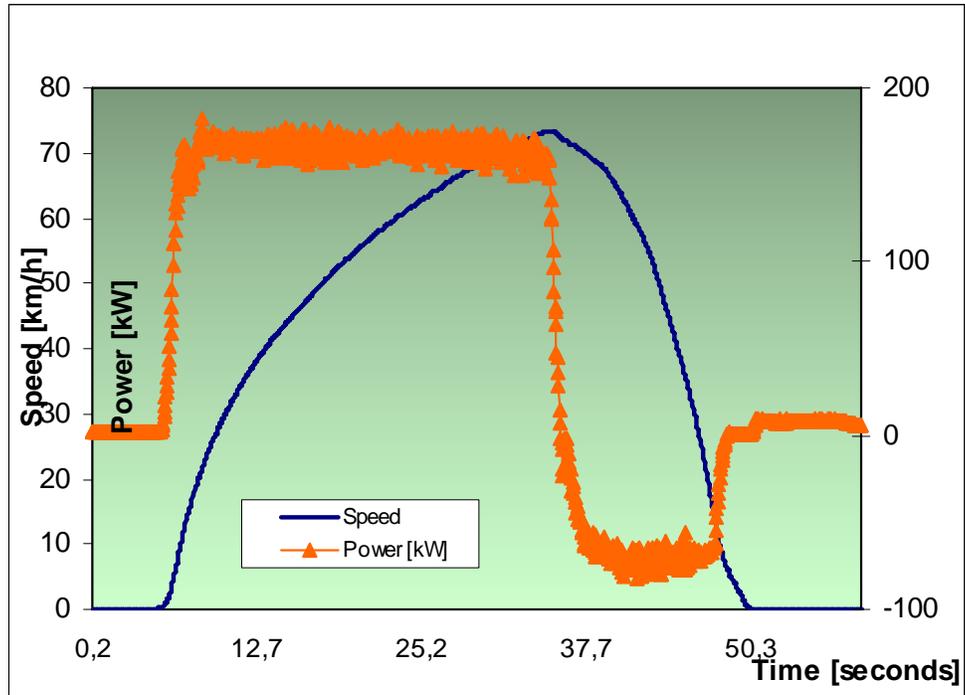
**Figure A-4**  
Acceleration 0% Slope - Test 4 (EMTU Track)

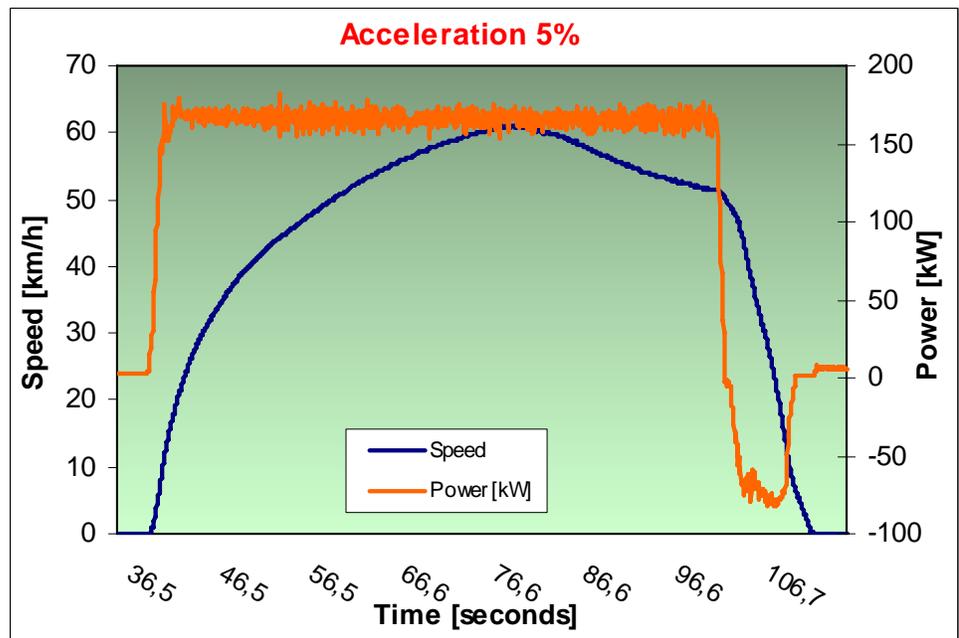
**Figure A-5**  
Acceleration 5% Slope - Test 5 (EMTU Track)

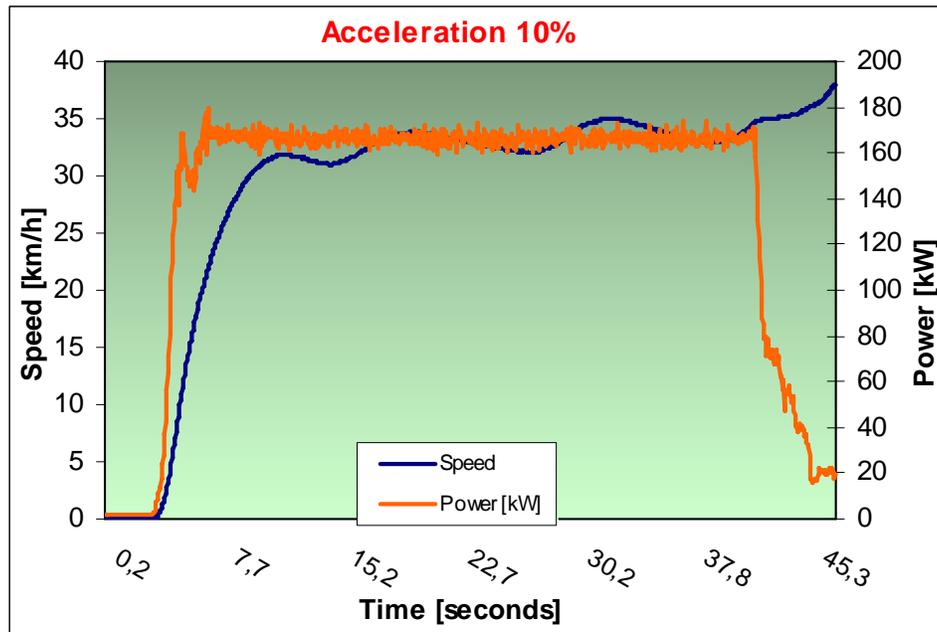
**Figure A-6**  
**Acceleration 10% Slope - Test 6 (EMTU Track)**

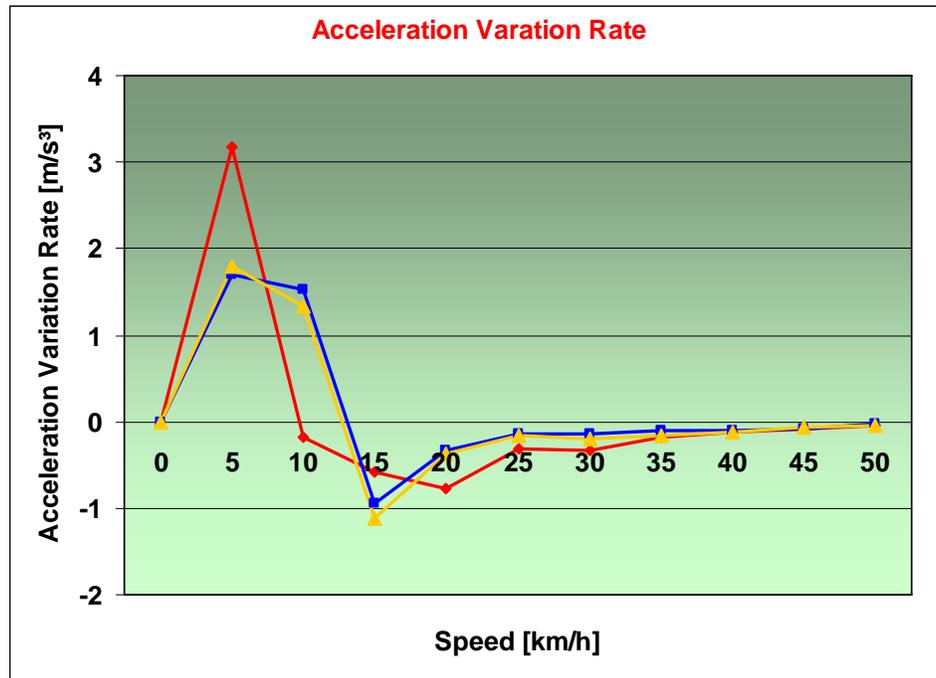
Figure B-1  
Acceleration Variation Rate – Acceleration Test

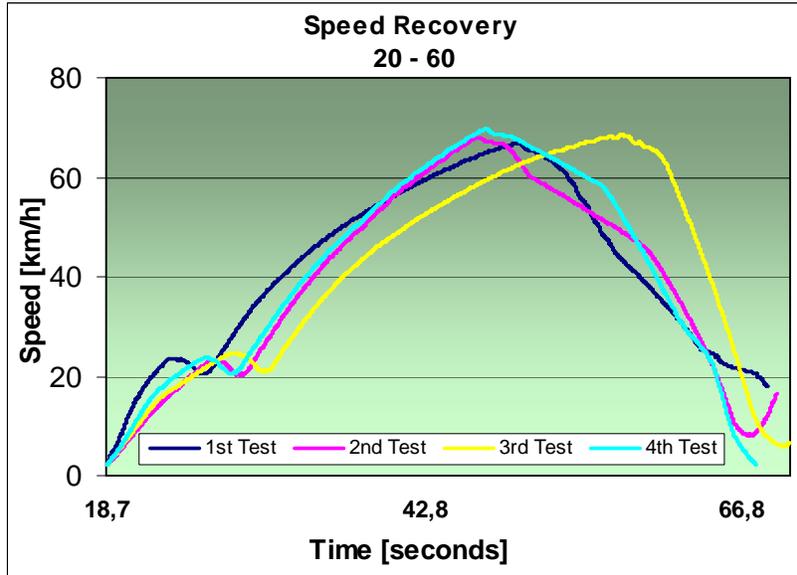
Figure C-1  
Speed recovery from 20 to 60km/h

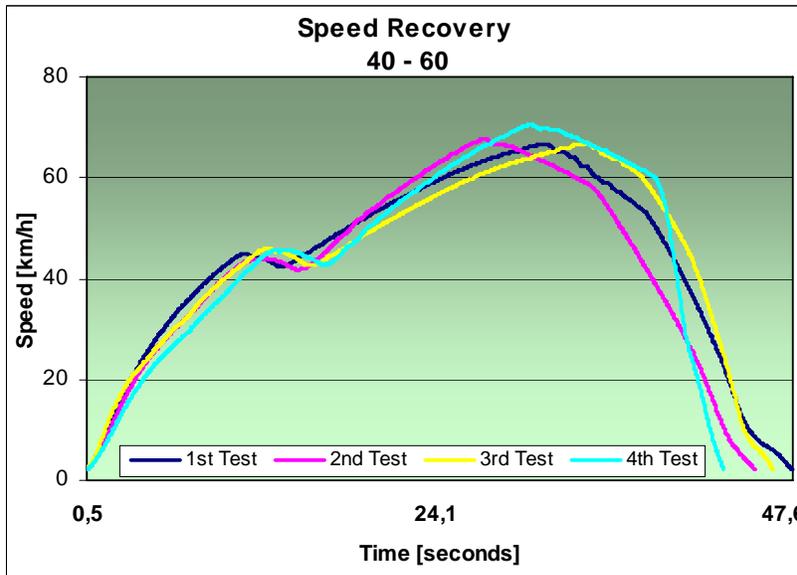
Figure C-2  
Speed recovery from 40 to 60km/h

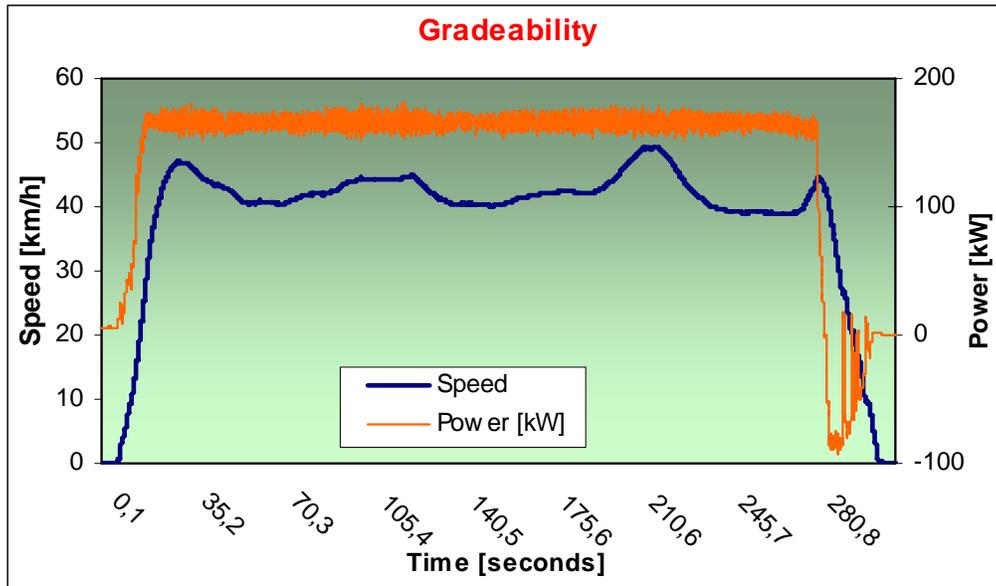
Figure D-1  
Gradeability Test

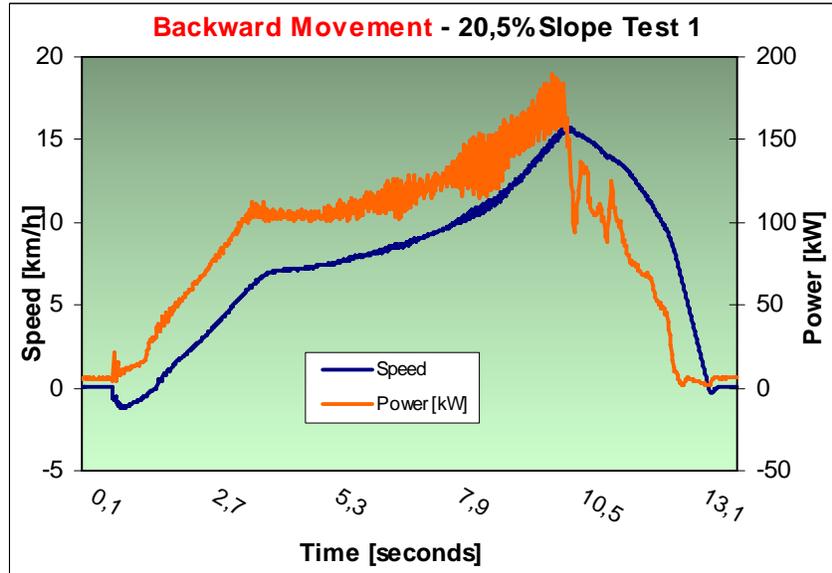
Figure E-1  
Backward Movement – Test 1

**Approved.** In both conditions, the backward movement was not over 0.1 m.

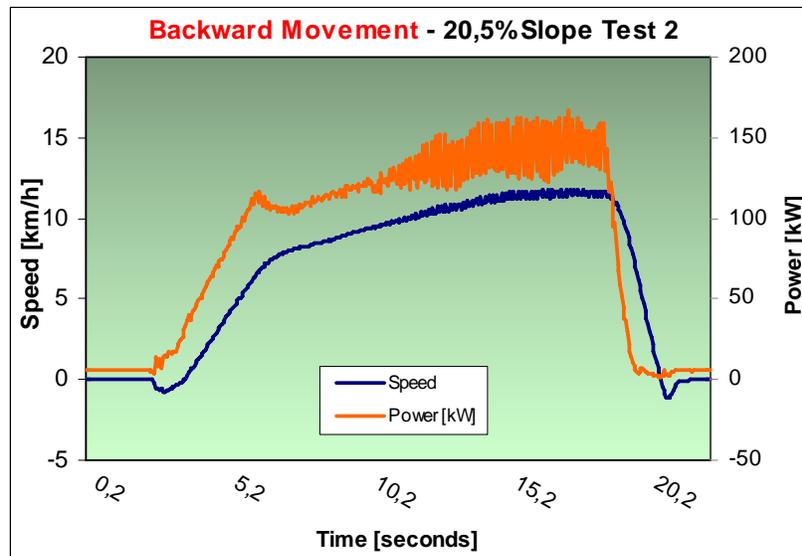
Figure E-2  
Backward Movement – Test 2

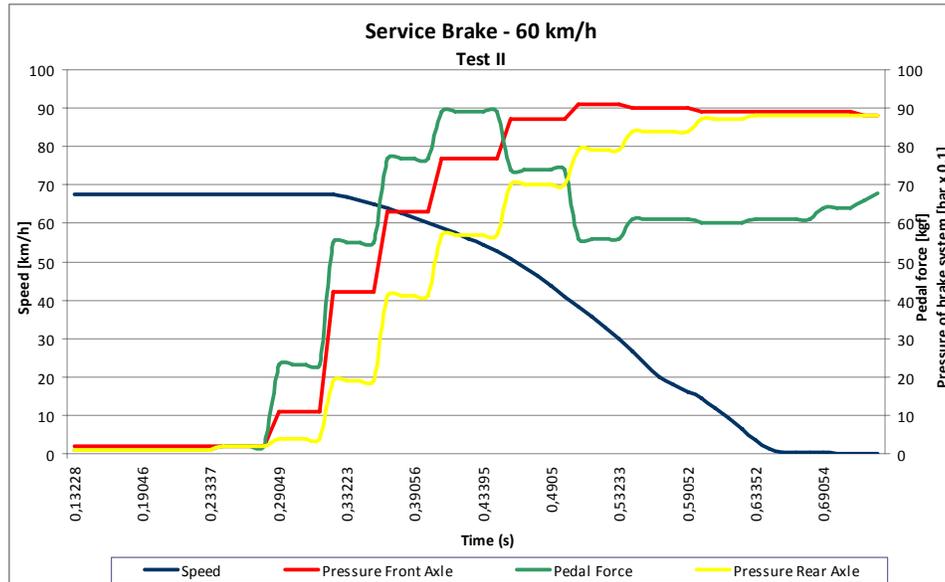
Figure F-1  
Service Brake - Test 1

The braking system is able to cause a deceleration greater than the specified 5 m/s<sup>2</sup> and with a response time shorter than the specified 0.6s. The vehicle is approved even considering that the measurements were not made in a specific track.

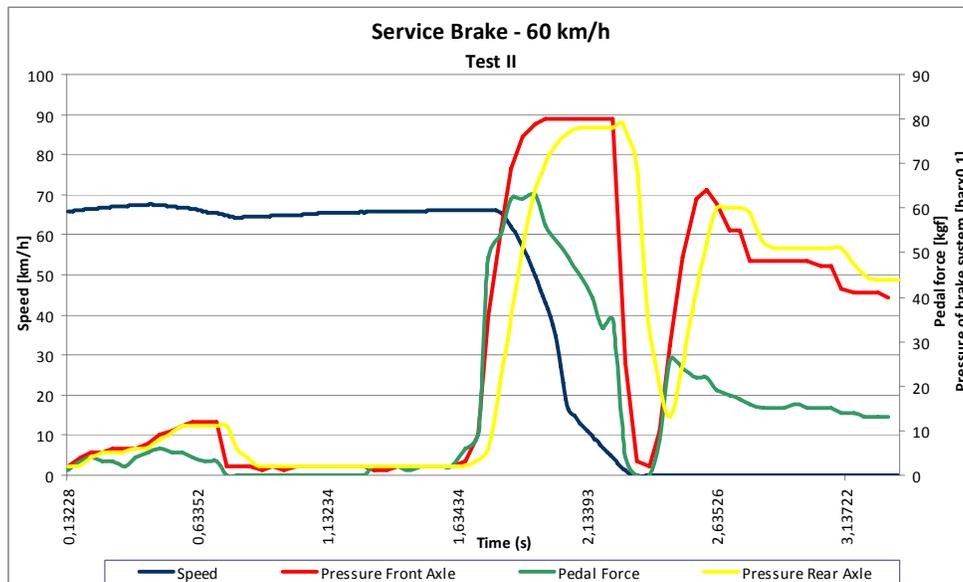
Figure F-2  
Service Brake - Test 2

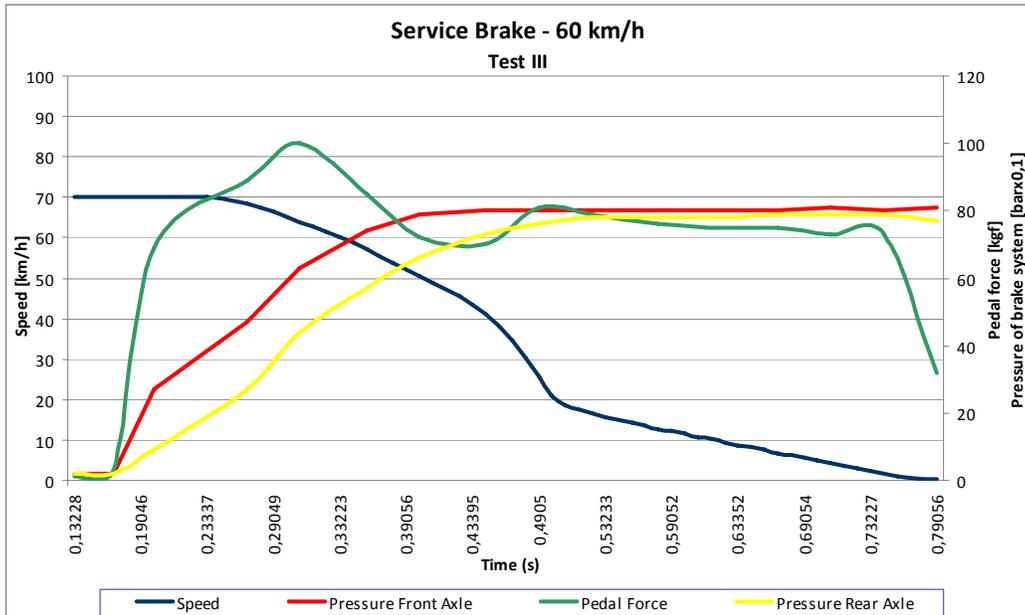
**Figure F-3  
Service Brake - Test 3**

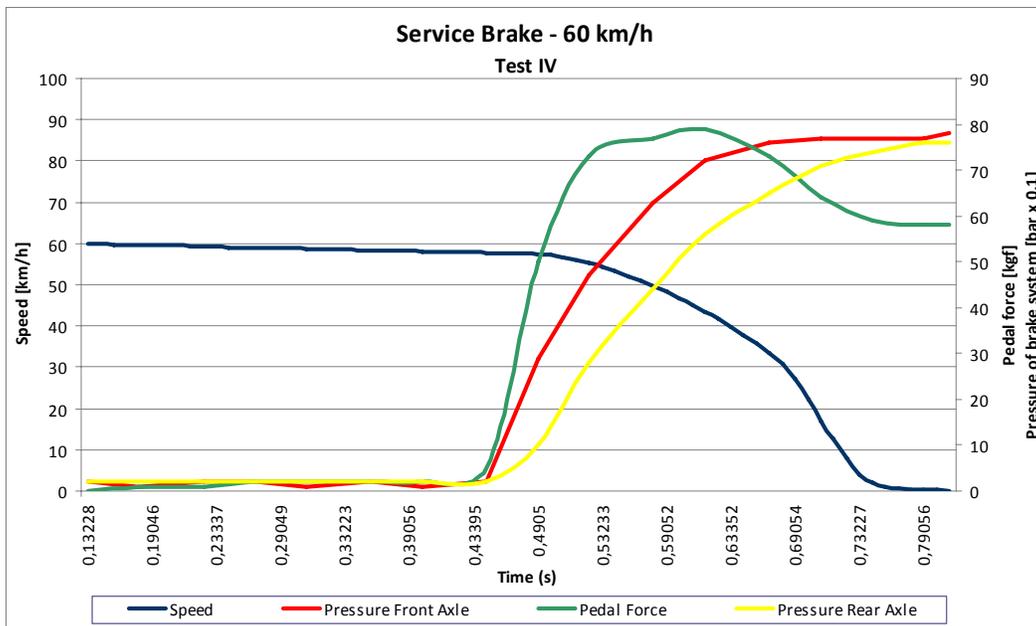
**Figure F-4  
Service Brake - Test 4**

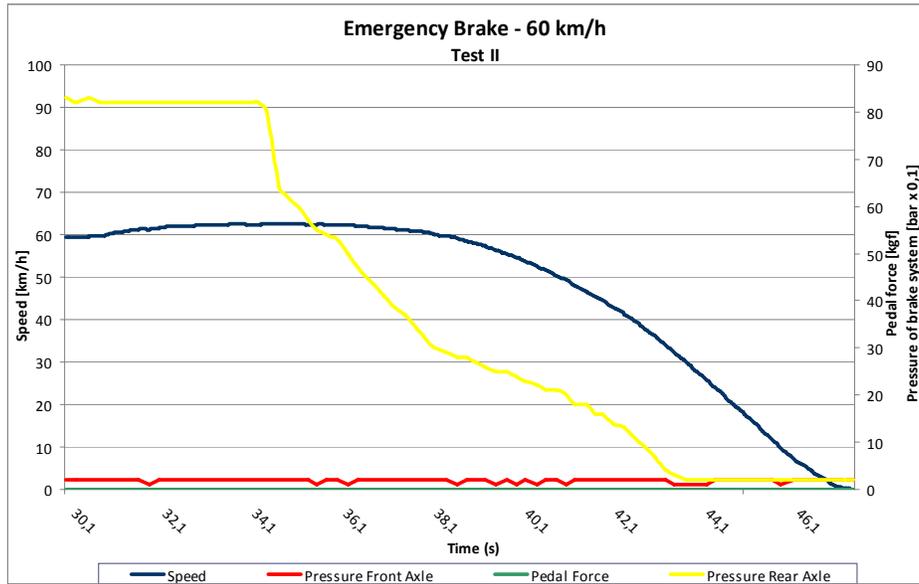
Figure G-1  
Emergency Brake Test

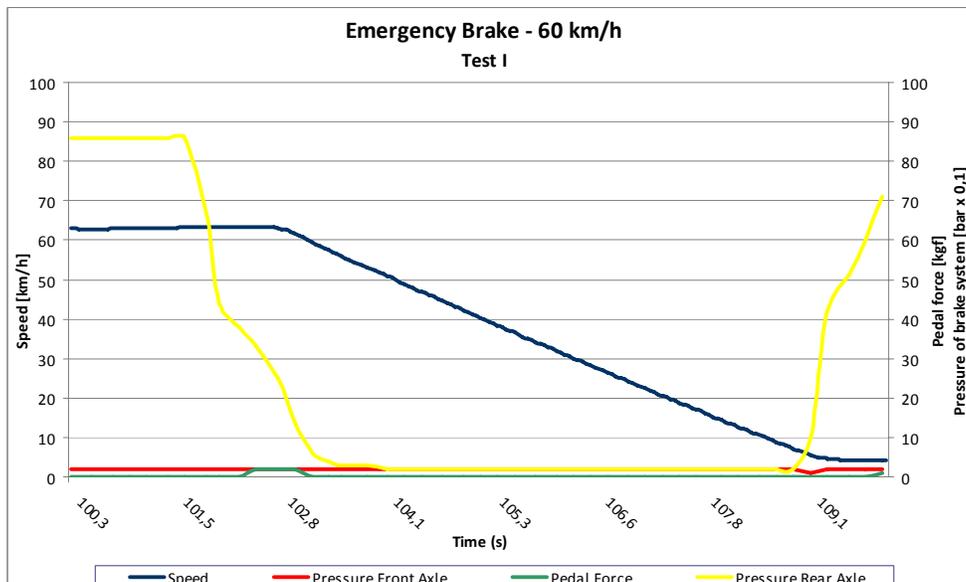
Figure G-2  
Emergency Brake Test

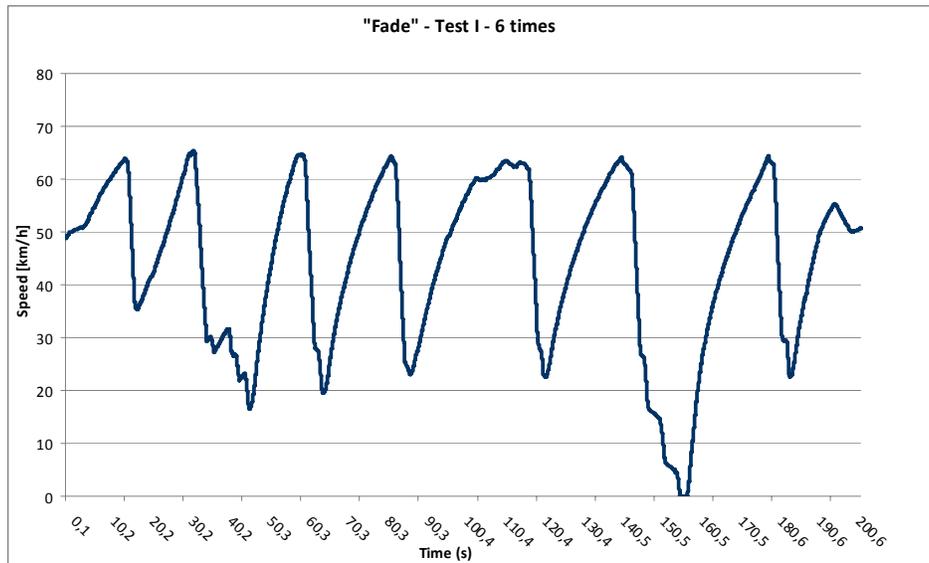
Figure H-1  
Fading Brake - Test 1

Test done in a 2X6 and 8-times cycle instead of a 20-time due to the route characteristics and conditions. At the end of each cycle it was necessary to turn back on the road and stop to measure the brake temperature.

No efficiency loss was observed between the first and third braking cycles. The average deceleration increase is attributed to the better tires efficiency due to the temperature increasing and mainly the better precision on the way the driver carried out the braking cycle.

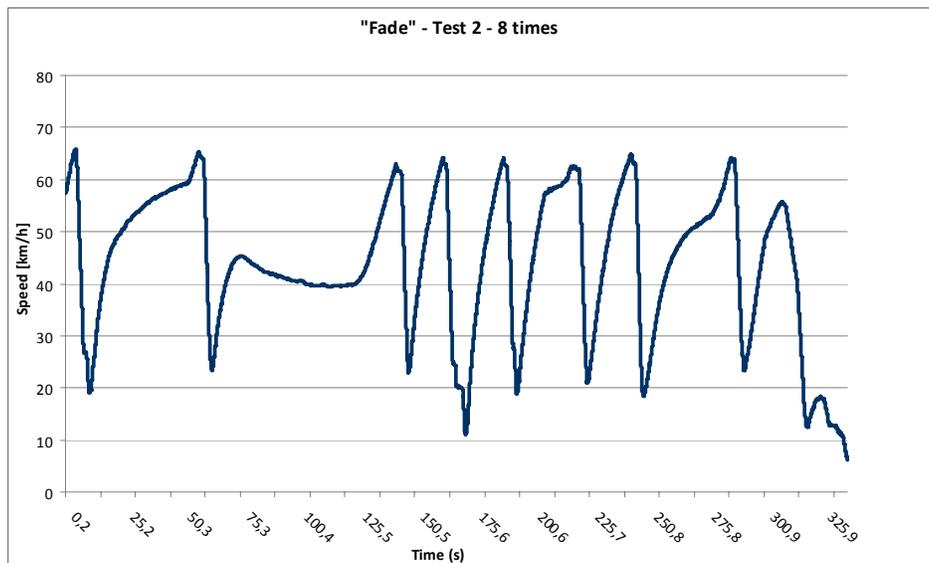
Figure H-2  
Fading Brake - Test 2

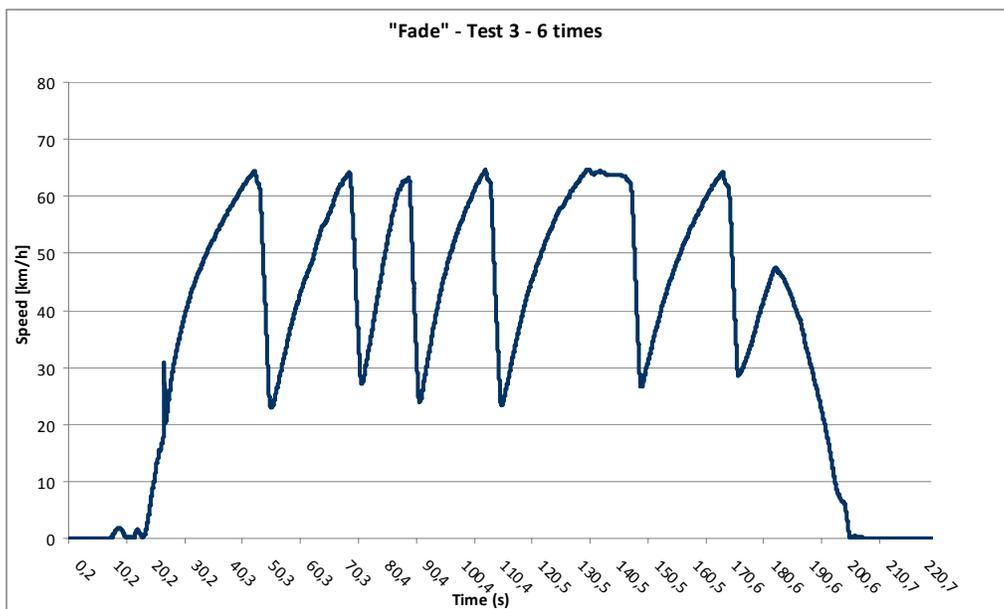
**Figure H-3**  
**Fading Brake - Test 3**

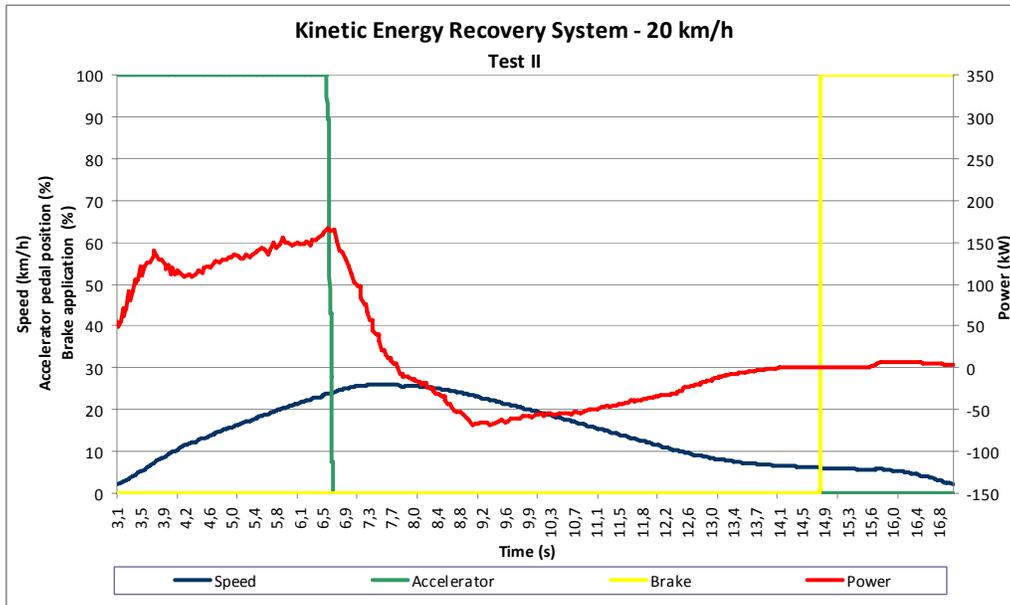
Figure I-1  
Regenerative Brake from 20 to 0km/h - Test 1

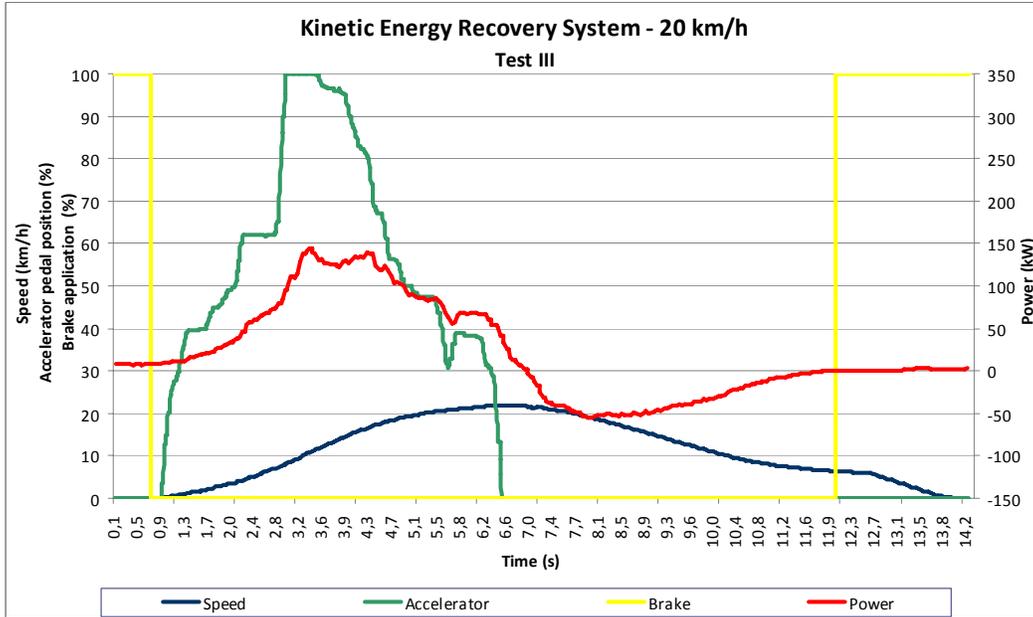
**Figure I-2**  
Regenerative Brake from 20 to 0km/h - Test 2

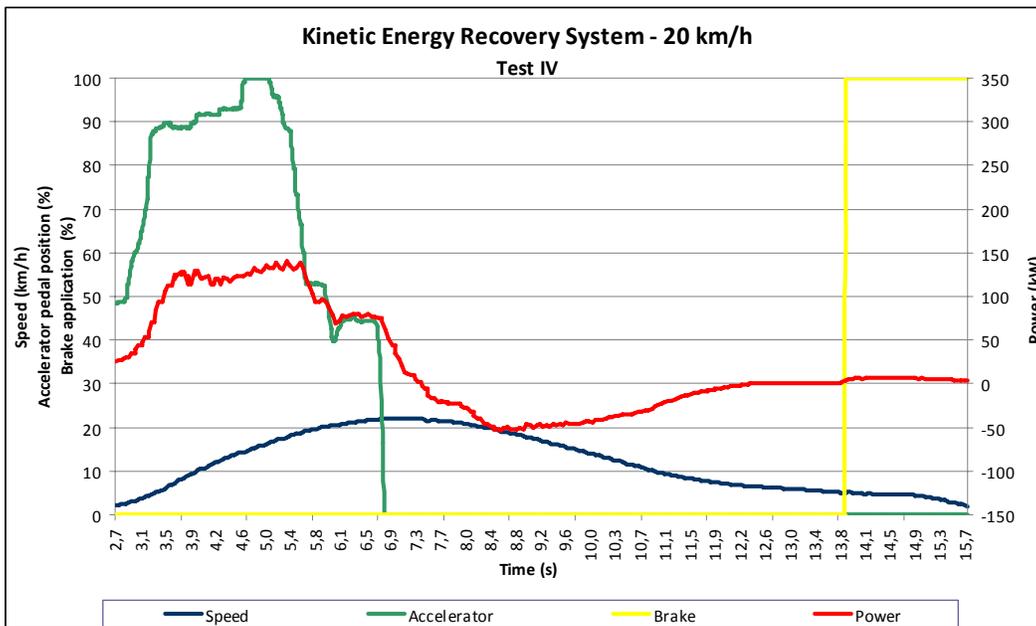
**Figure I-3**  
Regenerative Brake from 20 to 0km/h - Test 3

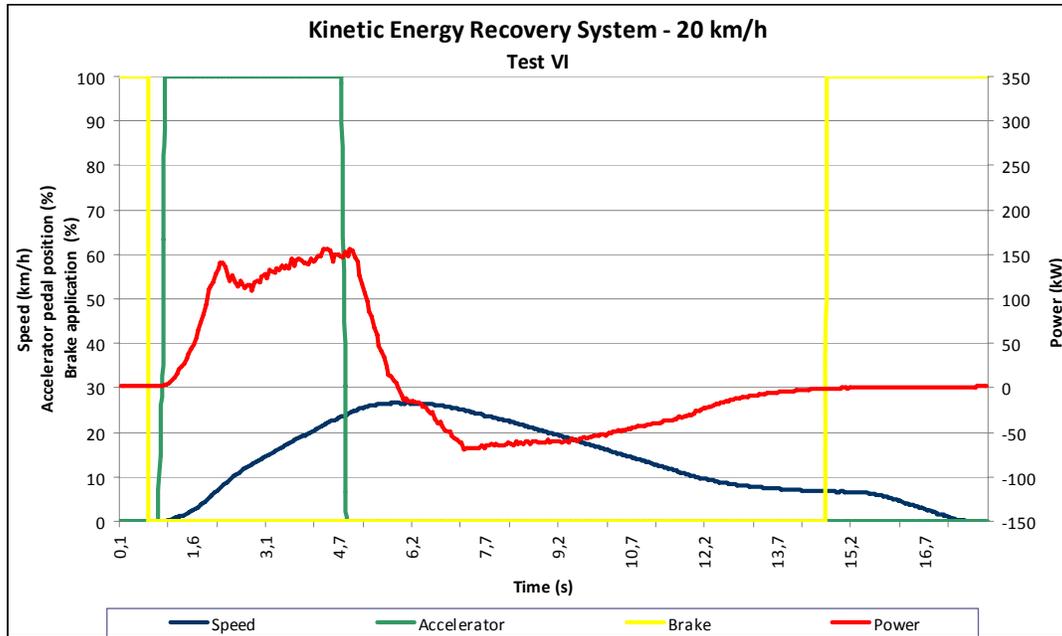
**Figure I-4**  
**Regenerative Brake from 20 to 0km/h - Test 4**

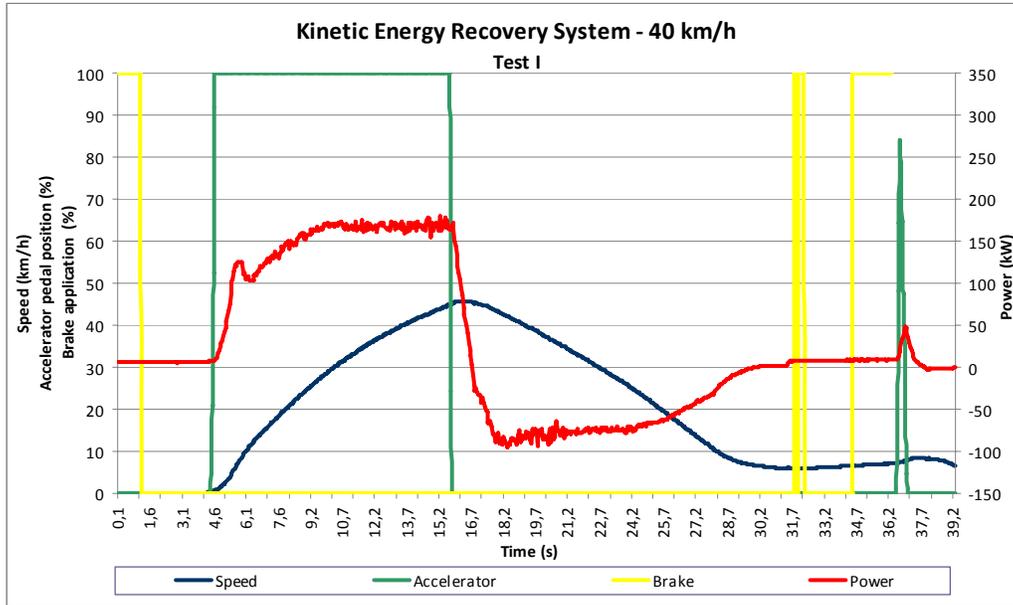
Figure J-1  
Regenerative Brake from 40 to 0km/h - Test 1

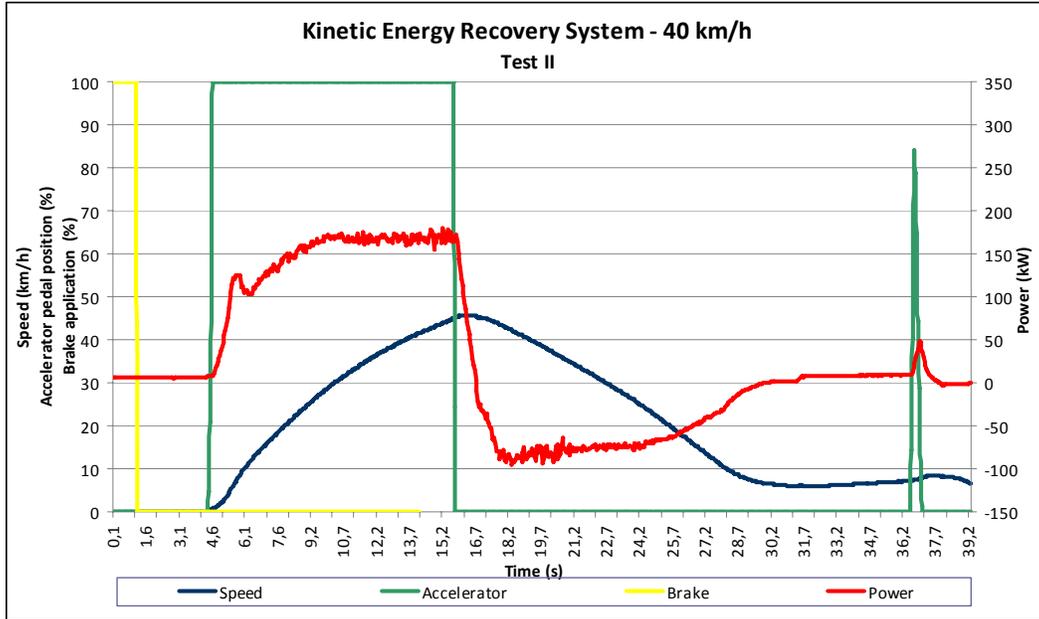
**Figure J-2**  
Regenerative Brake from 40 to 0km/h - Test 2

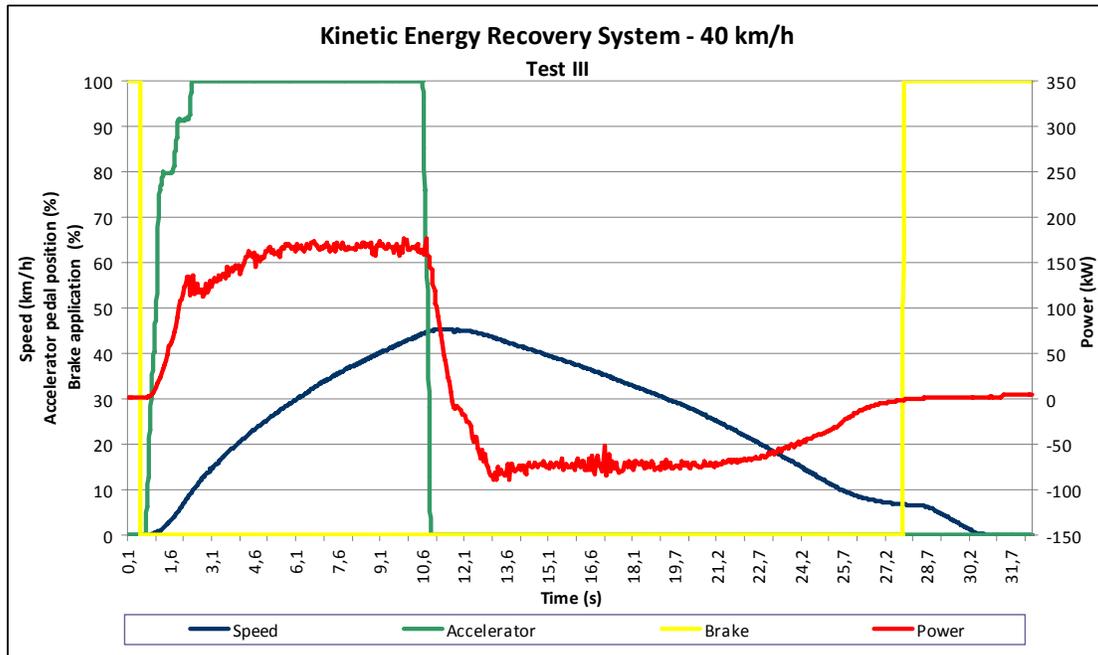
**Figure J-3**  
Regenerative Brake from 40 to 0km/h - Test 3

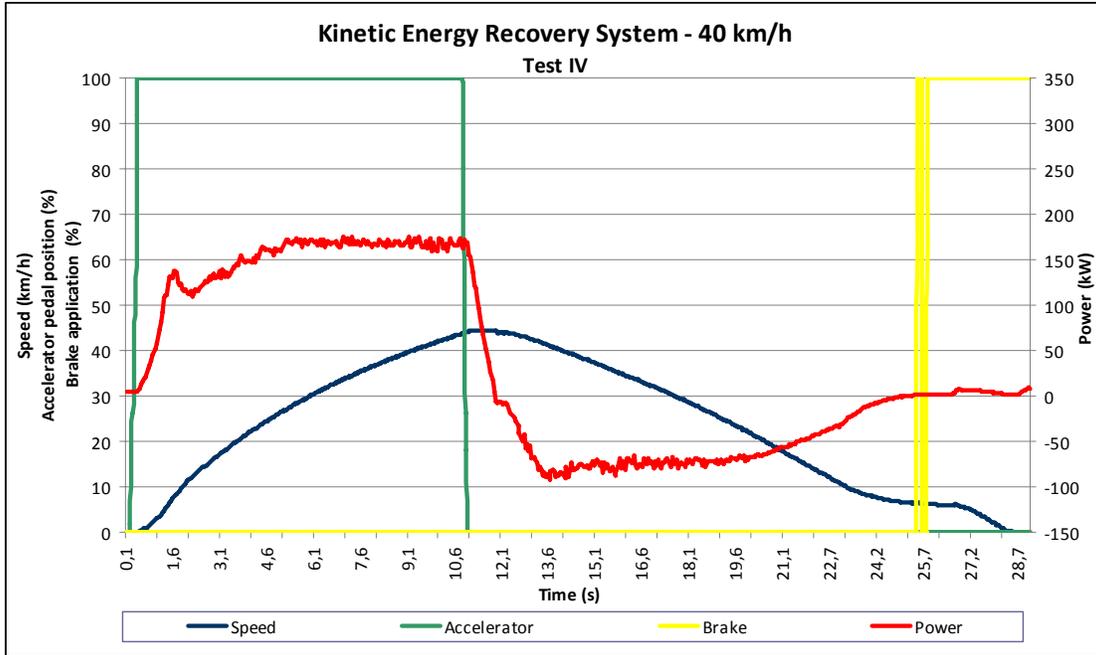
**Figure J-4**  
**Regenerative Brake from 40 to 0km/h - Test 4**

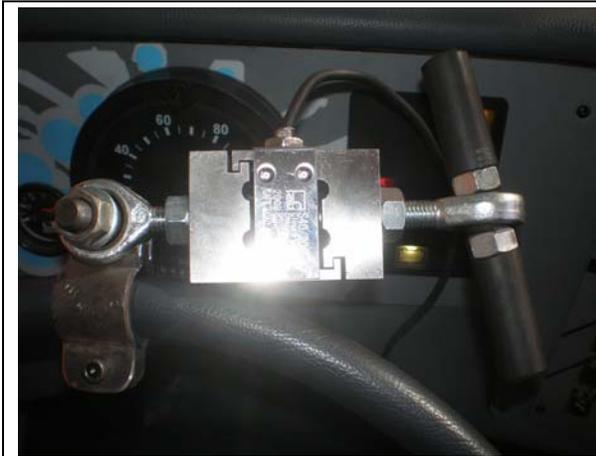
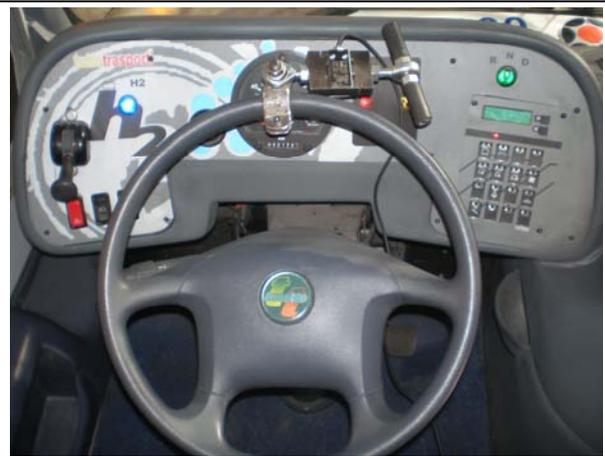
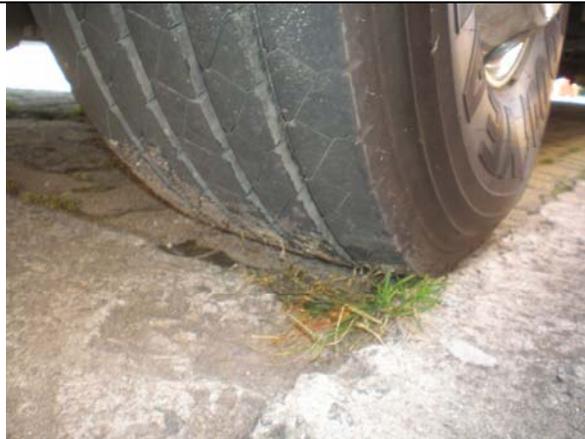
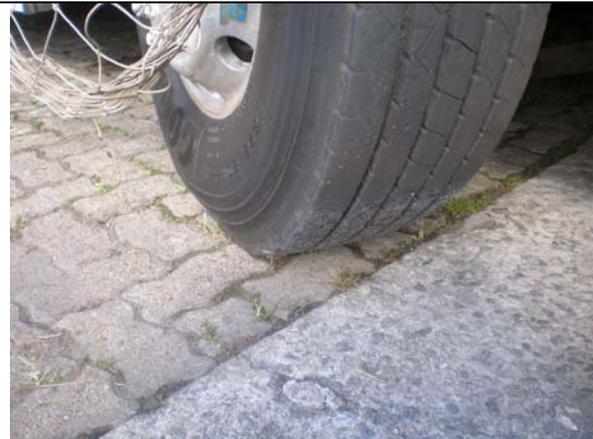
Load cell  
HBM S40

Load Cell Assembling

Left Side Surface

Right Side Surface

**Figure K-1**  
**Steering system force measurement**

Measurement done with the vehicle stopped (worst condition) in a dry and flat concrete surface with the tires calibrated as specified by the manufacturer and unloaded.
