Distribution Arc Flash

480-V Padmounted Transformers and Network Protectors

Technical Update, August 2009

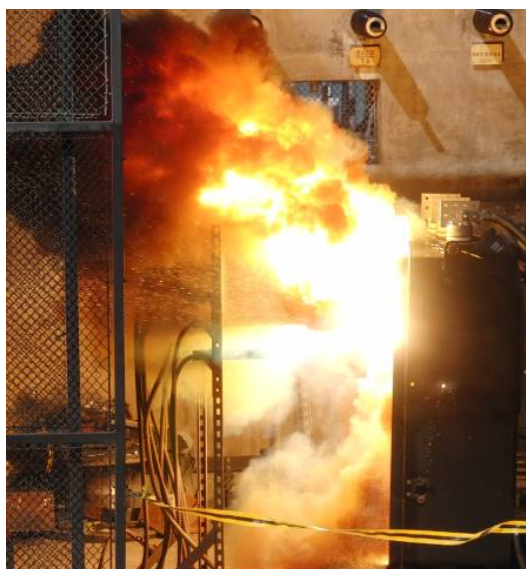
Figure ES-1
Example 480-V Network Protector Event

Tests of a 480-V network protector found that although some faults did not sustain, sustainable arcs are certainly possible in network protectors. Micarda dividers were not effective at containing the fireball from the arc. IEEE 1584 overpredicted incident energies for network protector faults; measurements were generally 30 to 75% of the default IEEE 1584 predictions. The fireball from a network protector failure is less focused than that found from previous tests on 480-V self-contained meters. For a given arc energy, a single point in front of the equipment may see less energy, but the fireball covers a larger area. Because arcs did not self-clear, incident energies were high, creating a large fireball in front of the enclosure (Figure ES-1).

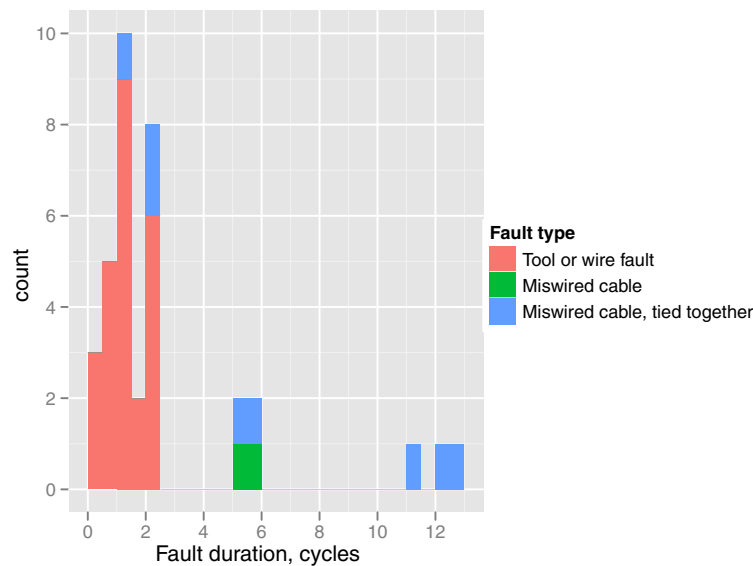
Figure ES-2
Fault Duration Histogram

Out of 35 tests in the secondary compartment of a 480-V padmounted transformer, we found no cases of sustained arcing. Most arcs self-extinguished in less than 2.5 cycles with a maximum of

12 cycles (see Figure ES-2). Incident energies were mostly less than 1 cal/cm² with the highest at 4.0 cal/cm². This is significantly less than the 20 cal/cm² required in the consensus change proposal for the 2012 NESC.

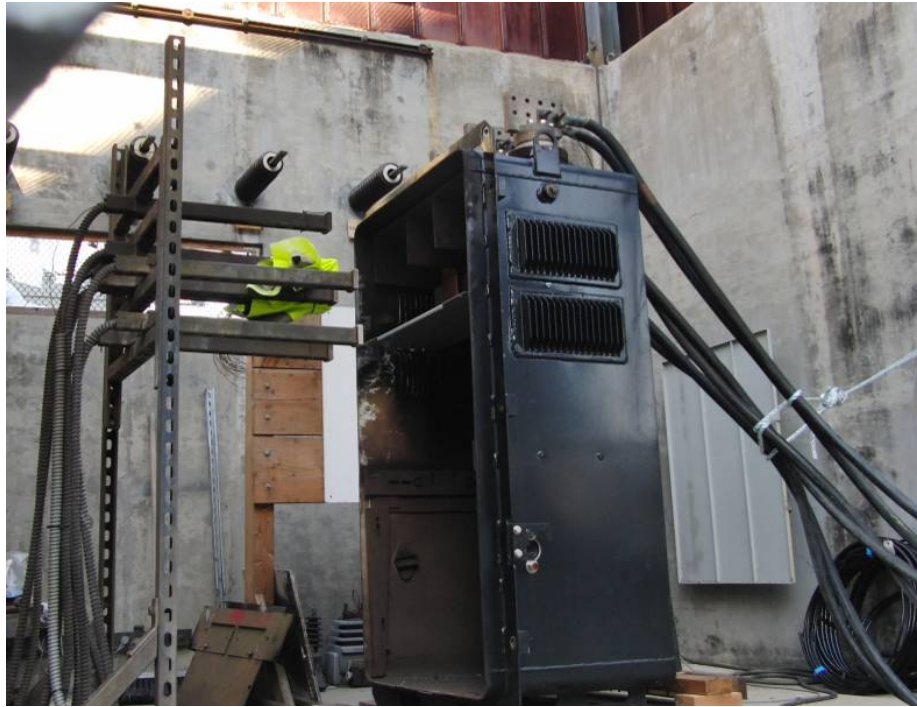
Figure 1-1
Network Protector Test Setup

Figure 1-1 shows the network protector used during tests. The internal operating mechanisms have been stripped from the unit. The unit is energized from the top, which is the network side of the unit. A common work procedure is removing the fuses on the network feed. Bus bars from the top were included in the box as shown in Figure 1-2.

The unit is fed by PG&E's 480-V source that's capable of supplying a bolted fault current of 44 kA (later upgraded to 52 kA).

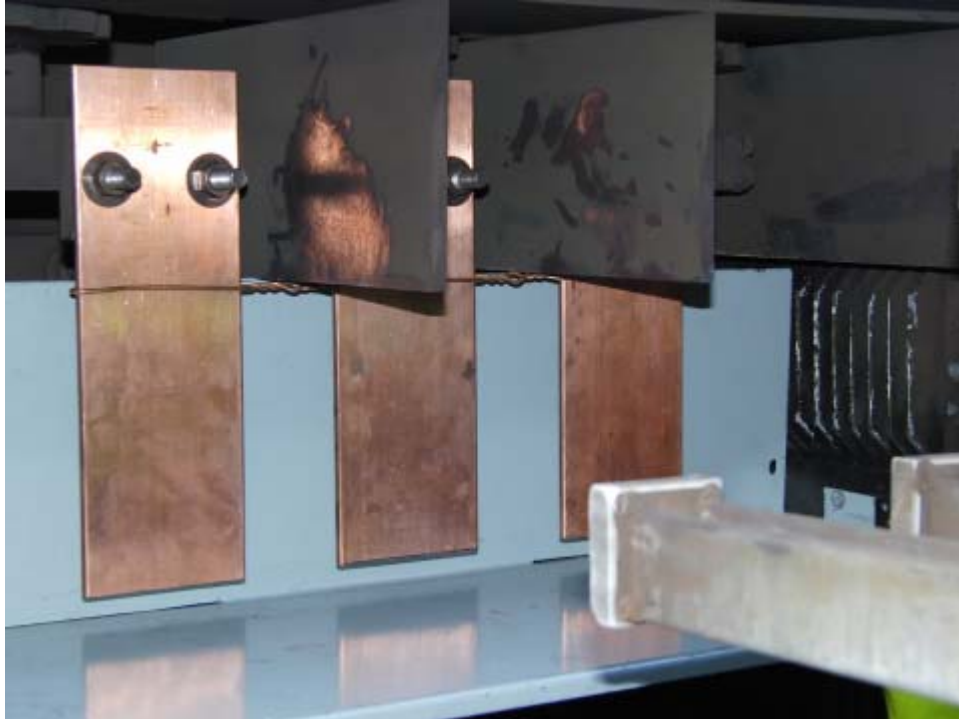
Figure 1-5
Configuration with a Conducting Plate Behind and Below the Bus Bars

In order to assess how confinement impacts arc sustainability, a metal ground plane was added behind and below the bus bars as shown in Figure 1-5. In this configuration, faults were able to sustain and did not clear until PG&E's circuit breaker tripped. Figure 1-6 shows the fireball from a test with a ground plane.

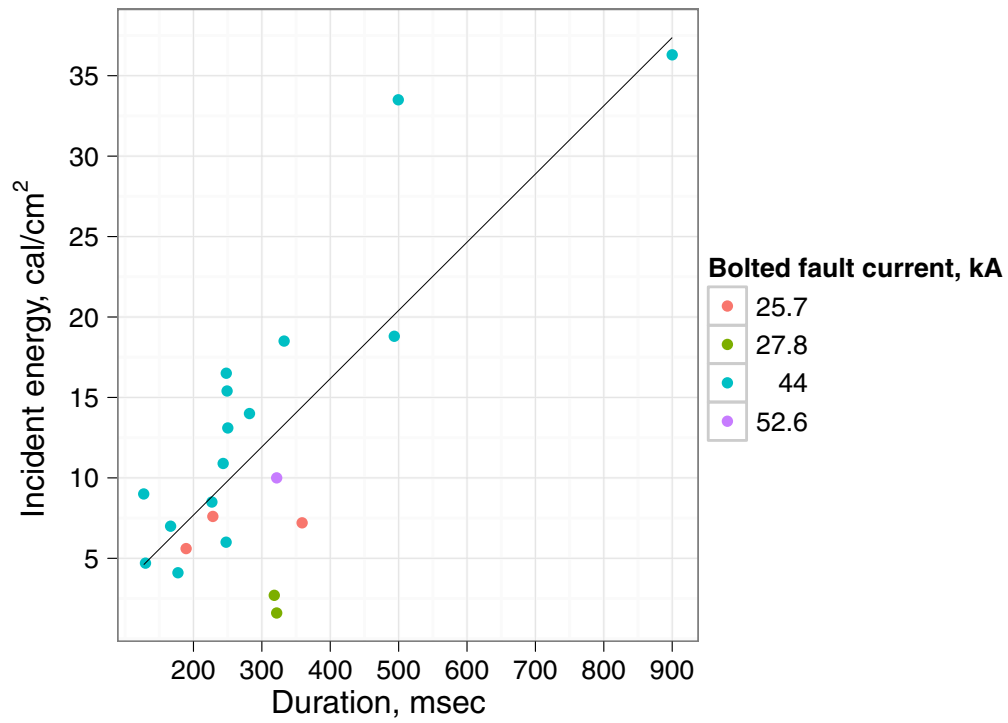
Figure 1-13
Relationship between Duration and Incident Energy

This section documents many of the calorimeter incident-energy readings obtained during the network protector tests. Unless otherwise stated, these incident energies were measured 18 in from the arc initiation point. Figure 1-13 shows how incident energy varied with duration. For the cases with a bolted fault current of 44 kA, the incident energy was reasonably linear. Figure 1-14 shows the relationship between arc energy and incident energy, and it is reasonably linear across fault current ranges. Figure 1-15 shows that the ratio between arc energy and incident energy is not strongly duration dependent, meaning that the incident energy is directly related to arc energy without an extra effect caused by duration. Figure 1-16 shows that arc power and incident heat rate also track linearly. These graphs support two basic assumptions used in IEEE 1584 and other analysis: (1) incident energy increases linearly with fault duration, and (2) incident energy is linearly related to arc energy.

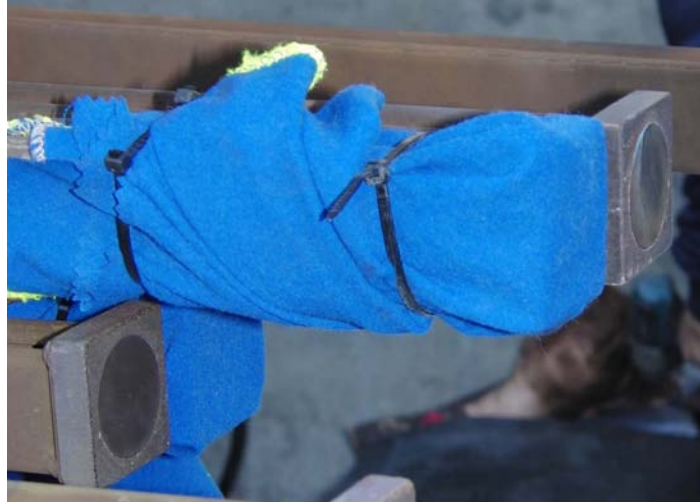
Figure 1-17
Calorimeter Arrangement

In many tests, calorimeter measurements were taken at different distances as shown in Figure 1-17 with the closest calorimeters at 18 in and the back calorimeters at 24 in from the arc initiation point. The measurements at each location track closely as shown in Figure 1-18. The slope of the linear fit to Figure 1-18 is 0.52, which equates to a distance factor of 2.3. This is higher than the distance factor of 1.473 used in IEEE 1584 for low-voltage switchgear. Note that in this configuration, the front calorimeters are located such that they may have shielded the back calorimeters. This shielding may have reduced the energy to the back calorimeters enough to produce an artificially high distance factor.

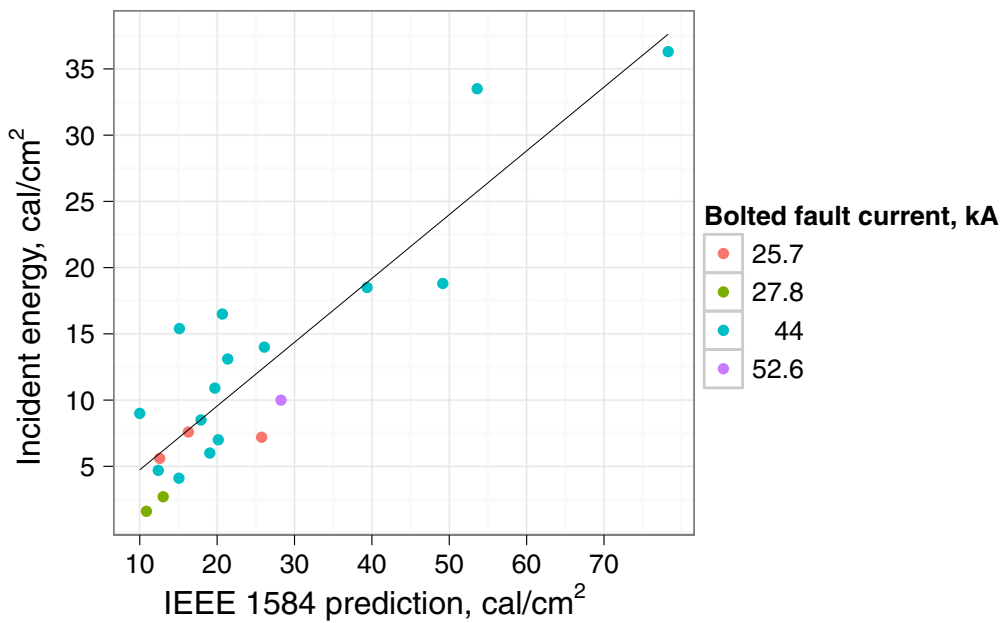
Figure 1-19 shows two different evaluations of the IEEE 1584 incident energy estimates and the network protector test results. The y-axis values are the measured incident energies. The x-axis values come from IEEE 1584 estimates using the duration and currents from the test. The differences are as follows:

- Comparison A – Meant to replicate the test more precisely – Actual fault current for each test is used along with the network protector bus bar gap of 2.5 in.

- Comparison B – Meant to replicate the default IEEE 1584 calculation – Bolted available fault currents are used along with the default gap distance of 1.25 in specified in IEEE 1584 for low-voltage switchgear.

Both comparisons show that IEEE 1584 generally overpredicts incident energies. Measurements are generally 30 to 75% of the IEEE 1584 prediction.

Comparison of IEEE 1584 predictions with test results (A: gap=2.5", actual arcing current, B: gap=1.25", using bolted fault current)

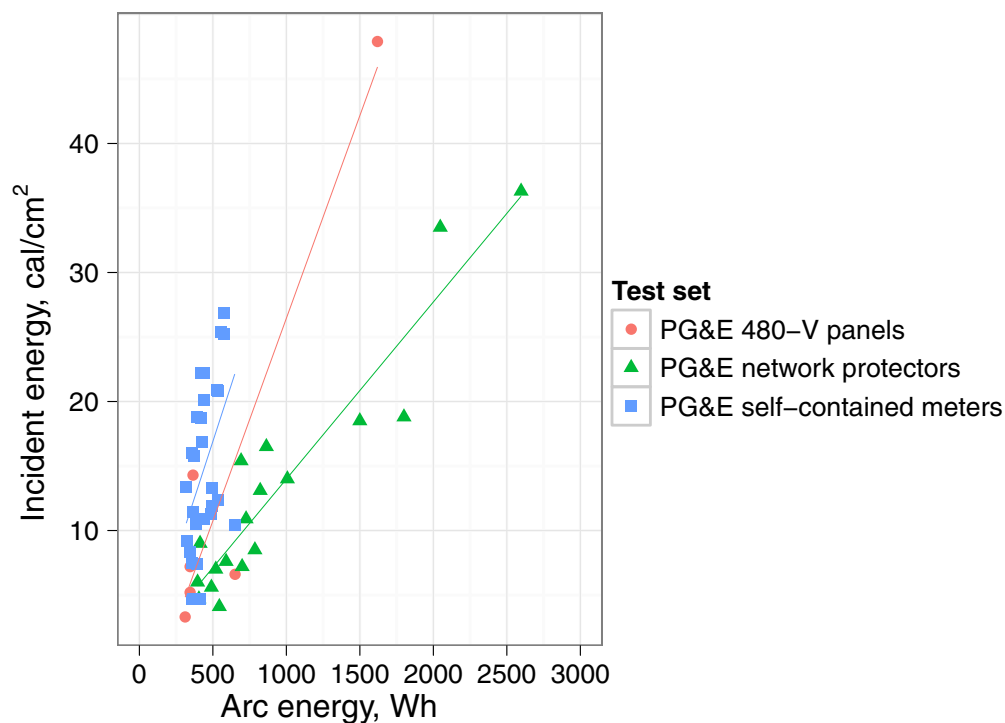
Figure 1-20
Comparisons for Network Protectors

Figure 1-20 compares the network protector test results to other 480-V equipment that PG&E has tested (see *Distribution Arc Flash: Analysis Methods and Arc Characteristics*. EPRI, Palo Alto, CA: 2009. 1018693.) This graph shows how much of the energy is transmitted from the arc to the measuring calorimeter. Differences include:

- *Self-clearing* – Faults in meters and small panels will self extinguish. Faults in large panels and network protectors may not.
- *Energy focusing* – The small meter housing focuses the arc energy straight out of the box in a relatively tight pattern. The larger network protector enclosure has less of a focusing effect, but the incident energy impacts a much wider area. Figure 1-21 compares two typical events.
- *Fault current* – For meters and small panels, incident energy decreases with higher fault current because the faults self extinguish faster. For network protectors and large panel boards, the incident energy increases with higher fault current because the faults may not self clear.

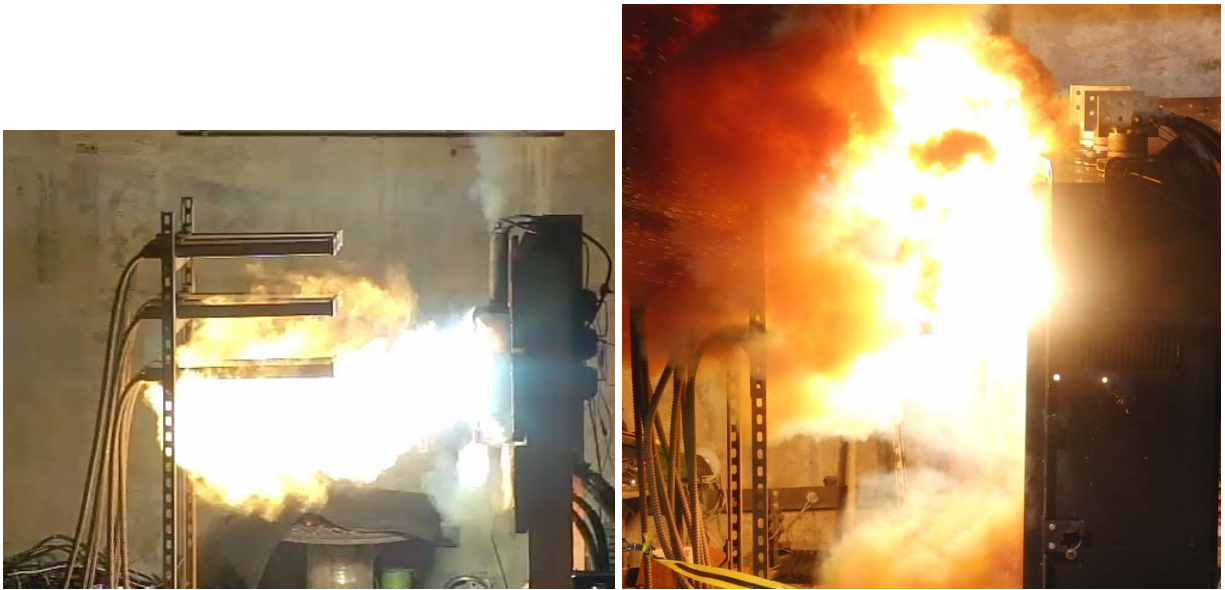
Figure 1-21
Comparison of a Meter Arc Flash and a Network Protector Arc Flash

The shape of the enclosure and the magnetic fields determine how the arc energy is released.

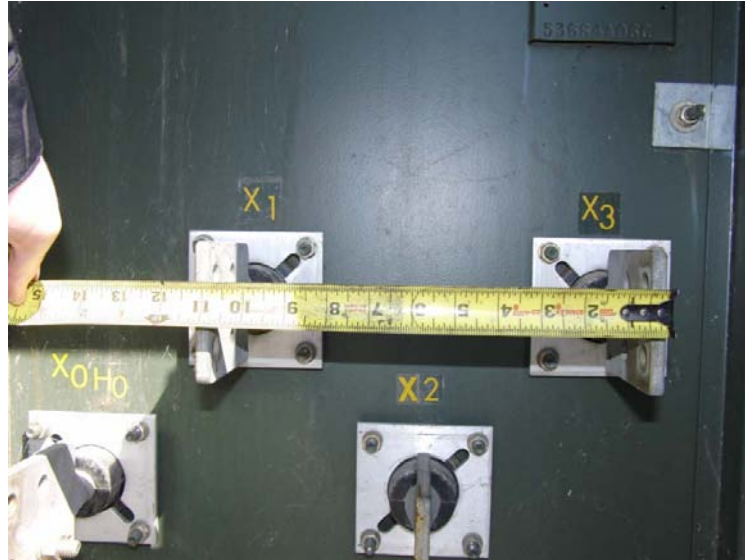
Figure 2-2
Test Unit

Figure 2-2 shows the spacings of the secondary configuration of the unit used for testing. The internals of the transformer were removed, and voltage was supplied to the secondary terminals from the back side from PG&E's 480-V fault current source.

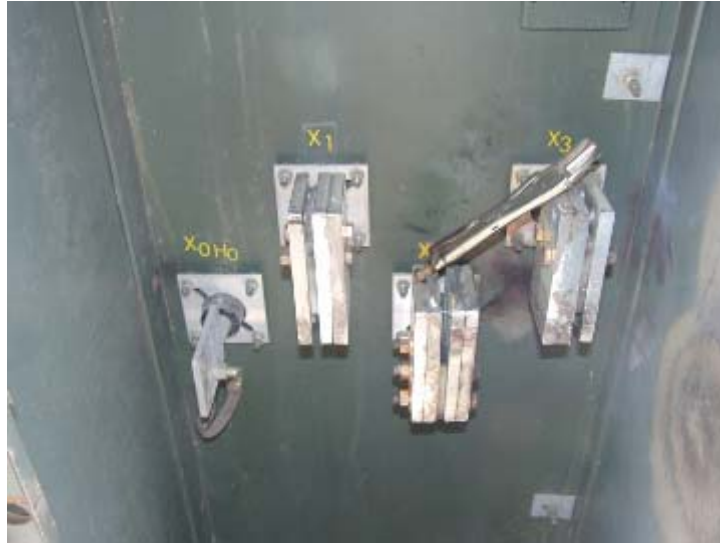
Figure 2-3
Vice Grip Test

Figure 2-3 shows a typical fault test initiated with a pair of vice grips laid across phases. The phase spacing in this configuration is approximately 2.75 in. This phase gap was progressively shortened by adding plates to see if tighter spacings would cause the arc to sustain.

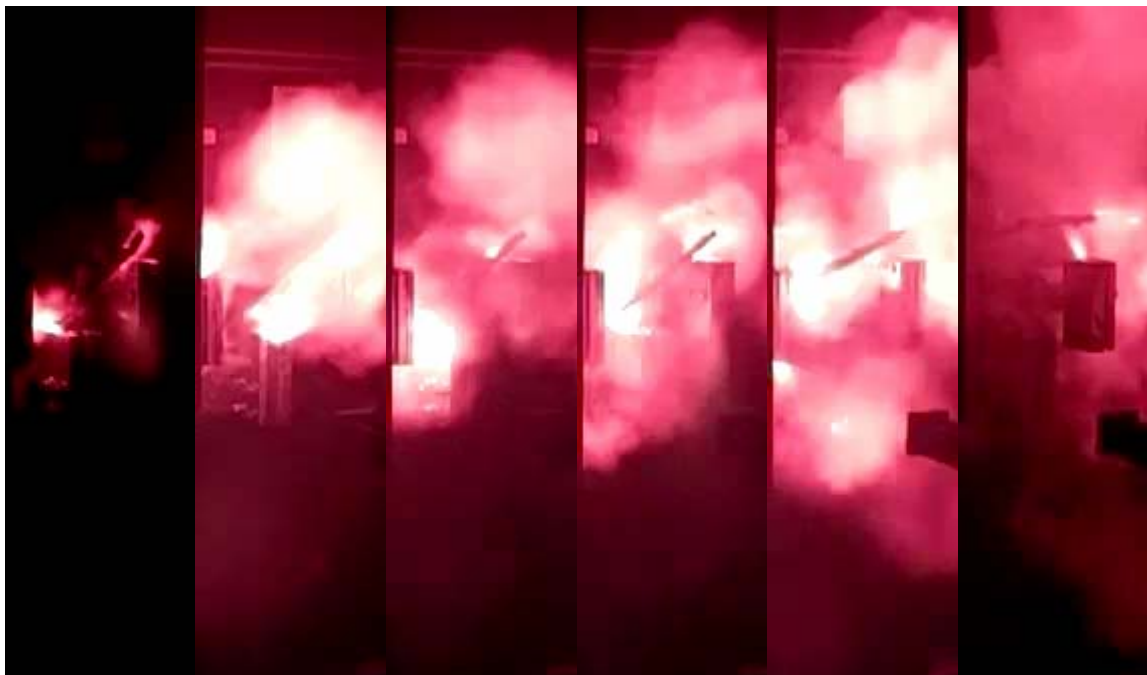
Figure 2-4
1200-fps Camera Snapshots through an Infrared-Passing Filter

Figure 2-4 shows a progression of high-speed video frames taken. The event lasted less than two cycles as shown in Figure 2-5. Note that the event progressed from a line-to-line fault to a three-phase fault in less than a quarter cycle.

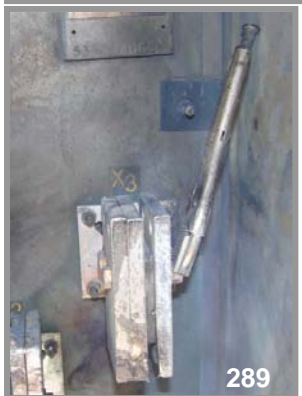
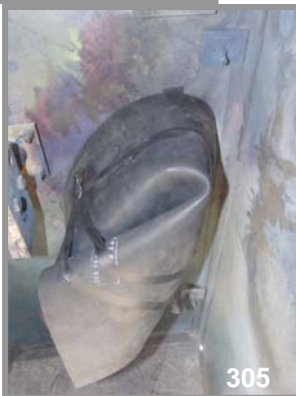
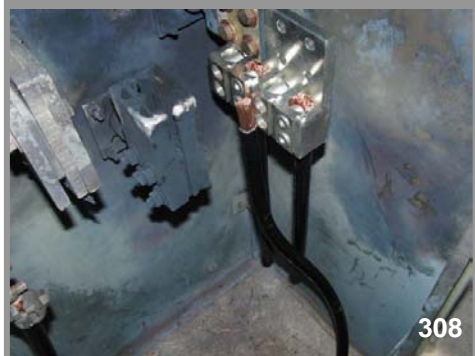
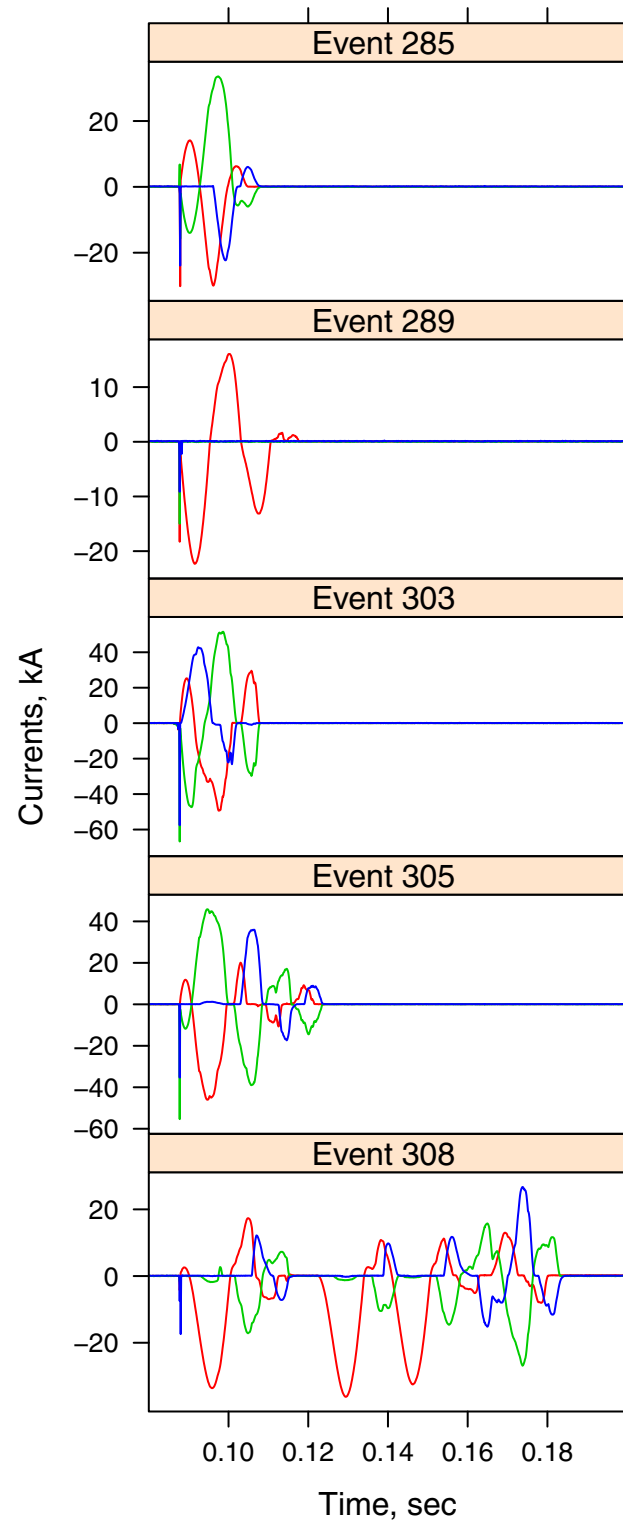
Figure 2-6
Fault Variations Tried

Figure 2-6 shows several fault initiations that were tested. Both phase-to-ground and phase-to-phase faults were attempted. Some common observations include:

- *Fault progression* – Faults generally became three-phase faults within a half cycle (with the exception of event 289 where the main point of arc initiation was well away from other phases).

- *Gap length* – Even to distances as close as two inches, faults could not sustain. The arcs grow into the open space around the electrodes until they cannot sustain. Arcs were first initiated at a distance of 3.7 in and reduced to 2 in.

- *Fault current* – This did not seem to change fault clearing characteristics. Bolted fault currents of 13, 28, and 53 kA were tested.
- *Blanket coverings* – One reason that the arcs clear quickly in the secondary compartment is that there is open space. To see if covering would restrict the arc and lead to sustained arcing, we initiated a phase-to-phase fault under a blanket, either with a #12 fuse wire or a wrench. See event 305 in Figure 2-6 for one example. In three such tests, arcs did not sustain any longer.

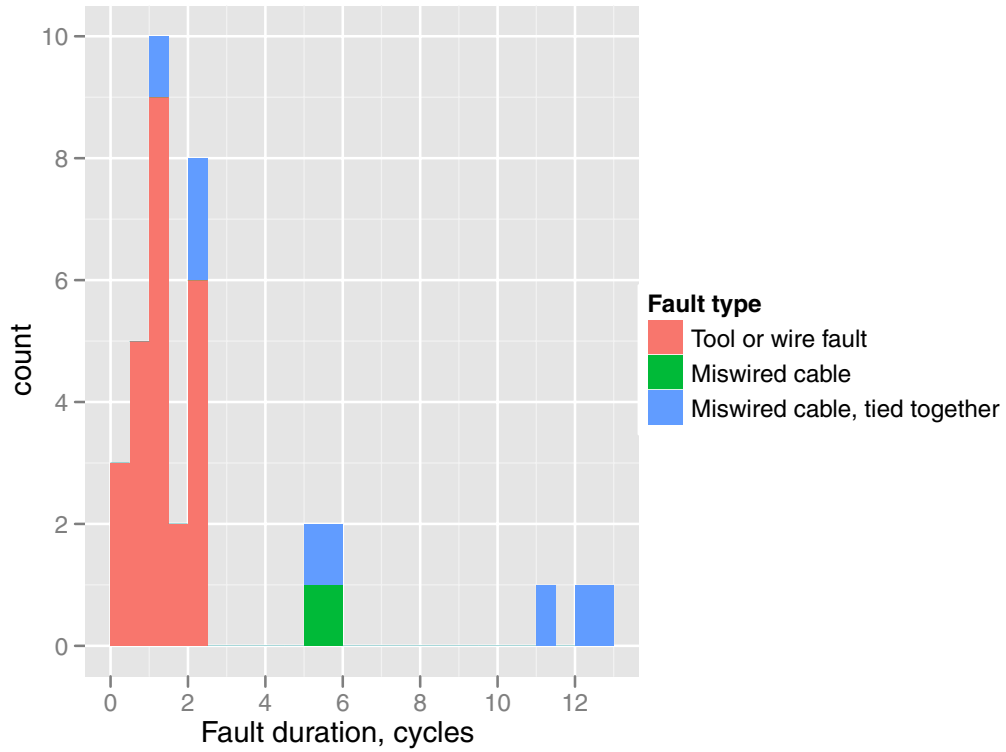
Figure 2-11
Fault Duration Histogram

Figure 2-11 summarizes the fault durations observed from the 35 tests with fault type shown by color. The “miswired cable” indicates the tests with the 500-kcmil conductor jumpering ground to phase or phase to phase, either tied down to adjacent stubs or free.

The durations show that the arcs cannot sustain long in secondary compartments with typical or even tighter-than-normal conductor spacings. Because the duration is short, incident energies are low, much lower than the 20 cal/cm² cited in the consensus change proposal drafted for the 2012 NESC.

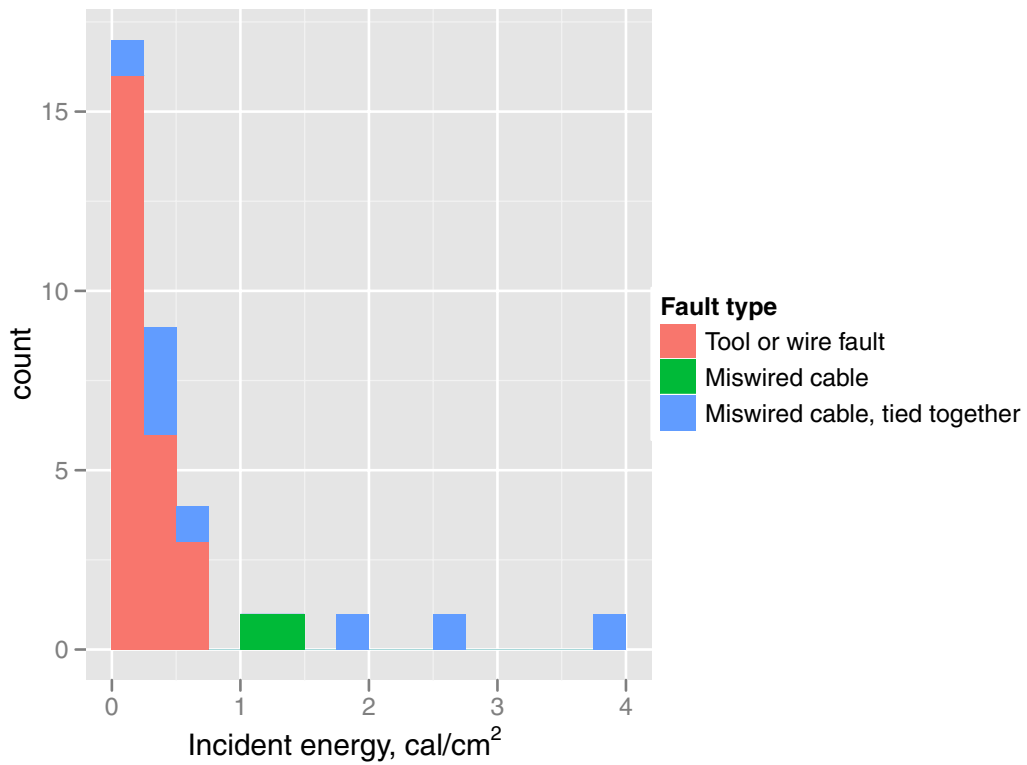
Figure 2-12
Incident Energy Histogram

Figure 2-12 shows distributions of incident energies measured at 21 inches from the fault location. This is longer than the 18 inches used for most of the PG&E 480-V tests.

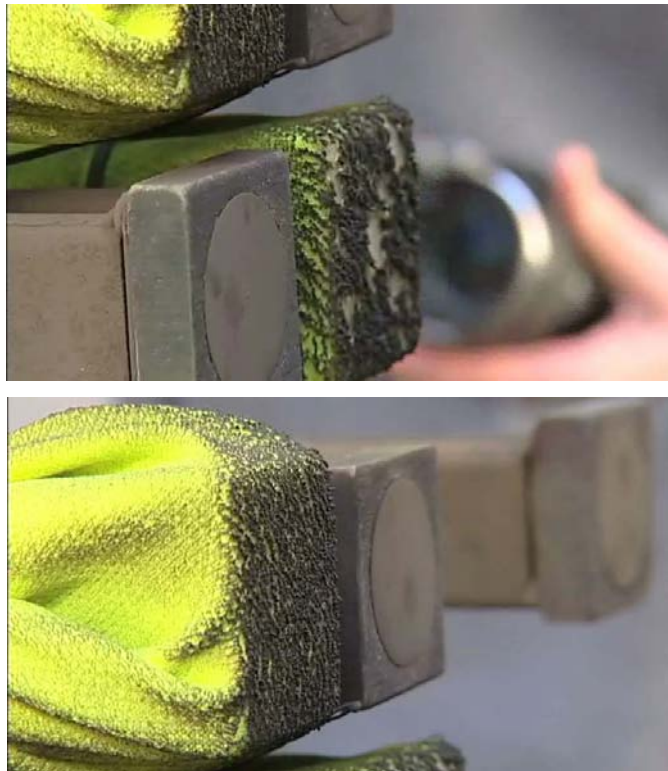
Figure 3-1
Clothing Test Result Example

At part of the network protector testing and padmounted transformer testing, flame-resistant (FR) fabric samples were placed in front of two calorimeters as shown in Figure 3-1. The padmounted transformer tests had so few events with significant incident energy that we only show the results from the network protector tests. Four calorimeters were clustered in front of the network protector as shown in Figure 3-2.

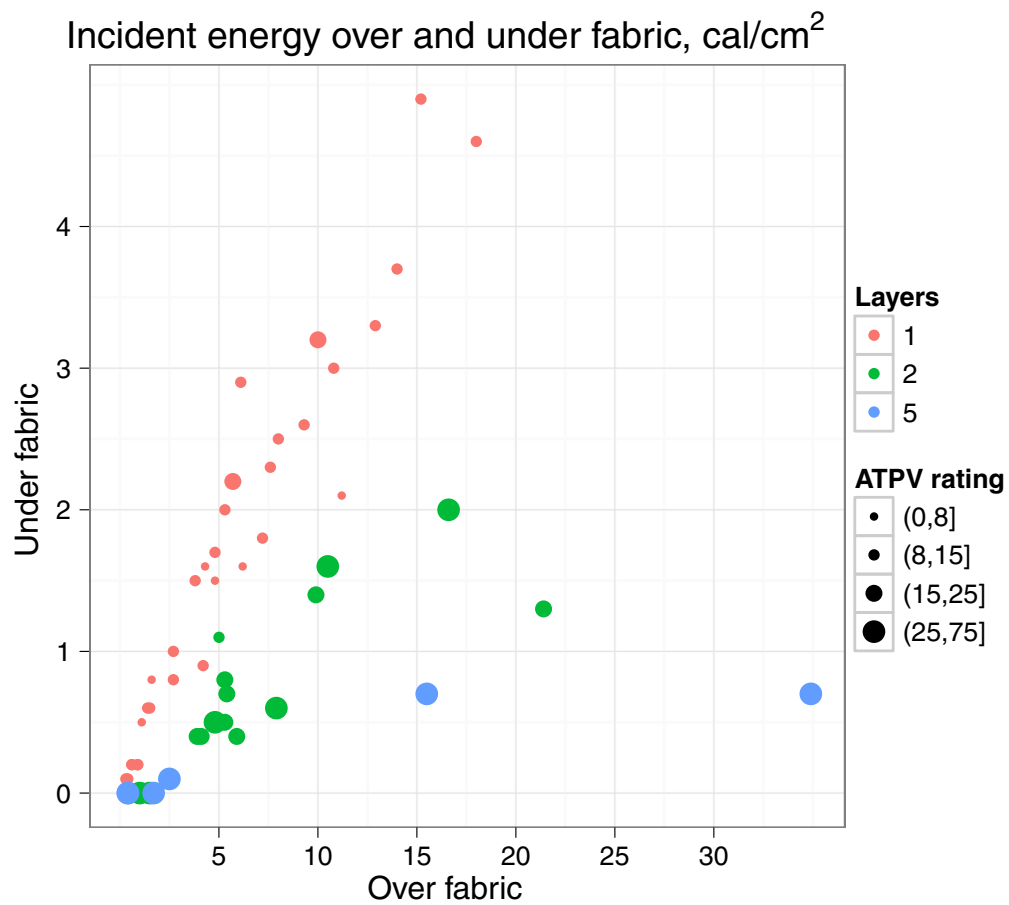
Figure 3-3 summarizes the fabric results by number of layers and rated Arc Thermal Performance Value (ATPV). The results fell out cleanly by number of layers in the fabric. The number of layers is a statistically significant parameter, while the ATPV rating is not a statistically significant indicator as shown in the analysis of variance in Table 3-1. The R^2 value for this linear regression is 0.65.
