Deaerator Tank Assessment Guideline

Current Industry Technology and Approaches

1021199

Technical Update, December 2010

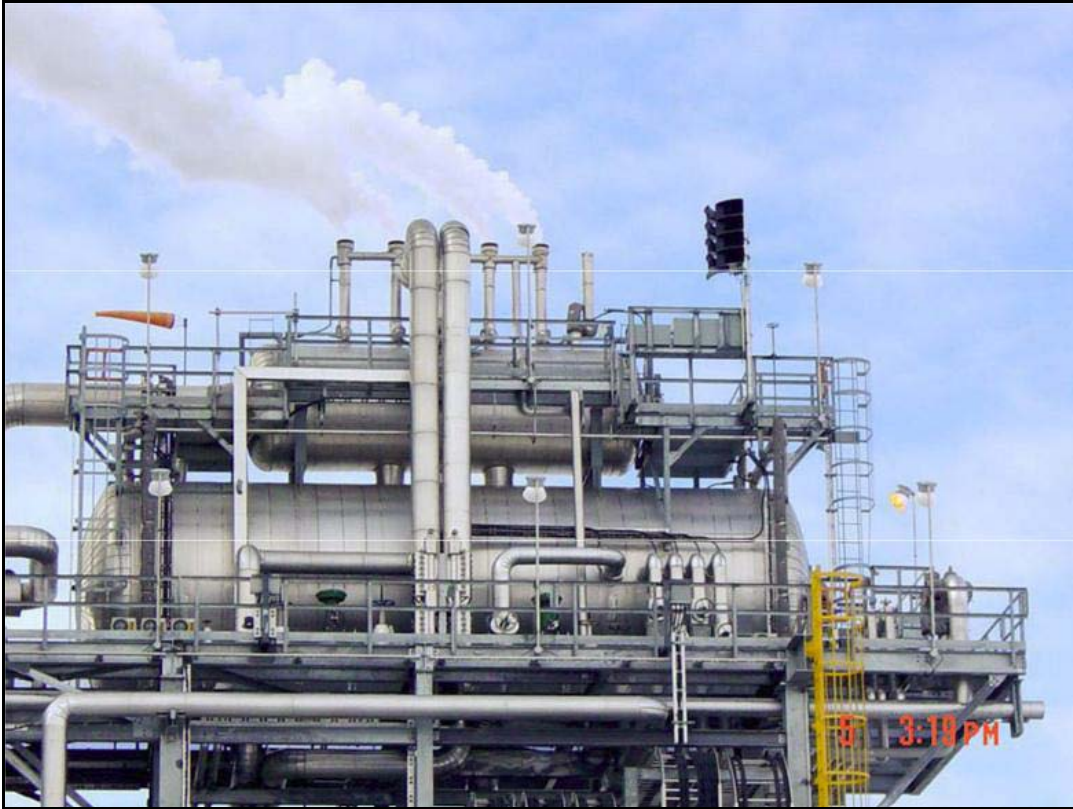
Figure 1-1
Deaerator in operation

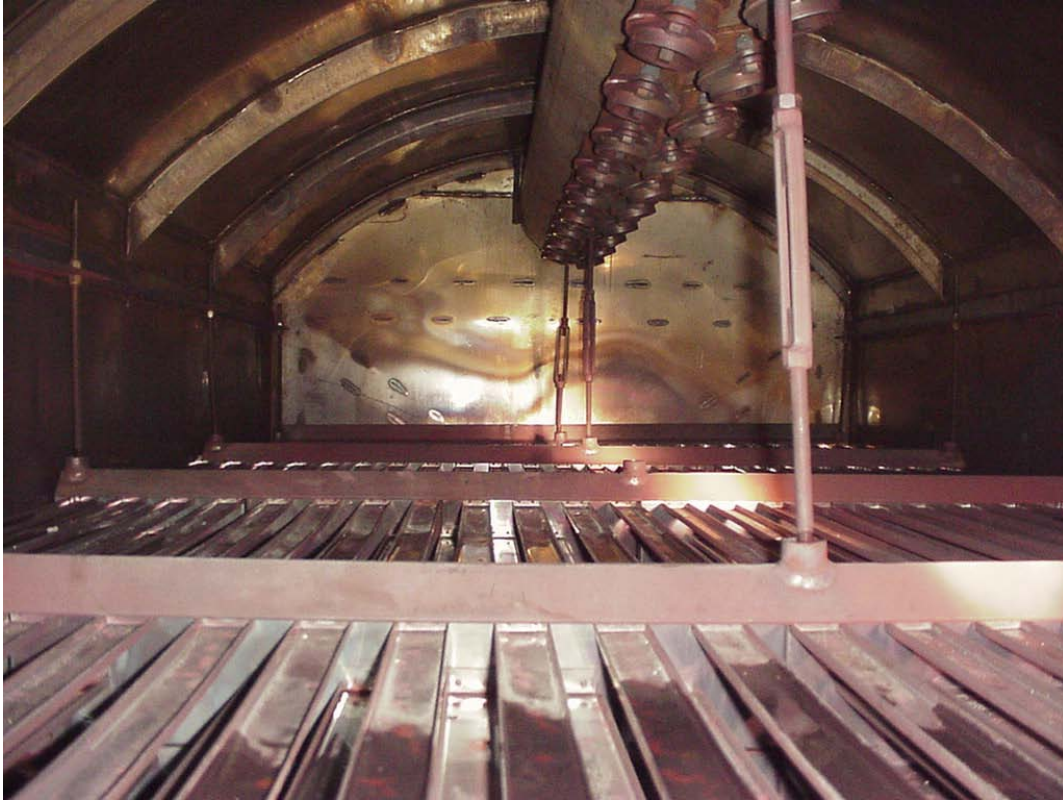
The remaining components are known collectively as the internals (see Figure 1-2 for typical arrangement.). Water enters the unit through a spray header or waterbox, is sprayed through spray valves, and cascades over the trays which are contained in the tray enclosure (see Figure 1-3 and Figure 1-4 for tray and spray valve photographs.). The primary purpose of the internals is to provide sufficient contact and residence time to heat and deaerate the feedwater. In addition, the internals serve to contain the non-condensable gases and prevent them from attacking the pressure shell of the unit.

Figure 1-2
Deaerator internals

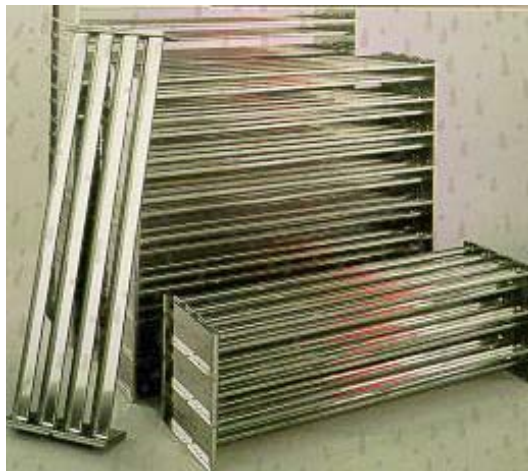
Figure 1-3
Deaerator trays

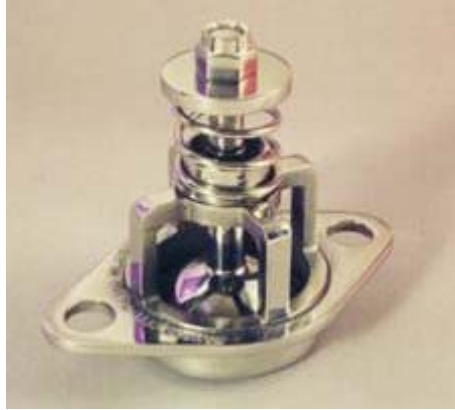
Figure 1-4
Deaerator spray valve

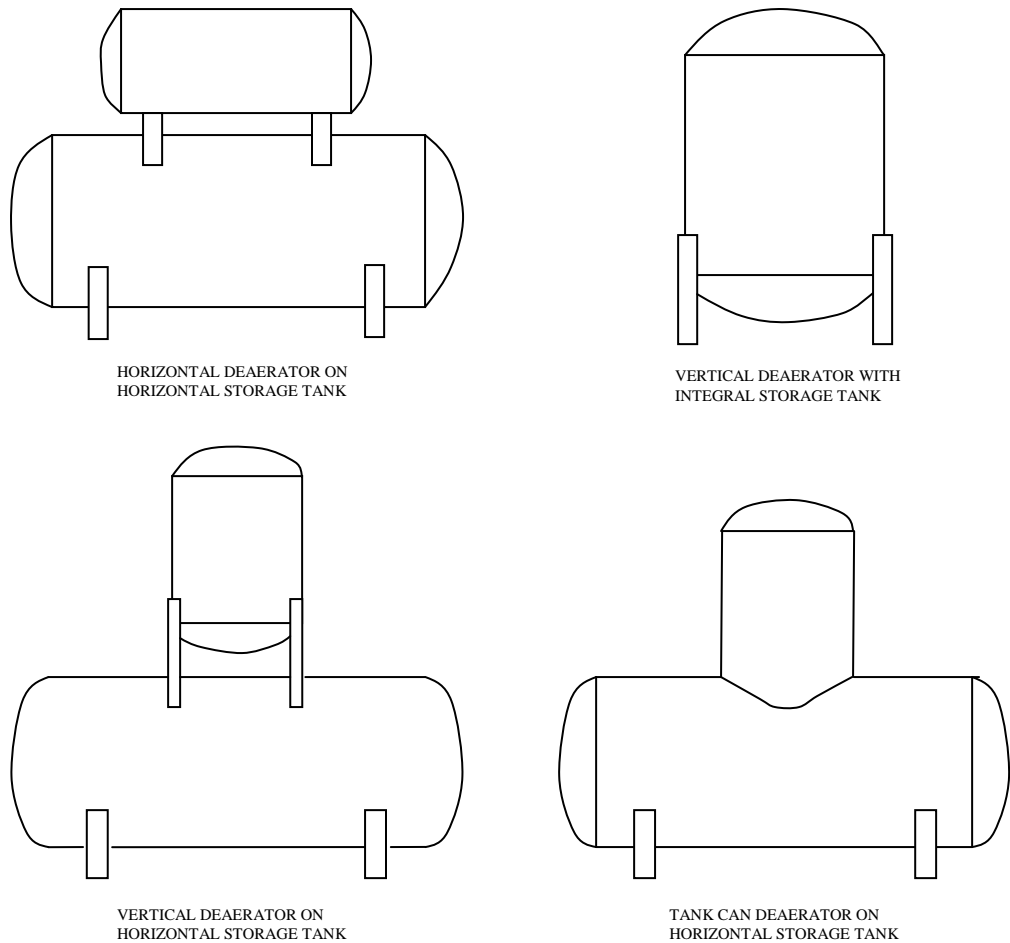
Figure 2-1
Orientation and combinations of deaerators and storage tanks. Source: Heat Exchange Institute standards and typical specifications for tray-type deaerators.

Deaerator systems for power generation utilities are designed and built as either spray-tray (sometimes referred to as simply “tray”) or spray-scrubber units. Although both systems can achieve the above performance requirements, utility systems require the high capacity provided by spray-tray deaerators. Spray-tray deaerators may be designed with varying orientations with respect to the storage tank (Figure 2-1). In high capacity utility systems it is most common to have a horizontal or vertical water deaerator vessel positioned over the storage tank, connected by a short length of water downcomer and equalizing piping. A typical vertical deaerator and storage tank with connections and names of parts is shown in Figure 2-2.

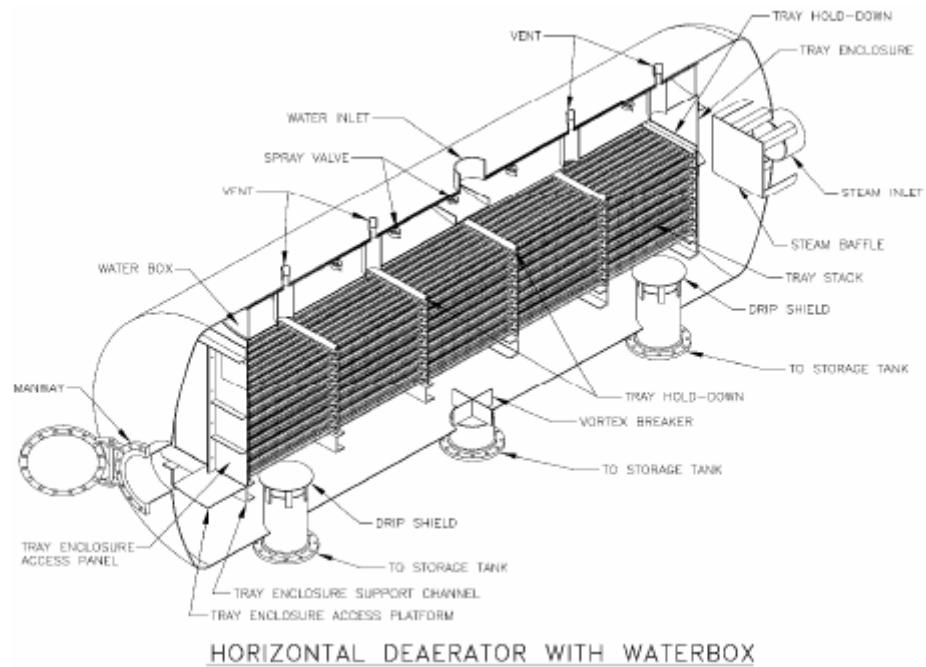
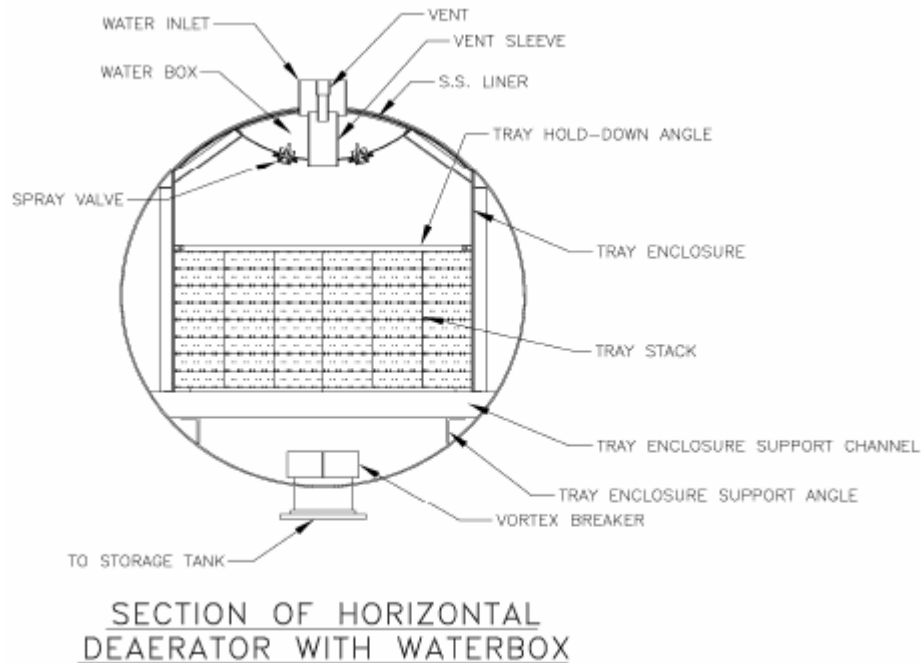
The components of a typical horizontal spray-tray system are shown in Figure 2-3. During operation, most of the dissolved oxygen is released in the spray chamber when droplets contact the non-condensable, free steam, but final oxygen is stripped when water droplets cascade through the series of trays at the bottom of the deaerator vessel. The direction of steam flow through the deaerator is typically countercurrent from the water direction (from the bottom up

Figure 2-3
Typical arrangement of horizontal deaerator with a waterbox (Courtesy of Kansas City Deaerator Company, Inc.)

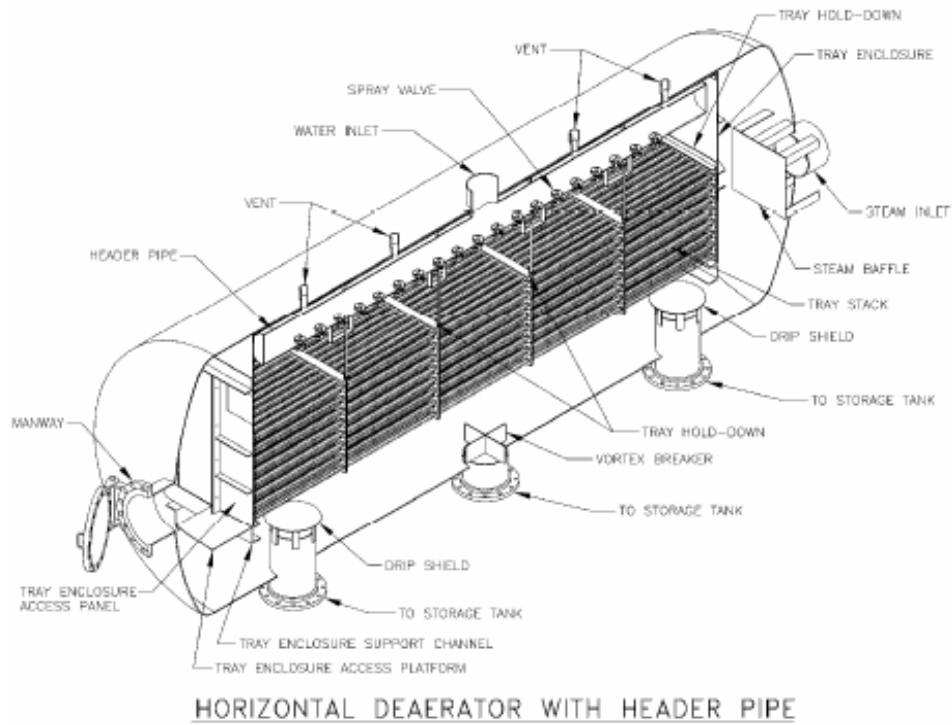
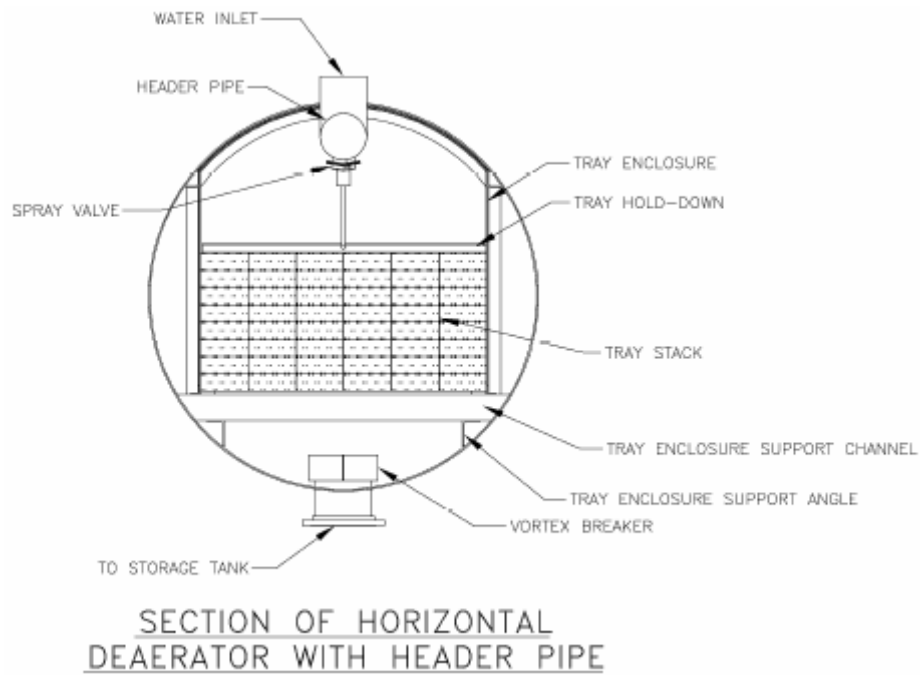
Figure 2-4
Horizontal deaerator with a header pipe distribution system (Courtesy of Kansas City Deaerator Company, Inc.)

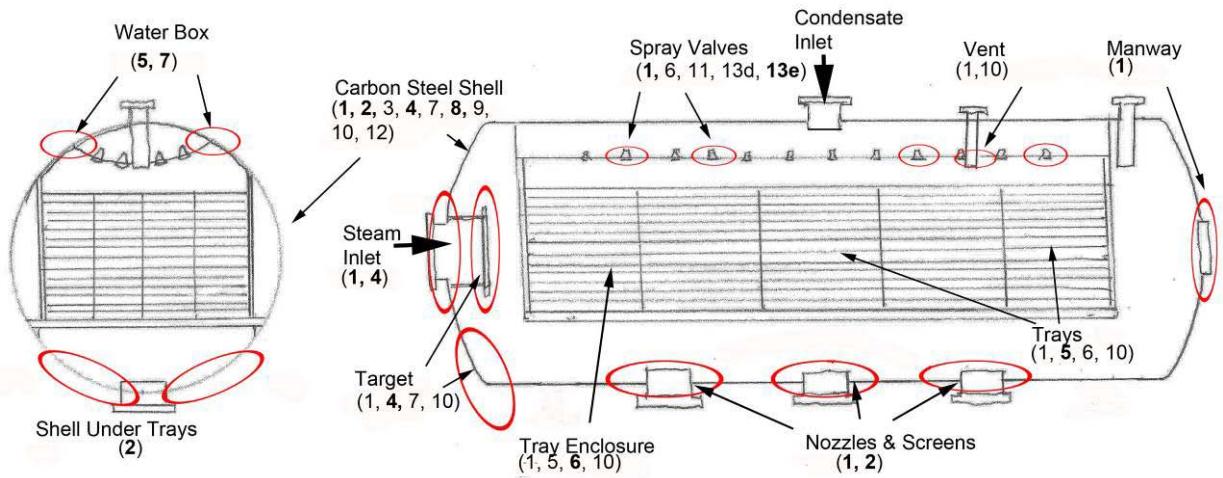
Figure 4-1
Damage mechanism locations within the deaerator heater

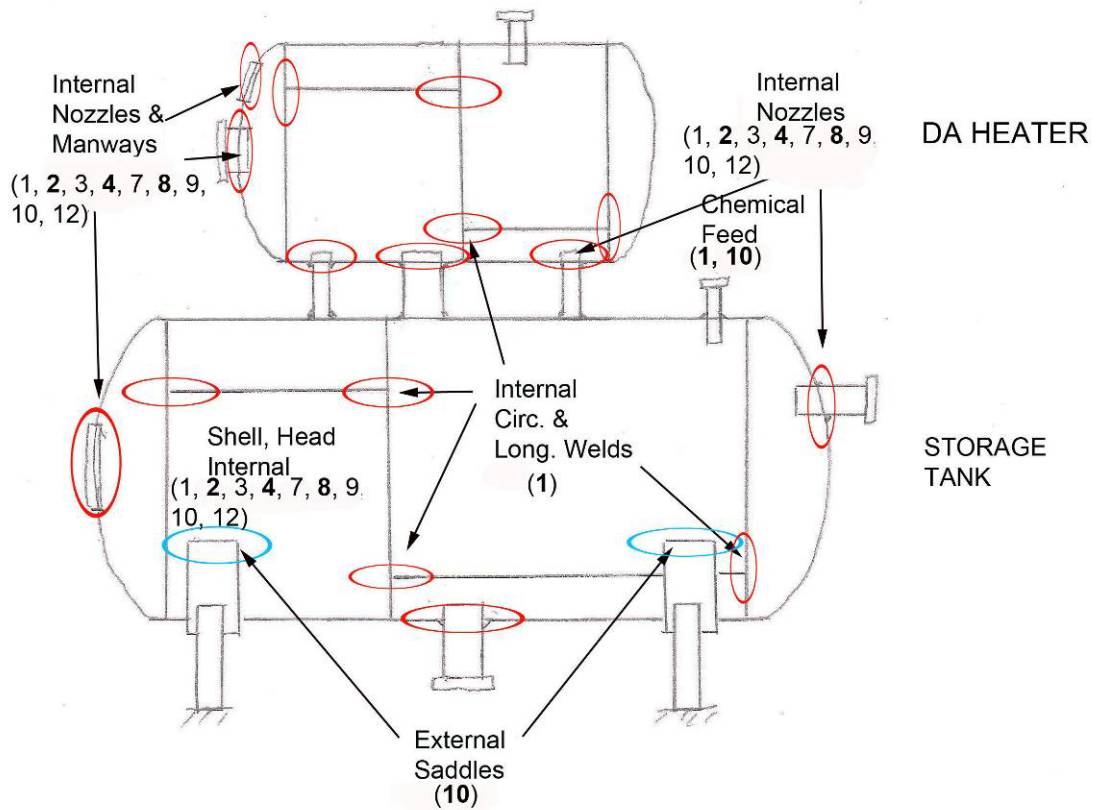
Figure 4-2
Damage mechanism locations on the inside and outside, including the deaerator storage tank

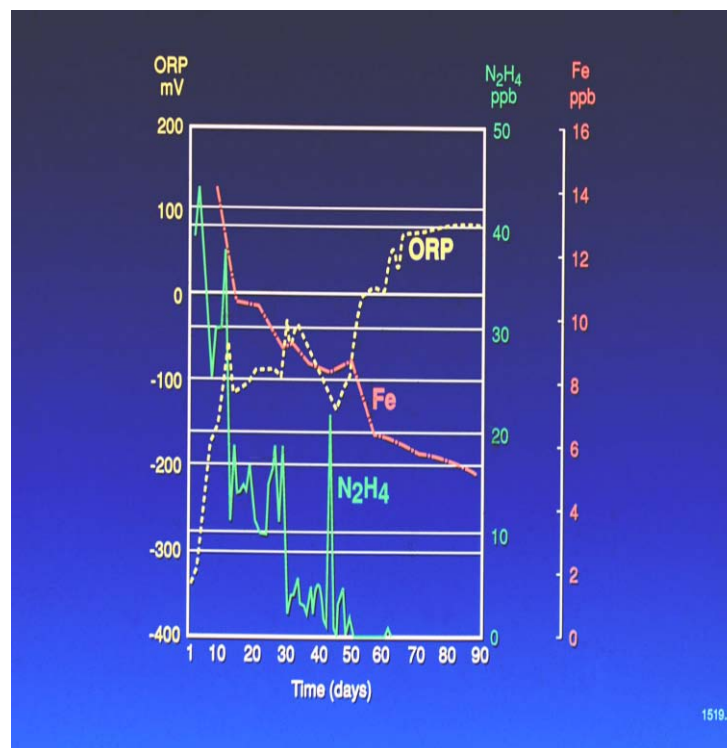
Figure 5-1
Change in oxidizing-reducing potential (ORP) and feedwater iron levels (Fe) at the economizer inlet when Hydrazine (N₂H₄) is gradually reduced on a 600MW drum rnit with an all-ferrous feedwater system (Source: R.B. Dooley, J. Mathews, R. Pate and J. Taylor, "Optimum Chemistry for 'All-Ferrous' Feedwater Systems: Why Use an Oxygen Scavenger," Proc. 55th International Water Conference, Pittsburgh, PA, Oct. 1–Nov. 2, 1994.)

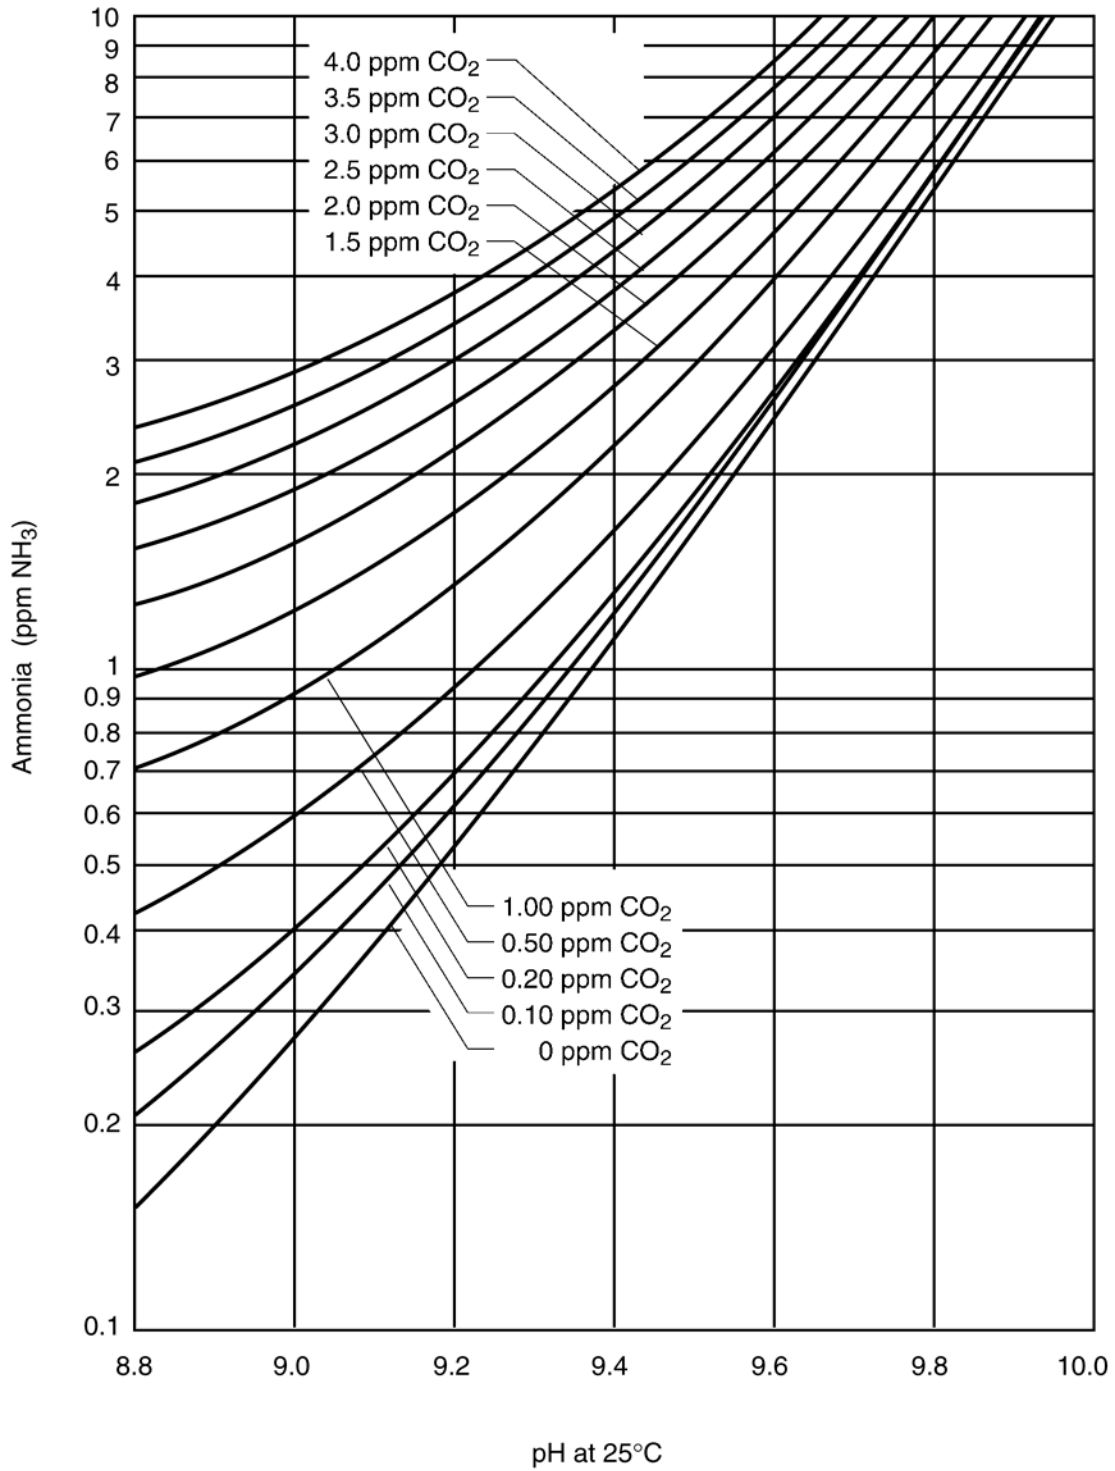
Figure 5-2
The pH relationship between carbon dioxide and ammonia in feedwater (Source: Cycle Chemistry Guidelines for Fossil Plants: Phosphate Continuum and Caustic Treatment, EPRI, Palo Alto, CA: 2004. 1004188)

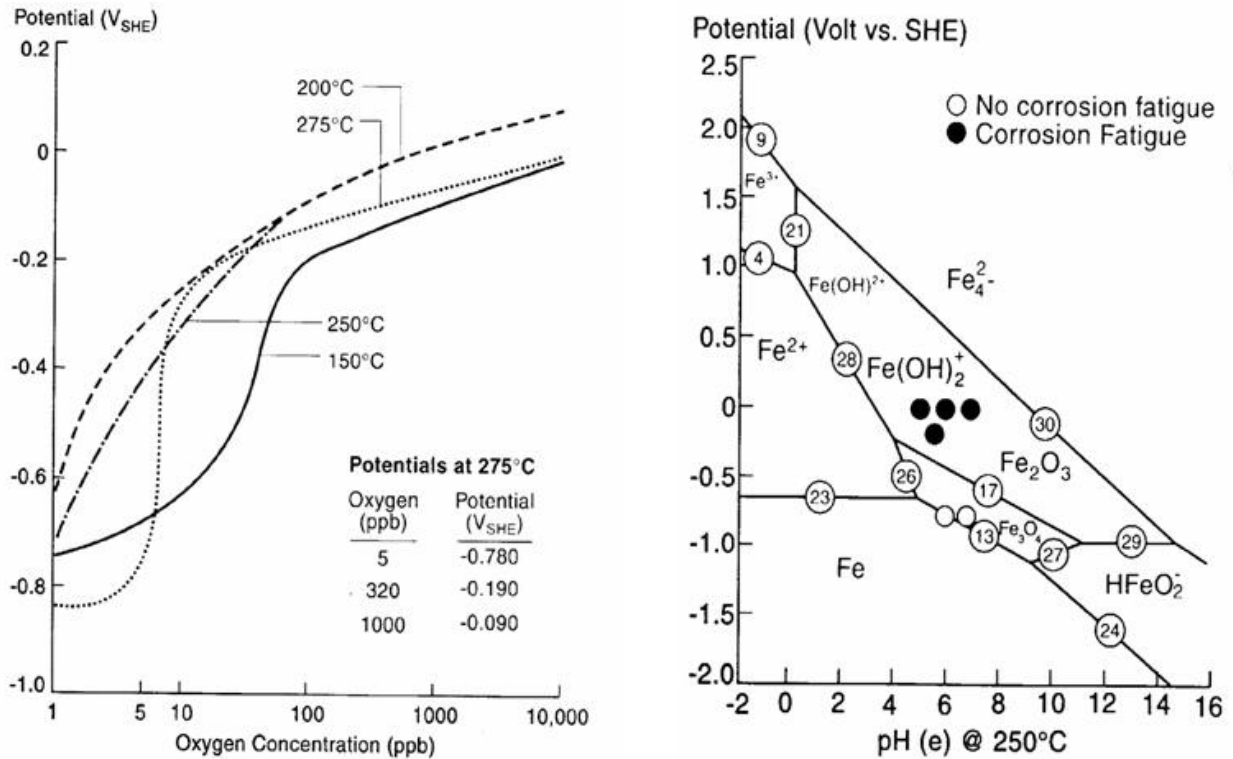
Figure 5-3
Corrosion fatigue and dissolved oxygen concentrations (Source “Corrosion Fatigue Boiler Tube Failures in Waterwalls and Economizers Volume 2: Laboratory Corrosion Studies EPRI, Palo Alto, CA 1992, TR-100455)

Removing dissolved oxygen from the feedwater prior to startup reduces the risk of corrosion fatigue. In Figure 5.3 the Pourbaix diagram on the right shows that the risk of corrosion fatigue is greater when the oxidation reduction potential is greater than - 0.5 mV with a pH (at 250°C (482°F)) between 6 and 8. (Neutral pH at 250°C (482°F) is 5.6) These graphs are at temperatures higher than typical DA operation, but similar principles apply. In the industry, maintaining feedwater dissolved oxygen levels below 100 ppb during the entire startup process is considered good practice.

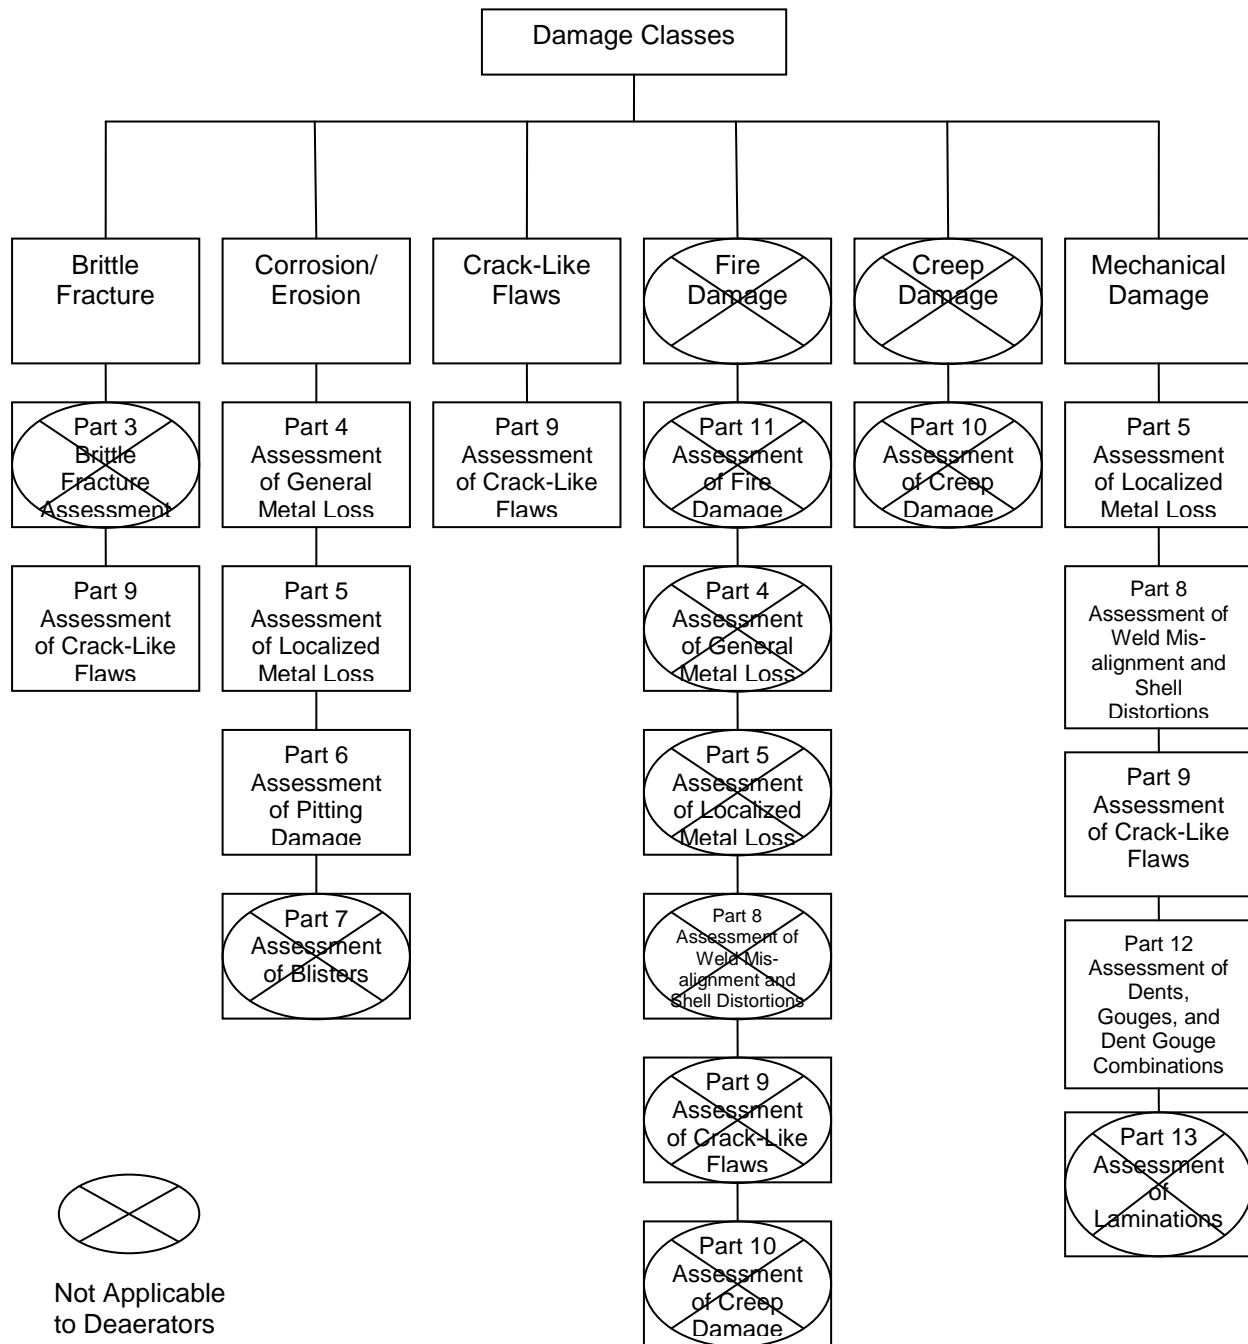
Figure 8-1
FFS assessment procedures for various damage classes, taken from Figure 2.1 in API 579-1/ASME FFS-1 and modified for deaerators.

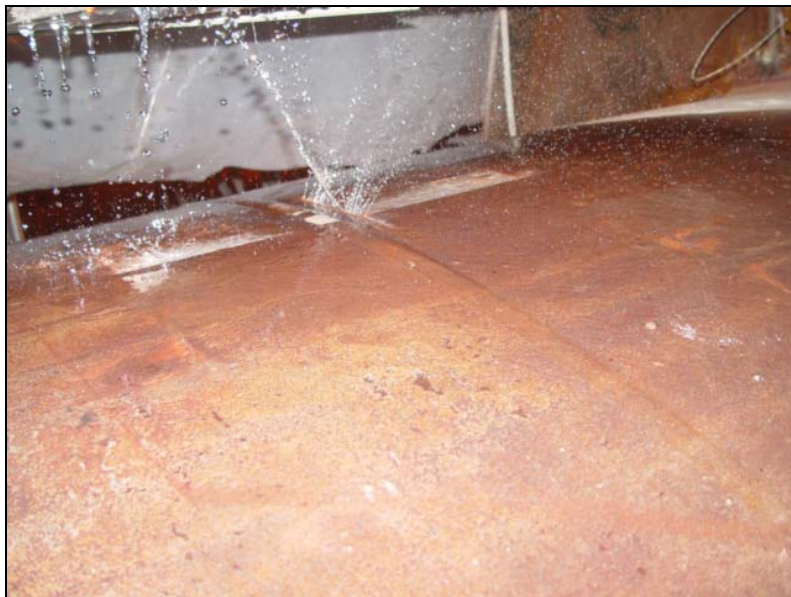
Industry:	Utility
Deaerator Type:	Spray-Tray
Damage Location:	Storage Tank Circumferential Weld
Damage Mechanism:	Corrosion fatigue
Cracking Orientation:	Circumferential
Component Material:	SA-212, Grade B
Years in Service:	Forty-Five Years
Tank Pressure:	150 psi Design/132 psi Operation

A crack was discovered in the center of the vessel on top near a circumferential weld. The crack was ~twelve inches long on the external surface and over twenty-five inches on internal surface. The crack initiated on the internal surface at the weld for a vacuum (stiffening ring). The top 70 degrees of the vacuum ring was removed to allow for repair. The weld was removed by grinding, followed by re-welding.

Figure 10-1
Photograph shows the crack in the circumferential weld of the deaerator storage tank

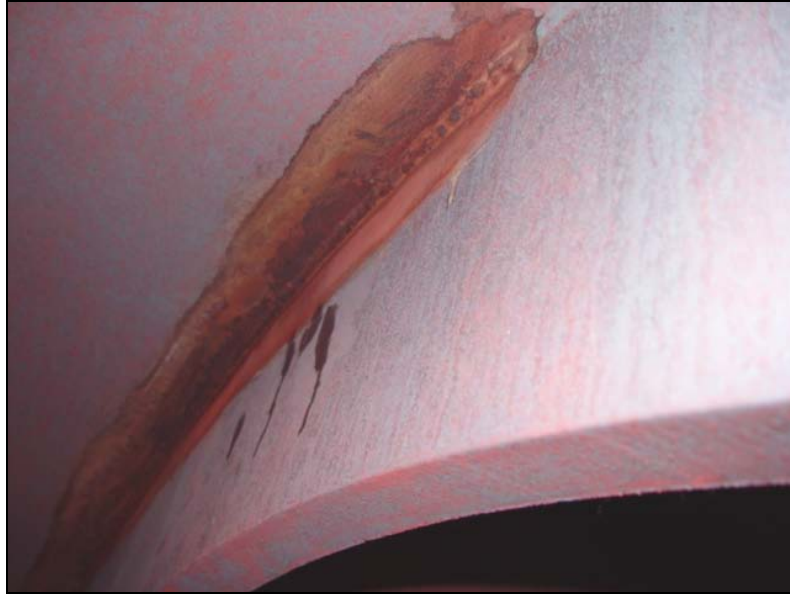
Figure 10-2
Photograph showing the same crack from inside the storage tank

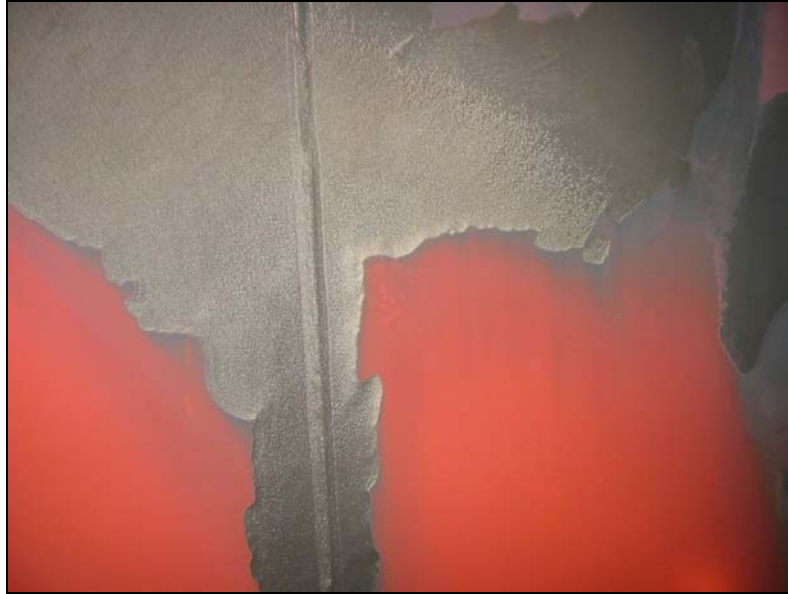
An original tray-spray deaerator heater was installed in 1980 but was replaced due to performance problem with a vertical spray-scrubber heater in 1983. The replacement DA was not post weld heat treated. During the twenty-six years of service, the vessel exhibited corrosion fatigue cracking at welds and significant thinning from flow accelerated corrosion of the shell adjacent to baffle plates (Figure 10.3). An inspection in 2009 revealed thinning at a weld joint, and a region of incomplete penetration of the weld (Figure 10.4). The unit was replaced with a new vertical spray-scrubber during 2009.

Figure 10-3
Flow accelerated corrosion on the ID of the spray-scrubber deaerator. The circumferential weld was previously ground.

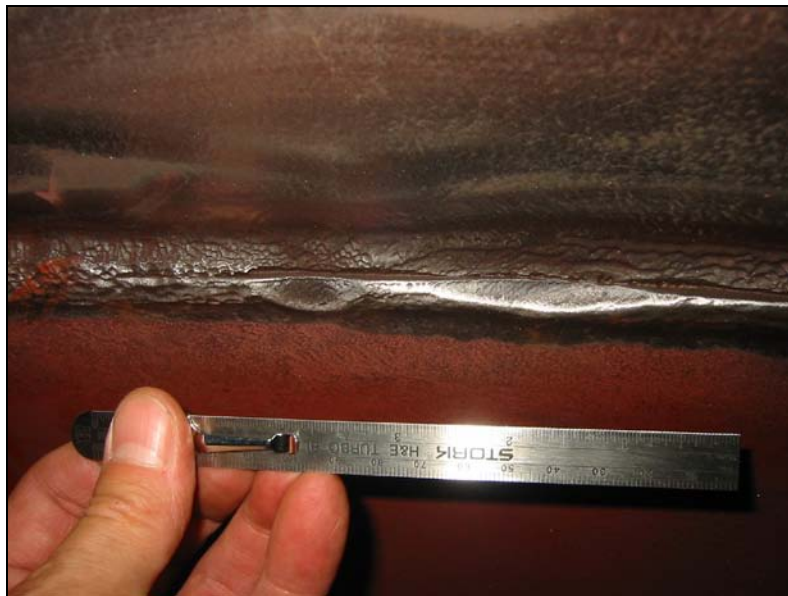
Figure 10-4
Flow accelerated corrosion of the DA heater circumferential weld seam revealed a partial penetration weld. The DA heater was replaced.

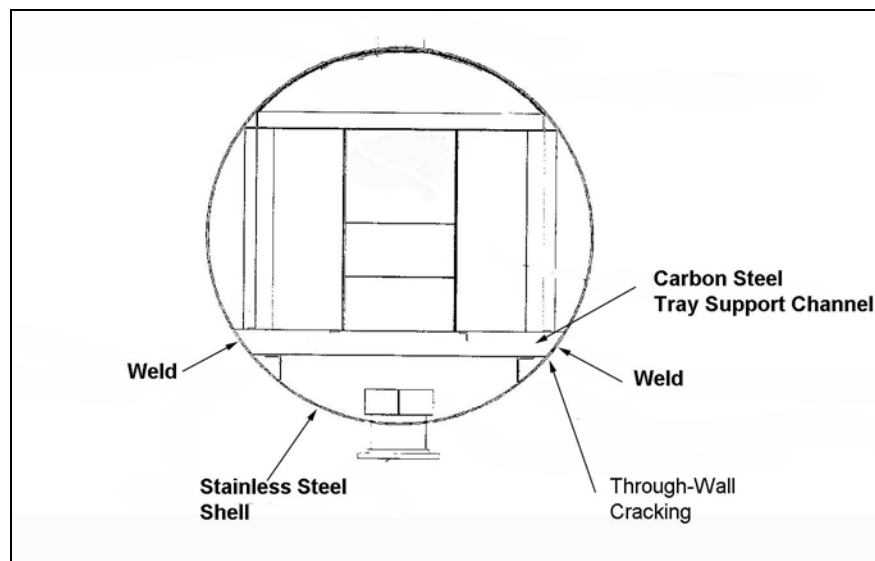
Two original carbon steel deaerator heaters were replaced during 2005 due to problems with severe flow accelerated corrosion. The new DA shells were fabricated from Type 304L stainless steel—carbon steel tray support channels were welded to the shell. The new units operated satisfactorily for approximately three years when a through-wall crack was discovered in the proximity of a support saddle attachment on one unit. Internal examination revealed cracking adjacent to an internal tray enclosure support channel. Further examination revealed that the carbon steel support channel had been rigidly welded to both sides of the stainless vessel walls (Figure 10.5). The analysis concluded that the difference in coefficient of thermal expansion for the stainless steel shell and carbon steel supports produced high stresses and yielding of the vessel wall, ultimately resulting in cracking. A check of the original vessel design revealed that the support channel was to be welded to one side only, and the channel was to “float” on the opposing wall. Additionally, the proximity of the support to the external saddle attachment increased rigidity and local stresses. A check of the mating stainless steel heater showed cracking in the same location, but the crack had not progressed completely through the vessel wall.

Figure 10-5
Drawing shows the failure location in the deaerator heater
