Deaerator Tank Assessment Guideline

Current Industry Technology and Approaches

Technical Update, December 2010

M&M Engineering Associates, Inc.

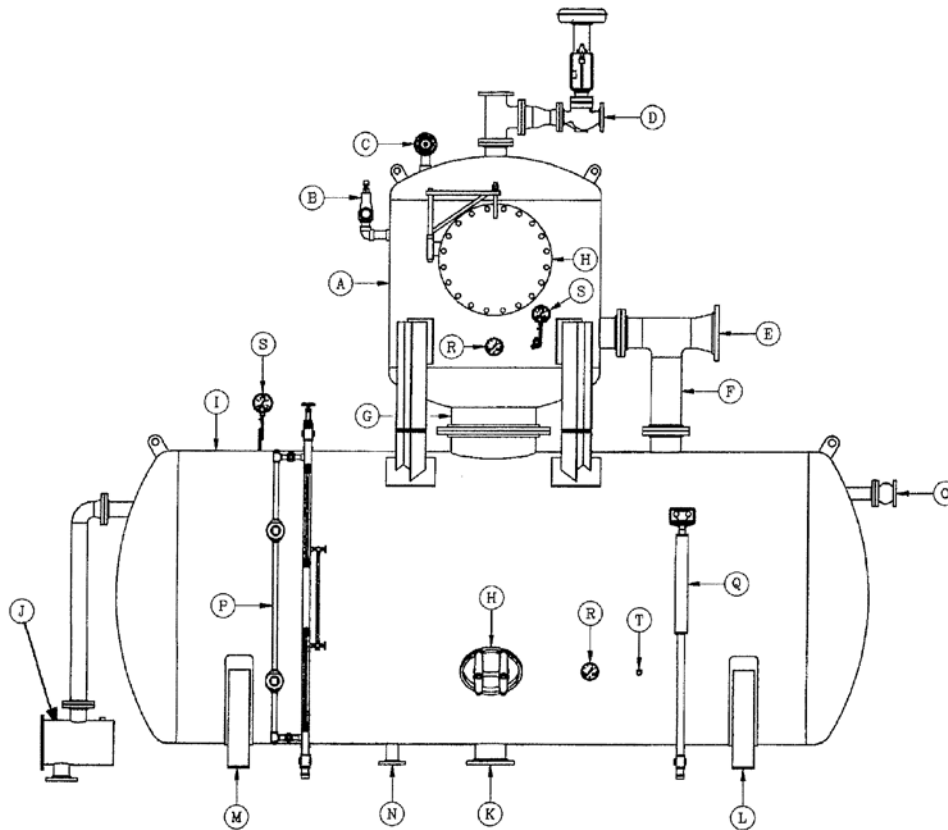
Typical Deaerator Connections and Accessories

Deaerator systems for power generation utilities are designed and built as either spray-tray (sometimes referred to as simply “tray”) or spray-scrubber units. Although both systems can achieve the above performance requirements, utility systems require the high capacity provided by spray-tray deaerators. Spray-tray deaerators may be designed with varying orientations with respect to the storage tank (Figure 2-1). In high capacity utility systems it is most common to have a horizontal or vertical water deaerator vessel positioned over the storage tank, connected by a short length of water downcomer and equalizing piping. A typical vertical deaerator and storage tank with connections and names of parts is shown in Figure 2-2.

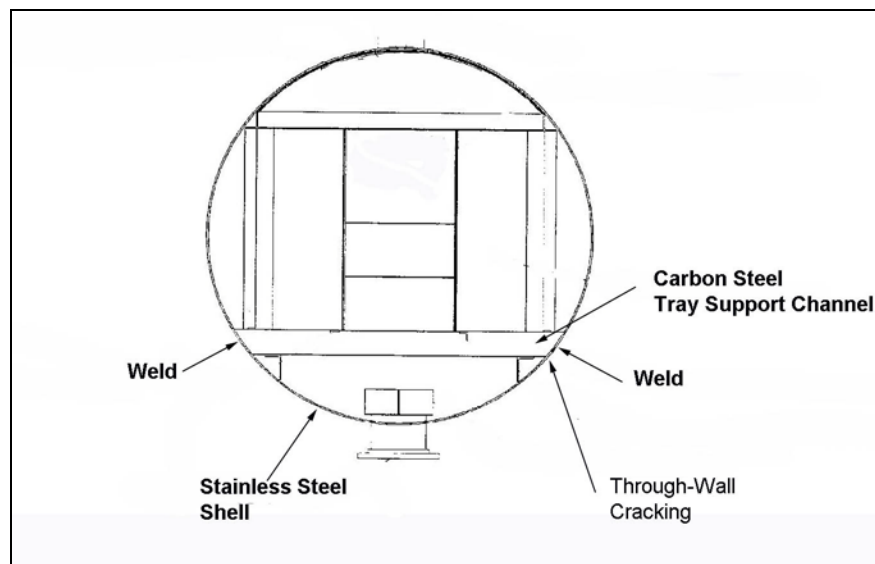
Two original carbon steel deaerator heaters were replaced during 2005 due to problems with severe flow accelerated corrosion. The new DA shells were fabricated from Type 304L stainless steel—carbon steel tray support channels were welded to the shell. The new units operated satisfactorily for approximately three years when a through-wall crack was discovered in the proximity of a support saddle attachment on one unit. Internal examination revealed cracking adjacent to an internal tray enclosure support channel. Further examination revealed that the carbon steel support channel had been rigidly welded to both sides of the stainless vessel walls (Figure 10.5). The analysis concluded that the difference in coefficient of thermal expansion for the stainless steel shell and carbon steel supports produced high stresses and yielding of the vessel wall, ultimately resulting in cracking. A check of the original vessel design revealed that the support channel was to be welded to one side only, and the channel was to “float” on the opposing wall. Additionally, the proximity of the support to the external saddle attachment increased rigidity and local stresses. A check of the mating stainless steel heater showed cracking in the same location, but the crack had not progressed completely through the vessel wall.

Figure 10-5
Drawing shows the failure location in the deaerator heater
