# Pileated Woodpecker Damage to Electric Utility Poles: Evaluation of the Sonic Dissuader

**1021375**

Final Report, June 2010

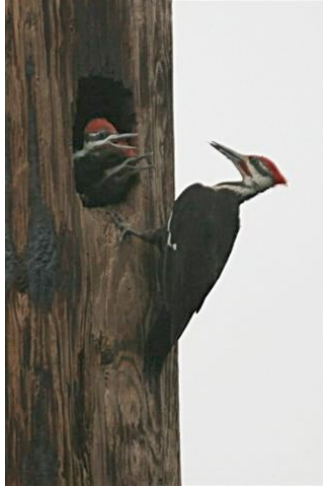
**Figure 1-1**  
**Male Pileated Woodpecker Feeding Nestlings in Utility Pole**

Pileated woodpeckers (*Dryocopus pileatus*) (Figure 1-1) are one of the largest North American woodpeckers (length 38-51 cm, weight 250-350 g) with males weighing an average of 10-15% more than females [2]. Pileated woodpeckers cause some of the most severe damage to electric utility poles especially in the southern states bordering the Atlantic and Gulf of Mexico, eastern Texas to Southern North Carolina, Pennsylvania into New England, and the Eastern Canadian provinces. They occupy southern Canada, and western, mid-western, eastern and southeastern U.S. in habitat largely consisting of deciduous or coniferous forests [2]. The diet of pileated woodpeckers consists mainly of ants and beetle larvae; however, fruits and nuts are eaten when available [3]. Breeding bird surveys indicate that pileated woodpecker populations have increased dramatically in the last 30 years, especially from 1966 to 1979 when statewide populations in Massachusetts, Michigan, and the province of Nova Scotia increased 25.7%, 26.3%, and 40.5%, respectively. The U.S. population has increased 1.3% per year ( $p < 0.01$ ) for the period 1980-2005 [4]. Possible explanations for the range expansion of the pileated woodpecker include exclusion of fire leading to an increase in numbers of trees, and an increase in dead and dying trees due to expansion of tree diseases. Pileated woodpeckers are an important species in forest ecosystems providing cavities that are used by other birds, mammals, reptiles, and invertebrates for shelter and nesting [2].

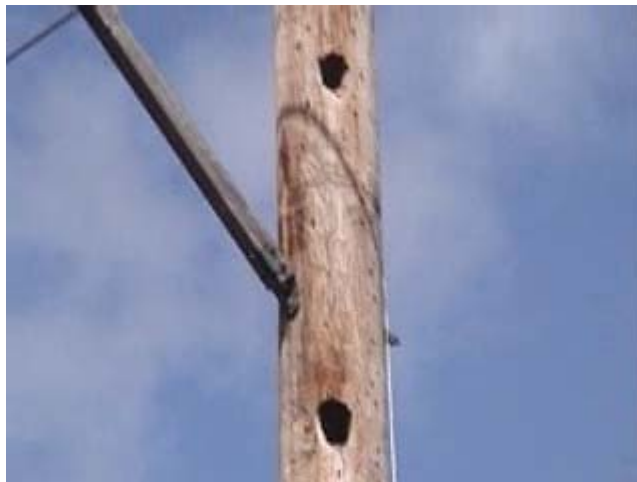
**Figure 1-2**  
**Pileated Woodpecker Roosting Cavities in a H-Structure Transmission Pole on New York State Electric and Gas (NYSEG) Hammondsport Line 04 May 2005**

Woodpecker-caused damage to electric utility poles may be attributed to several factors depending on the species. For example, ladder-backed woodpeckers commonly drill holes on the undersides of crossarms of smaller poles, sometimes widening holes to the extent of creating a hole completely through the crossarm. The acorn woodpecker creates both large holes for roosting and nesting and smaller holes for storing acorns. Pileated woodpeckers create distinctive damage on electric utility poles, typically in the middle to upper portion of the pole below the crossarm. The holes tend to have a square-shaped outline and initially have an angular cone shaped appearance inside. As the hole is widened for use as a roosting/nesting cavity, it loses its square shape and appears more round [1].

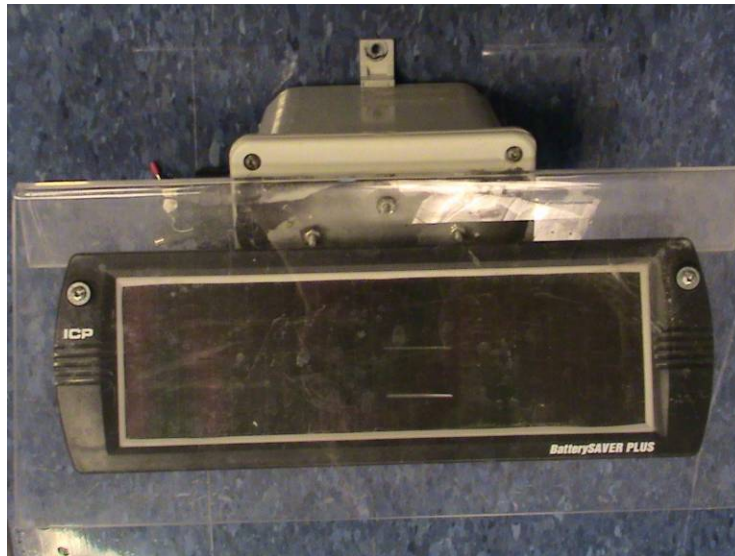
**Figure 1-3**  
**Sonic Dissuader Device Designed by Myrica Systems, Inc. (Winnipeg, Manitoba, Canada)**  
**Tested at NWRC 14 August-05 October 2007**

Two devices were used in this study, the Sonic Dissuader (Figure 1-3) and a control device (Figure 1-4). These devices were designed by Myrica Systems, Inc (Winnipeg, Manitoba, Canada) through funding from Manitoba Hydro during a 2 year project conducted in 2000-2002. Each unit when mounted on a pole is designed to detect vibrations caused from woodpeckers pecking on the pole that are different from vibrations caused from other sources. Each unit contains electronics for the purpose of data logging these events. When woodpecker vibrations are detected, they are logged digitally within each device. In addition, temperature and battery data are recorded to verify the environmental and charging conditions that the devices experience in the field. The devices contain a real time clock to keep track of the date and time of day. The Sonic Dissuader differs from the control box because it also emits sounds used to frighten away pileated woodpeckers, whereas the control device does not emit any sounds.

1. Call 1: Pileated woodpecker territorial announcement (4 sec)
2. Call 2: Pileated woodpecker threat chatter (16 sec)
3. Call 3: Pileated woodpecker communication chatter (21 sec)
4. Call 4: Pileated woodpecker drumming (4 sec)
5. Call 5: Merlin territorial announcement (5 sec)
6. Call 6: American Kestrel territorial announcement (6 sec)
7. Call 7: Red-tailed Hawk territorial announcement (4 sec)

Calls are played in sequence from 1-7. These calls are emitted as audio sounds from each Sonic Dissuader when the correct combinations of time of day, triggering events and sufficient battery voltage are met. A call can only be broadcast once within each 15 minute period. The Sonic Dissuader is powered by a solar charged lead-acid gel-cell and the control device is powered by a 6 volt lantern battery.

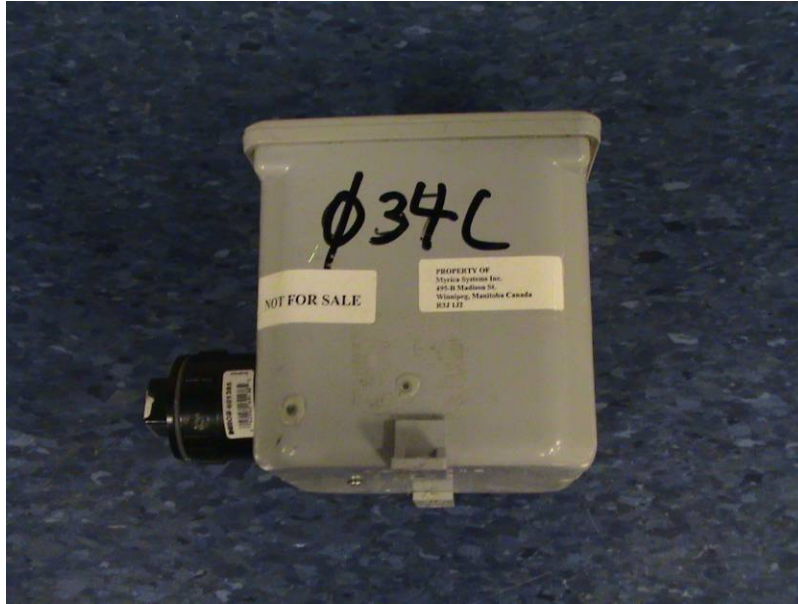
**Figure 1-4**  
**Control device designed by Myrica Systems, Inc. (Winnipeg, Manitoba, Canada) Tested at NWRC 14 August-05 October 2007**

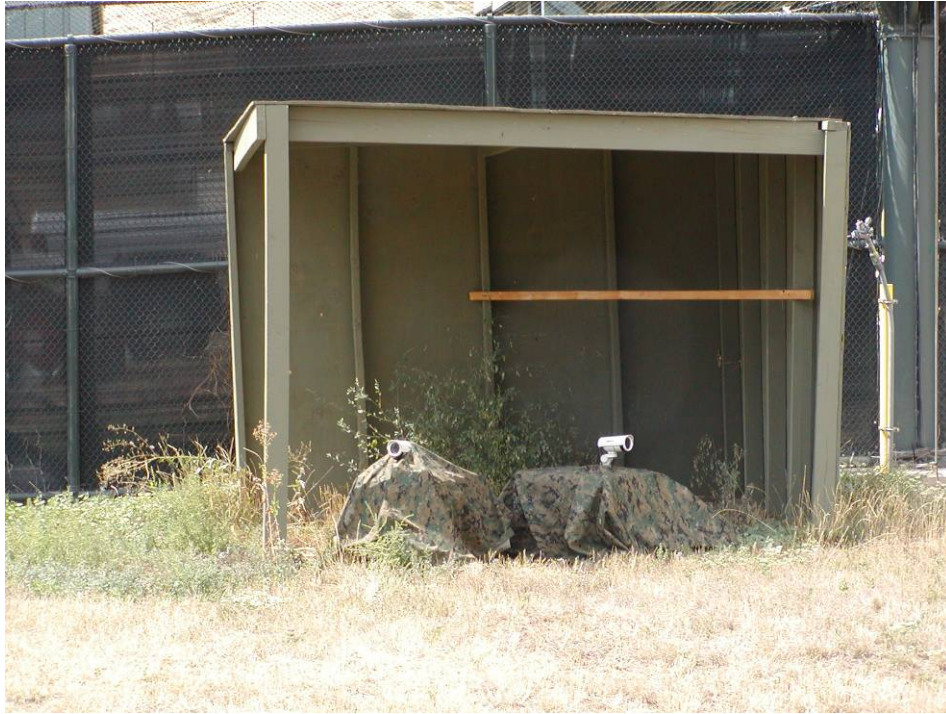
**Figure 2-3**  
**Video Camera Location within Wooden Shelter of NWRC Flight Pen During Testing**  
**Conducted 14 August 2007 through 05 October 2007**

Sonic Dissuader and control poles were taped (both video and sound) with video recorders during daylight hours (0545-2030) (Figure 2-3). From the tapes, we collected data on the total amount of time spent on the treated or control pole, and the total amount of time spent pecking (causing damage) on the treated or control pole. We also recorded the call number heard, time of the broadcast, and the amount of pecking that was done before and after the broadcast.

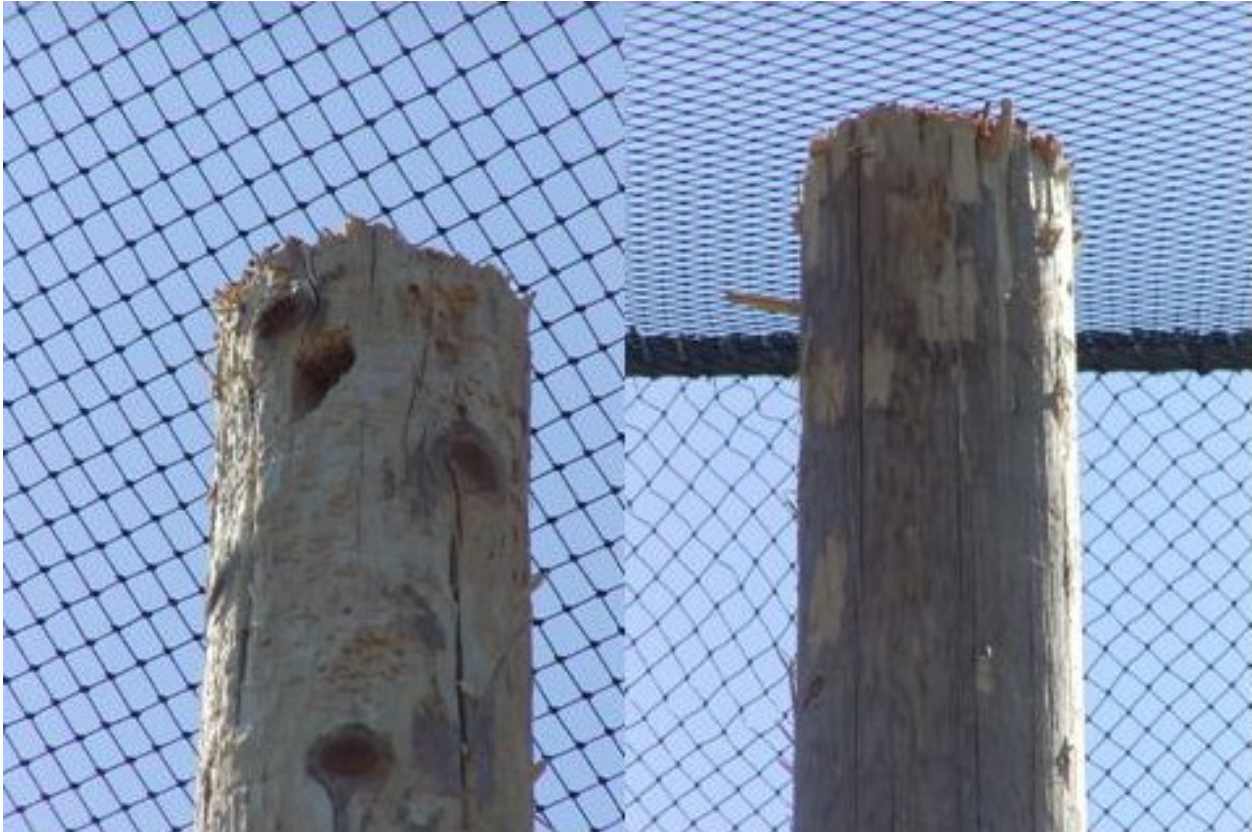
**Figure 4-1**  
**Photo of Bird 5 Test Poles (Sonic Dissuader Pole at Left, Control Pole at Right) from**  
**Testing Conducted at NWRC from 14 August through 05 October 2007**

between the treatments and controls. For example, bird 5, a male pileated woodpecker, caused 69.8 g of damage (woodchips removed) to the pole equipped with the Sonic Dissuader. This damage was caused during 2 hours and 18 minutes of pecking. The Sonic Dissuader pole at the end of the 5 day test period had 2-5.0 cm holes (Figure 4-1). In contrast, bird 1, a female pileated woodpecker caused only 1.1 g of damage (woodchips removed) to the Sonic Dissuader pole. This damage was caused during only 8 minutes of pecking.
