Mitigation of Explosive Cleaning Damage in 300 Series Stainless Steels

Interim Report

Technical Update, March 2011

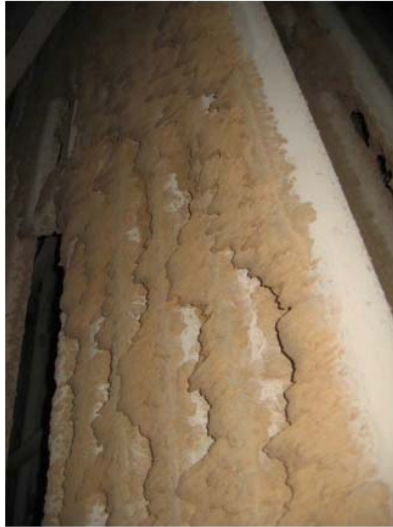
Figure 1-1
Boiler tubes covered in coal ash (slag). [1]

Explosive cleaning is a process by which power utilities remove coal ash (slag) from industrial coal-fired boilers by detonating a suitable explosive near slag covered boiler tubes. A photograph of slag covered boiler tubes is shown in Figure 1-1. Austenitic stainless steel tubes are commonly used in sections of a boiler. During the explosive cleaning process the tubes undergo a stress pulse that propagates through the tube as shown in Figure 1-2. A typical dynamite blast has two to three compressive pulses but because the geometry of a tube allows for the superposition of the pulses, tensile stresses are generated at specific locations throughout the tube. Each of these individual pulses represents one loading cycle that may contribute to the overall cumulative deformation in time leading to fatigue.

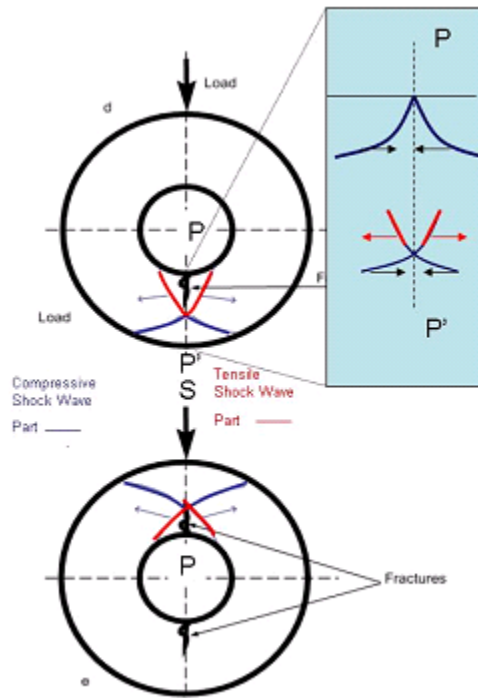
Figure 1-2
Propagation of a shock pulse through the cross section of a tube leading to failures at the internal diameter directly under and opposite to the position of the explosive load. [1]

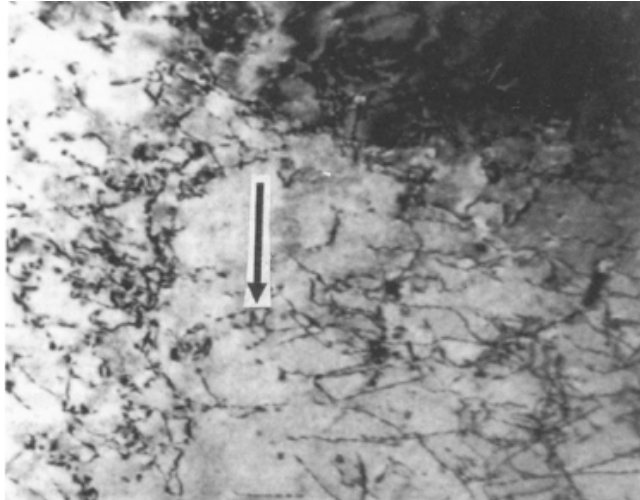
Figure 2-1
Evidence of dislocation loop in polycrystalline iron. [8]

Even though low SFE materials have been shown to deform primarily by slip of planar arrays of dissociated partial dislocations, cross-slip can occur for non-planar shock deformed materials [9]. Figure 2-1 shows a bright field TEM micrograph of dislocations in 304L stainless steel with an arrow pointing to dislocation loop source.

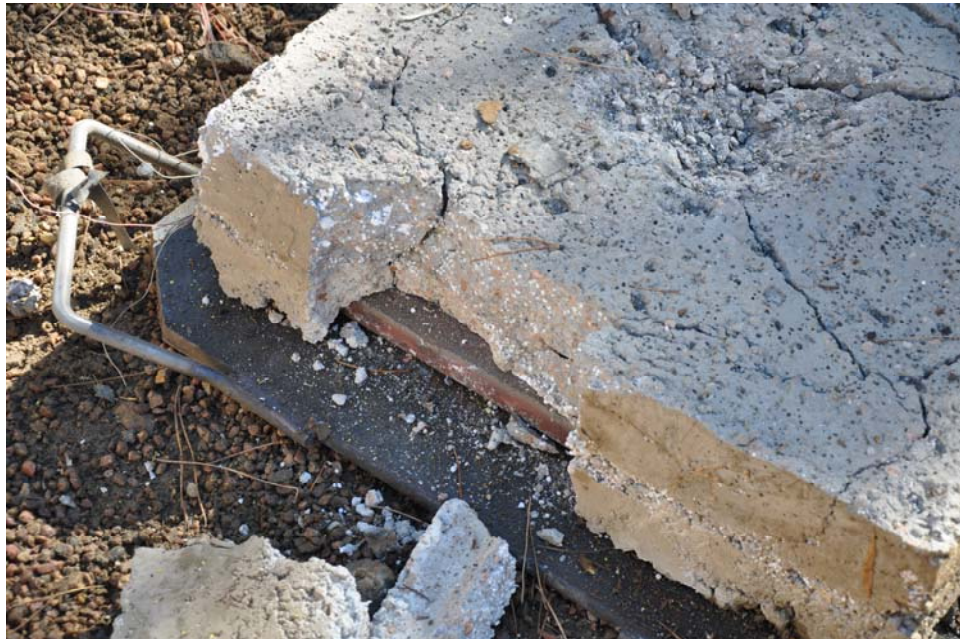
Figure 3-4
Photograph of damaged light concrete experimental setup after blasting.

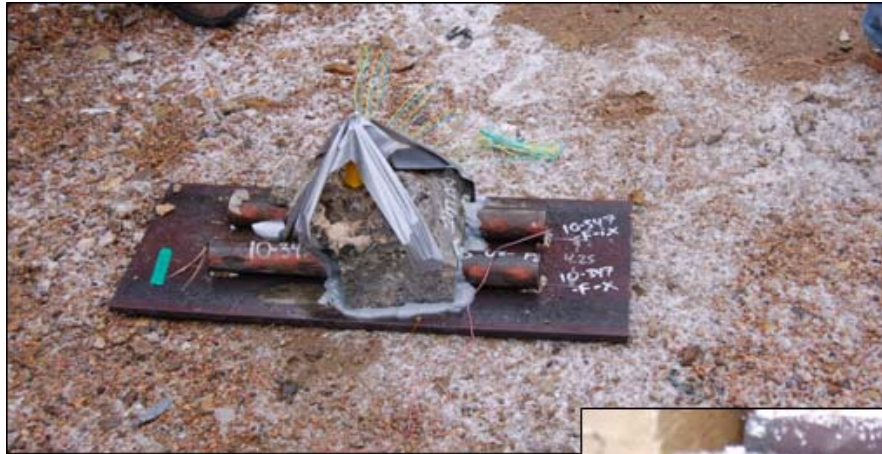
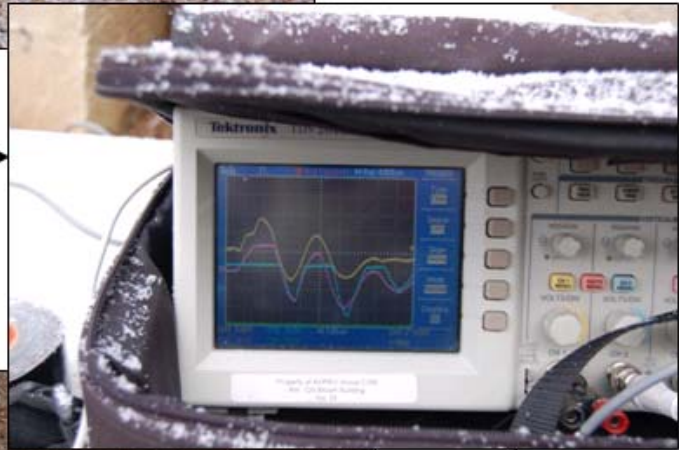
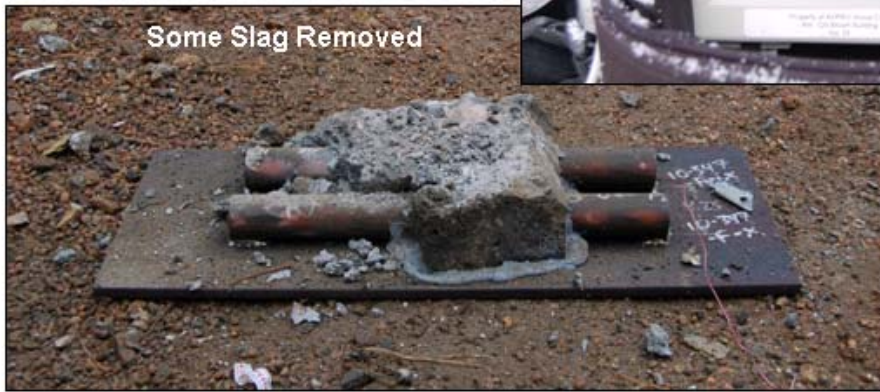
Figure 3-6
Photographs of progression of epoxied slag boulder experiment showing data collected on an oscilloscope.

Strain gages were attached to the internal diameter (ID) of several tubes in the bare tube and slag blasting matrices by using an applicator tool designed at CSM. The purpose of applying strain gages was to record the shape, amplitude and decay of pressure pulses delivered by the dynamite blasts. Linear strain gages were used to record hoop stress at various locations in the experimental setups. Figure 3-2 shows that the strain gages were applied to either the ID or OD surfaces of a tube, centered and longitudinally oriented at the top of the tube. Recording of the pressure pulses was successful. The data were recorded on a Tektronix TDS 2014 oscilloscope and exported to Microsoft Excel via a cross-over serial connection to a PC. A pair of plots is shown in Figure 3-5. The plots show that the strain experienced by one tube with the real slag boulder experiment and the strain experienced by another tube in a simulated slag by light concrete experiment is similar. The data in both plots are clipped at about 0.10 engineering strain due to the design of the amplifier circuit used to collect the data. Furthermore the pulse shape and attenuation (decay) of the pulse is similar. A series of photographs in Figure 3-6 shows the progression of a real slag boulder experiment with data collection.

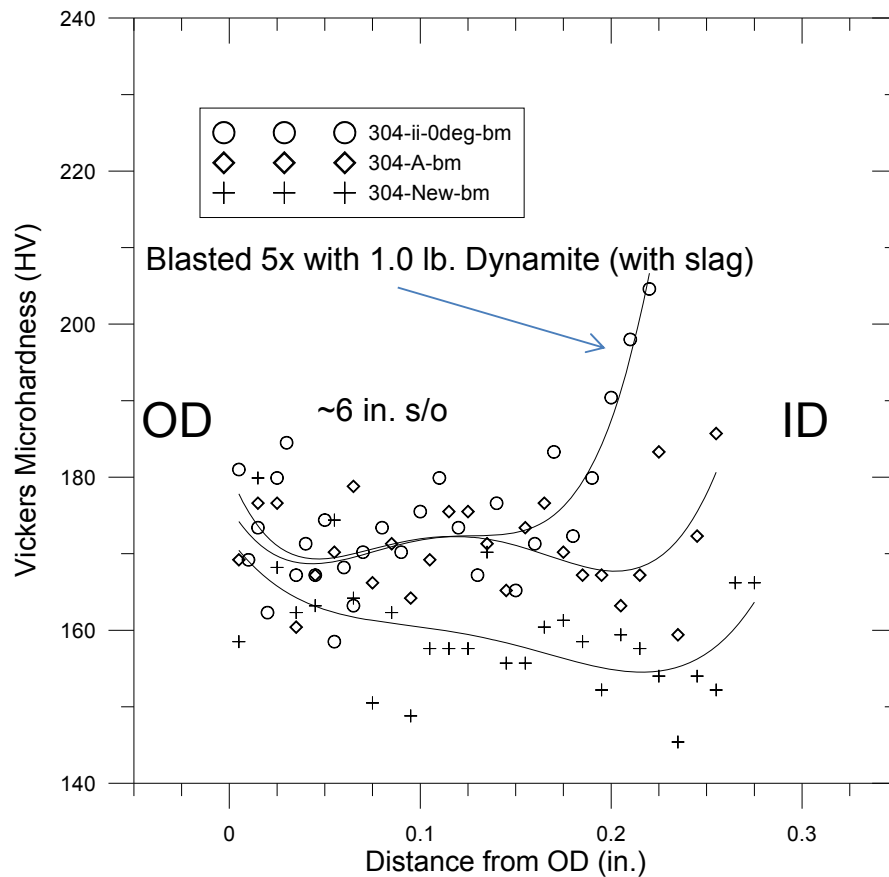
Microhardness traverses indicate that the shock pulse affects the mechanical properties closer to the ID and OD surfaces of the tube as compared with the tube wall interior. Figure 4-1 shows a plot of microhardness traverses for the three tube profiles in 304H stainless steel tube material: 304-New-bm, a new tube with no blasting experience; 304-A-bm, an in-service aged tube with no experience, and 304-ii-0deg-bm; the same in-service aged tube after blasting five times with 1.0 lb. charges for a total of 5.0 lbs. of UNIMAX Dynamite. The stand-off distance varied from 6 in. during the first blast to about 3 in. by the final blast which changed the blast intensity which was measured with strain gages. Although there is no noticeable deformation in the tube the mechanical properties have been affected.

Figure 4-1
Microhardness traverses comparing new tube material with in-service aged and in-service aged and blasted tube materials.

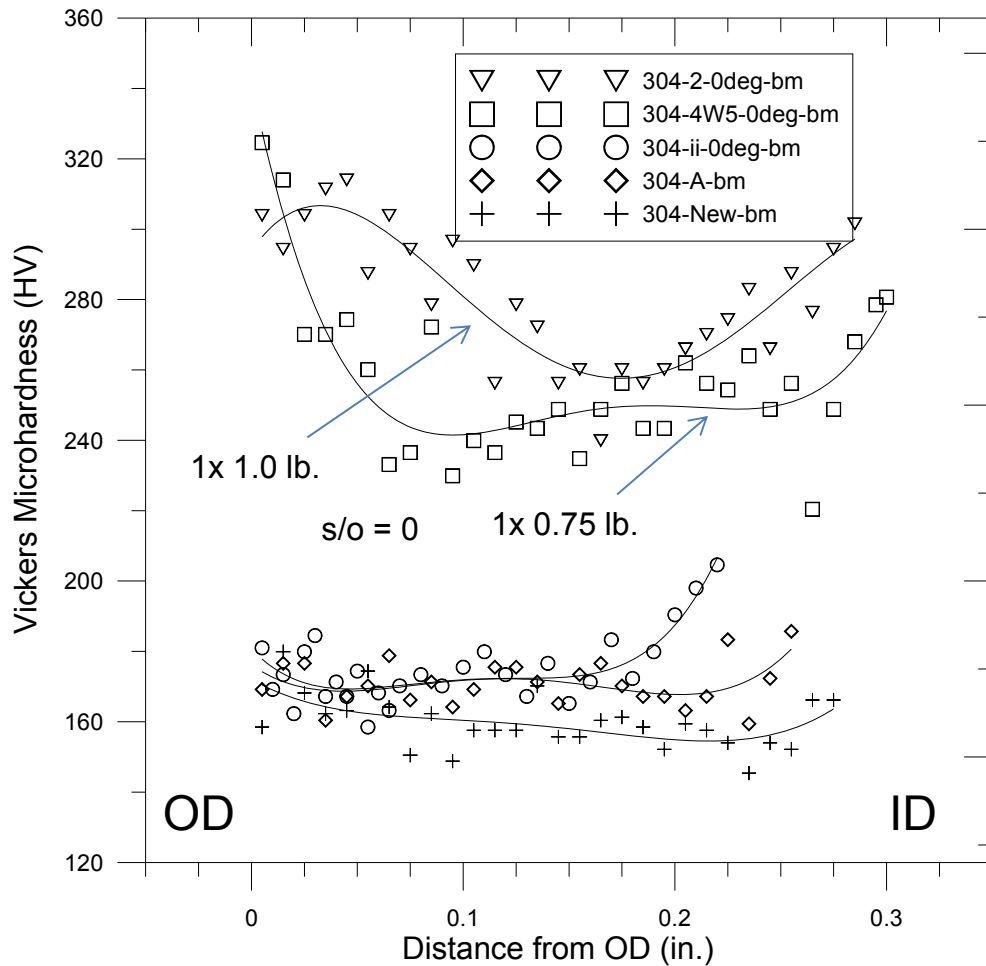
Figure 4-2 shows that microhardness increases strongly as a function of stand-off distance. In the plot, the lowest three microhardness traverses are the same as presented in Figure 3-5. Comparing traverses of samples blasted once each with the same charge amount (1.0 lb) or less (0.75 lb.) with no stand-off distance shows that the blast wave is greatly attenuated by the slag material. Tube samples 304-2-0deg-bm and 304-4W5-0deg-bm suffered considerable plastic deformation. Shock induced mechanical twinning was discovered in these samples, However it was confined to the OD surface of the tube.

Figure 4-2
Microhardness Traverses of 304H stainless steel tubes having various blasting exposure.

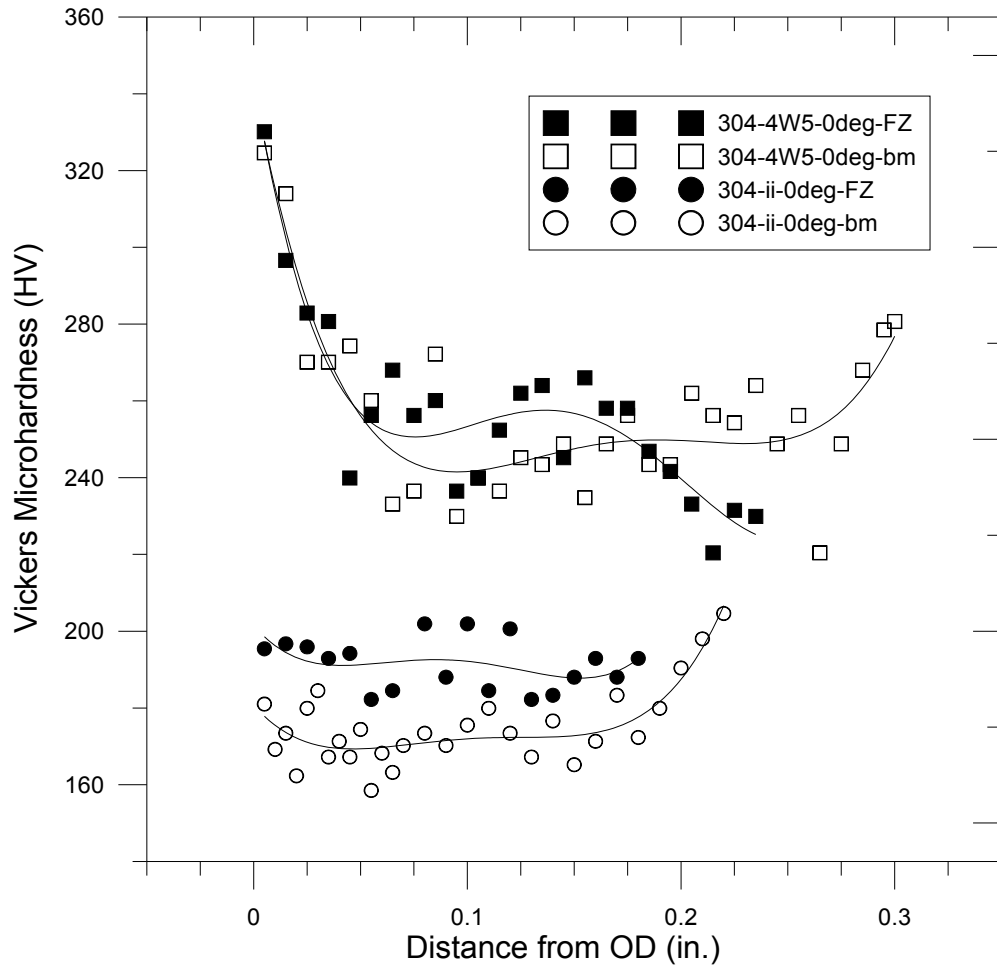
Micro hardness traverses of weld metal as compared to base metal are presented in Figure 4-3. It is shown that weld metal behaves similarly to base metal despite having dissimilar microstructure. The traverses were taken down the centerline of the weld deposit from OD to ID. A schematic showing the location of the Microhardness traverses is given in Figure 4-4. As in the previous plot the lower hardness traverses were taken in a tube blasted five times with 1.0 lb. charges of dynamite through several inches of simulated slag and the higher hardness traverses were taken in a tube blasted with a 0.75 lb. charge of dynamite with no stand-off distance. Weld metal did not show evidence of mechanical twinning. TEM analysis of deformation substructure

Figure 4-3
Microhardness Traverses of 304H stainless steel base metal and weld metal tubes having different blasting exposure.

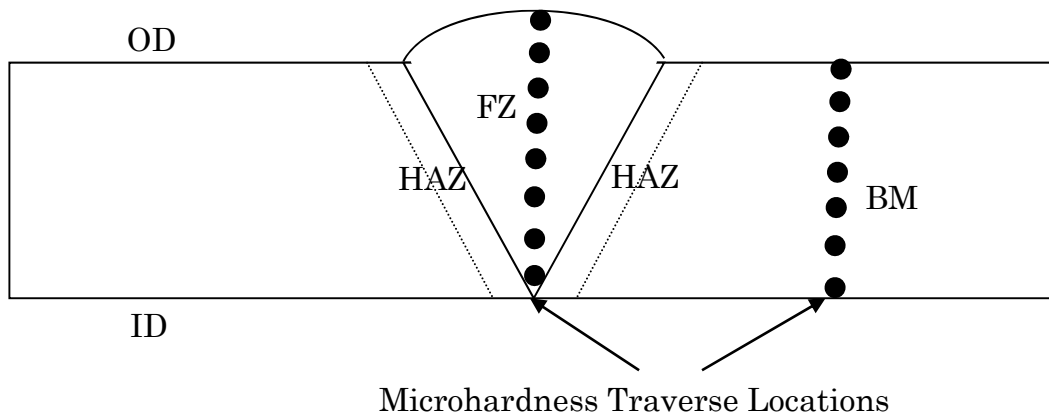
Figure 4-4
Schematic of longitudinal view of welded tube butt joint indicating the locations of fusion zone (FZ) and base metal (BM) microhardness traverse locations.
