# **Application Guide for Emerging Condition- Monitoring Techniques for Transformers**

**1024195**

Technical Update, December 2012

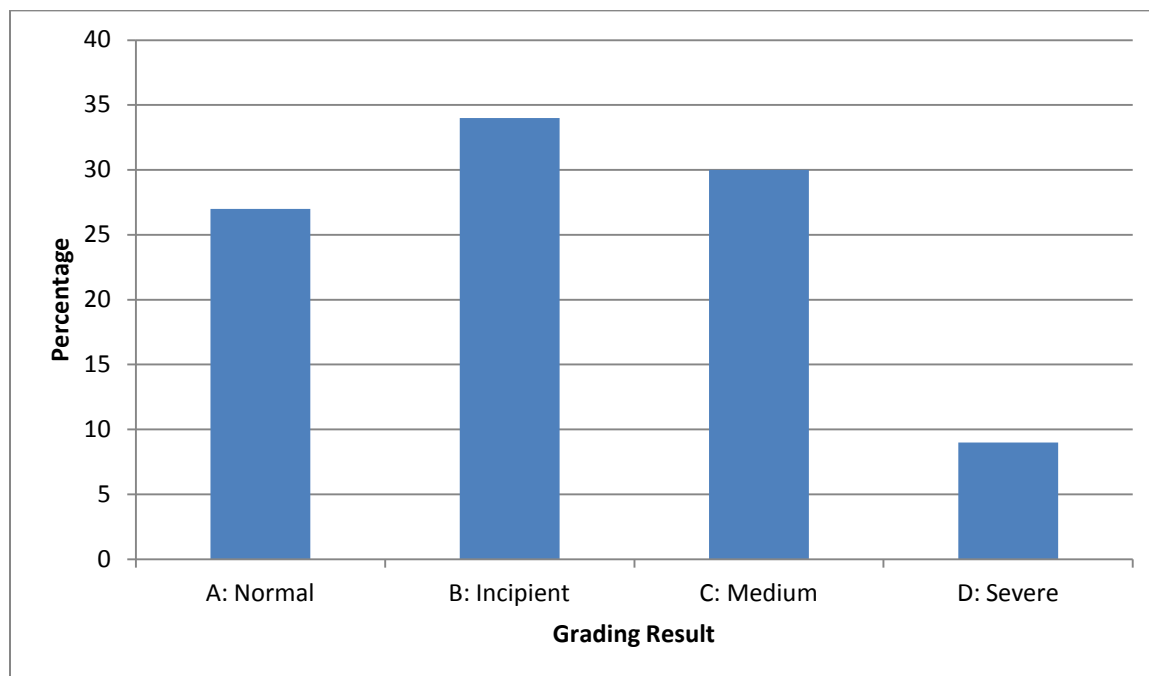
By 2008, 277 cases had been analyzed by the grading system [3]. The breakdown of grading results is shown in Figure 4-1. The grading system has proven to be a helpful assessment tool, and two areas of future research are planned. The first is to enhance the existing grading system for AE systems fitted to the four faces of a transformer. The second is to extend the grading tool to other approaches of AE, such as four-sensor portable systems or AE systems used together with electrical PD detection.

**Figure 4–1**  
**Grading Results for 277 AE Cases. The Grading System and the Results Used to Produce this Plot are Presented in [3].**

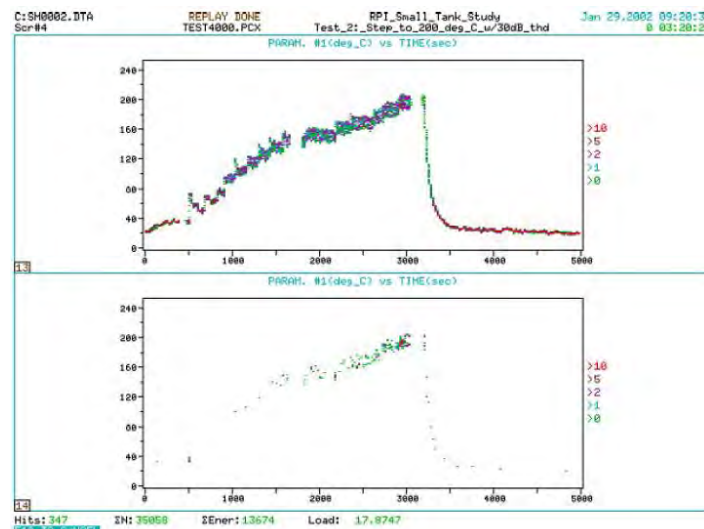
<b>Results</b>	AE activity started to pick up between 100 to 120°C. AE activity became pronounced as the temperature reached 200°C and gas bubbles were observed in the oil on a regular basis.				
<b>Lessons Learned</b>	Rapid changes in temperature seem to cause turbulence in the oil, which manifest as an AE source. AE activity seems to increase steadily as temperature rises from 100 to 200°C. AE could be used for detection of hot-spots in a transformer.

**Figure 4–2**  
**Temperature versus Time Plot; Lower Plot Shows Only Temperatures Where AE Was Detected**

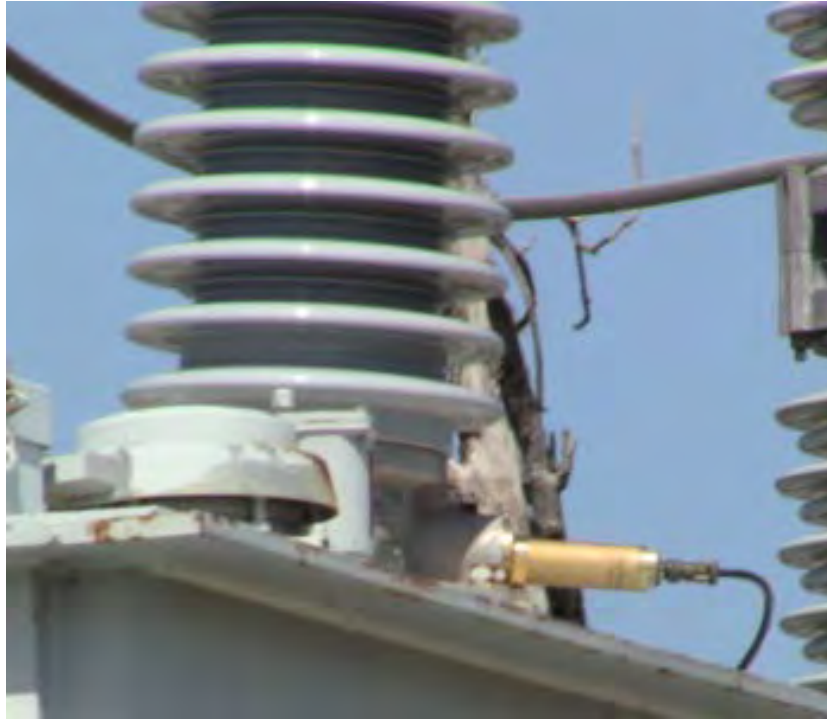
**Figure 6–2**  
**Bushing Tap Coupler in a Bushing Capacitance Test Tap**

Each requires the fitting of bushing tap couplers to the bushings capacitance test tap (see Figure 6-2).

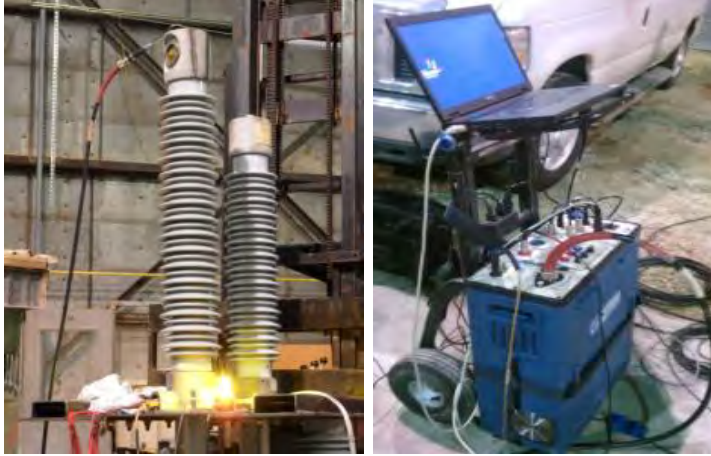
**Figure 6–5**  
**Power Factor Testing Set-Up at EPRI's Lenox Facility**

Power factor testing measurements were obtained using a test fixture fabricated by EPRI that allowed the bushing to be mounted vertically in air (see Figure 6-5). This arrangement should have little to no effect on  $C_1$  power factor measurements. Bushings were situated vertically for at least 48 hours prior to testing.

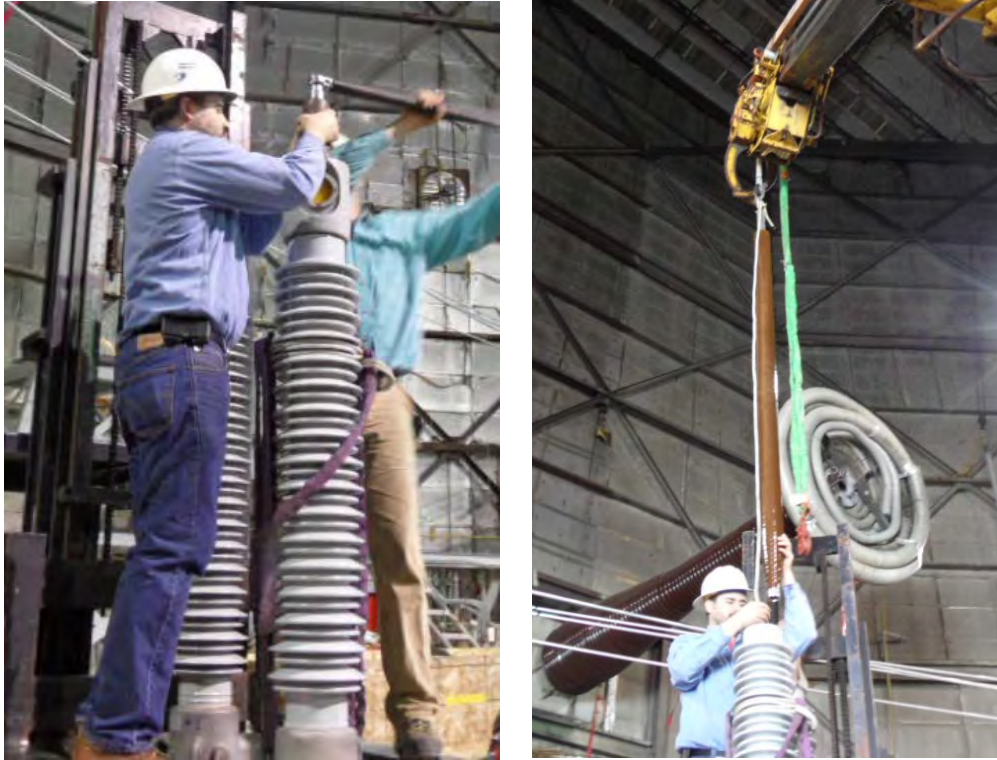
The bushing core was removed from each bushing by removing the upper collar to release the clamping pressure, unthreading the lower resin cone, and then lifting the core out (see Figure 6-7).

**Figure 6-7**  
**Removing a Bushing Core**

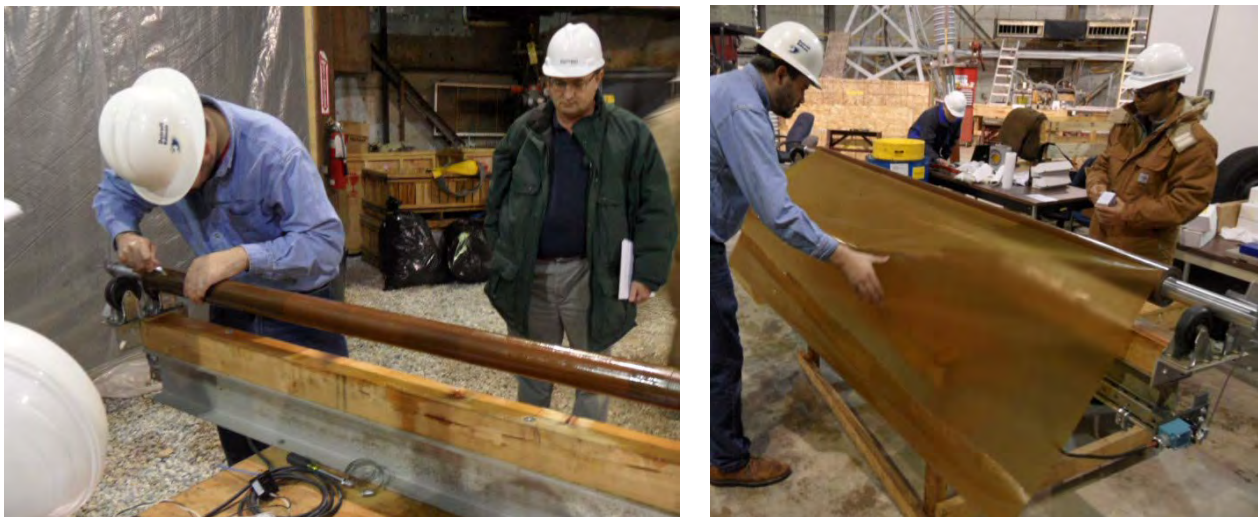
**Figure 6-8**  
**Unrolling the Paper**

The core was then placed horizontally on a set of rollers to allow for easy and controlled unrolling of the paper core (see Figure 6-8).

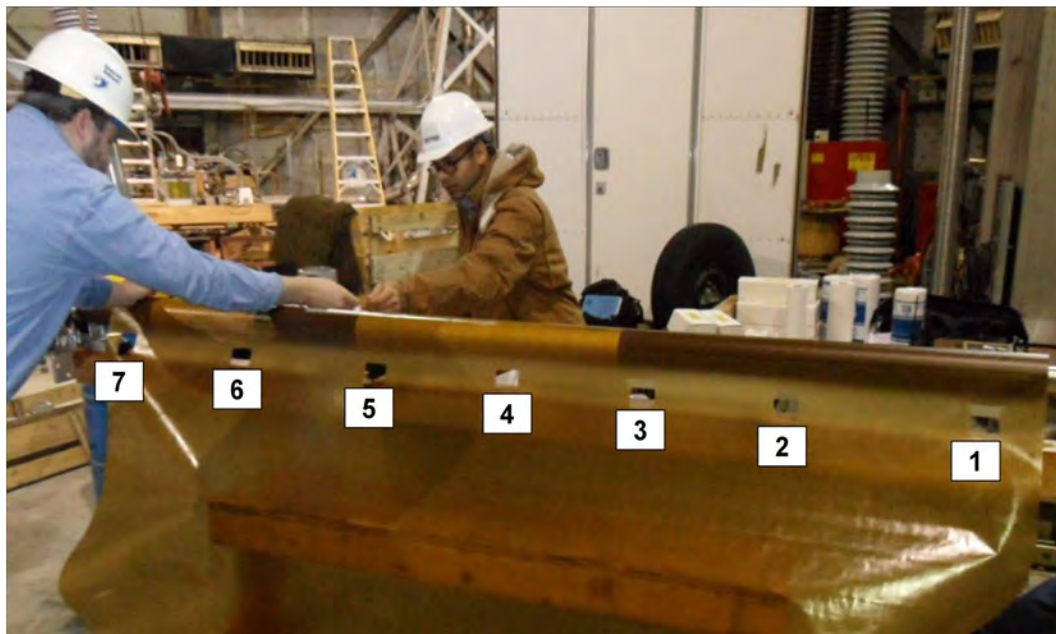
In addition, paper samples were obtained at regular intervals for analysis of the degree of polymerization (DP). This is a measure of the paper's thermal degradation. Squares, approximately 2 cm x 2 cm (0.79 in. x 0.79 in.), were taken roughly after every 50 layers of paper (e.g., six radial locations for the 69 kV bushings, or nine locations radially for the 138 kV bushings). At each layer where samples were taken, seven samples were taken axially along the length of the core at regular intervals (see Figure 6-10). A select subset of these samples were sent for testing to assess the overall condition of the paper, as well as the distribution of DP spatially throughout the core.

**Figure 6–10**  
**Samples were Obtained Axially along the Length of the Core at Regular Intervals**

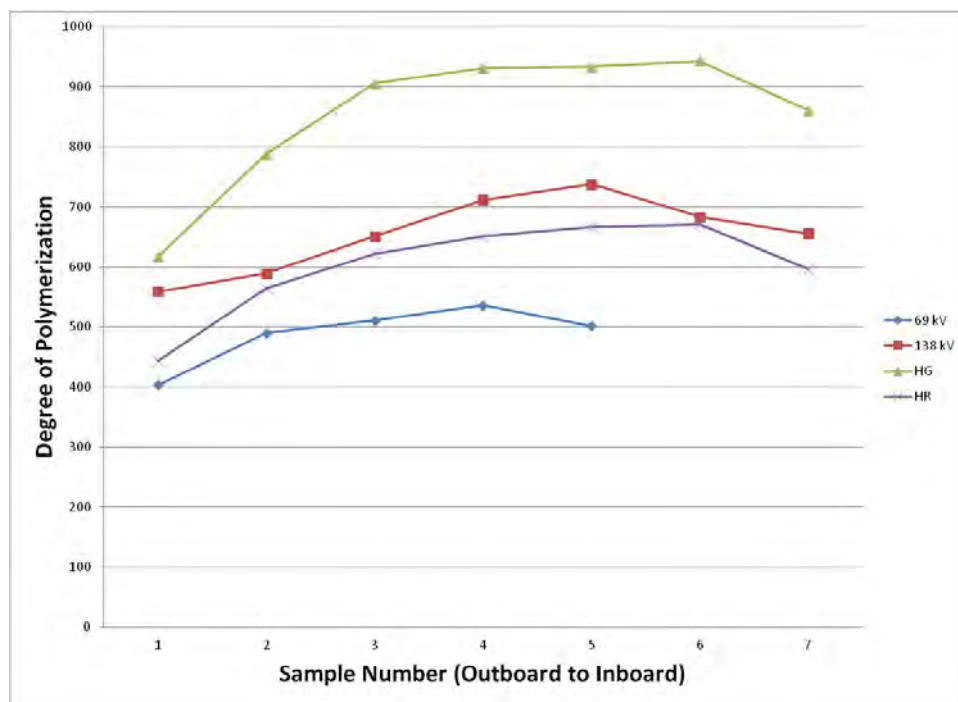
In the example results shown in Figure 6-11, there is a drop-off in DP toward the air (outboard) end of the bushings. This is generally expected, as the air provides a less efficient cooling medium than the oil in which the lower end is immersed. Moreover, there is also a decrease radially, with outer layers being significantly lower. This decreasing trend is consistent between all the bushings tested so far (see Figure 6-12).

**Figure 6–11**  
**Comparison of Bushings Axial DP Distribution against Others Tested**

Some of the DP results obtained so far have indicated that a significant amount of thermal degradation has taken place throughout the bushings. While there is no established DP end-of-life value for bushings, values were lower than expected (more degradation).

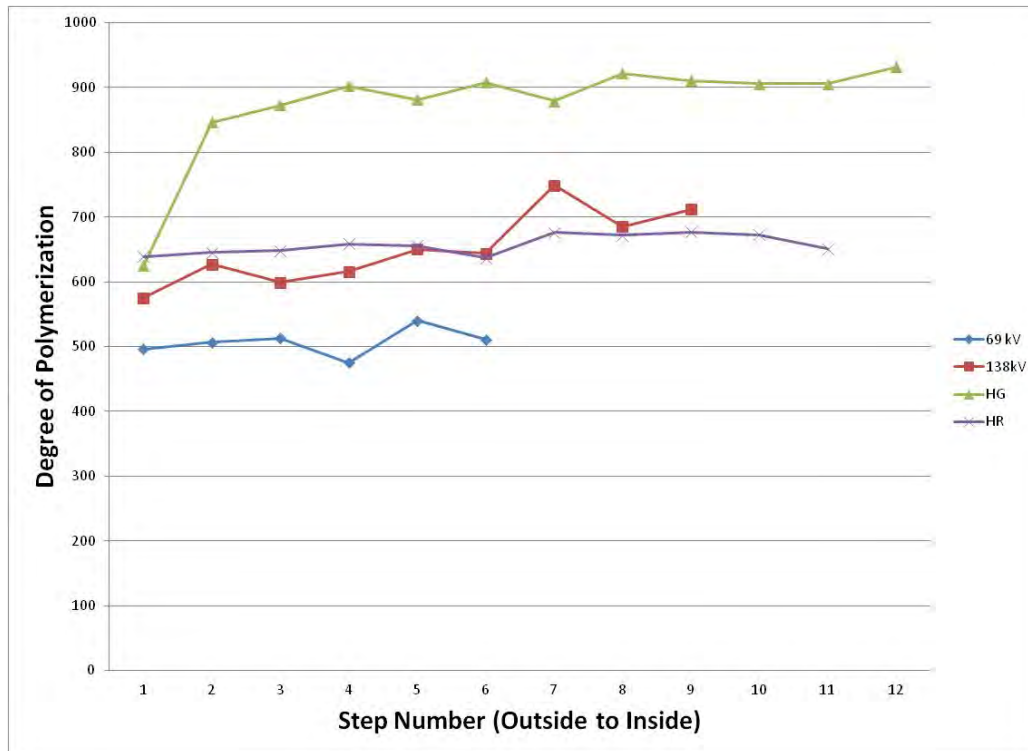
**Figure 6–12**  
**Comparison of Bushings Radial DP Distribution against Others Tested**

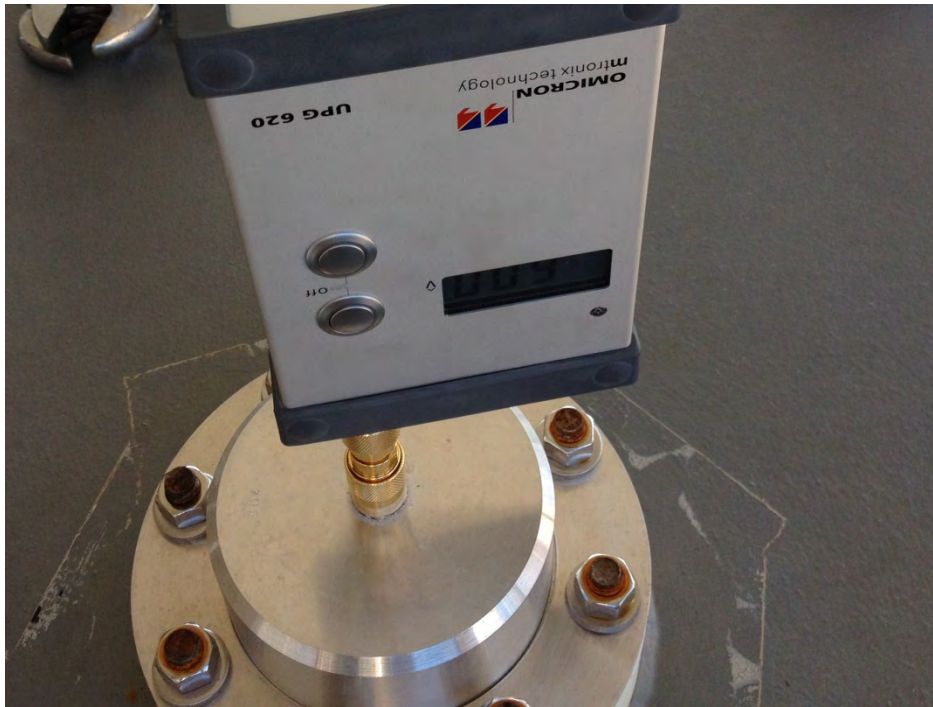
**Figure 7–1**  
**UHF Calibrator Injecting Signals into the UHF Sensor Mounted to the Lid of the Test Transformer**  
**(Sensor Designated U04)**

- UHF calibration pulses were produced by a UHF Calibrator (Omicron Model UPG620)
- UHF calibration pulses were inserted into the permanently mounted UHF sensor on the top lid of the test transformer (designated U04). (See Figure 7-1.)
- UHF signals were measured from the remaining three permanently mounted UHF sensors on the transformer (designated U01, U02, and U03).
- UHF signals were also measured from two UHF probes temporarily inserted into the bottom drain valve.

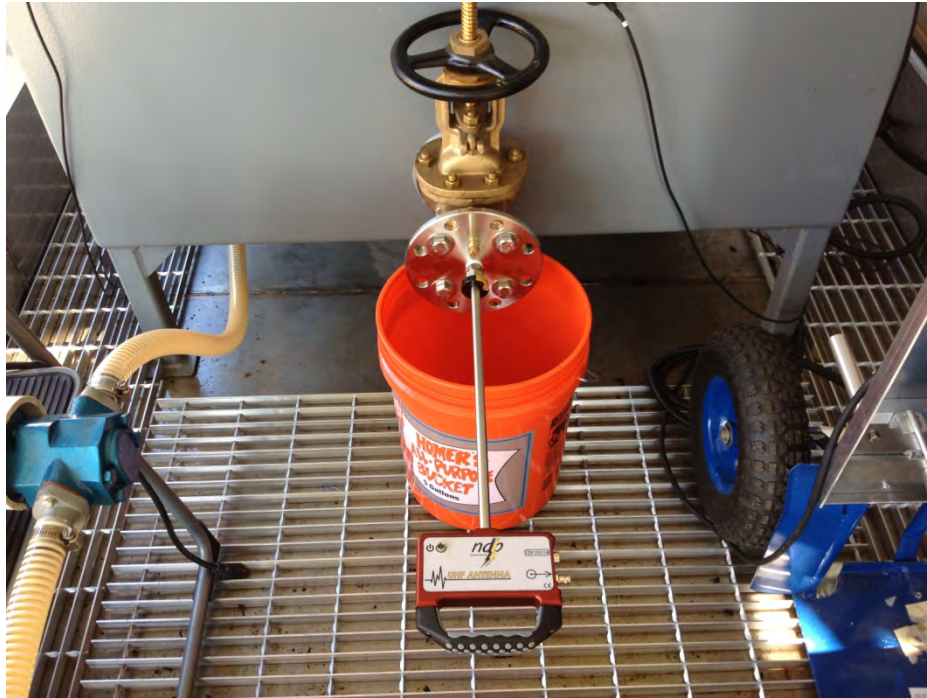
**Figure 7-2**  
**Drain Valve UHF Probe Manufactured by NDB Technologies (Supplied as Part of Their AE-150 System)**

- The first UHF probe used in the drain valve was manufactured by NDB Technologies and supplied as an option to NDB's AE-150 system. (See Figure 7-2.)
- The second UHF probe used in the drain valve was an Omicron UVS 610, supplied as an option to the MPD 600 measurement system. (See Figure 7-3.)
- Each drain valve UHF sensor was inserted into the valve such that the tip of the sensor was flush with the inside wall of the transformer – i.e., the sensor was at the threshold of protruding into the transformer tank.

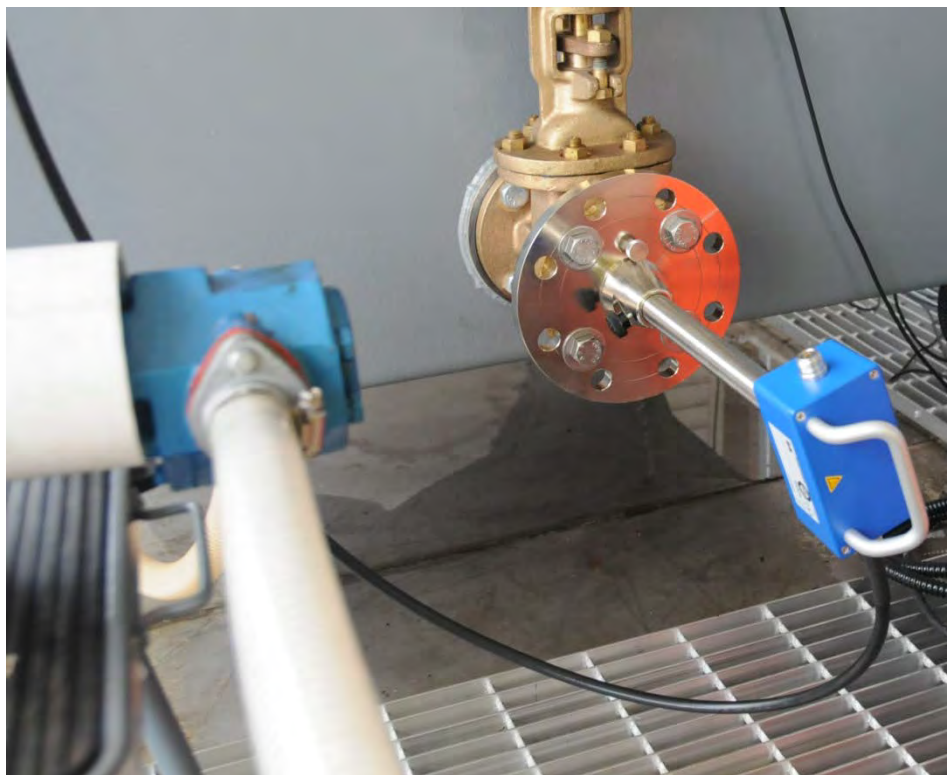
**Figure 7-3**  
**Omicron Drain Valve UHF Probe UVS610 Supplied as an Option to the MPD600 Measurement System**

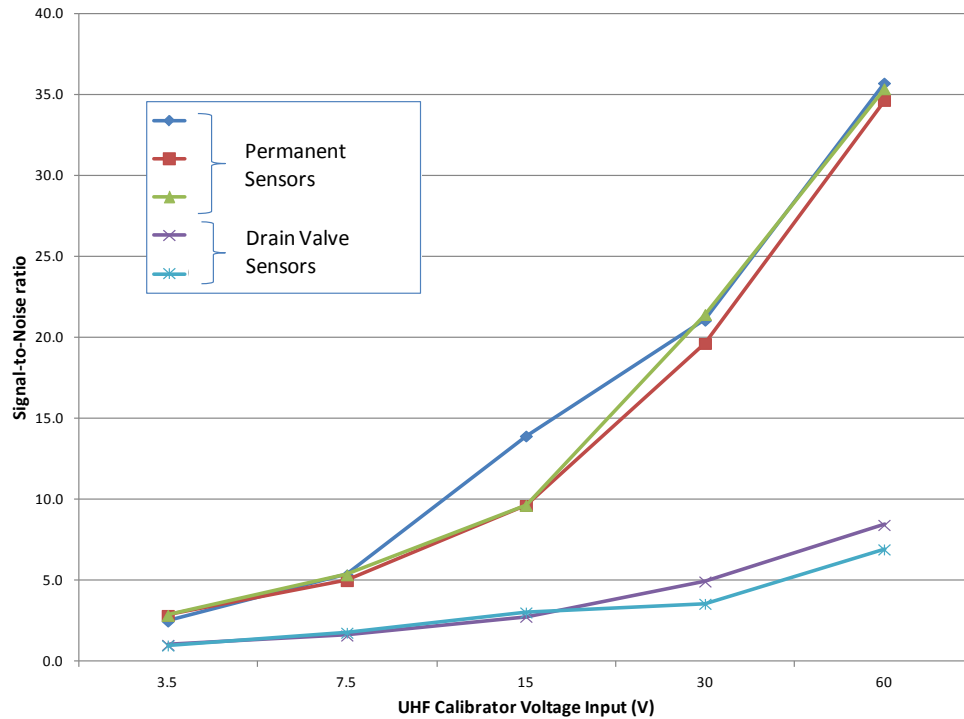
- For each voltage level of the calibrator input, the following measurements were made from each of the four sensors: background noise (peak-peak) and measured pulse magnitude (peak-peak).
- For each voltage level of the calibrator input, the signal-to-noise ratio was then calculated by dividing the measured pulse magnitude by the measured noise.
- The resulting signal-to-noise ratio as a function of calibrator input is shown in Figure 7-4.

**Figure 7-4**  
**Signal-to-Noise Ratio of the Three Permanently Mounted UHF Sensors and Two Drain Valve Sensors**

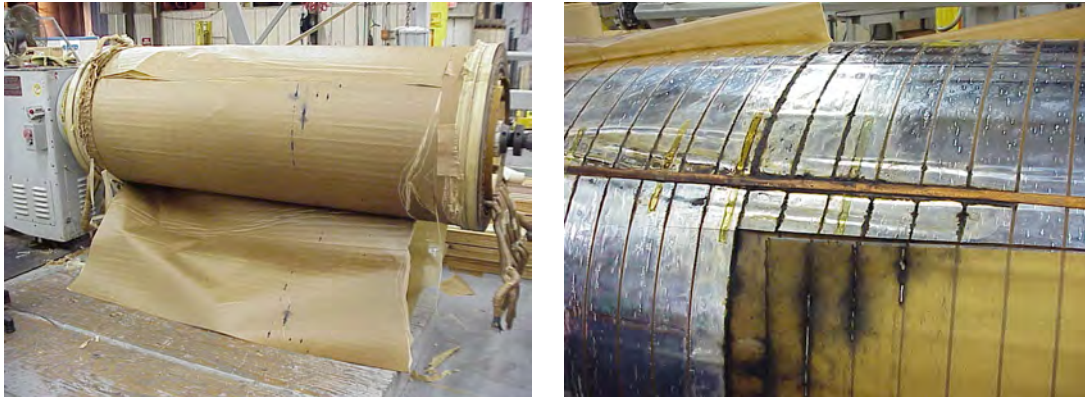
The transformer was subsequently un-tanked and visually inspected for signs of arcing on the surface, but none were found. The coil assembly, indicated by FRA to be significantly different, was taken to the local manufacturer and unwound. The results are shown in Figure 11-2 below. The bond between the copper ribbon and the inner static shield on the H1H2 winding had lost good contact and had begun to produce small arcs and carbon deposits.

**Figure 11-2**  
**Insulation Damage Found by Unwinding Coil Assembly**

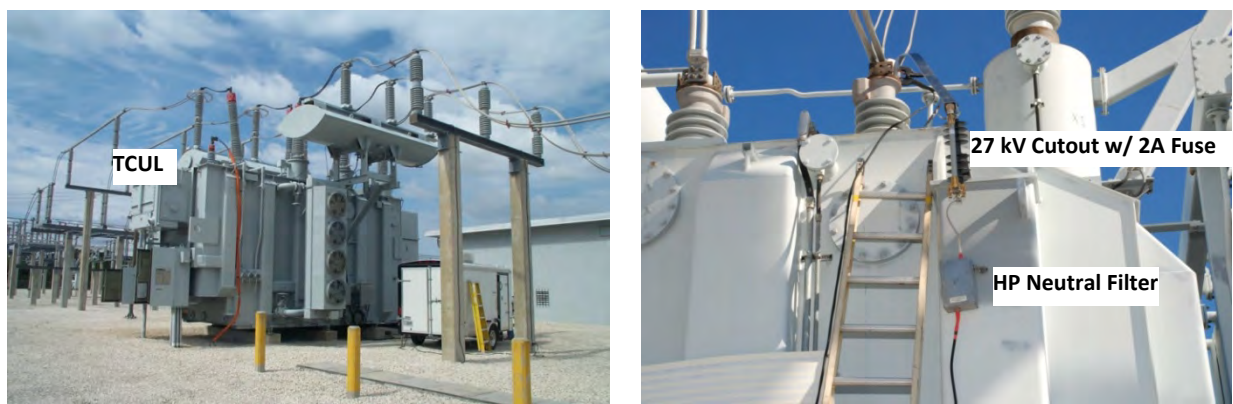
**Figure 11-6**  
**First OLFRA Installation on a Three-Phase Auto-Transformer with All Three Phases in One Tank**

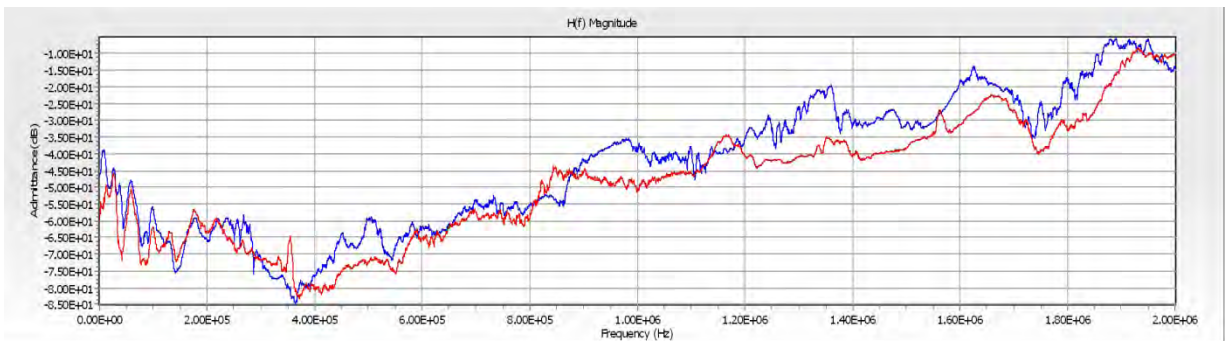
**Figure 11-16**  
**H3-H0X0 Data: Blue Trace = 1st Year, Red Trace = 3rd Year**

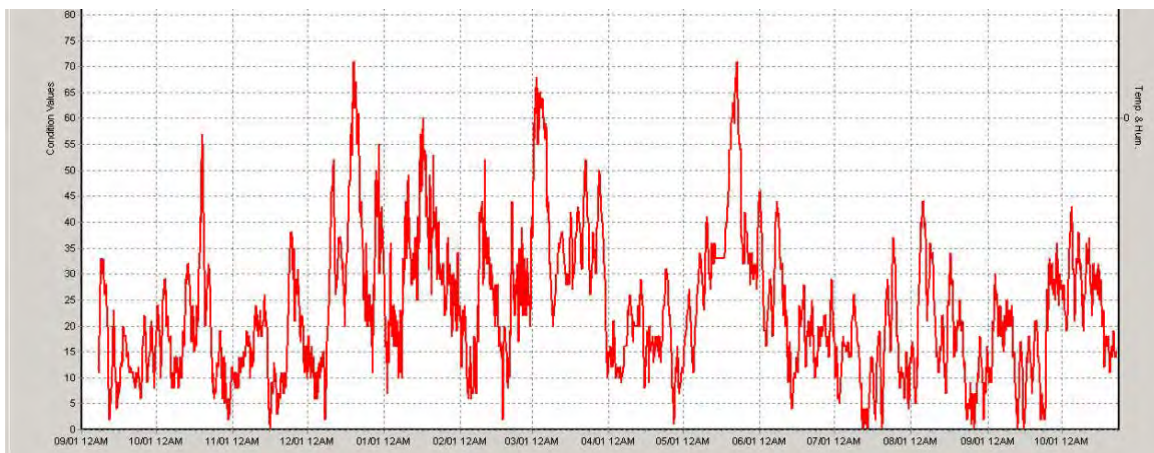
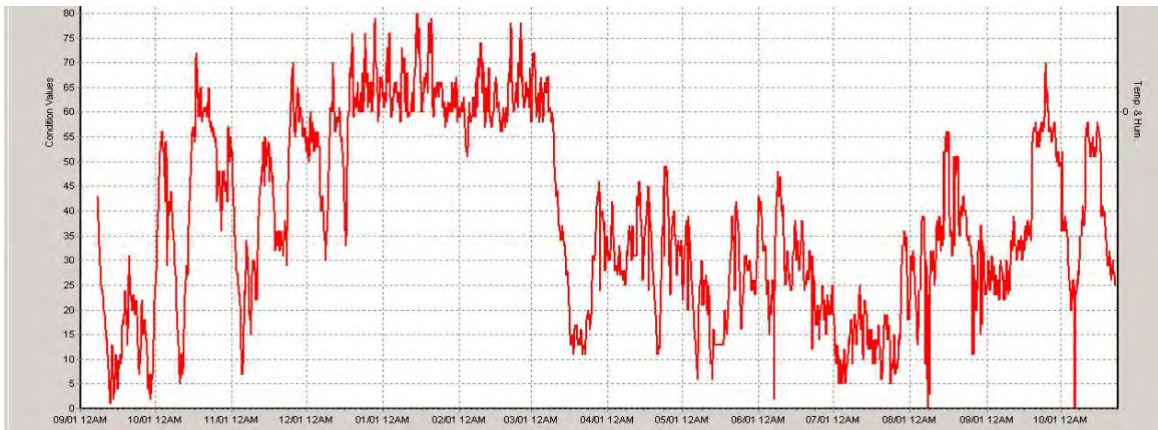
**Figure 11–20**  
**Condition Value Trend for the H1 Bushing**

**Figure 11–21**  
**Condition Value Trend for the H2 Bushing**

**Figure 11–22**  
Condition Value Trend for the H3 Bushing

**Figure 11–23**  
Condition Value Trend for the X1 Bushing

**Figure 11–24**  
Condition Value Trend for the X2 Bushing

**Figure 11-25**  
**Condition Value Trend for the X3 Bushing**

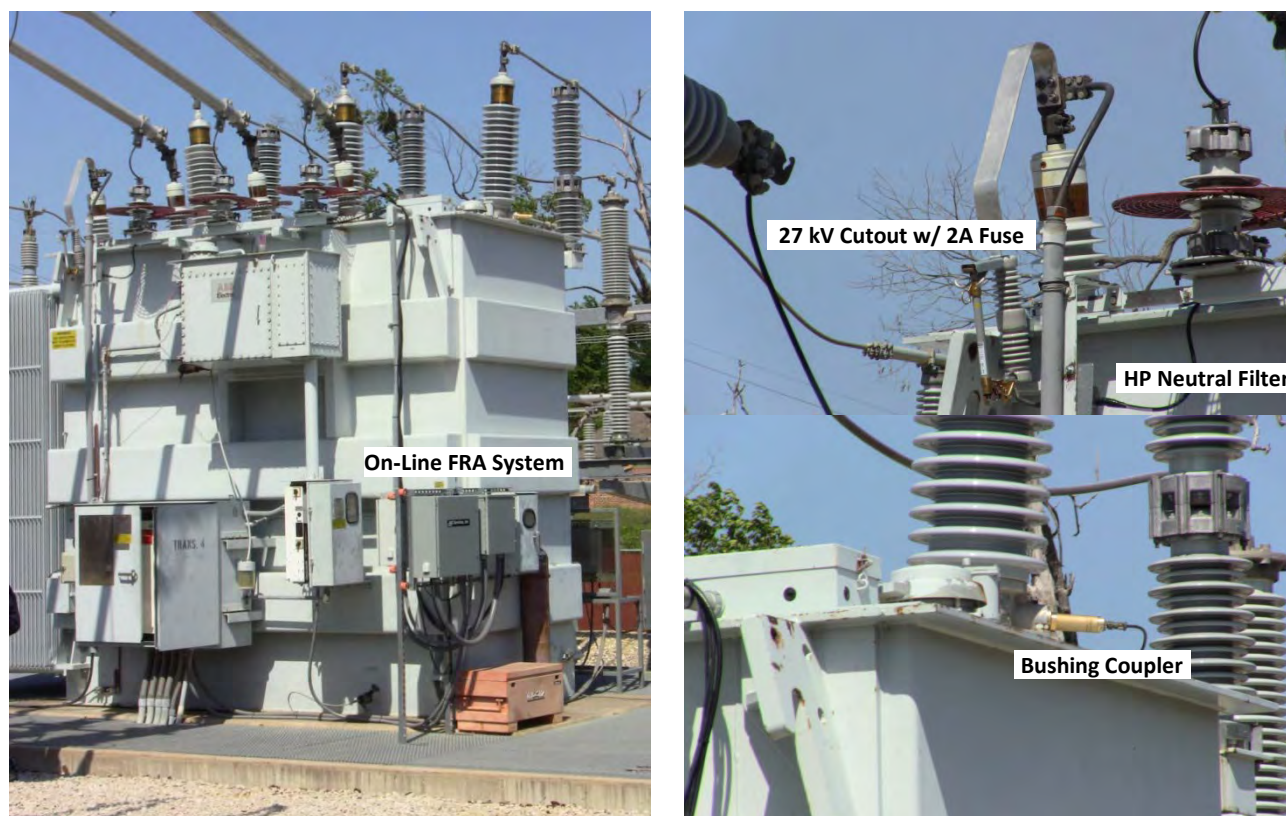
**Figure 11-27**  
**OLFRA Installation on a Delta-Wye Transformer with an LTC**

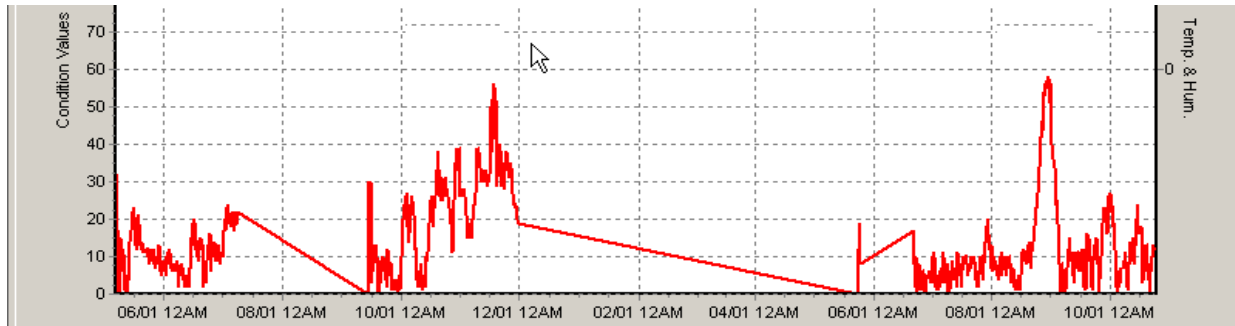
**Figure 11-39**  
**H1 Bushing Condition Value**

**Figure 11-40**  
**H2 Bushing Condition Value**

**Figure 11-41**  
**H3 Bushing Condition Value**

**Figure 11–42**  
**X1 Bushing Condition Value**

**Figure 11–43**  
**X2 Bushing Condition Value**

**Figure 11–44**  
**X3 Bushing Condition Value**
