Plant Engineering: End-of-Life Guide for Medium-Voltage Cables and Accessories

2012 TECHNICAL REPORT

1025259

Final Report, October 2012

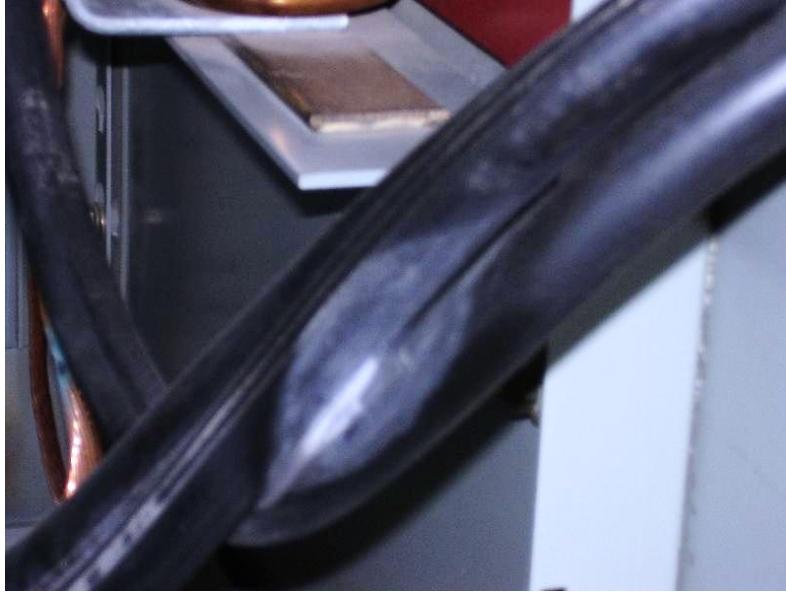
*Figure 2-1
Partial discharge (corona) between two non-shielded medium-voltage phase conductors*

With respect to aging, non-shielded cables can be subject to partial discharge (corona) where the surfaces of two phases are close together. The partial discharge leads to erosion of the jackets and eventually the insulation and can lead to failure. Figure 2-1 shows evidence of partial discharge erosion (corona attack). The white powder in the vicinity of the area where the cables come near to contact indicates that partial discharge damage is occurring. Figure 2-2 shows partial discharge between a phase and a ground.

If such conditions are identified, the circuit should be de-energized, and the damage site inspected. Repairs should be made as appropriate, and the cables separated from each other or ground. The process of corona erosion is relatively slow, but it can cause failure in a decade or so if not corrected.

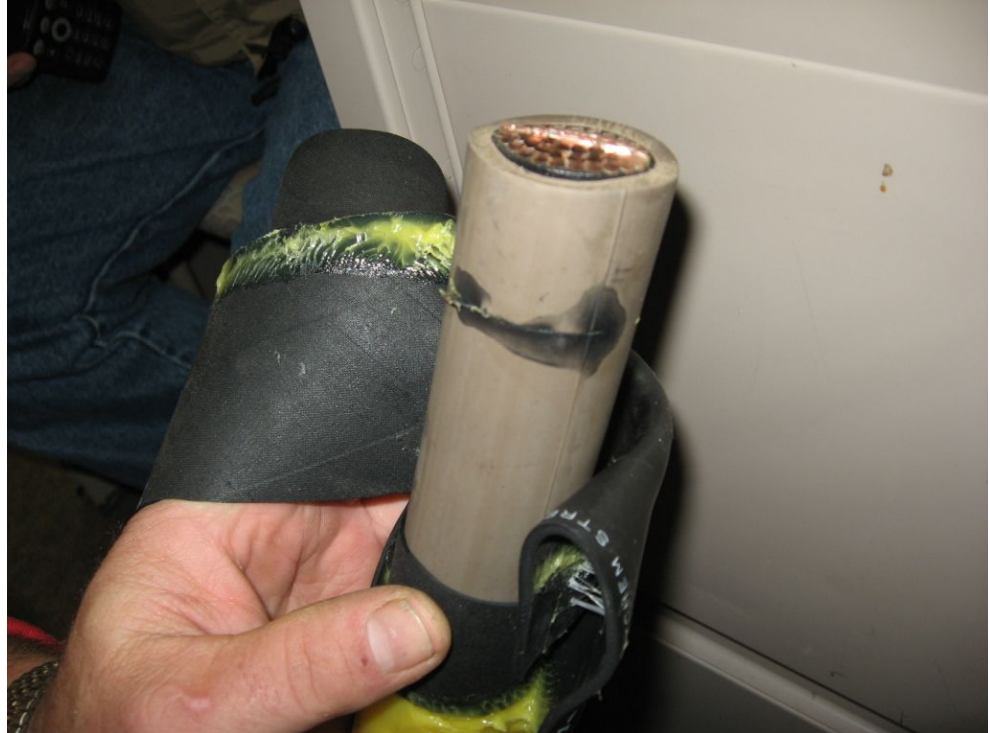
Figure 2-4

Damage to a newly installed cable splice that was identified by a withstand test. The black spot on the cable is where the technician accidentally cut through the insulation when removing the semiconductor shield.
