Aging Cable Assessment Guideline

3002000921

Final Report, December 2013

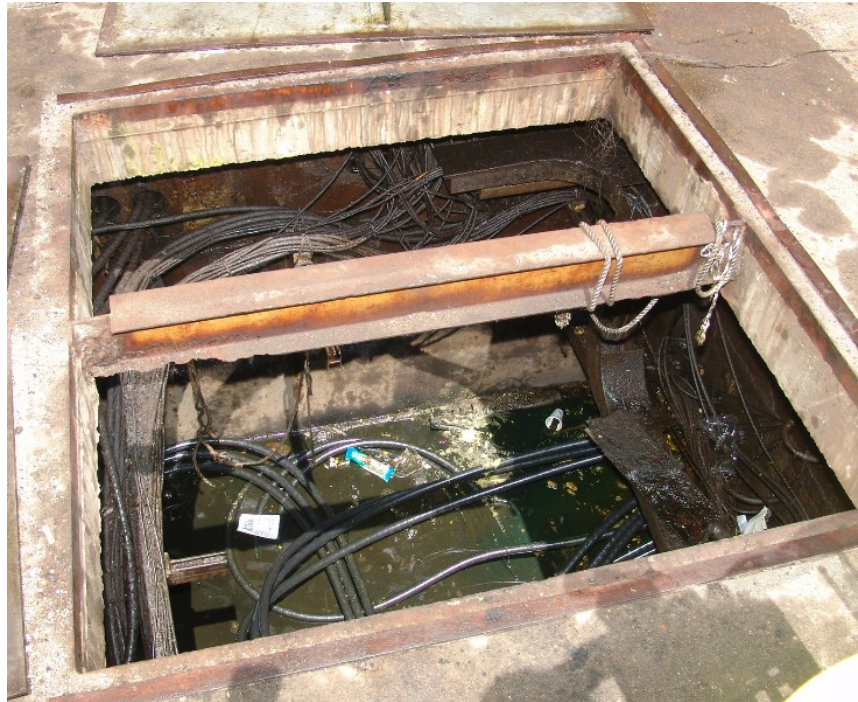
*Figure 1-1
Below-grade vault in yard partially filled with water*

The practical effect of dielectrophoresis is that moisture is drawn to the higher dielectric field regions, even in an alternating field. This high stress point is likely to be a small void that is a portion of the initial tree formation. The void that was initially filled with gas now becomes filled with water. Although this does not fully explain the formation of the water tree, it does shed some light on the growth of such trees and the dispersion of moisture in an energized cable. Dielectrophoresis provides a way for water to propagate through the insulation to feed water tree formation, both in the insulation and at the interface between the conductor shield and the insulation. Figure 1-1 shows a poorly designed cable vault that easily fills with stormwater from the concrete yard area.

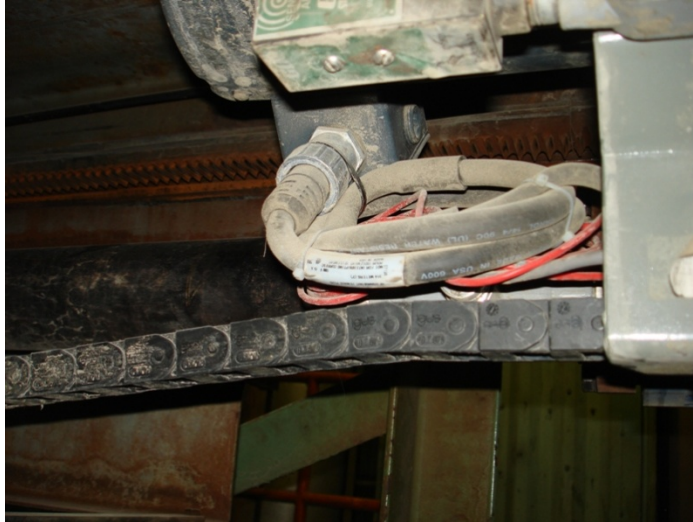
*Figure 1-3
Power cable tightly rolled due to excess length in prefabrication*

A number of physical conditions can adversely affect medium-voltage cable life, including over-bending, compression, cuts, and gouges. When a shielded cable is bent into too tight a bend radius, the insulation-to-shield interfaces can be ruptured or split—creating gaps where partial discharge (PD) can occur, which would lead to short life. Figure 1-3 is an example of tight radius bending.

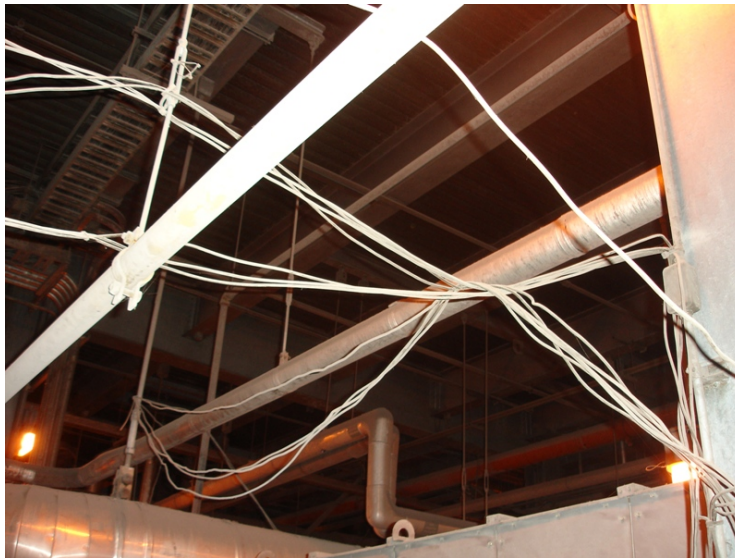
*Figure 1-4
Poorly run DCS cable back-fit modification*

Permanent compression of the shield and insulation system can cause elevated potential stress in the insulation or shield damage. Cuts and gouges, depending on their severity, can damage shields or even cause elevated potential stress in the insulation where cables are poorly routed as shown in Figure 1-4.

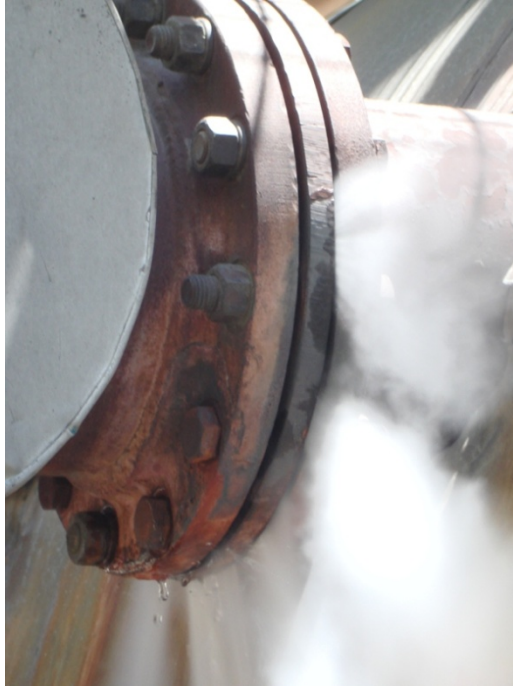
*Figure 1-6
Temporary leaks of high-energy steam can degrade nearby cables*

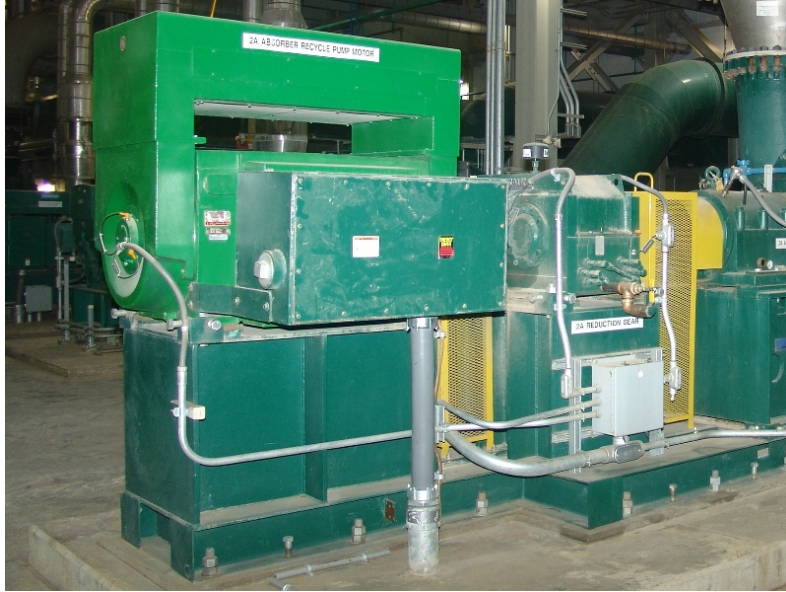
*Figure 1-7
Properly routed power cable not in heat exhaust*

Consideration to those vents with high temperatures is also necessary. Most often ignored are large-motor air slot outlets. These motors are also air-cooled through their stators, and the air exhausted is often in excess of 50°C (122°F). The motor leads and the stator heater leads are often routed through this air stream and results in a long-term “baking” of the leads. Examples of good and poor cable routing are noted in Figures 1-7, 1-8, 1-9, and 1-10.

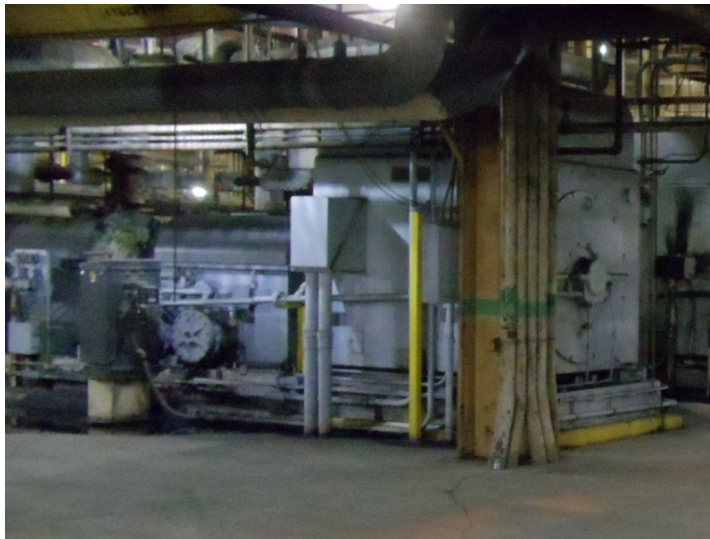
*Figure 1-8
Power cable properly routed away from heat vents on 48-year-old motor*

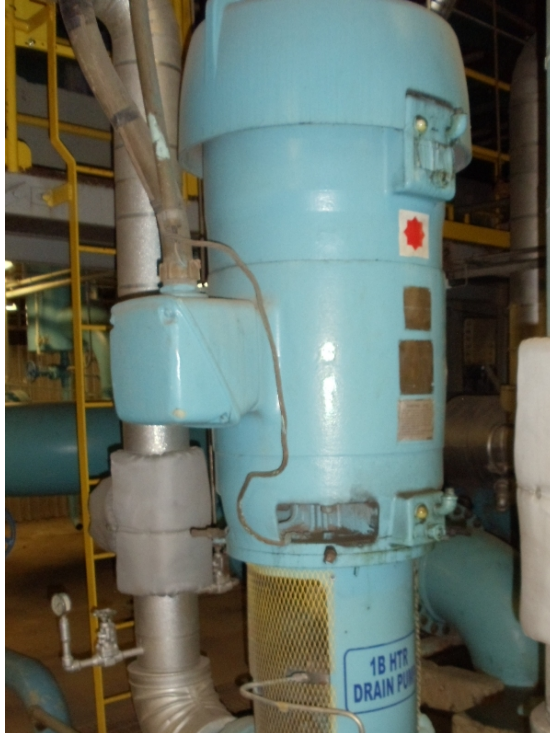
Figure 1-9
Junction box leads poorly placed immediately below the discharge vent hood

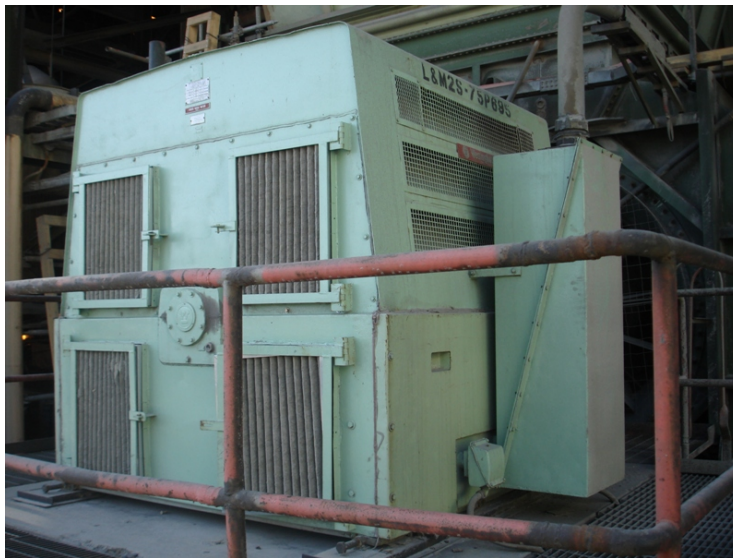
Figure 1-10
Junction box and leads poorly designed in exhaust flow

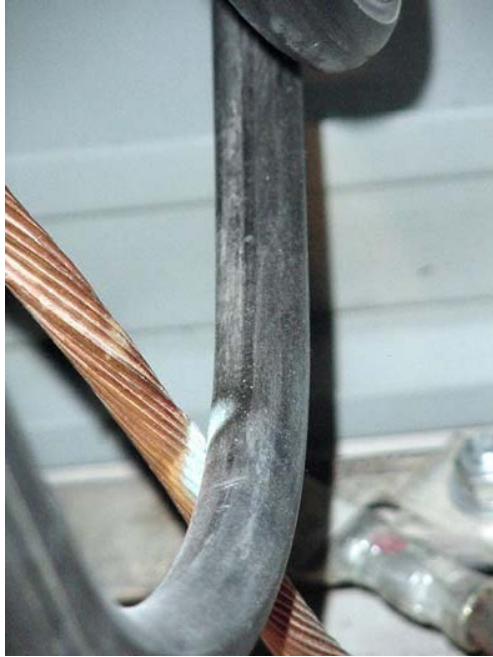
*Figure 1-11
Corona discharge indication on a cable and ground*

Non-shielded cable can be subject to surface PD (corona) in the small gap adjacent to the location at which the cable touches a grounded metal surface. Corona discharges occur from ionization of the air gap between the cable and the grounded surface. The conductor voltage distributes across the insulation, jacket, and air gap, with a large portion of the voltage across the air. With high voltage across a small gap, voltage stress higher than the breakdown stress of the air occurs. The gap discharges, and the voltage redistributes across the insulation and jacket so that the discharge is stopped. However, each electron stream discharge causes a small increment of damage to the polymer surface, resulting in erosion of the polymer. Over an extended period, these discharges can erode the surface of the cable's jacket and continue to slowly reduce the dielectric strength of the insulation system. In such cases, the presence of corona discharge is often indicated by a white powder in the vicinity of the discharge. Corona attack can be identified by visual examination during maintenance when terminations and junction boxes are accessible. An example of corona discharge is shown in Figures 1-11 and 1-12.

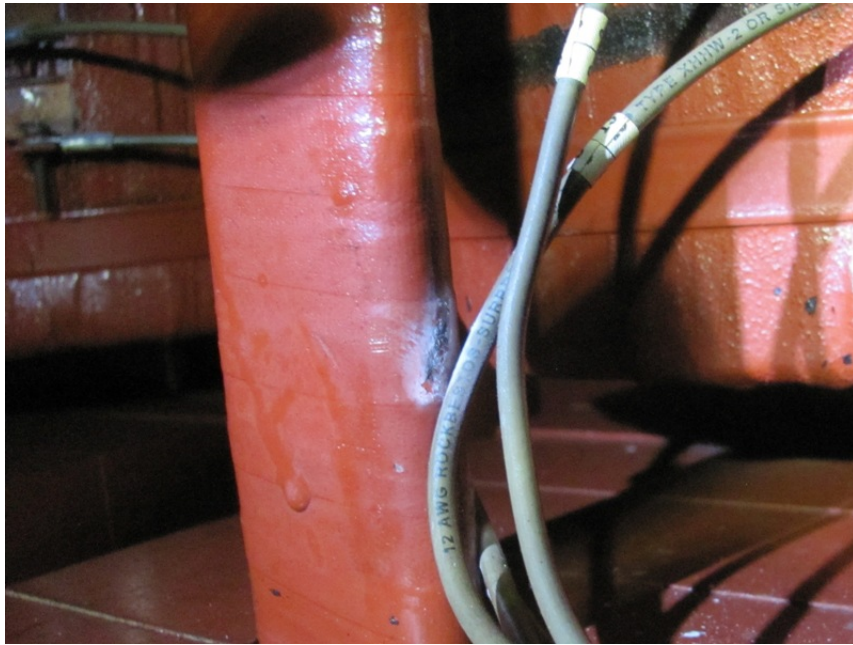
*Figure 1-12
Partial arc indication on current transformer cable and phase bar of a 13.8-kV motor*

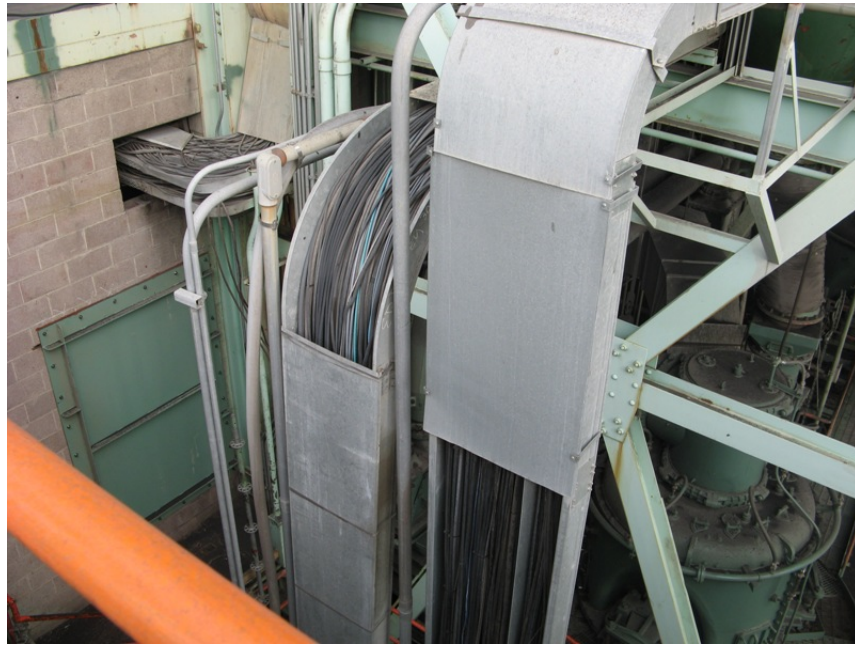
*Figure 1-13
Missing cable tray covers expose cables to UV radiation in sunlight*

Many people overlook the presence of UV light on cable surfaces. Most fossil-fired stations have cable trays running in unenclosed areas exposed to sunlight. Here the effects of sunlight will become apparent. Most design engineering firms have these trays covered to protect them not only from the weather, but also from sunlight. The problem occurs when workers have to access the trays and do not re-cover them with tray covers. UV light can be generated by sunlight and by artificial light. UV can cause damage to the backbone of the polymer, reducing the properties of the material. If the rubber component is of non-black formulations, the UV can affect the color and cause a minor to major change in the color. Carbon black-filled rubber components are much less susceptible to UV because the black helps to absorb the UV light and stabilize the product. The best condition would be to protect the cables in a low light area or in a covered cable tray or conduit. When strong lighting is added to the interior of stations, it may inadvertently increase the exposure of the unprotected cables to UV light and degrade the surfaces (many of these strong area lights also emit UV radiation). Note the poor condition of the cable tray covers on this outdoor unit in Figure 1-13.
