# Low-Voltage Cable Aging Management Guidance

2013 TECHNICAL REPORT

**3002000924**

Final Report, December 2013

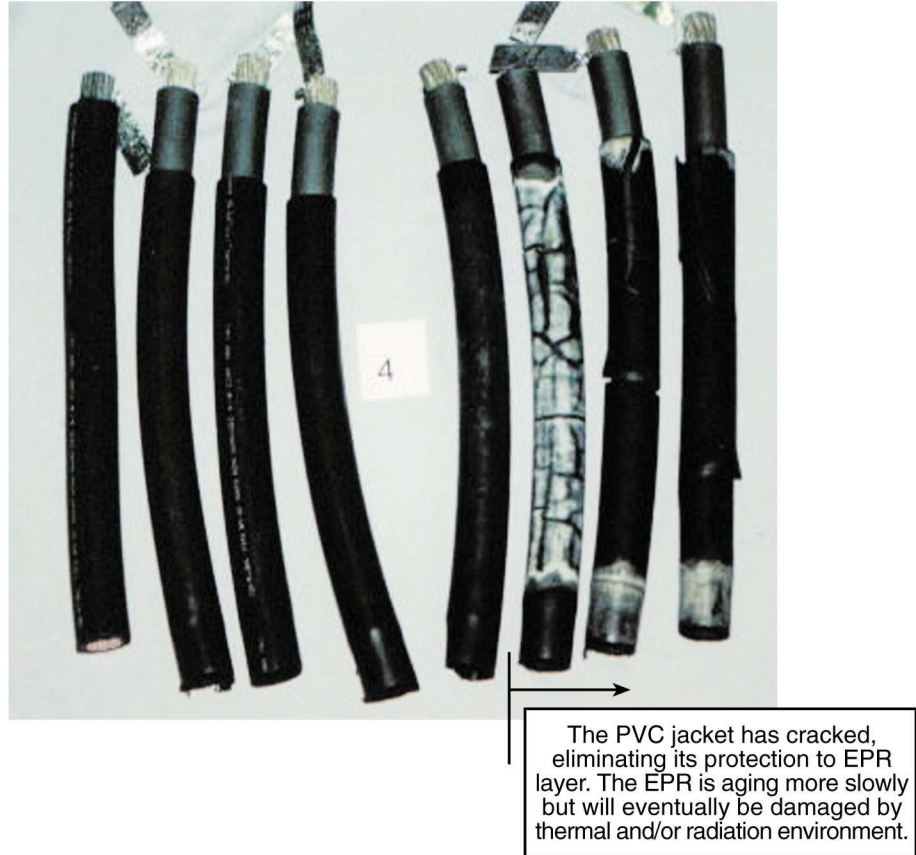
Figure 6-2  
 Progressive Aging of PVC Jacket and EPR Insulation When Exposed to the Same Environments

Figures 6-1 and 6-2 present visual examples of the effects of thermal aging on PVC<sup>8</sup> and ethylene propylene rubber (EPR) used for cable insulation and jackets. All of the specimens were subjected to the same aging temperature and were removed from the aging ovens at one-week intervals (shown left to right as aging time increased). Figure 6-3 shows similar aging steps on Hypalon-jacketed cables that were aged during development of training aids used for the assessment of cable aging [2].

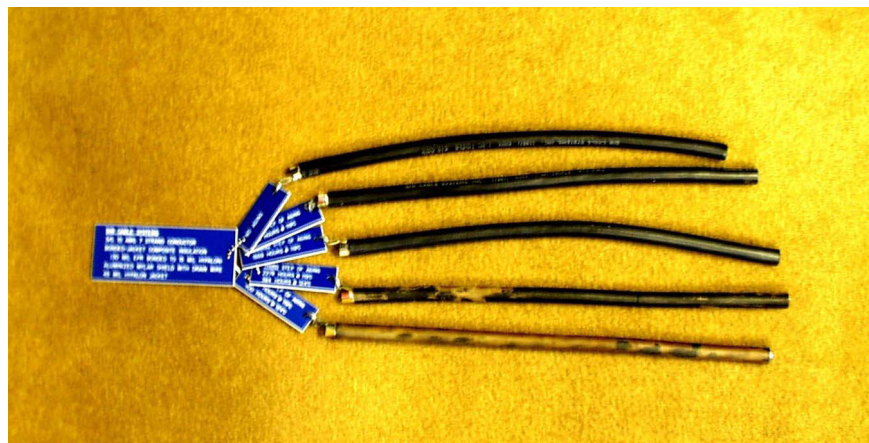
Figure 6-3  
 Aged Hypalon Jackets on Cables with Bonded Jacket EPR/Hypalon-Insulated Conductors

In Figure 6-3, aging increases from top to bottom. The bottom two cable samples were highly thermally aged. The upper three cables retain their original black surface color. The lower two cables show progressively more bloom from thermal stress. **Note:** Bonded jacket insulation of the single conductors of these Boston Insulated Wire Co. cables showed residual flexibility, even in the highly aged cable.

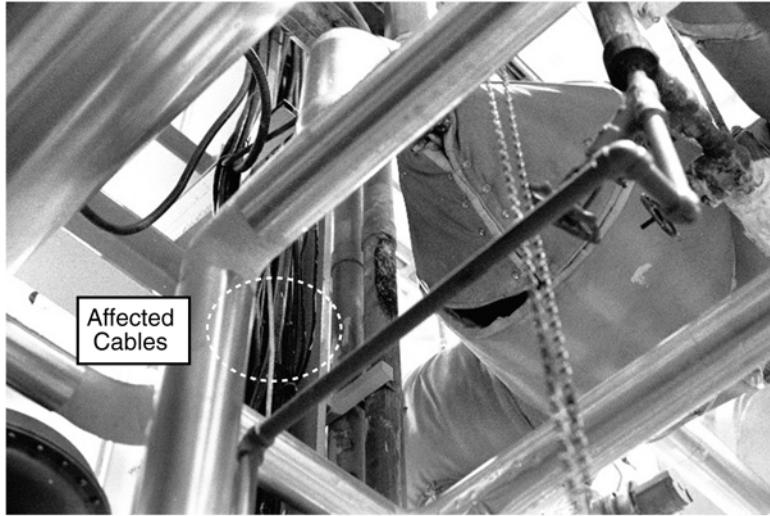
*Figure B-1  
Displaced Thermal Insulation on Valve Operator*

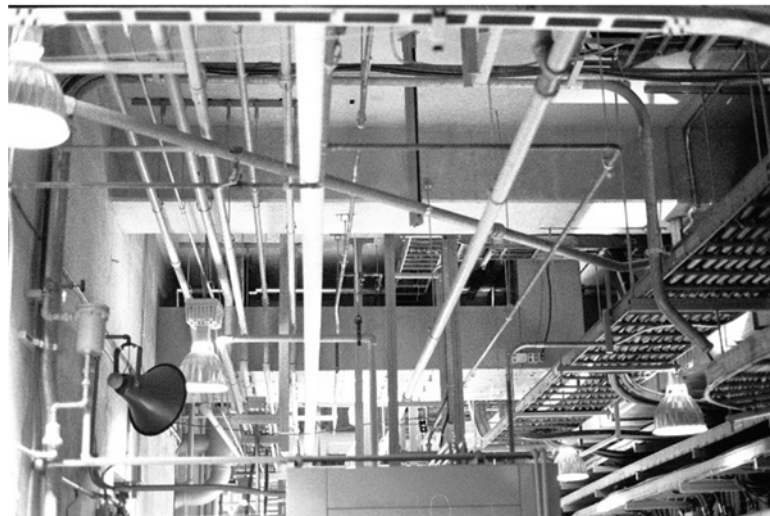
Figure B-3  
*Heat from High-Intensity Lamps*
