# Long-Term Operations: Evaluation of the KEMA Smart Cable Guard System for On-Line Partial Discharge Detection

3002003001

Final Report, May 2014

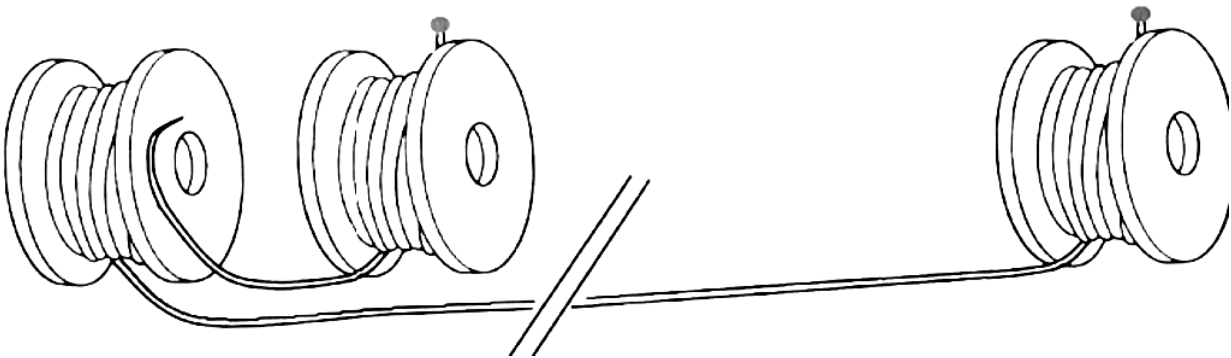
Due to the long cable sections used and the limited laboratory test floor space, the cables were tested on reels, connected in series to each other. A sketch of the test configuration is presented in Figure 2-1.

**Figure 2-1**  
**Configuration of cable sections in the test setup**

There were other cable sections used as end matching impedances, to satisfy the conditions dictated by Figure 2-1. However, since these were not test objects, but rather they belonged to a test power supply, their design is of no significance.

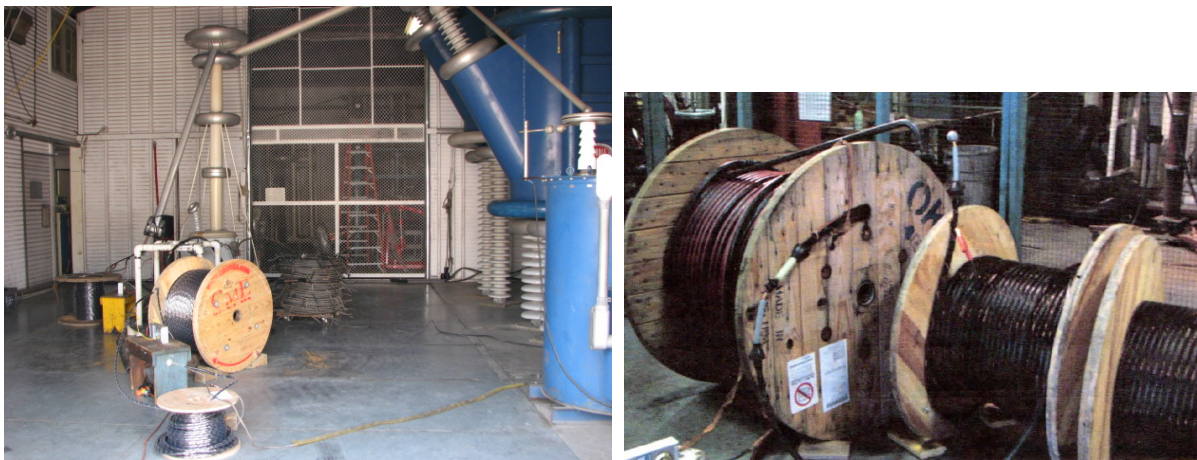
Because of the extended duration of the project and the need to move the model cable system from one part of the laboratory to another, different power supplies, inductive coils, and transformers (to compensate for the cable capacitive load) were employed. In all cases, preliminary tests were performed to demonstrate partial discharge-free performance of the test setup, unless intentionally created partial discharge sources were introduced. Typical examples of the test configuration are provided in Figure 2-2.

**Figure 2-2**  
**High-voltage test setup**

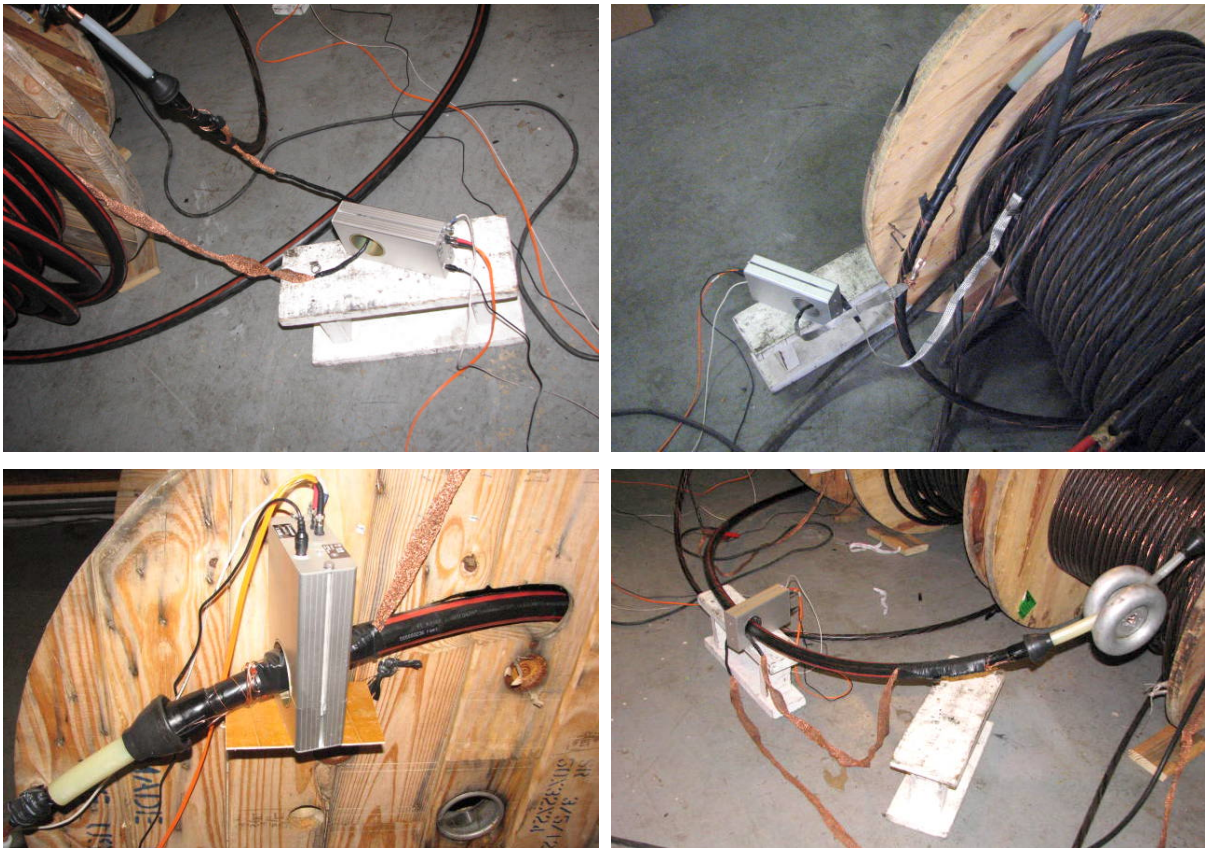
Selected examples of the sensor/injector unit positioning are shown in Figure 2-3. In all arrangements the sensor/injector unit case was electrically insulated from the cable components, including the neutral jumpers.

**Figure 2-3**  
**Placement of partial discharge sensors (sensors/injectors)**

- On top of the jumpers connecting cable neutrals (configured with higher or lower inductance)
- Over the entire cable, incorporating both the conductor and metallic shield
- On top of the cable core, with the metallic shield removed
- Over the cable with its neutral in place plus an additional neutral jumper running in the opposite direction (as compared to the original neutral)

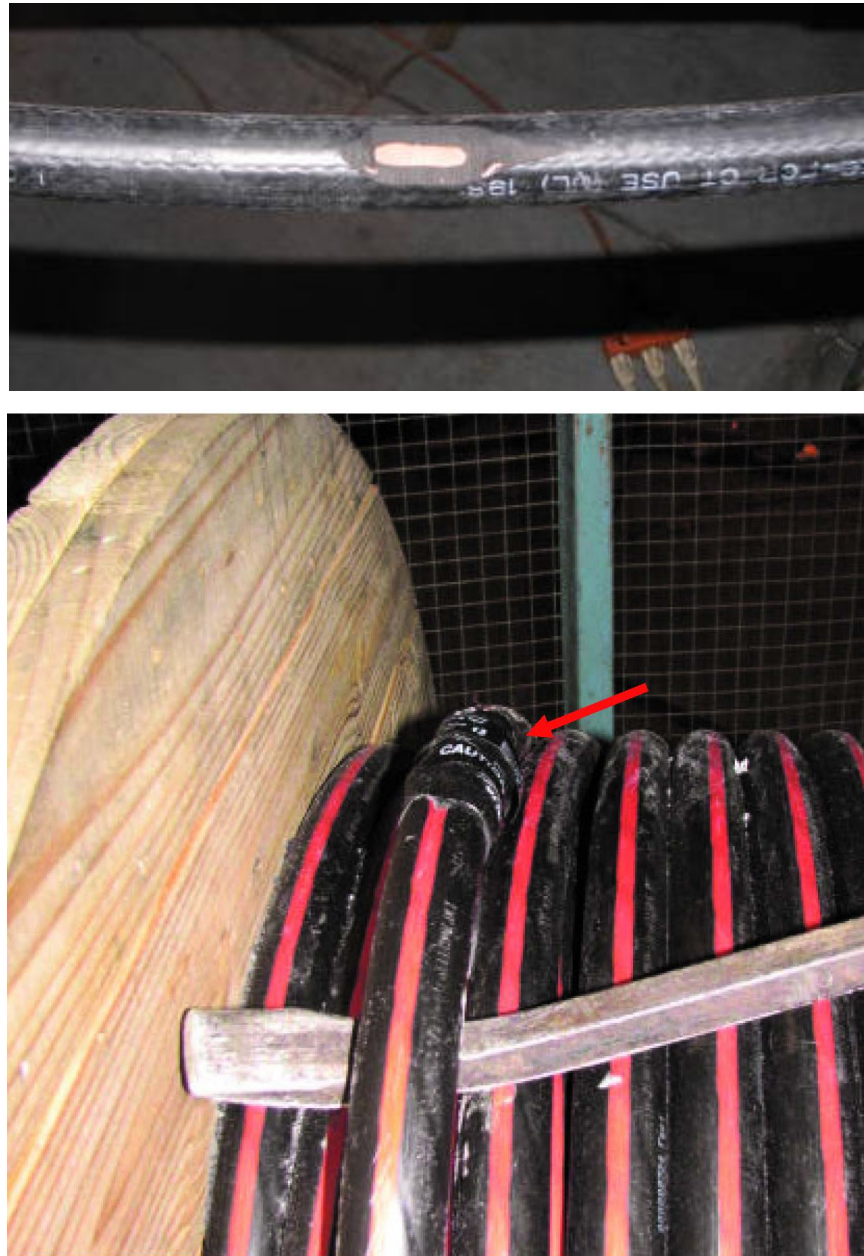
purposely damaged areas were covered by wrapping a few layers of semiconducting tape over them. Figure 2-4 shows the exposed insulation, using as an example the EPR insulated cable (top picture), and a completed artificial defect with the semiconducting tapes applied, using as an example the TR-XLPE insulated cable (bottom picture).

**Figure 2-4**  
**Artificial cable defects, introduced to serve as the source of partial discharges**

The defects in both cables were introduced in a similar way. First, the outer layers of the cables were removed using a grinding tool that left rough surfaces, so that a section of the insulation was exposed. Next, neutral wires that had been damaged to provide access to the cable core were placed directly over the exposed insulation and their continuity was re-established. Finally, the

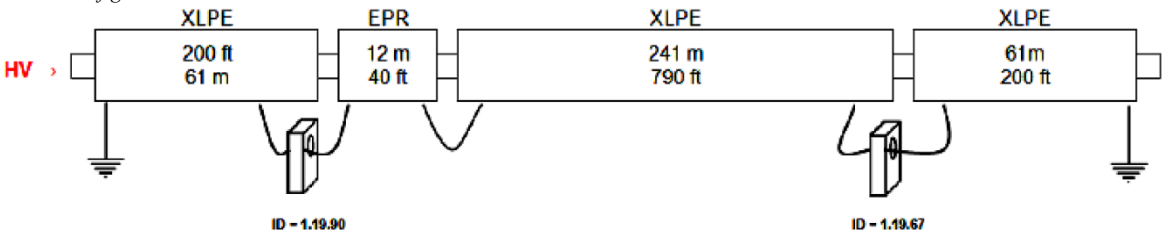
| Date | Action Performed | Result | Reason(s) |
|---|---|---|---|
| 5/16/12 | <p>Initial circuit configured to locate PD in a Unishield cable.</p> <p>Initial circuit consists of two 200 ft #2 XLPE impedance coils, one 40 ft Unishield test cable and one 790 ft #2 XLPE load cable.</p> <p>Initial application of 11 kV to the test circuit for two hours.</p> | None | System was not configured on KEMA's end per email from 5/21/12 |

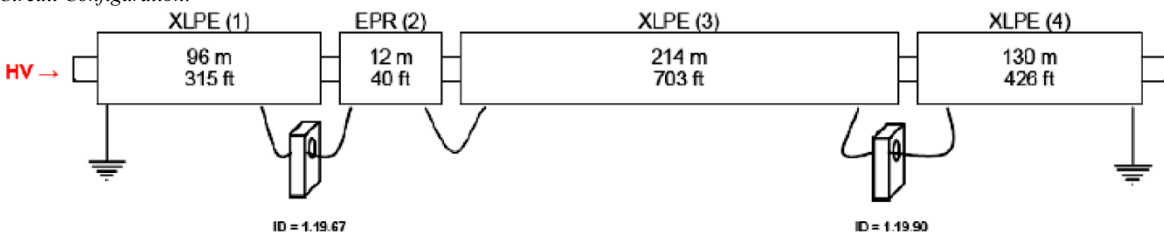
| Date | Action Performed | Result | Reason(s) |
|---|---|---|---|
| 6/4/12 | Circuit re-configured with (1) 315 & (4) 426 ft #1/0 XLPE impedance coils, (2) 40 ft Unishield test cable and (3) 703 ft #2 XLPE load cable. | No PD shown on KEMA system | No significant PD present in test cable. |

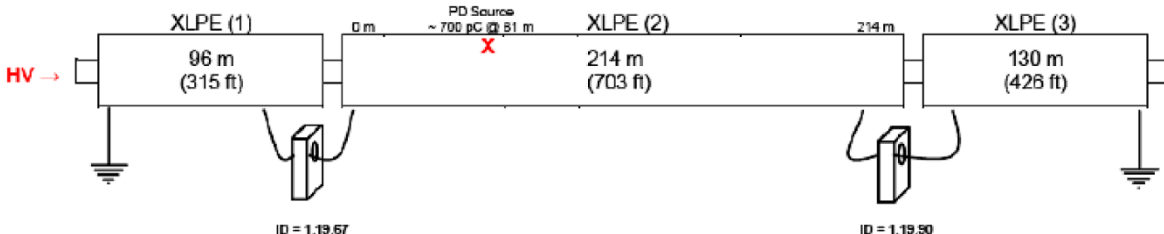
| Date | Action Performed | Result | Reason(s) |
|---|---|---|---|
| 6/5/12 | Circuit re-configured by removing 40 ft Unishield test cable and reassigning 703 ft #2 XLPE load cable to test cable by introducing damage to the cable at 81 m that produces PD of ~700 pC locally. | No PD shown on KEMA system. | Sensor Units did not detect any PD. KEMA recommends a change in the positioning of the Sensor Unit and also only one connection to ground |

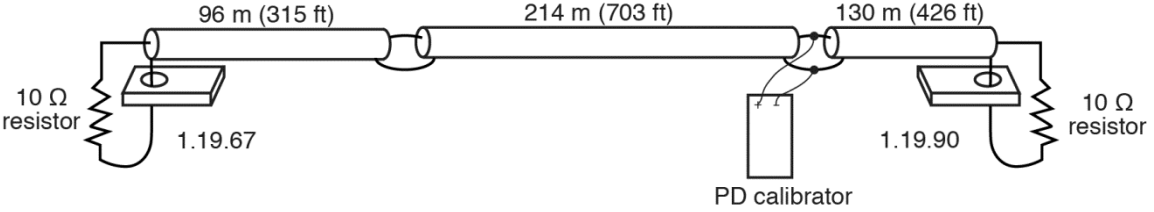
| Date | Action Performed | Result | Reason(s) |
|---|---|---|---|
| 9/25/12 | System re-configured as recommended by KEMA. Additionally, one end of the cable and one sensor located behind a screening wall. | PD shown exactly where it was expected on KEMA website. | |

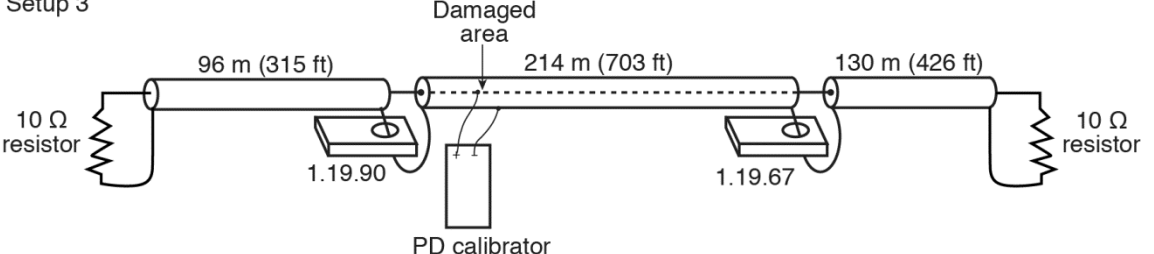
| Date | Action Performed | Result | Reason(s) |
|---|---|---|---|
| 10/1/12 | System re-configured per KEMA's instructions. Effectively restored to original configuration with the addition of load resistors. Note sensor and cable were returned to the same side of the wall as primary sensor. | PD shown where expected with the addition of some noise. | Possibly due to the second sensor not being shielded by the wall. |

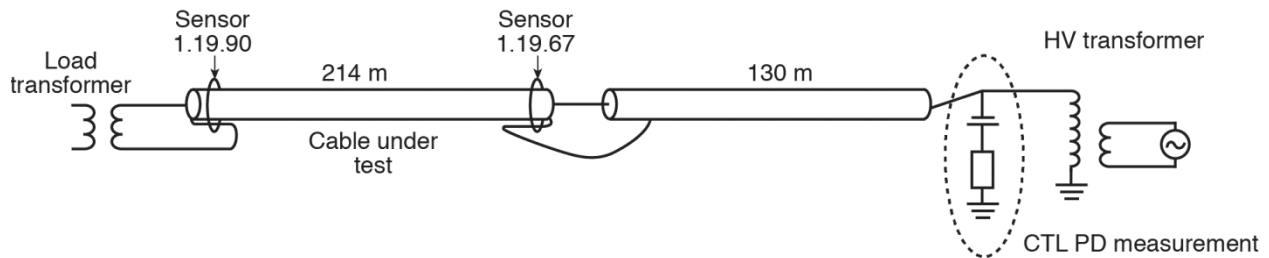
Some adjustments were made to the test setup to make it possible to energize the test setup. In the end the test setup was as shown below. At the left end the cable under test was terminated by the transformer. The secondary side of that transformer was not connected to anything else. At the right-hand side a transformer energizes the test setup and CTL's partial discharge measurement equipment is connected [Figure 3-1].

**Figure 3-1**  
Sketch of the model cable system used during the final stage of the project

The cable under test contained an artificial defect at about 1/3 of the cable length. For this defect a nail was put in the insulation, touching the conductor. A partial discharge calibrator was connected between the nail and the metallic earth screen of the cable.

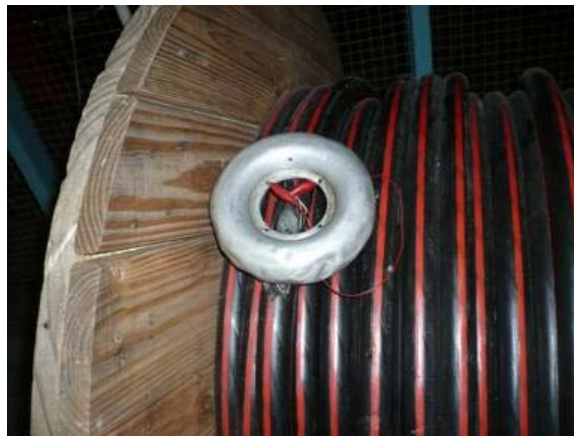
*The defect was cleaned out, it was covered by a metal part at a distance of a few centimeters (see photo below [Figure 3-2]). The setup was energized again. Partial discharges were detected by CTL's equipment with amplitude of about 1000 picocoulombs and a repetition rate of a few partial discharges per cycle. The Smart Cable Guard system recorded [completed] about ten measurement records of 20 ms each. A single partial discharge was detected by Smart Cable Guard [during the 200 ms window, presumably containing close to one hundred individual partial discharge pulses] at 34% of the cable length with amplitude of 125 picocoulombs.*

**Figure 3-2**  
**Hole in the cable insulation covered with a donut—compare to Figure 2-4**

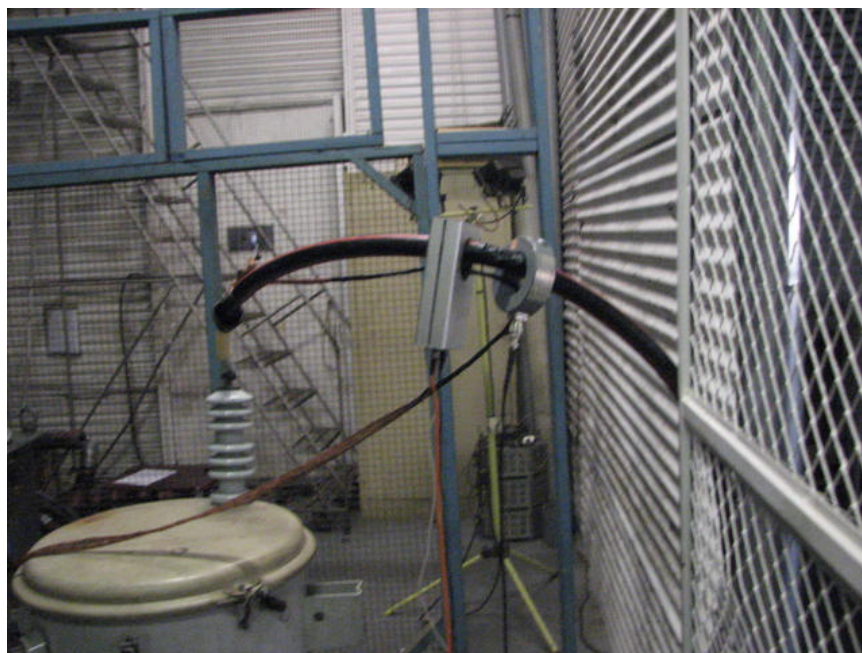
The tests were completed when KEMA's additional equipment arrived at CTL. Unfortunately, by that time, Dr. Wagenaars had already left. The main goal of these additional tests was to measure the impulse shape of the pulses generated by the partial discharge calibrators employed, to address concerns indicated in Dr. Wagenaars' discussion. For this purpose, Fisher high-frequency current probes were used as a reference during these tests. An example of a probe placed next to one of the sensors/injectors is shown in Figure 3-3.

**Figure 3-3**  
**Sensor/injector unit and Fisher current probe attached to the model cable system**

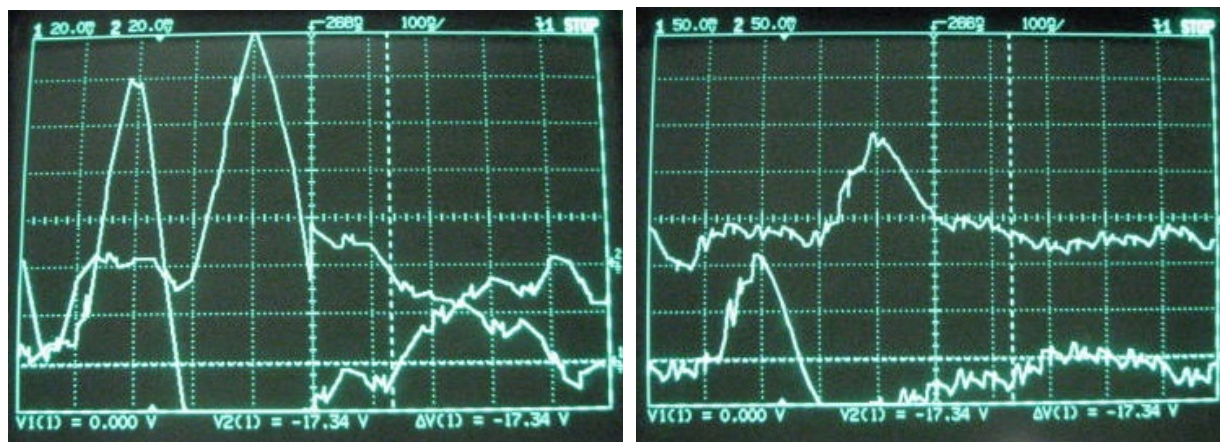
Figure 3-4 provides a single pulse oscillogram recorded from the Fisher probe outputs, at the 2000-picocoulomb (left picture) and 500-picocoulomb (right picture) settings of the partial discharge calibrator. The shift between two pulses on each oscillogram corresponds to the travelling time of the partial discharge signal along the 214-m (703-ft) cable section.

**Figure 3-4**  
**Calibration partial discharge pulses recorded with the help of Fisher current probes**

It should be noted that the pulse width is about 200 ns. Assuming that this corresponds to a half-cycle of a sinusoidal wave, one can roughly estimate that the main frequency of the signal (carrying most of the impulse power) is about 2.5 MHz, which perfectly fits into the Smart Cable Guard frequency band of 100 kHz to 10 MHz. The oscillograms also show that there was no noise close (or even comparable) to 500 picocoulombs.
