Plant Engineering: Evaluation and Insights from Nuclear Power Plant Tan Delta Testing and Data Analysis – Update

2015 TECHNICAL REPORT

3002005321

Final Report, September 2015

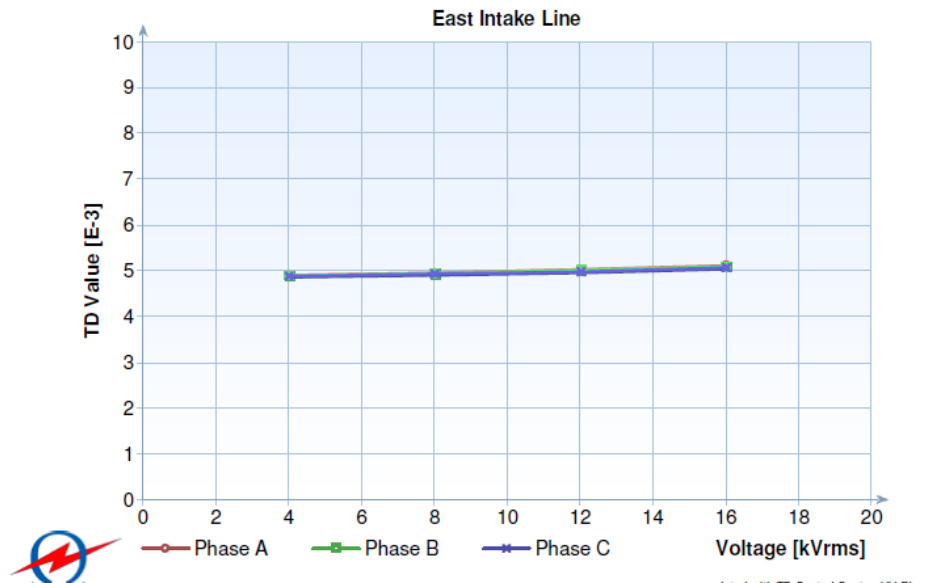
Phase C Summary: 0.1 Hz, 403.5 nF

Voltage [kVrms]	4.0	8.0	12.0	16.0		
TD Value [E-3]	4.9	4.9	5.0	5.1		
Std. Dev. [%]	0.00	0.00	0.00	0.00

Figure 2-2
 Good $\tan \delta$ results showing low magnitude, zero percent standard deviation, and delta $\tan \delta$ is nearly zero (minimal slope to the line)

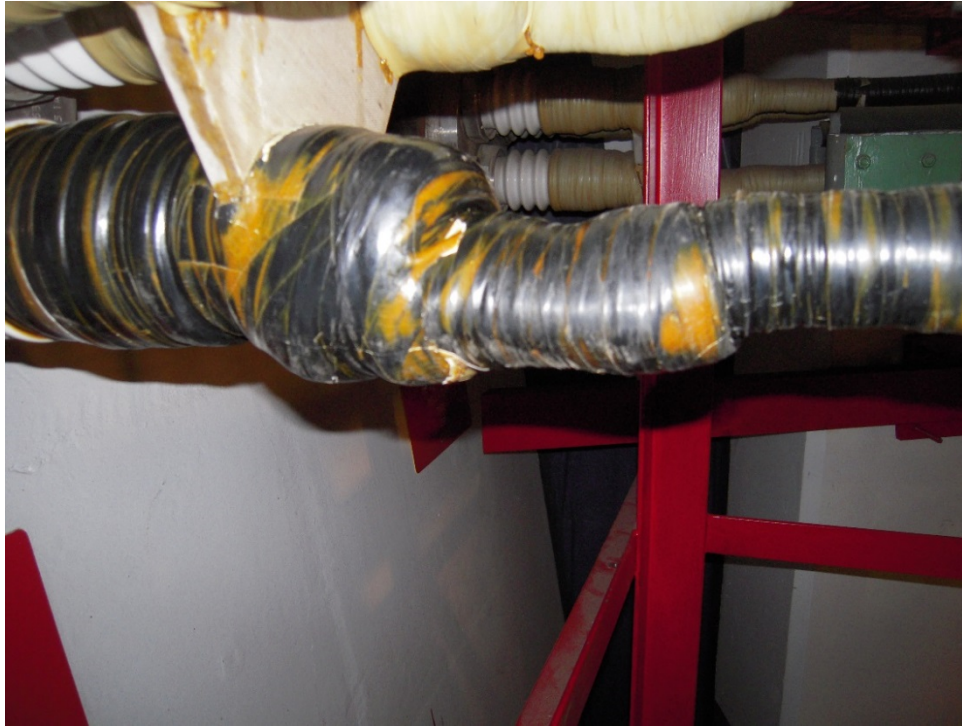
Figure 4-4
Noticeable overheating of the C phase penetration. Note the tan color of the parallel cables in the background.

Removal of the tape over the connection revealed a high resistance connection that was cleaned, remade, and reinsulated. The post-repair testing seen in Figure 4-5 confirms that the thermally degraded termination was the cause of the “action required” test results. It also demonstrates that it is possible to determine more than just wet cable degradation with tan δ testing.

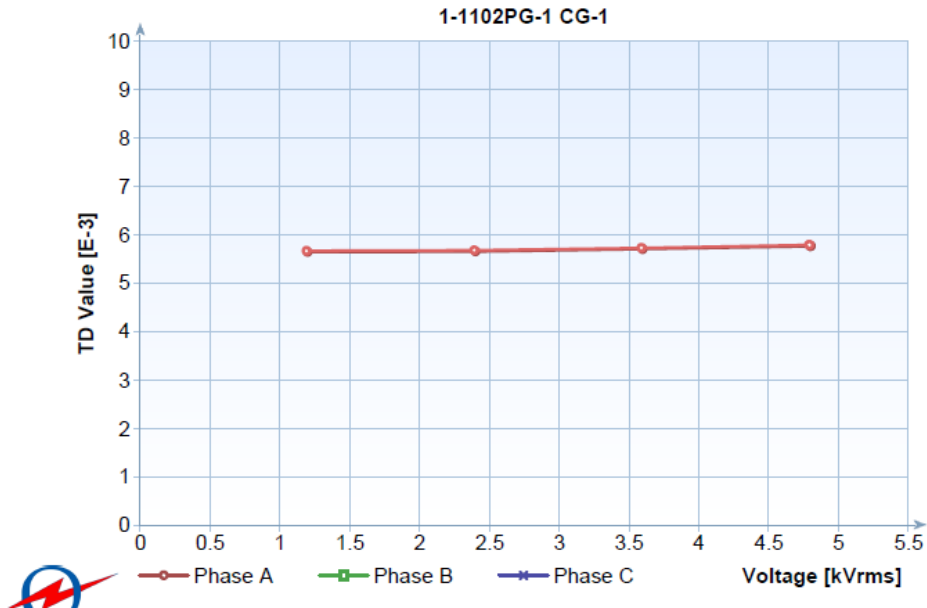
Figure 4-5
 Post-repair testing for a reactor coolant pump motor showing the C phase. Only the C phase was retested so the data appear under the A phase.

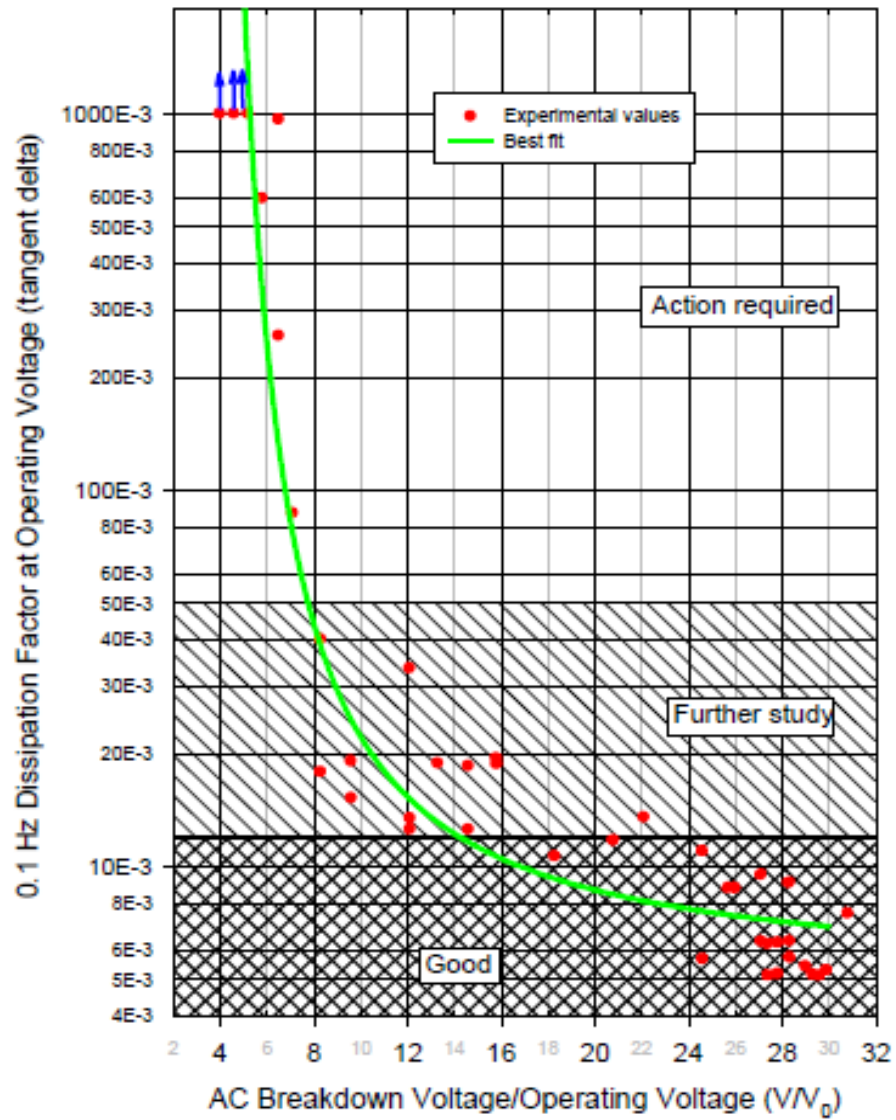
Note: Laboratory testing of short sections of good and degraded cables indicate that high tan δ test results correlate well with reduced ac breakdown strength.

Figure 4-6
Plot of ac breakdown voltage versus $\tan \delta$ at operating-line-to-ground voltage

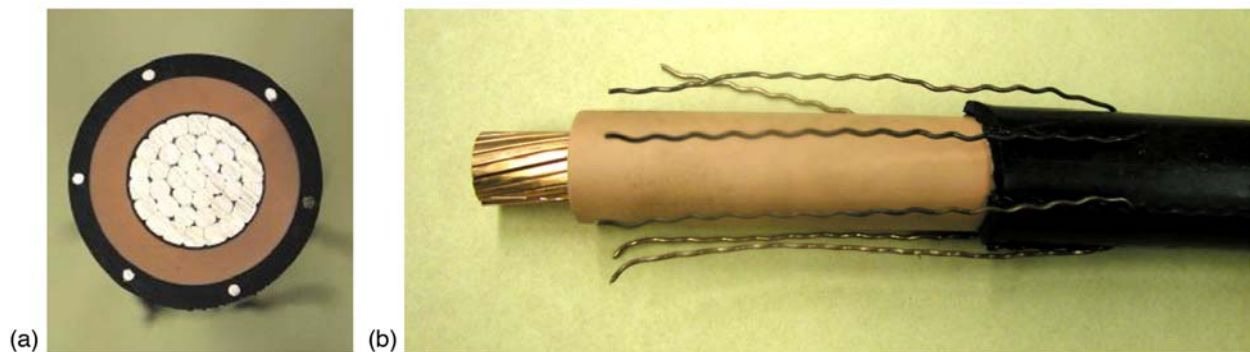
Figure 6-1
Construction of pink EPR compact design cable [a] transverse view, [b] lengthwise view

The major differences in this design from other EPR types is the use of six, corrugated, bare copper drain wires embedded in a semi-conducting, extruded, thermoplastic shield. This layer acts as both a shield and jacket for this design. The combined insulation shield/jacket with embedded metallic shield drain wires requires a compromise between the bonding strength of this layer and the insulation. Ease of prepping the cable for terminating and splicing requires a trade-off between a minimum adhesive strength that can be stripped it away easily enough not to destroy the insulation surface for a splice or termination versus better electrical stress properties if the semi-conducting surface was more strongly bonded to the insulation surface.

Figure 6-1 shows the construction of the compact design cable.

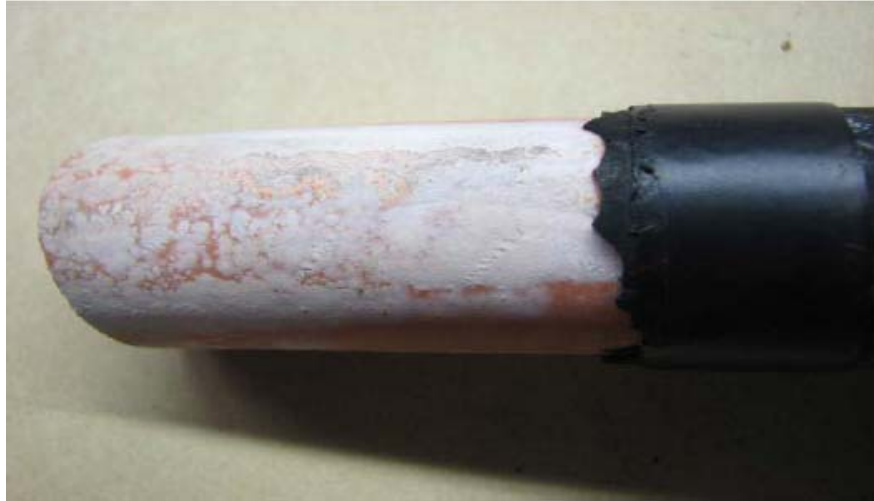
This delamination pocket creates stress between the insulation and insulation shield, and subsequently partial discharging occurs. The energy released by this partial discharge disintegrates the EPR at the surface as seen as the white areas in Figure 6-4, reducing the overall dielectric strength of the remaining insulation by as much as 50%.

Figure 6-4
The white substance in the figure is the partial-discharge-affected surface of the EPR insulation.

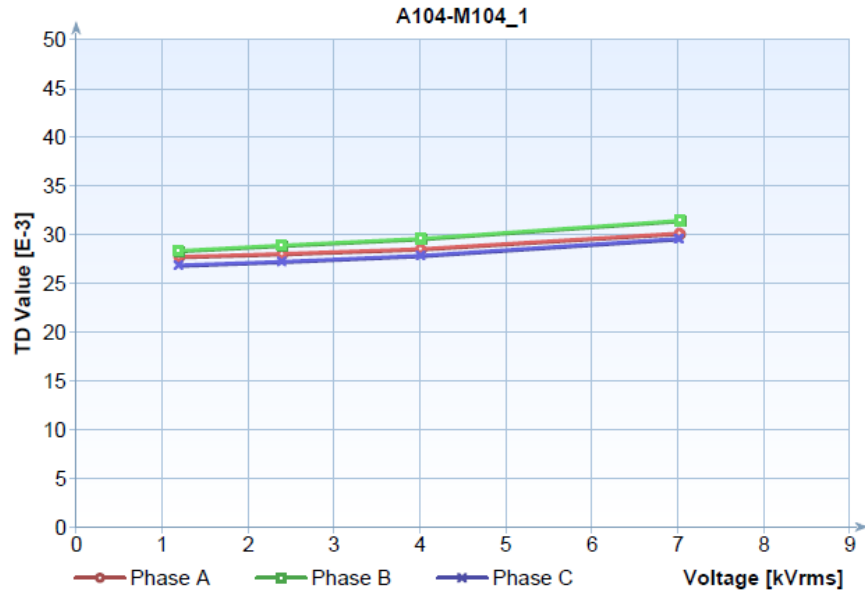
Voltage [kVrms]	1.2	2.4	4.0	7.0			
TD Value [E-3]	26.9	27.3	27.9	29.6			
Std. Dev. [%]	0.00	0.00	0.00	0.01

Figure 7-2
Typical “good” brown EPR insulation tan δ test results

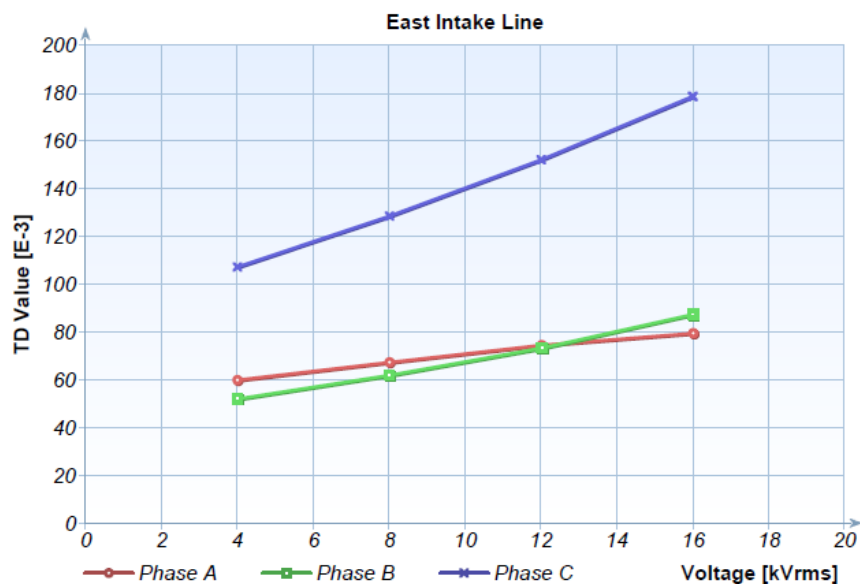
Voltage [kVrms]	4.0	8.0	12.0	16.0			
TD Value [E-3]	107.11	128.53	151.95	178.55			
Std. Dev. [%]	0.05	0.09	0.05	0.14

Figure 7-3
Example of “action required” brown EPR with suspected bad splices

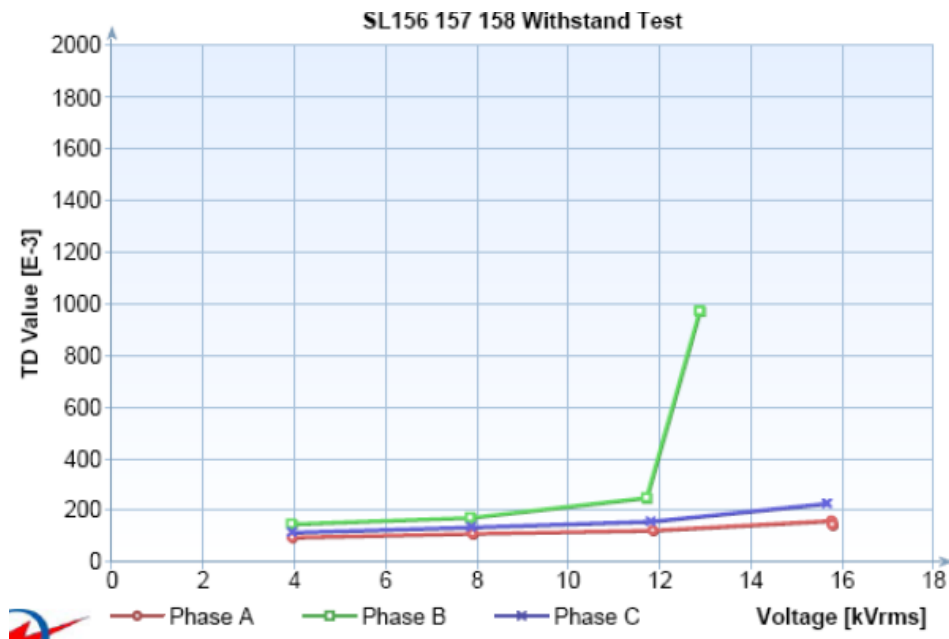
The test data shown in Figure 7-4 identified a degraded splice. The cable failed during a monitored withstand test. It is presumed that this cable would have failed in service due to the degraded splice. When the splice was opened, it was found that the zinc tape used for the metallic insulation shield had turned to zinc oxide powder. This created a non-continuous shield. The heat shrink splice could be seen visibly to have a poor shrink on one end that would have allowed water ingress into the splice. It is surmised that the electrical stress combined with water resulted in the deterioration of the zinc into the zinc oxide that is visible in Figure 7-5.

Figure 7-4
One documented case where a cable failed during a monitored withstand test

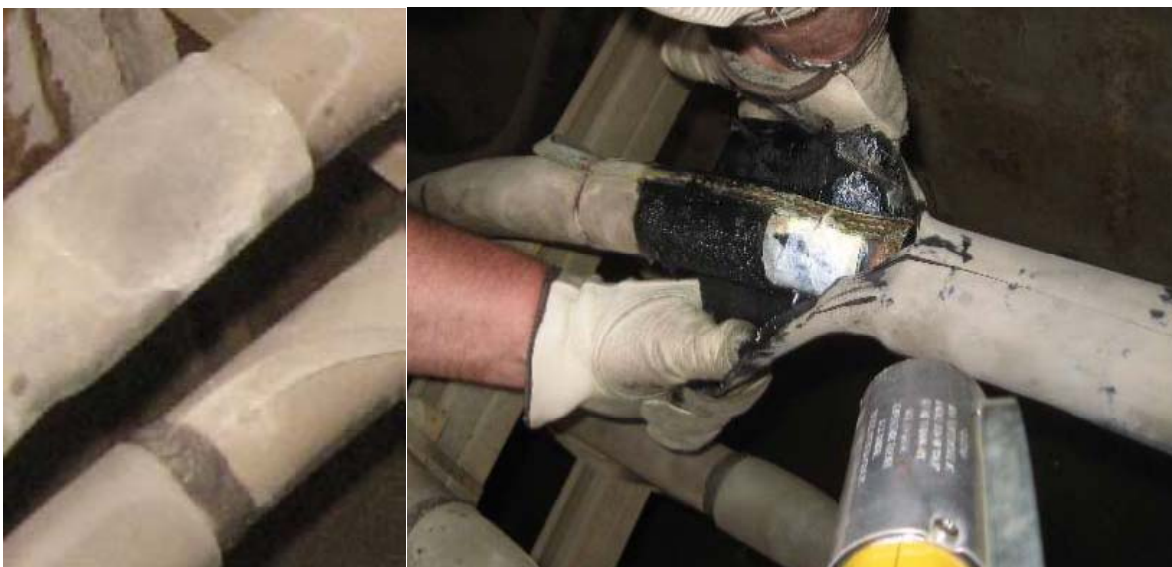
Figure 7-5
Splice with a poor heat shrink being opened and exposing the degraded zinc metallic insulation shield

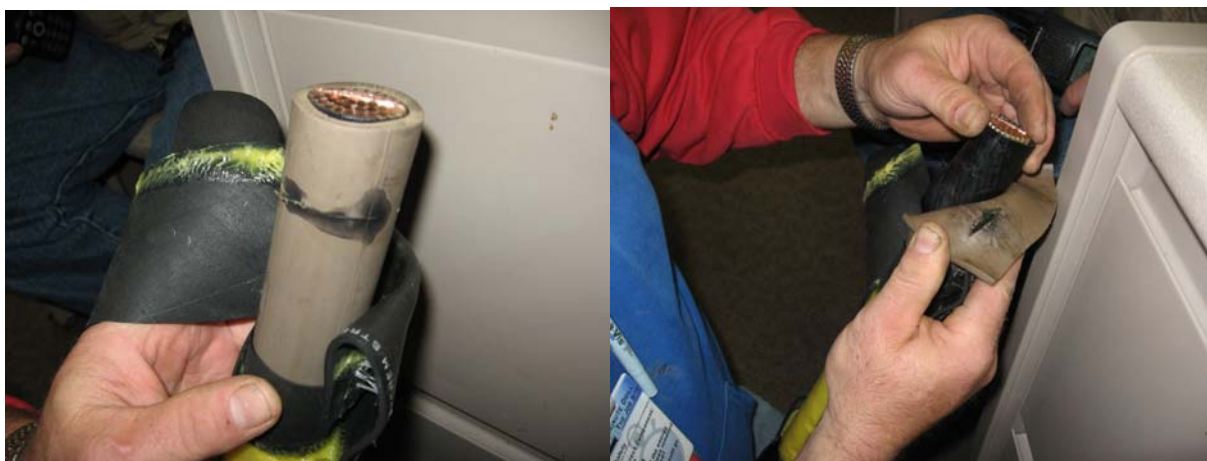
Figure 7-6
New splice of a 15-kV cable operated at 13.8-kV that failed at the 12-kV $\tan \delta$ step prior to the 16-kV withstand test

The black mark on the insulation in the left photo is the residue of the test set arc flash. The photo on the right shows that the brown EPR insulation was cut clean through to the conductor shield (black layer around the copper conductor). At a 13.8-kV operating voltage (8-kV line-to-ground), the voltage stress is high enough that this cable would have failed in a matter of hours or days in service. This points out the importance of verifying circuit integrity via a withstand test for all repaired or newly installed cables (a similar defect at a termination would result in the same condition).

It is often questioned whether repaired or replaced cables should be $\tan \delta$ tested and/or withstand tested. The recommended practice is to do both. $\tan \delta$ values are taken to provide a new baseline for comparison with future tests. Withstand testing is done to confirm workmanship for installation, terminations, and splices if applicable. An example of why this is important is shown in Figure 7-6.

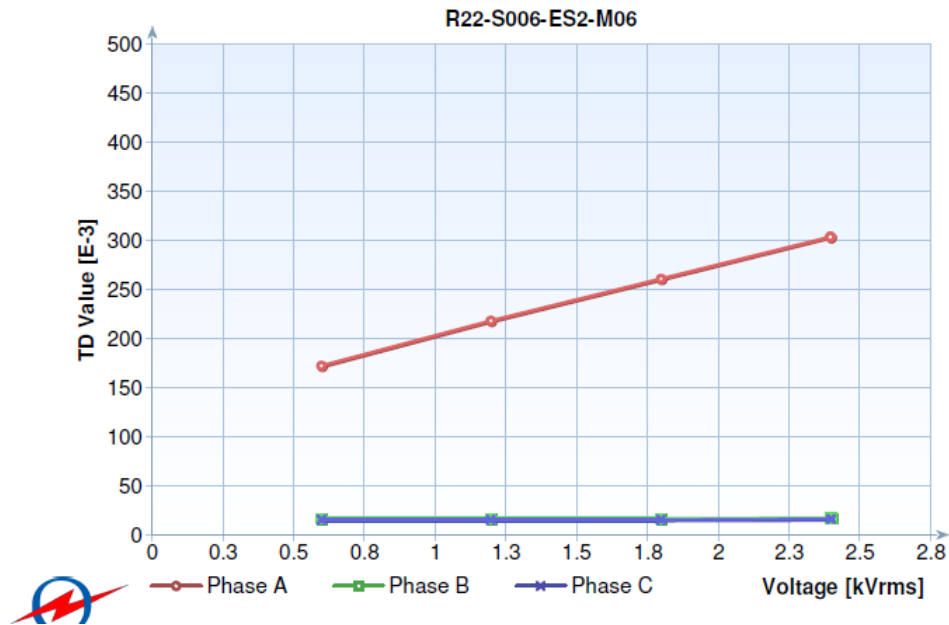
Voltage [kVrms]	0.6	1.2	1.8	2.4			
TD Value [E-3]	15.1	15.2	15.4	15.6			
Std. Dev. [%]	0.00	0.00	0.00	0.00

Figure 9-5
“Action required” delta tan δ test results

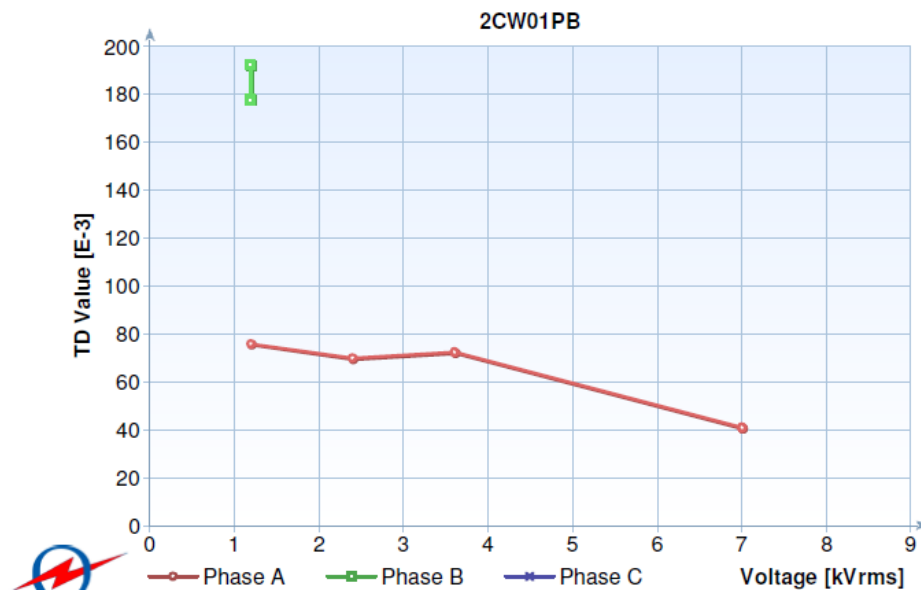
Figure 9-6
Tan δ test with negative delta tan δ identified bad splice

Investigation targeted the terminations first, but the retest results were unchanged. The splices on all three phases were replaced, and the circuit was retested (Figure 9-7). The splices were forensically evaluated. The splice was not degraded, but the metallic shield was found to be discontinuous across the splice. The cable splice was reconfigured, and the cable subsequently tested almost like a new cable of this type.

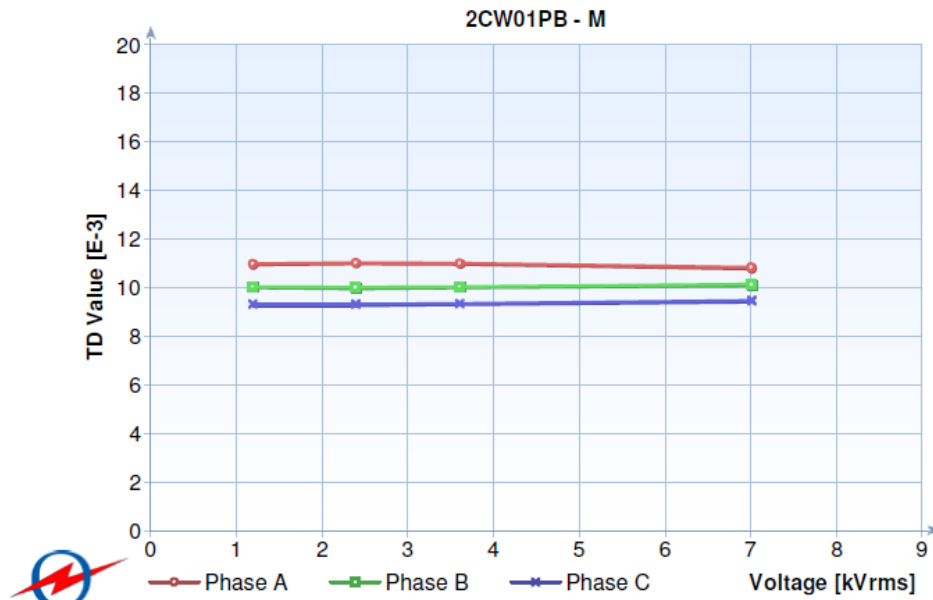
Voltage [kVrms]	1.2	2.4	3.6	7.0			
TD Value [E-3]	9.30	9.31	9.33	9.46			
Std. Dev. [%]	0.00	0.00	0.00	0.00

Figure 9-7
Cable with initial negative delta tan δ post-splice replacement results

Investigation into any test results with negative delta tan δ is recommended. Regardless of whether the cable contains splices, it is almost always easiest to confirm the termination condition first and then investigate the splice.
