# Arc Flash Update for 480-V Network Protectors

2015 TECHNICAL REPORT

**3002006373**

Final Report, June 2015

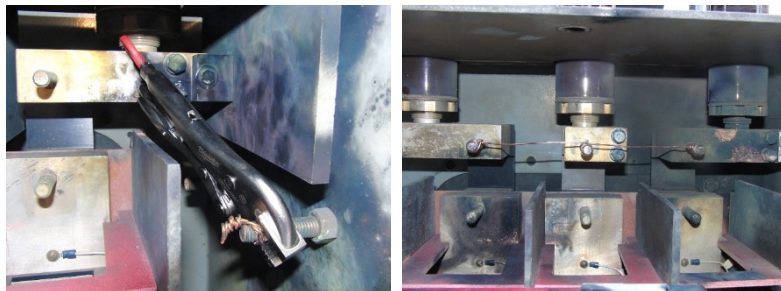
*Figure ES-1*

For work in 480-V network protectors, the main new finding is that arcing did not sustain longer than 1.5 cycles if the back bus bars were de-energized. (See examples of self-cleared fault initiations in Figure ES-1.) Incident energy exposures are likely to be below 8 cal/cm<sup>2</sup>. Based on this finding, workers could wear single-layer flame-resistant (FR) clothing.

*Fault initiations that self-cleared with the back bus bars de-energized*

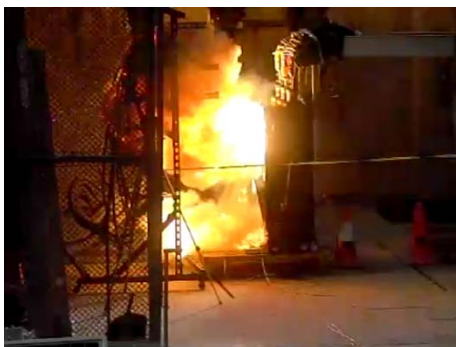
*Figure ES-2*  
*Arc flash with the back bus bars energized*

If the back bus bars are energized, either by the transformer in the back or with a closed circuit breaker, sustained faults are likely (see Figure ES-2). An analysis must be done to evaluate incident energy exposures.

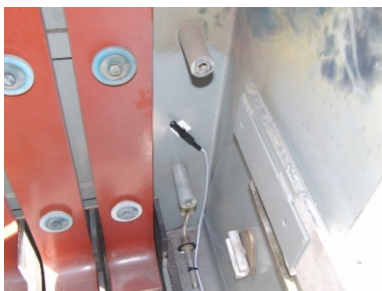
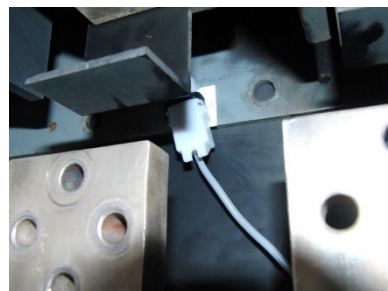
*Figure ES-3*  
*Examples of fiber-optic sensor use*

The fiber-optic sensors (see Figure ES-3) performed well for detecting arcs in network protectors and external applications. Sensors and cabling were robust to nearby arcs, and performed well even when covered with soot.

Inside network protectors, one omnidirectional sensor on the back wall should be adequate for events with substantial arc energies. For increased sensitivity, three sensors could be used on the back wall. Some nuisance tripping may be seen in very high fault current faults.

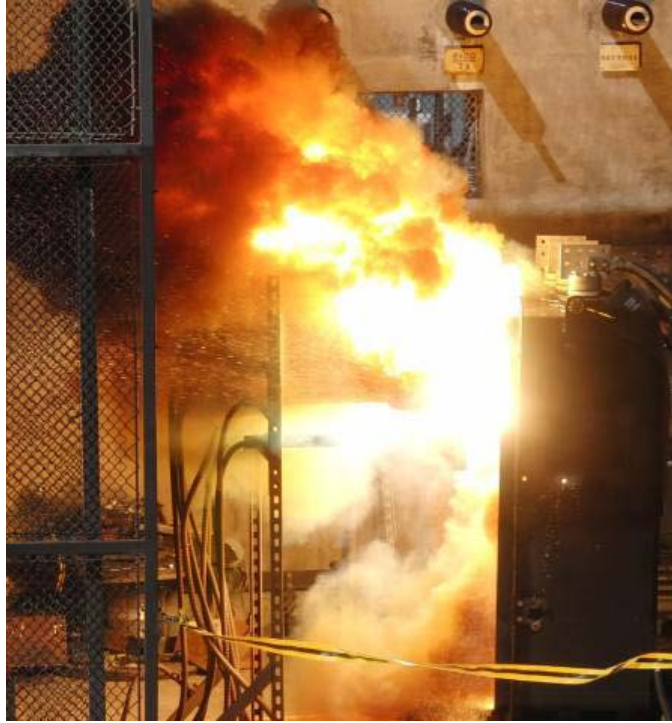
*Figure 1-1  
Example 480-V network protector event [EPRI 1020210, 2009]*

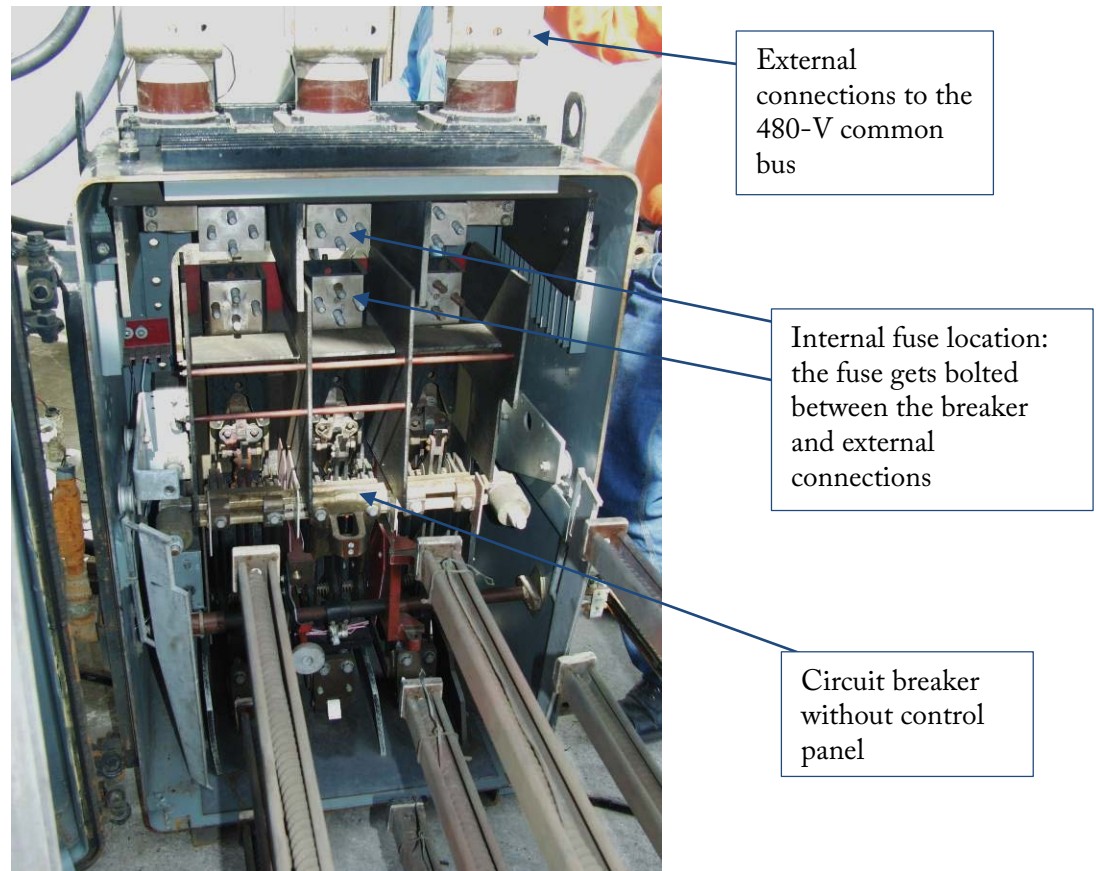
*Figure 1-2  
Interior of a CM-22 480-V network protector with the circuit breaker controls removed*

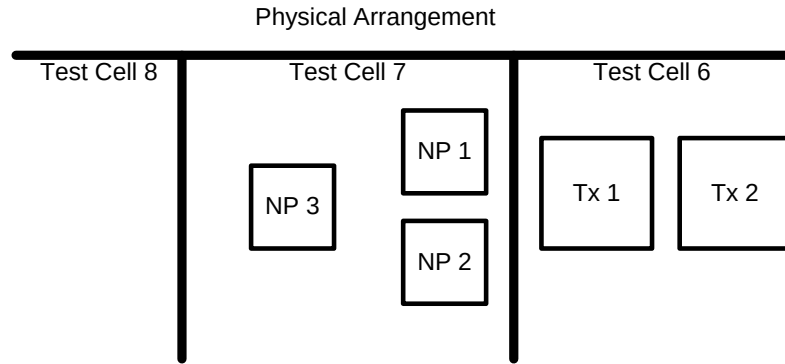
*Figure 1-4*  
Plan view of the test setup

Tests were performed at PG&E's High Current Laboratory in San Ramon, CA. Two 2500 kVA transformers, TX1 and TX2, were set up each feeding a functional Westinghouse CM-22 network protectors, NP1 and NP2, through back throat plate providing 50kA available bolted fault to top of a third sacrificial network protector, NP3. NP3 contained a circuit breaker that was installed fully into the network protector and left in the open position for most of the testing. The back bus bar of NP3 that would normally be connected to its own transformer, was left unconnected with a cover installed over the throat plate opening to mimic the enclosed nature seen in real service conditions. This allowed arc initiation in NP3 with a configuration that is as close as possible to what would be seen in actual operation if its transformer was de-energized. Figure 1-3 shows the single line diagram, Figure 1-4 shows the plan view of the physical layout, and Figure 1-5 is a photo of the test cell with the network protector setup.

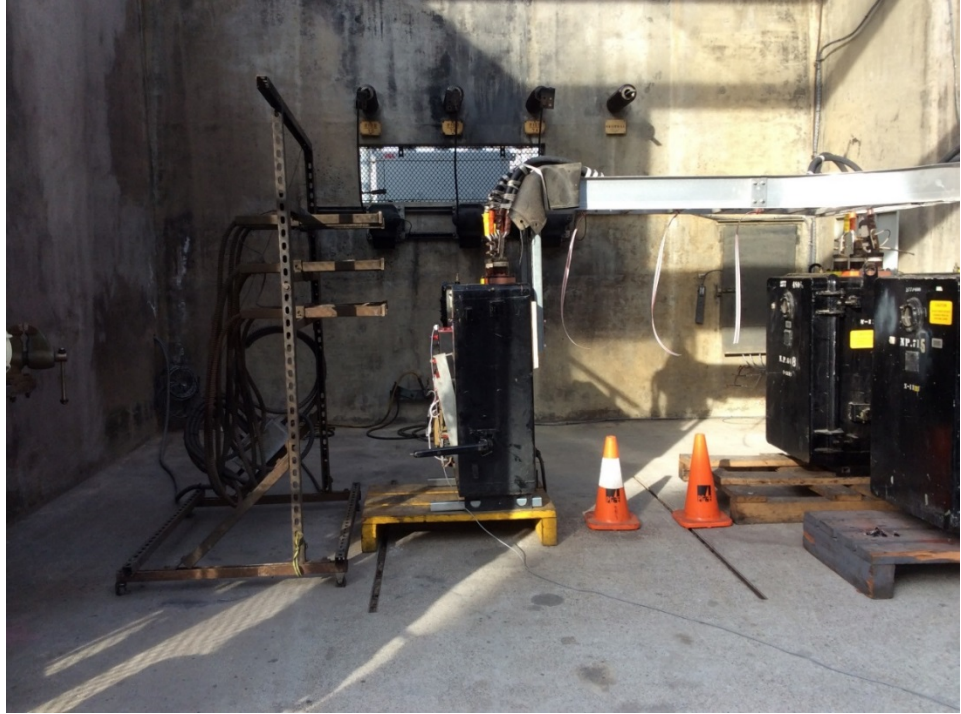
For the tests on NP3, incident energy was measured by nine copper calorimeters on stands spaced 8" apart and positioned 18" away from the top electrodes coming into the network protector. See Figure 1-6. Calorimeters were built and calibrated according to ASTM specifications [ASTM E 457 – 08, 2008; ASTM F1959, 2006].

*Figure 1-6  
Calorimeter array placement*

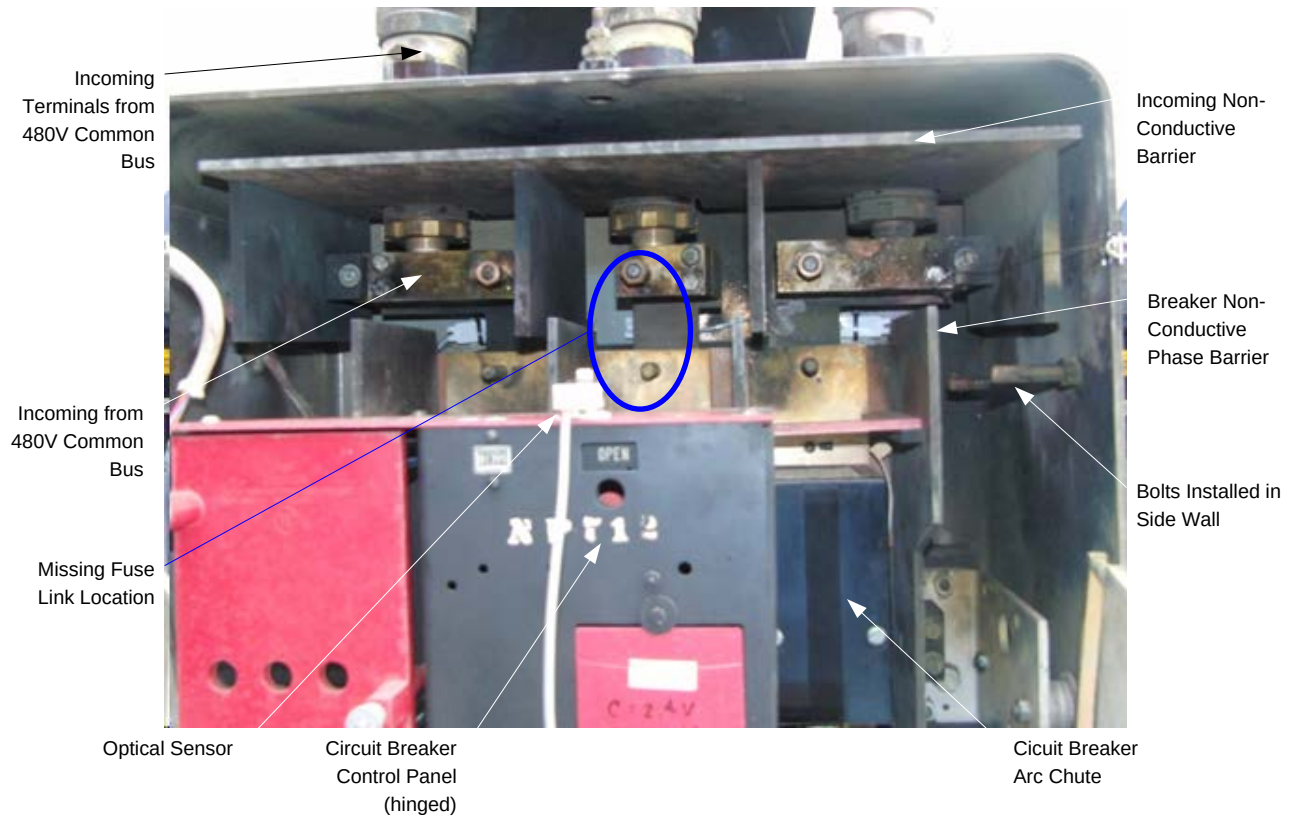
The internal construction of the inside top of the network protectors includes a substantial non-conductive barrier around and between the incoming buses from the top of the network protector along with non-conductive barriers between phases attached to the top of the breaker. See Figure 2-1. With these intact, direct phase-to-phase contact becomes unlikely; therefore, we started testing phase-to-case contacts on one of the outside phases. Actual in-service conditions would likely result in contact from a phase to the outside edge of the side case of the protector with some sort of tool or wrench. When these arcs failed to sustain, bolts protruding into the case were installed in the side wall of the protector, one near the front and one directly in-line with the incoming bus (shortest possible arc gap).

*Figure 2-1  
Interior NP3 with the non-conductive barrier installed*

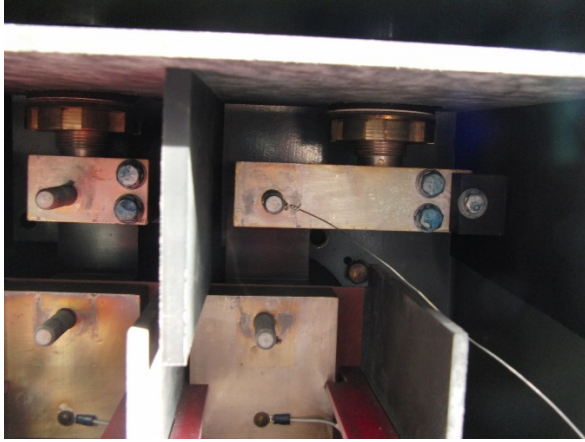
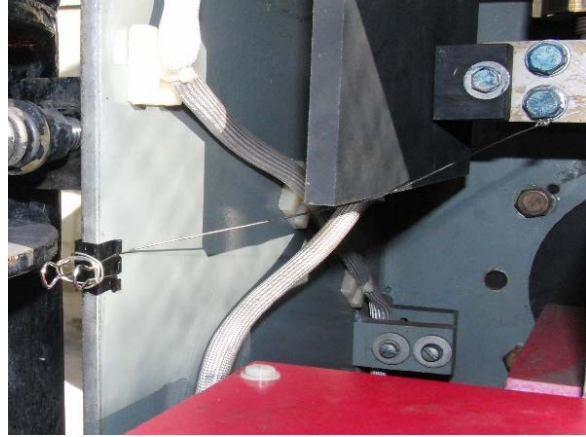
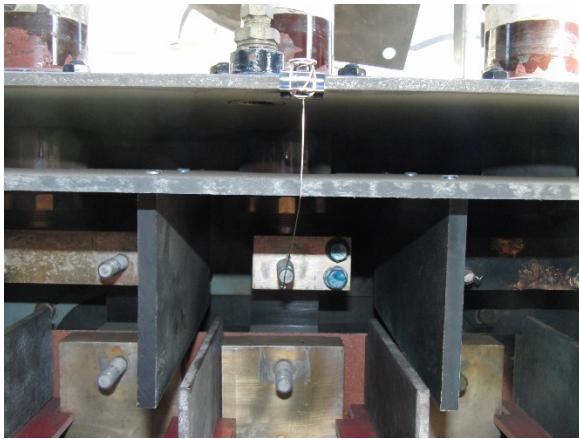
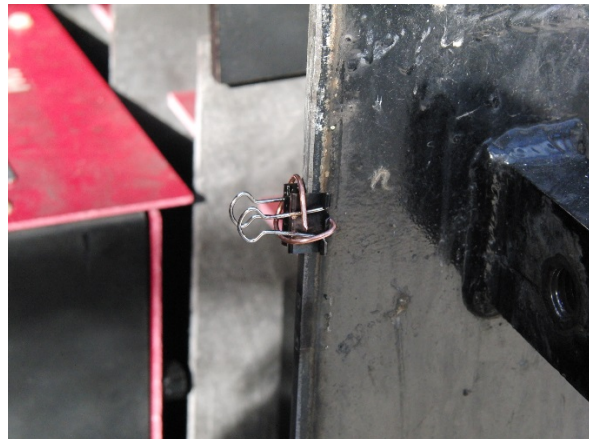
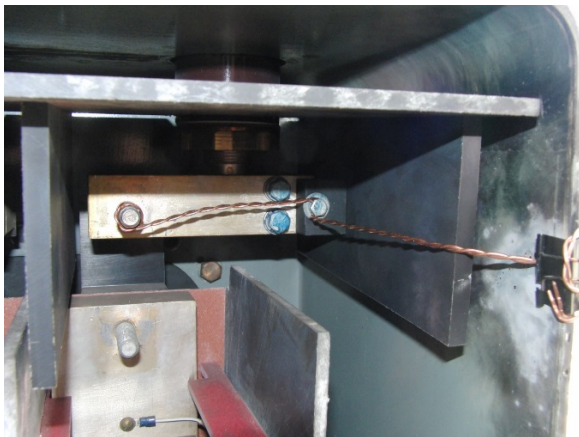
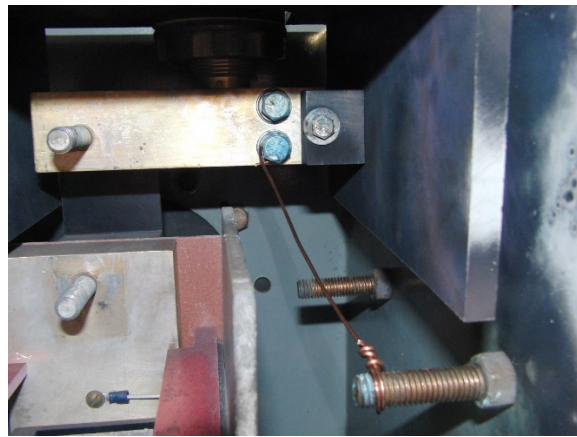
Figure 2-2 and Figure 2- show typical arc initiation points and arc durations for various phase-to-ground initiation points.

Test 13: AΦ to Case - 20 AWG - **0.14 cycles**

Test 33: CΦ to Case - 20 AWG - **0.17 cycles**

Test 34: BΦ to Case - 20 AWG - **0.17 cycles**

Test 14: AΦ to Case - 14 AWG - **0.25 cycles**

Test 15: AΦ to Case - 2-#14 - **0.35 cycles**

Test 16: AΦ to Front Bolt - #14 - **0.41 cycles**

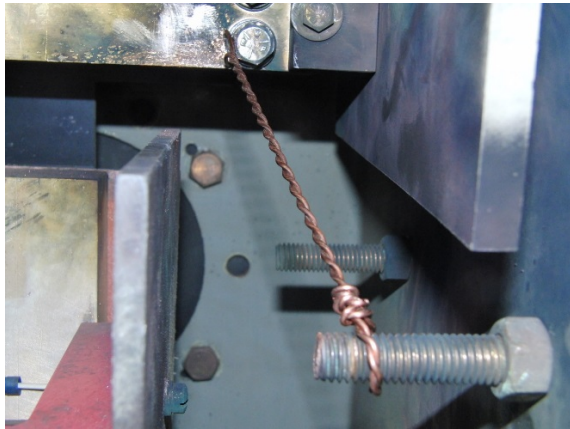
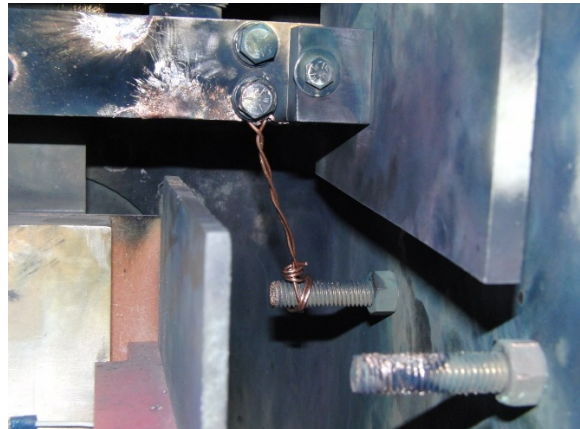
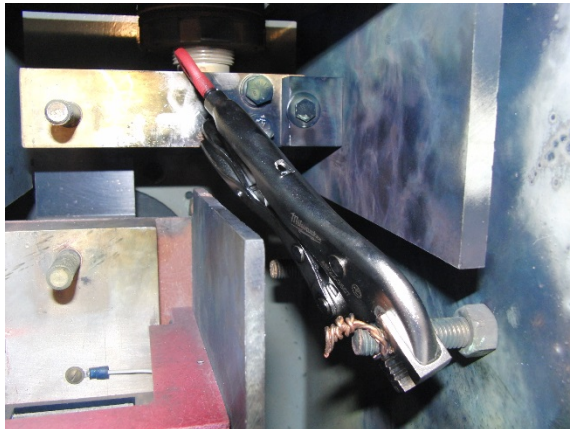
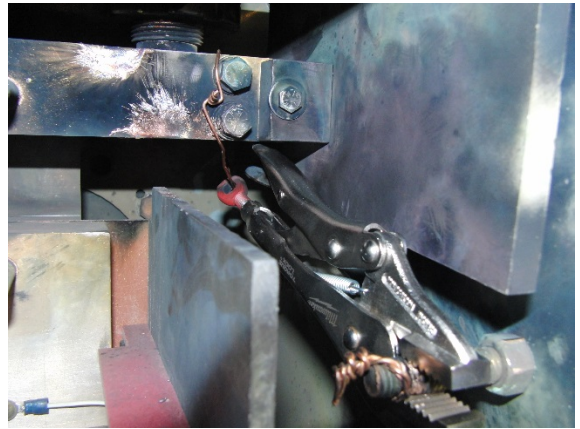
*Figure 2-2 (continued)*

Test ID 17: AΦ to Front Bolt- 2-14 AWG - **0.51 cycles**

Test ID 23: AΦ to Back Bolt- 2-14 AWG - **0.55 cycles**

Test ID 18: AΦ to Front Bolt- Vise Grip - **1.5 cycles**

Test ID 19: AΦ to Front Bolt- Vise Grip - **1.0 cycles**

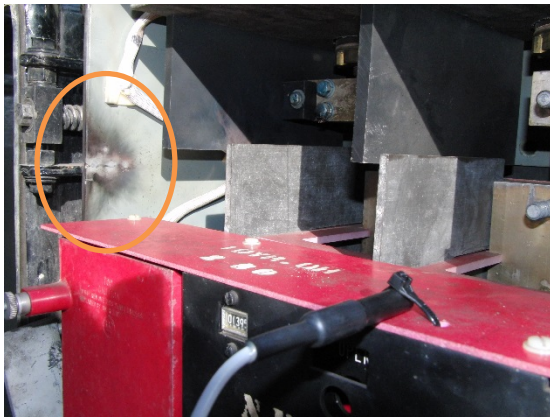
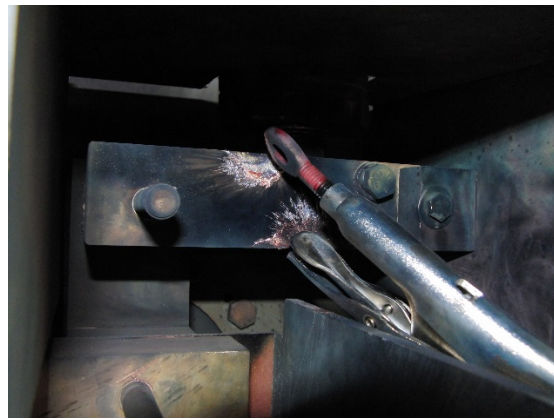
*Figure 2-3*  
*Examples of post-test damage*

These short-duration arcs resulted in very little damage to the inside of the network protector. Figure 2-4 shows typical damage after some events.

Post Test ID 33: CΦ to Case - 20 AWG

Post Test ID 18: Vise Grip

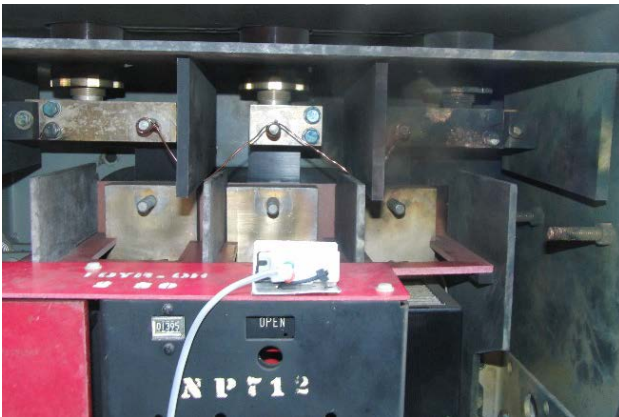
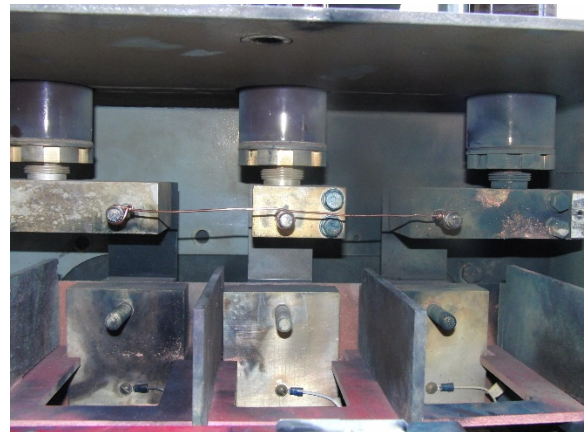
Figure 2-5 shows the arc initiation points and arc durations for three-phase initiations both with and without the insulating barrier installed. You can see from the Test ID#44 photo, that the damage from Test ID#43 was minor.

Test ID 43: AΦ-BΦ-CΦ 20AWG with Barrier -  
**0.34 cycles**

Test ID 44: AΦ-BΦ-CΦ 20AWG without Barrier -  
**0.28 cycles**

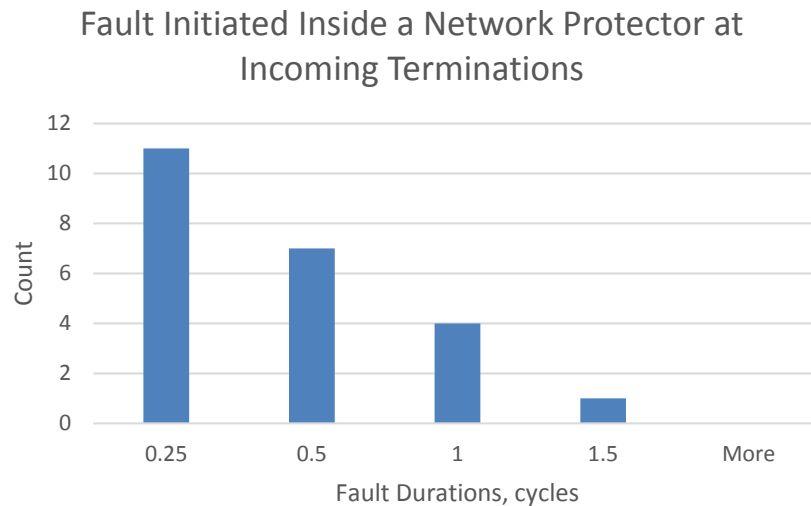
Realistic events all self cleared in less than 1.5 cycles with negligible incident energy.

*Figure 2-5  
Fault duration histogram*

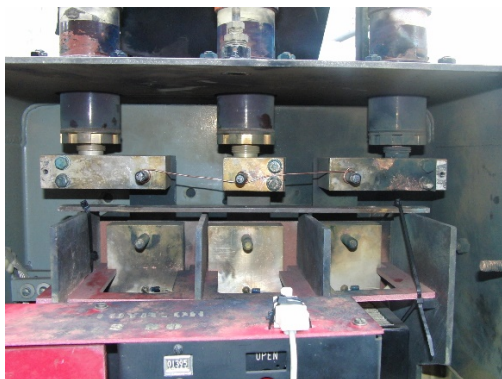
All of these cases had a flat metal bar laid between phases. Obviously, with the insulating barriers in place, this condition is impossible. As the fault starts, the magnetic forces will tend to push away from the source. In some cases, these forces will push the bar out of contact. In other cases, these forces reinforce the contact. If the bar is firmly in contact, the fault is bolted, so there is little arc energy.

Test ID 57: 3Φ with a conductive plane

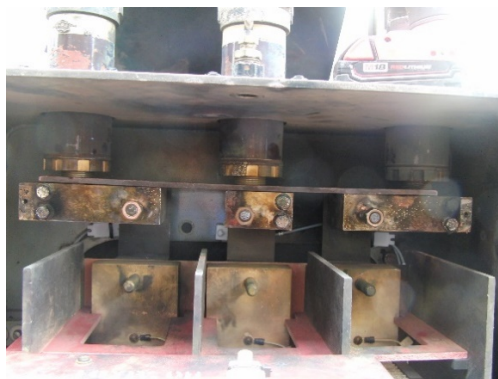
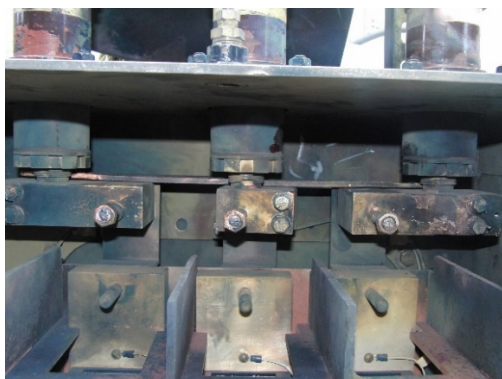
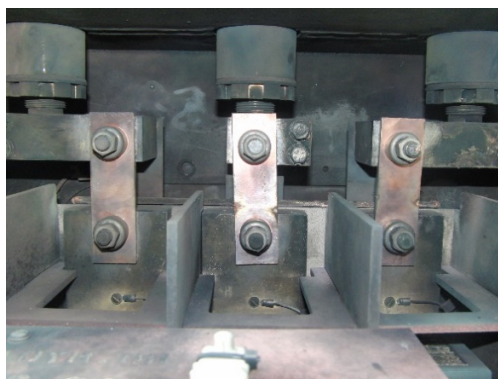
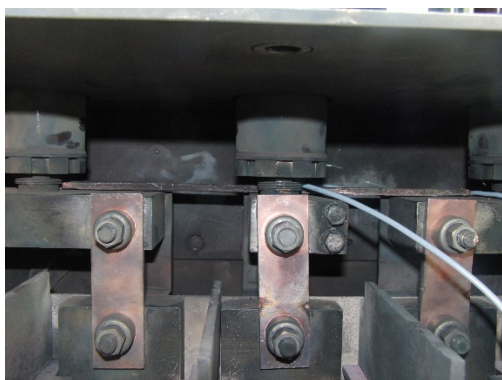
*Figure 2-6  
Extreme fault initiations*

Test ID 61: 3Φ bar front fuse terminal

Test ID 62: 3Φ bar back fuse terminal

Test ID 63: 3Φ bar top breaker

Test ID 64: 3Φ bar back fuse terminal

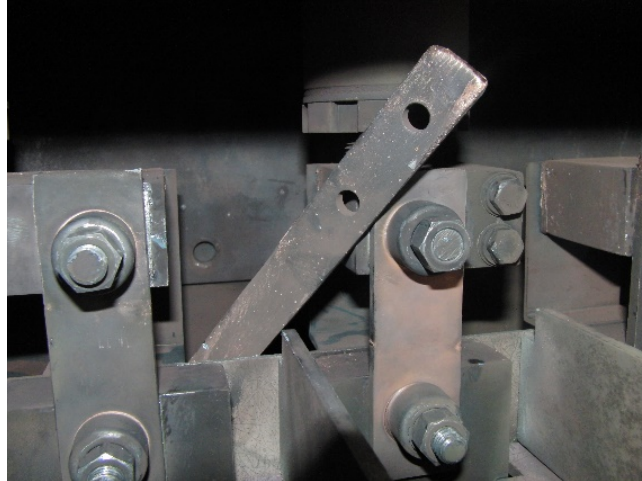
An event causing sustained arcing. Replicates a scenario where a worker drops a tool that falls to the back bus bars.

Figure 2-7  
Test ID 65: Phase-to-phase-to-wall fault initiation

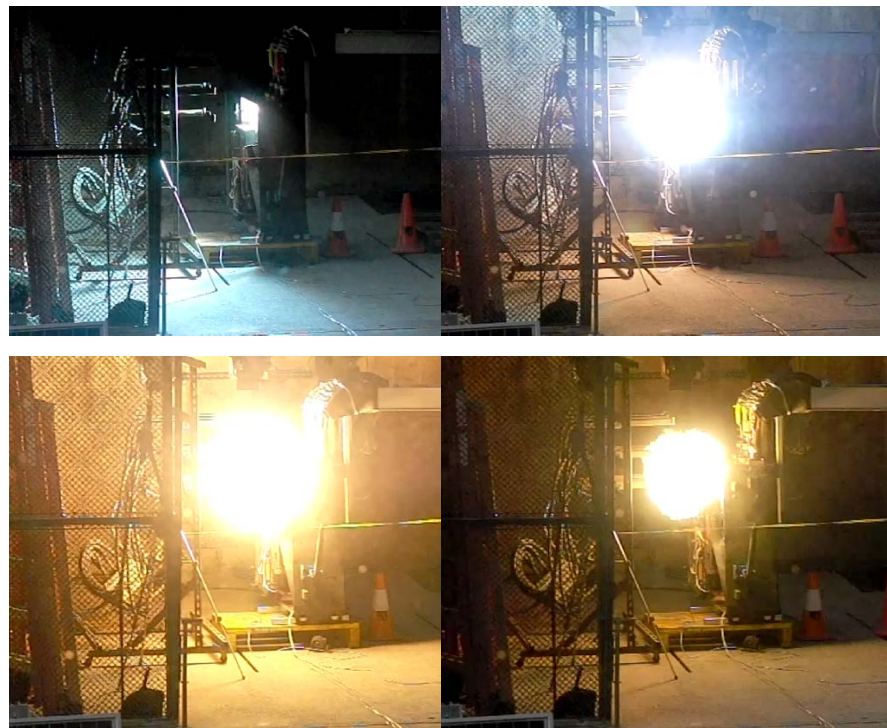
Figure 2-9 and Figure 2-10 show the evolution of the incident energy throughout the event. As can be seen the presence of the breaker causes the energy to come out wherever possible. At the end of the 4<sup>th</sup> cycle, you can see energy coming out the bottom of the enclosure, indicating full involvement of the back bus bar. By the 7<sup>th</sup> and 8<sup>th</sup> cycle, arcs have propagated to all parts of the breaker, including just below the arc chutes. See Figure 2-11 and Figure 2-12 for post-test damage below the arc chutes.

Figure 2-8  
Test ID 65: First cycle

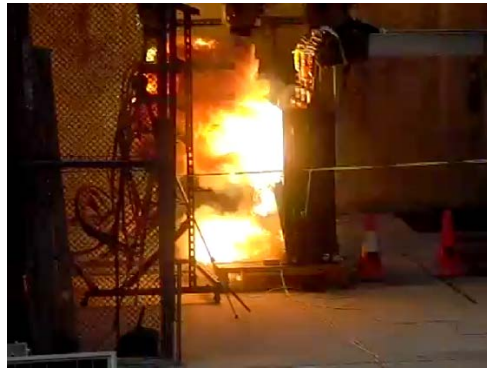
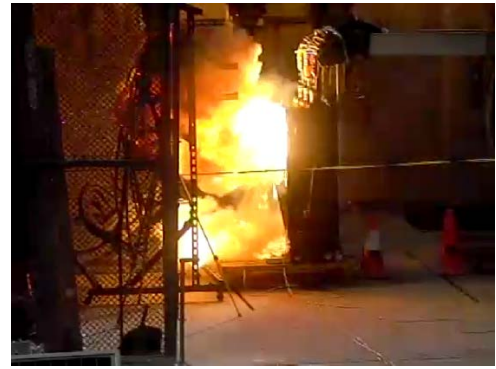
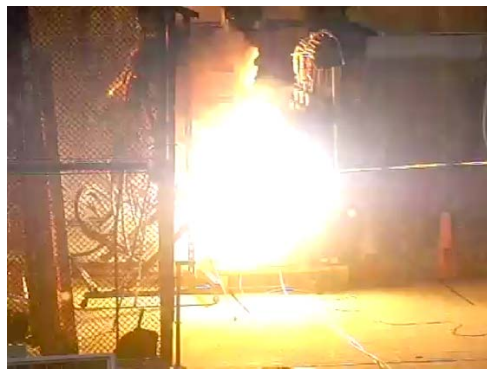
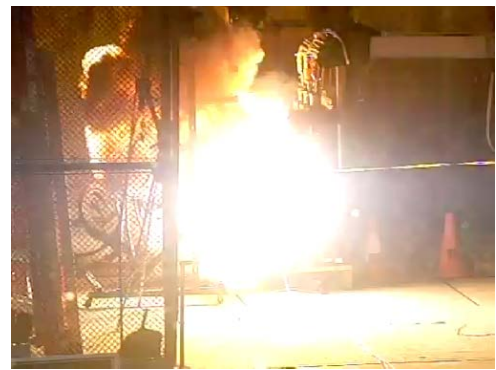
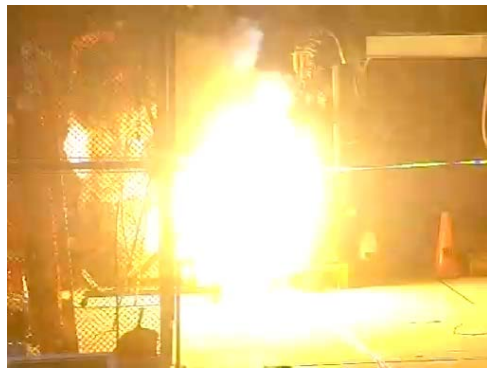
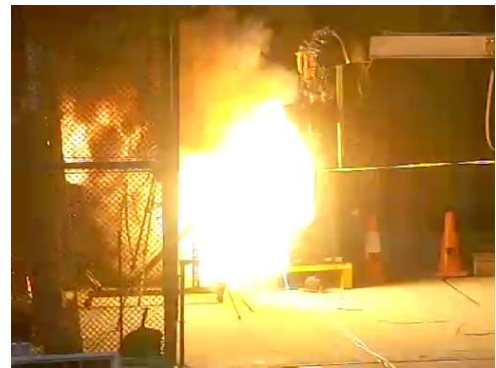
End of 4<sup>th</sup> cycle

End of 5<sup>th</sup> cycle

Start of 6<sup>th</sup> cycle

Middle of 7<sup>th</sup> cycle

Middle of 8<sup>th</sup> cycle

Middle of 12<sup>th</sup> cycle

Arcing shifts to the bottom part of the protector.

If the transformer behind the network protector is not de-energized, more exposed bus work is available for arc initiations. Figure 2-8 shows a fault initiated with a copper bar running from the upper middle phase to an outer phase of the back bus bar on an outer phase. The bar also makes contact with the back wall of the network protector. The back bus bars were energized because the circuit breaker was closed. (There was no connection to a source from the back.)

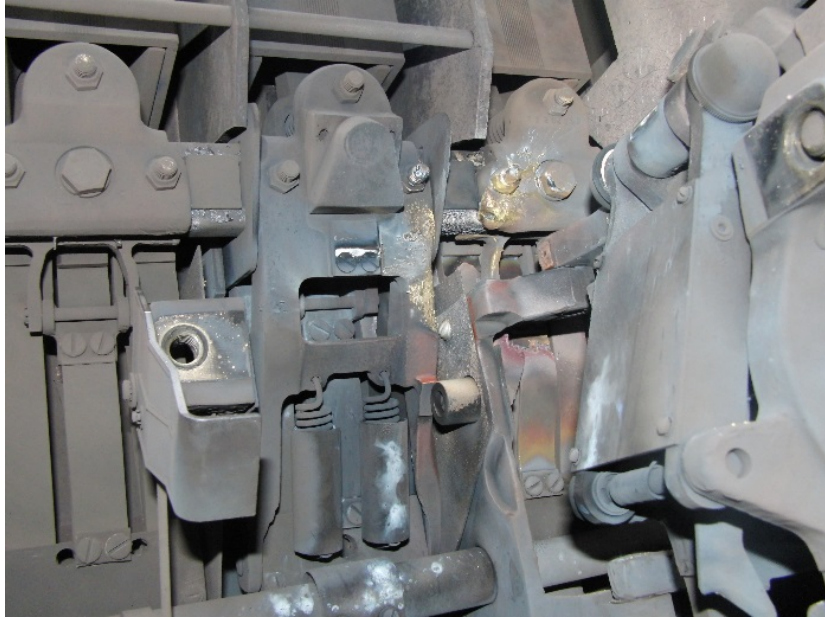
*Figure 2-10*  
*Post Test ID 65: Damage at the circuit breaker*

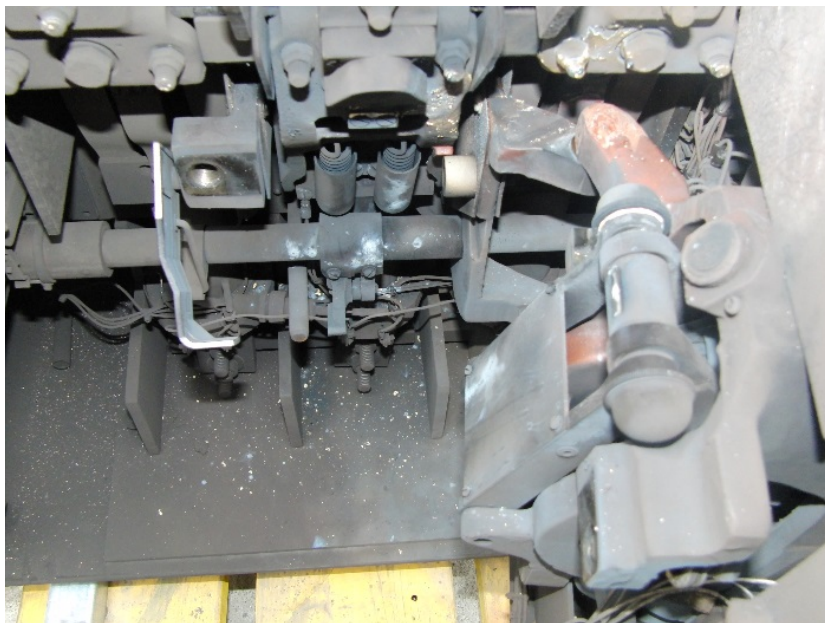
*Figure 2-11*  
*Post Test ID 65: Damage below arc chutes, behind the control module*

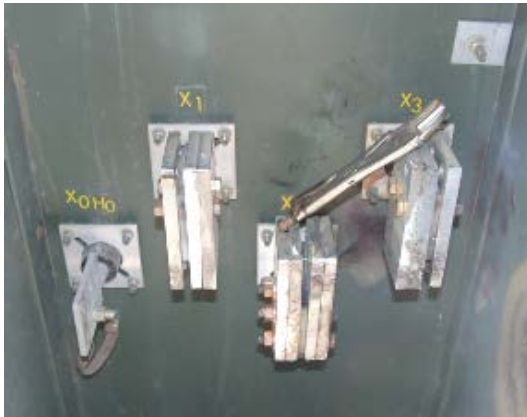
### Padmounted transformers

These electrode spacings are wide enough for arcs to clear in a few cycles, even with a tool bridging the gap.

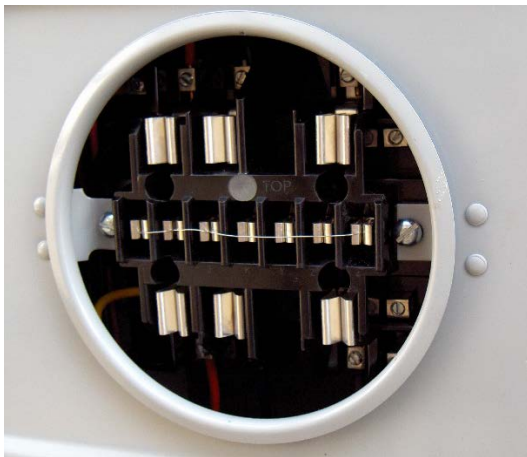
### Transformer-rated meter sockets

Although these have tight spacings and a confined enclosure, arcs extinguish quickly because the small leads (#10 in this case) between the main power panel and the meter panel burn clear, clearing the fault current like a fuse.

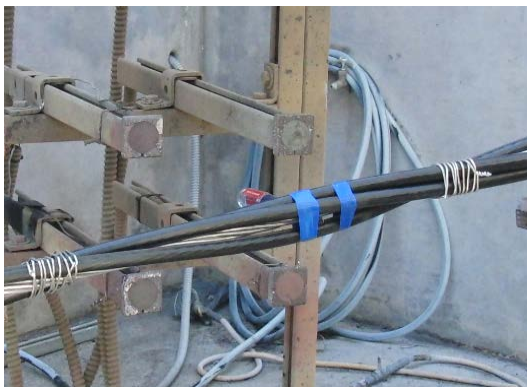
### Overhead quadraplex

Although these have tight spacings, there is no arc confinement. In addition, faults were started either as phase to neutral or phase to phase. In both cases, there is just a single arc.

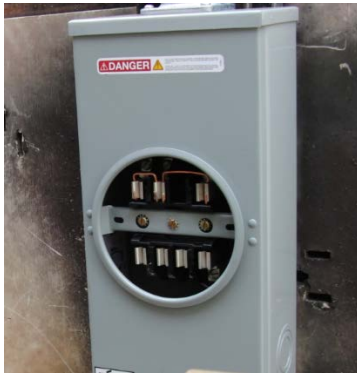
### Ringed self-contained meter sockets

These meter sockets meet many of the criteria for sustained arcing: tight confinement, close electrodes, and three-phase arcing. The main factor that limits duration is the amount of metal in the enclosure—arcing sustains until metal burns back enough for arcs to self clear. Faults clear faster at higher fault currents.

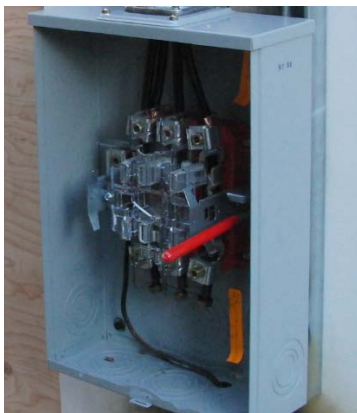
### Ringless meter sockets

The ringless design has less confinement but more metal than the ringed design. In tests, peak incident energies were lower in the ringed design because the fireball out the front was less focused. Electrode size again limited arcing.

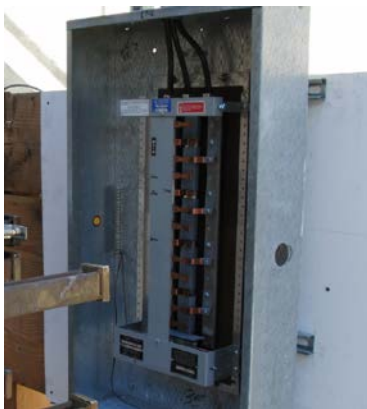
### Small panelboards

For the panelboards with 50- and 100-A ratings, faults normally self-cleared because of mechanical damage to the bus bars. On these, the bracing is not sufficient to hold together the bus bars for longer-duration faults. These bus bars were not facing, another factor reducing the likelihood of sustained arcing. As with the meter sockets, faults cleared faster at higher currents.

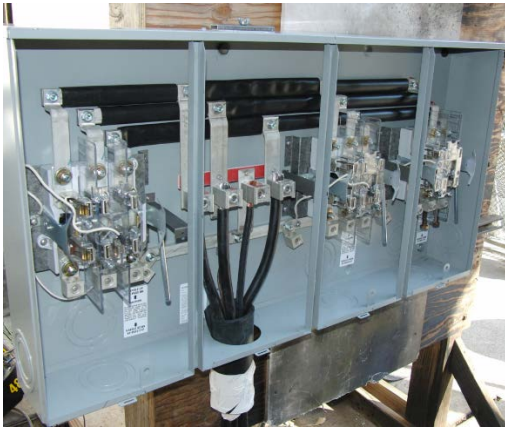
### Multi-bank meter sockets

These meter sockets have much more robust electrodes than the single-meter sockets above. With the robust electrodes, tight spacings, and enclosure confinement, faults can arc for long durations.

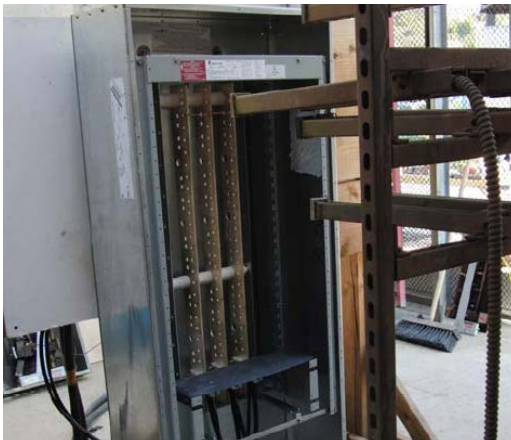
### Large panelboards with facing electrodes

Panelboards like this have prime conditions for sustained arcing: large electrodes with robust supports, tight electrode spacings, facing electrodes, and a conducting barrier at the top that confines the fireball and provides a conducting path for current.

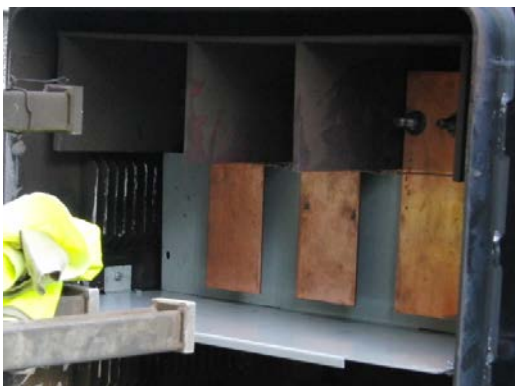
### 2009 network protector tests

In these tests, gutted protectors were fitted with a conducting back plane and bottom plane. Because the bus bars are flat rather than facing, arcs tend to separate. Arcing sustains because the back and front planes provide confinement and conductive arc paths.

The 2009 tests were done in a stripped network protector housing. These conditions more closely match the situation with a fault on the back bus bars. The back bus bars (Figure 2-18) have tight spacings to the back wall and arc confinement provided by the bottom of the enclosure (the arcs will motor to the bottom of the enclosure).

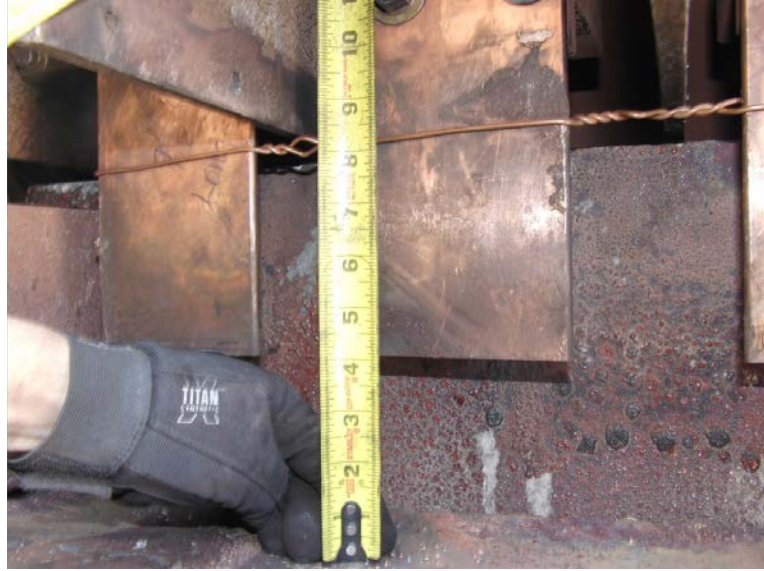
Result of tests on network protectors published in EPRI 1020210 [2009] provided the basis for the network requirements in the 2012 NESC. These tests found sustained arcing with incident energy rates comparable to those predicted by IEEE 1584-2002. The main difference between the 2009 tests and the tests in this report is arc confinement. A conductive bottom barrier was included in the 2009 tests (see Figure 2-16). This barrier was normally one to two inches from the bus bars, but distances of four, six, and ten inches were also tested. At ten inches, arcs did not sustain, but at six inches and below, arcs sustained.

*Figure 2-15  
Distance to the bottom barrier in the 2009 tests*

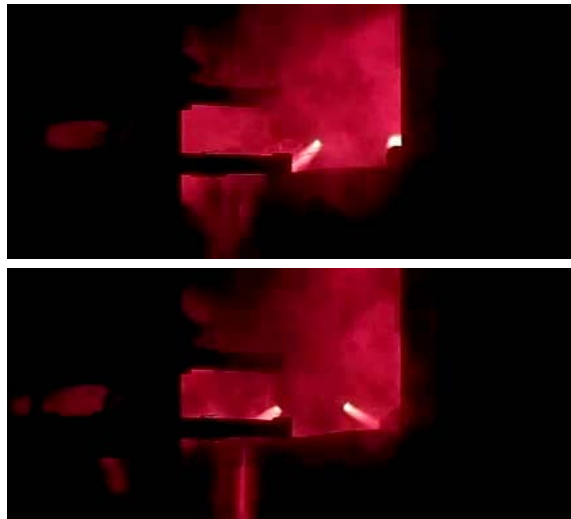
Figure 2-17 shows an example of the end-barrier effect. With the wide bus bars in the network protector, the arcs tend to push away to the edges of the bus bars and flair away from each other. The conducting barrier at the bottom provides a path for current flow.

*Figure 2-16  
Examples of arc paths with the end barrier in the 2009 tests in a network protector*

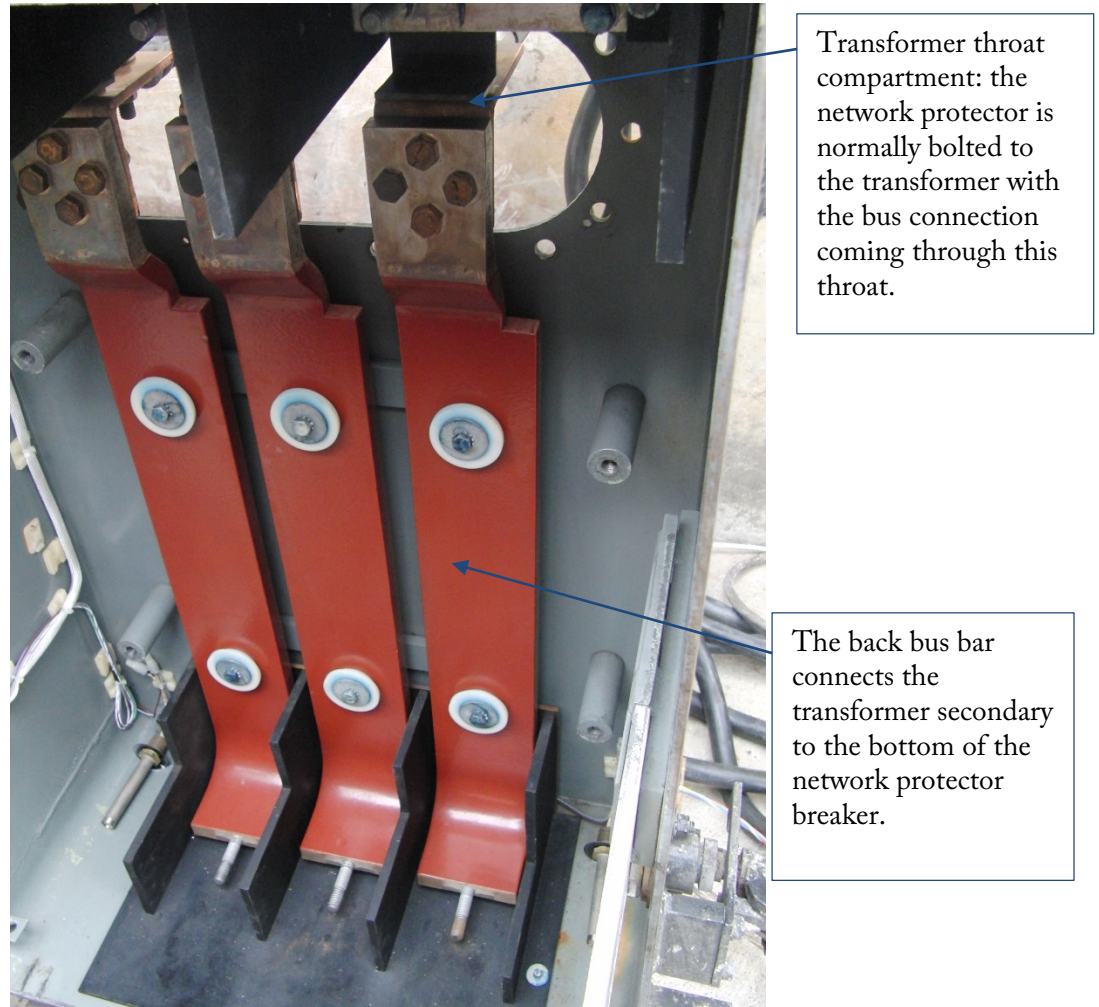
*Figure 2-17*  
*Interior of a CM-22 480-V network protector with the circuit breaker removed*

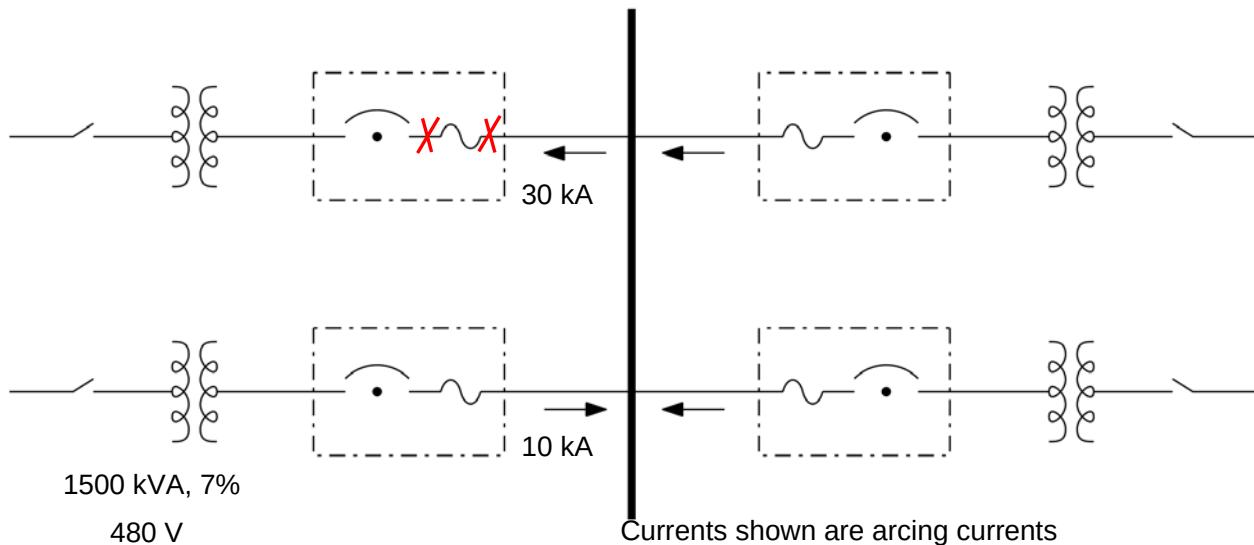
Figure 2-18

Spot network example showing infeeds to the network protector in the top left

For analysis purposes, consider using a duration of three or four cycles. As an example, for a four-transformer spot network with infeeds from three 1500-kVA transformers (Figure 2-19), the bolted fault current is 77 kA, and IEEE 1584-2002 predicts the arcing current to be 30 kA. For a four-cycle duration at a working distance of 18 in, IEEE 1584-2002 predicts an incident energy of 4.8 cal/cm<sup>2</sup>. With the transformer sizes increased to 2000 kVA, the predicted incident energy increases to 6.2 cal/cm<sup>2</sup>. For most 480-V applications, workers can wear single-layer clothing. An alternative to calculations is to assume that this work has 8 cal/cm<sup>2</sup> exposure.

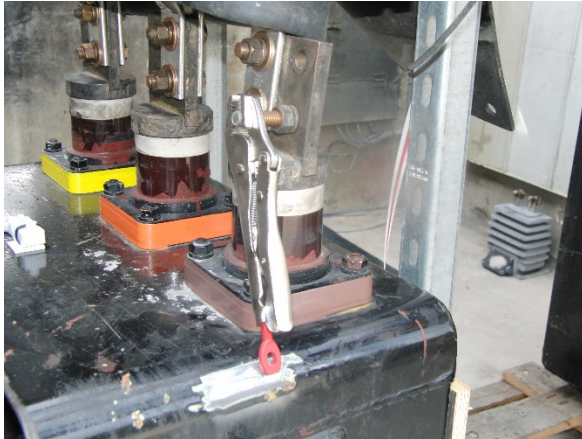
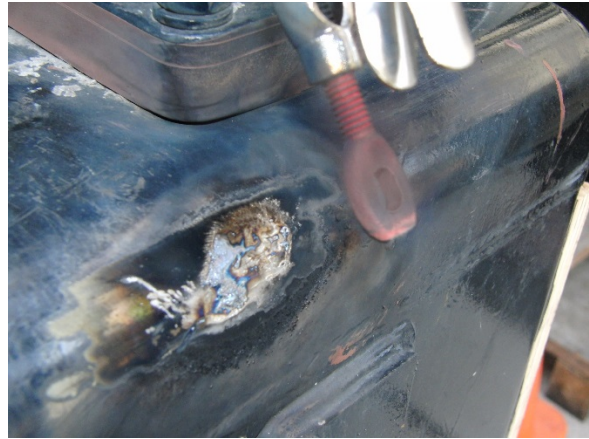
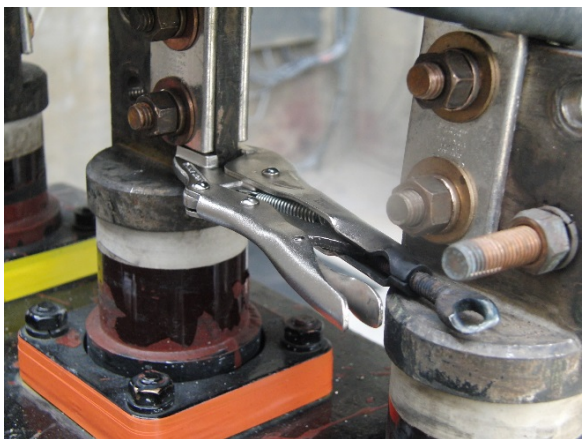
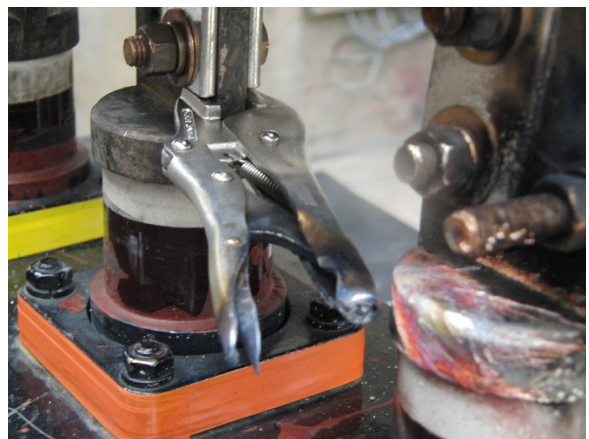
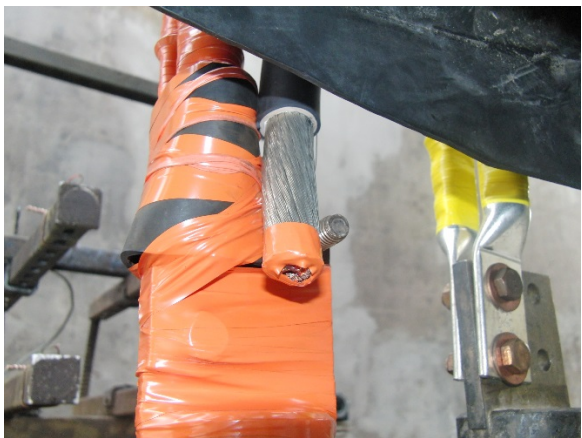
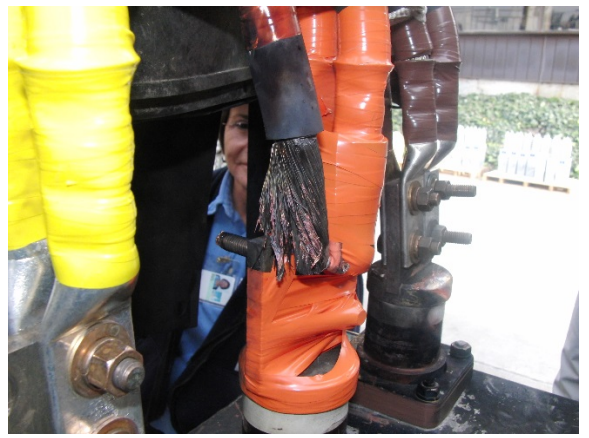
*Figure 3-1  
Exterior arc initiation points, arc durations, and post-test damage*

The construction of older network protectors typically has multiple large insulated cables terminated on the NEMA pad that sticks out of the top of the network protector going to the 480-V common bus. These are often taped after installation but can be left un-taped. In any event, if the network protector is being replaced, these bolted terminations must be exposed to allow removal of the bolts. The most likely scenarios for faults to occur is wrench contact with the case or an adjacent phase during bolt removal or a loose cable coming into contact with an adjacent phase during cable removal. The EPRI team varied fault initiation to come as close as possible to these field conditions. Figure 3-1 and Figure 3-2 show the arc initiation points and arc durations for various conditions and the post-test damage. Complete results are shown in Appendix A.

Test ID 46: AΦ to case, vise grip; 0.14 cycles

Post Test ID 46

Test ID 48: AΦ-BΦ vise grip; 2.65 cycles

Post Test ID 48

Test ID 55: CΦ-BΦ cable; 1.57 cycles

Post Test ID 55

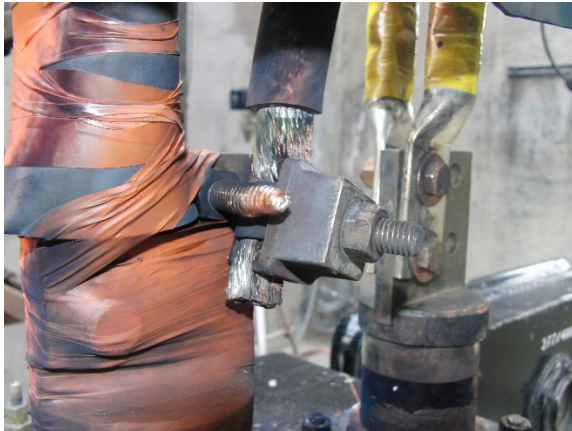
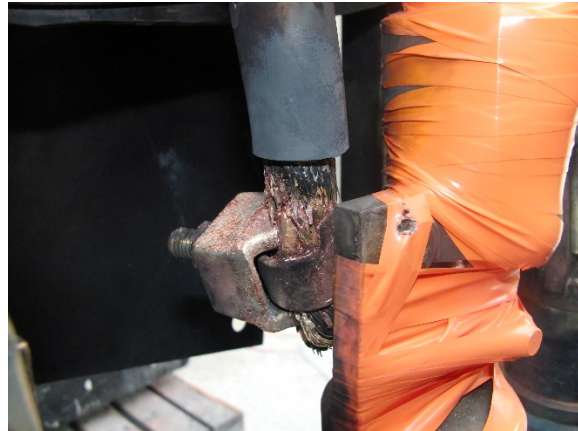
*Figure 3-1 (continued)*

Test ID 56: CΦ-BΦ cable; 1.09 cycles

Post Test ID 56

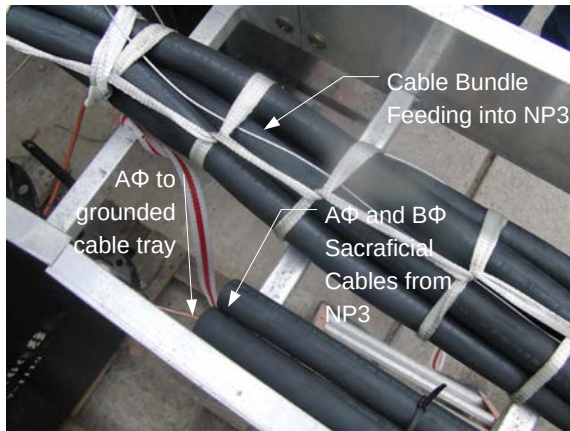
Test ID 50: A  $\Phi$  Ground end; 0.56 cycles
