# Arc Flash Update for 480-V Network Protectors

2015 TECHNICAL REPORT

**3002006373**

Final Report, June 2015

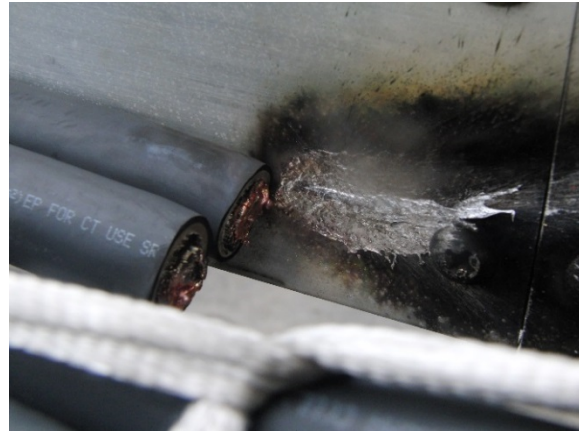
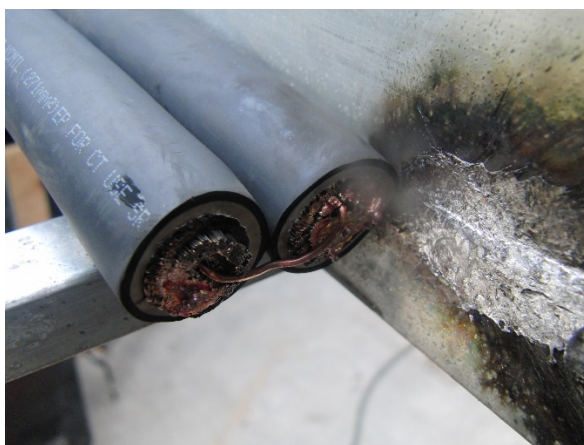
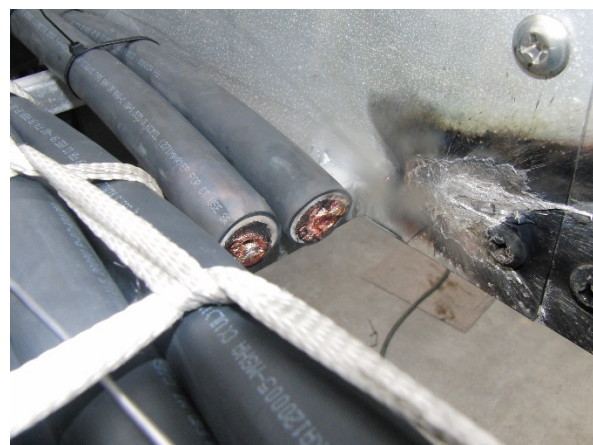
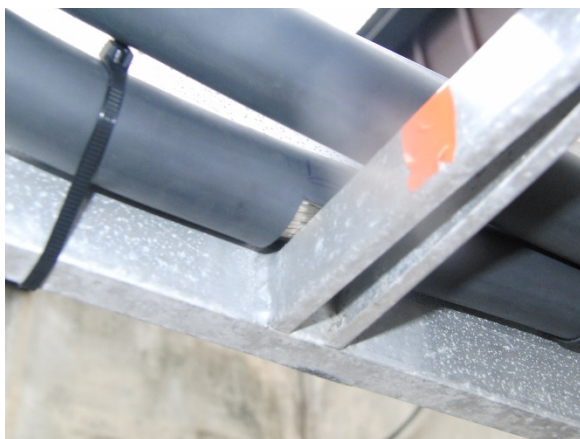
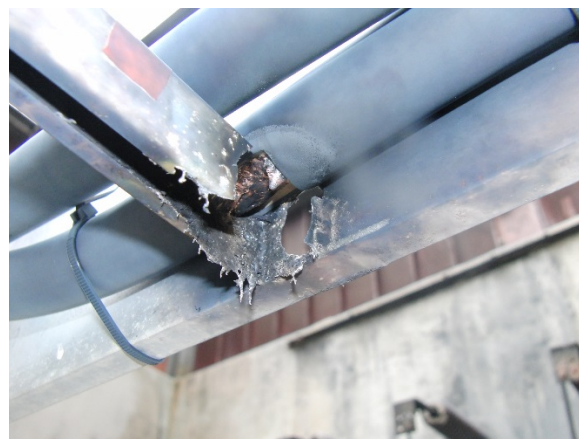
Figure 3-2  
Cable tray arc initiation points, arc durations, and post-test damage

Post Test ID 50

Test ID 51: A  $\Phi$  0.09 cycles

Post Test ID 51

Test ID 52: A  $\Phi$  Ground middle; 3.52 cycles

Post Test ID 52

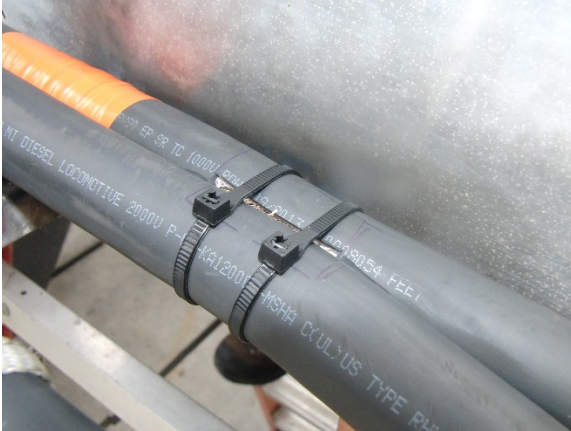
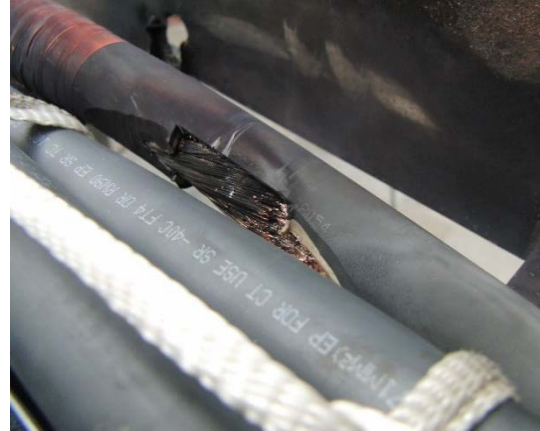
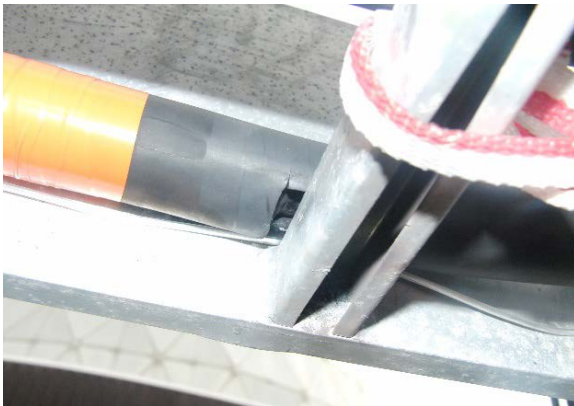
Figure 3-2 (continued)  
Cable tray arc initiation points, arc durations, and post-test damage

Test ID 53: AΦ-BΦ Middle; 1.54 cycles

Post Test ID 53-Note: Only AΦ cable remained in the tray; BΦ flew out of tray

Test ID 54: AΦ-Ground middle; 2.59 cycles

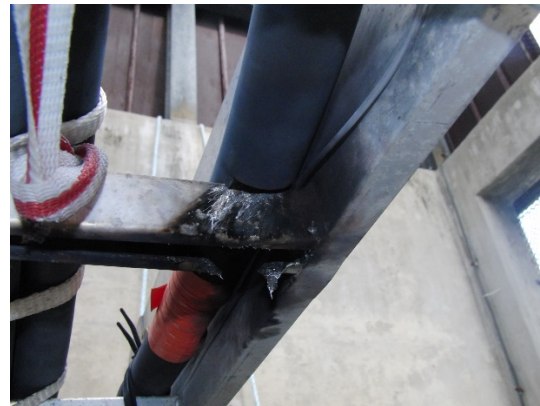
Post Test ID 54

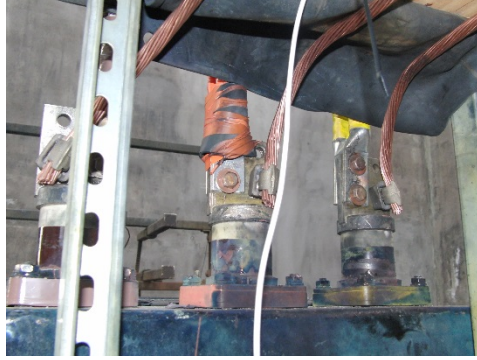
Faults on the bus bar would travel to the end points away from the sources due to magnetic forces. In field conditions, it is conceivable that the bus bar could extend completely to a wall or a piece of equipment. To allow simulation of this condition, one end of the bare wires were attached to the NP3 termination, and the other ends of the bare wires were continued to a solid surface that was either covered with a rubber blanket or left as exposed metal. See Figure 3-5.

Cables attached to NP3

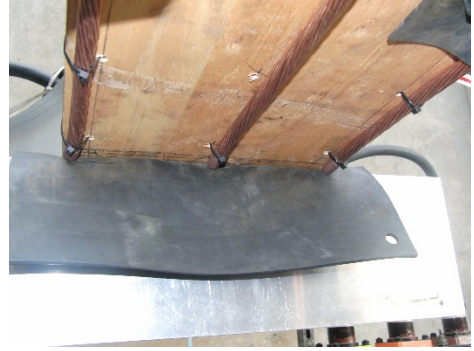
*Figure 3-3*  
*Bus bar test setup*

Cables end at a solid surface

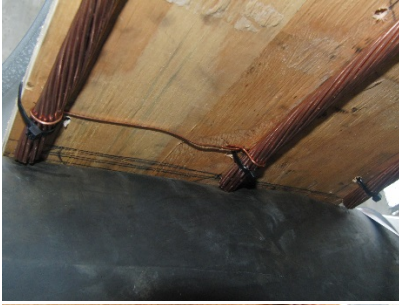
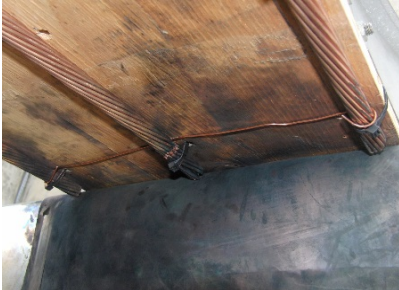
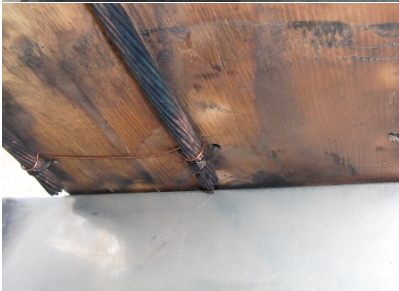
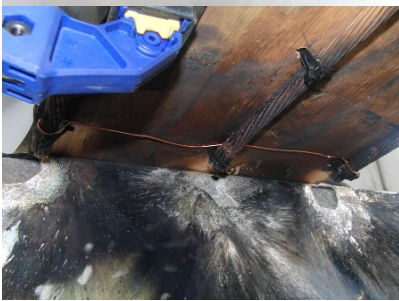
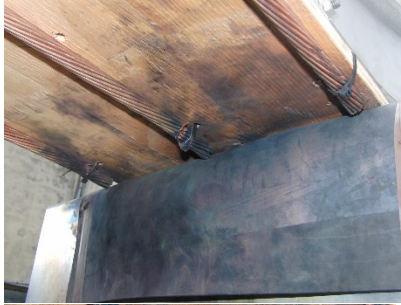
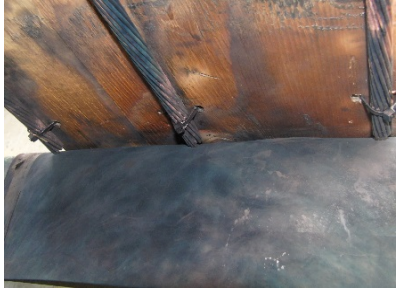
Figure 3-6 shows the arc initiation points, arc durations, and the post-test damage for the bus bar simulations. Complete results are shown in Appendix A.

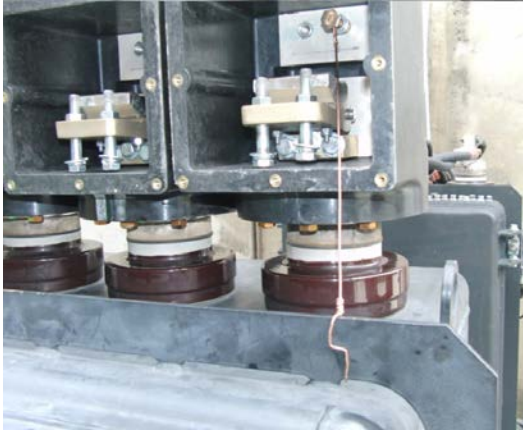
External fuse compartments are another option to improve worker safety by moving the fuses outside of the network protector. Figure 3-7 shows examples of fault initiations from a series of tests done by EPRI at the PG&E San Ramon test laboratory in 2012. These compartments were insulated, making phase contact difficult. With a design like this, workers can open or replace fuses one phase at a time.

In nine tests in this series, faults were initiated at 480 V with #12 conductors with a mix of single-, double-, and three-phase faults. All fault currents self-cleared in less than one cycle. Damage was minimal.

Test 2012-2: A $\Phi$  to case; **0.53 cycles**

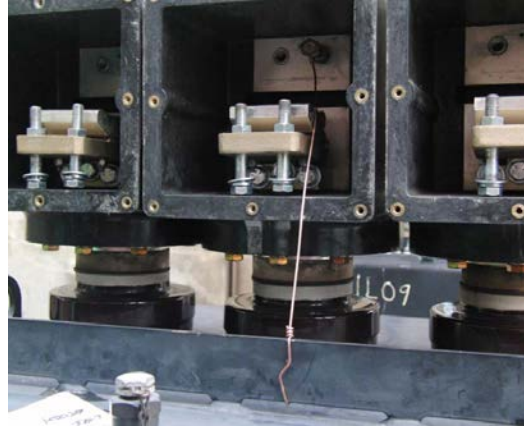
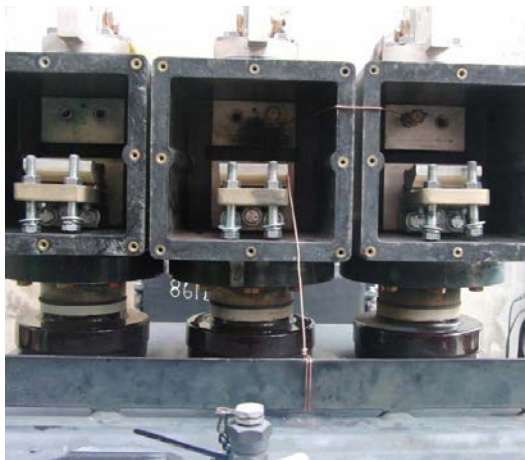
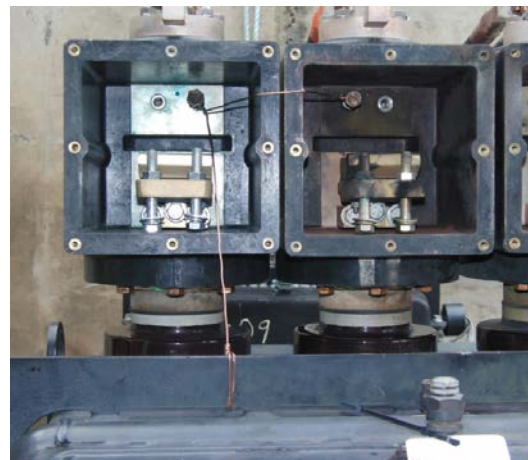
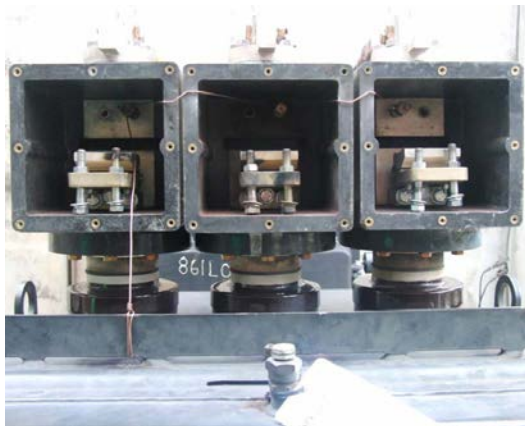
*Figure 3-5*  
*Fault initiations and fault durations in external fuse compartments*

Test 2012-3: B $\Phi$  to case; **0.71 cycles**

Test 2012-5: B $\Phi$  to A $\Phi$  to case; **0.67 cycles**

Test 2012-6: C $\Phi$  to B $\Phi$  to case; **0.35 cycles**

Test 2012-7: Three-phase to case; **0.45 cycles**

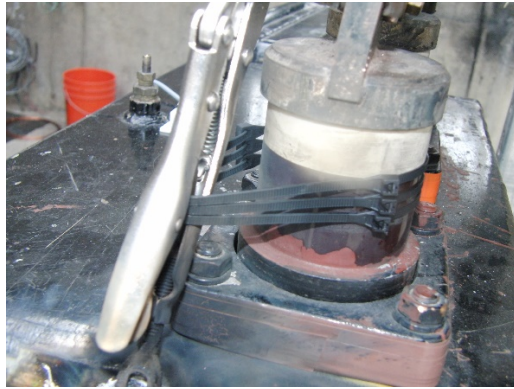
Two extreme faults were initiated above NP3 as shown in Figure 3-8. A pair of vise grips was attached with wire ties to bridge the gap from phase to the case. These arcs did not self-clear. They were cleared by laboratory circuit breakers (test ID 47) or by network protectors (test ID 49). Clearing times were under four cycles. With longer clearing times, the arcs may have burned clear. While these arcs are bolted faults, there are no arcs to generate energy. Because the durations were so short, the incident energies measured were too small to estimate heat rates from. It is likely that the heat rates are low because the faults are nearly bolted. Damage was minimal because the duration of the events were under four cycles. This fault event is not considered realistic.

Test ID 47: Vise grip tie-wrapped

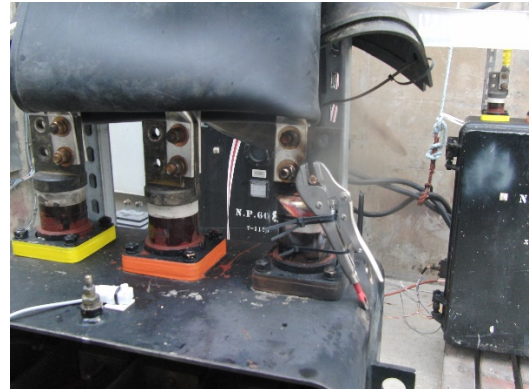
*Figure 3-6*

Test ID 49: Vise grip tie-wrapped

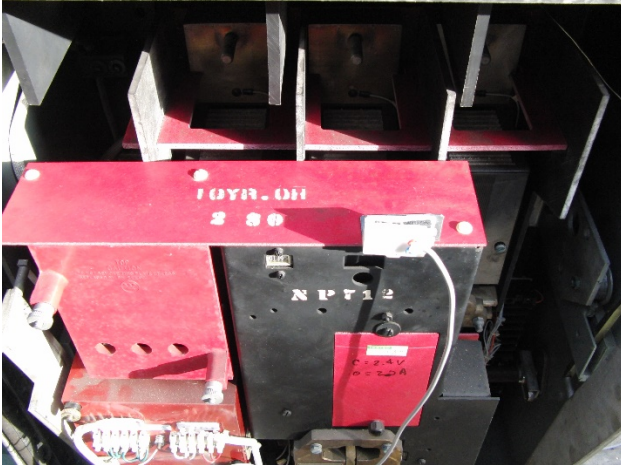
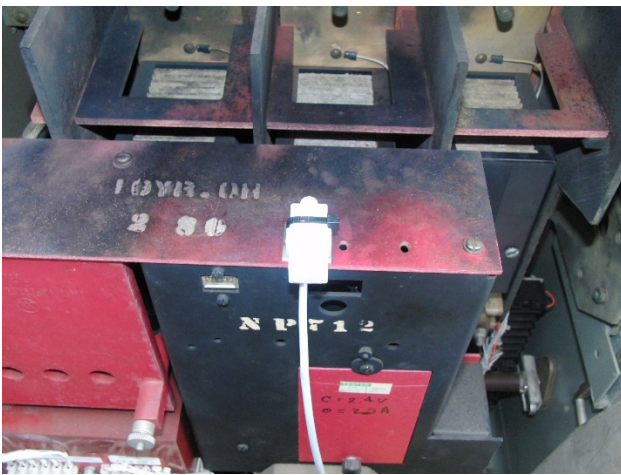
*Figure 4-1  
Omnidirectional sensor at the top of the breaker module*

Both the omnidirectional sensor (180° field of view) and the torpedo sensor (90° field of view) were placed inside NP3 on top of the breaker control module to determine the sensor and relay pickup time during fault initiation. The 20AWG fuse wire generated the least intense arc flash, but the sensors in this position detected the flashes successfully. In order to detect  $A\Phi$  initiation (the most severe position), the torpedo sensor had to be moved as far as possible away from the back of the NP3 network protector. See Figure 4-1 and Figure 4-2.

Omnidirectional sensor pointed in:

- Top front edge of breaker module
- Successfully detected arcs started at any location at the top of NP3 with 20AWG wire

Omnidirectional sensor pointed up:

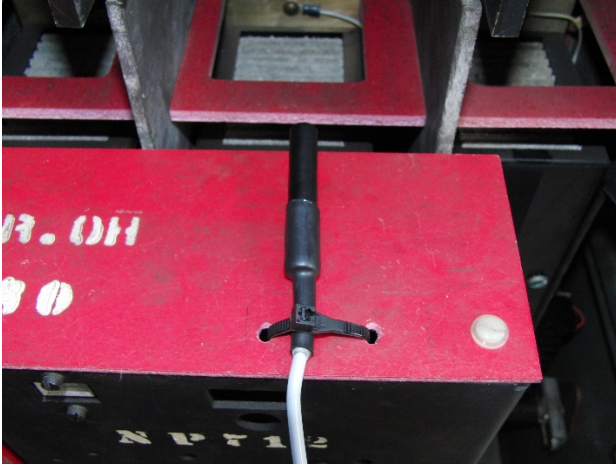
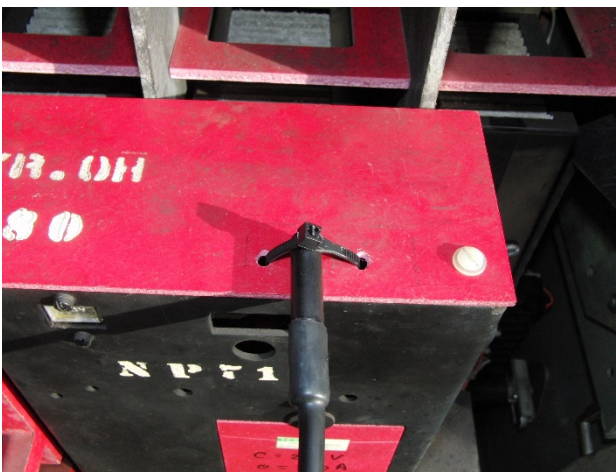
Torpedo sensor pointed in

- Top of breaker module
- Did not detect arc started at AΦ with 20 AWG wire

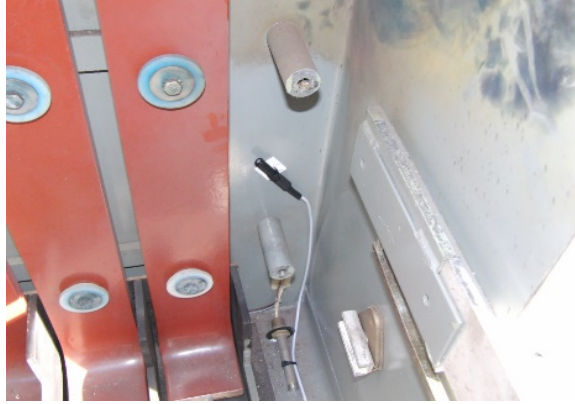
*Figure 4-3*  
*Torpedo sensor on the back wall*

Torpedo sensor on the bottom of the back wall pointing up at a 45° angle

- The sensor did not pick up for AΦ, BΦ, or CΦ to case initiations.
- It did pick up when AΦ was initiated with a wire to the back bolt.

There was some concern that the sensor location at the top of the breaker module would be susceptible to false tripping from external light entering the network protector cabinet through the viewing window on the front door. Therefore, the sensors were moved to the back wall of the network protector to see if a location there would be able to detect arcs. The torpedo sensor was located at the bottom right of the protector, pointing up at a 45° angle. This position points the sensor at faults that might start from the upper fuse link terminals. See Figure 4-3.

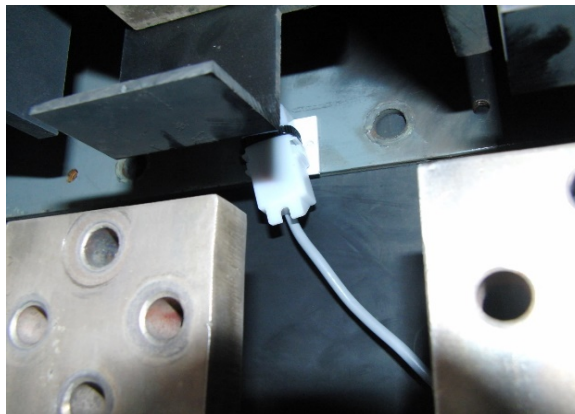
*Figure 4-4*  
*Omnidirectional sensor on the back wall*

Omnidirectional sensor on the back wall behind BΦ pointing forward

- The sensor did not pick up for AΦ case, #20 wire even with door closed.
- The sensor did pick up AΦ was initiated with wire to front bolt with #14 wire.

Figure 4-4 shows placement of and omnidirectional sensor on the back wall behind the middle phase. Arcs were then initiated to determine if the sensor would detect the arcs.

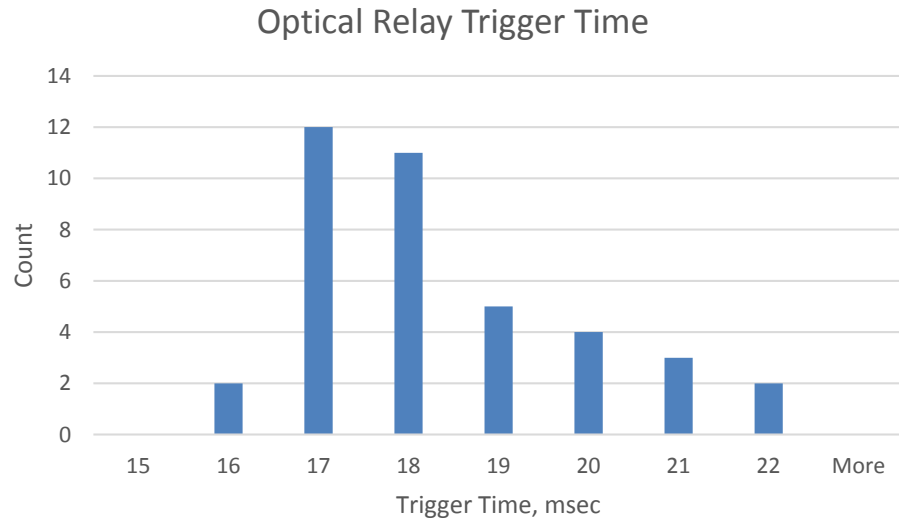
In all cases where the sensor detected the arc, relay pickup times were fairly constant between 15 msec and 22 msec. See Figure 4-5 for a histogram of the relay pickup times. The relay trip signal was then sent directly to either the NP1 and NP2 or the high-side trip device, the laboratory vacuum circuit breaker. The network protectors tripped on average faster than the high-side breaker, the network protector trip times averaged 2.5 cycles versus the laboratory circuit breaker trip times that averaged 3.5 cycles.

*Figure 4-5*  
*Optical relay trigger times*

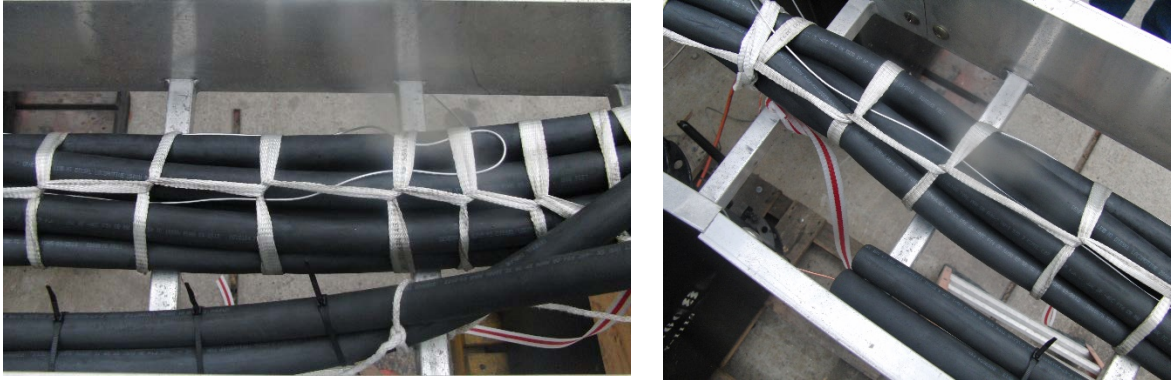
When the fault initiation was made inside the cable tray, the sensor type was changed to a continuous fiber cable. The cable was run inside the power cable bundle and was deliberately located on the side away from the arc initiation points. See Figure 4-6.

*Figure 4-6*  
*Continuous-fiber cable sensor*

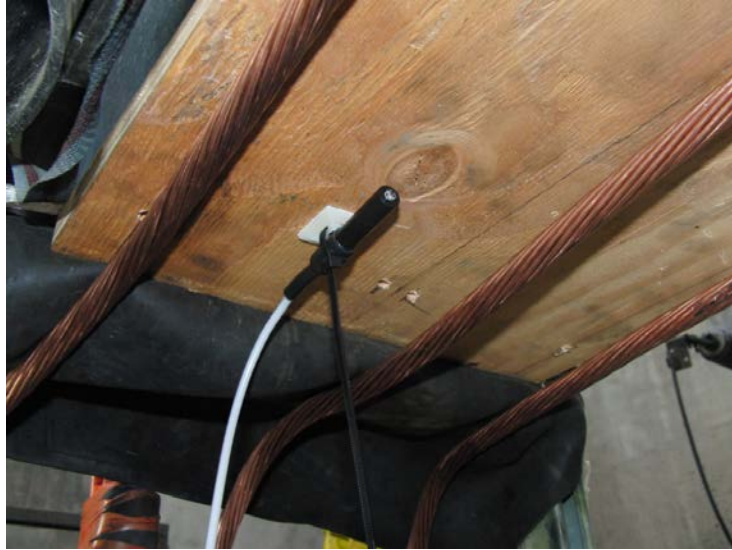
When the fault initiation was made on the simulated bus bar, the sensor type used was the torpedo sensor located at the source end to the 'bus bar' pointed towards the end as shown in Figure 4-7.

*Figure 4-7*  
*Torpedo sensor for the simulated bus bars*

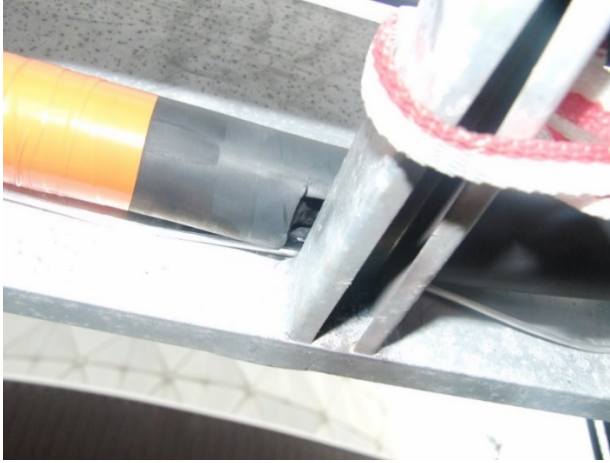
Test ID 54: Continuous Fiber Cable:

- Located in cable tray between phase conductor and the ground plane
- Sensor detected arc
- Relay sent trip signal: 15.2 ms
- Sensor remained functional post test: arc duration 43.7 ms

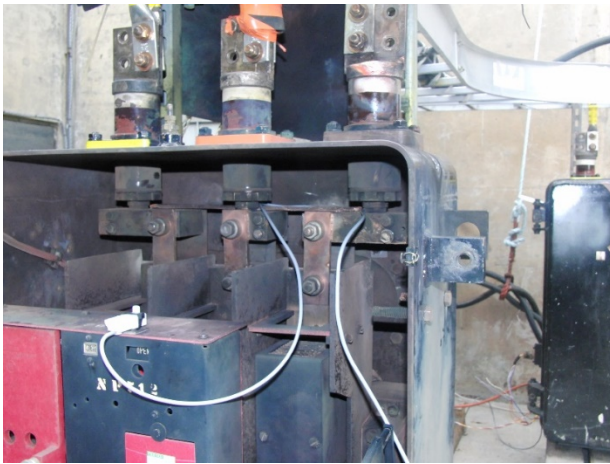
Test ID 64: Omnidirectional Sensor Cable:

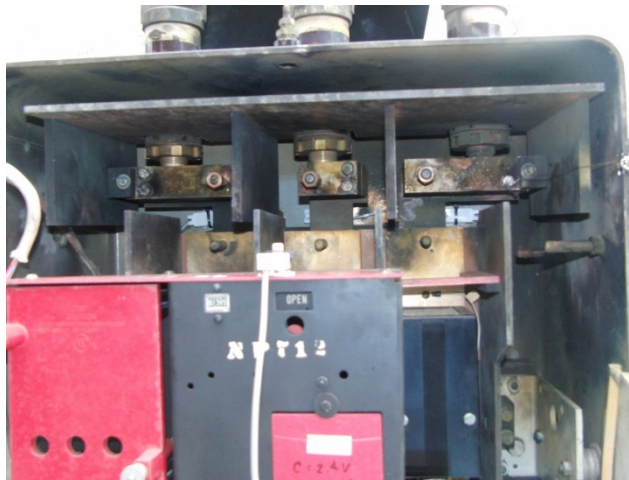
1. Top middle of the breaker module
2. Back wall, behind A $\Phi$  fuse terminal
3. Back wall, behind B $\Phi$  fuse terminal
4. Back wall, behind C $\Phi$  fuse terminal

Figure 4-9  
*Sensor positions inside NP3*

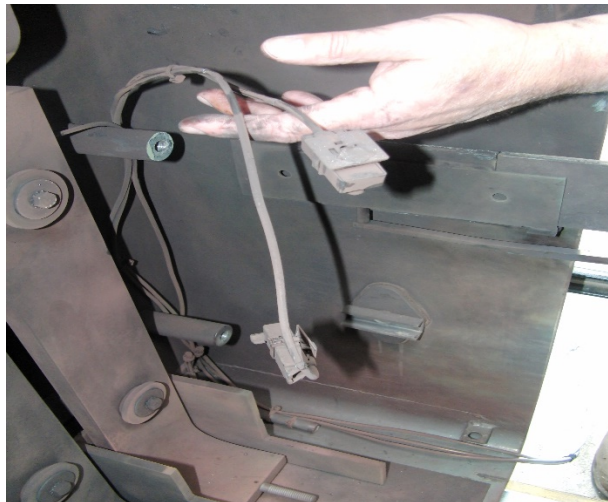
These sensors remained functional through all tests. They successfully detected and sent trip signals for all of the internal extreme initiated arcs, Test ID's 60 through 65. This includes the sustained fault of 12 cycles of 50 kA available fault with over 7 cal/cm<sup>2</sup> of measured heat. They were very dirty but still were able to sense fault current and send the trip signal. See Figure 4-9 for sensor placement and Figure 4-10 for sensor condition after testing.

Figure 4-10  
*Post Test 65: Condition of the omnidirectional sensors on the back wall*

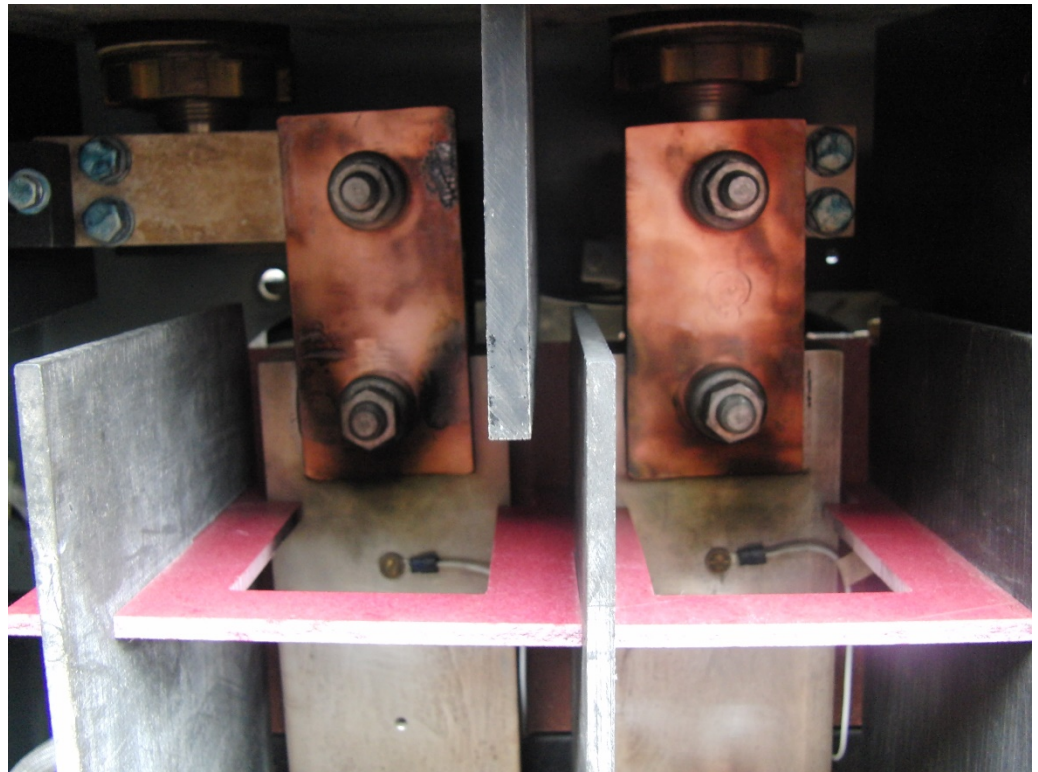
For test ID 62 and 63, the sensors mounted inside NP2 on the top of the breaker module (inputs 5 and 6) picked up from flash through the arc chutes. This would have represented a nuisance trip from sensors in that location. For test ID 68, we believe the flash reflected off the back wall and went into NP2 through the open throat plate on the back (sensor inputs 5 and 8). After this test, the open throat plate was covered with rubber blankets to prevent this reflection. Test ID 74 had sensors 5, 6, 8, and 9 inside NP2 picked up. However, subsequent to this test, NP2 was opened and inspected. Considerable arcing occurred at the fuse clip location in both B $\Phi$  and C $\Phi$ . These sensors would have definitely picked up on that arcing, so it is indeterminate if arcing in the arc chutes would have caused a nuisance trip for sensors in this location. See Figure 4-11.

*Figure 4-11*  
*Arcing inside NP2 at fuse terminal location C  $\Phi$  left-B  $\Phi$  right*

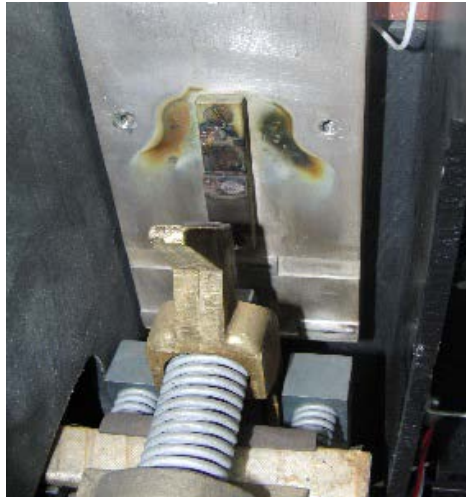
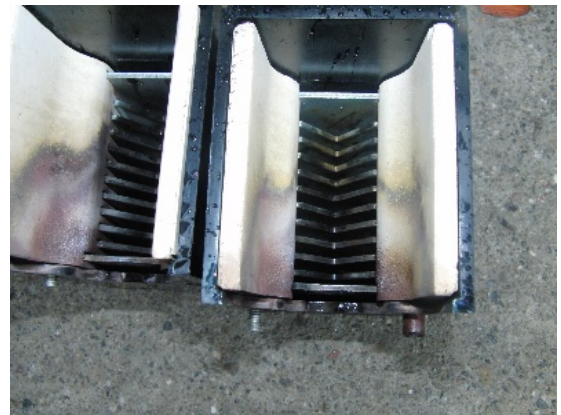
*Figure 5-1  
Conditions of arcing contacts and arc chutes*

Before Test ID 60 and after Test ID 74, the arc chutes of NP2 were removed and examined. Minor arcing damage could be seen after Test ID 74 as shown in Figure 5-1. While the network protector is not likely to survive many arcs of this magnitude, it can clearly survive a few of them

Pre-Test ID 60: Arcing Contact

Post Test ID 74: Arcing Contact

Post Test ID 74: Arcing Chute

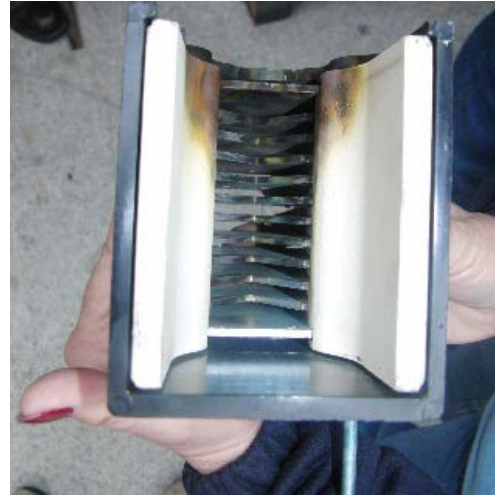
Pre-Test ID 60: Arcing Chute
