# **SOURCEBOOK FOR MICROBIOLOGICALLY INFLUENCED CORROSION IN NUCLEAR POWER PLANTS**

Prepared by  
GEORGE J. LICINA  
Structural Integrity Associates, Inc.  
3150 Almaden Expressway, Suite 226  
San Jose, California 95118

NP-5580

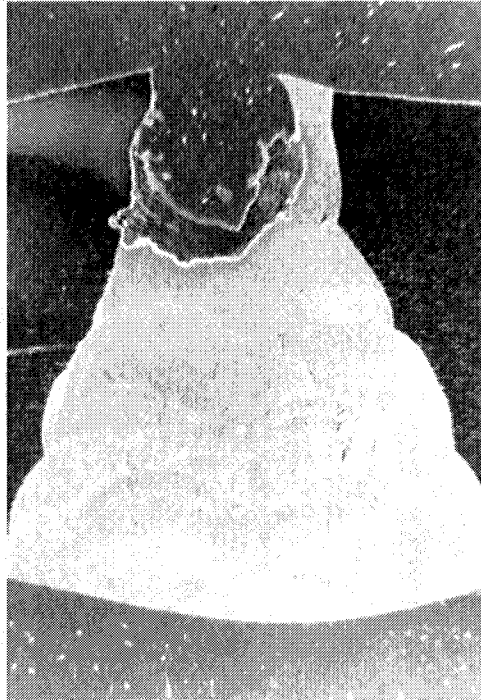
**FIGURE 3-9**  
Preferential Attack of Austenite in Stainless Steel  
Weld Metal (Case History 10)

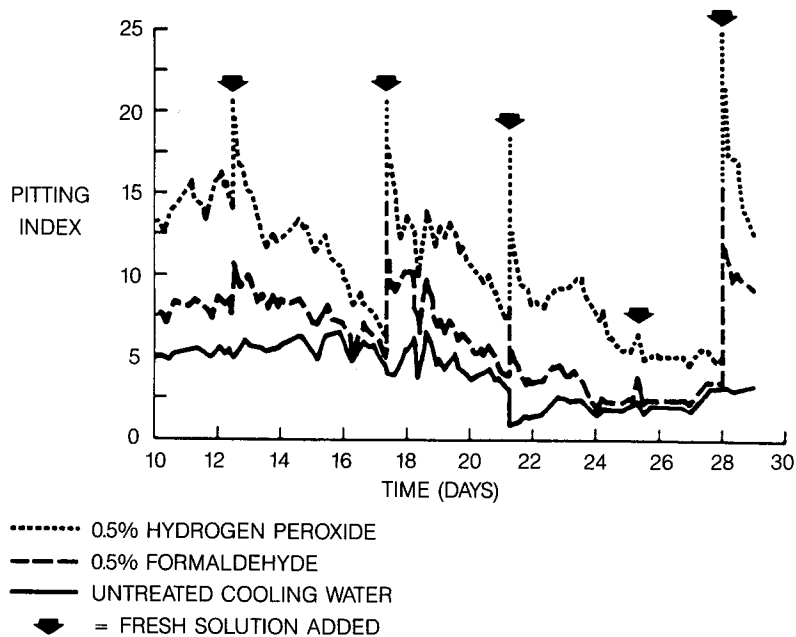
**FIGURE 7-1**  
LPR "Pitting Index" Rates During Portion of First Laboratory Tests
