# **Infrared Thermography for Plant thermal Loss Management**

TE-114093

Technology Review, November 1999

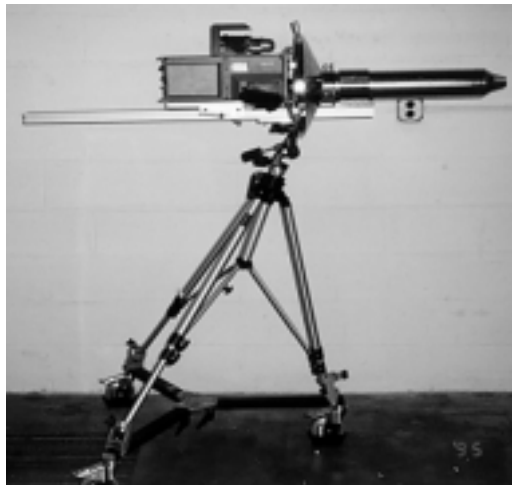
The active cooling HTL is shown in Figure 3. In this design the cooling scheme utilizes vortex tube coolers and the plant air supply to maintain the lens at an acceptable temperature while inside the boiler.

Figure 3: Active System

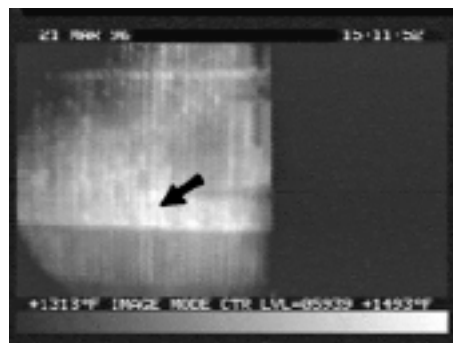
Figure 5: Thermal Image

Another example of boiler wall flame impingement is shown in Figure 5. The High Temperature Lens looks through an observation port in a side wall across the boiler to the opposite wall. The thermal image serves as a good visual representation of the section of waterwall and it highlights the affected area.

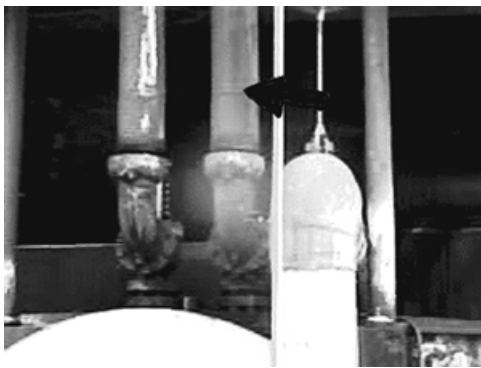
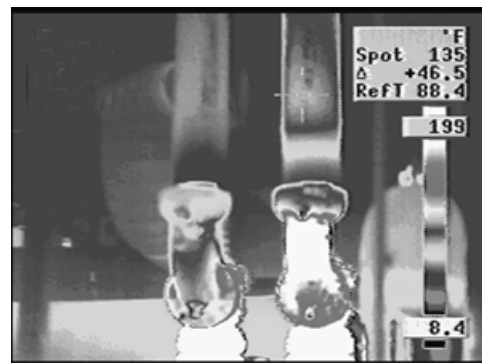
The Boiler Drum Safety Relief Valve (SRV) of Figure 8 indicates higher temperatures on the downstream exhaust piping as compared to the SRV in Figure 9. This measurement of higher temperature on the downstream exhaust piping is an indication of steam passage through the right SRV, probably due to a deteriorated valve seat. The valve should be inspected at the next opportunity and repaired as necessary. All applicable boiler SRVs should be surveyed using IRT.

Figure 8: Visual of SRV

Figure 9: Thermal Image of SRV

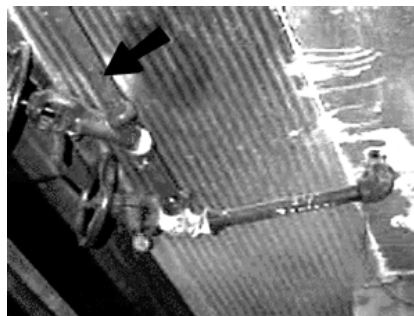
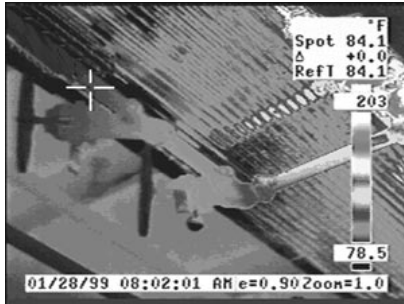
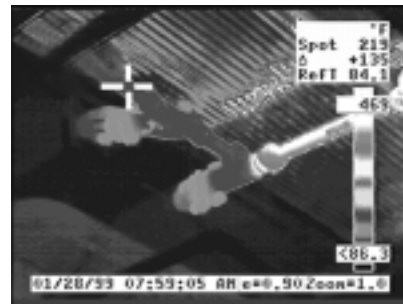
A visual image of a belly drain line and valve is shown in Figure 12. When viewing the thermal images, Figure 13 is a boiler mud drum (a.k.a. belly) drain line and valve that is indicating a normal thermal pattern, i.e. downstream piping from the double isolation valves is measuring ambient temperature. Figure 14 is a boiler mud drum drain line and valve that is indicating an abnormal thermal pattern, i.e. downstream piping measuring temperatures significantly higher than ambient. (NOTE: Caution must be taken to make sure that downstream piping is not indicating elevated temperatures due to possible back flow from another leak throughout the boiler drain system piping.)

Figure 12: Visual Belly Drain Line and Valve

Figure 13: Thermal Normal Pattern

Figure 14: Thermal Abnormal Pattern

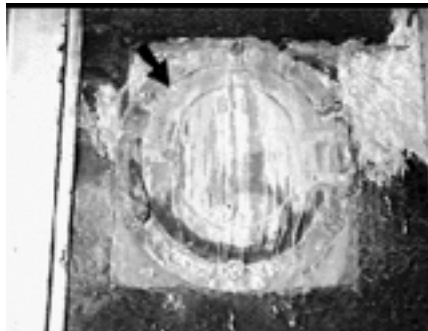
IRT can detect air-in-leakage through voids into a balanced draft (negative pressure) boiler. The visual image of Figure 15 shows a boiler manway cover. The thermal image (Figure 16) displays a pattern that would indicate air infiltration through the upper left-hand side of the manway. The manway cools toward the upper left indicating a draft of air across the cover. If there were no air infiltration, the entire manway cover would be uniform in temperature. Undesired infiltration of air into a boiler will impact the thermal efficiency of the unit, and impact its ability to maintain vacuum.

Figure 15: Visual Boiler Manway Cover

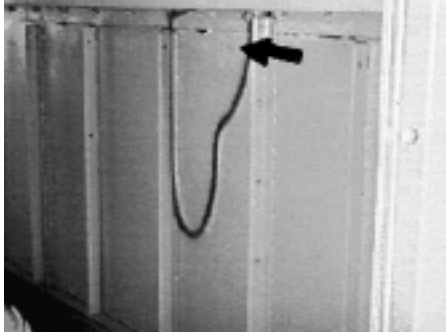
The thermal profile of this section of the boiler casing/lagging shown in Figure 17 indicates that there is missing or deteriorated insulation behind the lagging at the spots where the temperatures are the highest. If insulation problems are suspected on a particular unit, IRT can be used in the manner shown in Figure 18 to inspect entire sections of wall, literally in seconds. Deteriorated insulation is not one of the more costly effects on performance; however, high ambient temperatures caused by insulation deterioration can cause local instrumentation problems and an unpleasant work environment and safety hazard.

Figure 17: Visual of Boiler Casing

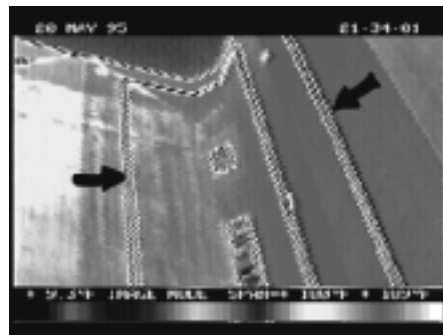
Figure 19: Thermal Image

The thermal image shown in Figure 19 was taken from the inside of a mono-tube boiler during a hydro flush test prior to unit start-up. The picture isolates a section of the water-wall. When the boiler is filled with 200°F (93°C) water during the course of this test, all of the tubes should rise in temperature uniformly from ambient to approximately 200°F (93°C). If there is a restriction that prohibits flow in one or more tubes, there will be an effect similar to the one in the thermal image below. The arrows point to a single cold tube that is unable to fill because of a restriction (probably slag from welds made during water-wall replacement or repairs). A restricted tube will not receive the cooling it needs from the flow of water through it. If it goes undetected, it will probably rupture at a point in time after the unit is brought on line. This would cause unscheduled downtime and associated costs. The tube needs to be cleared and re-inspected prior to unit start-up.

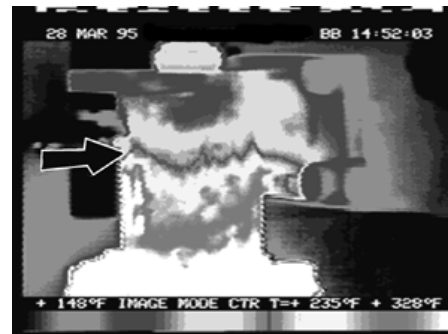
The popit valves on steam-supplied soot blowing systems seal off steam flow to the soot blowers (Figure 22). When soot blowers are not activated, the thermal pattern of a normally operating popit valve will indicate a good steam seal in the form of a uniform line of temperature measurement, as in the thermal image, Figure 23. If the popit valve's thermal pattern appears like the thermal image, Figure 24, it is a good indication of a leaking popit valve.

Figure 22: Visual Popit Valves

Figure 23: Normal Thermal Pattern

Figure 24: Abnormal Thermal Pattern

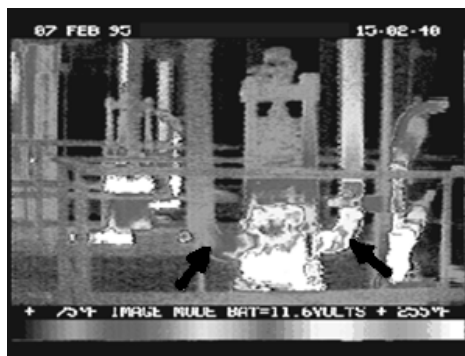
The main steam relief valve shown in Figure 25 is normally closed during plant operation. It has two un-insulated outlet headers (see arrows on visual and thermal images). Referencing the color scale at the bottom of the thermal image (refer to Figure 26), the temperatures measured on the left outlet are approximately equal to the ambient temperature (75°F to 100°F or 23.8°C to 37.8°C). The temperatures measured on the right outlet header are consistently hotter. This is an indication of steam passage through the right side of this valve, probably due to a deteriorated valve seat. The valve should be inspected at the next opportunity and repaired as necessary.

Figure 25: Visual of Main Steam Relief Valve

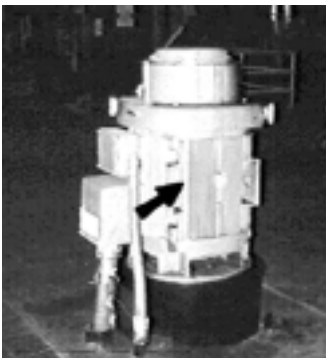
This condensate pump motor, Figure 33, exhibited increased temperatures (173°F or 78.3°C) on the casing (Figure 34) when compared to another motor of the same design and function. An investigation into this anomaly revealed that this motor was being overloaded with respect to its designed amp rating. The motor should either be operated within specification, or replaced with a larger unit designed to handle higher current loads. An internal inspection of the motor should be done in order to assess possible damage sustained by the equipment from being exposed to conditions of excessive heat over extended periods of time.

Figure 33: Visual of Condensate Motor

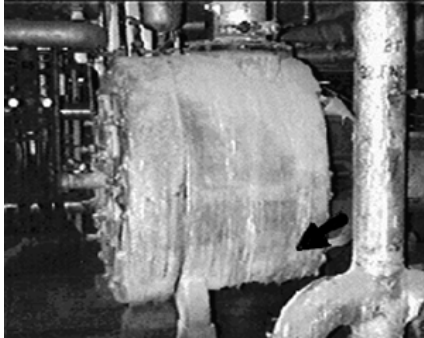
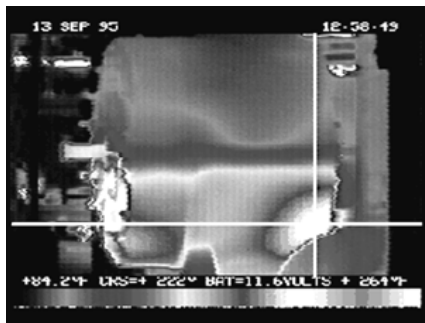
A baseline thermal image of this Dry Vacuum Pump is shown in Figure 35. Five months after this baseline image was taken (Figure 36), a subsequent inspection revealed the results shown in Figure 37. Hot spots were beginning to develop at areas near the bottom of the pump. Operations reported that they were not receiving the expected performance from this piece of equipment. An

investigation into the problem revealed that the pump was becoming clogged with mud and sludge in the cooling water system causing the internal valves to overheat. The system needed to be flushed. After the system was flushed, the hot spots faded and pump performance returned to an acceptable level (Figure 38).

Figure 35: Visual Image Dry Vacuum Pump

Figure 36: Baseline Thermal Image

Figure 37: Thermal Image of Anomaly

Figure 38: Thermal Image of Corrected Pump

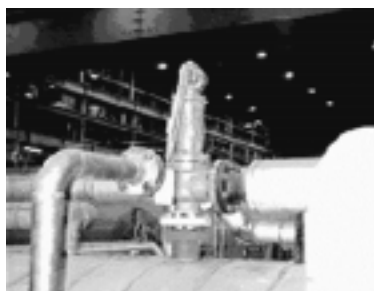
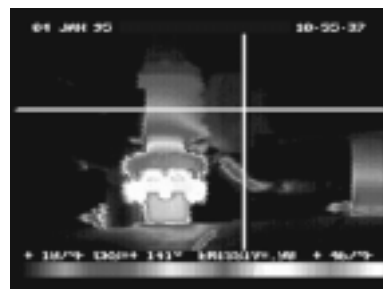
The visual image (Figure 41) shows a feedwater heater relief valve with hot pressurized steam at the bottom, or shell side, and the outlet side on the right. A defect exists which was determined by comparing the temperature of the valve at the shell side (approximately 500°F or 260°C), to the temperature of the valve outlet (394°F or 201°C indicated by the crosshairs). The combination of a 106°F (41.1°C) temperature differential, and an extremely hot outlet temperature (394°F) is an almost certain indication that the valve is passing a considerable amount of steam. In the two thermal pictures, the defective valve is shown in Figure 42. The temperature contrasts between the replacement valve and the defective valve are dramatic. In the thermal image of the replacement valve (Figure 43), the shell side valve temperature is approximately 450°F (232°C). Comparing this with the outlet temperature of 141°F (60.6°C) [refer to crosshairs], the temperature differential is now in excess of 300°F (148.9°C). The temperature differential between the old valve and the replacement valve is over 200°F (93.3°C). This assures that the problem has been corrected. Additionally, the thermal image of the replacement valve provides baseline information for the PDM Group to use to trend this new valve over time.

Figure 41: Visual Feedwater Heater Relief Valve

Figure 42: Thermal Image Showing Defect

Figure 43: Thermal Image After Correction

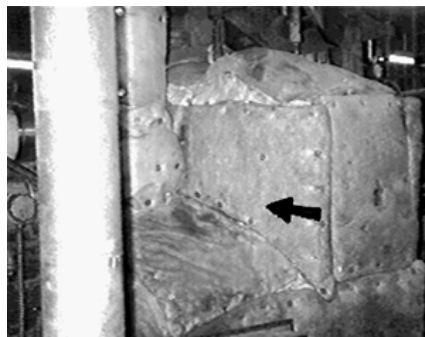
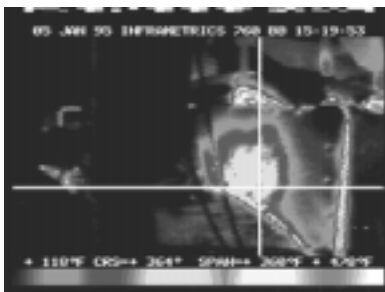
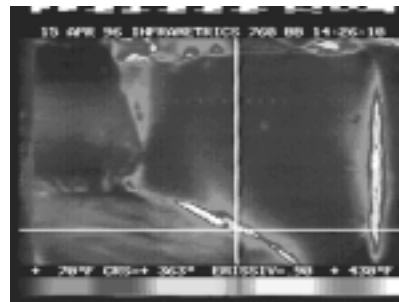
Boiler feed pumps (Figure 44), because of their high pressure operation, are subject to seal leaks and piping attachment leaks. Early detection of these leaks have a tremendous impact on maintenance and maintenance planning. Leaks are generally not self-correcting; therefore, the detection of leaks can be made with IR thermography, and sometimes acoustics, long before they are detected by other means such as audio or visual.

An example of a water/steam leak as detected by IR is shown in the following thermogram. The thermal image, Figure 45, illustrates an extremely high temperature on the surface of insulation on a high pressure boiler feed pump. The high temperatures of the water flashing to steam is able to saturate the insulation through to the surface where it is detectable with IRT. The thermal image, Figure 46, was taken after repairs were completed.

Figure 44: Visual Image of Boiler Feedpump

Figure 45: Thermal Image of Defect

Figure 46: Thermal Image After Corrected
