EPRI TR-100422  
Project 7801-7  
Final Report  
June 1992

# **Waltz Mill Testing of 765-kV Paper-Polypropylene-Paper (PPP) Cable**

Prepared by  
Westinghouse Electric Corporation  
Ruffs Dale, Pennsylvania

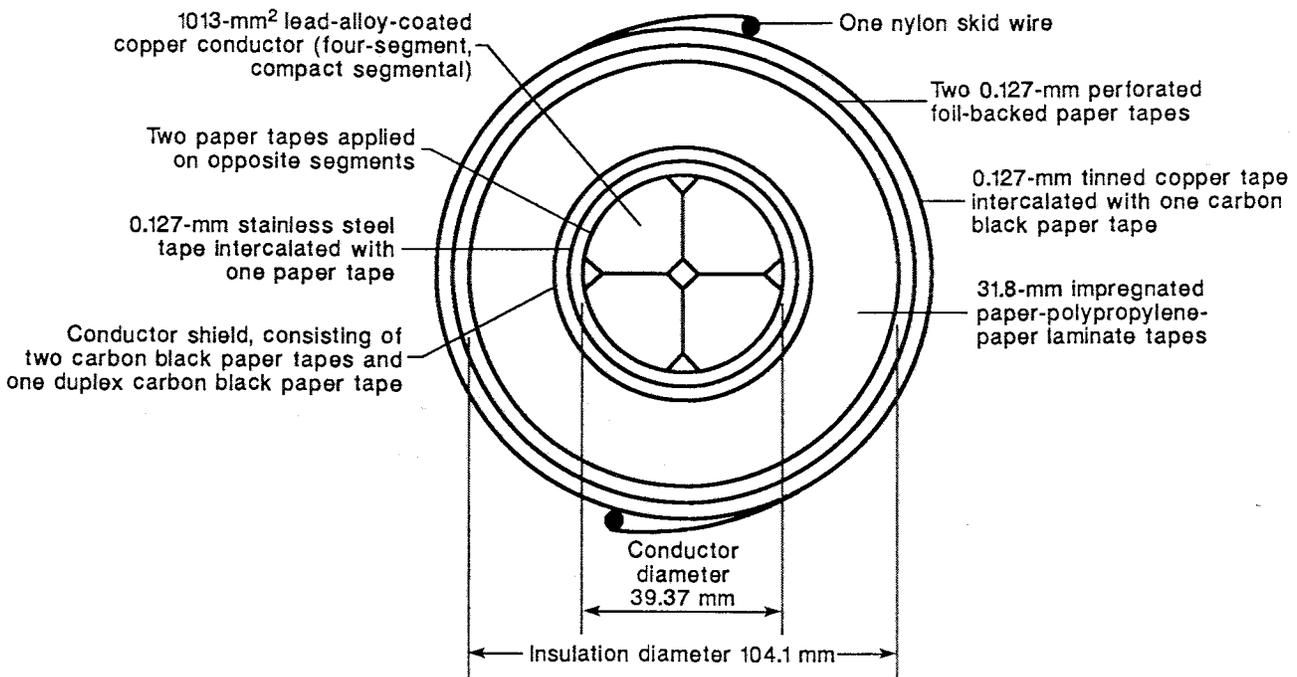
Figure 2-1. Waltz Mill 765-kV PPP Cable

Figure 2-1 shows details of the cable construction. Main features are a 1013-mm<sup>2</sup> (2000-kcmil) compact segmental copper conductor and a 31.8-mm (1.250-in) wall of paper-polypropylene-paper (PPP) insulation impregnated with polybutene. For the Waltz Mill sample, nylon rather than metallic skid wires are used to electrically isolate the cable shield from the grounded pipe. This allowed us to make power factor measurements on the cable as described in section 4.

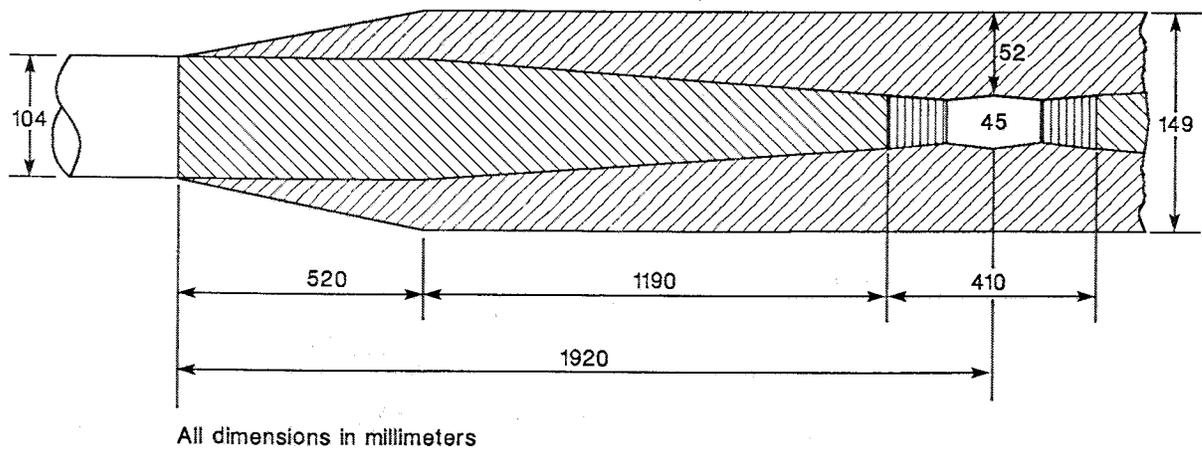
Figure 2-2. Schematic of Waltz Mill 765-kV Splice Design

Each of the two splices as shown in Figure 2-2 has an overall length of 3.84 meters. The insulation thickness of 52 mm over the FM connector is constructed of impregnated PPP tapes.

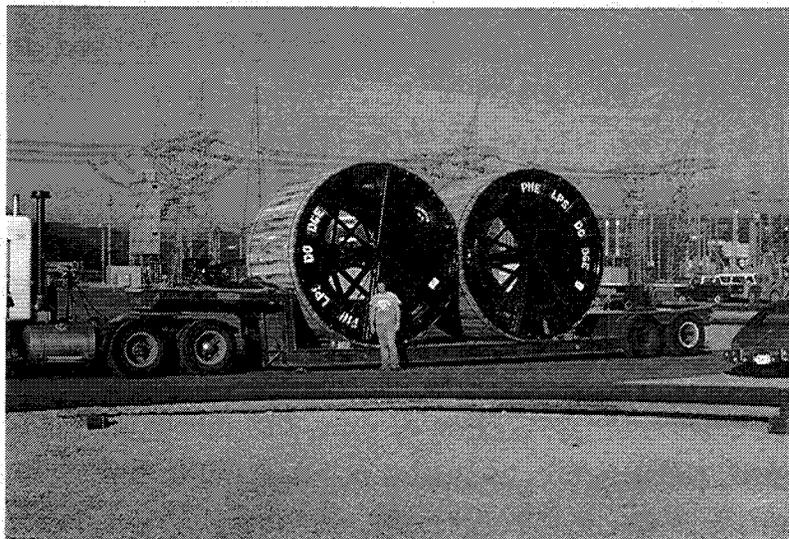
Figure 3-1. PPP Cable Arriving at Waltz Mill

The cable was shipped to Waltz Mill on three reels, two of which are shown in Figure 3-1. Two of the reels were used for the main run and one for the loop segment.

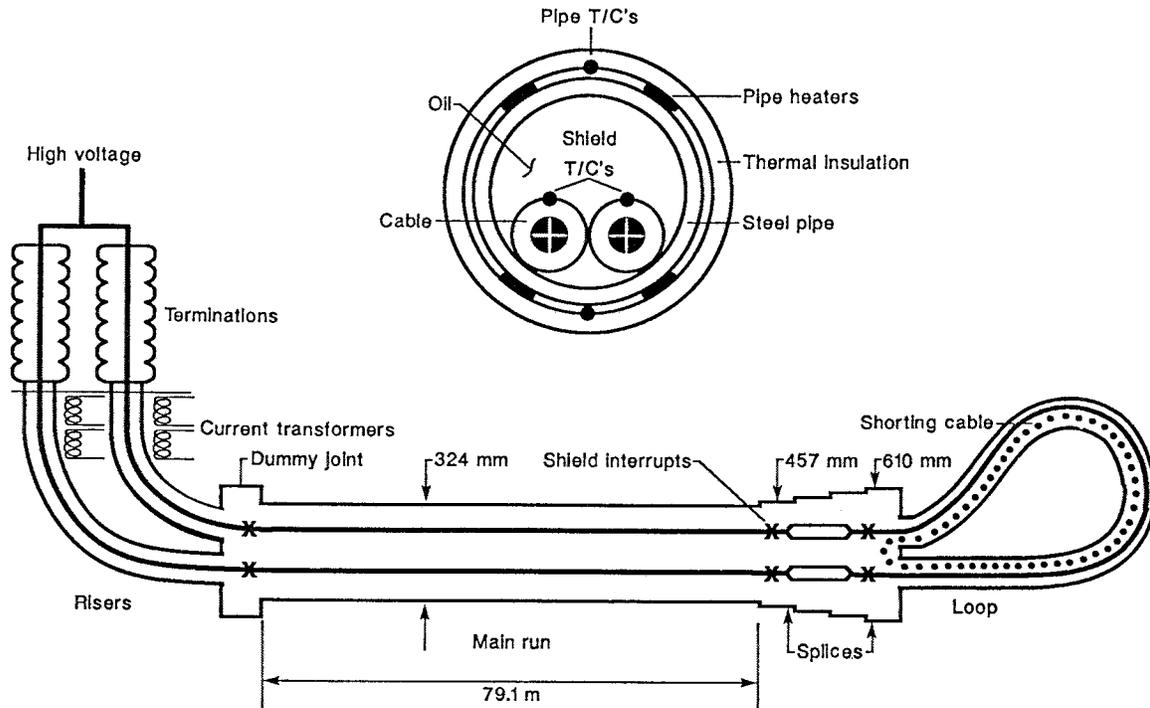
Figure 3-2. Schematic of Waltz Mill Test Bay 34

The installation was carried out under representative field conditions, i.e. using the same procedures and personnel that would be used in a commercial installation for this type of cable. It consisted of pulling the three lengths of cable into the test bay pipes and fabricating the splices and terminations. Shield interrupts were built into the cable, dividing it into seven distinct segments as shown schematically in Figure 3-2 and described below.

There is a shield interrupt on each side of each splice. Their locations are shown in Figure 3-2.

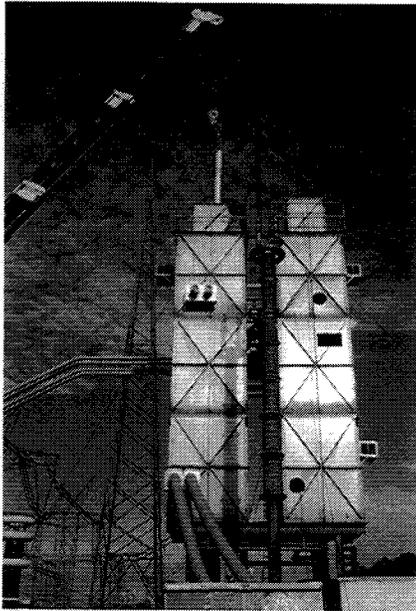
Figure 3-3. Enclosure Arrangement During Cable Termination

Two riser sections provide the transition from the terminations to the main run. The potheads were mounted on a steel structure 4.57 meters high. Figure 3-3 shows this structure with the air-conditioned enclosures that were used during termination of the cable. Two views of the completed potheads, along with the riser pipes, are shown in Figures 3-4 and 3-5. The stainless steel pipes that enclose the riser sections of cable are 219 mm in diameter and have a 3.05-meter radius of curvature. They extend 12.2 and 9.1 meters, respectively, from the base of each pothead to the dummy joint, and are covered with a 25.4-mm thickness of rigid urethane insulation.

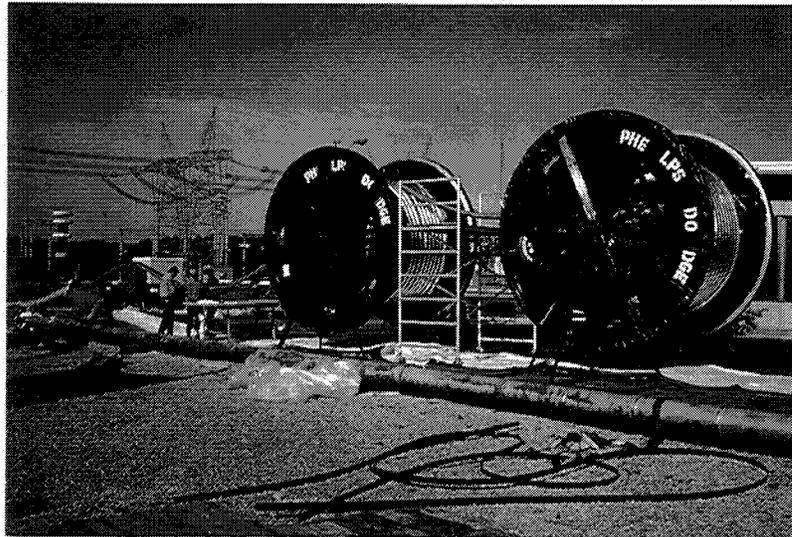
Figure 3-6. Installation of 765-kV PPP Cables in Main Run

Figure 3-6 is a view of the two cable reels set up near the splice end, with the cables being pulled into the main run pipe. The completed installation of the main run piping is shown in Figure 3-7, with the splice enclosure in the foreground and the EHV substation in the background.

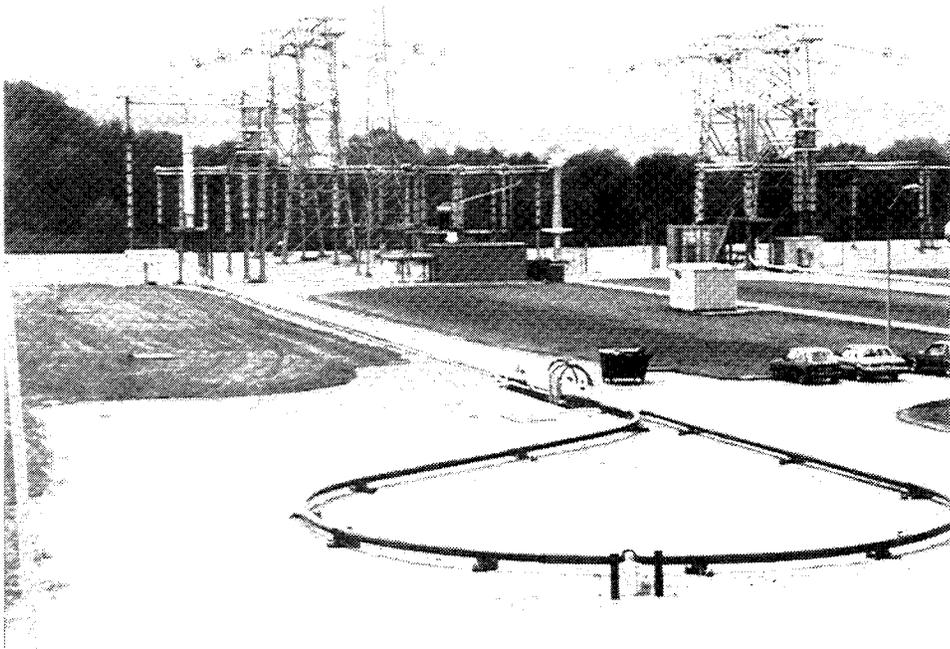
Figure 3-8. Aerial View of Test Bay

The loop can be seen in the aerial view of the test bay in Figure 3-8.

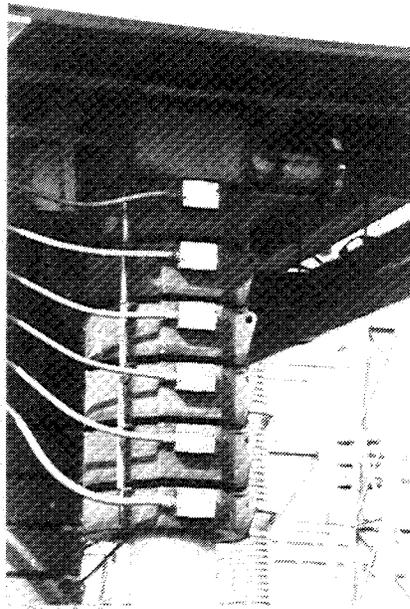
Figure 3-9. Current Transformers Located Under the Pothead Stand

The current circuit is completed on one end by the loop and on the other end by the connection of the potheads to a common bus, which in turn is connected to the high voltage bus. Load current is derived from eleven current transformers, each capable of inducing a potential of about four volts in the test loop. These current transformers, and a metering transformer, are installed around the cable under the two potheads. Figure 3-9 shows a close-up view of five of the current transformers, with the metering transformer at the bottom of the stack.

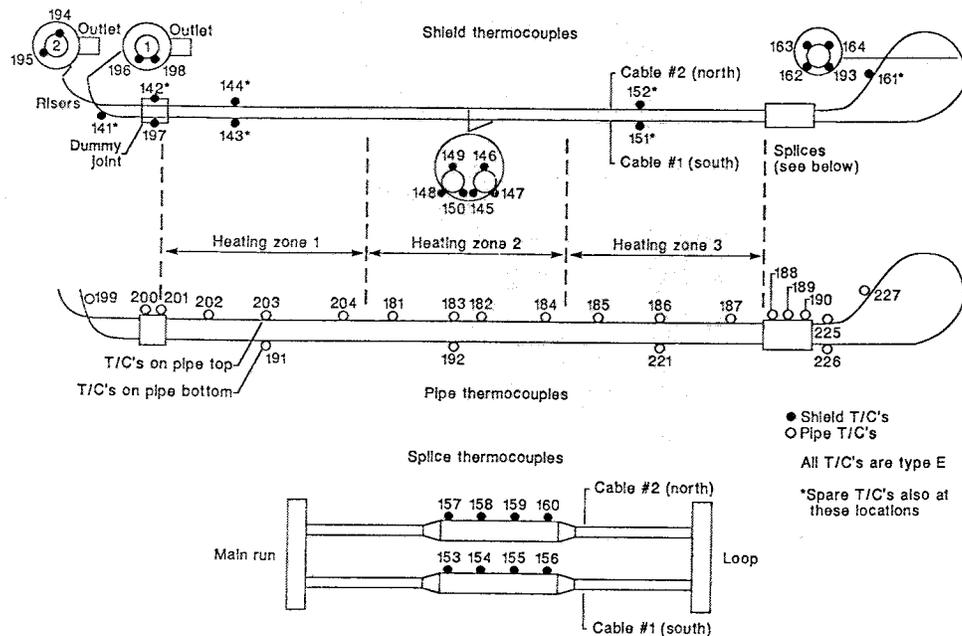
Figure 3-10. Thermocouple Locations on Cable Shield and Pipe

The temperature of the test sample is monitored by 52 thermocouples attached to the pipe and cable shield, as shown in Figure 3-10. Twenty-two of these are attached to the top or bottom of the pipe. The other 30 are attached to the cable shield. An additional 6 thermocouples attached to the shield serve as spares, to replace any of the adjacent active thermocouples that might become disabled. The shield thermocouples are located on top of the cable, except as indicated in Figure 3-10. All thermocouples are routed to the station computer which scans them at five-minute intervals. Figure 3-11 shows a thermocouple attached to the main run cable during the pulling operation. All thermocouples are type E (Chromel/Constantan).

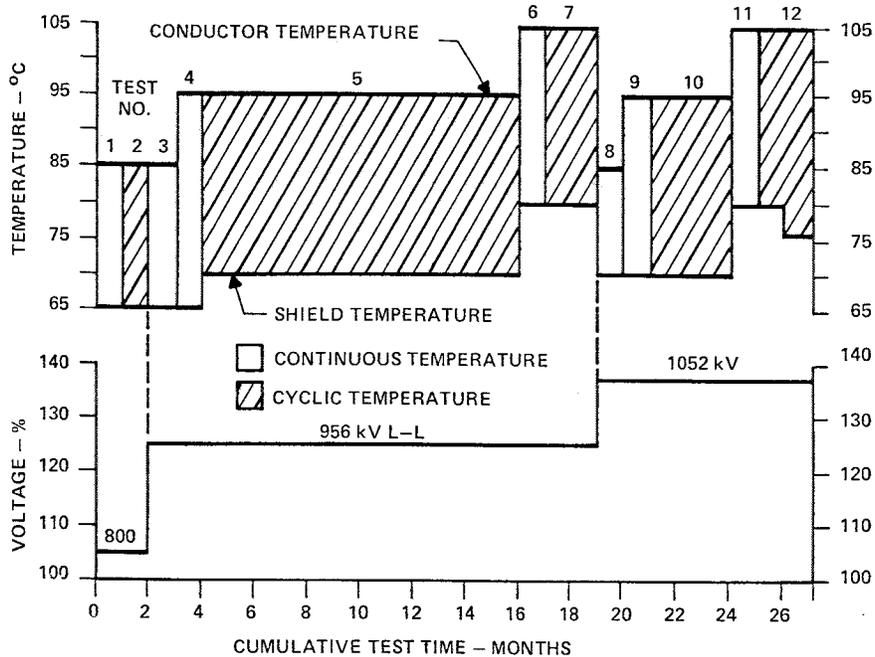
Figure 4-1. Waltz Mill Test Profiles for 765-kV PPP Cable

The accelerated life test program established at Waltz Mill consists of operating the sample at voltage and temperature levels above rated values over a cumulative test time of approximately two years. The test parameters are gradually increased with each test period. In the beginning of the test program, these parameters are at, or only slightly above, rated conditions. By the end of the program, test parameters are substantially above the rated levels.

During some test periods, temperature is maintained continuously at the test condition, while during other periods, the sample is heated to the test condition, then allowed to cool to near ambient. These two periods are referred to respectively as "continuous" and "cyclic". Voltage is maintained at a constant level during each test period, regardless of the type of temperature control.

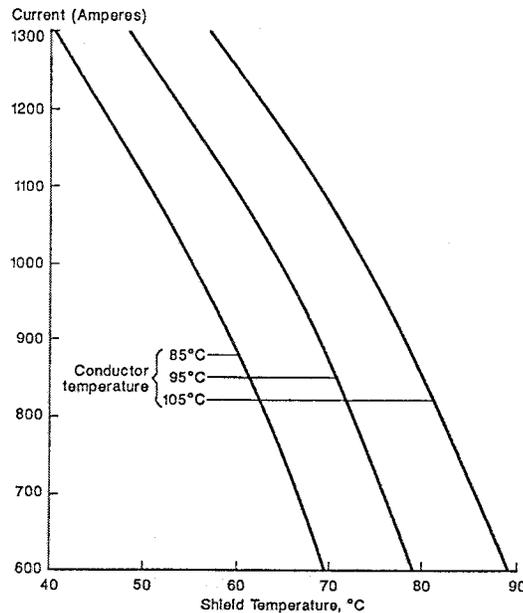
Figure 4-2. Temperature Curves for 765-kV PPP Cable Energized at 956 kV, Phase-to-Phase

Since the conductor temperature cannot be measured directly, its value is established by calculation, based on measurements made at the EPRI EHV Laboratory in Yonkers. Figure 4-2 shows the shield temperature and current required to achieve the conductor temperatures called for in the test program. The data shown are for a line-to-line voltage of 956 kV (125% of rated). For the 105% voltage level, shield temperatures about 1.5°C higher than those shown are required to achieve the same conductor temperature at a given current. For the 137.5% voltage level, shield temperatures 1°C lower are required. These numbers indicate the relatively small effect the dielectric losses have on a PPP-insulated cable, when compared with a paper-insulated cable.

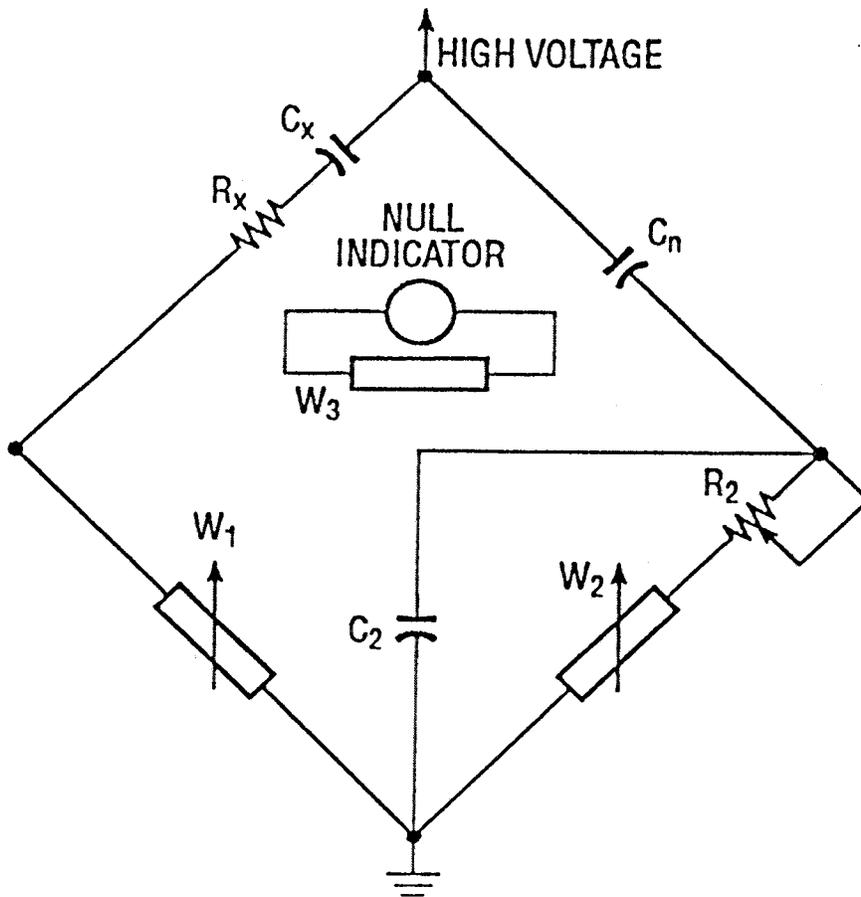
Figure 4-3. Bridge Circuit for Dissipation Factor Measurements

Measurements are made at one-month intervals throughout the test program under the following guidelines:

1. Before the start of each new test period, measure dissipation factor at ambient temperature, all previous lower test temperatures, and the new test temperature. Repeat these measurements at the start of each subsequent month for all test periods lasting longer than one month.
2. At each temperature, measure dissipation factor at the voltage level of the current or upcoming test period, at all lower test voltage levels, and at 110 kV (phase-to-phase).

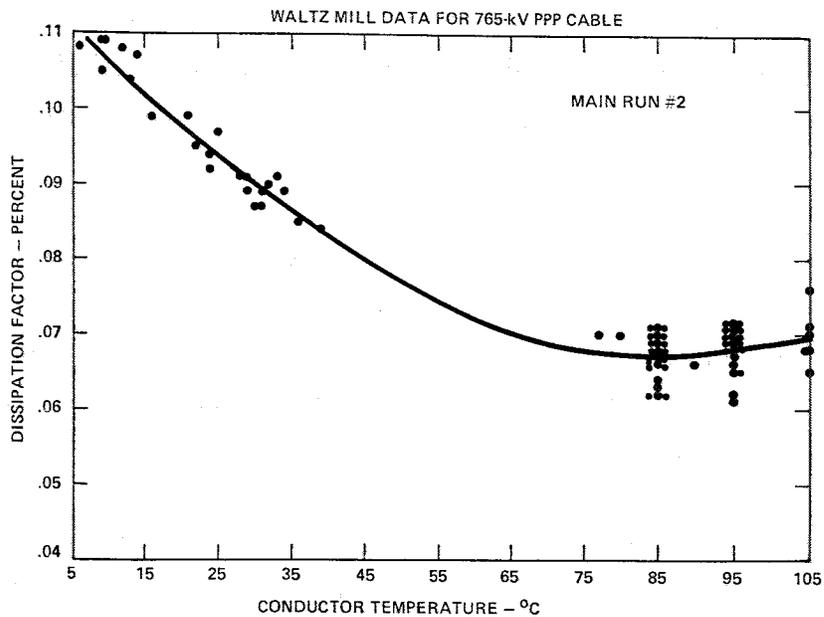
Figure 5-2. Variation of Dissipation Factor with Conductor Temperature for Main Run No. 2

The effect of temperature on the dissipation factor of main run no. 1 is given in Figure 5-2. These data indicate the dissipation factor does not significantly increase with increasing temperatures until the normal operating temperature has been exceeded by 10°C or more.

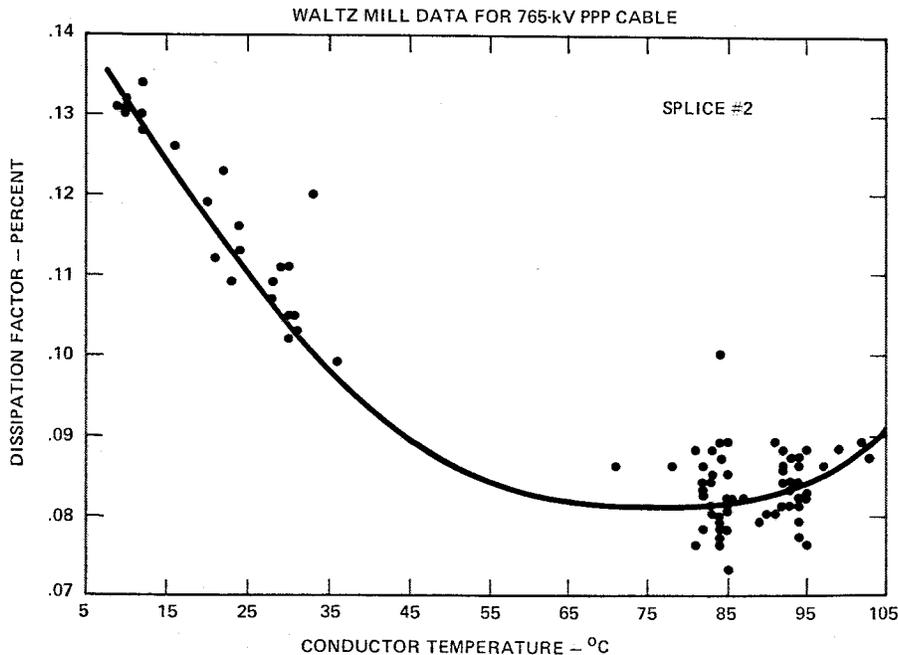
Figure 5-4. Variation of Dissipation Factor with Conductor Temperature for Splice No. 2.

During the final 18 months of testing, the dissipation factor averaged 0.079 percent for both splices. Figure 5-4 gives the variation of dissipation factor with conductor temperature for Splice No. 2.

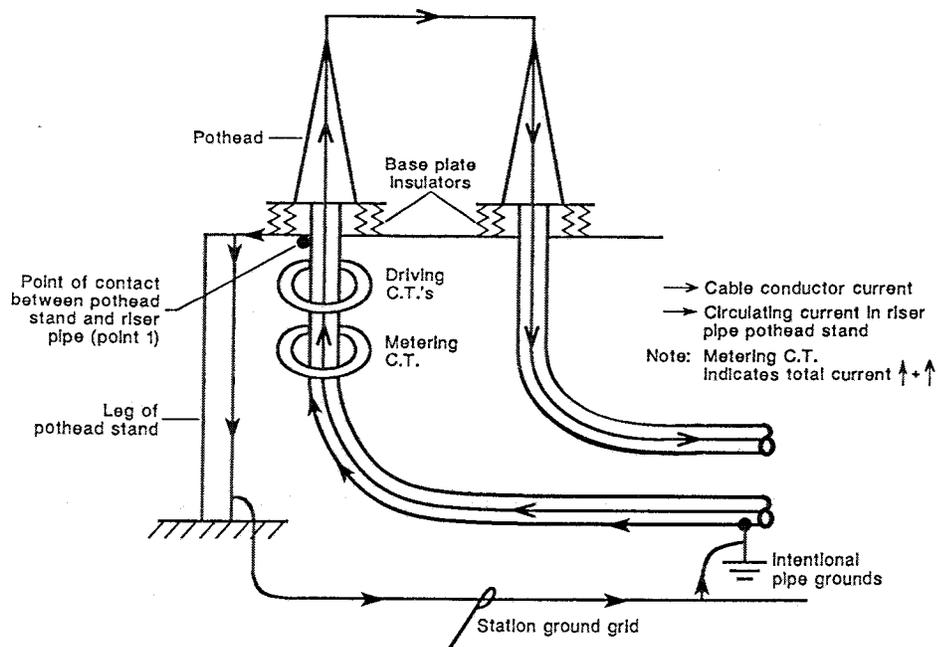
Figure 6-1. Short in Current Circuit

During the ninth month of test period no. 5, a point of contact was discovered between the pothead stand and one of the stainless steel riser pipes. As shown in Figure 6-1, this contact created a parallel circuit with the conductor current, and caused the metering CT (current transformer) to detect the sum of these two currents rather than just the conductor current. The immediate problem, which was caused by improper installation of an adapter plate below the pothead, was resolved by grinding the adapter plate to provide adequate clearance.

The end result of the short circuit was that the conductor current had been lower than planned for most of the test program up to that time, and, consequently, the conductor temperature was lower than had been intended. In periods when we thought the conductor temperature was 95°C it was actually closer to 88 or 89°C. In test periods where we were shooting for 85°C, it was closer to 80°C. When we simulated the short with a bolted connection, we found that the conductor current represented only 72% of the total current. Analysis of temperature data from the loop section indicated the problem had existed from the start of the test program and that the conductor current was about 75% of what we had thought it was.

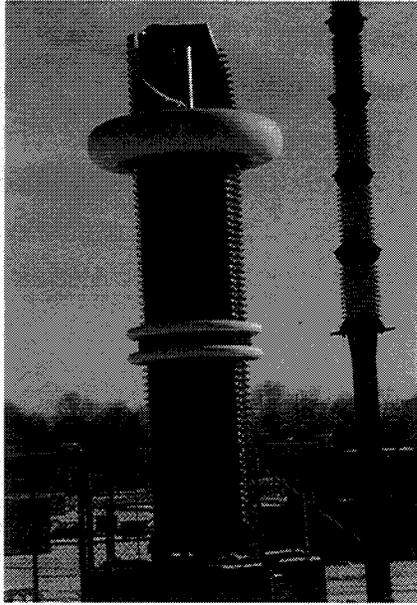
Figure 6-2. Damaged 1600-kV Standard Capacitor

A standard capacitor, rated at 1600 kV, was installed in the EHV substation when the test facility was built and was used in making dissipation factor measurements on the 765-kV sample during the early portions of the test program. However, just after test period no. 7, severe cold weather (-30°C) created stresses that shattered the upper porcelain of the capacitor, as shown in Figure 6-2. Fragments were scattered up to 30 meters away. Fortunately, it was not energized at the time and no one was in the area.

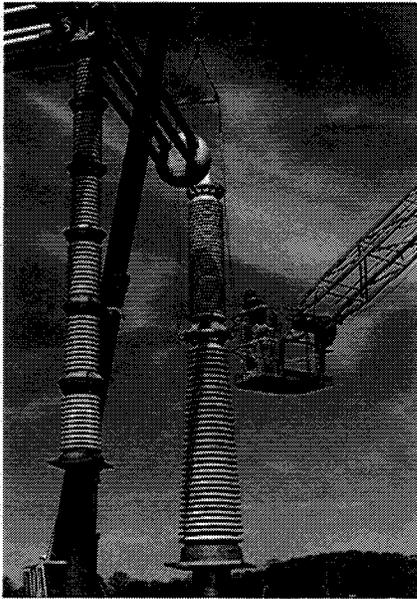
Figure 6-3. Installation of 1000-kV Standard Capacitor

An 800-kV standard capacitor, which was available from a previous project, was substituted for the remainder of the 765-kV test. A comparison of dissipation factor data taken immediately before and after the exchange showed there was no difference. A new 1000-kV standard capacitor was ordered, but arrived after the 765-kV program was completed. Figure 6-3 shows it being installed in May 1985.
