Inhibition of IGA/SCC on Alloy 600 Surfaces Exposed to PWR Secondary Water

Volume 3: Precracking Model Boiler Tests

TR-106212-V3

Final Report, November 1998

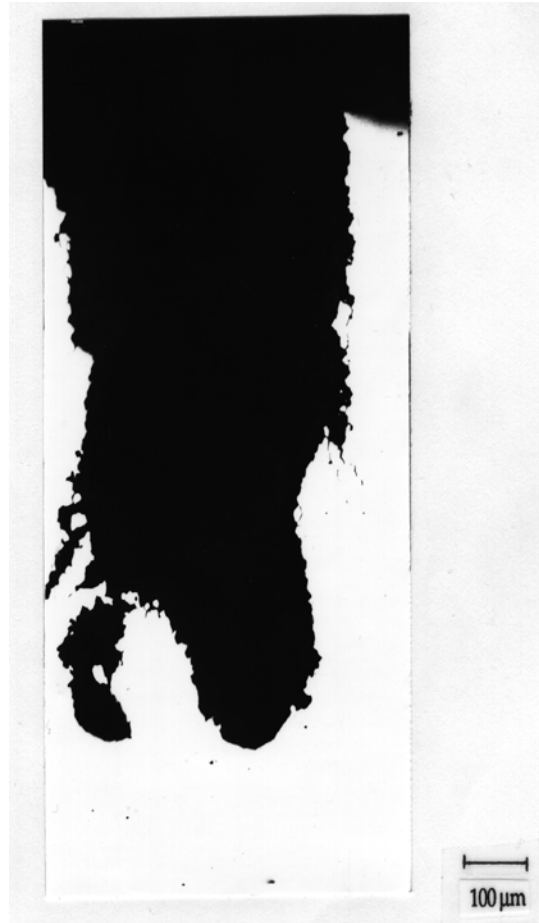
Figure 3-1
Intersection 16-14-2-2 Following Precracking Test 16-14 With a 65% Through Wall Crack (After Tube Bulging) - No Etching

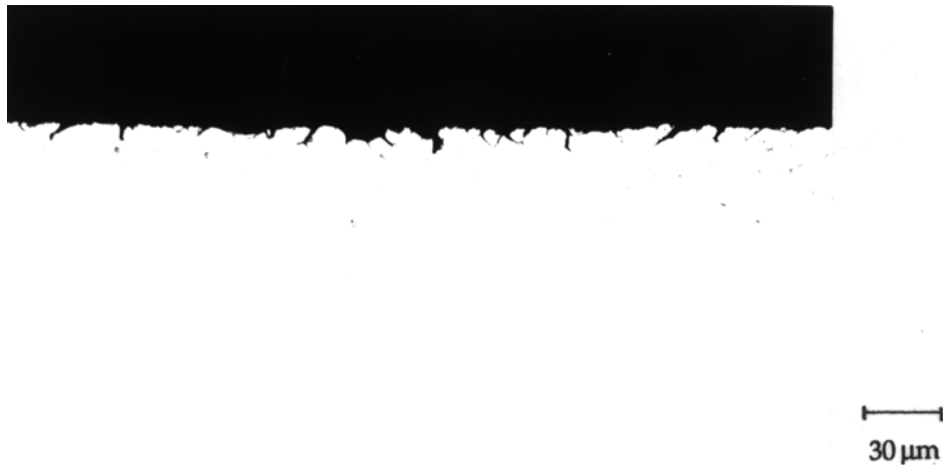
Figure 3-2
Intersection 16-14-2-2 Following Precracking Test 16-14 With an Area of Shallow IGA/IGP - No Etching

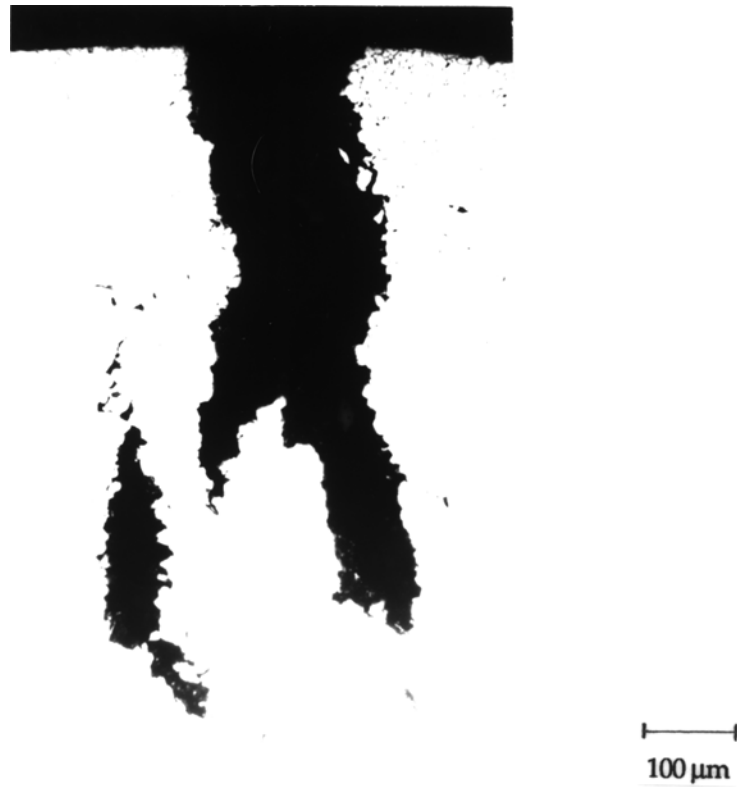
Figure 3-3
Intersection 15-15-2-3a Following Precracking Test 15-15 With a 65% Through Wall Crack (After Tube Bulging) - No Etching
