# Fiber-Optic Fabry-Perot High-Temperature Strain Measurement System Feasibility Study

TR-107212  
3876-06

Final Report, January 1997

Prepared by  
Mechanical Technology Incorporated  
968 Albany-Shaker Road  
Latham, New York 12110

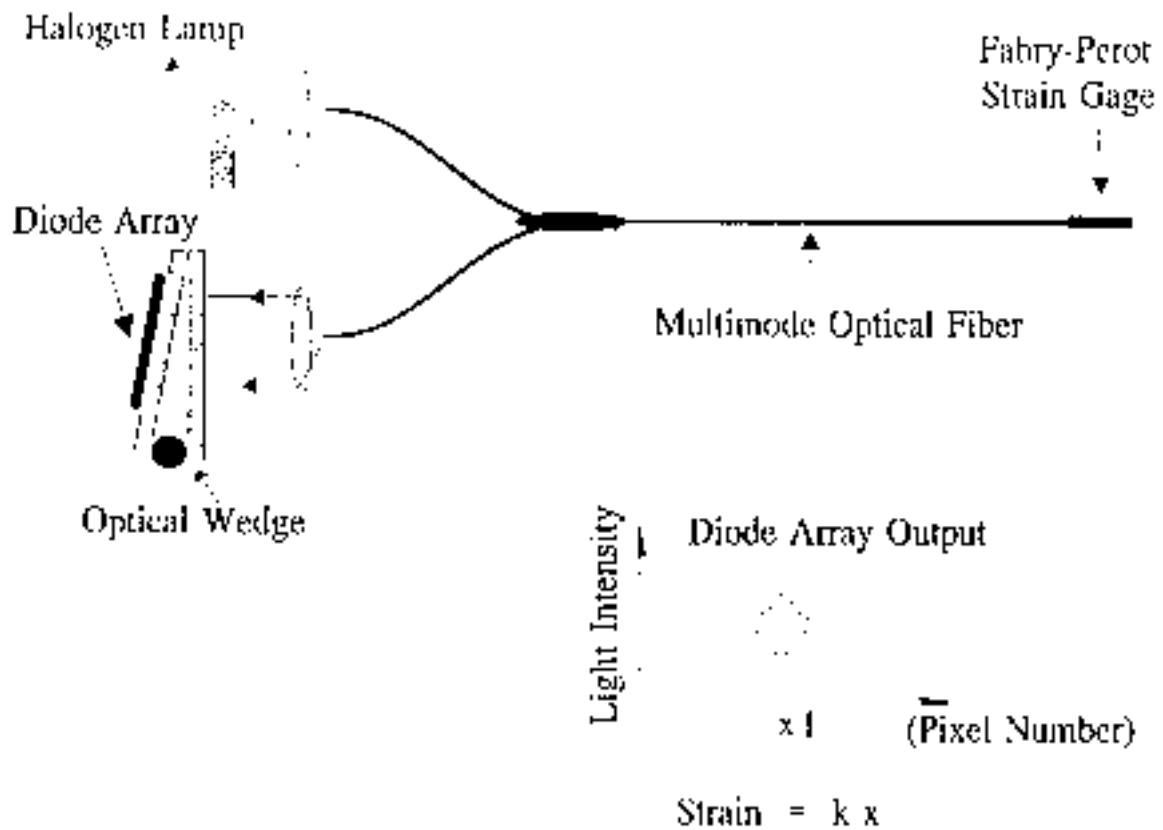
The spectrum analyzer portion of the WFS100 is an optical wedge (a Fizeau analyzer), which has a varying interference cavity length as a function of position along its length. The light intensity reflected from a Fabry-Perot sensor is maximally transmitted through the optical wedge at a position where the optical path length matches the optical path length of the Fabry-Perot cavity. A strain applied to the Fabry-Perot strain sensor changes the cavity length, resulting in a shift in the position of the maximum light intensity transmitted through the optical wedge. A linear photodiode array placed at the back of the optical wedge detects the transmitted beam, and a simple peak detection algorithm determines the location of the peak of the transmitted signal.

Figure 2-1 Schematic of White-Light Interferometer

The detector (optical wedge/Fizeau) interferometer portion of the system has a varying optical path length and provides a method to scan over a certain range to match with the sensing interferometer. This range determines the measurement range of the strain sensor. The light intensity at the linear diode array can be written as [9]

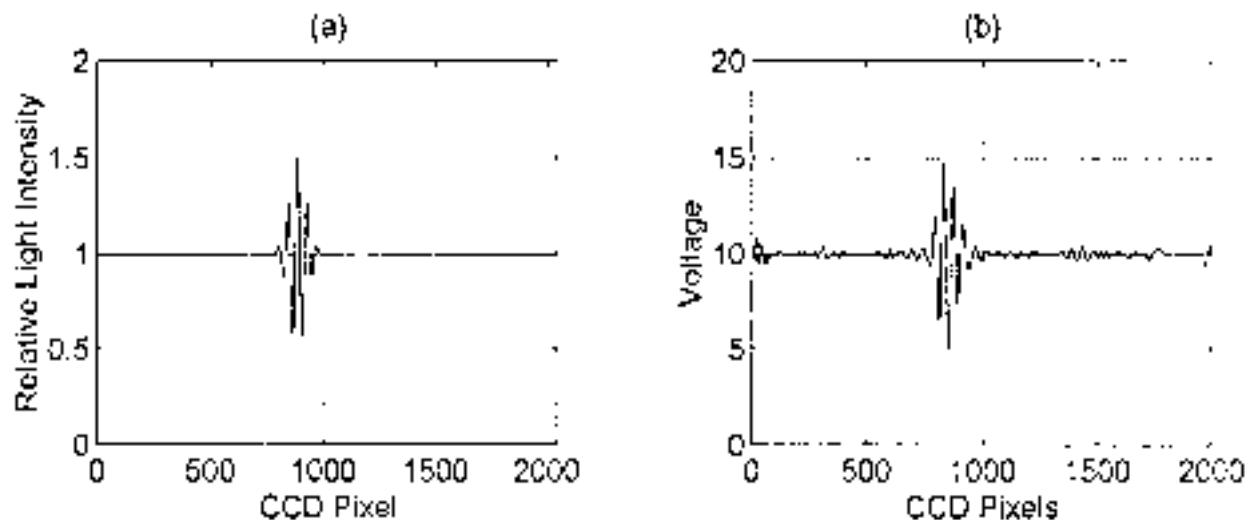
Figure 2-2 a) Theoretical Plot of the White-Light Interferometer Output Signal  
b) Corresponding Experimental Output Signal

The position of the peak light intensity (when  $\phi(x) = \phi_s$ ) on the linear array uniquely determines the cavity length of the Fabry-Perot strain sensor which is related to the strain sensed by the gage. The simple optical wedge analyzer and the linear array replaces expensive spectrum analyzer and sophisticated signal analysis needed to demodulate the reflected optical signal. The linear array in the demodulator used in this study has 512 pixels and the peak of the transmitted signal is detected to the accuracy of one-eighth of a pixel. Thus, the resolution of this system is 0.025% of full range, which implies that a strain sensor with a measurement range of 10,000  $\mu\epsilon$  can resolve strain levels as small as 2.5  $\mu\epsilon$ . This demodulator has now been upgraded with a 2048 pixel array to read strain levels smaller than 1  $\mu\epsilon$ .

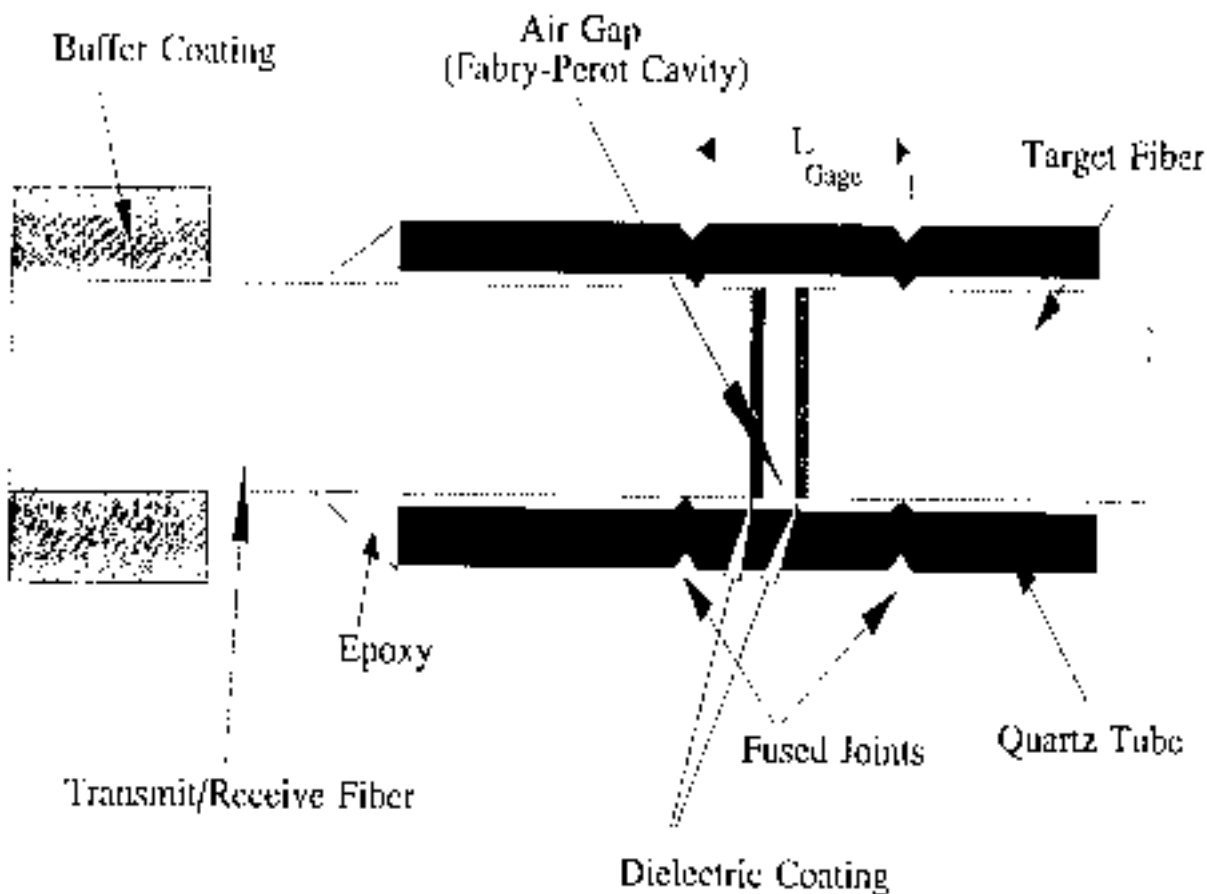
As shown in Figure 2-3, two optical fibers are inserted into a hollow glass tube from both ends. The outer diameter of the fiber is same as the inner diameter of the hollow tube. The fiber end faces are cut square, a partial reflective coating is applied to the transmit/receive fiber, and the target fiber is coated with a multilayer dielectric mirror to produce higher reflectance. The fibers are fused to the glass tube as shown in Figure 2-3. The distance between the points where the fibers are attached to the glass tube is defined as the gage length. The target fiber could be a metal fiber with its end face polished to reflect the light.

Figure 2-3 Extrinsic Fabry-Perot Strain Sensor

The construction methods for the noncompensated gage and the compensated gage are illustrated in Figures 2-3 and 2-4. In the case of the noncompensated gage, the Fabry-Perot gap is placed at the center of the 10-mm-long glass tube, and the incoming fiber and the target fiber are fused on either side of the gap at a distance 2.25 mm from the center. The gage length is 4.5 mm. This could vary from gage to gage depending on the range of the sensor. If the soldered joint of the incoming fiber fails, the gage length becomes 7.25 mm as illustrated in Figure 2-4. Thus, the scale factor changes to  $7.25/4.5$ , which equals 1.6. In the case of the compensated gage, the metal rod is attached to the tube at the end and the gage length is 2.9 mm. If the soldered joint of the incoming fiber fails, the gage length becomes 9 mm as illustrated in Figure 2-4. Thus, the scale factor changes to  $9/2.9$ , which equals 3.2.

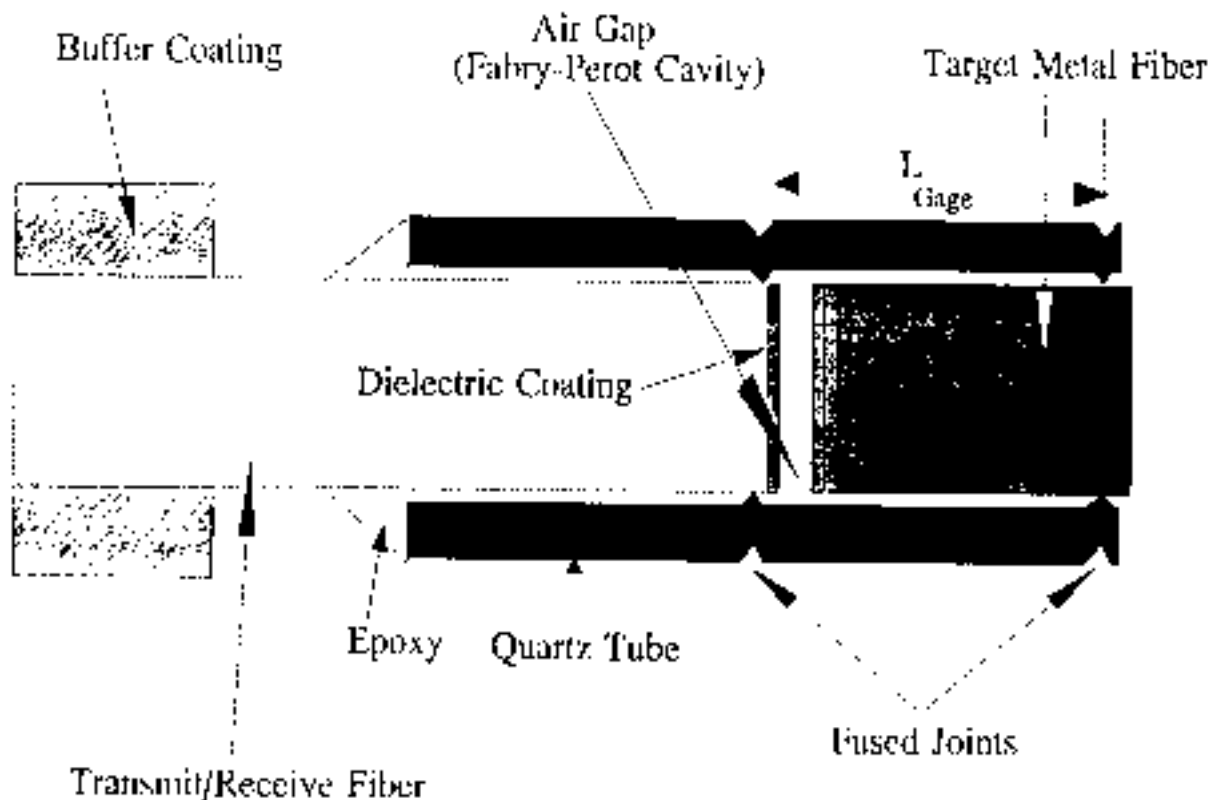
constructed by replacing the target optical fiber by a metallic fiber made from the same material as the structure to which the gage is bonded. Also, the transmit-receive fiber is attached to the glass tube very close to its end face as shown in Figure 2-4. Since the thermal growth of the metal rod is equal and opposite to the growth of the structure, the thermal strain will be compensated. This same gage could be used for measuring temperature.

Figure 2-4 Temperature-Compensated Extrinsic Fabry-Perot Strain Sensor

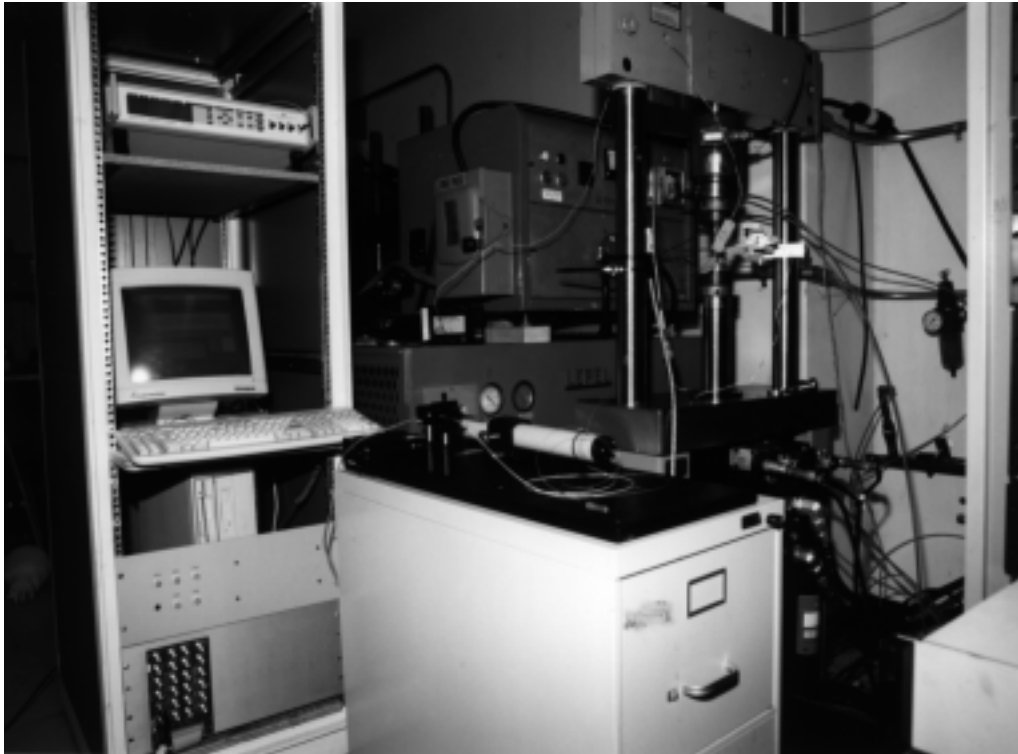
Figure 2-8 shows the entire experimental setup used for sensor calibration. The white-light interferometer and the data acquisition system are mounted on a rack placed close to the MTS machine. A close-up view of the virtual instrument created using the LabView software package is shown in Figure 2-9. Figure 2-10 shows the test specimen mounted on the MTS machine with the induction heater coil surrounding the specimen. The optical fiber leading to the Fabry-Perot sensor, the thermocouple used for monitoring the temperature, and the extensometer are also shown in Figure 2-10.

Figure 2-8 Photograph of Complete Experimental Setup

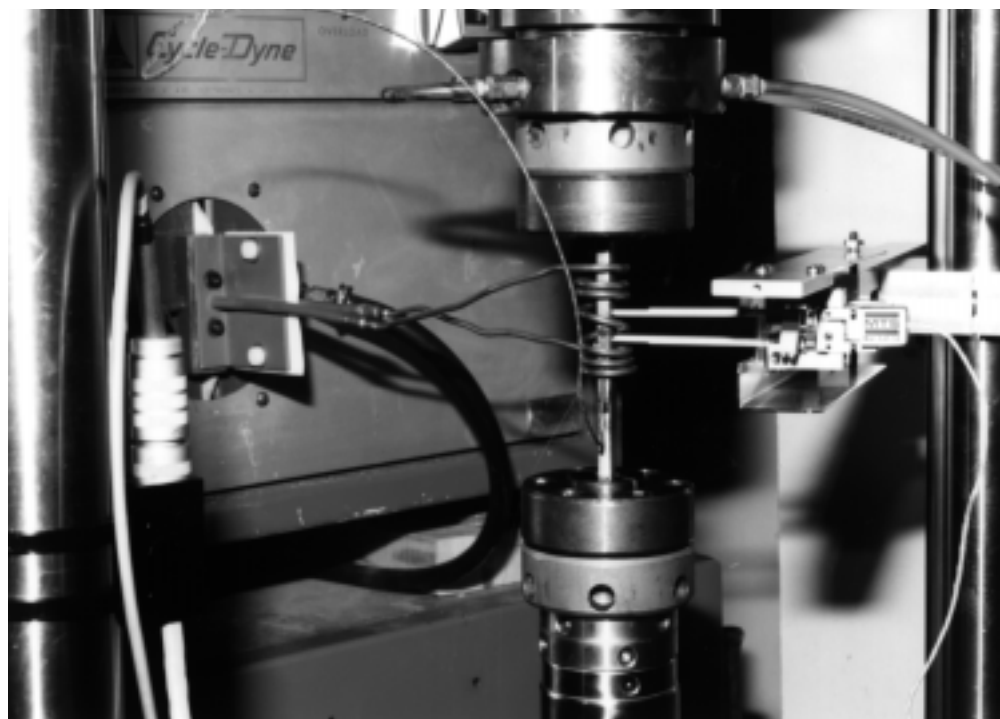
Figure 2-10 Test Specimen Mounted on MTS Machine

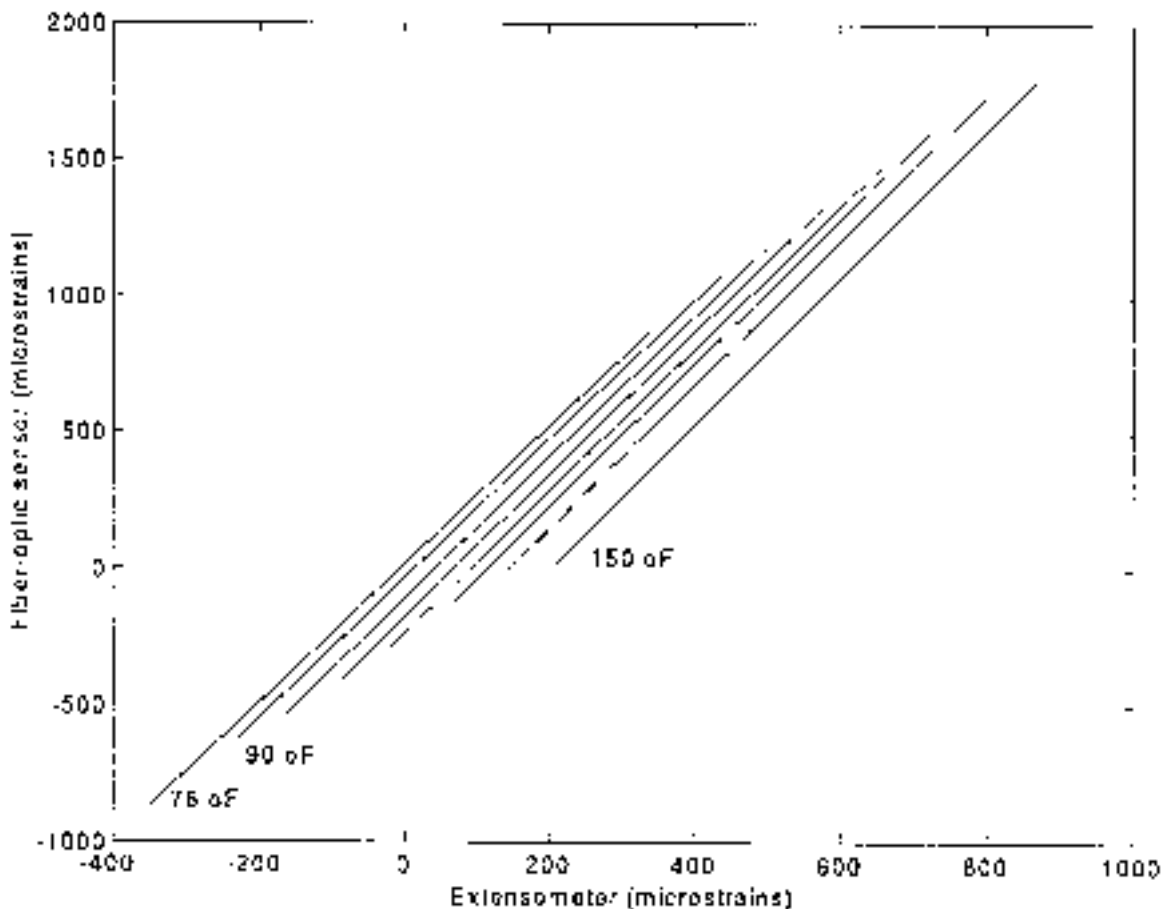
Figure 2-12 Calibration Plot for Temperature-Compensated Gage

Next, a temperature-compensated gage ( $\pm 2000 \mu\epsilon$ ) was attached to the specimen in a similar method using EPO-TEK 353 adhesive. This gage performed well at room temperature, and the temperature was increased at 10°F intervals. The calibration plot for this gage is shown in Figure 2-12. At 150°F (66°C), the temperature once again shot up to 200°F (95°C) accidentally, and the gage failed. This was a puzzle, because the sudden temperature jump did not cause the strain to exceed the limit of the sensor. The gage was examined under the microscope, and a crack was noted on the surface of the epoxy. A close-up photograph of the failed gage is shown in Figure 2-13. It was not clear whether the crack extended to the gage or was limited to the epoxy.

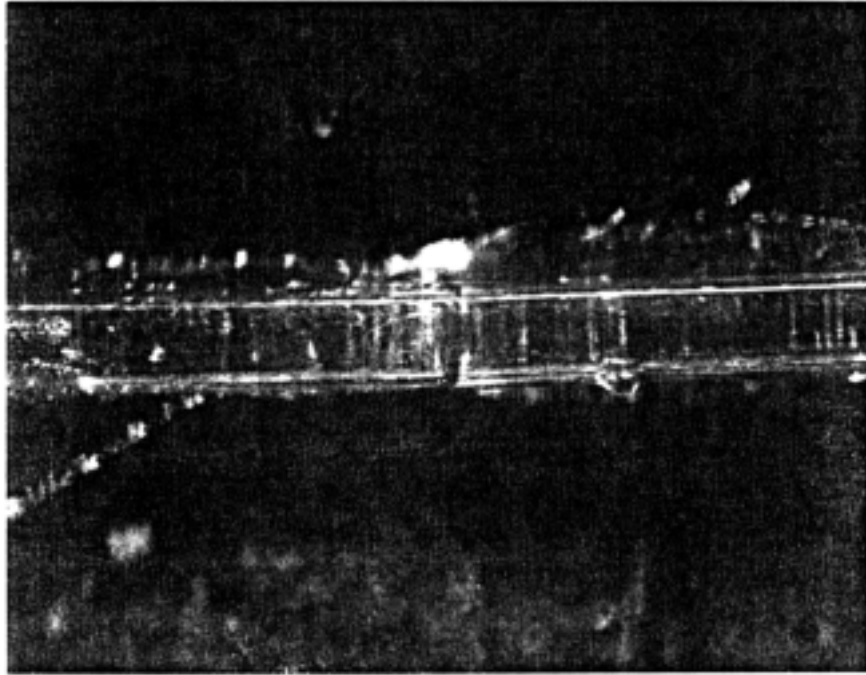
Figure 2-13 Close-up View of Failed Fiber-Optic Strain Gage

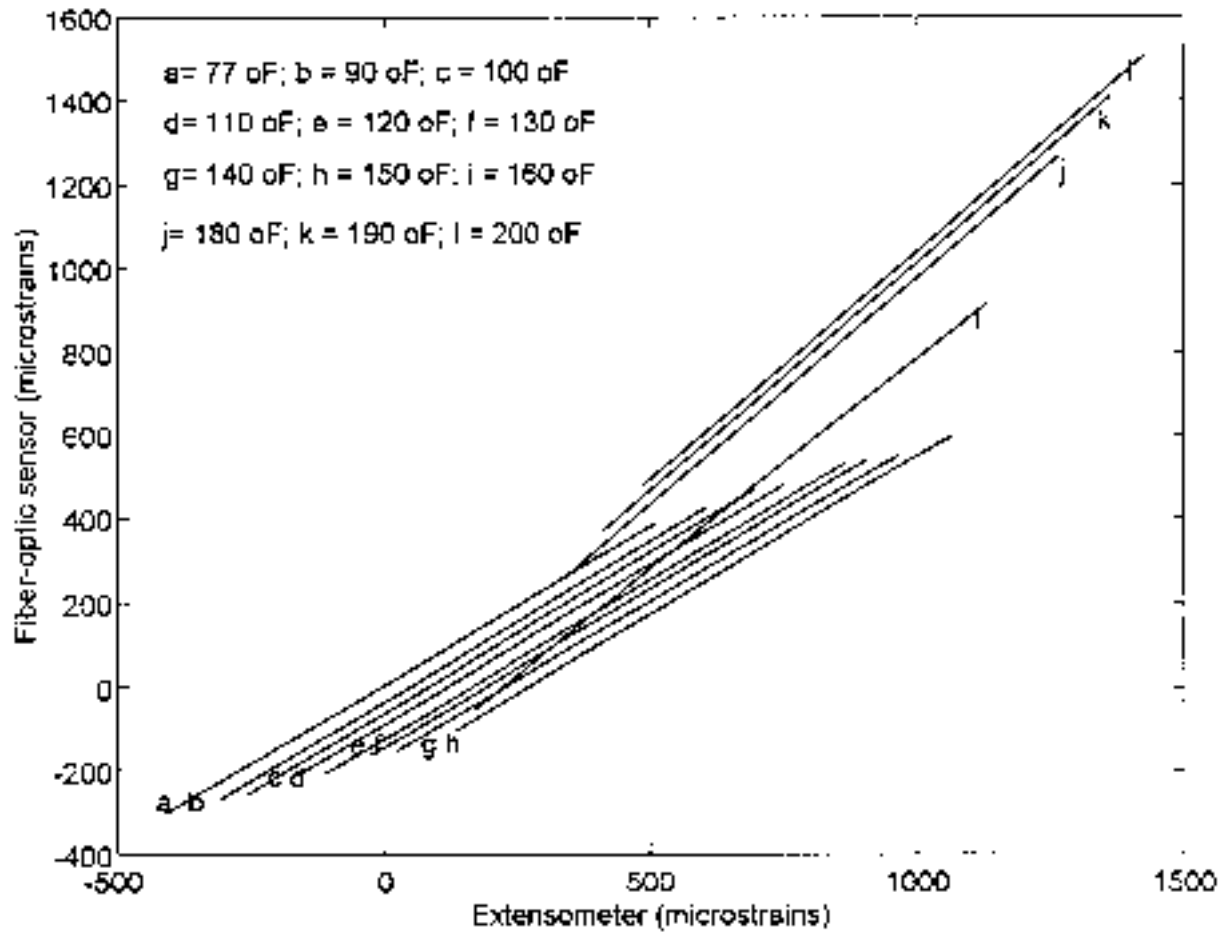
In order to investigate the possibility of the crack extending to the gage, a similar test was conducted on a similar gage. The data shown in Figure 2-14 was acquired at 10°F intervals while the specimen was heated to 200°F (95°C). Initially, the gage showed reduced sensitivity, 0.75 times the value of the extensometer. At around 150°F (66°C), the sensitivity changed to 1.0 and remained close to this value until 200°F (95°C). The gage was allowed to cool down, and data was gathered once again at 10°F intervals. The calibration plot is shown in Figure 2-15. The calibration factor fluctuated between 1.0 and 1.10 until reaching 120°F (50°C). Below this temperature, the gage sensitivity changed once again to a different value, 1.5.

Figure 2-14 Calibration Data for Elevated Temperature Testing

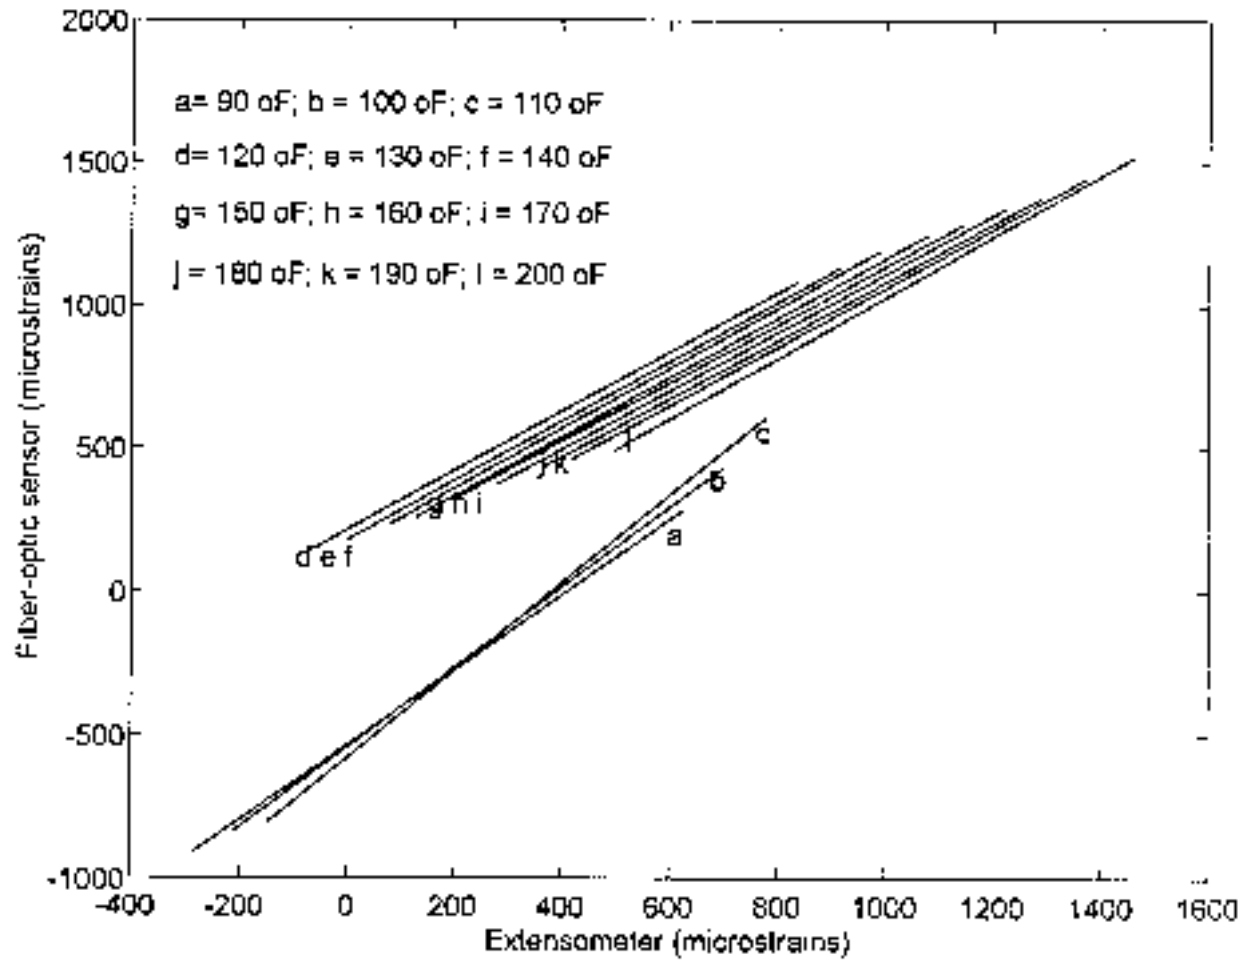
Figure 2-15 Calibration Data During Cooldown

The gage was allowed to cool overnight and was then tested. The calibration factor had changed to 3.1. The explanation is that the gage started to fail around 150°F (66°C) during the warm-up cycle, when the sensitivity changed the first time. From that point on, it kept on failing until it reached the final 3.1 calibration factor. A crack similar to the previous gage was noticed when the gage was inspected under the microscope. Figure 2-16 illustrates the two gages and the cracks. Careful analysis revealed that the gages had failed at the fused joint of the transmit/receive fiber, which explains the difference in calibration factor throughout the entire calibration process.

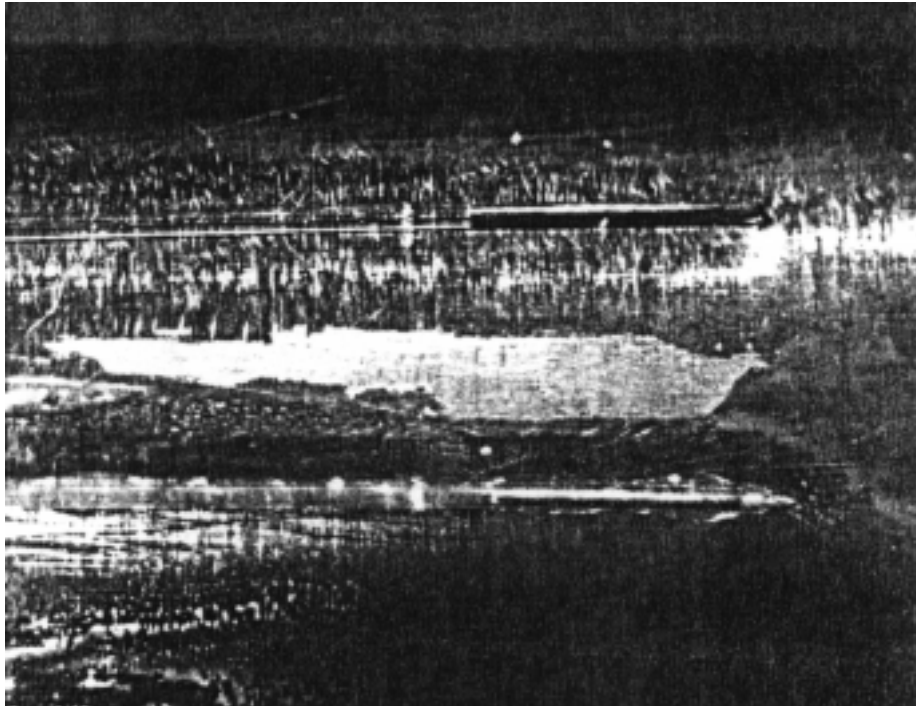
Figure 2-16 Photograph of Failed Gages

A possible explanation for the scale factor discrepancy is the change in gage length due to glass tube fracture at the fused locations. Fiber-optic strain gages are manufactured by inserting two optical fibers from both ends of a small hollow glass tube as shown in Figure 2-17. The fibers are attached to the glass tube using arc fusion (or CO<sub>2</sub> laser), and the fused joints are potential failure sites. Excessive strain on the transmit/receive

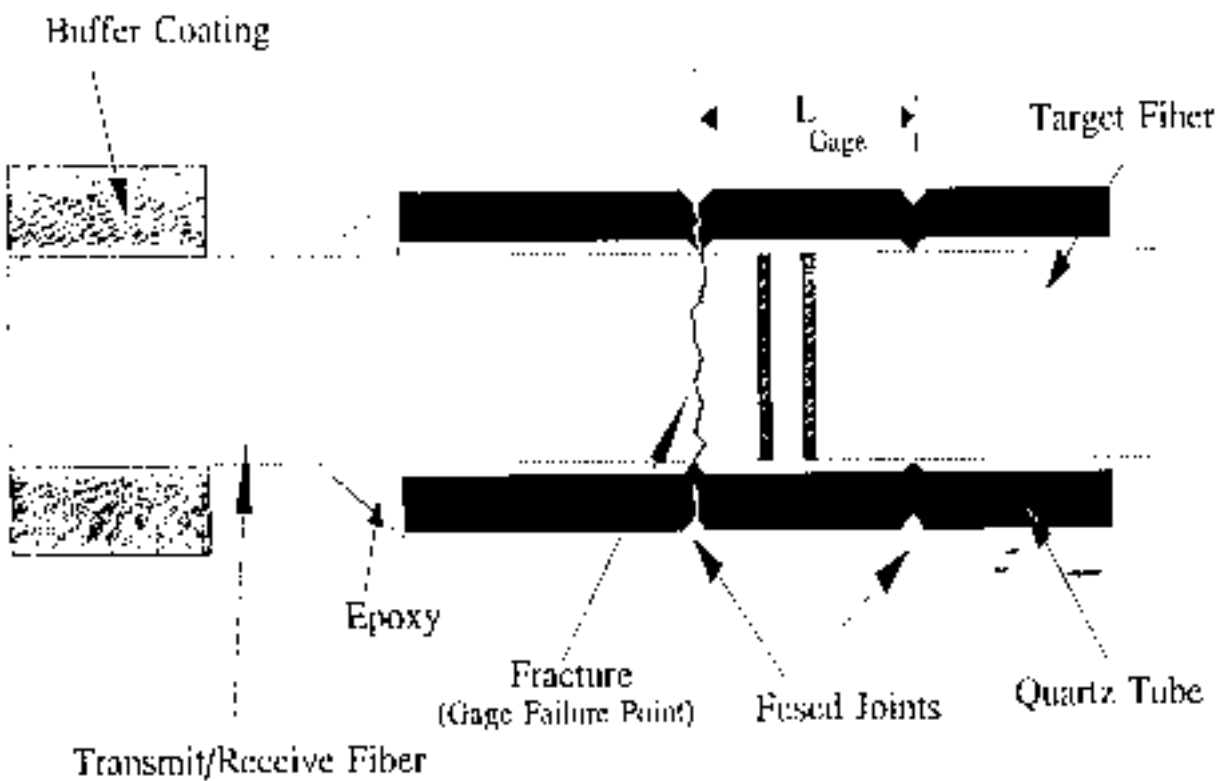
fiber caused all the gages to fail at this joint. When the fused joint fails, the gage length changes to the point where the fiber is attached to the glass tube, which, in this case, will be close to the end of the tube. At the end of the tube, the fibers are attached to the tube by the adhesive used for bonding the gage to the specimen.

Figure 2-17 Schematic of a Failed Fabry-Perot Strain Gage

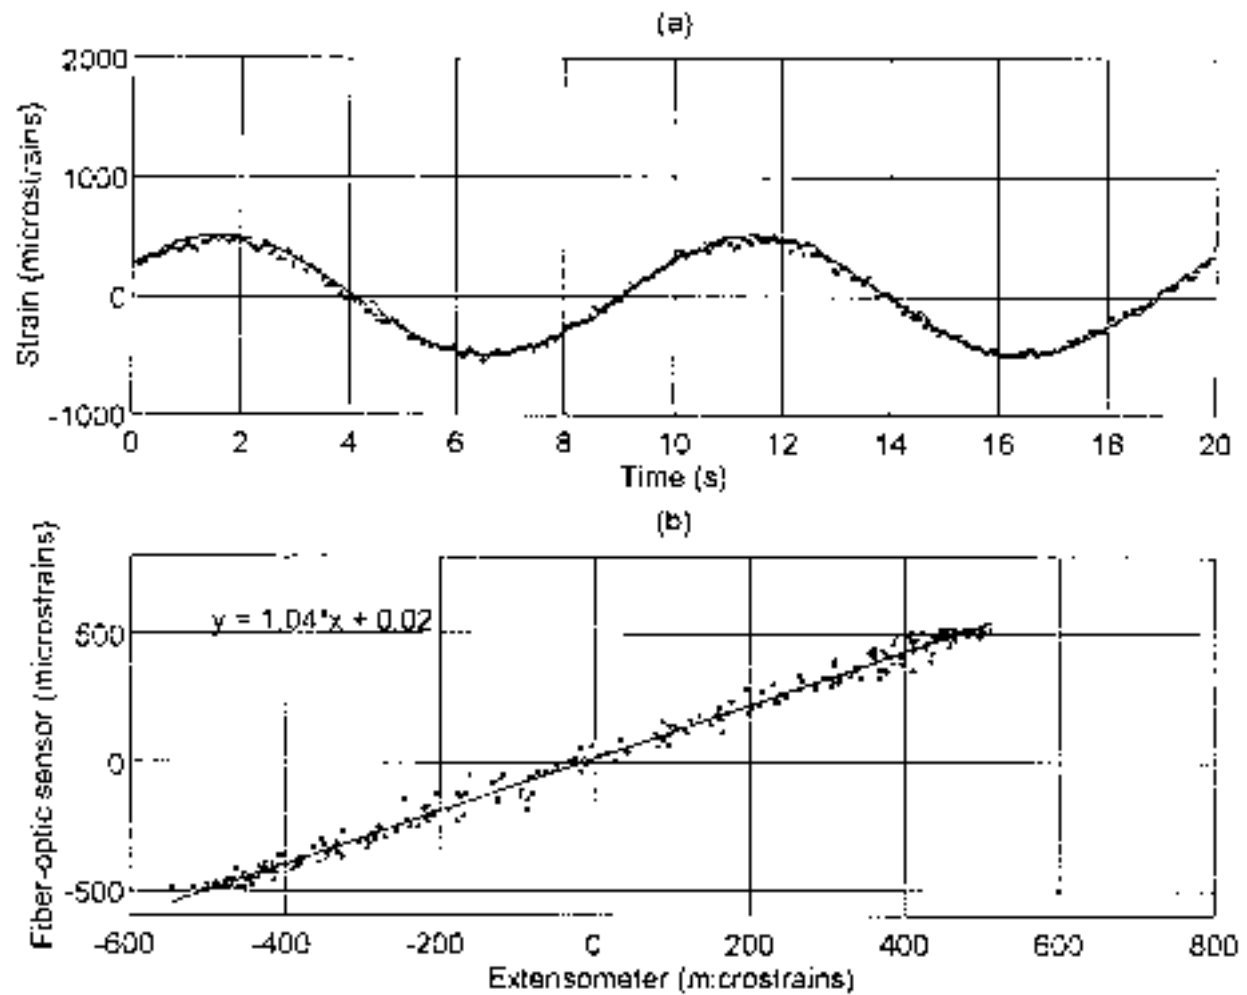
Figure 2-18 Data from Low-Frequency Dynamic Calibration  
a) Strain data from fiber-optic sensor and extensometer  
b) Dynamic calibration data

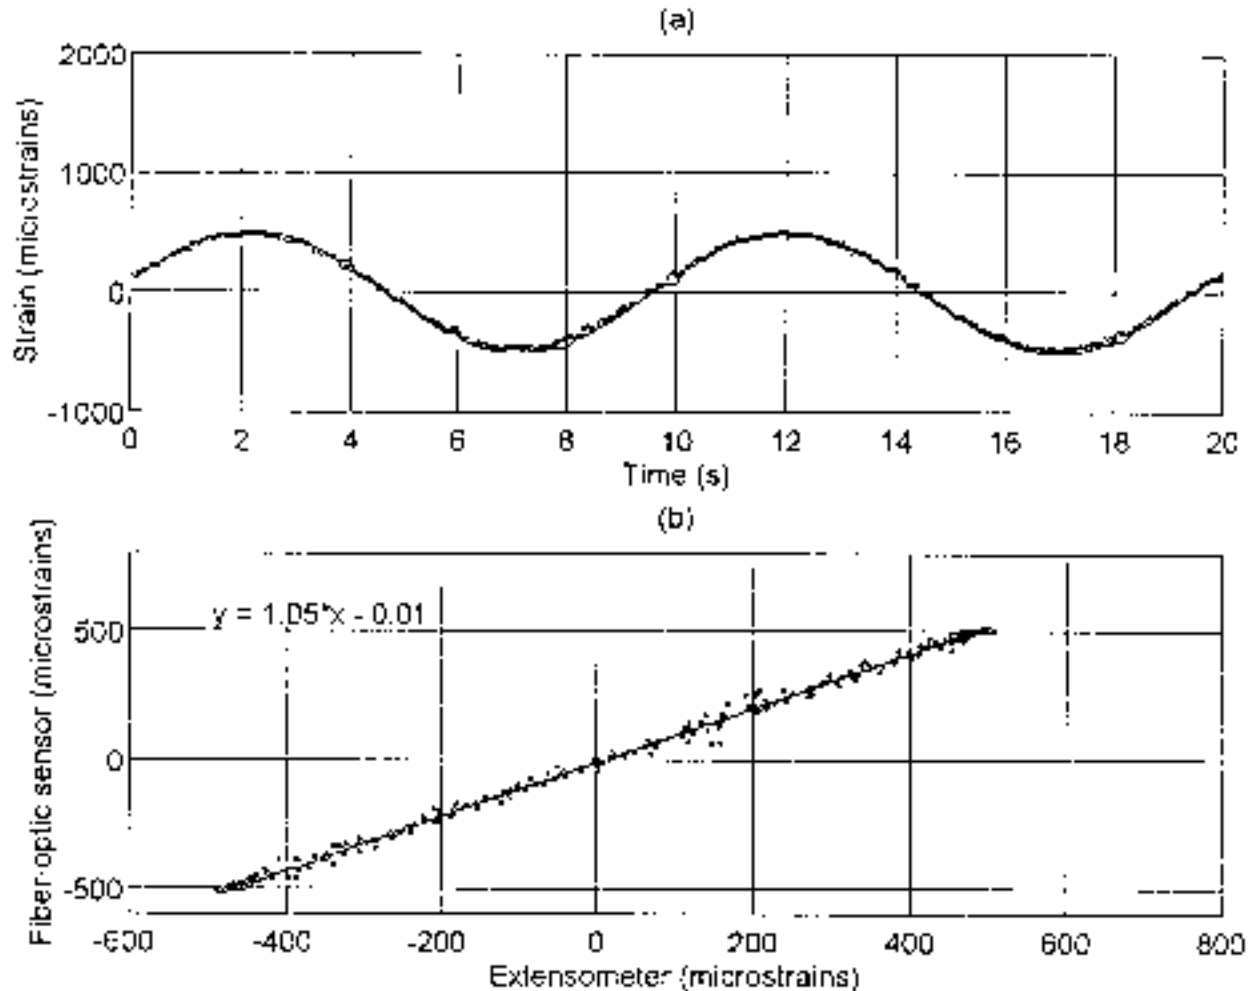
The two sets of data indicate that the calibration values of the gage did not change within the accuracy of the tests over the 1-hour period of 0.1-Hz cyclic loading (corresponds to about 360 cycles).

Figure 2-19 Data after 1 hr of 0.1-Hz Cyclic Loading  
 a) Strain data from fiber-optic sensor and extensometer  
 b) Dynamic calibration data

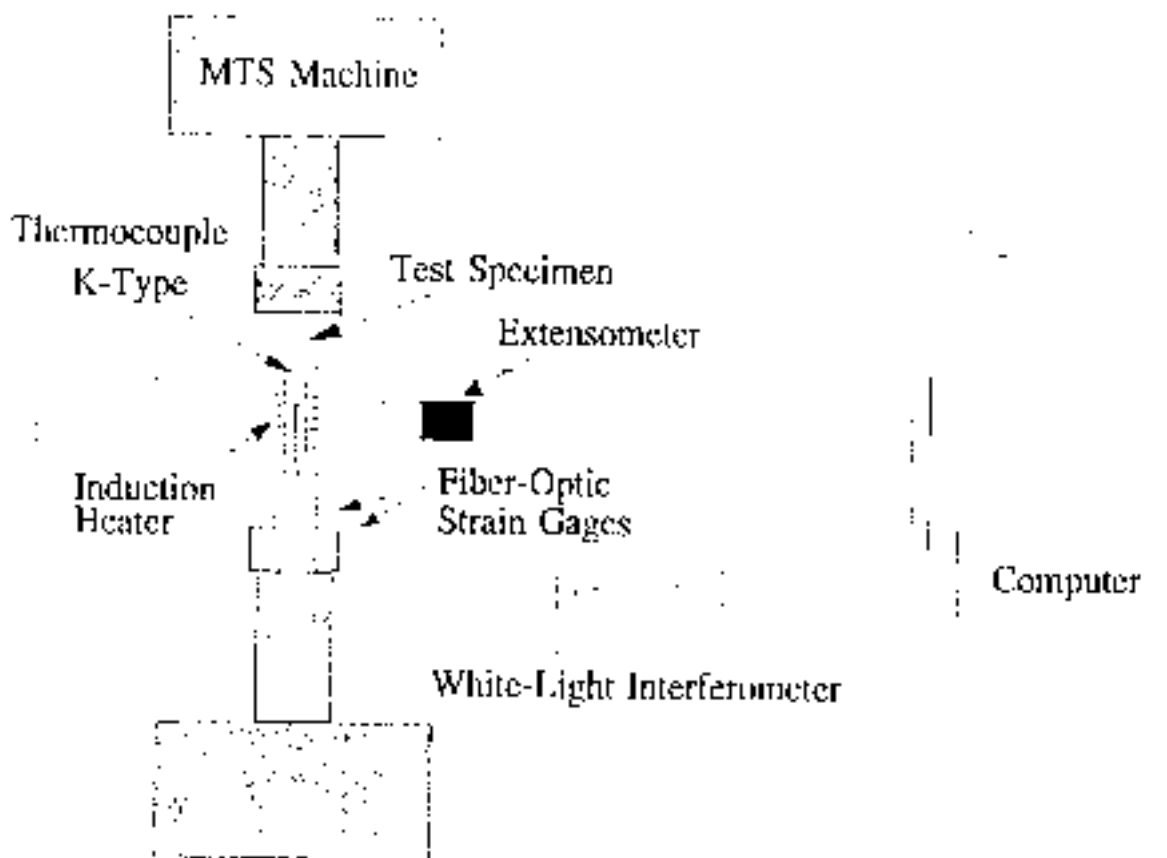
To determine the ability of the gage to measure temperature, a temperature-compensated gage was evaluated. Figure 2-20 illustrates the setup used for temperature testing. A K-type thermocouple was attached to the test specimen next to the two gages and the test specimen was loaded on the MTS machine with the induction heater wrapped around the specimen. The specimen was heated at 10°F intervals from room temperature to 200°F (95°C), and the corresponding strain reading from the fiber-optic strain gage and the thermocouple were recorded simultaneously. At every instant, the specimen was maintained at temperature until thermal equilibrium was reached.

Figure 2-20 Setup Used for Temperature Testing

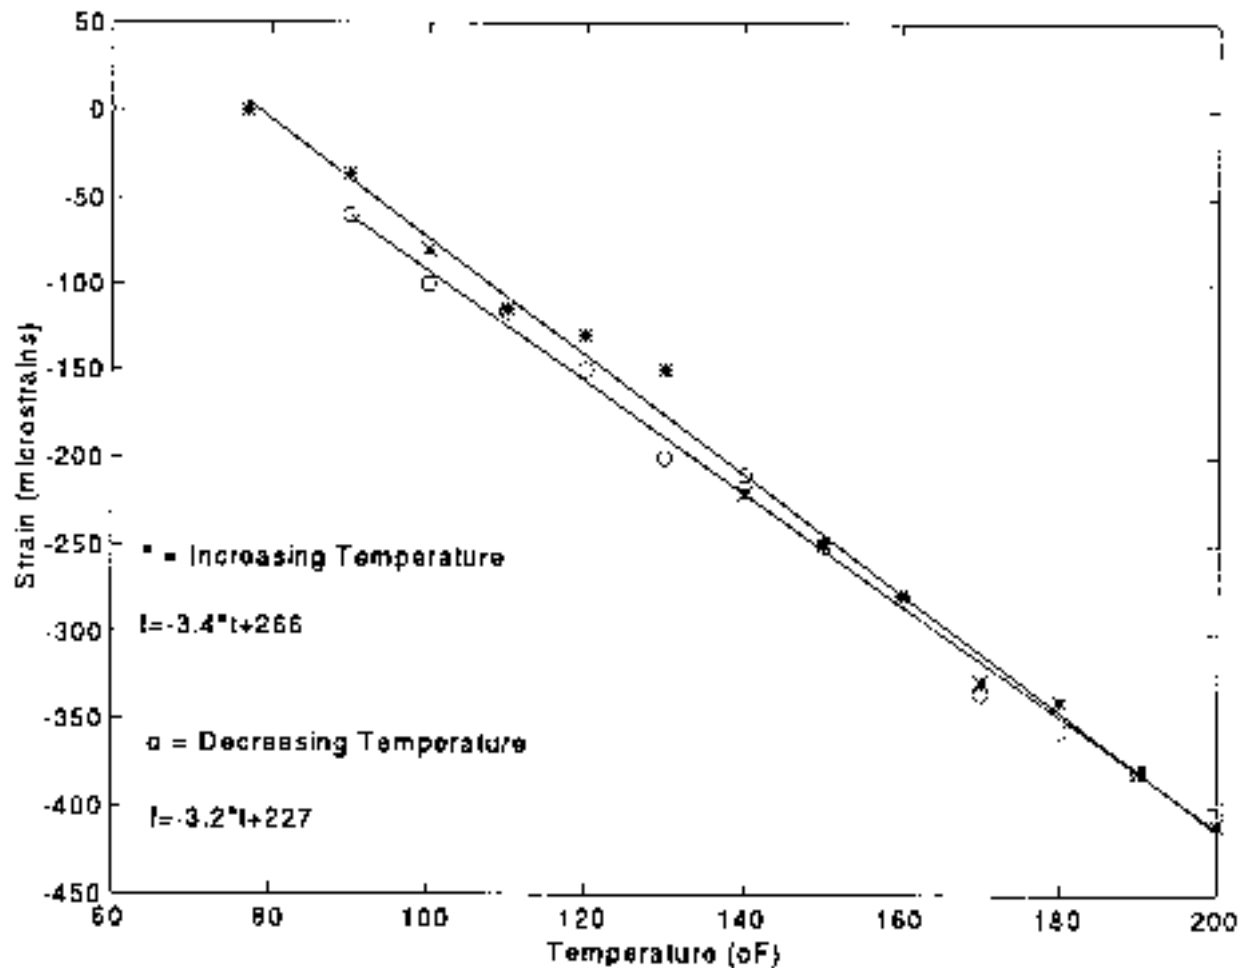
The data gathered up to 200°F (95°C) shows promise for using these sensors as temperature sensors. Figure 2-21 presents a strain versus temperature plot; the temperature reading shown was obtained from the K-type thermocouple. The strain read by the fiber-optic sensor was negative, since the thermal growth of the fiber resulted in a reduced interferometer gap (equivalent to compression). The strain as a function of temperature is linear. The slope of the decreasing temperature plot is about 6% lower than the increasing temperature case. This may have been introduced by the induction heater inducing voltage on the thermocouple during the heating-up time. During the cooldown period, the induction heater was off.

Figure 2-21 Plot of Strain versus Temperature

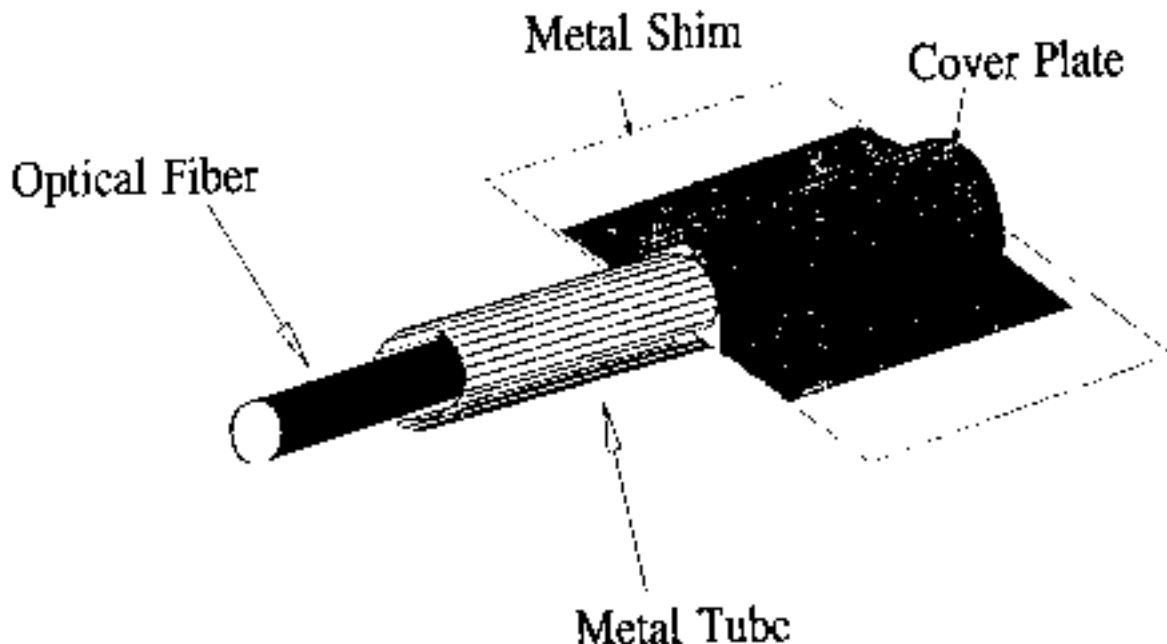
Figure 3-1 Schematic of the spot weldable fiber-optic strain gage.

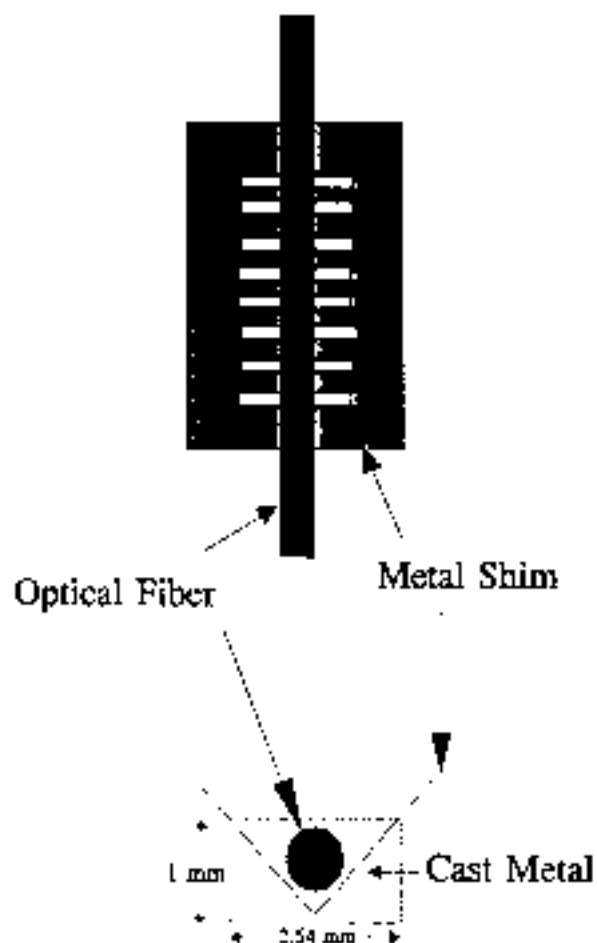
Figure 3-2 shows a sketch of the casting configuration. The material used to encapsulate the gage was selected after evaluating the physical properties of the gage and the operating temperature. The encapsulating material had to survive at the operating temperature of 1000°F (538°C), be nonreactive with the gage, not damage the gage during manufacture, and be as compatible as possible with the operating characteristics of the gage.

Figure 3-2 Configuration for Casting Process

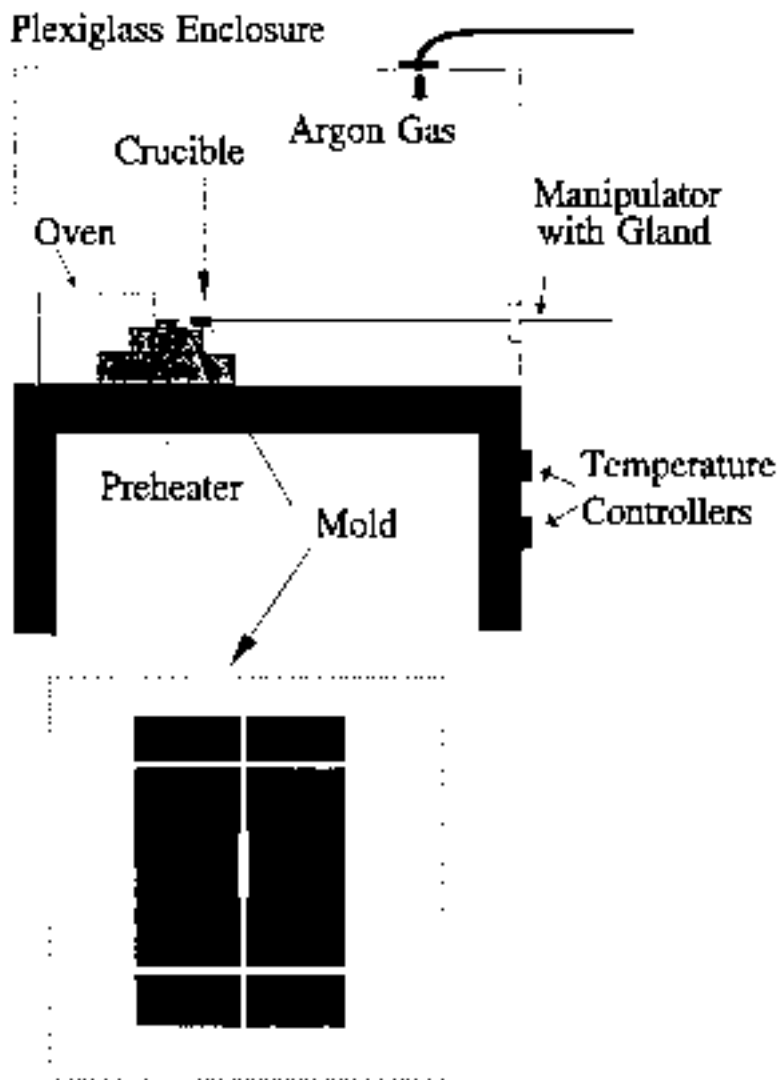
Small crucibles to melt the brass alloy and mold it to hold the fiber and the metal shim were made out of graphite. The casting environment needed to be inert to prevent oxidation. Therefore, an enclosure was built from plexiglass, which had inlets to fill the enclosure with argon to create an inert environment (see Figure 3-3). Heating elements and insulation were placed inside the enclosure so that the crucible could be heated to 2000°F (1095°C) to melt the brass alloy. Another similar heating unit was placed inside to preheat the mold to 1700°F (929°C). Thermocouples were installed to monitor the mold and crucible temperatures, along with controllers to accurately control the temperatures. A manipulator and gland seal were manufactured to move the crucible and pour the molten metal into the mold.

Figure 3-3 Casting Setup

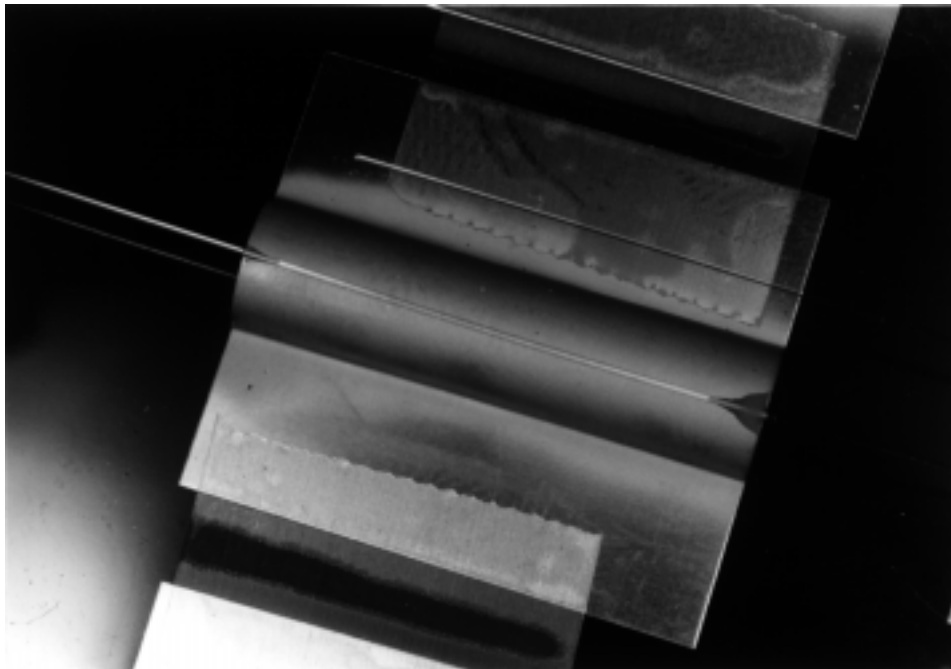
Figure 3-5 Optical Glass Fiber on Metal Tab with Epoxy Holding It in Place

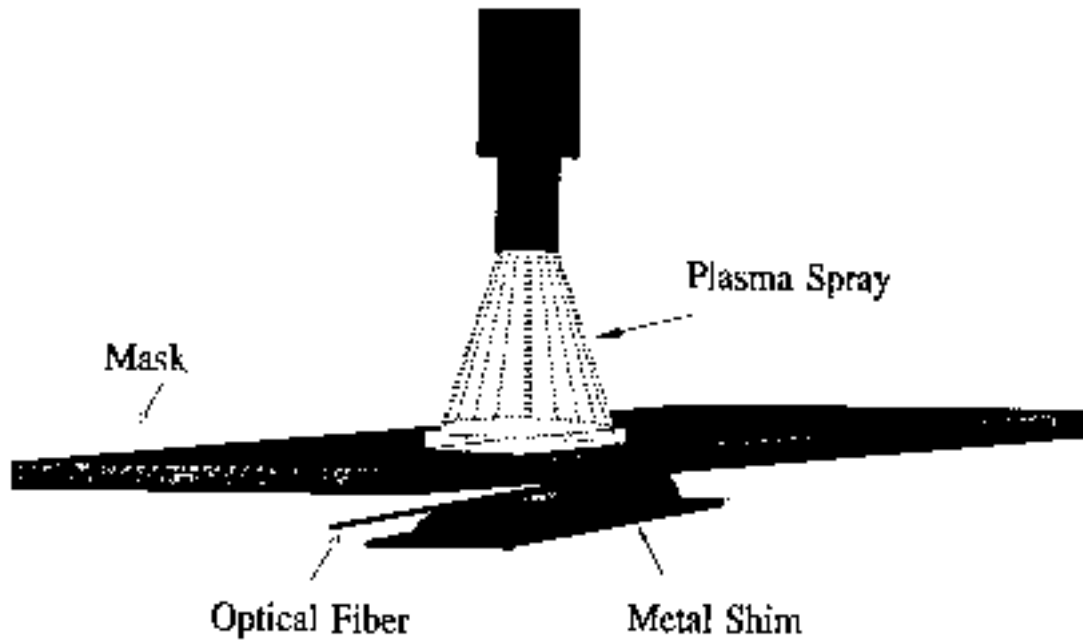
Figure 3-6 Plasma Spray Setup

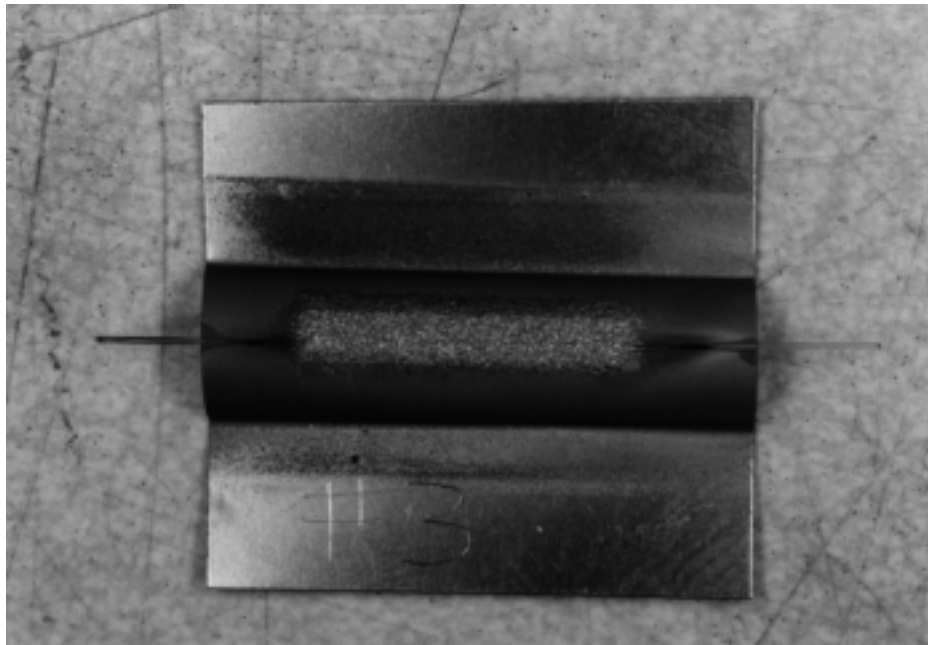
Figure 3-7 Piece of Optical Fiber Attached to Metal Shim by Plasma Spray Method
