# Fiber-Optic Fabry-Perot High-Temperature Strain Measurement System Feasibility Study

TR-107212  
3876-06

Final Report, January 1997

Prepared by  
Mechanical Technology Incorporated  
968 Albany-Shaker Road  
Latham, New York 12110

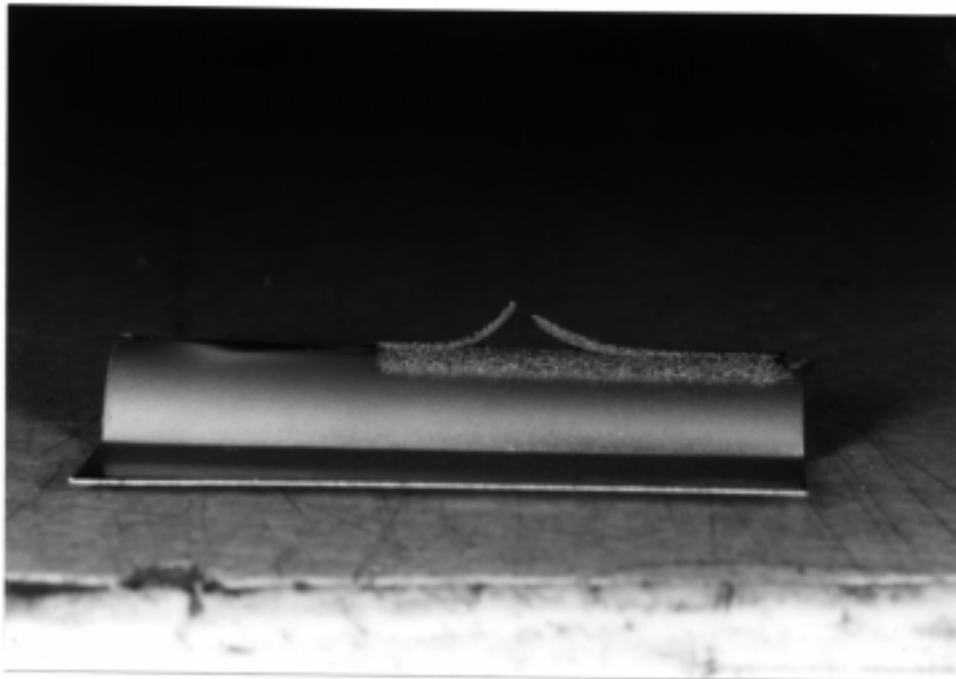
In a final effort, an actual gage was used on a metal tab as shown in Figure 3-8. The results are shown in Figure 3-9. Once again, the weak area in the gage assembly caused a failure, plus the heat caused the gage to curl as shown in Figure 3-9. The glass gage construction method needs to be improved prior to making any more attempts with this technique. The program doesn't have sufficient funds to completely investigate this method. However, since the plasma spray process showed success with bare fibers it is a technique worthwhile investigating in future programs.

Figure 3-9 Results of Fiber-Optic Strain Gage

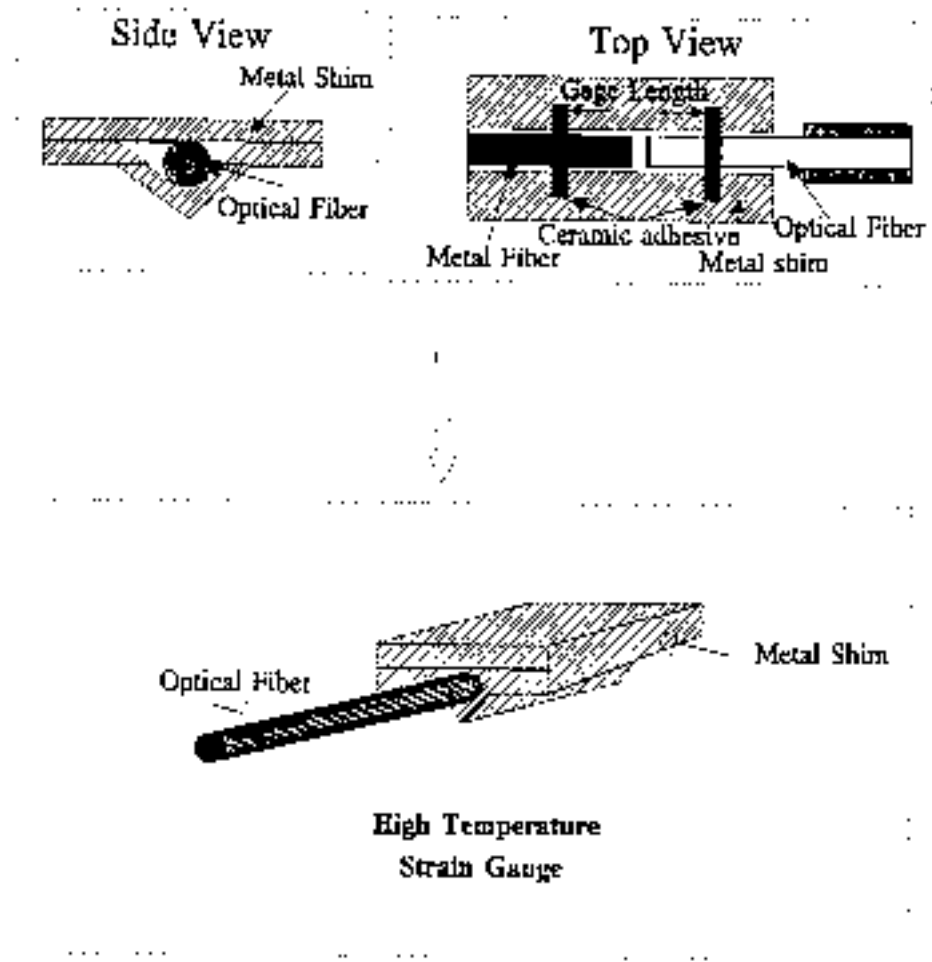
Creating Fabry-Perot sensors directly on the metal shim eliminated the need to attach the glass tube to the shim. The Fabry-Perot strain gages used in this study were constructed by inserting two optical fibers from both ends of a hollow glass tube as shown in Figure 2-3. The transmit/receive fiber and the target fiber, with the end face polished for reflection, were fused to the glass tube. Due to thermal stress, these gages generally failed at the fused joint of the transmit/receive fiber at elevated temperatures.

Figure 3-10 Alternative Concept for Constructing Fabry-Perot Sensors

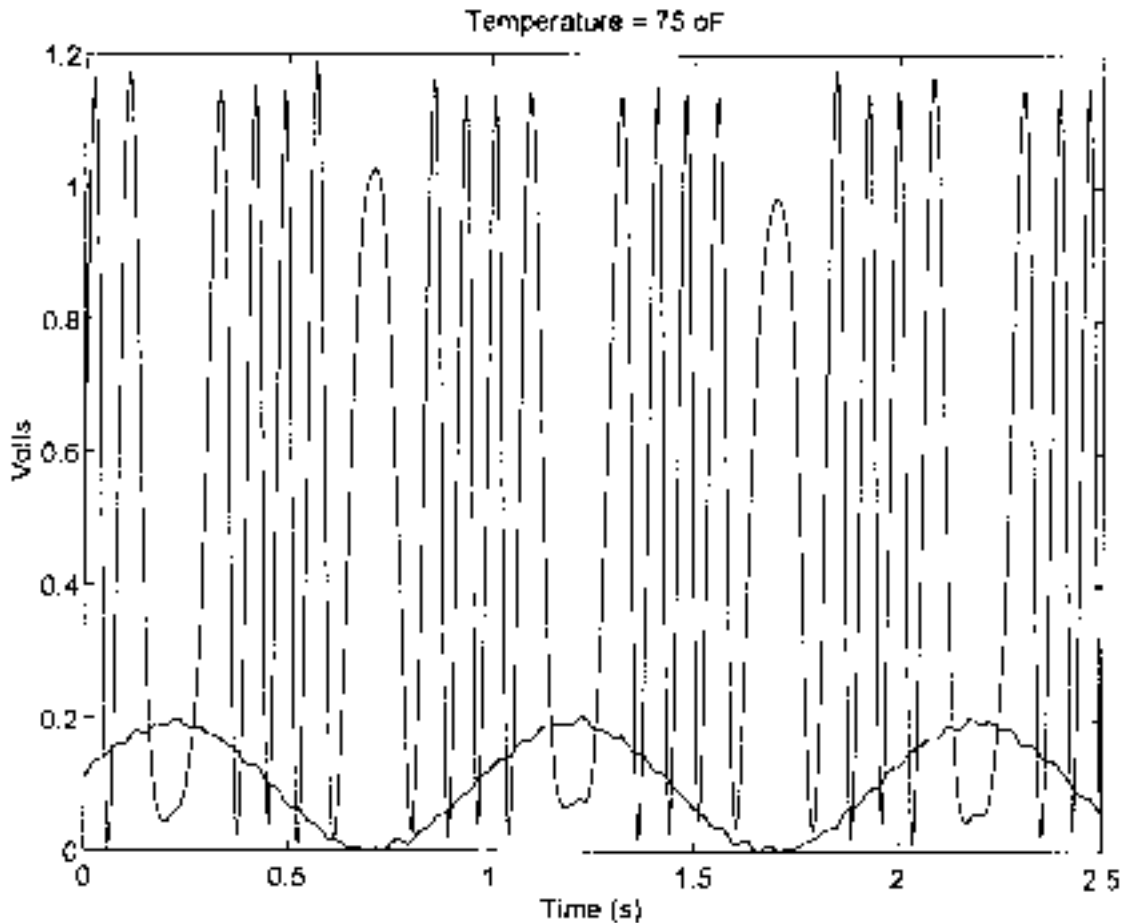
The prototype sensor was attached to a cantilever beam and subjected to an oscillatory strain. Typical data are shown in Figure 3-11. The optical fringes generated from the strain looked very clean and encouraging.

Figure 3-11 Fiber-Optic Sensor Output Illustrating Optical Fringe Movement Due to Sinusoidal Oscillation

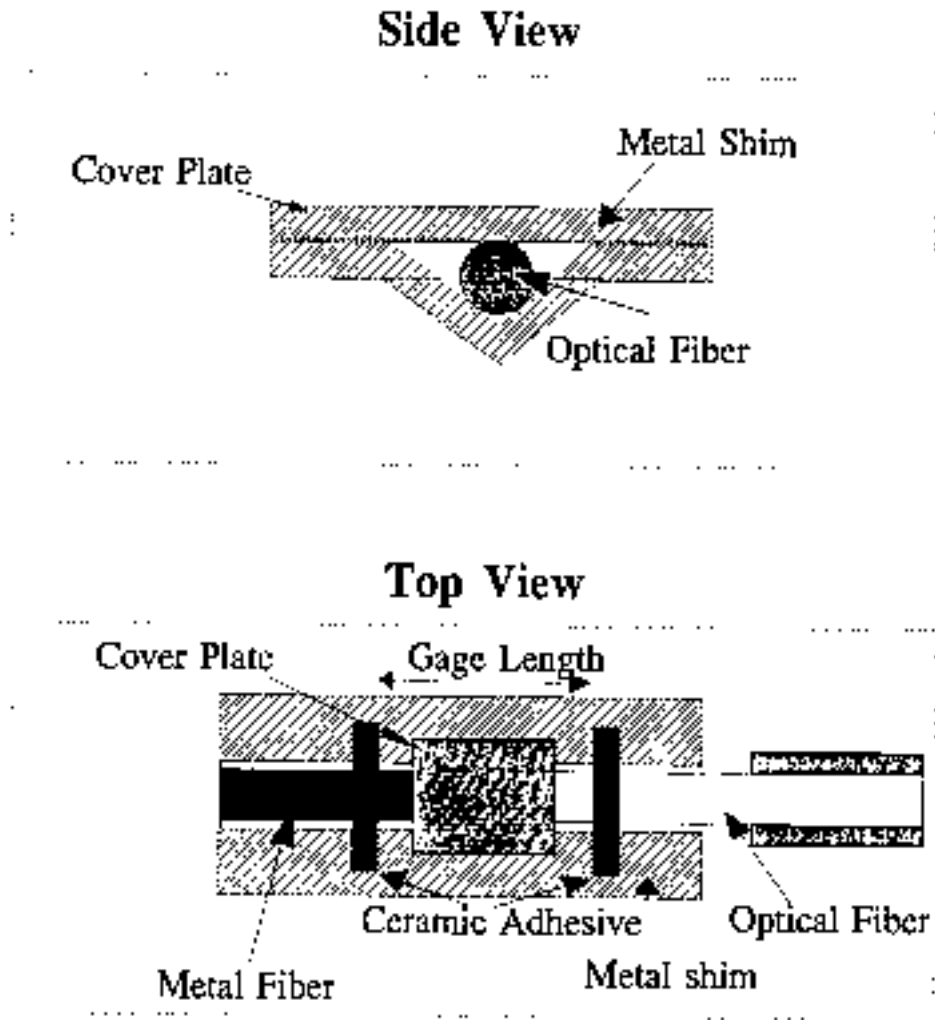
Figure 3-12 Metal Strain Gage

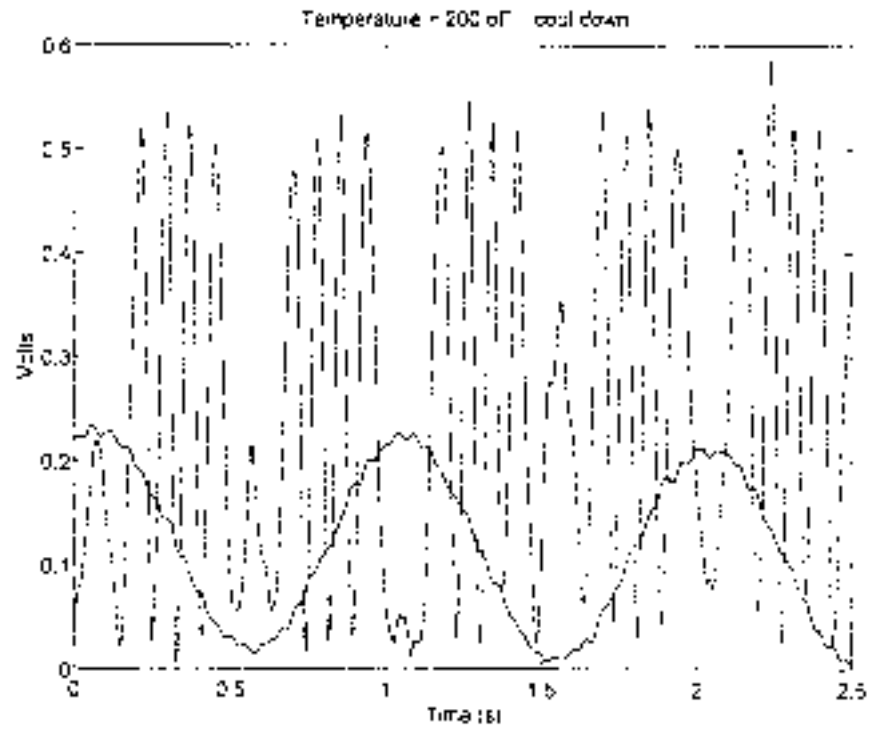
Figure 3-14 Data after cool down to 200°F

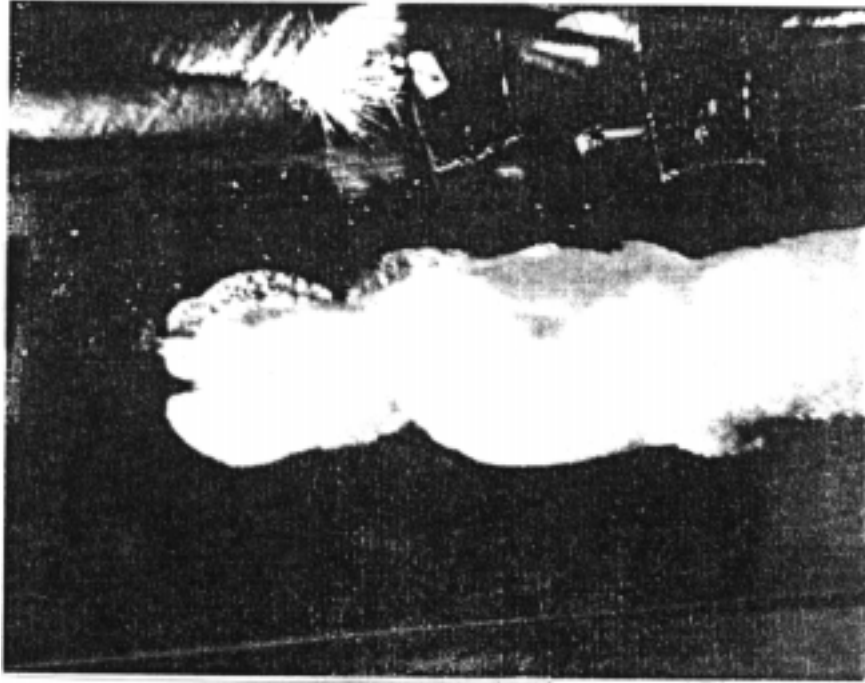
Three small pieces of optical fibers were attached to a steel specimen using the above-mentioned adhesives as shown in Figures 3-17 through 3-19. The specimen was heated up to 600°F (315°C) and allowed to cool down. Only Aremco 571 showed microcracking, as shown in Figure 3-20, and the other two remained intact. Next, the sample was reheated to 1000°F (538°C) and was allowed to cool. Sauereisen #8 started to lift off the specimen while heating up. Duralco 4700 remained unchanged up to 750°F (400°C), then it burned off, which was confirmed by microscope inspection, and the fiber had fallen out as shown in Figure 3-21. Microscope inspection showed the

Figure 3-17 Optical Fiber Attached with Duralco 4700

Figure 3-18 Optical Fiber Attached with Sauereisen #8

Figure 3-19 Optical Fiber Attached with Aremco 571

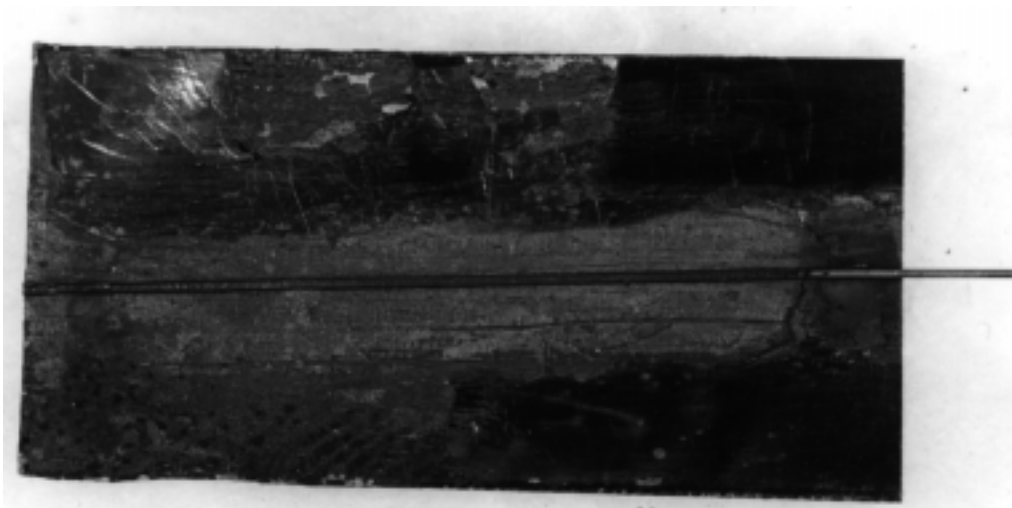
This is a technique that has promise in the long term. The main reason for the limited success with this technique is the robustness of the glass gages. Once the glass gage construction method is improved and their robustness increases this technique should work well. The plating methods and the bracing technique also needs development.

Figure 3-24 Metalized fiber-optic strain gage braced to a metal shim

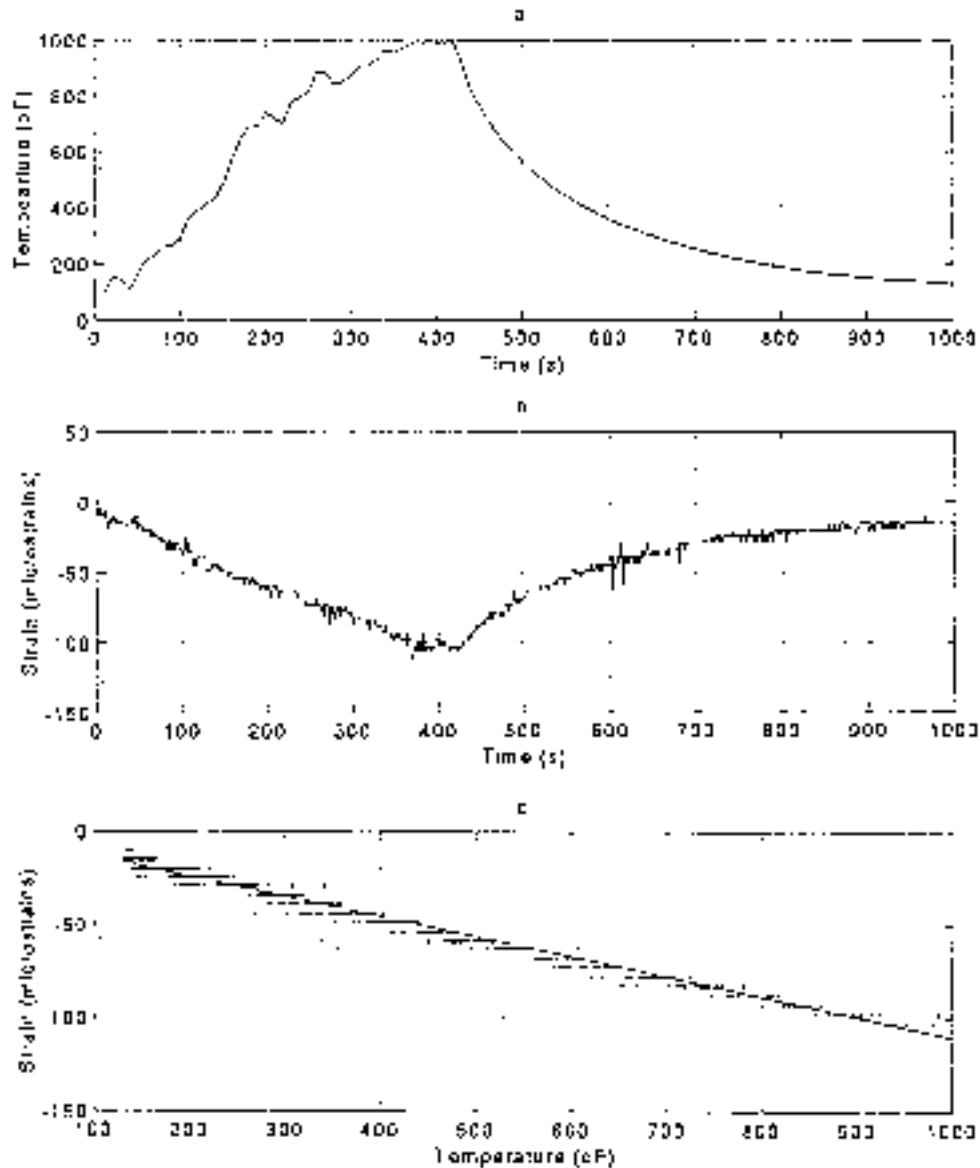
As expected the fiber-optic sensors can easily operate at 1000°F (538°C), however the major hurdle is the attachment method to sense strain. The thermal strain on steel pipes at 1000°F (538°C) is of the order of 6000  $\mu\epsilon$ . This requires the range of the fiber-optic strain sensors to be 0 to 10,000  $\mu\epsilon$ . The current gages have a maximum range of  $\pm 3000 \mu\epsilon$  which means a total measurement range of 0 to 6000  $\mu\epsilon$  is possible, by making the gages with its signal peak placed at the extreme left (corresponding to 0  $\mu\epsilon$ ). However the difficulty is when the gages are attached to a metal with an adhesive it sees a residual compressive strain anywhere from 100 to 2000  $\mu\epsilon$ . This means the peak of the optical signal has to set at the center so that the final gage can see the full range. This is only a short term problem. The gages were improved to  $\pm 5000 \mu\epsilon$  later in the program.

Figure 3-25 Thermocouple and Sensor Readings

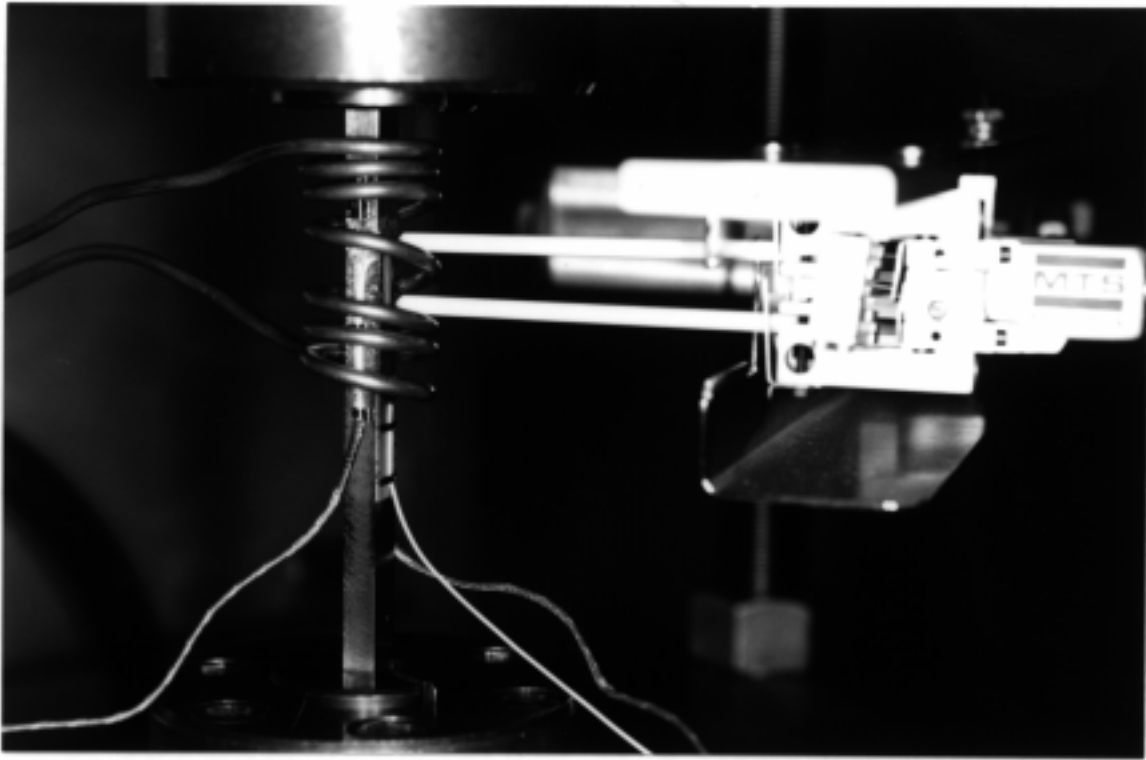
INVAR. This specimen material was chosen so that the thermal strain at the maximum temperature did not exceed the measurement range of the current strain gages. A fiber-optic strain gage ( $\pm 3000 \mu\epsilon$ ) was mounted on a tension specimen using the Cotronics cement (rated for 650°F [345°C] for long term). Figure 3-26 shows a photograph of the specimen set up on an MTS machine. The high-temperature, 0.5-in (1.27 cm) gage length extensometer was placed at the same location as the fiber-optic strain gage but on the opposite side of the specimen.

Figure 3-26 High Temperature Strain Measurement Setup

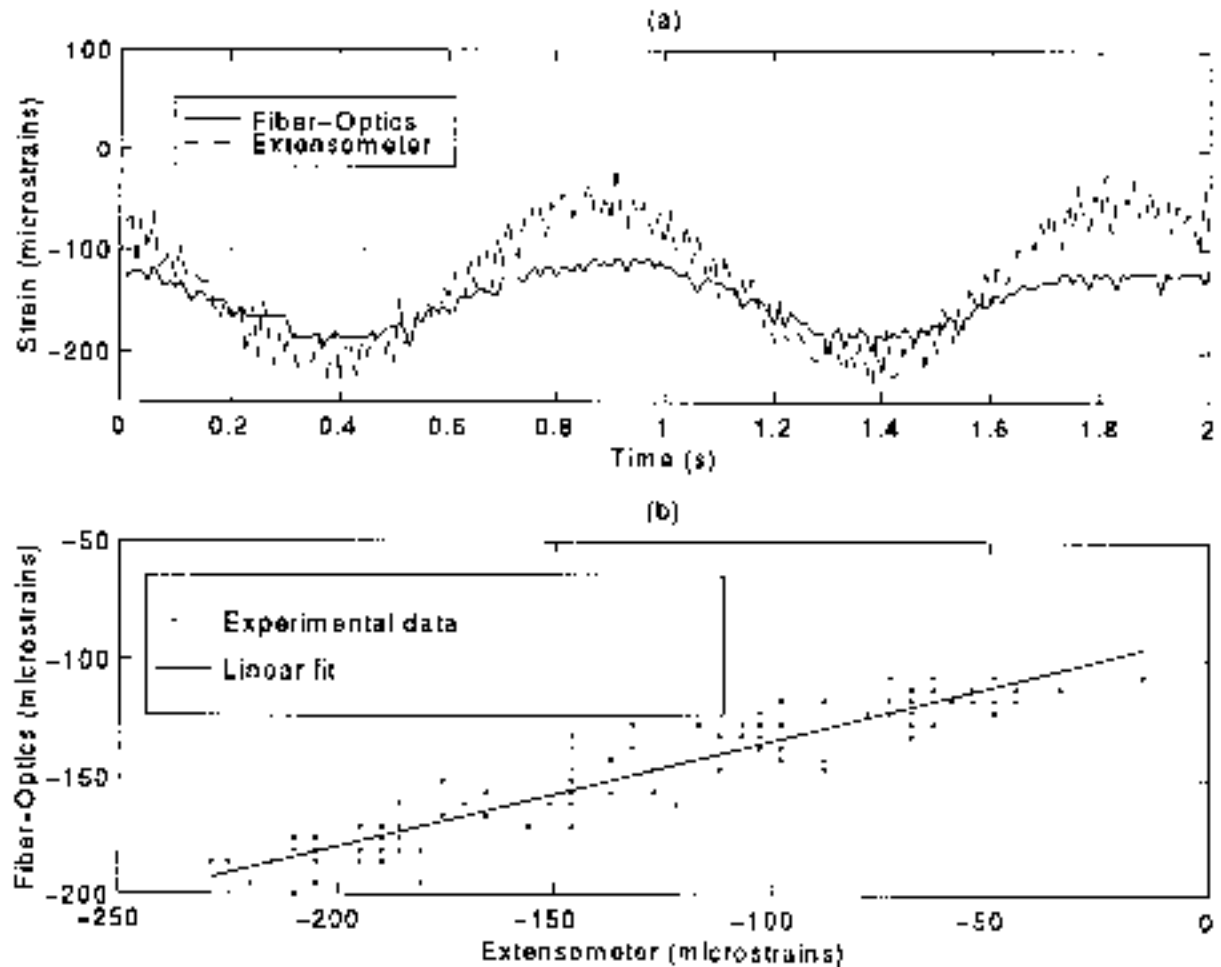
Figure 3-27 a) Strain Values Measured Using the Fiber-Optic Strain Gage and the Extensometer b) The calibration plot

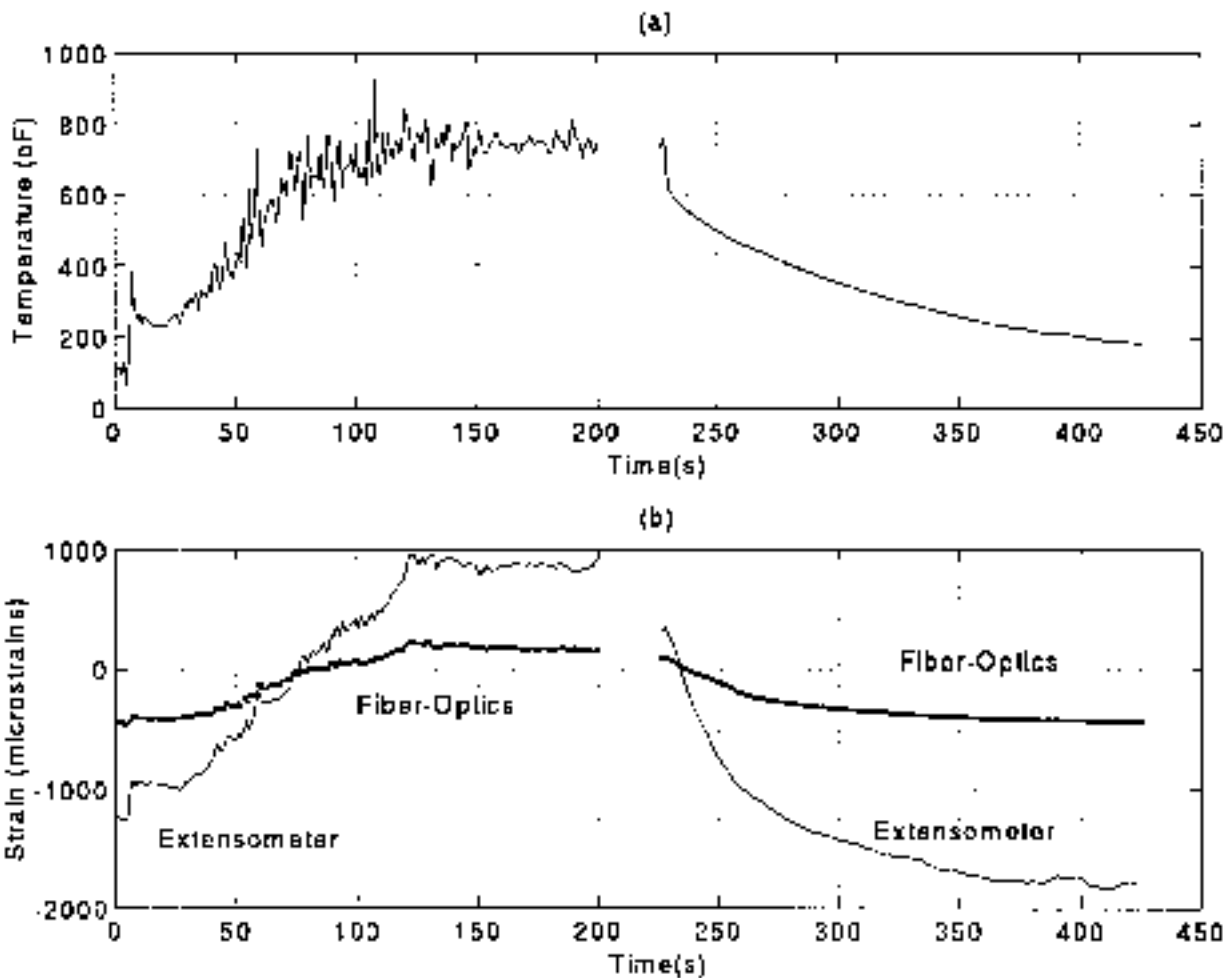
respectively. The values are in good agreement with the previous cyclic loading value.

Figure 3-28 a) Thermocouple Reading b) Fiber-Optic Sensor and Extensometer Readings

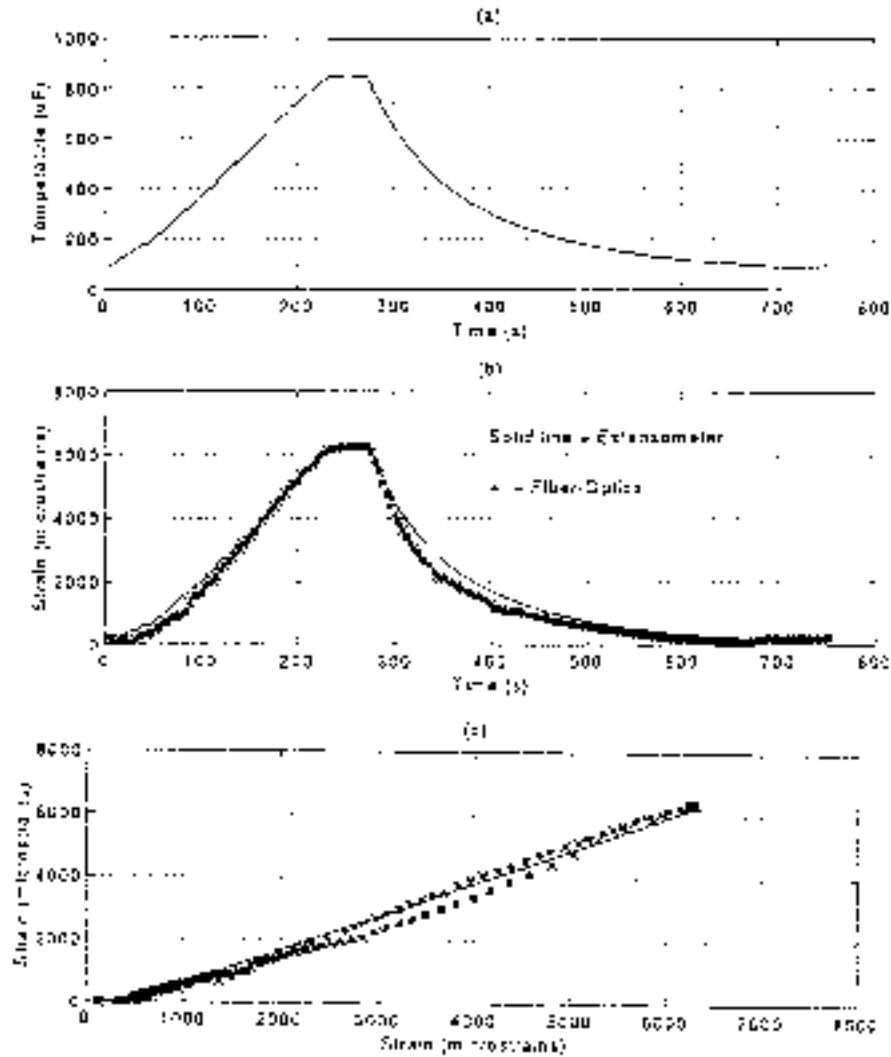
A  $\pm 3000\ \mu\epsilon$  fiber-optic strain gage was attached to a steel specimen using Sermetel 588 and tested up to 1000°F (538°C). The sensor survived the temperature and the attachment cement did not show any cracking or debonding. As mentioned earlier, this cement is the ideal candidate for strain gage packaging. However, more testing is needed to fully characterize the physical properties of the ceramic coat. Figure 3-29 shows the thermal strain sensed by the high-temperature extensometer and the strain gage. The sensor data matches the extensometer reading at higher temperatures (400 to 1000°F) (205-538°C), but shows deviation at lower values (less than 200°F [93°C]). Since the gage range was not sufficient to measure the total strain, the fiber-optic sensor saturated off around 4200  $\mu\epsilon$ . The 4200  $\mu\epsilon$  was achievable because the gage showed a substantial amount of residual strain during the curing stage of the ceramic coat.

Figure 3-29 Thermal strain sensed by the extensometer and the fiber-optic strain gage (attached with Sermetel 588)

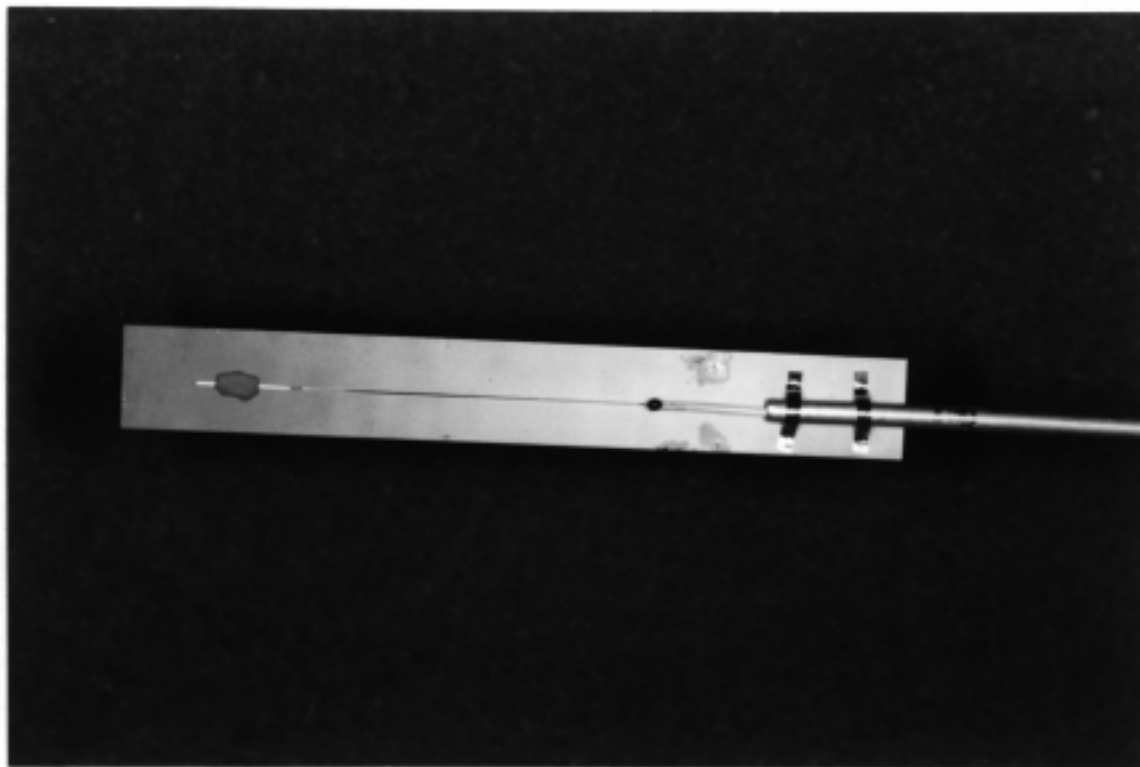
Two spot-weldable strain gages were constructed in the laboratory. Figure 3-30 illustrates the gage bonded to a stainless steel shim with the ceramic coat. These gages were calibrated in the laboratory by placing them in an oven. Figure 3-31 shows the calibration curve for one of the gages and the nonlinear response. One reason for this behavior could be the thermal expansion characteristics of the ceramic coat used to adhere the gages to the metal shim. The manufacturer's data sheet indicated that the mean thermal expansion coefficient for this ceramic coat is  $5 \times 10^{-6}$  and  $8.7 \times 10^{-6}$  for the first cycle and temperature exposure for the second cycle. The thermal expansion versus temperature plot from the manufacturer's data sheet is shown in Figure 3-32. As this plot indicates, the heating and cooling are not the same. Further, thermal expansion below 200°F is very nonlinear, but, from 200 to 1000°F (95 to 538°C), is very linear. This could partly explain the nonlinearity in the gage calibration under 200°F (95°C) and the hysteresis. Further work is needed to characterize the ceramic coat.

Figure 3-30 Gage Bonded to Stainless Steel Shim with Sermetel 588 (ceramic coat).

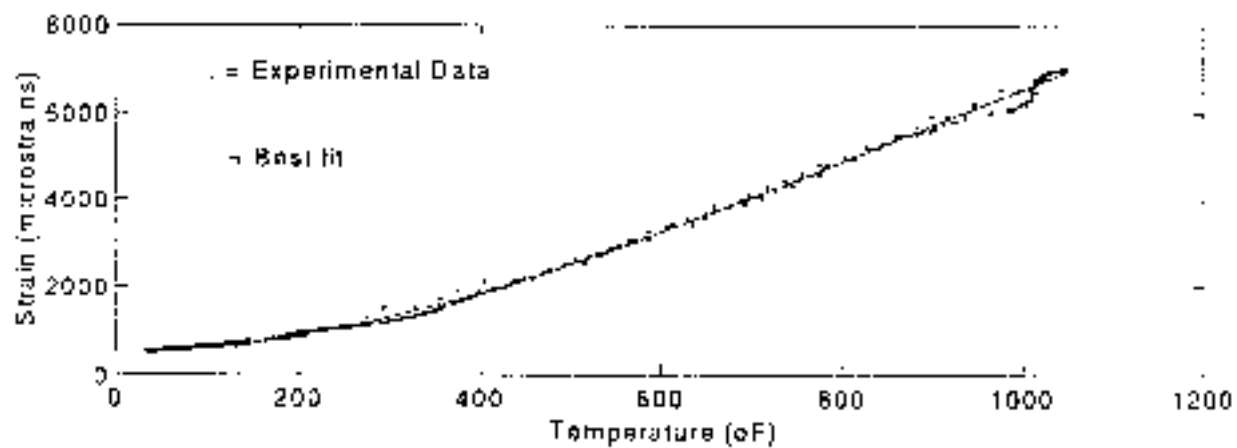
Figure 3-31 Calibration Curve for the High-Temperature Gage (attached with Sermetel 588)

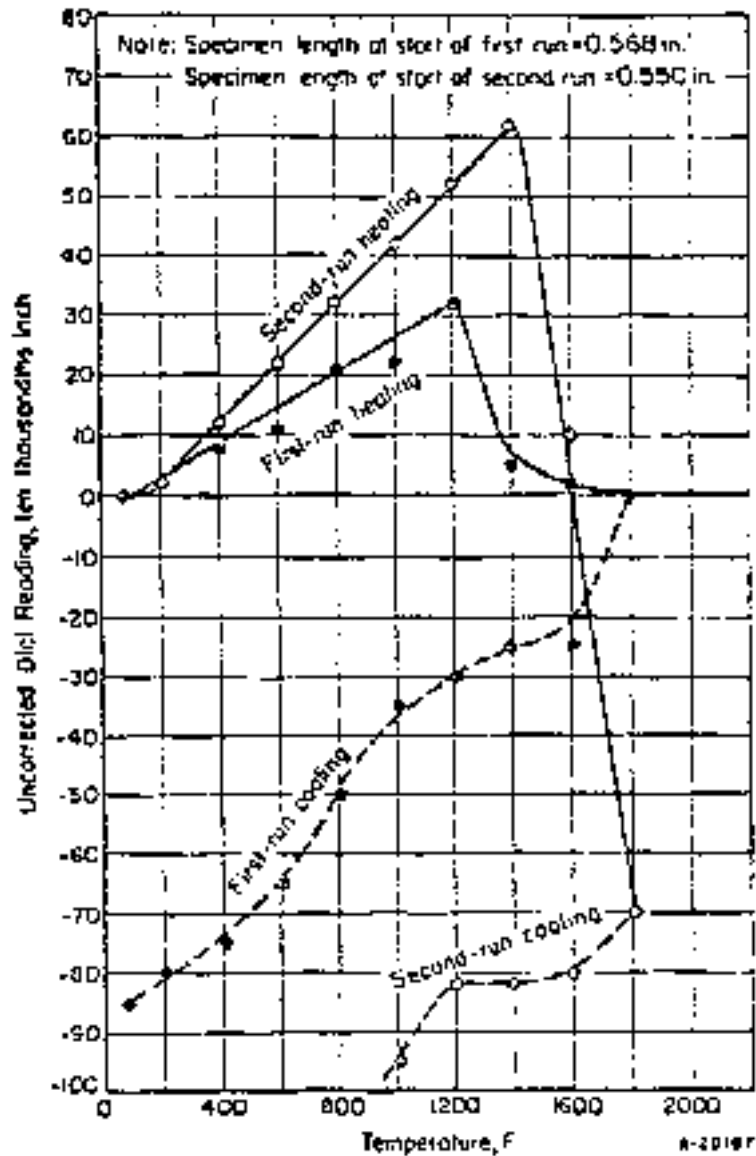
Figure 3-32 Thermal Expansion versus Temperature Plot for Sermetel 588 (manufacturer's data).

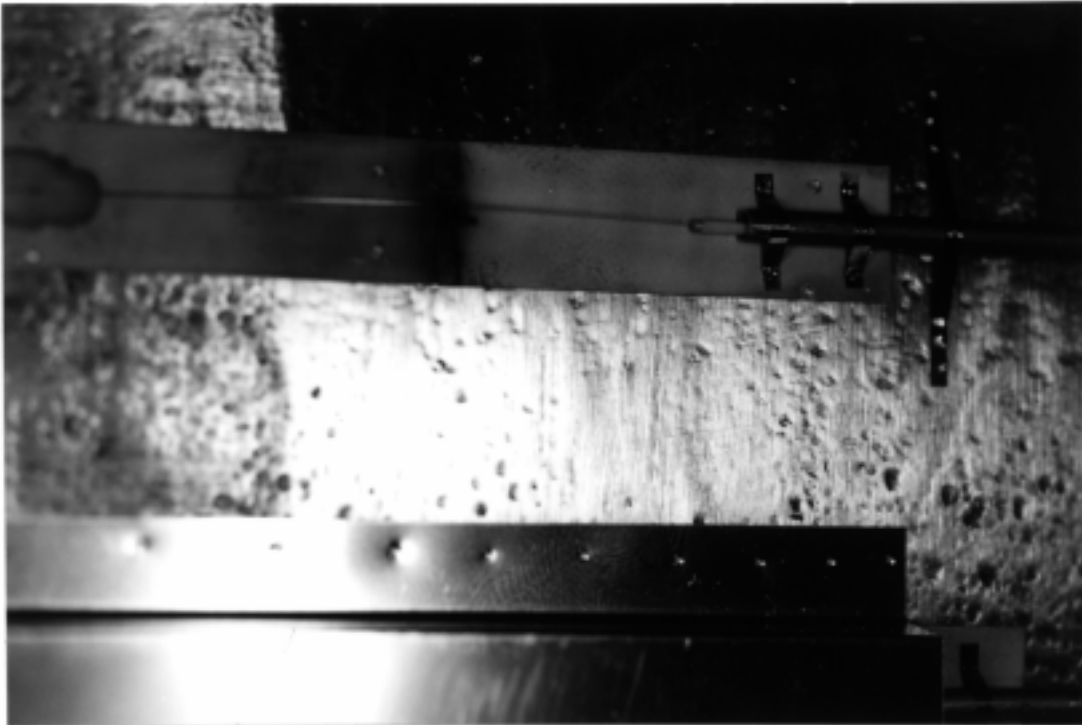
In December 1994, the two gages were spot welded on the main steam line in the longitudinal direction. During this period, the insulation of the steam pipes was being replaced, and this short window was the opportunity to install the gages. Figure 3-33 illustrates a gage after attachment to the pipe, and Figure 3-34 illustrates a protective cover placed over the gages. The lead-in section of the fiber had a stainless-steel tubing around it. As shown in the photographs, the tube was bent to bring the fibers out of the insulation area. Once the gages were installed, the pipe was covered with 10 in. (25.4 cm) of insulation. The optical fibers (terminated with ST-type couplers) were tied to a support bar close to this location. Two fiber-optic extension cables (roughly 50-ft [15 m] long) were used to connect the gages to the sensor demodulator. This arrangement is illustrated in Figures 3-35 and 3-36.

Figure 3-33 Fiber-Optic Strain Gage after Attachment to Steam Pipe

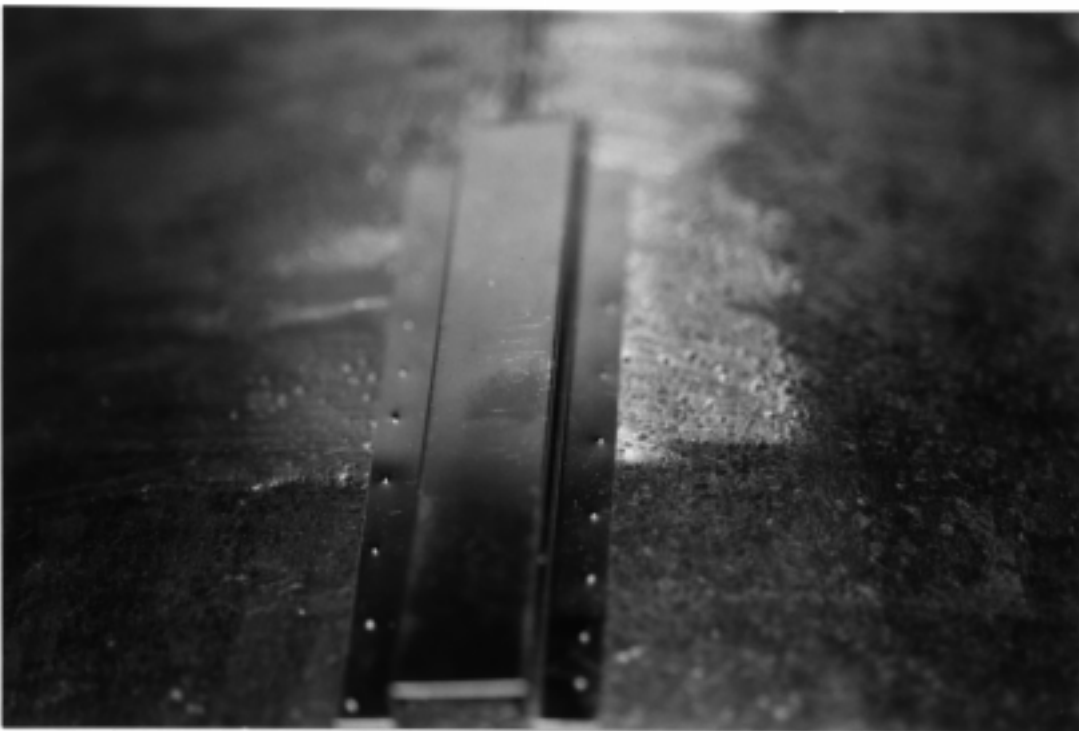
Figure 3-34 Protective Cover Placed over Gages

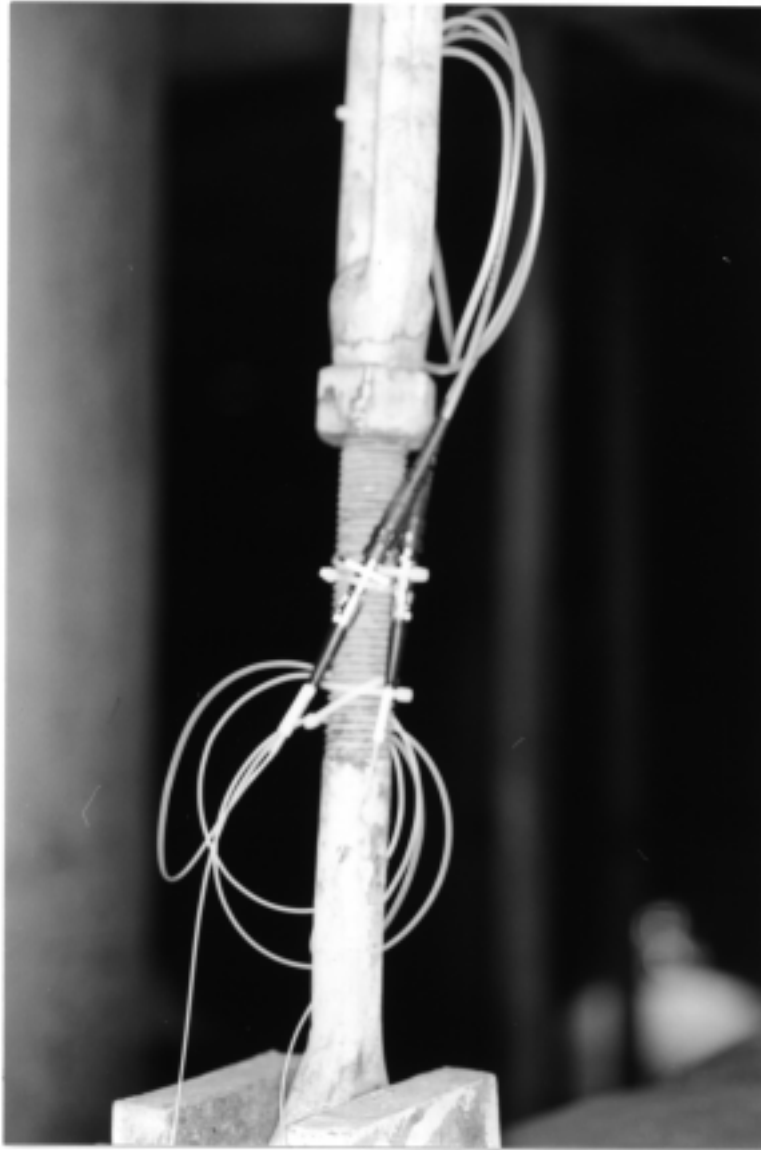
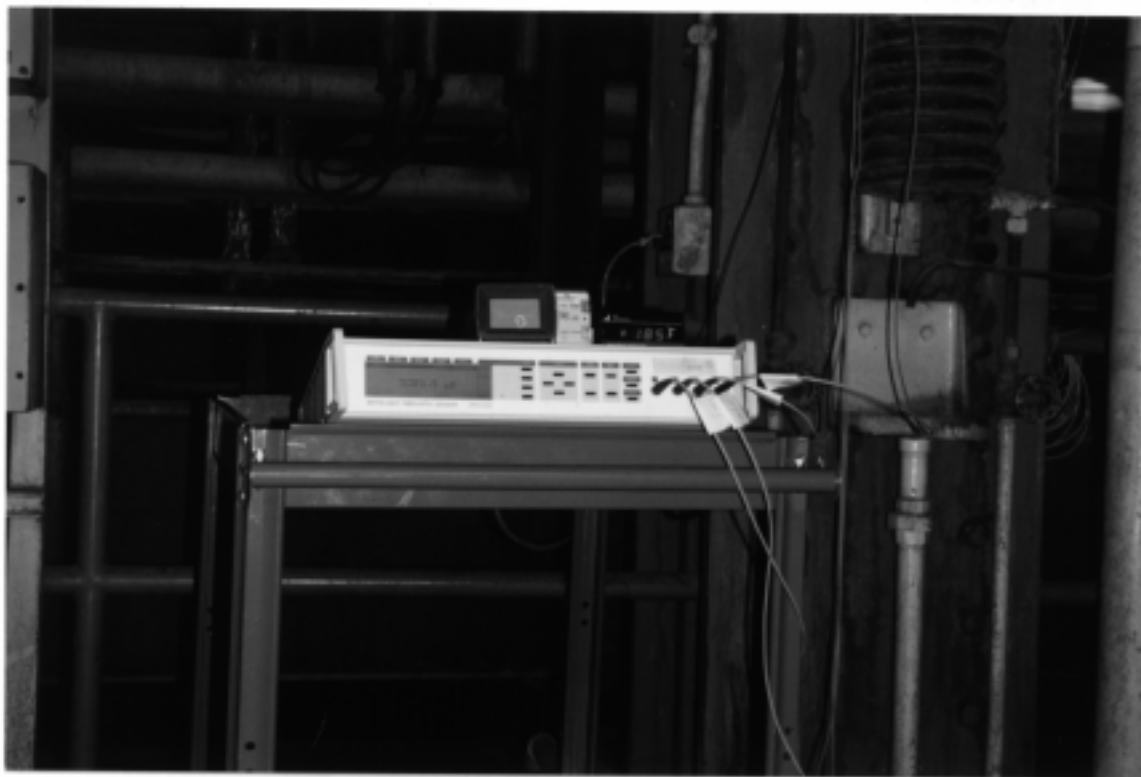
Figure 3-35 Fiber-Optic Extension Cables Connecting Gages to Sensor Demodulator:  
View 1

Figure 3-36 Fiber-Optic Extension Cables Connecting Gages to Sensor Demodulator:  
View 2

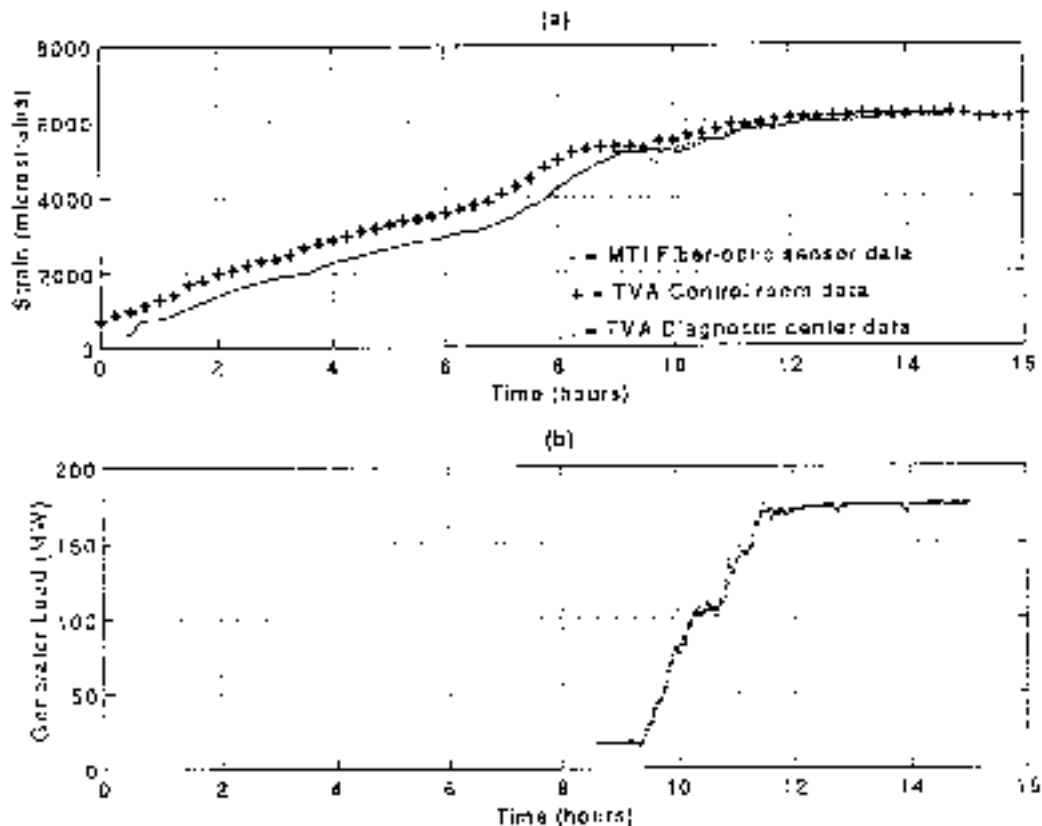
The fiber-optic strain gages were mounted in the axial direction on the steam pipe. Thus it is reasonable to assume that most of the strain seen by the gages was due to thermal expansion. Using the calibration value obtained during the laboratory calibration for the stainless steel shim, the fiber-optic strain value was converted to temperature value. This conversion is shown in Figure 3-37. It is evident from Figure 3-

37 that the fiber-optic sensor data lags the estimated strain data during the initial warm-up period and slowly catches up to the final steady-state value at about 1000°F (538°C). By the time the generator was producing maximum load, the fiber-optic sensor data matched well with the data estimated from the power plant temperature sensors. The initial lag for the fiber-optic data is probably due to the fact that these gages were mounted on the outer surface of the steam pipe and it took a while for the metal to heat up to the equilibrium temperature. Where as the temperature sensors were in the steam path and were measuring the steam temperature directly.

Figure 3-37 Host utility test data.

The gages performed very well up to the operating temperature of the steam pipe (1050°F [566°C]). However, they did not survive the long-term testing, and the reason for this is not known. A lack of funding under this project prevented further work, but a similar task was performed under EPRI project WO3462-01. In this project, the thermal expansion of a stainless steel rod was used to measure temperature and the gages survived the long-term testing. However, the temperature of this test was only 650°F (345°C). Although it is not the same environment, it did prove that the gages have the potential to survive long term at high temperatures. In order to derive more conclusive results, further testing is needed to characterize the gages.

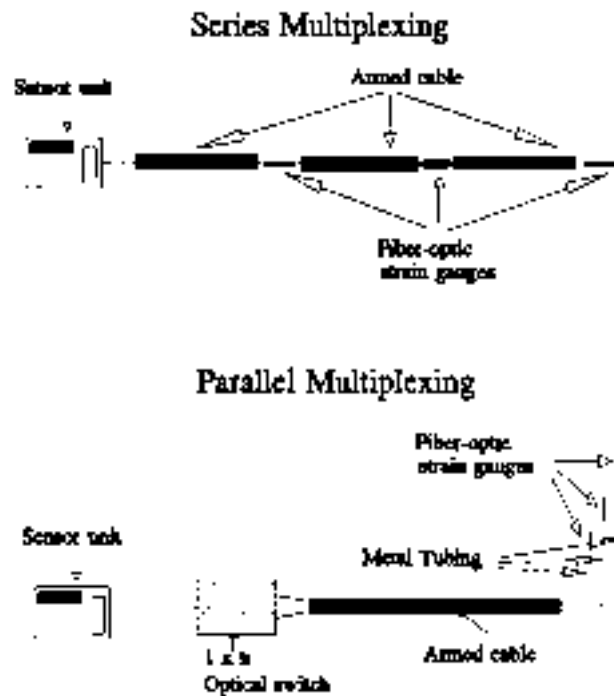
As shown in Figure 4-1, fiber-optic sensors can be multiplexed in series or in parallel to obtain information from several sensing locations. Both methods have their merits and limitations. Series multiplexing may appear attractive because it uses only one optical fiber to carry information to and from the sensors. However, if one gage fails, the sensors beyond this point will not provide information. On the other hand, if the sensors are multiplexed in parallel, all gages except the failed one would provide information. The trade-off for parallel multiplexing is that every sensor needs a lead-in optical fiber to transport information to the electrooptics. For the high-temperature application of interest here, this requires that the lead-in fibers be ruggedized to survive the environment. Therefore, the optical fibers have to be placed inside an armed cable. In general, several (20 to 30) optical fibers can be placed inside one of these cables. For this reason, the size of the cable does not change whether a single optical fiber for a lead-in cable (series multiplexing) or 20 fibers (parallel multiplexing) are used.

Figure 4-1 Schematic of fiber-optic sensor multiplexing schemes

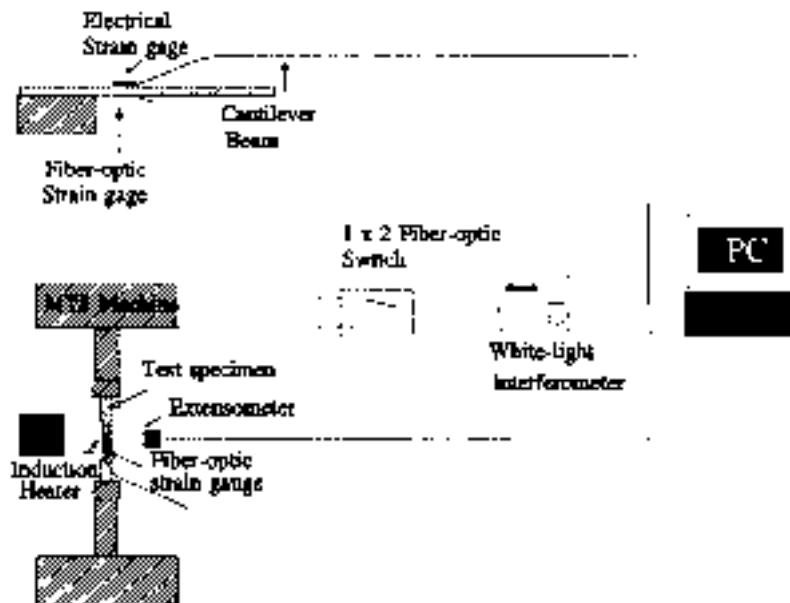
optic switch was operated at 2 Hz, and the scan rate for the data acquisition was also set at 2 Hz.

Figure 4-2 Experimental setup for sensor multiplexing

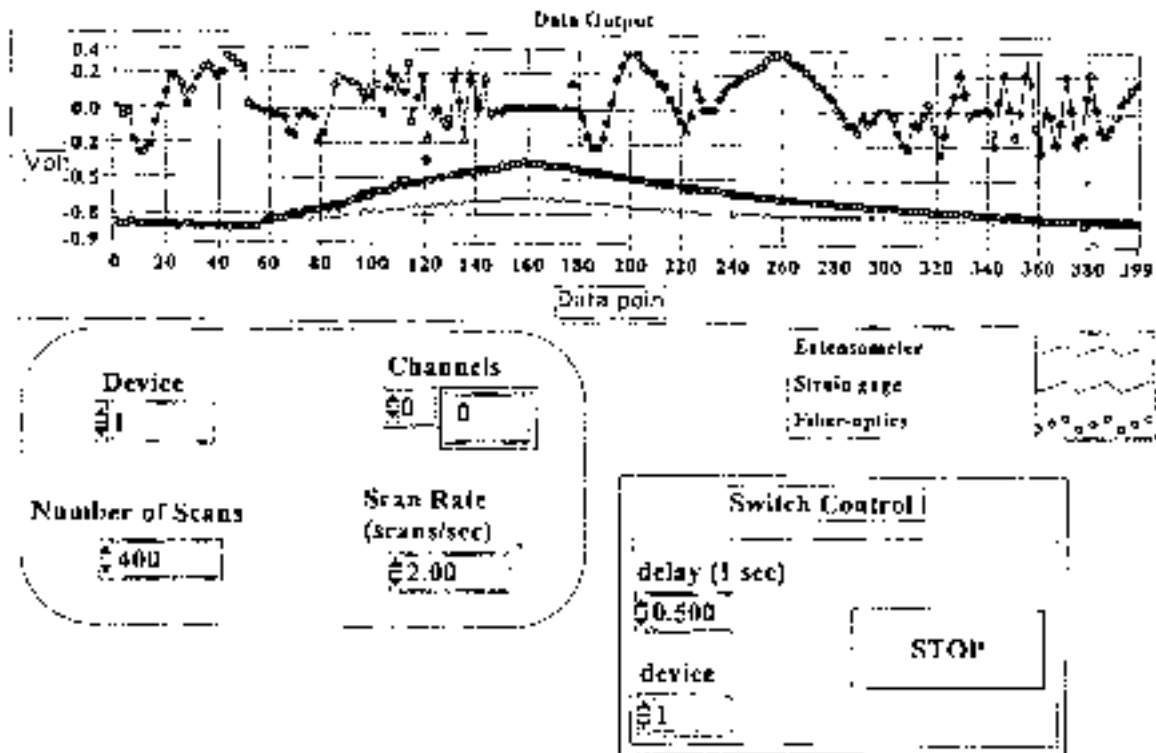
As shown in Figure 4-3, data from the fiber-optic matched well with data from the electrical strain gage. In addition, the fiber-optic gage measurement of thermal strain showed a higher value than the extensometer. The reason for this discrepancy is that the two fiber-optic strain gages used in the experiment were not identical and had different gage lengths. The sensor unit would allow only one gage length to be inserted at a given time. Therefore, the gage factor (or calibration factor) was inserted into the data after the fact.

Figure 4-3 Front Panel of Data Acquisition System
