# Fiber-Optic Fabry-Perot High-Temperature Strain Measurement System Feasibility Study

TR-107212  
3876-06

Final Report, January 1997

Prepared by  
Mechanical Technology Incorporated  
968 Albany-Shaker Road  
Latham, New York 12110

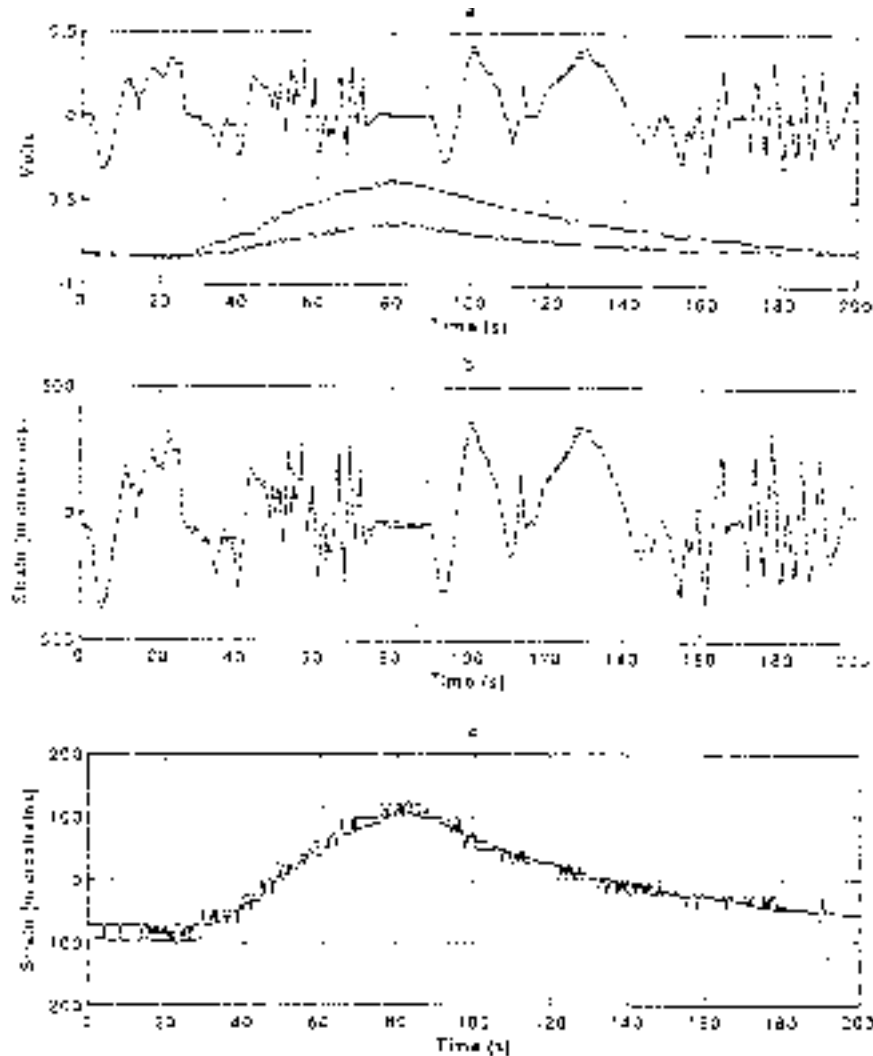
Figure 4-4 illustrates the cumulative signal and the separated signals generated during the experiment. As these plots indicate, the fiber-optic sensor data matches well with the electrical strain gage signal and the extensometer signal. It is also evident in these plots that the fiber-optic sensor occasionally picks up an erroneous data value caused by noise in the system. The noise introduced during switching is one reason that faster switching between the two fiber-optic sensors is not possible.

Figure 4-4 Cumulative Signal and Separated Signals  
 a. Cumulative data from four sensors  
 b. Processed data for the cantilever beam sensors  
 c. Processed data for the thermal strain specimen  
 (dots represent the fiber-optic sensor data)
