EPRI TR-108132  
Final Report  
January 1998

# On-Line Welding Repair for Leaking Pipe Components

Process leakage from cracked socket welds and leaking threaded connections during plant operation can lead to unscheduled shut-downs and loss of revenue to power plant owners. On-line repair methods have been developed to provide permanent repairs without taking the system off-line or isolating the leaking component. A temporary repair method to seal leaking threaded end caps has been developed that can be used to stop the leakage until the next scheduled shutdown when a permanent repair can be made. This report provides well-documented and demonstrated welding methods and procedures to repair cracked socket welds and leaking threaded connections on-line and under pressure.

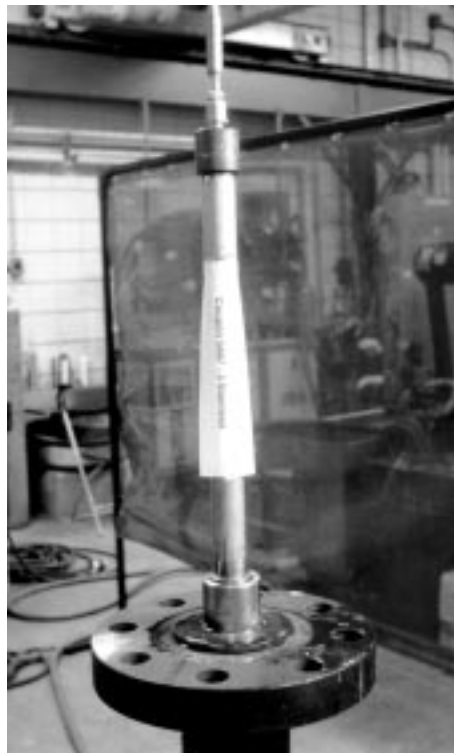
Figure 3-1  
Assembled Mockup

A pressurized test fixture was fabricated for weld parameter development. The fixture was designed to hold the test coupons at a comfortable height for welding. Provisions were made to attach a hydraulic pump to the test coupons in order to maintain a positive internal pressure and water level during the repair sequence. The mockup is shown in Figure 3-1. The SC Hydraulic power unit pump used during testing is pictured in Figure 3-2. The mockup assembly is described in Appendix A.

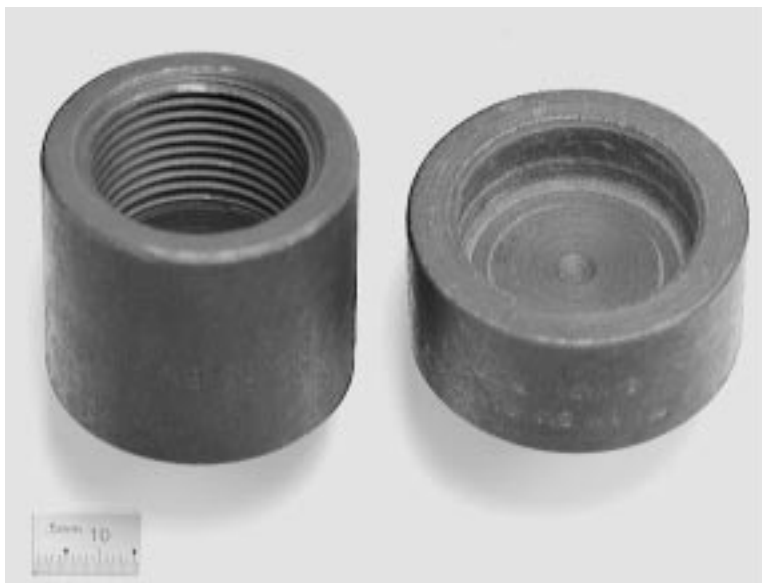
Figure 3-3  
Carbon Steel Threaded and Socket End Caps

The weld coupons were made using one-inch Schedule 80 A106 carbon steel and A312 304 stainless steel pipe. Threaded pipe caps and socket end caps of carbon steel and stainless steel material were used (see Figure 3-3). The pipes were cut to a length of 18 inches and threaded on one end to accept the pressure fitting for connection to the hydraulic pump. The pipes to be used with the threaded end caps were also threaded on the opposite end to accept the threaded pipe caps. For the pipes used with the socket end caps, the sockets were attached to the pipes by welding using the GTAW process.

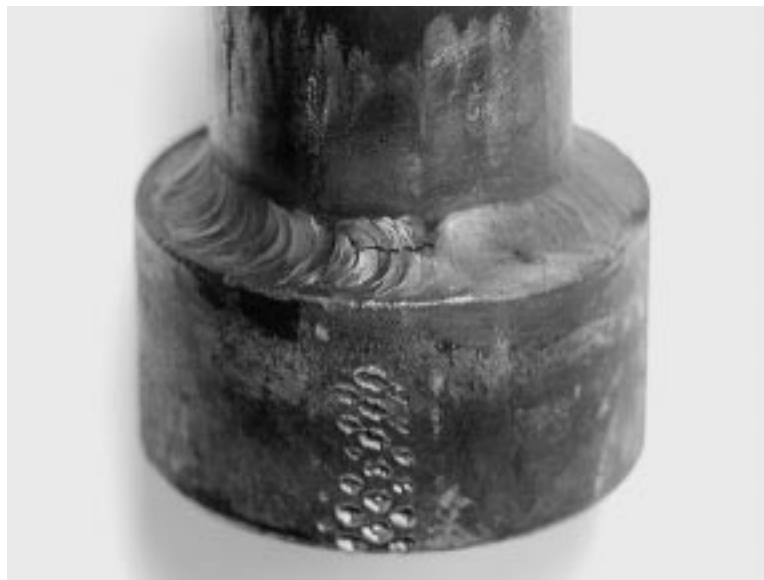
Figure 3-4  
 Fatigue-Induced Crack in Socket Weld

The fatigue crack in the socket welds was created by welding a small portion of the socket weld (approximately 1/2"). The socket end of the weld coupon was then clamped in a vice, and the weld was cracked by flexing the pipe back and forth (see Figure 3-4). Then, the remainder of the root was welded so that the capped pipe could be filled with water and pressurized.

This test was done on a carbon steel socket welded coupon with a fatigue-induced flaw in the weld (see Figure 3-4). The pipe was pressurized to 150 psi and water began leaking from the flaw. The metal above and below the crack was peened toward the crack, and peening was done directly on the crack location in order to thoroughly seal the water leakage. Repair welding was performed using the SMAW process, reverse polarity, and a Sandvik E309L-16 electrode. One weld bead was placed directly over the peened crack, and a second bead was placed above the first pass. Figure 4-5 shows an overall cross-section of the weld coupon with the weld repair. Figure 4-6 shows a cross-section of the fatigue crack sealed by welding.

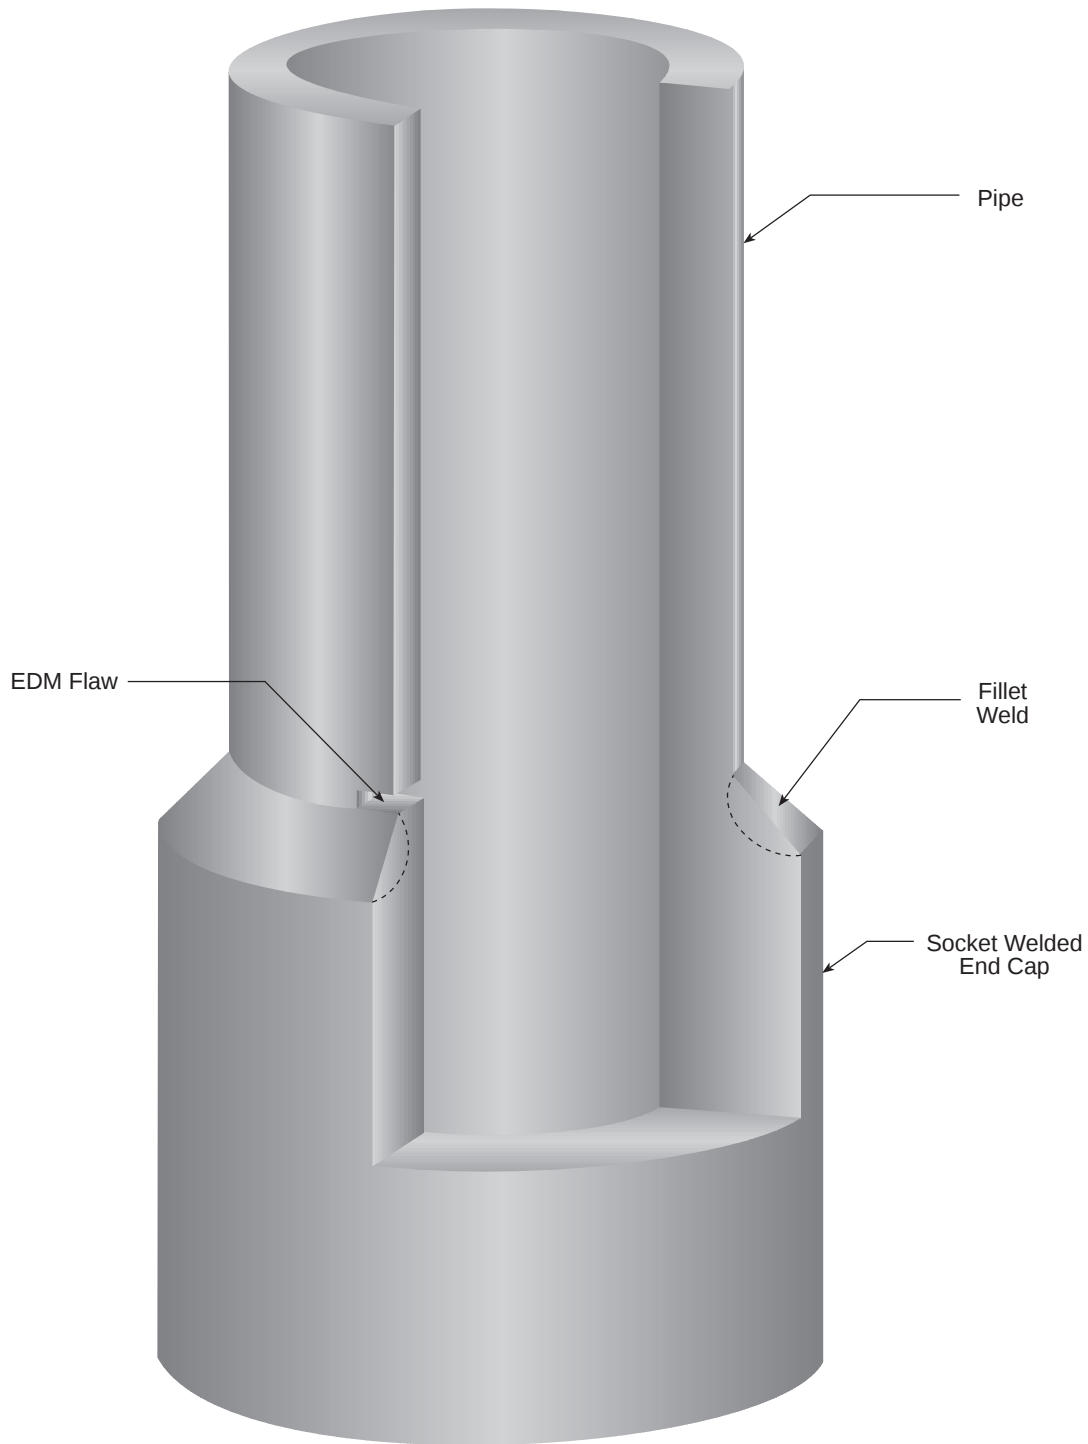
Figure 3-5  
Placement of EDM Notch in Socket Weld Coupons  
(Flaw Size Is Exaggerated)

Another method used to place flaws in the socket weld coupons was electrical discharge machining (EDM). The placement of the flaw is shown in Figure 3-5. The size of the notch was 0.010" wide by 0.250" long through the pipe wall at the toe of the socket weld.

The weld test coupon was flawed by placing an EDM notch through the pipe wall at the fillet weld joining the end cap to the pipe (see Figure 3-5). The mockup was pressurized to 150 psi. At this pressure, the water leakage from the EDM flaw was visible as a spraying stream (see Figure 4-1).

The weld coupon for Test SSS-1 was flawed by placing an EDM notch through the pipe wall at the fillet weld joining the end cap to the pipe (see Figure 3-5). The weld coupon was pressurized to 150 psi. Welding on the leaking socket end cap was done using the SMAW process, AC polarity, and a Sandvik ER309L-16 electrode. Before any welding was done, the peening gun was used to mechanically deform the metal around the leaking flaw and close the leak. Then, a weld bead was placed slightly below the flaw location. The shrinkage caused by welding re-opened the leak and peening was again used to stop the water flow. A second weld bead was placed directly over the flaw, and no water leakage was observed. A third weld bead was placed slightly below the second bead to cover the peening marks, and no water leakage was observed. Figure 4-16 shows the EDM flaw sealed by welding (magnified 10x).

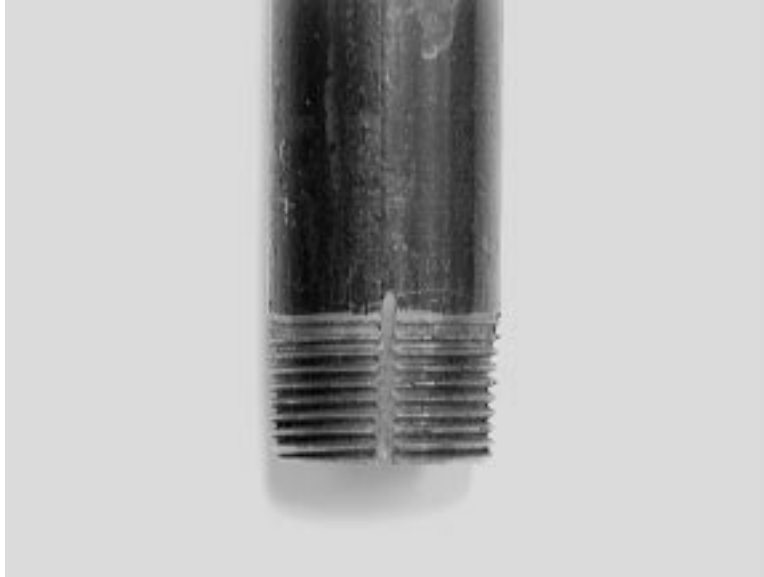
Figure 3-6  
Groove Cut in Threads to Induce Water Leakage

On the threaded end cap coupons, water leakage was induced by placing a groove in the pipe threads. Initially, the grooves were machined to exact dimensions of 0.014" wide by 0.062" deep extending nearly the length of the threads. For later tests, the grooves were made using a pneumatic wheel grinder with a wheel thickness of 1/16" (see Figure 3-6). Use of the grinder made it possible to place the flaw in the threads more quickly and more easily than by machining.

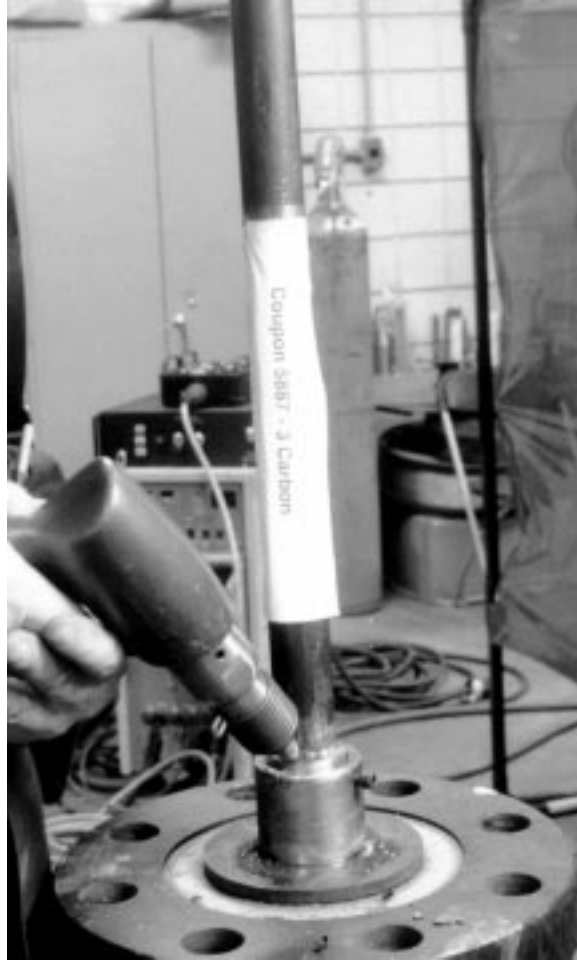
Figure 4-2  
Mechanical Peening of Socket Weld

Welding on the leaking socket end cap was done using the SMAW process, AC polarity, and a Lincoln E7018 electrode. Based on results from previous RRAC programs, welding over flowing water would not be successful; thus, mechanical peening was performed on the flaw to plastically deform the metal around the flaw and stop the leak (see Figure 4-2) [1,2].

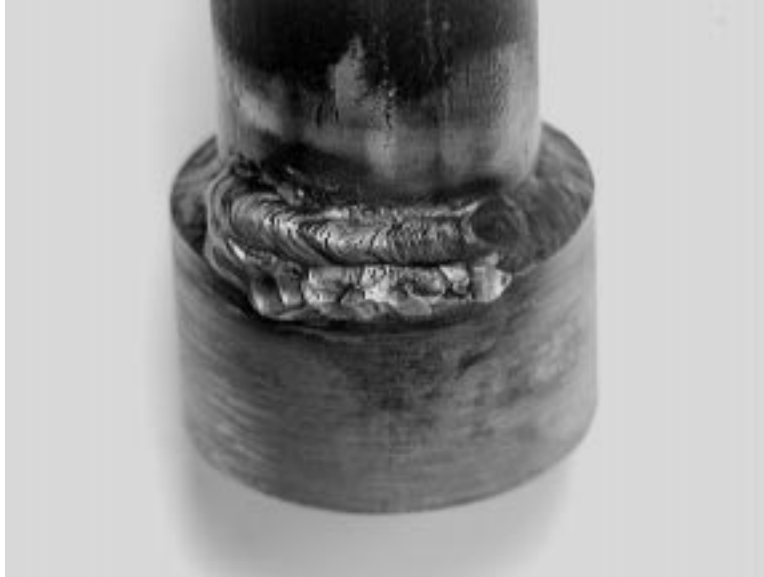
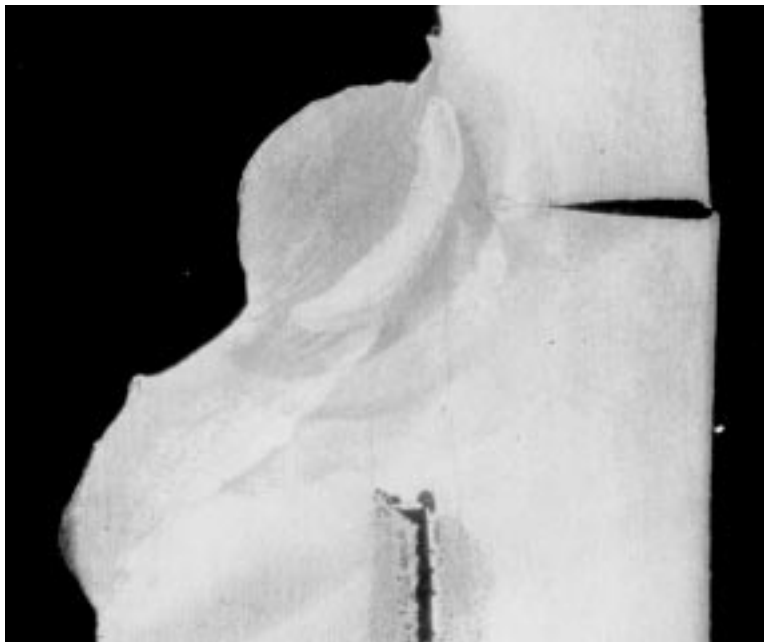
After mechanical peening, a weld bead was placed slightly below the flaw location. The shrinkage caused by welding re-opened the leak and peening was again used to stop the water flow. A second weld bead was placed directly over the flaw, and no water leakage was observed. A third weld bead was placed above the second bead, and again, no water leakage was observed (see Figure 4-3). Figure 4-4 shows a cross-section of the repair weld at a magnification of 6.3x.

Figure 4-3  
Test Coupon CSS-1 after Welding

Figure 4-4  
Cross-Section of Coupon CSS-1 Showing EDM Flaw Sealed by Welding  
(Magnified 6.3x)

Welding with AC polarity allowed a slower travel speed and less heat input to the base metal. If too much heat is applied to the weld coupon the water inside vaporizes, and the steam could potentially blow through the molten metal. The lower heat input allowed the welder more time to make a proper weld without being concerned about blow-holes in the weld. After peening and welding, no water leakage was observed at a pressure of 1,000 psi.

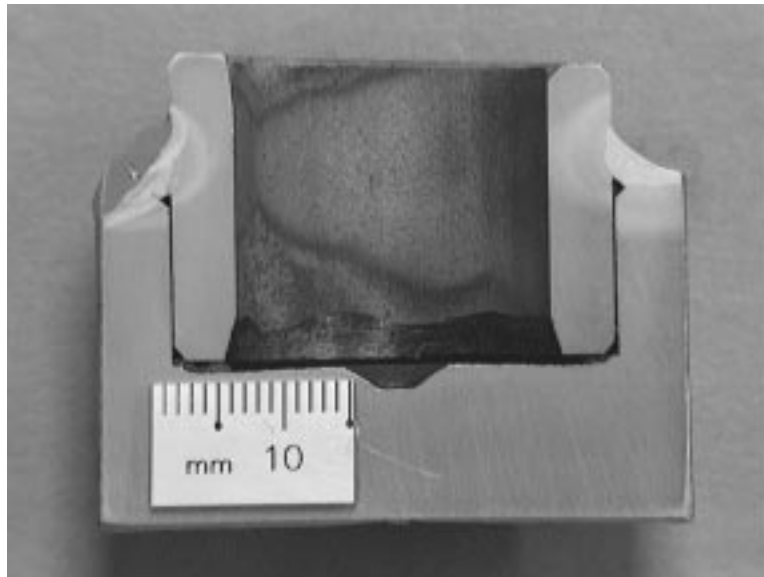
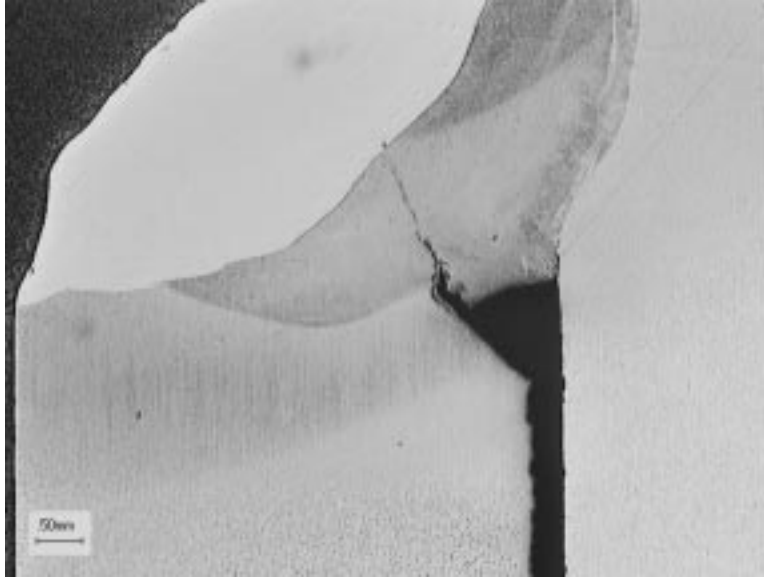
Figure 4-5  
Cross-Section of Coupon CSS-2

Figure 4-6  
Cross-Section of Coupon CSS-2 Showing Fatigue Flaw Sealed by Welding  
(Magnified 10x)

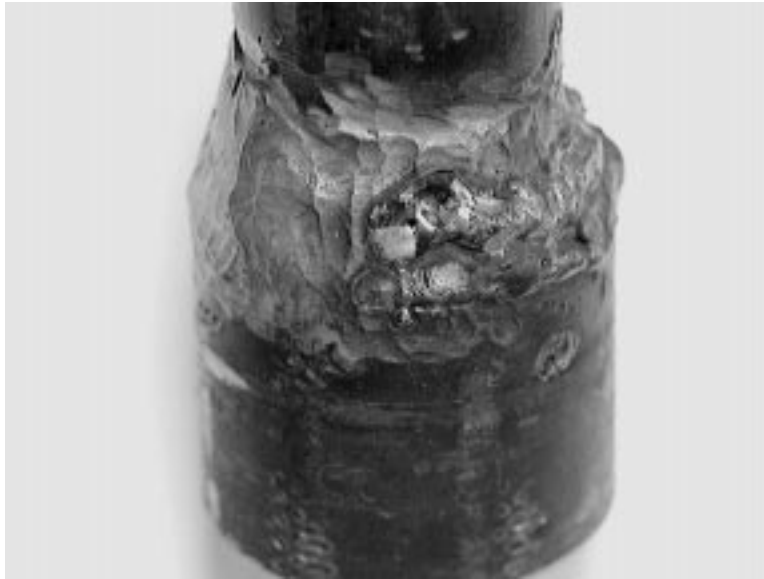
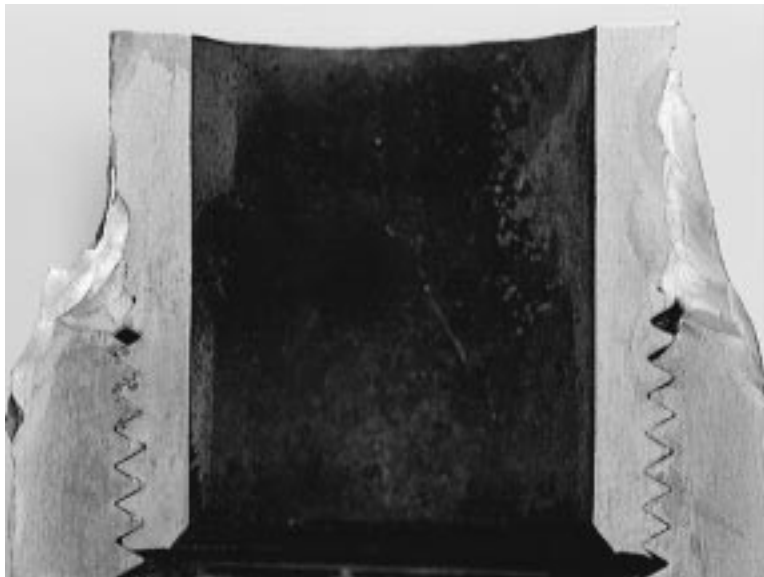
150 psi and water began to flow around the annulus between the pipe and the cap. Welding was attempted using the SMAW process, AC polarity, and a Sandvik E309-16 electrode. The weld bead was placed directly over the point where the water was leaking, which resulted in a poor weld repair that did not stop the water flow (see Figures 4-7 and 4-8).

Figure 4-7  
Test Coupon CST-1 after Welding

Figure 4-8  
Cross-Section of Test Coupon CST-1 after Welding

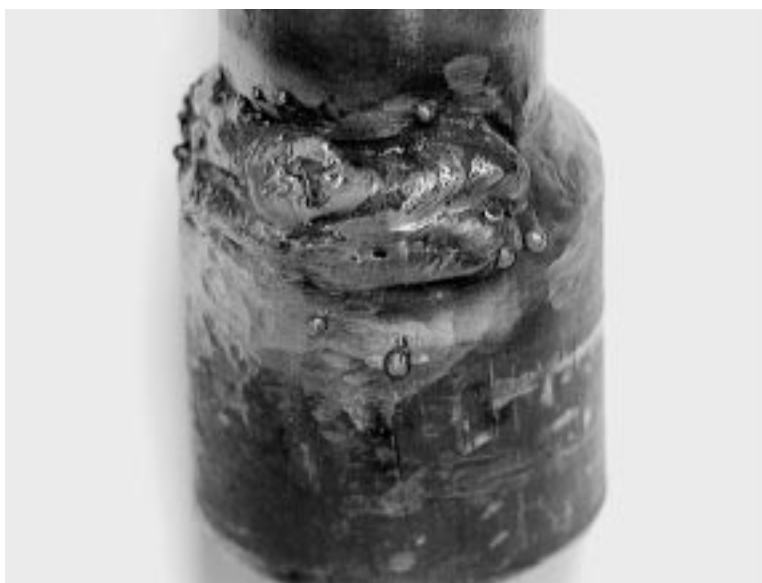
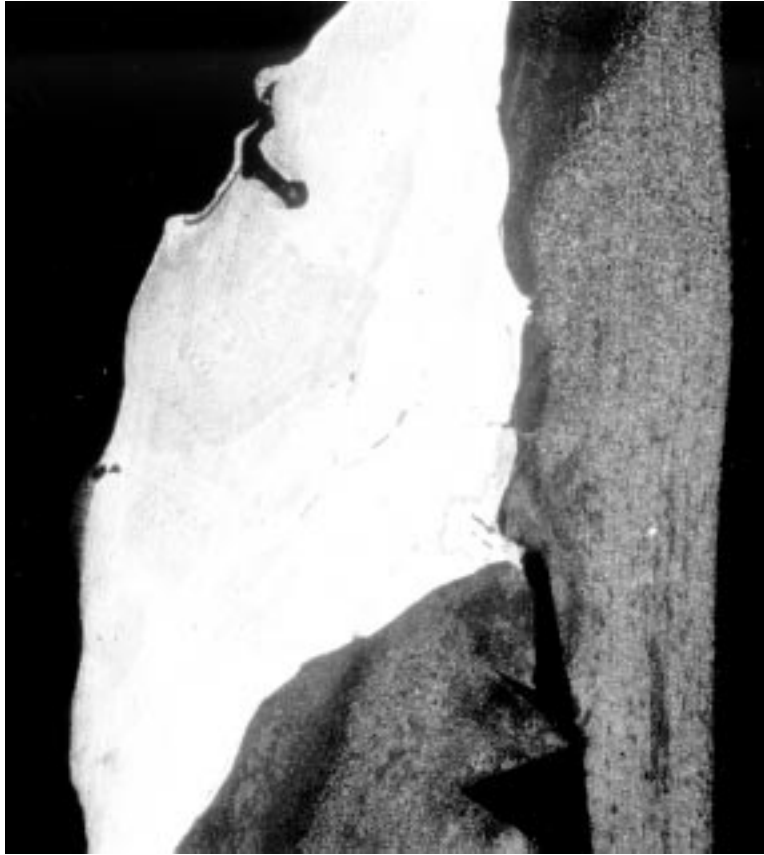
Test CST-2 was performed on a carbon steel pipe with a threaded pipe cap. The flaw was placed in the pipe threads using a pneumatic grinder as described in Section 3.6. The weld coupon was pressurized to 150 psi, and welding was performed using the FCAW process, reverse polarity, and a 308L wire developed in the RRAC's underwater welding program. Welding was initiated adjacent to the leak location and continued around the annulus of the pipe and ended on the opposite side of the leak. Another weld bead was initiated just below the leaking hole, continued around the pipe, and stopped at the same point below the leak. A third bead was started just above the leaking hole, continued around the pipe, and terminated at the same point above the leak. The weld metal was then peened in toward the hole to stop the water leakage. A fourth weld bead was placed directly over the leak location causing the leak to re-open. The leakage was stopped by peening and another weld bead was placed over the hole. This process of welding and peening was continued until no water leakage was observed (see Figure 4-9). A total of eight weld beads was placed on this particular weld coupon. Figure 4-10 shows a cross-section of the repair weld at a magnification of 6.3x.

Figure 4-9  
Test Coupon CST-2 after Welding

Figure 4-10  
Cross-Section of Weld Repair on Coupon CST-2  
(Magnified 6.3x)

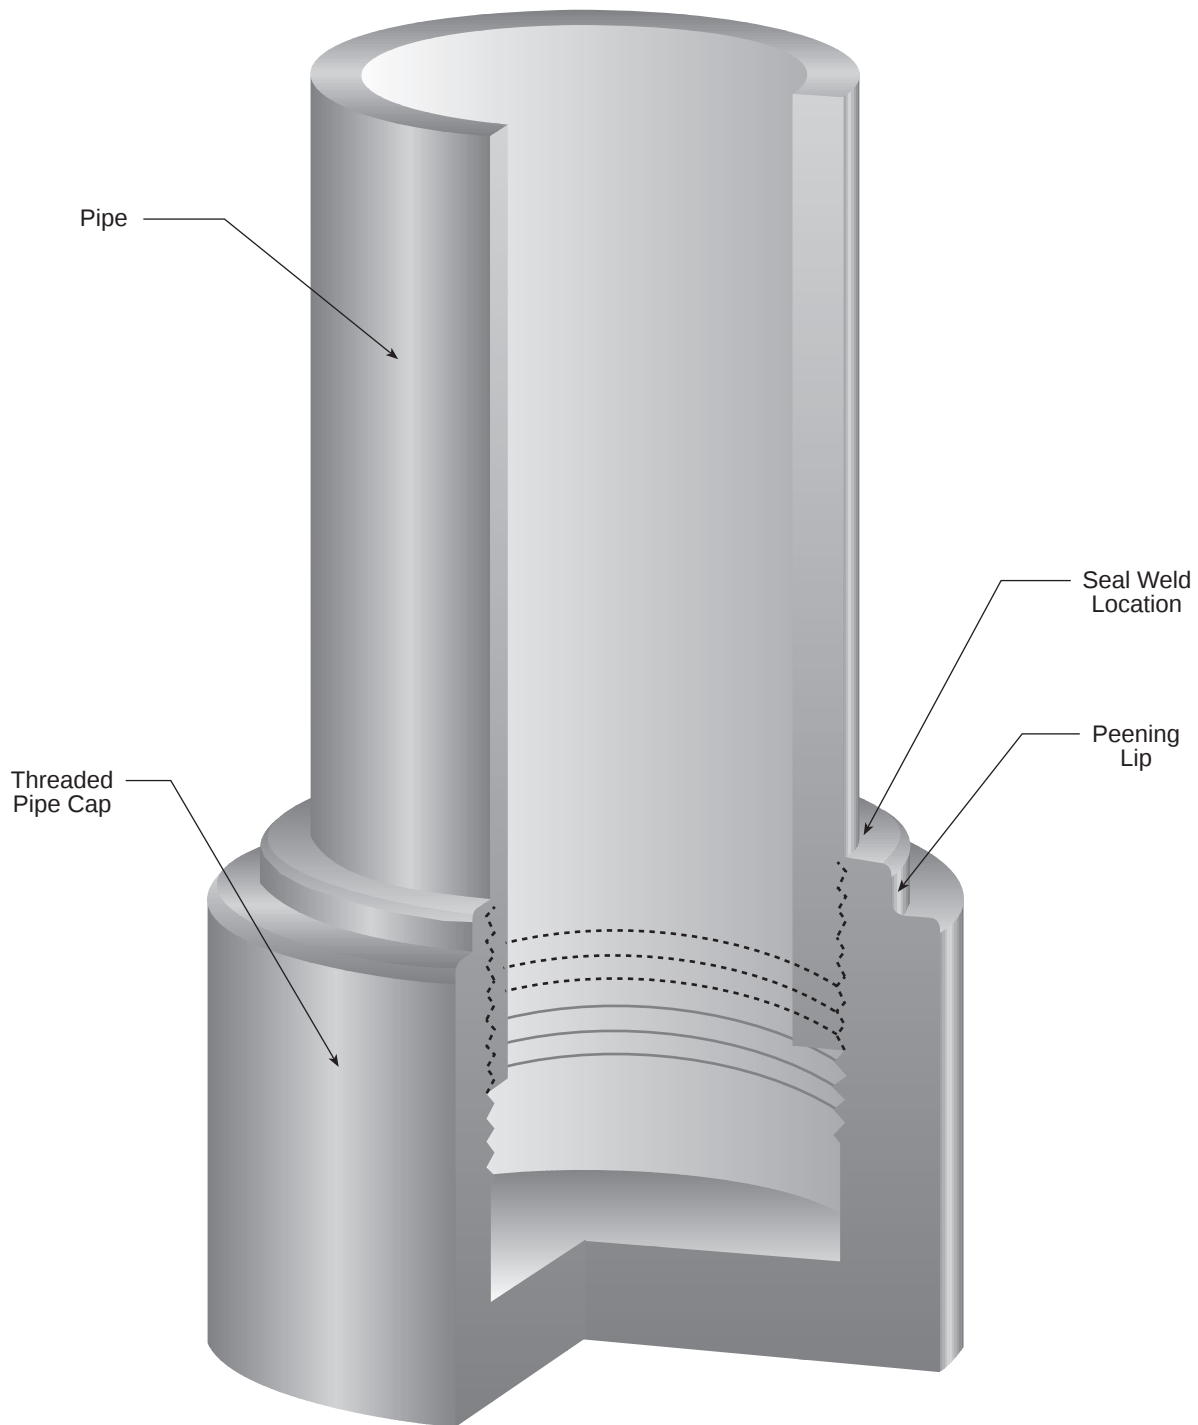
Figure 4-11  
Threaded Pipe Cap with Machined Peening Lip

The flaw was placed in the weld coupon for this test using a pneumatic grinder. The threaded pipe cap used in this test was modified in an effort to make the process of mechanical peening more effective. A small lip was machined into the pipe cap in order to reduce the thickness of the cap making it easier to deform the metal by peening, and thereby, close the water leak (see Figure 4-11).

The mockup was fitted with the modified pipe cap and pressurized to 80 psi. Welding was done using the FCAW process, reverse polarity, and a 308L wire developed in the RRAC's underwater welding program. First, peening was done on the 1/8" lip on the pipe cap to deform the peening lip into the pipe threads, thereby stopping the water

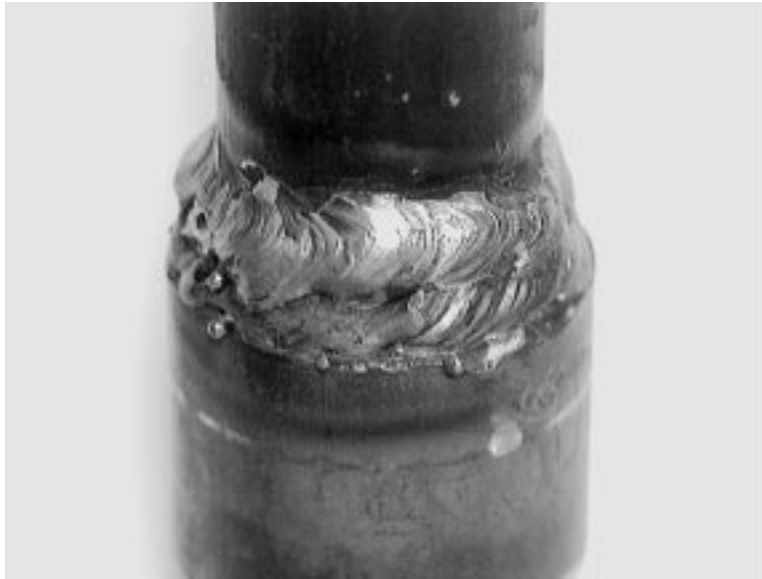
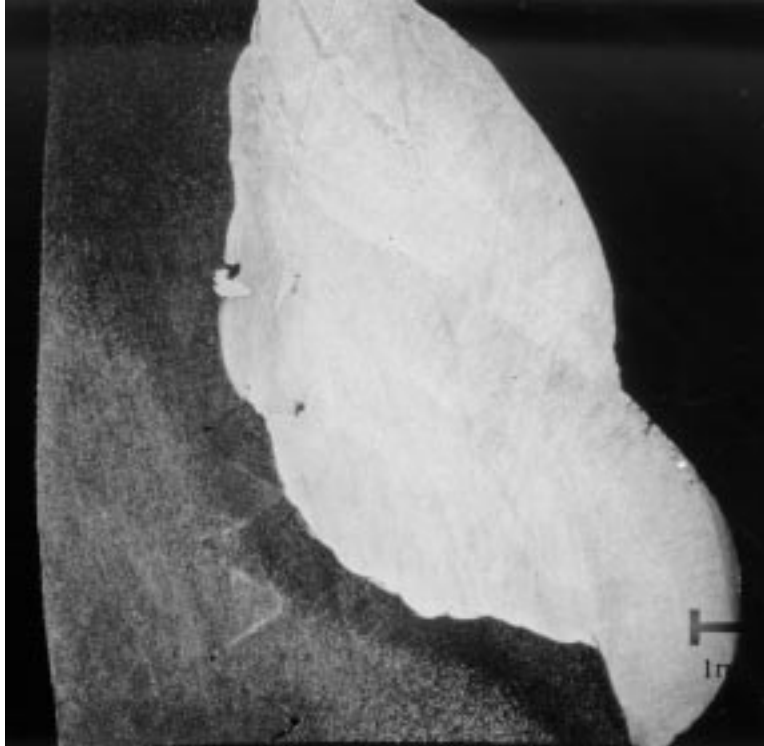
flow. Then, a continuous weld bead was placed on the machined lip around the entire circumference of the pipe, and no leakage was observed. Placement of the first weld bead was such that the metal lip was consumed, and the weld bead fused slightly into the pipe wall. A second bead was placed on and just above the first bead to tie the repair weld more fully into the pipe wall (see Figures 4-12 and 4-13).

Figure 4-12  
Test Coupon CST-3 after Welding

Figure 4-13  
Cross-Section of Weld Repair on Coupon CST-3  
(Magnified 6.3x)

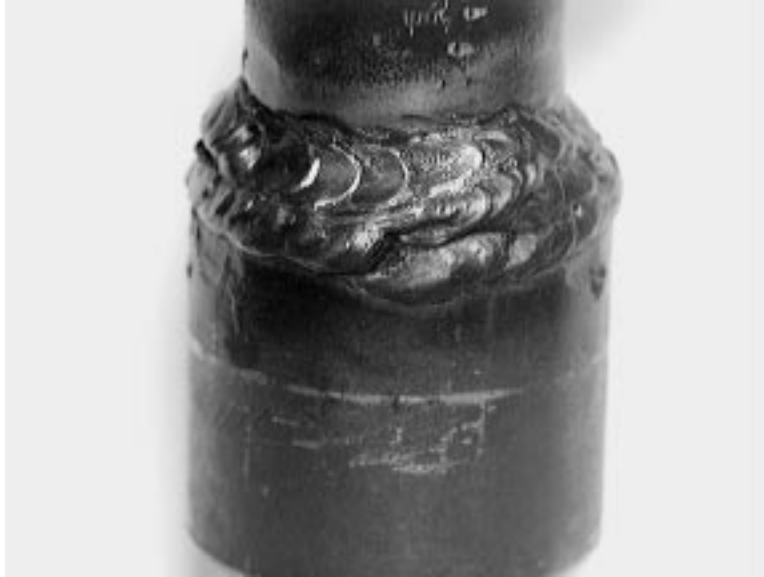
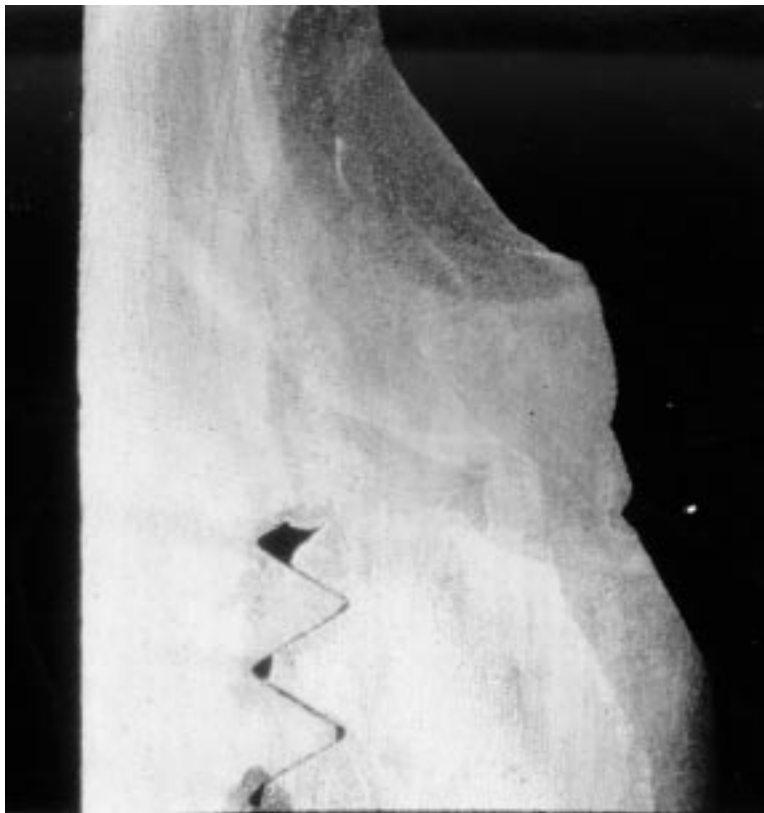
Welding was initiated on the pipe coupon adjacent to the leaking flaw and continued away from the flaw, around the pipe, and terminated on the opposite side of the leak. After the welding of the first pass, the leaking hole was peened shut. A second weld bead was placed on top of the first pass to completely seal the leak. After welding with the E6011 rod, a E7018 electrode was used to place 3 cover passes over the seal welds (see Figure 4-14). Figure 4-15 shows a cross-section of the completed weld repair at a magnification of 6.3x.

Figure 4-14  
Test Coupon CST-5 after Welding

Figure 4-15  
Cross-Section of Weld Repair on Coupon CST-5  
(Magnified 6.3x)

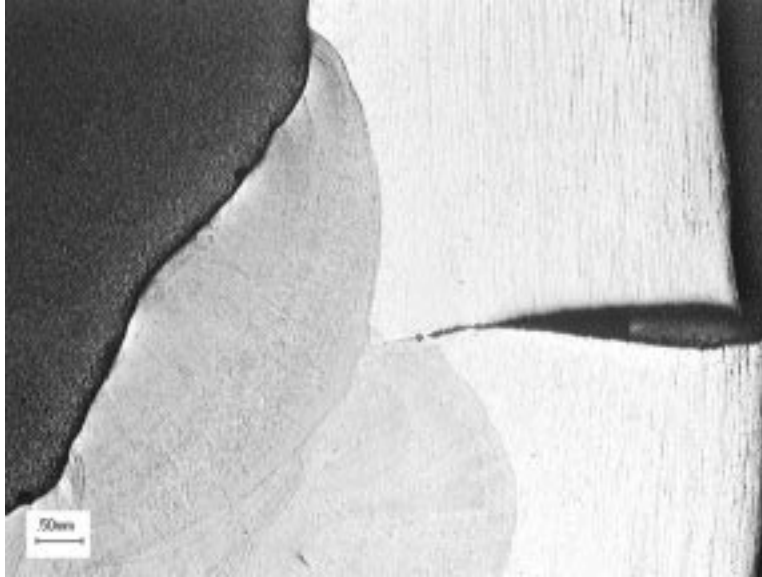
Figure 4-16  
Cross-Section of Coupon SSS-1 Showing EDM Notch Sealed by Welding  
(Magnified 10x)

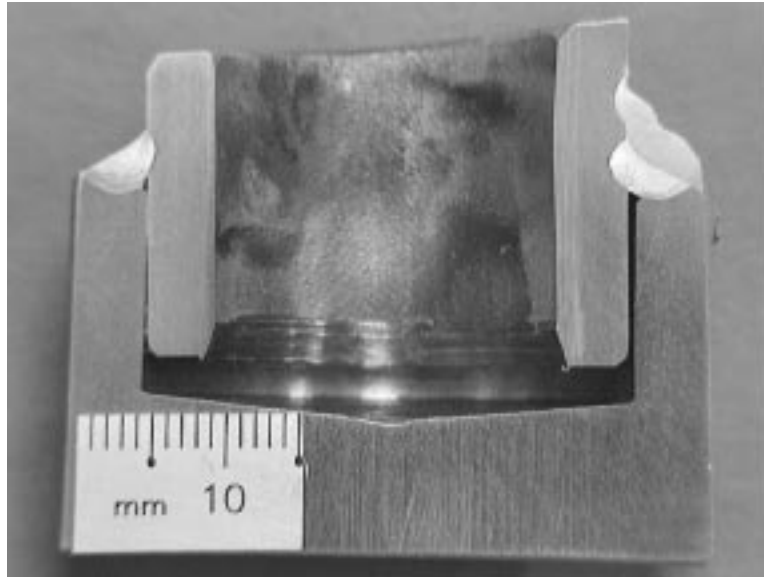
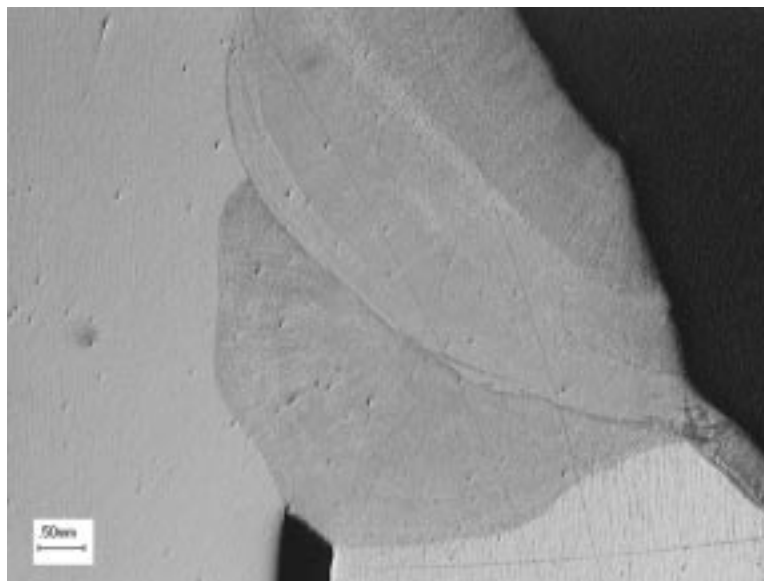
No water leakage was observed at a pressure of 1,000 psi after welding.

Figure 4-17  
Cross-Section of Coupon SSS-2 with Weld Repair (Repair Weld on Right Side of Coupon)

Figure 4-18  
Cross-Section of Coupon SSS-2 Showing Repair Weld  
(Magnified 10x)

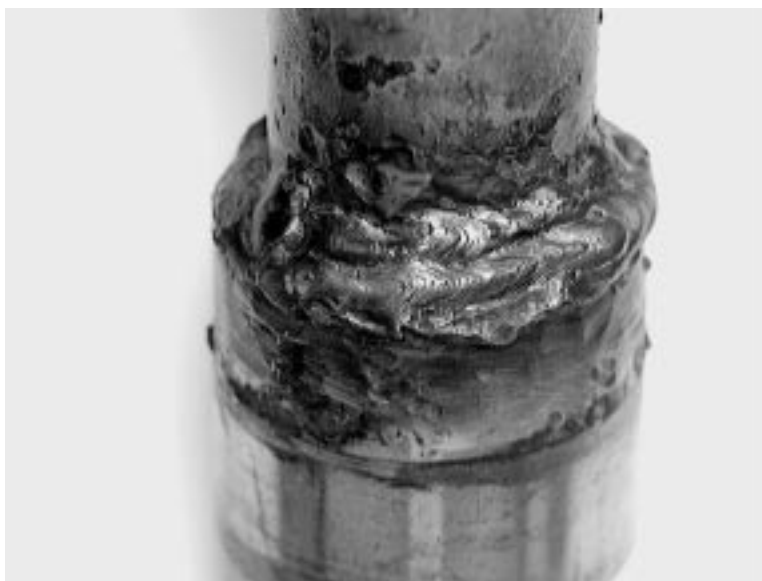
Figure 4-19  
Test Coupon SST-1 after Welding

A flaw was placed in the pipe threads of the test coupon by machining (see Section 3.6). The pipe coupon was pressurized to 150 psi. Welding was done using the SMAW process, straight polarity, and a Sandvik E309L-16 electrode. Welding was initiated adjacent to the leak location and continued around the annulus of the pipe, then terminated on the other side of the leak. Another weld bead was started just below the leaking hole, continued around the pipe, and stopped at the same point below the leak. A third bead was started just above the leaking hole, continued around the pipe, and stopped at the same point above the leak. The weld metal was then peened in toward the hole to stop the water leakage. Then, three more beads were welded around the pipe to completely seal the leak (see Figure 4-19).

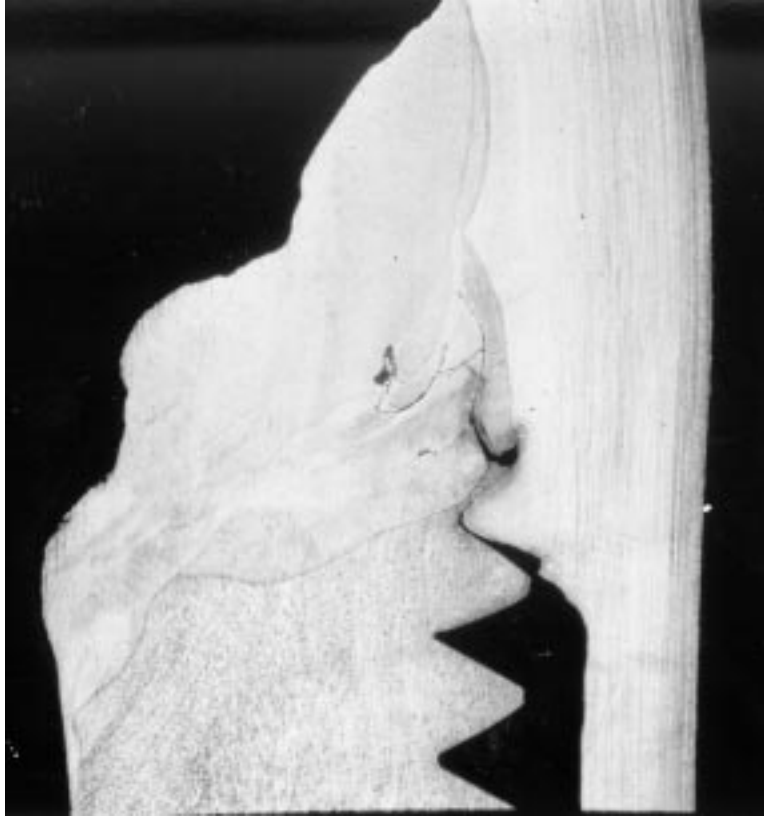
A cross-section of the weld repair was taken at the point where the water was leaking from the pipe cap (see Figure 4-20). This picture shows small cracks and porosity in the weld repair.

Figure 4-20  
Cross-Section of Weld Repair on Coupon SST-1  
(Magnified 6.3x)

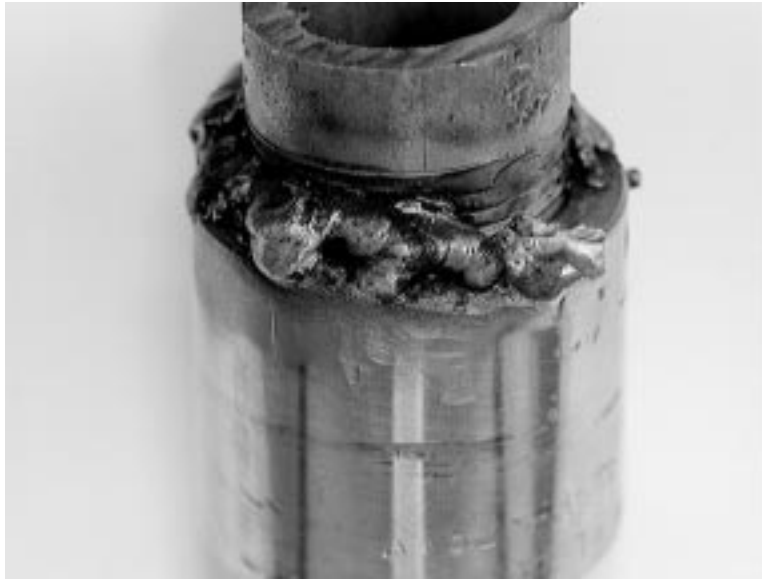
Figure 4-21  
Test Coupon SST-2 after Welding

The weld coupon for this test was prepared by cutting a groove in the pipe threads using a pneumatic grinder (see Section 3.6). The pipe was pressurized to 150 psi, and welding was performed using the FCAW process, reverse polarity, and a 308L wire developed in the RRAC's underwater welding program. Before welding, peening of the leaking threads was attempted, but water continued leaking around the pipe cap. Welding was started adjacent to the leak and continued around the pipe to the opposite side of leak. The resulting weld had a very poor appearance and was full of porosity (see Figure 4-21).

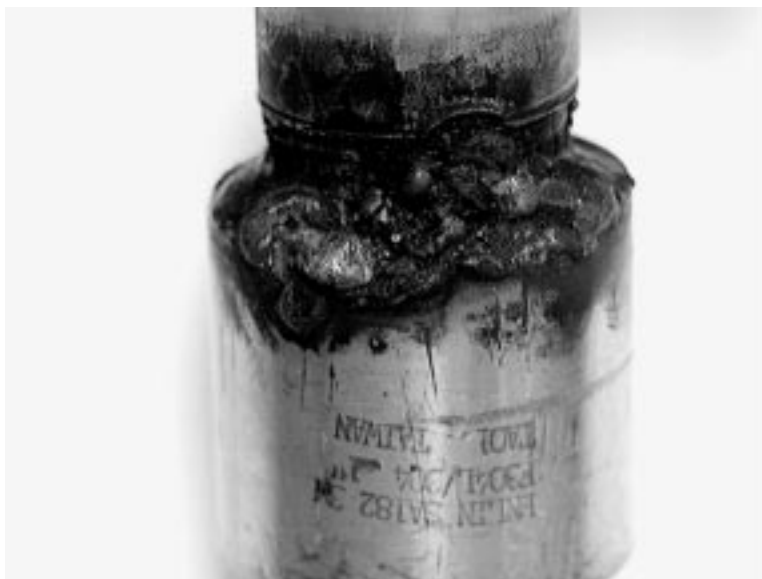
Test SST-4 was performed on a threaded pipe cap coupon with a flaw induced by grinding a groove in the pipe threads. The pipe was pressurized to 100 psi and welding was done using the SMAW process in reverse polarity with a Sandvik E6011 electrode. The objective of this test was to try the E6011 electrode with the “whip” technique, which was successful on carbon steel, to determine the usefulness of this repair method on the stainless steel coupon. Welding was attempted by starting next to the leak and continuing around the pipe. It was immediately determined that the E6011 rod was not compatible with the stainless steel material because of porosity in the weld and the poor appearance of the weld (see Figure 4-22).

Figure 4-22  
Cross-Section of Coupon SST-4 after Welding

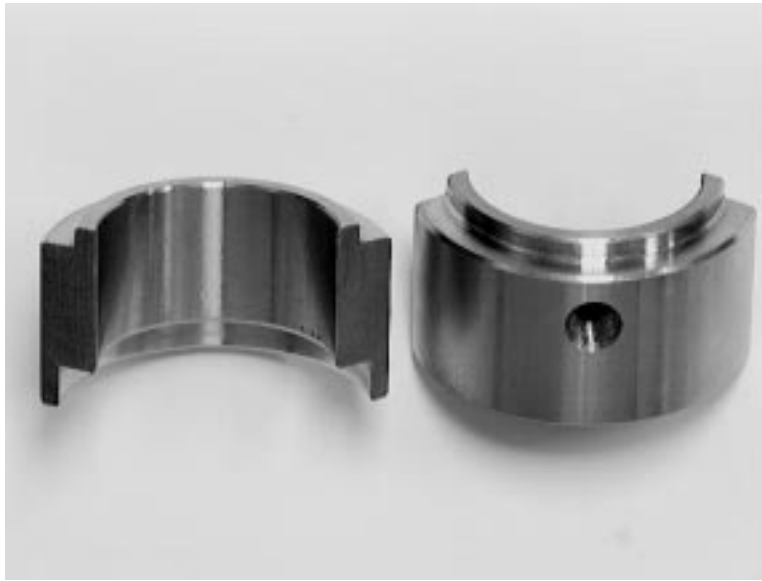
Figure 4-23  
Split Collar

pipe above the leaking threads, and welding the collar to the pipe and pipe cap to make a permanent weld repair.

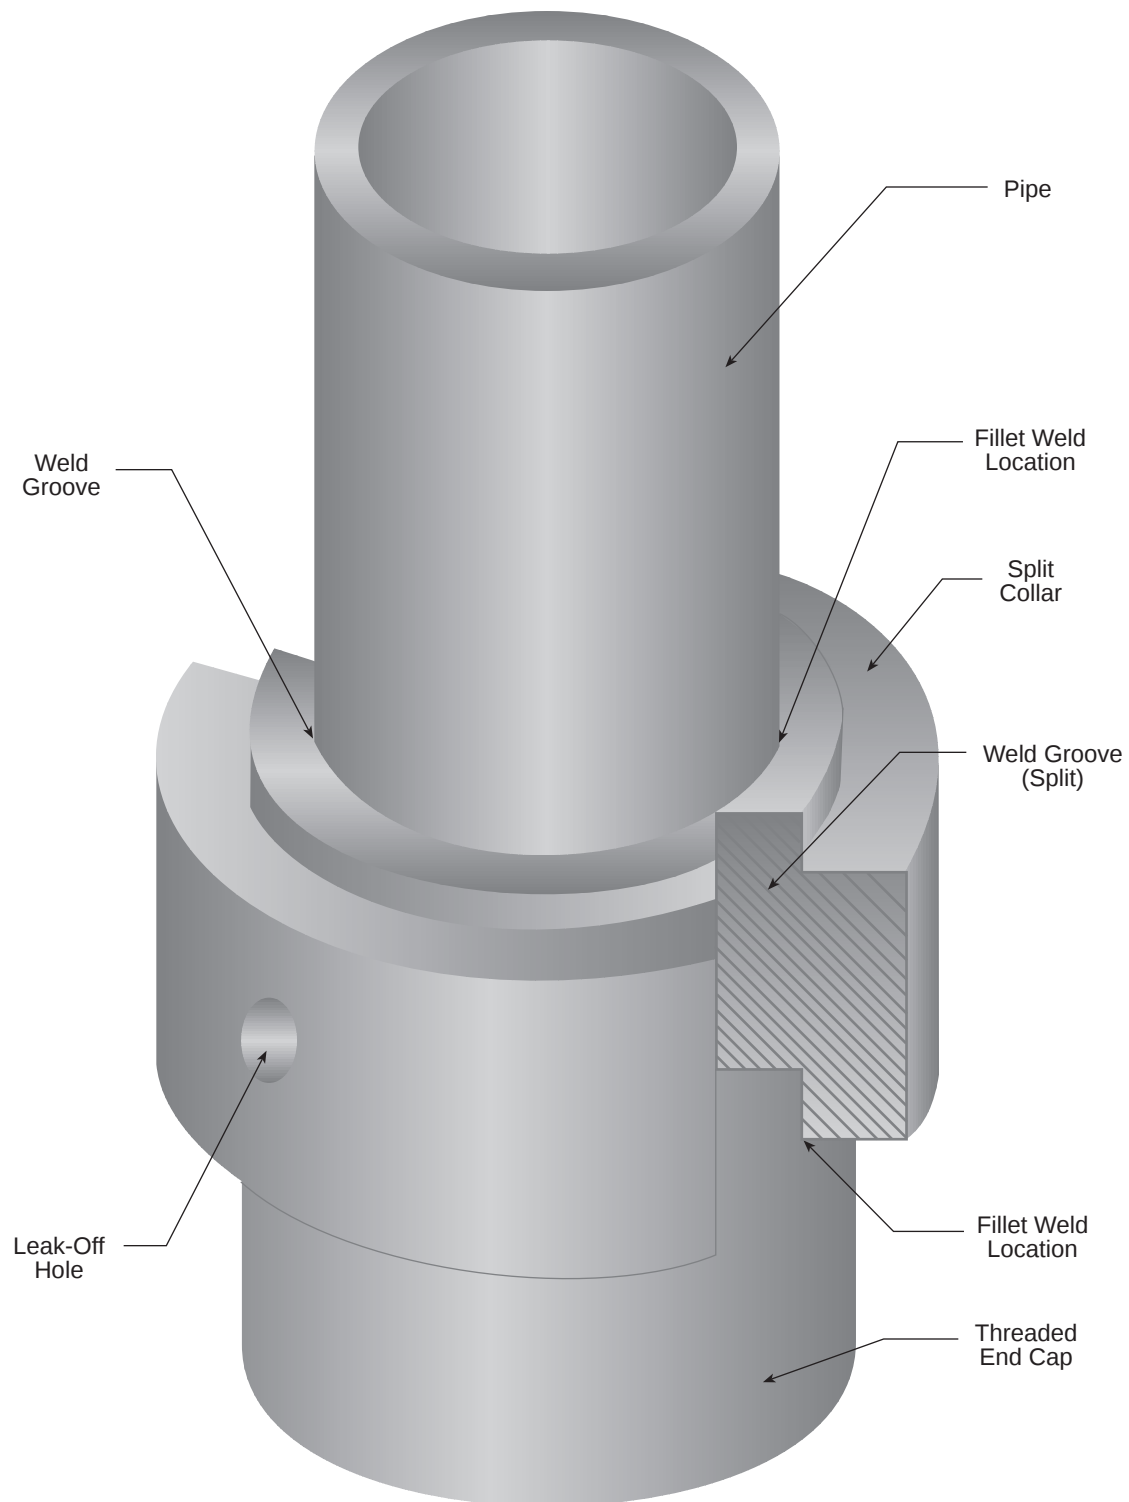
Figure 4-24  
Split Collar on Pipe and Pipe-Cap Assembly

The split collar is made with a threaded hole in one half to allow pressure and steam created by welding temperatures to escape; thereby, preventing blow holes in the weld repair. After welding the collar to the pipe, a pipe plug can be threaded into the leak-off hole and welded to permanently seal the water leakage. A schematic drawing of the split collar placed on a pipe and threaded pipe-cap assembly is shown in Figure 4-24.

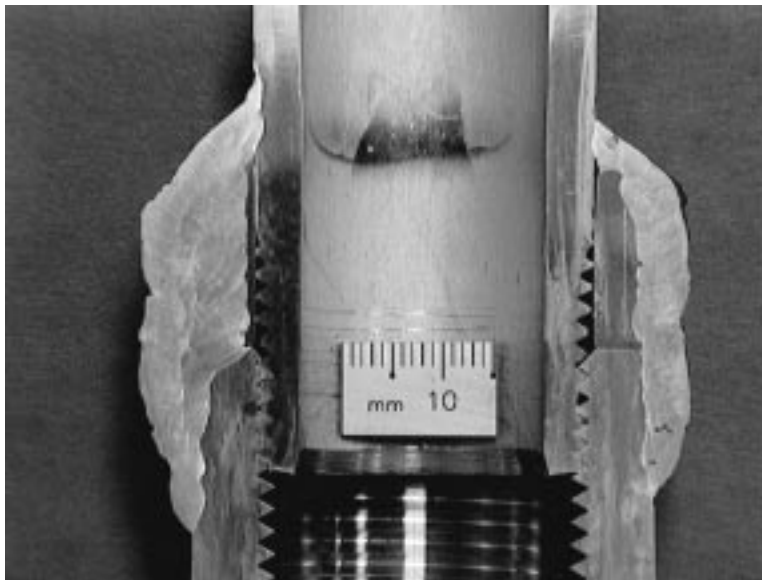
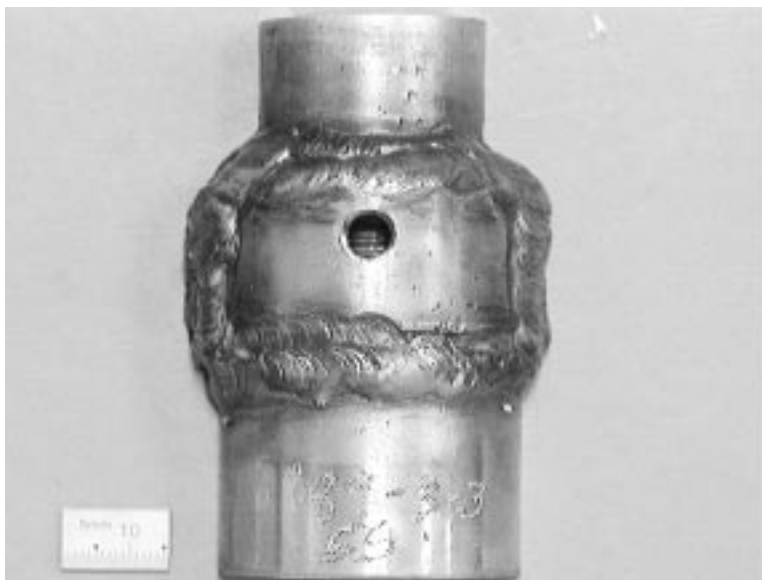
The two V-shaped weld grooves on either side of the pipe were welded first. Welding was continued around the lower circumference of the split collar to seal the collar to the pipe cap. Then, the upper circumference of the collar was welded to seal the collar to the pipe. During the weld repair, excess water and steam was allowed to escape through the leak-off hole, thereby preventing porosity and blow holes in the weld. After completing the weld sequence, a pipe plug is threaded into the leak-off hole and welded to provide a permanent repair to the leaking pipe cap. Figures 4-25 and 4-26 show a cross-section and exterior view, respectively, of a stainless steel threaded pipe cap coupon that was repaired using the split-collar technique. Appendix E provides a detailed weld sequence for repairs made using the split-collar technique.

Figure 4-25  
Cross-Section of Stainless Steel Threaded Pipe Cap Coupon Repaired Using Split Collar

Figure 4-26  
Exterior of Stainless Steel Threaded Pipe Cap Coupon Repaired Using Split Collar

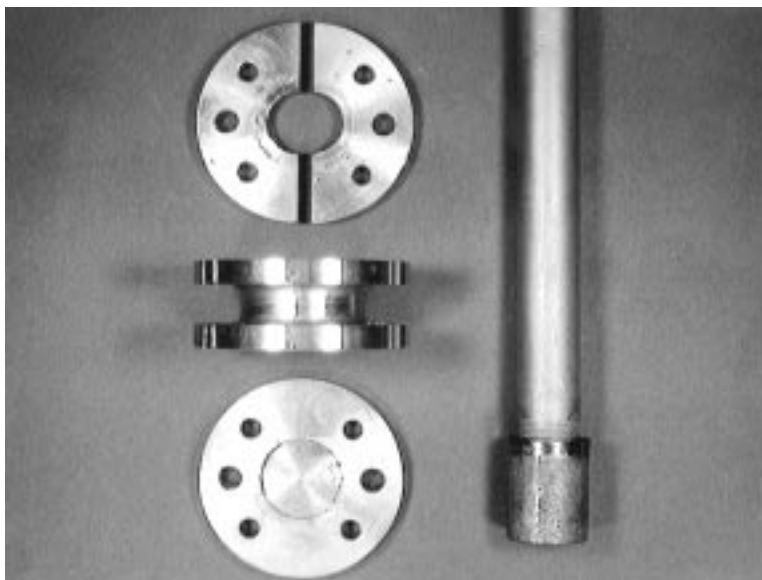
Figure 4-27

The coupling consists of three separate components, a split flange, an I-flange (referred to as I-flange because of its shape) and a bottom flange. The hole in the center of the split flange is of the same diameter of the pipe being repaired. The hole in the center of the I-flange is of the same diameter of the pipe cap being repaired. Before attaching the coupling, a graphite packing ring is placed around the pipe at the point of the leak (see Figure 4-27).

Unassembled Mechanical Coupling and Pipe with Threaded End Cap and Graphite Packing Ring
