EPRI TR-108132  
Final Report  
January 1998

# On-Line Welding Repair for Leaking Pipe Components

Process leakage from cracked socket welds and leaking threaded connections during plant operation can lead to unscheduled shut-downs and loss of revenue to power plant owners. On-line repair methods have been developed to provide permanent repairs without taking the system off-line or isolating the leaking component. A temporary repair method to seal leaking threaded end caps has been developed that can be used to stop the leakage until the next scheduled shutdown when a permanent repair can be made. This report provides well-documented and demonstrated welding methods and procedures to repair cracked socket welds and leaking threaded connections on-line and under pressure.

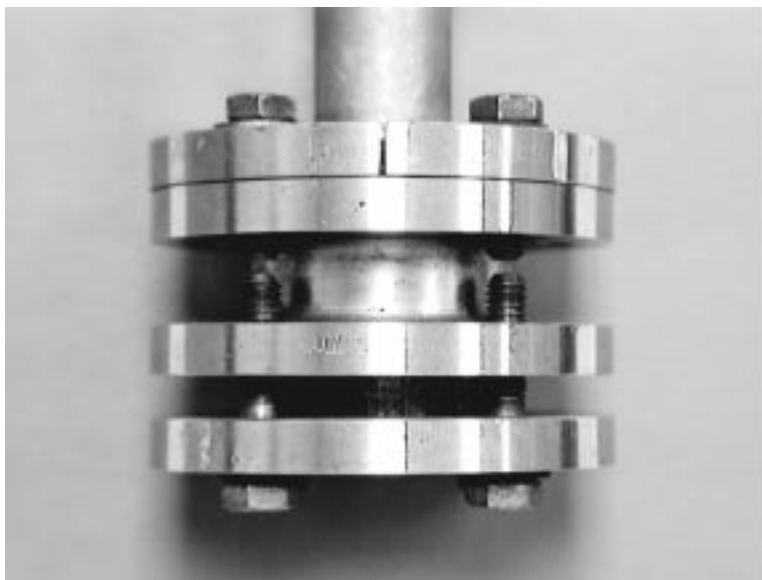
Figure 4-28  
Assembled Coupling Attached to Pipe with Threaded End Cap

Next, the I-flange is slipped over the pipe cap and packing ring. The split flange is then placed around the pipe and bolted securely to the I-flange. The final step in the repair is to bolt the bottom flange to the I-flange. The four bolts in the bottom flange are first threaded in by hand and then progressively tightened to pull the split flange against the packing ring. This presses the graphite packing into the leaking threads, thereby stopping the leak. The assembled coupling is shown in Figure 4-28. Appendix F gives detailed instructions for assembly and use of this temporary mechanical coupling for stopping leaks in threaded pipe caps.

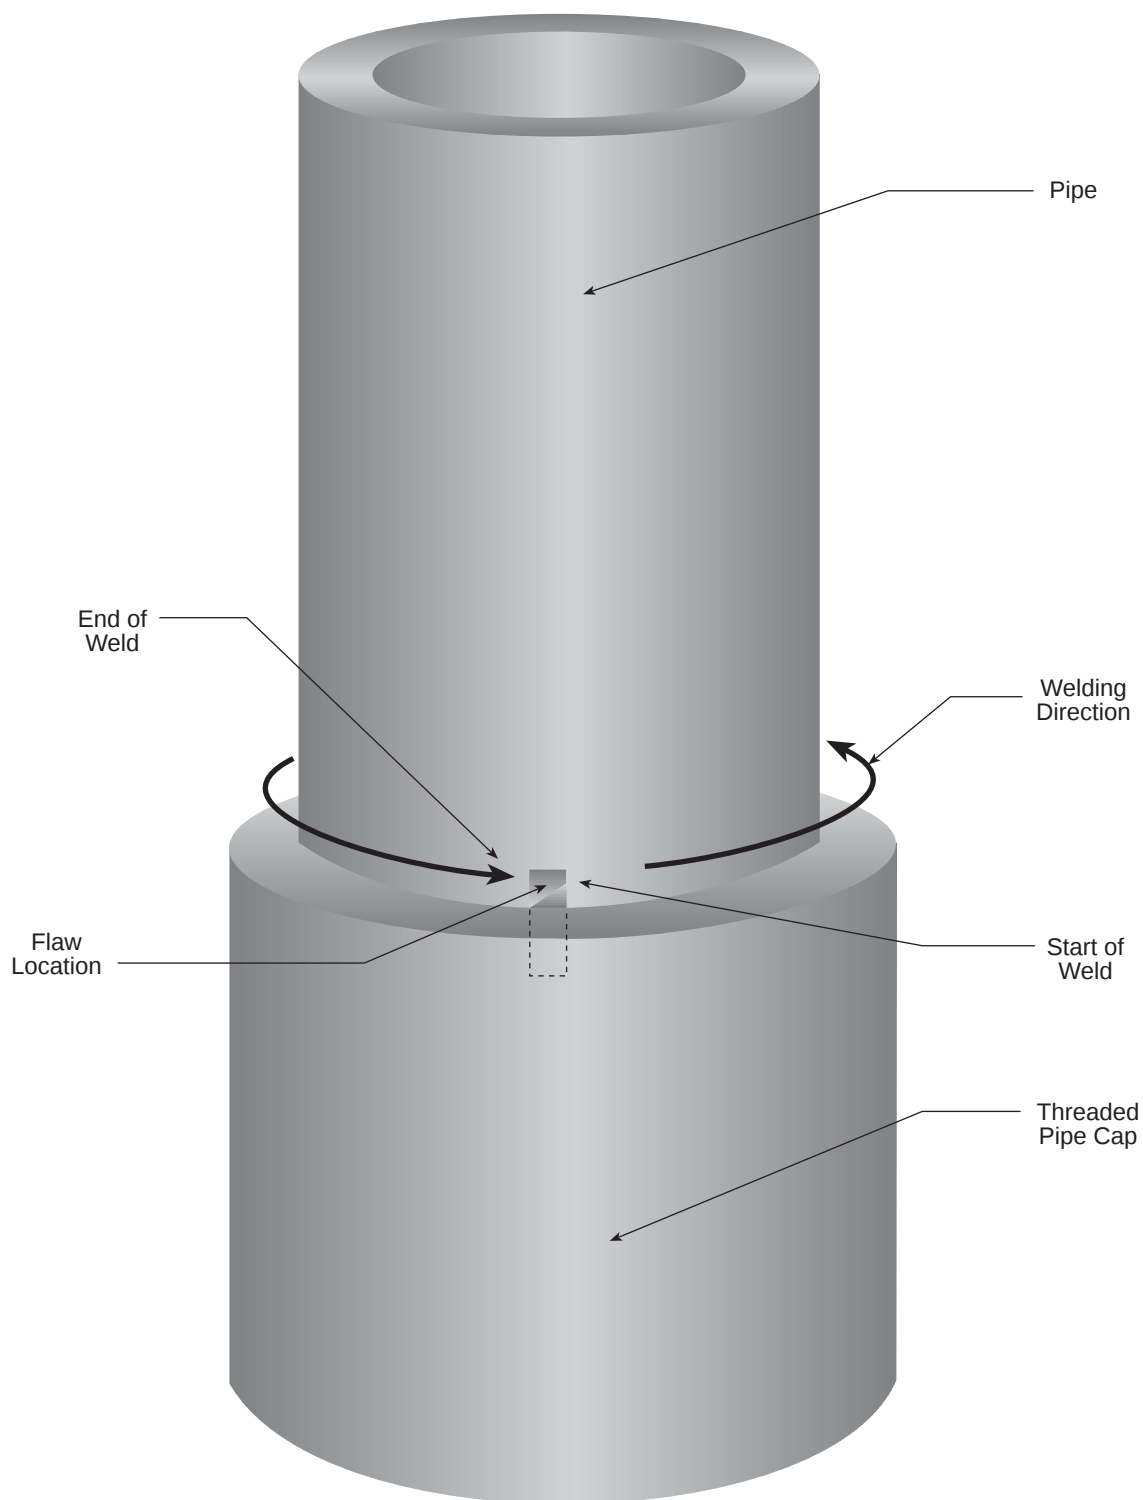
Figure D-1  
Weld Placement for Threaded Fitting Repair

- 5.1 SMAW
  - Recommended covered electrode material specifications for initial seal welding of carbon steel threaded fittings are ASME SFA-5.1 E6010 and E6011.
  - Recommended covered electrode material specifications for cover pass welding of carbon steel threaded fittings include: ASME SFA-5.1; E7018, E6010, E6011, or E6013 covered electrodes.
  - Use “whip” technique to minimize heat input to base material.

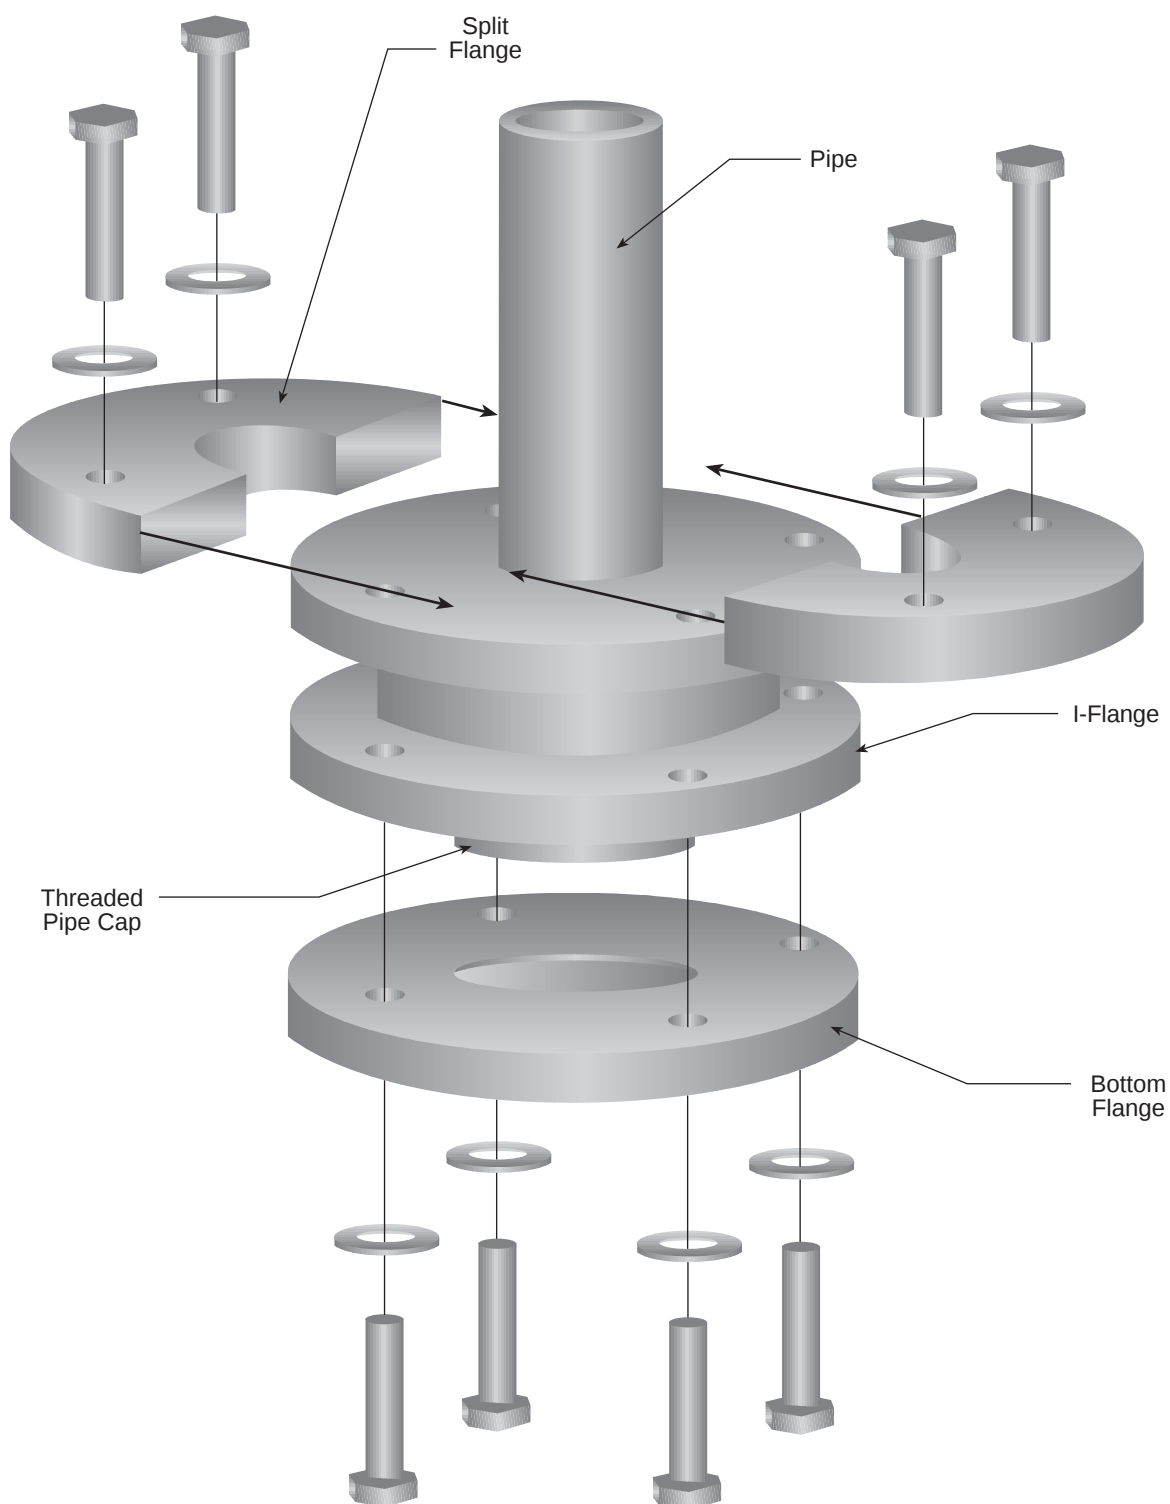
Figure F-1  
Assembly Drawing for Temporary Coupling

- 4.4 Slide the I-flange over the end cap.
- 4.5 Place the two halves of the split flange around the pipe and bolt securely to the I-flange.
- 4.6 Place the bottom flange beneath the I-flange in contact with the bottom of the end cap. Place the bolts through the bottom flange and thread the bolts into the I-flange by hand. The space between the bottom flange and the middle flange should be equal around the circumference of the coupling.
- 4.7 Using a wrench, each bolt should be tightened one full turn following the pattern shown in Figure F-2. Care should be taken to tighten each bolt the same amount in order to keep the faces of the middle and bottom flanges parallel.
- 4.8 Continue tightening each bolt one full turn following the given pattern until the leakage from the pipe threads is completely stopped.
