Pump Troubleshooting

Technical Report

TR-114612-V1

Final Report, April 2000

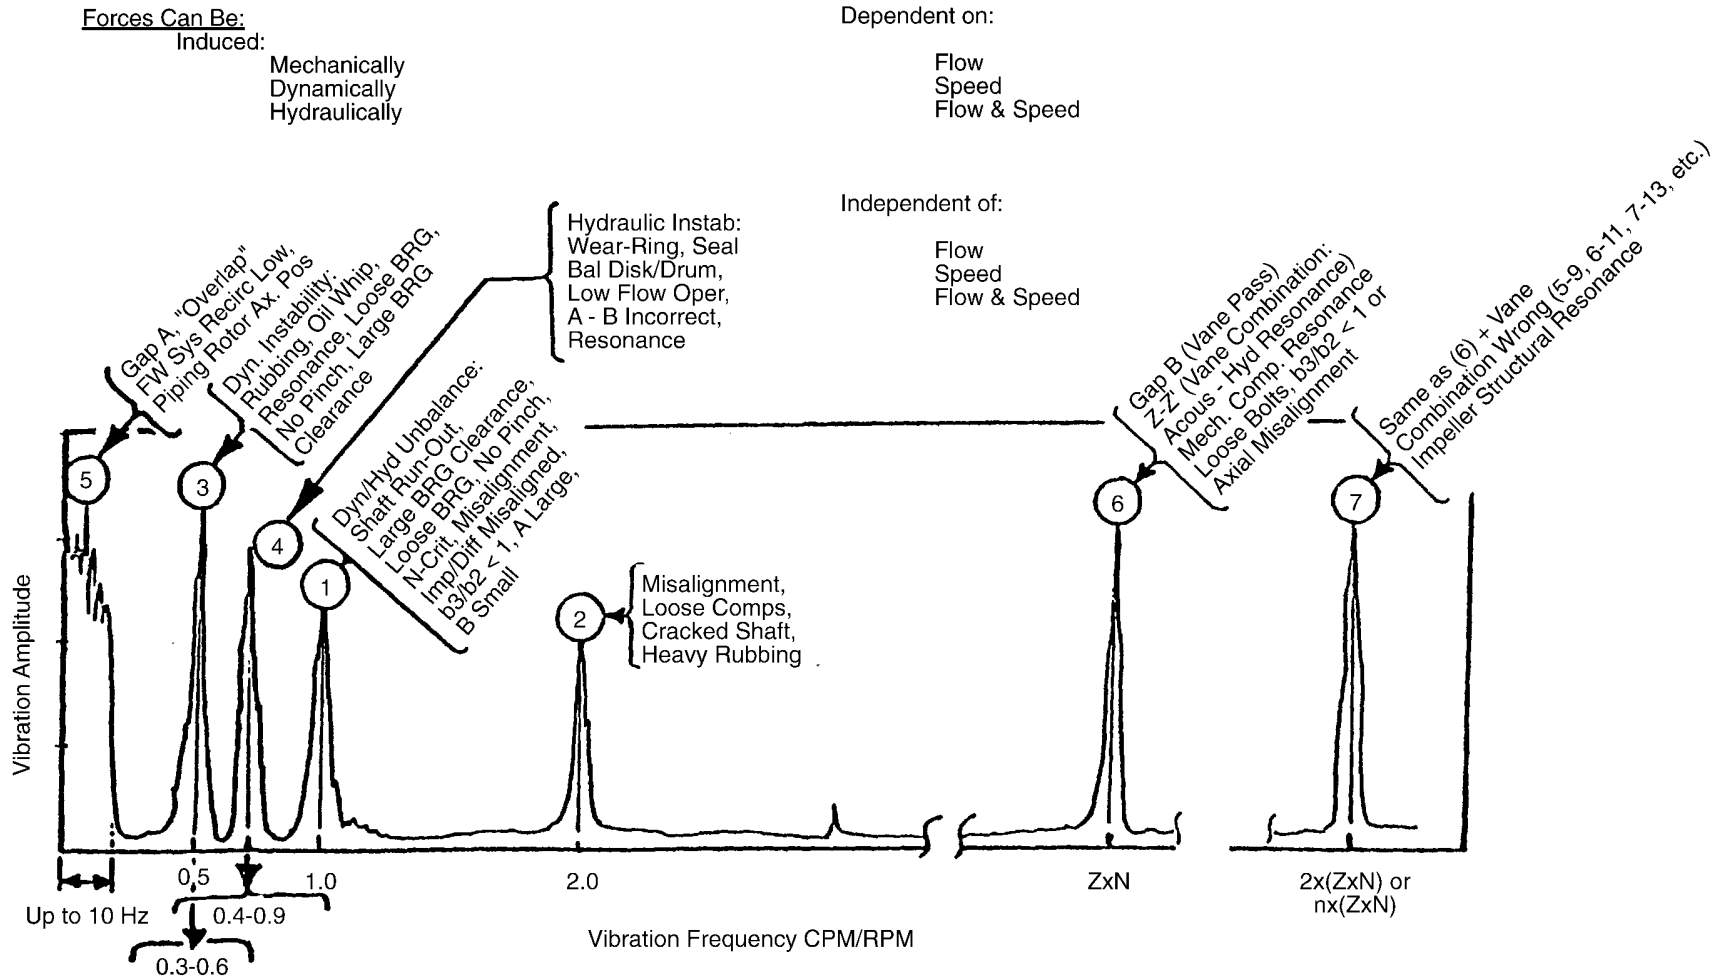
Expected hydraulically and dynamically induced vibration components in high-energy-input centrifugal pumps (all large utility pumps included)

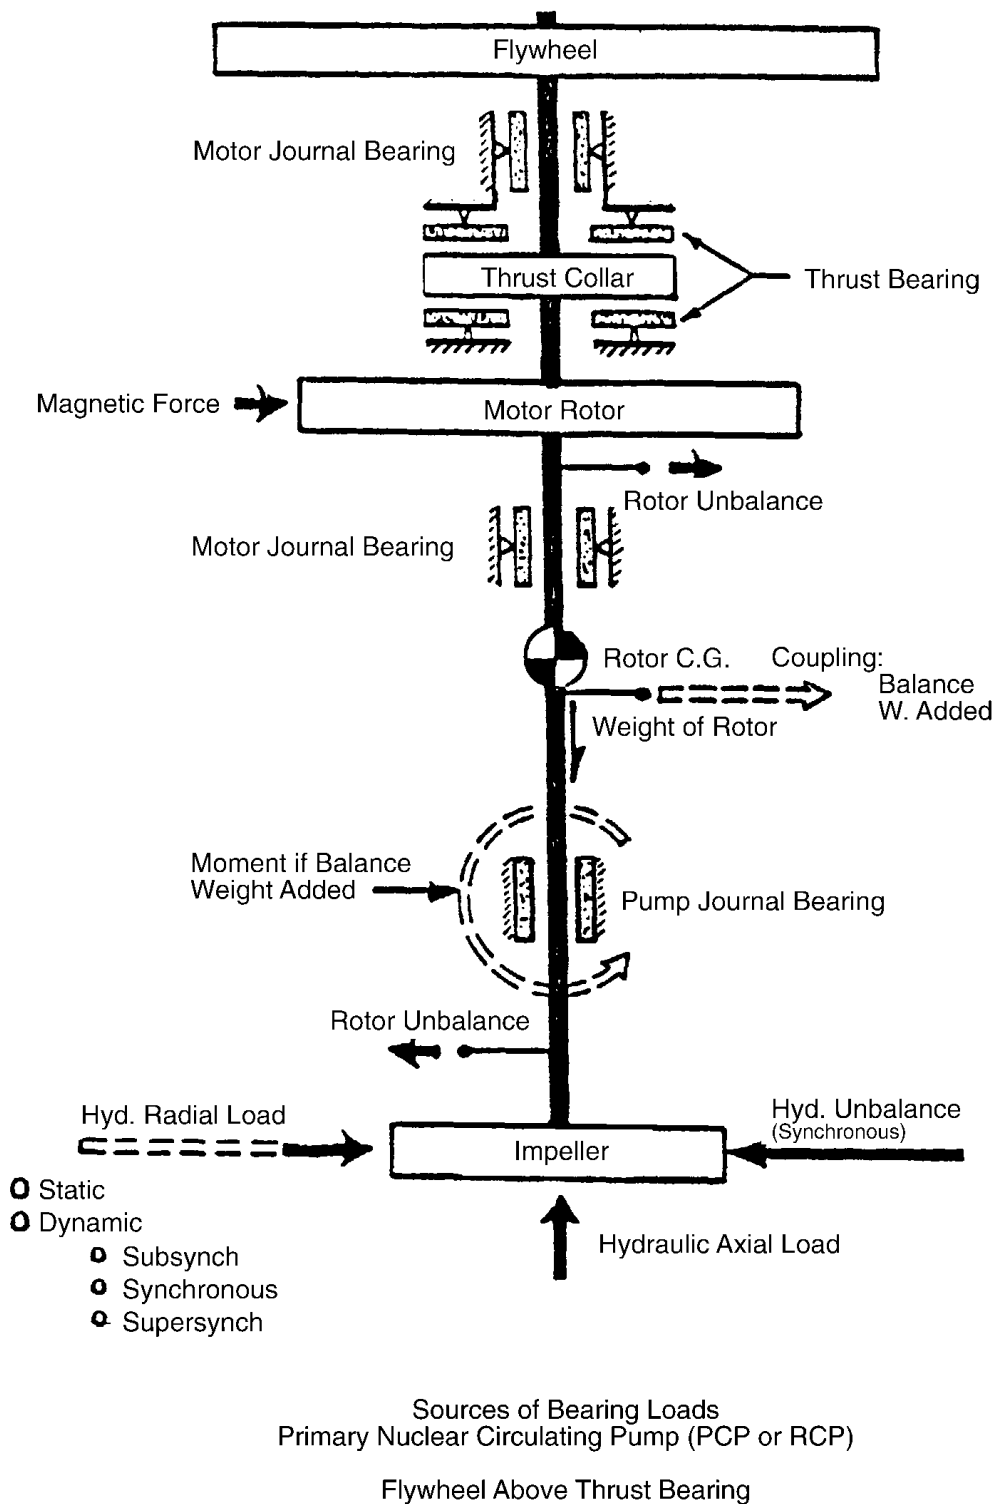
Figure 4-5
Sources of Bearing Loads and Shaft Stresses in Primary Coolant Pumps

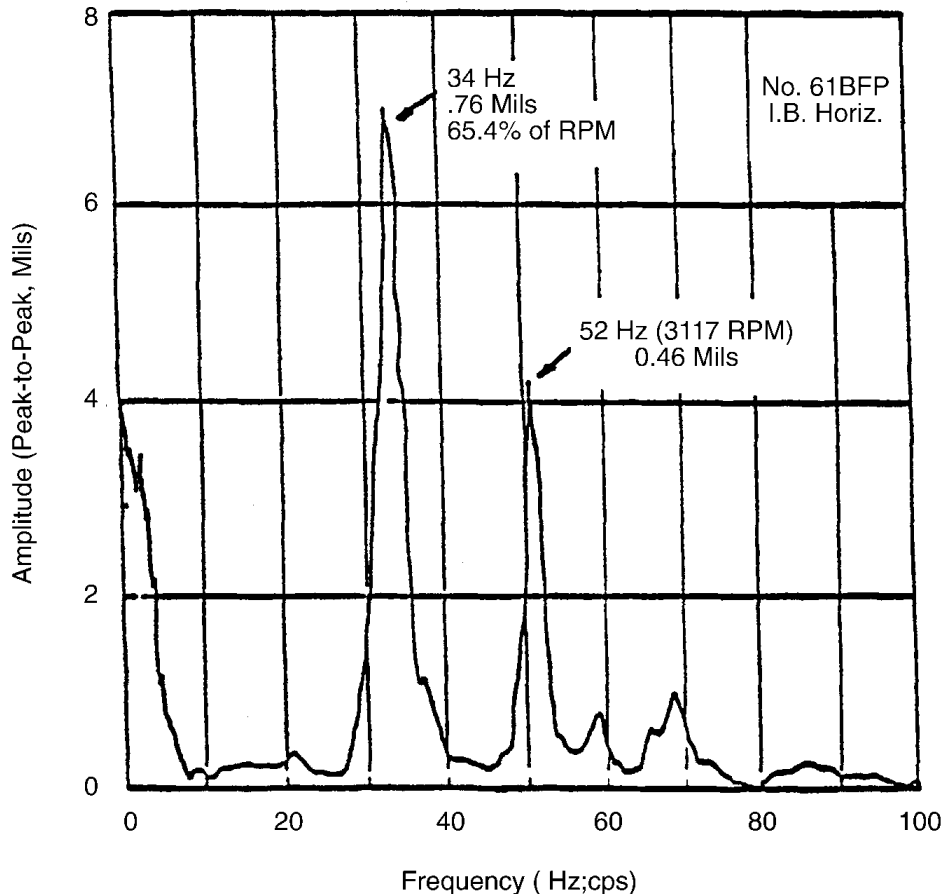
Louisville Gas & Electric Company, Cane Run Power Station: The onset of a subharmonic resonance as detected in the inboard horizontal component of the No. 61 boiler feed pump, model HPT-35-12 stages, as shown in Figure 5-2. The magnitude of this subharmonic component rapidly increased to above 7 mils, necessitating a unit shutdown.

Figure 5-2
Destructive Subsynchronous Vibration Component

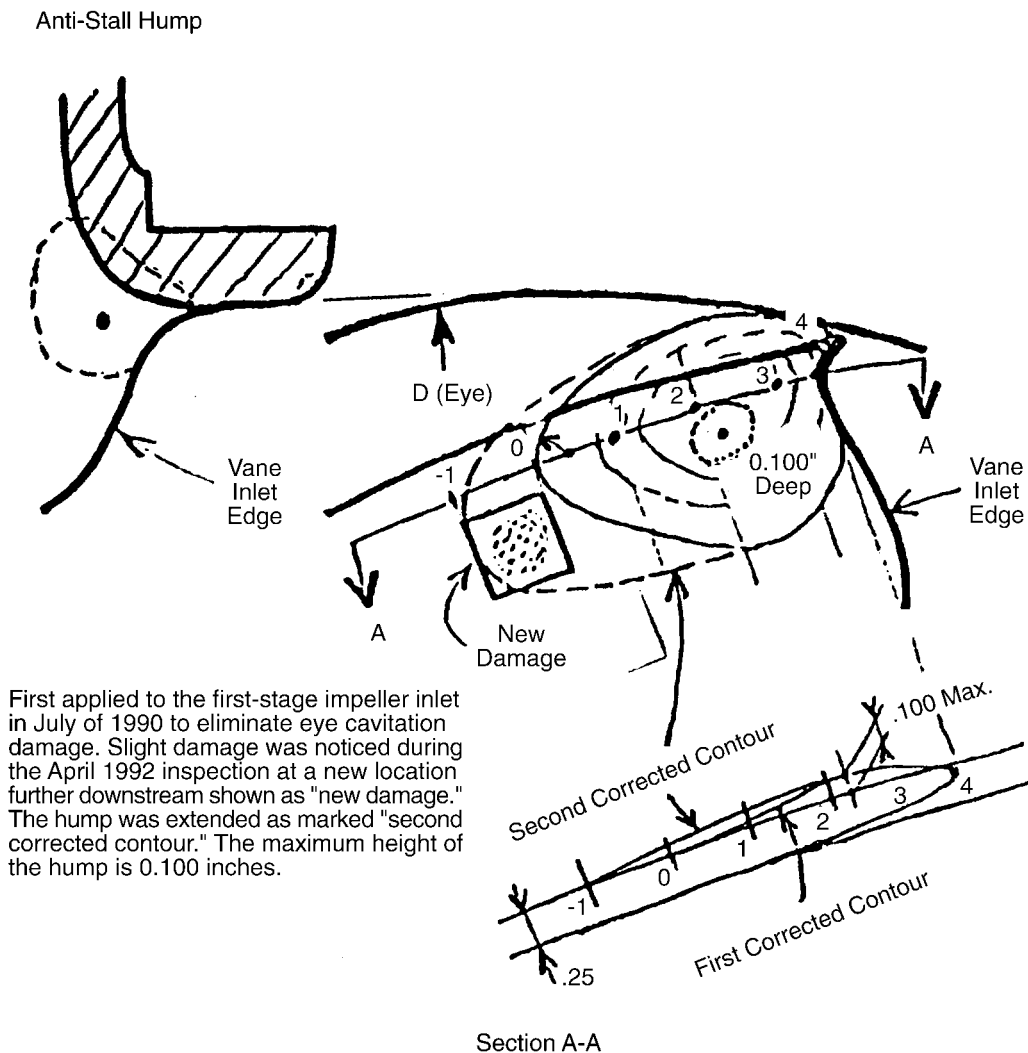
Figure 13-4
The Anti-Stall Hump on the Main BFP of Unit 5

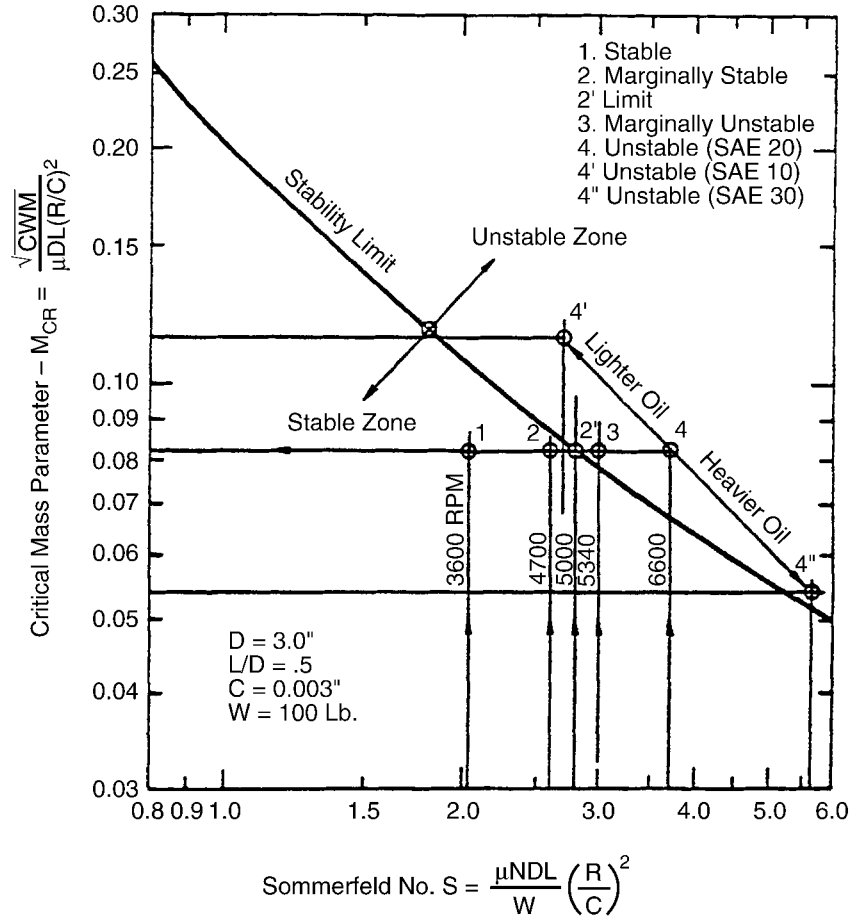
Figure 14-14
Bearing Stability Chart for Three-Grooved Journal Bearings
