# Non-Class 1 Mechanical Implementation Guideline and Mechanical Tools

B&W Owners Group Generic License Renewal  
Program, BAW-2270, Revision 2, 1999

**TR-114882**

Final Report, April 2000

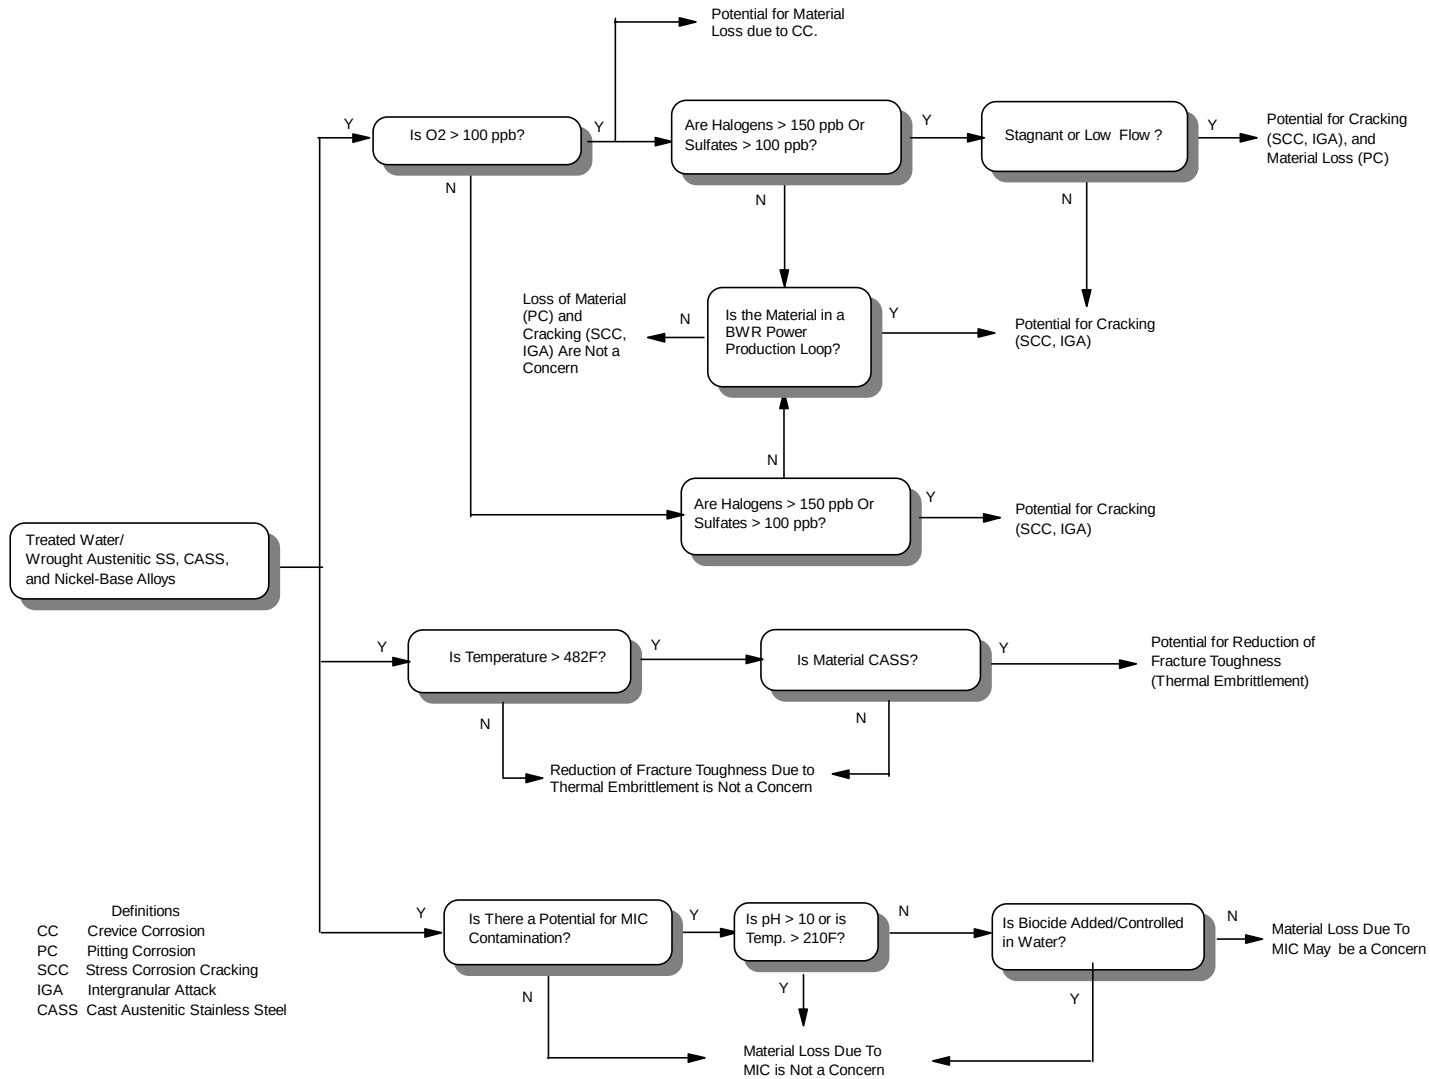
Figure 1 Treated Water/Stainless Steel

corrosion, erosion-corrosion, and MIC; cracking because of SCC and IGA; and loss of material properties because of selective leaching.

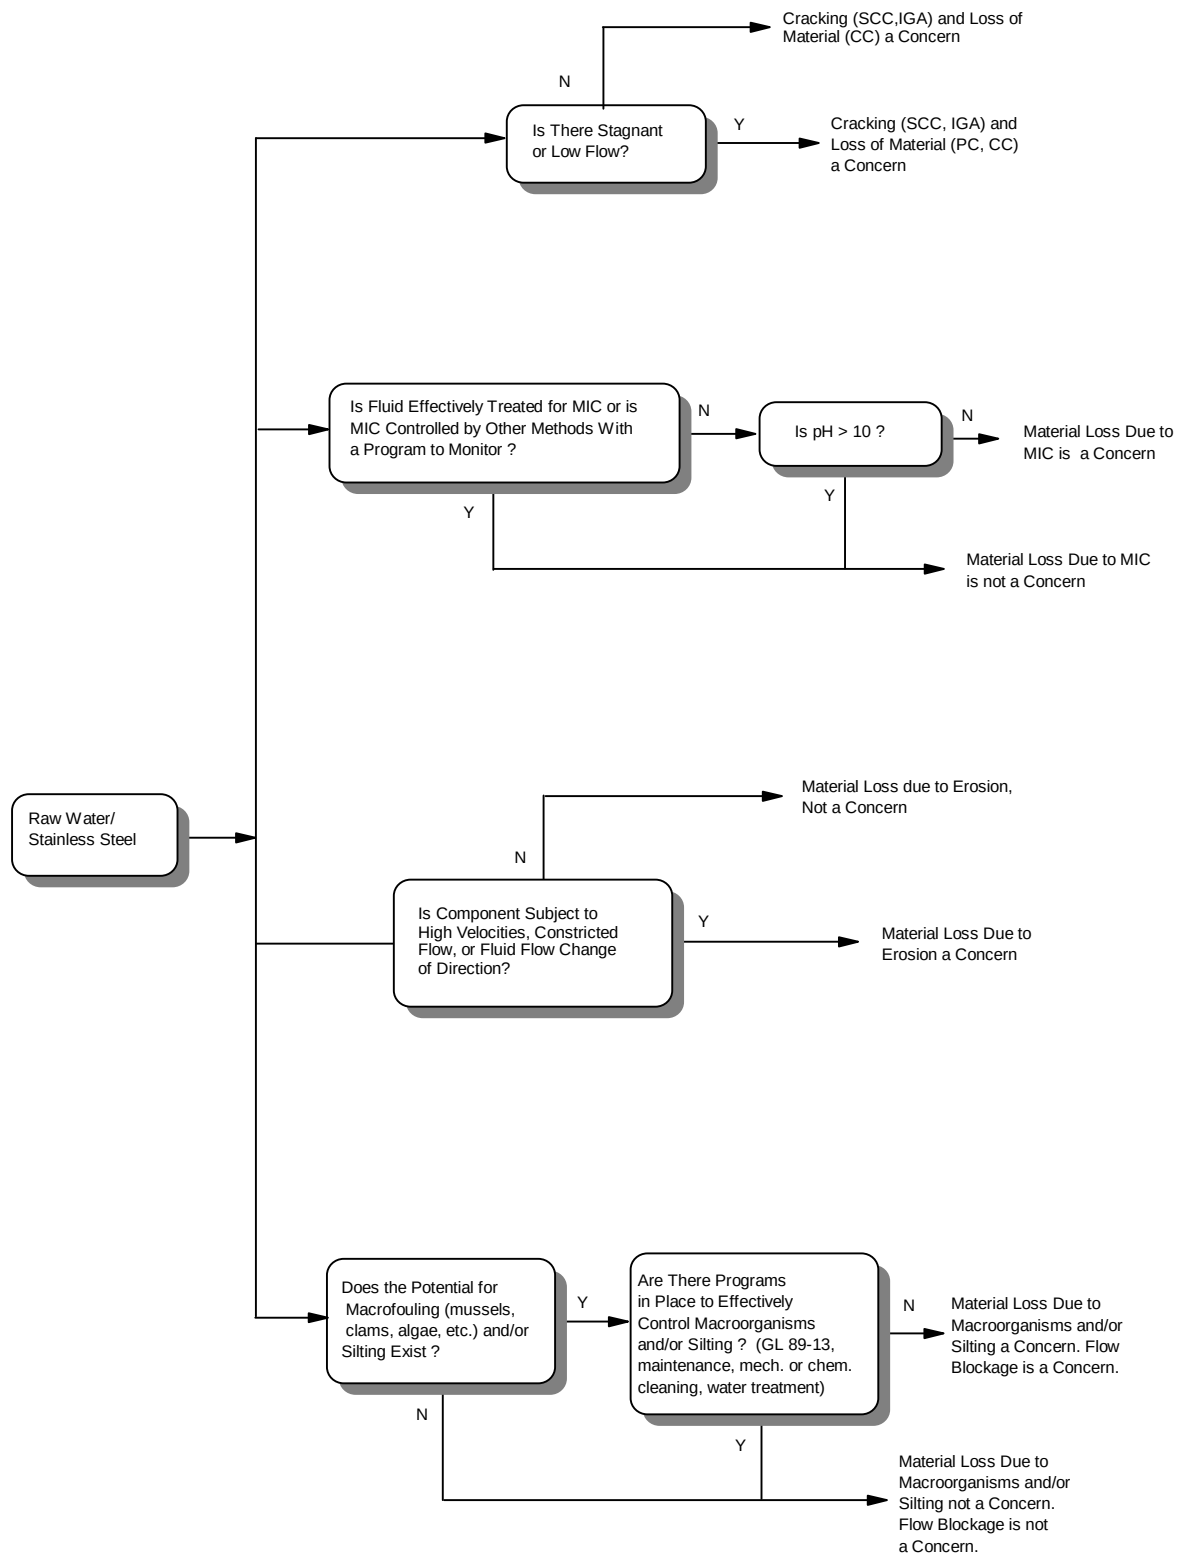
**Figure 3 Raw Water/Stainless Steel Tool**

The last branch addresses the potential for damage as a result of macroorganisms and/or silting. If the potential does exist, the logic includes consideration of effective programs to control these contaminants.

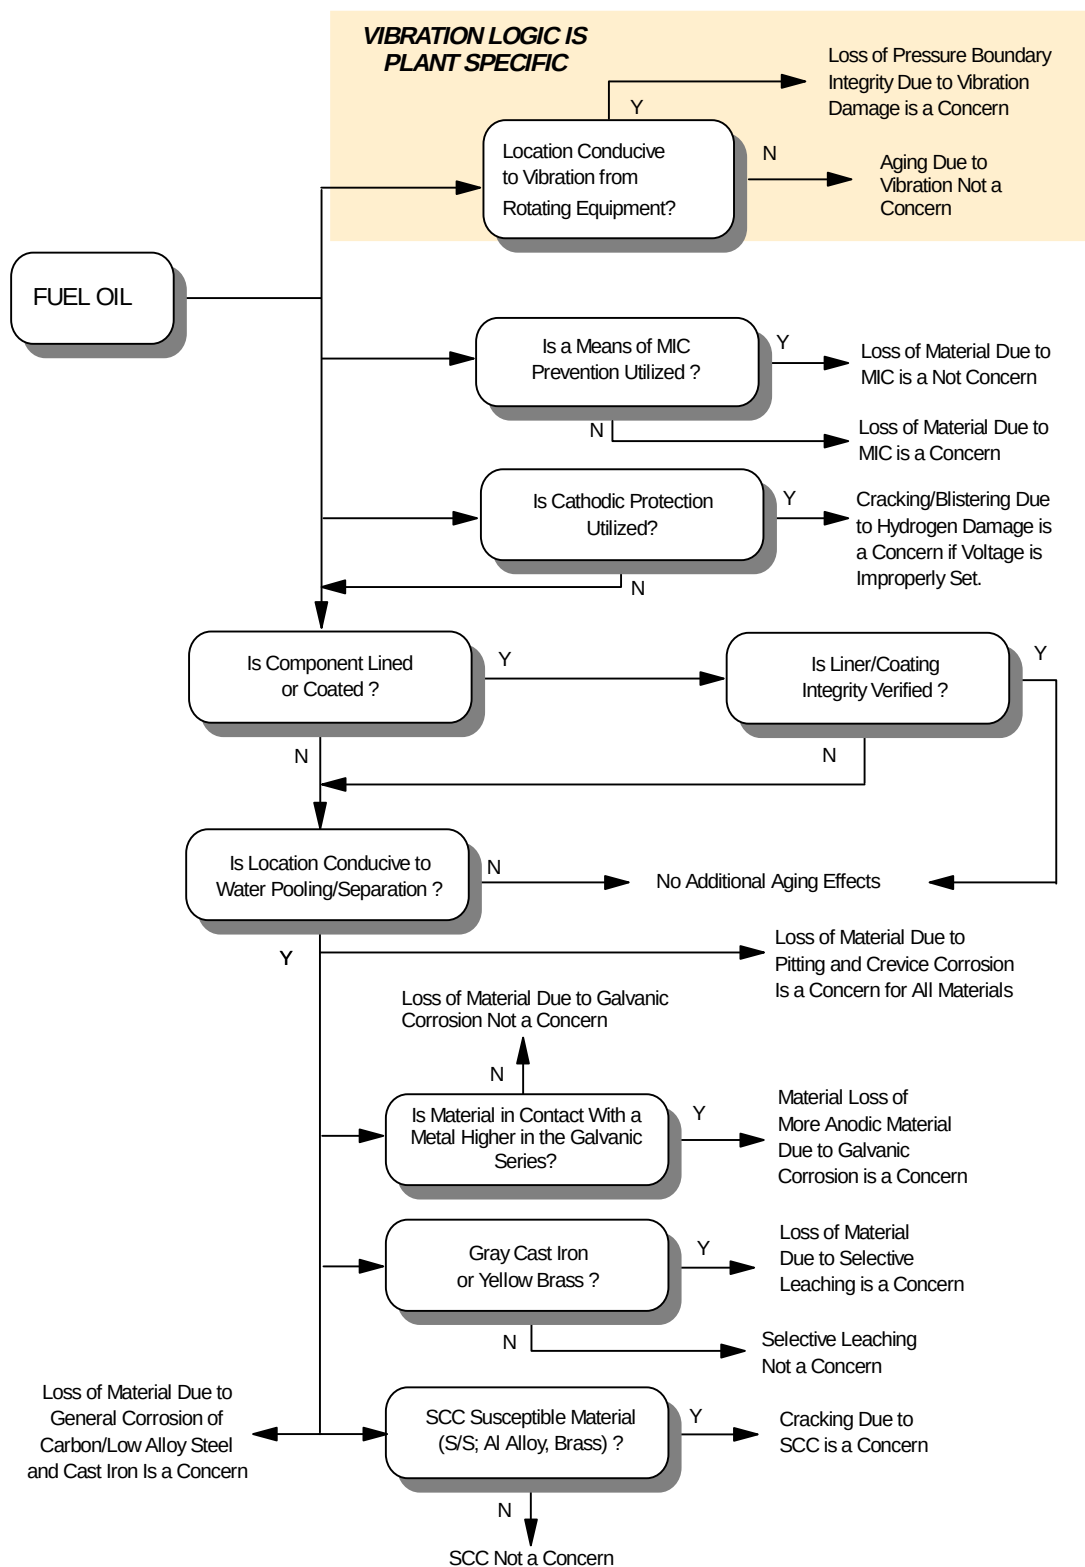
Figure 2 – Fuel Oil Tool

Stress-corrosion cracking only affects a subset of materials used in fuel oil systems. All stainless steels within the scope of this tool are considered susceptible. Pure aluminum is not susceptible, however, aluminum alloys containing more than 12% zinc or more than 6% magnesium are susceptible. Of the copper alloys covered by this tool, only those (which includes admiralty metal) containing greater than 15% zinc (including admiralty and Muntz) are susceptible to SCC.

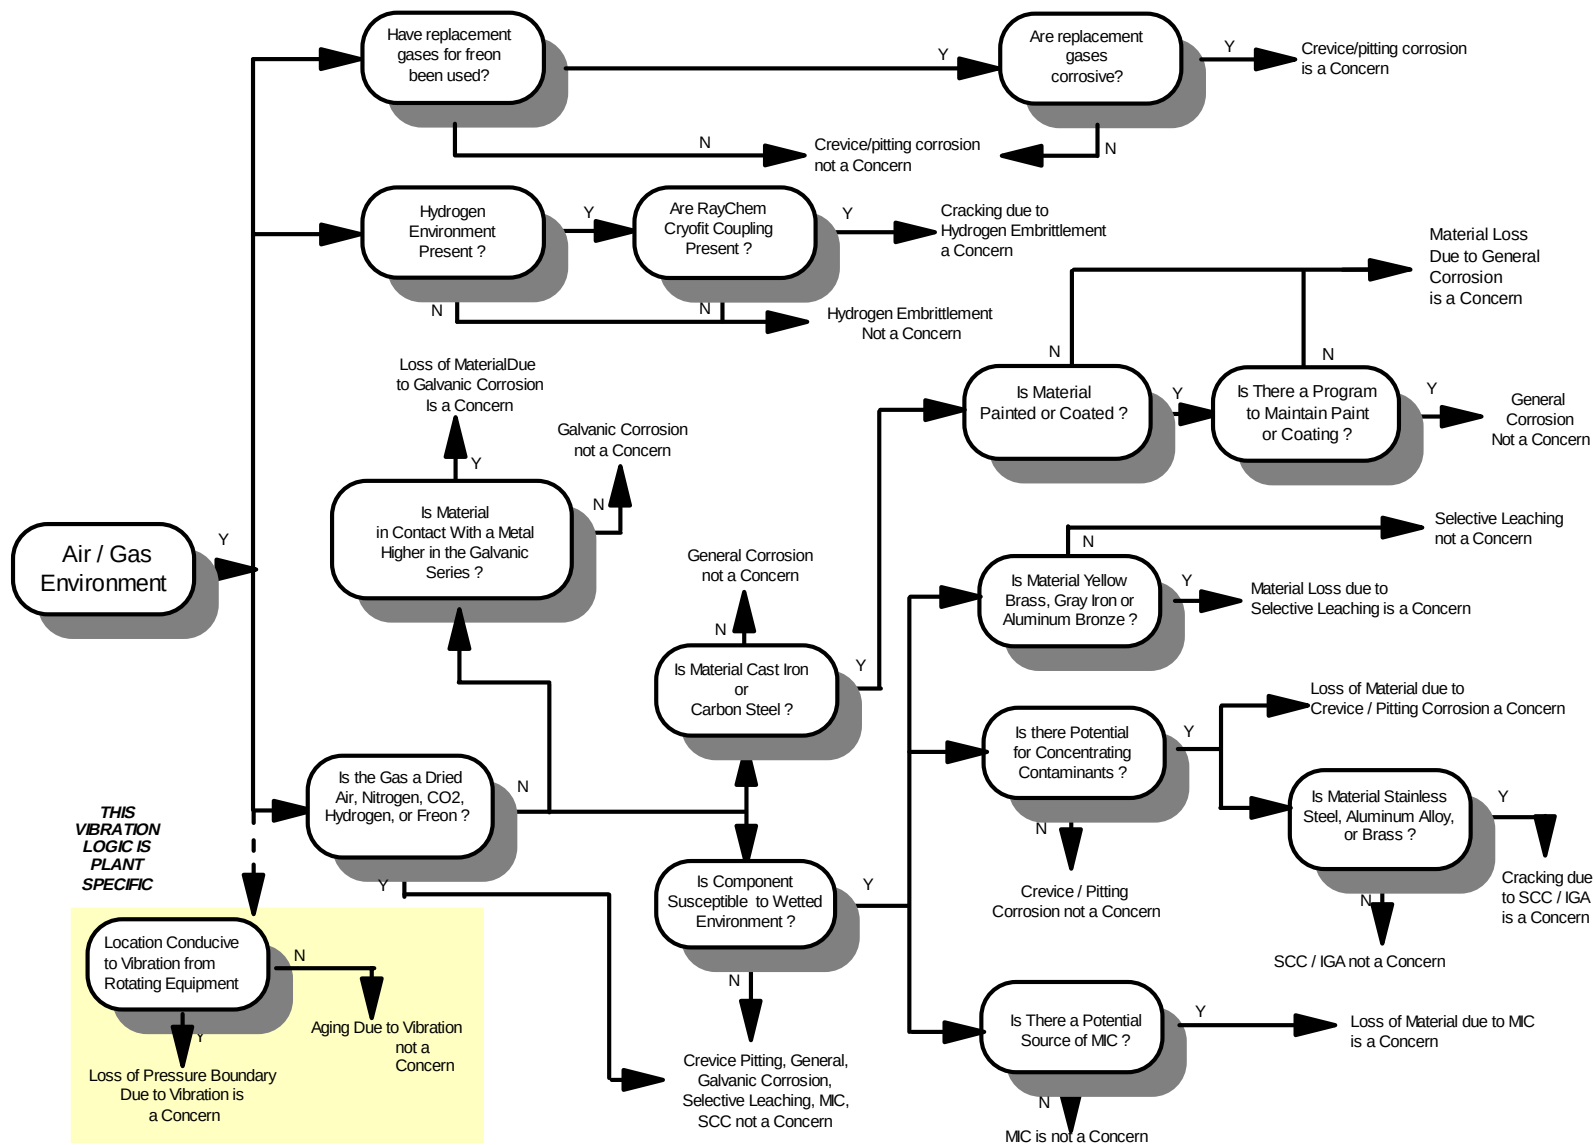
Figure 1 Air/Gas Tool

The logic is very simplistic in that it focuses attention on components and piping which are in close proximity to rotating or vibrating equipment. No specific proximity distances are identified as these will vary based on the type of equipment and the material used.

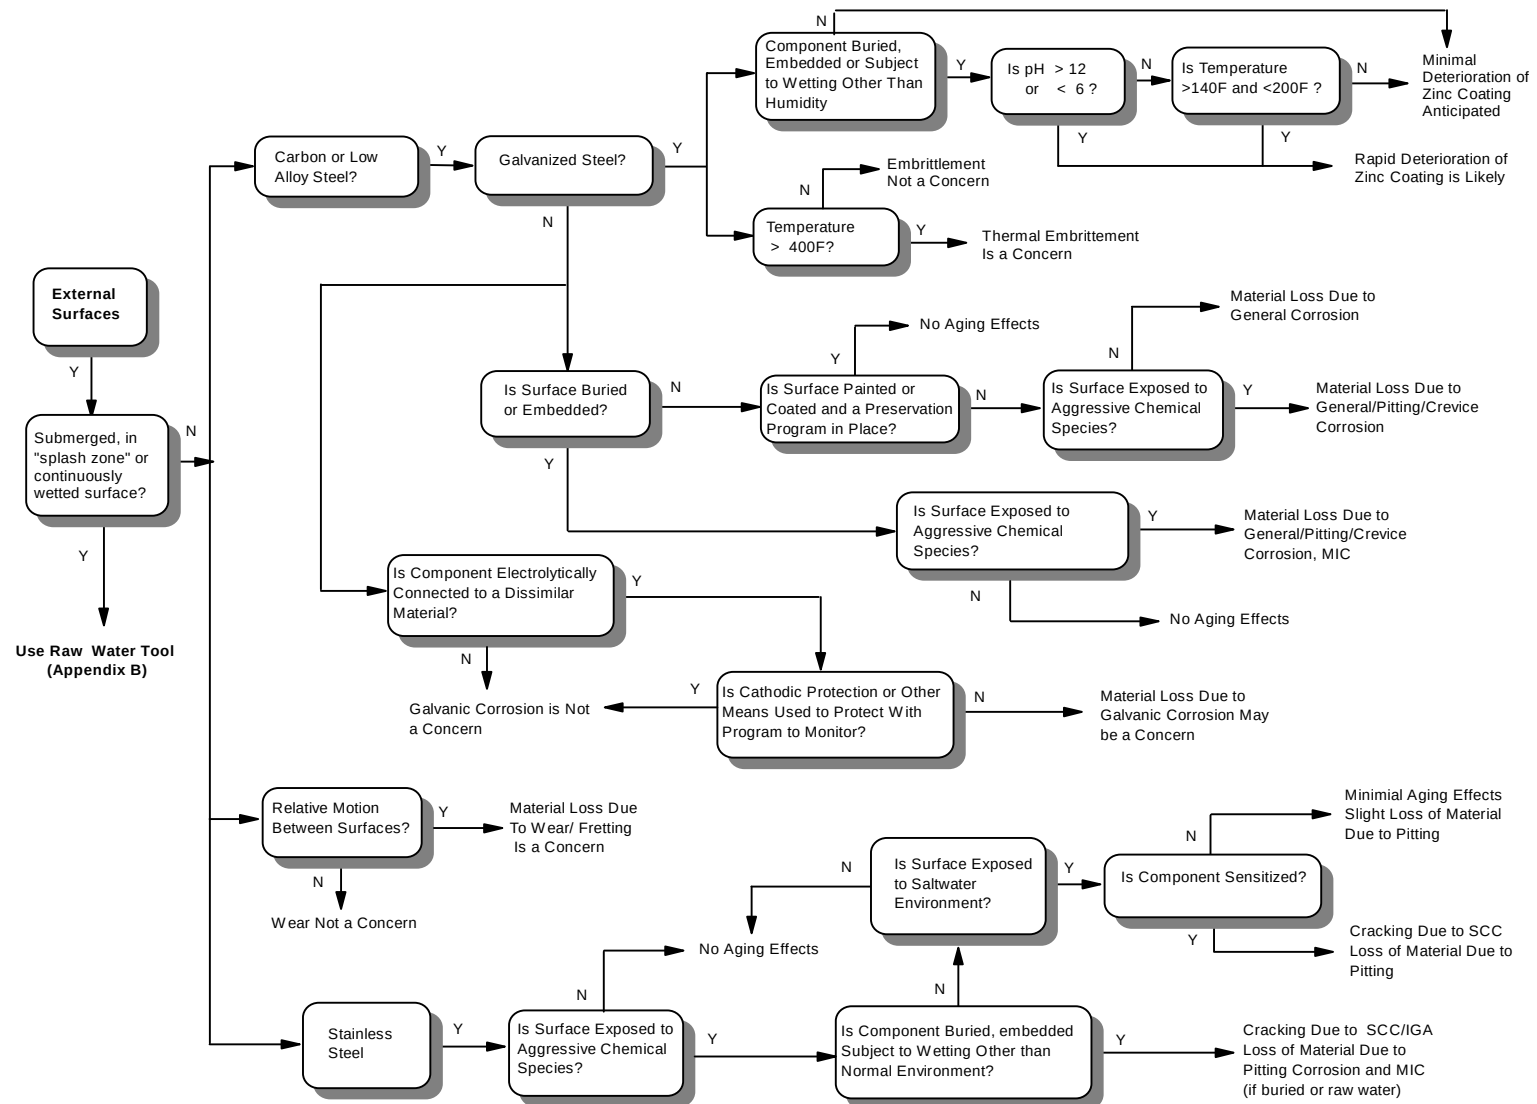
Figure 1 External Surface Tool

The lower branch of the galvanized steel logic addresses the potential embrittlement of galvanized steel at temperatures above 400°F. Thermal embrittlement of the material at these temperatures affects the base material and not just the zinc coating. Interactions between the zinc and carbon steel base material can result in embrittlement of the base material at high temperatures resulting in a loss of fracture toughness of the base material.
