Evaluating and Avoiding Heat Recovery Steam Generator Tube Damage Caused by Duct Burners

1012758

Final Report, March 2007

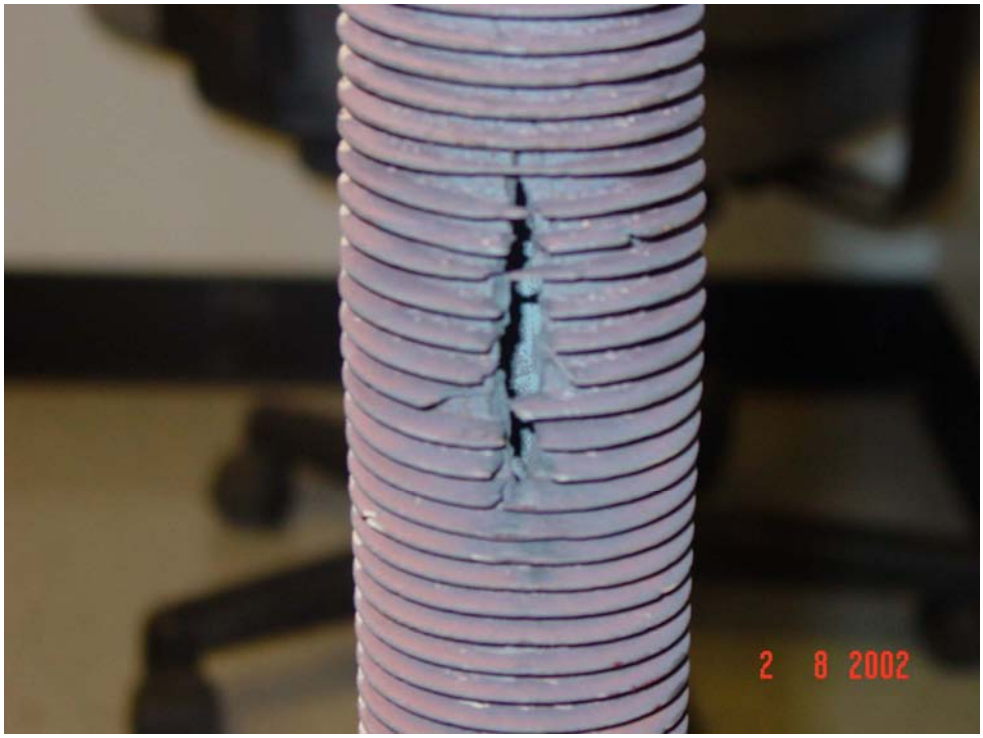
Figure B-4
Creep Rupture Failure in the Second Row of Superheater Tubes (Finned) Downstream of Duct Burner. It is one of many that occurred within three years of the over-fire event.

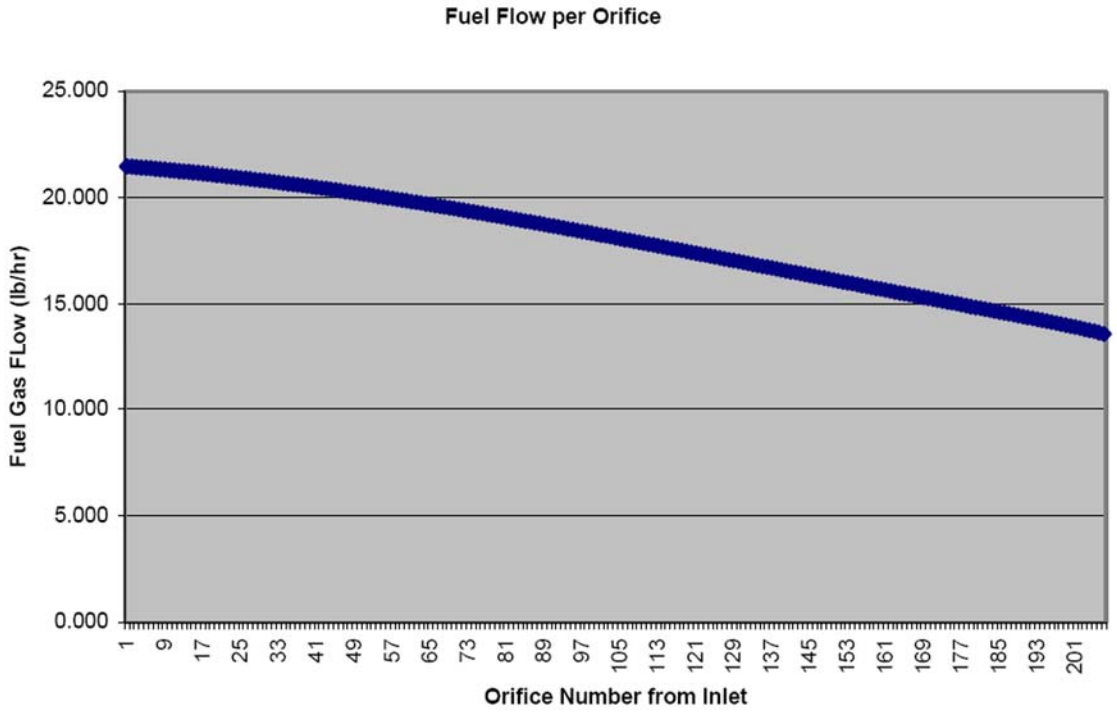
The 625-MMBtu/hr maximum output DB array consisted of seven burner runners with 207 orifices per runner. Engineering calculations revealed that under normal DB firing conditions, the burner openings (orifices) across the length of each burner runner should produce an average estimated flow of 17.9 lb/hr per orifice with a significant systematic variation of +20/-24% lb/hr (Figure B-5). This suggested that some significant gas temperatures and heat flux variations in the downstream tube coils could be present.

Figure B-5
Estimated Gas Flow across the Length of Duct Burner Runners. Due to the pressure drop in the runner fuel pipe the fuel flow rate is higher in the burner openings nearest the fuel inlet side of the runner.

To assess the influence of DB firing and the possible need for DB orifice tuning, measurements of the temperature of each of the outlet steam nozzle pipes in the HP Superheater 1 coil just downstream from the burner array was used to ensure design integrity and temperature uniformity associated with DB firing. The initial measured HP superheater 1 outlet nozzle temperature variations were as high as 34 °C (62 °F). In order to improve this side-to-side temperature distribution in the HP Superheater 1 coils, some of the burner orifices were plugged with a pin. More holes were plugged toward the gas inlet end of the runners. Some burner holes in the opposite end of the burner runners were enlarged.

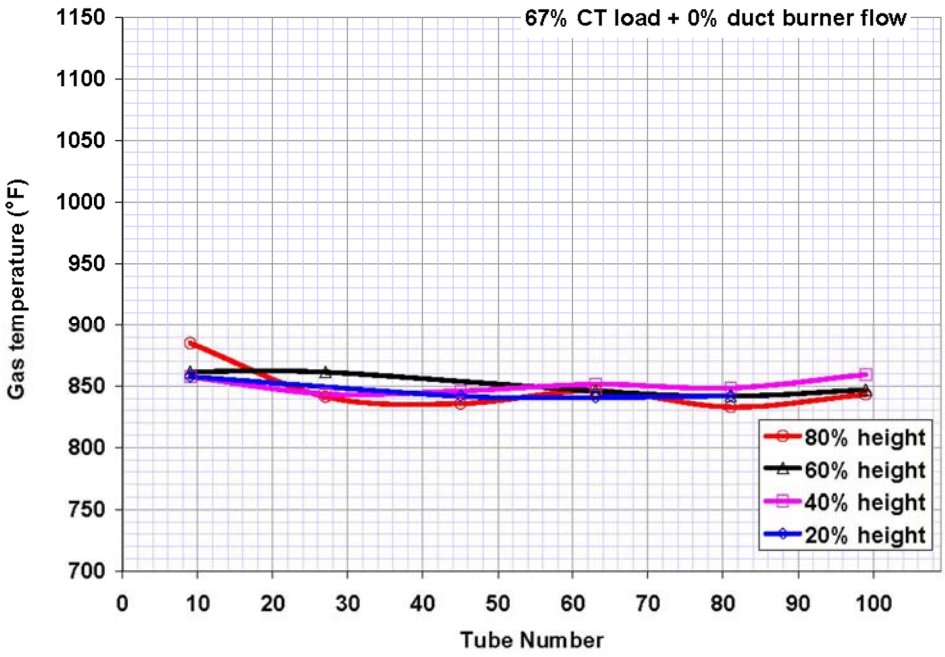
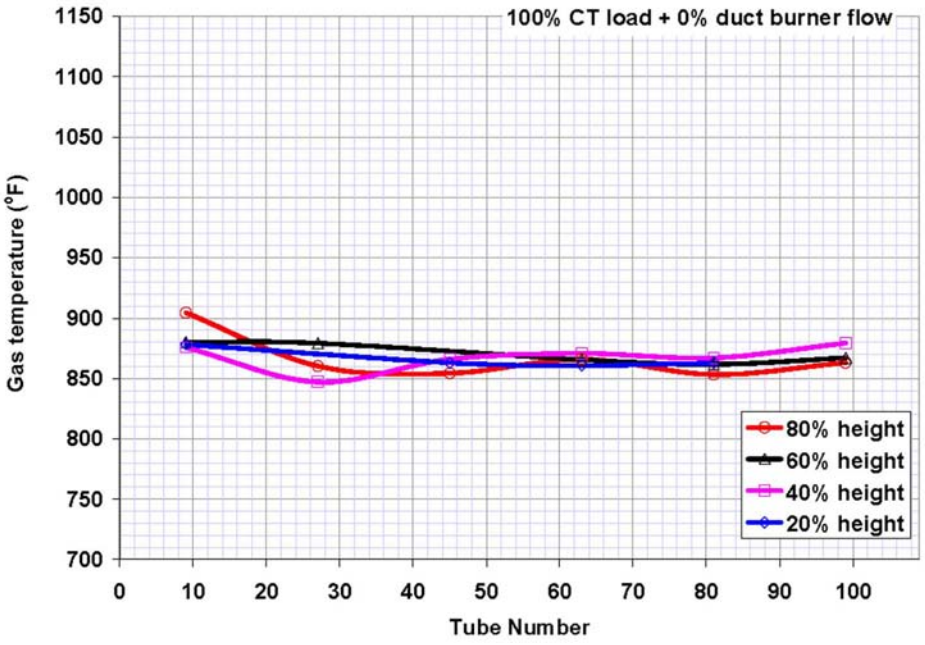
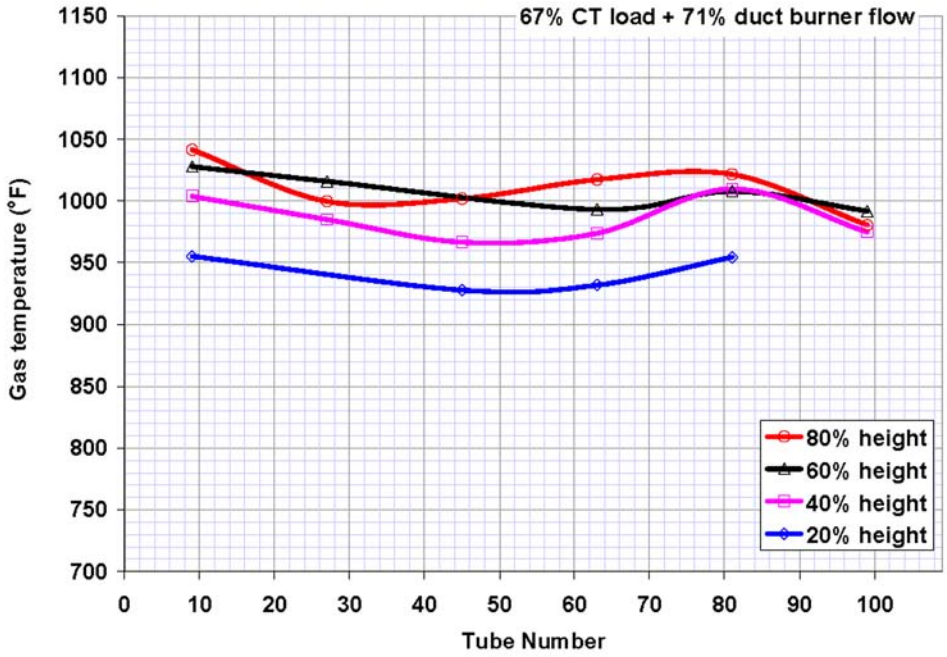
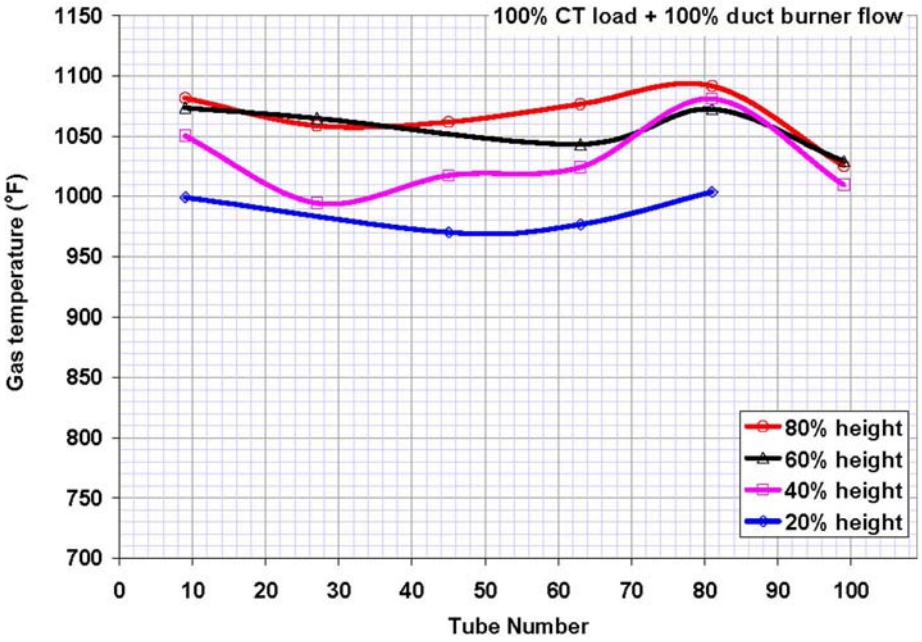
Findings from the gas-side thermocouples revealed that with the DB out of service and the combustion turbine operating at 67% or 100% of its normal full load value, there was a very uniform side-to-side and top-to-bottom gas temperature distribution (Figures B-6 and B-7). However with the DB operating at their preferred fuel flow rates for the part- and full-load CT operating conditions, there was still a significant (~ 50 °F to 70 °F) side-to-side and even more severe (~ 80 °F to 90 °F) top-to-bottom gas-temperature profile at the leading edge of the HP evaporator (Figures B-8 and B-9). This indicated that the initial modification of the burner orifices was not sufficient. This was further verified with HP Superheater 1 coil outlet steam nozzle pipe temperature measurements.

Figure B-6
Gas Temperatures at the Leading Row of the HP Evaporator with the Combustion Turbine at Approximately 67% of its Normal Operating Load and the Duct Burners Off

Figure B-7
Gas Temperatures at the Leading Row of the HP Evaporator with the Combustion Turbine at Approximately 100% of its Normal Operating Load with the Duct Burners Off

Figure B-8
Gas Temperatures at the Leading Row of the HP Evaporator with the Combustion Turbine at Approximately 67% of its Normal Operating Load and the Duct Burners Firing at Approximately 70% of their Normal Full Load Fuel Flow Rate

Figure B-9
Gas Temperatures at the Leading Row of the HP Evaporator with the Combustion Turbine at Approximately 100% of its Normal Operating Load and the Duct Burners Riring at Approximately 100% of their Normal Fuel Full Load Flow Rate

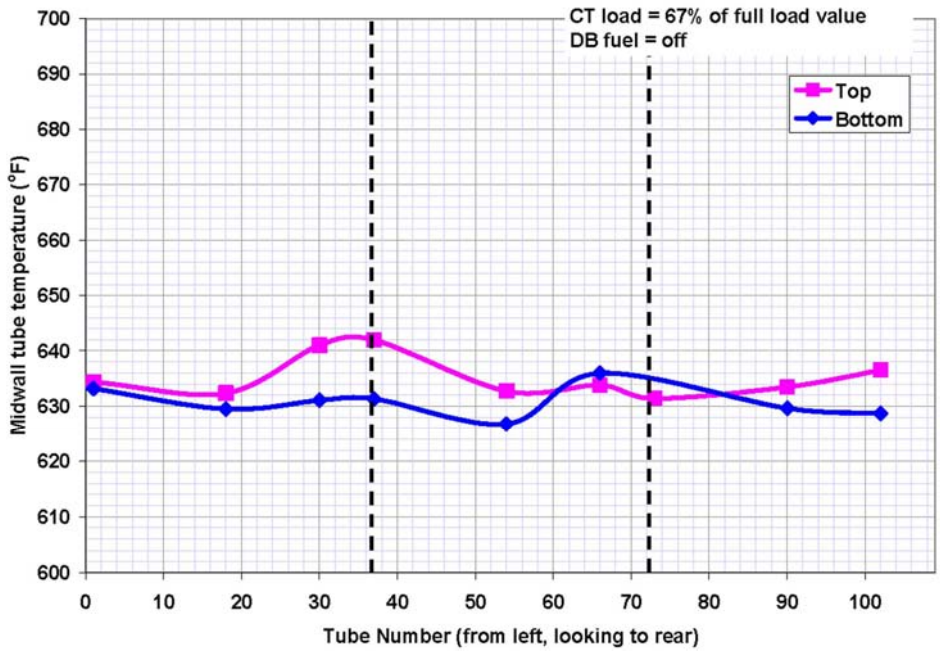
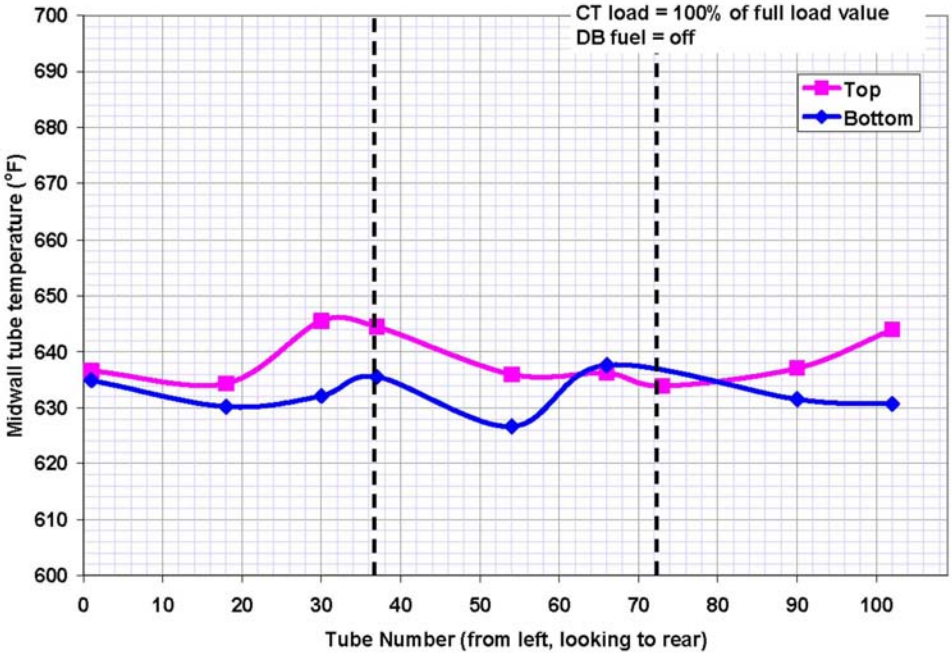
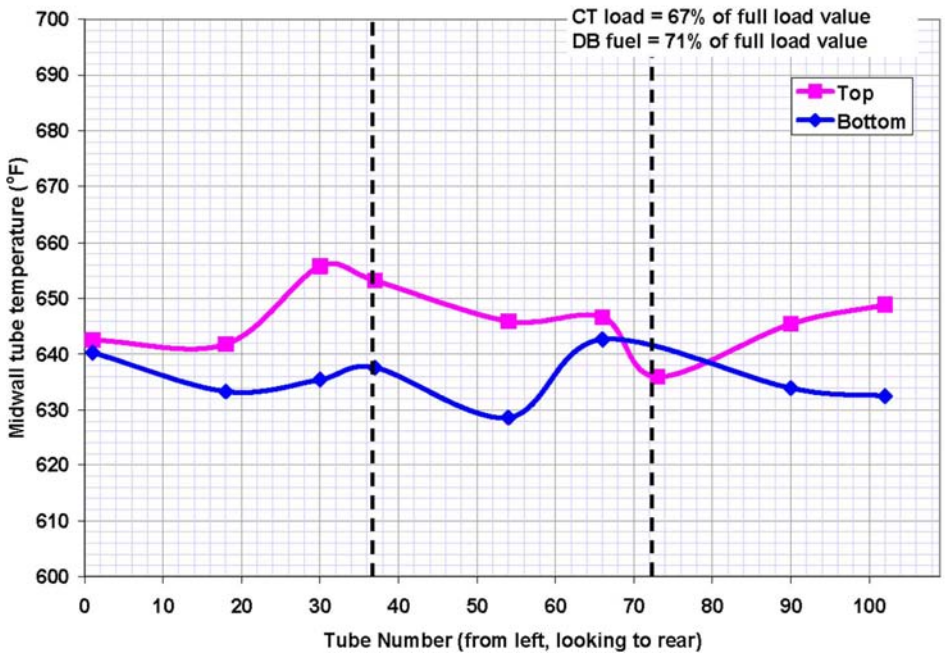
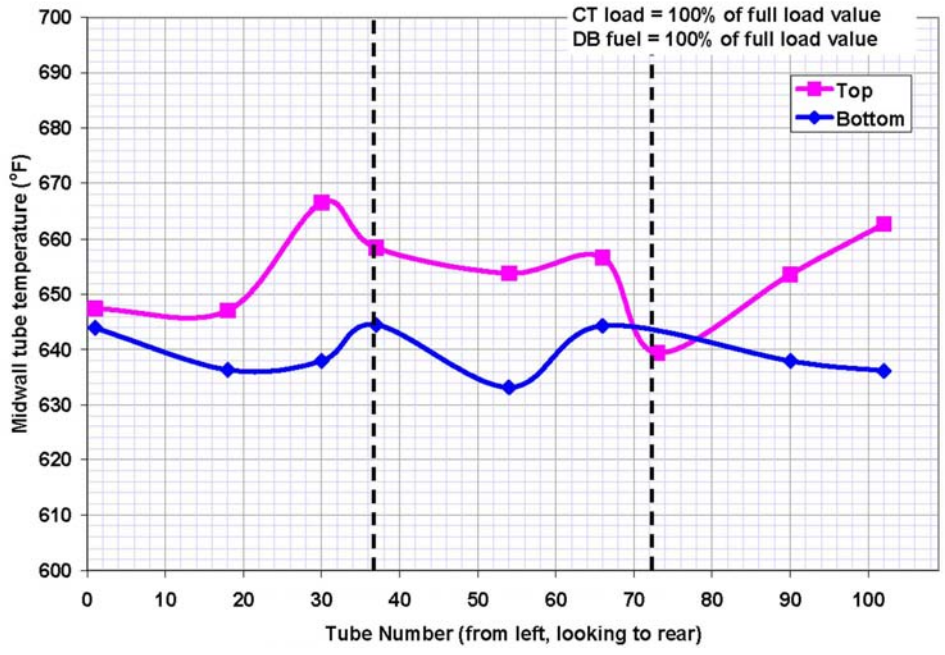
Prior to further tuning the DB, the measured HP evaporator mid-wall tube metal temperatures were evaluated and found to be moderate (Figures B-10 through B-13). With no duct firing, the maximum temperature pickup between the lower and upper measurement locations was 10 °F to 13 °F for 67% and 100% of the normal CT load, respectively. The maximum side-to-side tube-temperature variation was in the range of 8 °F to 11 °F with no duct firing. With the CT at 67% of its normal full load value and the DBs operating with 71% of their normal full load value, the maximum tube temperature pickup between the lower and upper measurement locations was 20 °F and the maximum side-to-side temperature variation was approximately 14 °F. With the CT at its normal full load value and the DBs operating at their normal full load value, the maximum tube temperature pickup between the lower and upper measurement locations was 28 °F and the maximum side-to-side temperature variation was approximately 20 °F.

Figure B-10
Mid-wall Tube-metal Temperatures at the Leading Row of the HP Evaporator with the Combustion Turbine at Approximately 67% of its Normal Operating Load with the Duct Burners Off

Figure B-11
Mid-wall Tube-metal Temperatures at the Leading Row of the HP Evaporator with the Combustion Turbine at Approximately 100% of its Normal Operating Load with the Duct Burners Off

Figure B-12
Mid-wall Tube-metal Temperatures at the Leading Row of the HP Evaporator with the Combustion Turbine at Approximately 67% of its Normal Operating Load and the Duct Burners Firing at Approximately 71% of their Normal Fuel Full Load Flow Rate

Figure B-13
Mid-wall Tube-metal Temperatures at the Leading Row of the HP Evaporator with the Combustion Turbine at Approximately 100% of its Normal Operating Load and the Duct Burners Firing at Approximately 100% of their Normal Fuel Full Load Flow Rate

Although the HP evaporator gas and tube metal temperature measurements and engineering calculations revealed that there was an adequate margin against departure from nucleate boiling, it was decided to make a second modification to the burner orifices. After this second modification, the HP Superheater 1 outlet header nozzle temperature variation during duct firing was decreased from 34 °C (62 °F) to 9 °C to 11 °C (16 °F-19 °F), which is deemed to be an acceptable variation.
