PQTN SOLUTION

Published by the Electric Power Research Institute No. 5 2007

Solving Power Quality Problems in Medical Imaging Systems

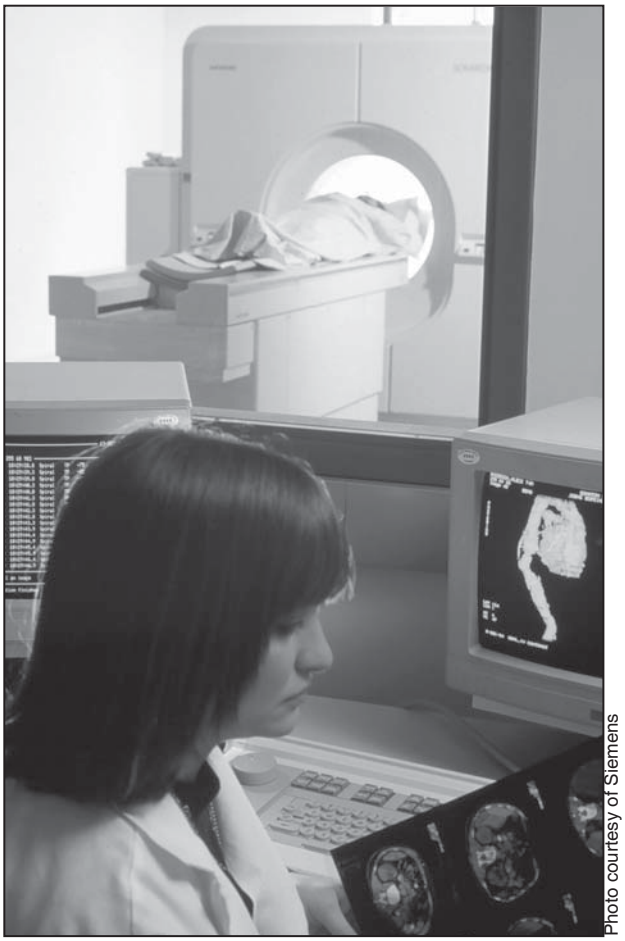
Figure 1. Computed Tomography Scanner

Computed tomography scanners, such as the one shown in Figure 1, use X-ray tubes similar to standard X-ray systems. However, the CT scanner employs an X-ray tube that rotates around the patient, who must lie very still for up to half an hour, often in

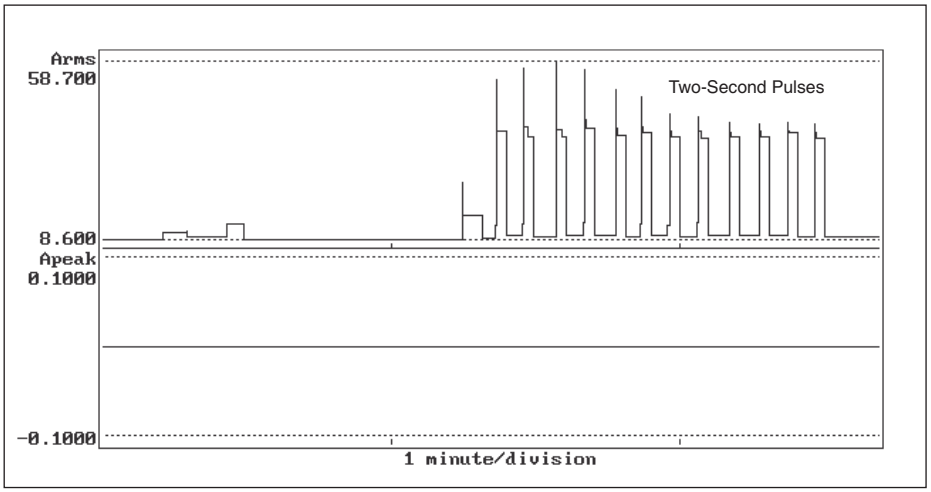
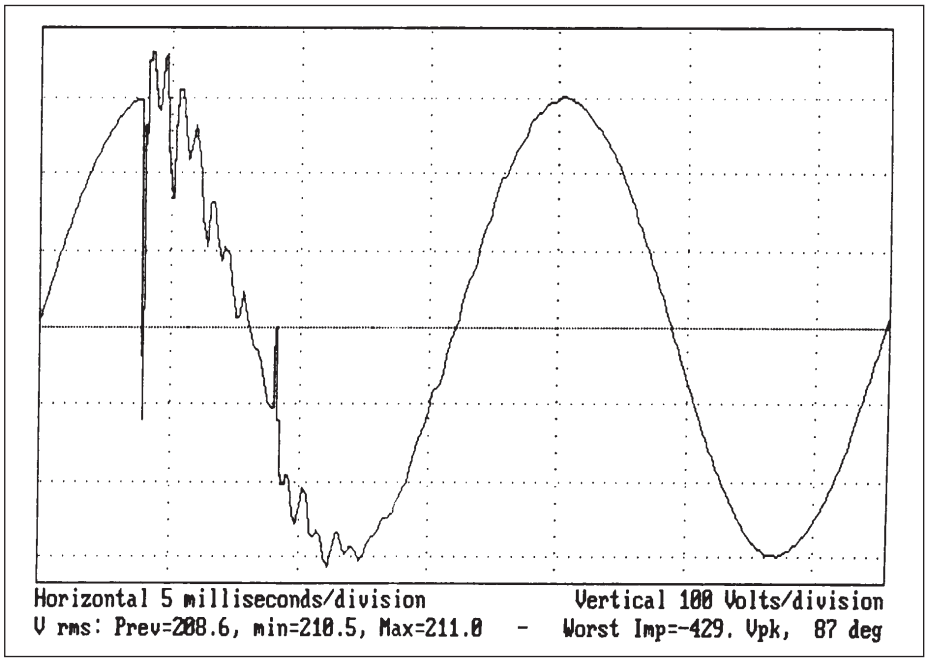
Figure 2. RMS Current of a Typical CT Scanner During a Scan

Like that in the conventional X-ray machine, the X-ray tube of a CT scanner switches on and off repeatedly. However, as shown in Figure 2, the rotating X-ray tube in the CT scanner draws current in pulses lasting about two seconds, whereas the current pulses of a conventional X-ray tube last only about four cycles (70 milliseconds). The longer, two-second pulse of the CT scanner's X-ray tube makes its imaging process more vulnerable to power disturbances. For example, a voltage sag occurring during one of these pulses can cause such severe degradation of the X-ray image that it cannot be used for diagnostic purposes, even if the microcomputer processing the image is not interrupted. Or, if the supply voltage sags below the scanner's undervoltage protection limits, the scanner may reset in the middle of a procedure, losing all the images stored in its memory.

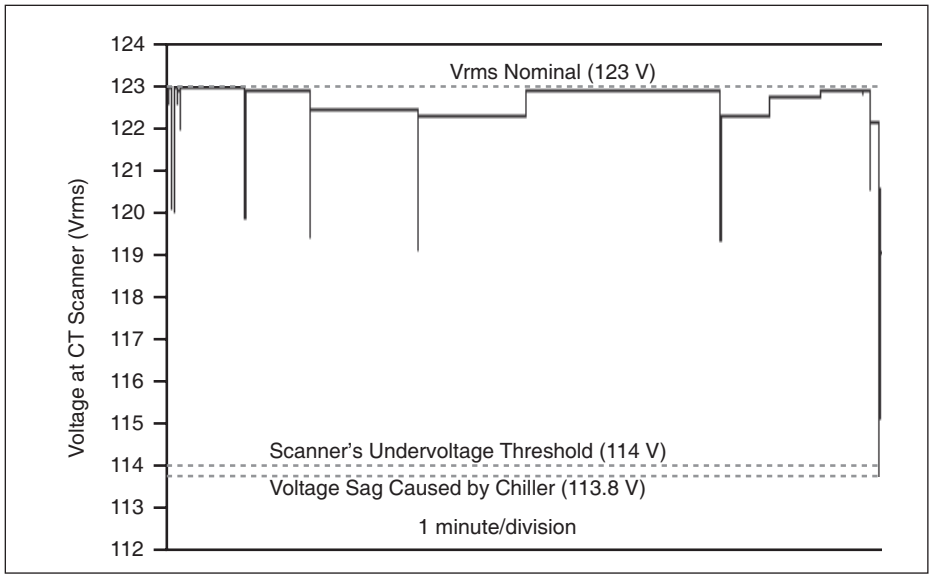
Figure 4. RMS Voltage Recorded at the Kansas CT Scanner

By this time, the director of maintenance for the Kansas hospital had pinpointed another possible cause for the scanner failures: The scanner shutdowns most often occurred when the chiller in the hospital's air conditioning system started. The maintenance director solved the problem by manually starting the chiller only when the CT scanner was not in use. However, this solution was less than ideal—manually starting the chiller overrode the hospital's energy-management system, significantly increasing the facility's energy costs.

Again, the hospital contacted Western Resources, who called in Ward Jewell, electrical engineer and Associate Professor at Wichita State University. Jewell monitored the voltage at the CT scanner to confirm that the voltage sags corresponded to the starting of the chiller. Figure 4 shows the RMS voltage at the CT scanner. Most of the voltage sags were caused by the normal operation of the CT scanner. These sags dipped to no less than 119 volts. However, the sag caused by the chiller-starting dipped to 113.8 volts. Jewell determined that the scanner's undervoltage trip threshold was set too high (at 114 volts) by the installer, who misunderstood the manufacturer's instructions. After the manufacturer's field technician reset the threshold to 108 volts, the scanner was able to oper-

ate while the hospital chiller started.

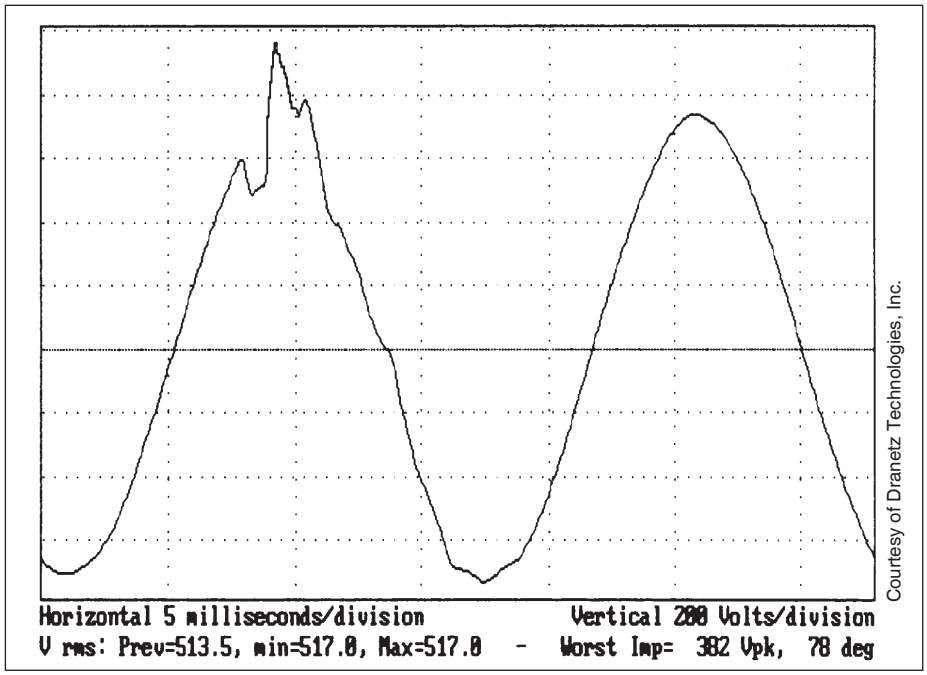
Figure 5. Attenuated Transient Recorded at the Nevada CT Scanner

In another medical clinic in Nevada, a CT scanner was experiencing repeated computer lockups and component failures. The power was brought to the CT scanner by a 480-volt service feeding a 480-to-208-volt isolation transformer. Using a power monitor, the medical equipment service company identified the cause of the failures: a voltage transient, shown in Figure 3, produced by the local utility switching on a power-factor-correction capacitor bank, located only a block away. The hospital's isolation transformer had little effect upon the ringing transient.

In the Nevada case, where capacitor switching caused a CT scanner to lock up, the medical equipment company recommended the use of an "active-tracking filter" (a low-pass filter with surge suppressors), which was specifically designed to attenuate the ringing transient of about 1 kHz caused by energizing the capacitor bank. The filter, installed on the 480-volt line to protect all downstream equipment, significantly attenuated the transient and eliminated the scanner lock-ups and component failures. Figure 5, on page 3, shows the attenuated transient at the CT scanner.
