Turbine-Generator Topics for Power Plant Engineers: Motoring of a Synchronous Generator

1022588
Technical Update, February 2011

Lanier Consulting, LLC

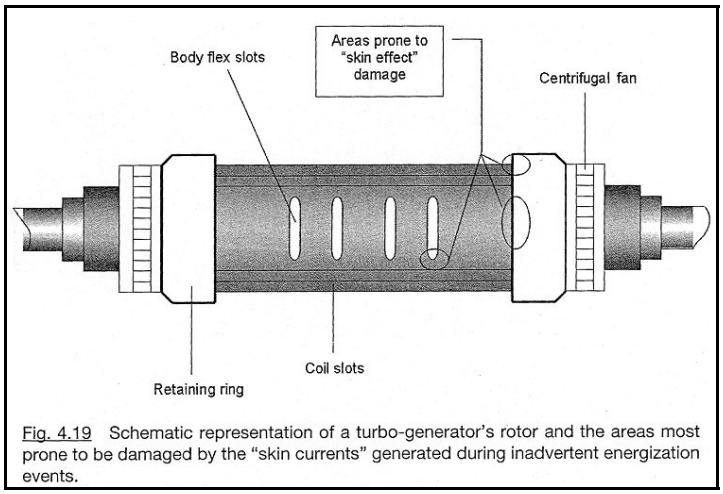
Figure 4-1
Schematic representation of turbo-generator's rotor

The major areas of concern are: 1) the forging at the ends of the cross slots. [Photos 3 and 4]; 2) the interface where slot wedges butt together [Photo 5]; 3); the interface between the retaining ring fit and the forging or the retaining rings and the wedges [Photo 6]; and 4) the slot wedge to body interface. See the sketch below from Reference 1.

Fig. 4.19 Schematic representation of a turbo-generator's rotor and the areas most prone to be damaged by the "skin currents" generated during inadvertent energization events.

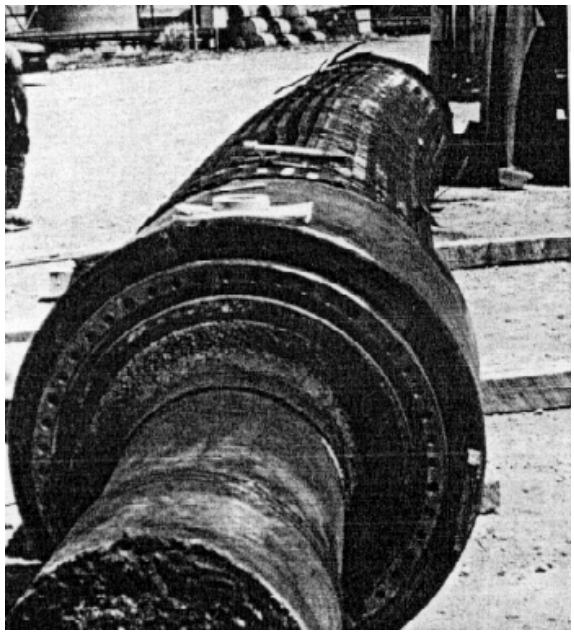
Both motoring currents and negative sequence currents will be discussed here. It is difficult to discuss one problem without the other; they both cause unwanted and harmful current to flow on the rotor forging. Like many maladies there are extremes. Operating with negative sequence currents near the design limit and motoring a unit from rest are both harmful to the rotor, in either case there was over heating of the rotor. One more severe than the other. Here is an analogy of walking and tripping. You can trip on the nap of a rug and fall, or you can trip off the top of the Sears Tower. In either case you fell, one more severe than the other. Photo 1 is an example of a Sears Tower rotor over heating event.

Damage evaluation is easy in some motoring situations, once the smoke has cleared. See the first photograph in the Photo Section. But, for a majority of motoring events, generator or turbine damage is not immediately clear; and in many casus no damage or insignificant harm occurs. If other than Synchronous Motoring takes place for tens of minutes, the generator casing may need to be opened for a visual inspection.

1. Worst case motoring

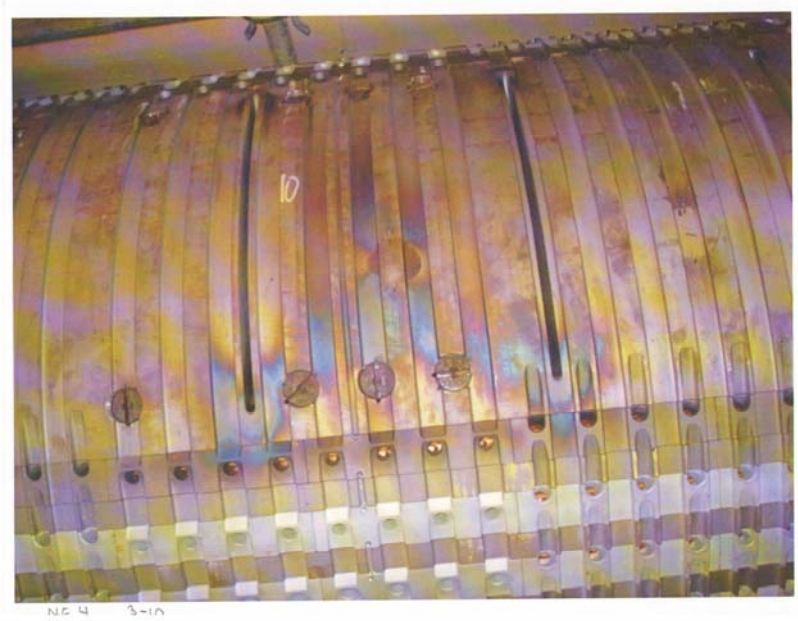
On the 2 pole forgings, pole face “cross slots”, also called body flex slots, are machined into the forging to balance out the stiffness of the forging. [Photo 2] Motoring surface currents can not bridge these slots; as the current flows axially along the forging it bunches up at the end of the cross slot causing heating. [Photos 3 and 4] This localized heating, if severe, will increase the forging steel material hardness which could become the source for a forging crack. All of the overheated areas on the forging must be checked for changes in hardness.

2. Pole forging with cross slots

3. Overheating at cross slot (You can almost see the current flow path)

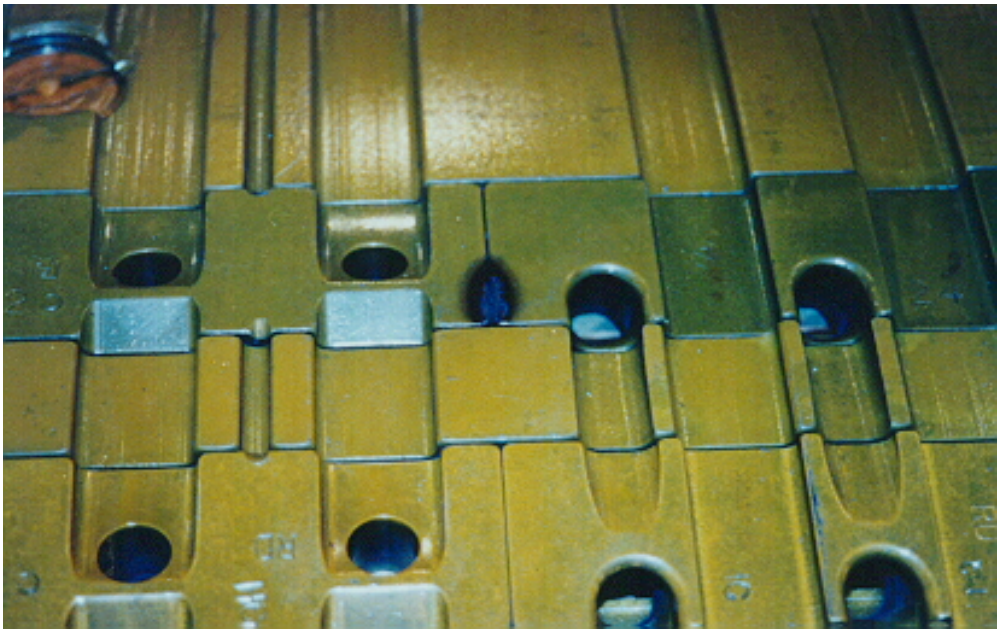
4. Overheating at cross slot

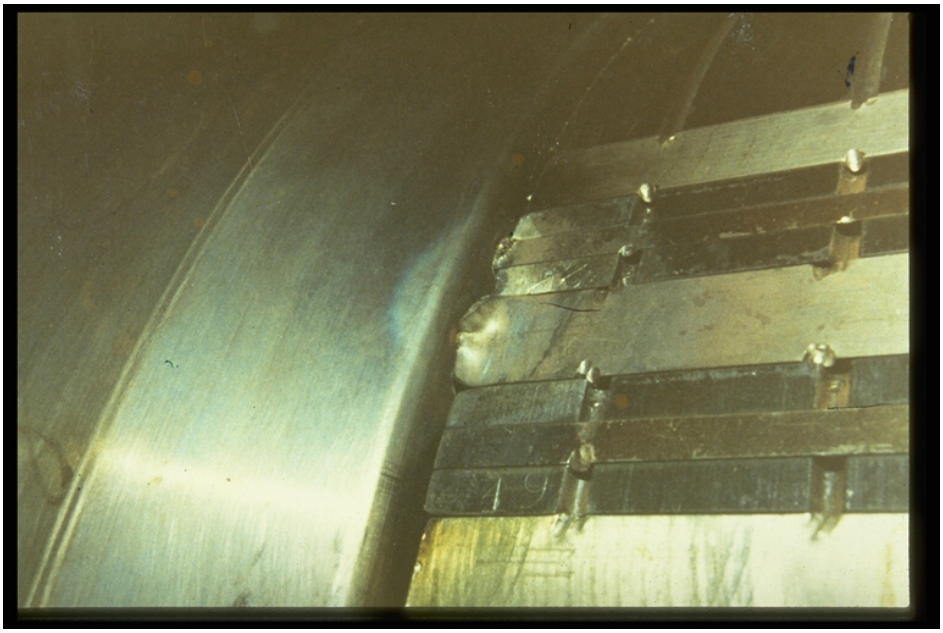
5. Overheating at wedges

6. Overheating, welding, at the retaining ring
