SF_6 Leak Location and Sealing Solutions: 2013 Update

Technical Update, December 2013

Hoffman Power Consulting

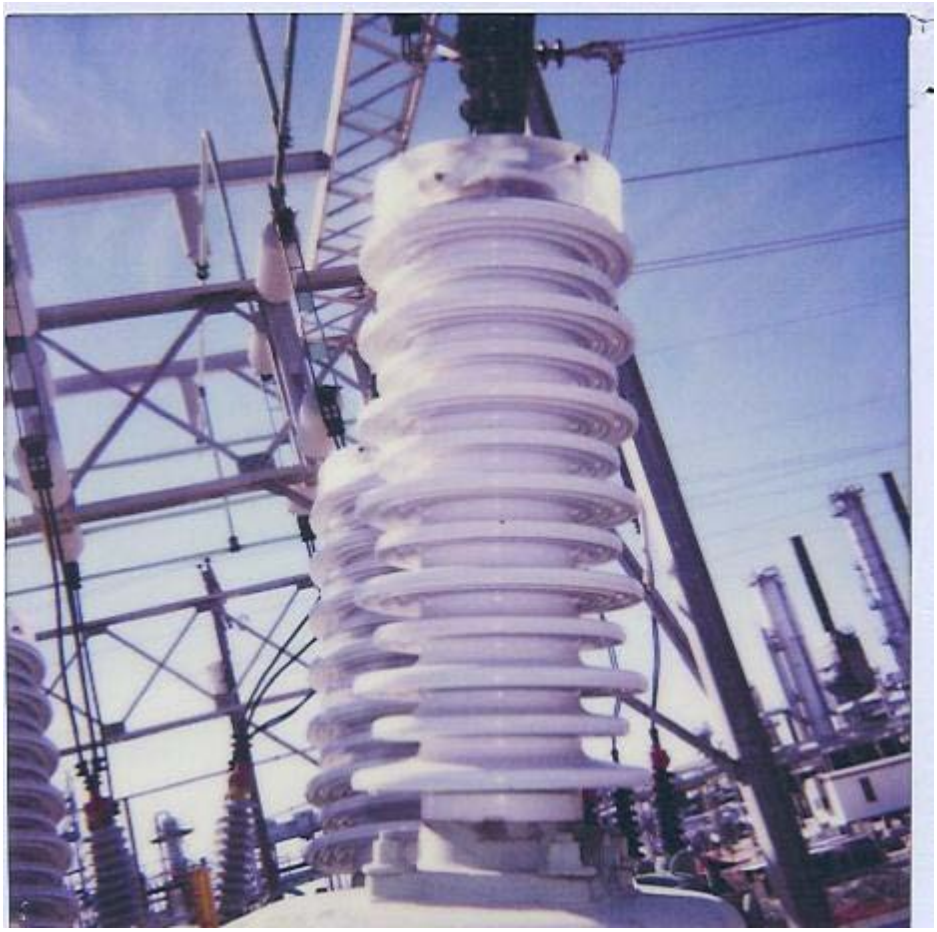
In Figure 6-3, an enclosure of nylon composite was fabricated to seal a leak at the top of a bushing. Two outages were required – on the morning of Day One, a 1-hour outage was needed for the leak seal technician to obtain precise measurements for the enclosure. The device was fabricated and overnighted to the client. A second outage of 4–6 hours was then taken to install the enclosure. Sealant is injected into a channel inside the clamp to seal the leak. The clamp remains in place and can be easily removed when needed.

Figure 6–3
An enclosure of nylon composite was fabricated to seal a leak at the top of a bushing.

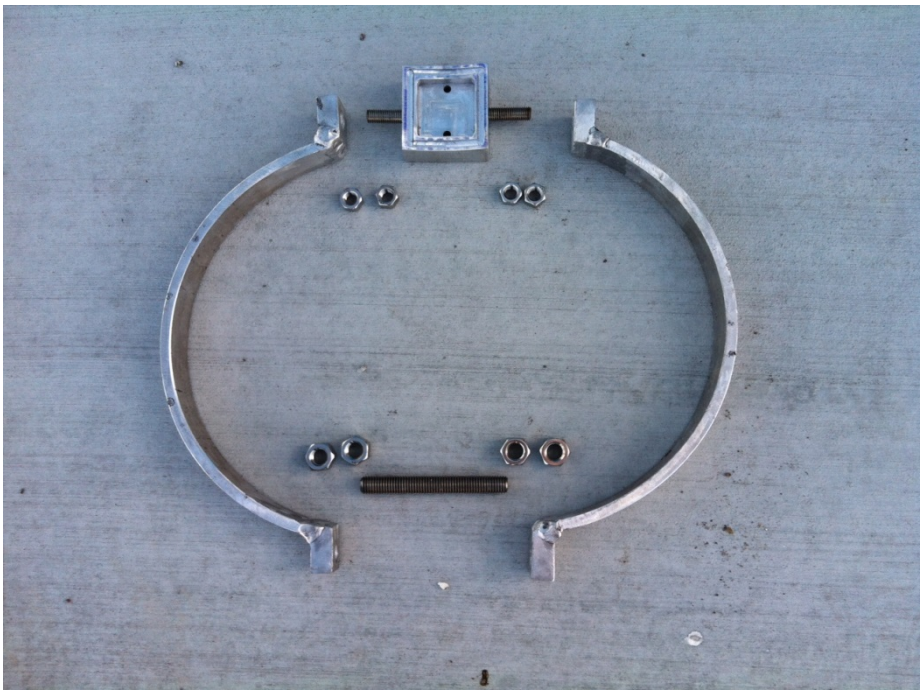
Figure 6–4
Leak is identified.

Figure 6–5
Clamp is manufactured.

Figure 6–6
Clamp is installed over the leak with injectors to facilitate sealant injection.

The sealant used is not an epoxy. Specially formulated for use with high voltage electrical apparatus, the sealant is flexible and easily removed. It maintains a "memory" that allows for expansion and contraction as needed due to temperature changes and vibration. The substance has excellent dielectric properties as documented by test results from an independent laboratory. Figures 6-4 to 6-7 show another example from the utility.

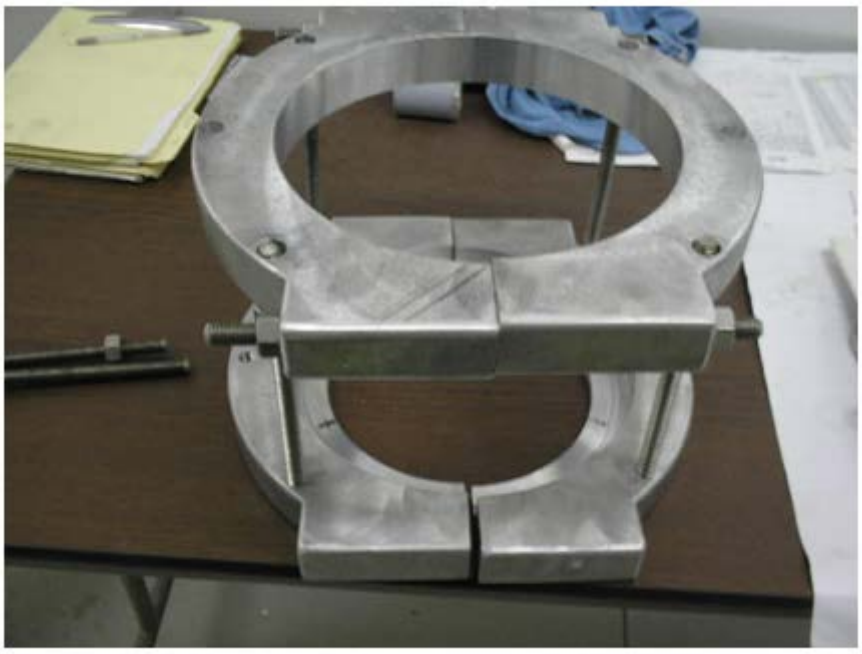
Figure 6–8
Precise measurements are taken prior to designing the clamp.

Figure 6–9
The clamp is designed and manufactured.

Figure 6–10
The clamp is installed over the leak.

A large utility had completed a number of successful gas leak repairs working with an outside contractor. A significant SF_6 leak was identified in a breaker at a substation. The first option was to re-gasket the breaker, but the time required to remove the breaker from service was an issue, as it would have required five days of down time, loss of transmission, and $20,000 due to the placement of the breaker. Instead, the utility determined the optimal solution was to repair the breaker by installing a custom clamp and injecting sealant (see Figures 6-8 to 6-10). This approach resulted in just one day of downtime and approximately $21,000 to fix all of the leaking components.
