Plant Engineering: Evaluation and Insights from Nuclear Power Plant Tan Delta Testing and Data Analysis – Update

2015 TECHNICAL REPORT

3002005321

Final Report, September 2015

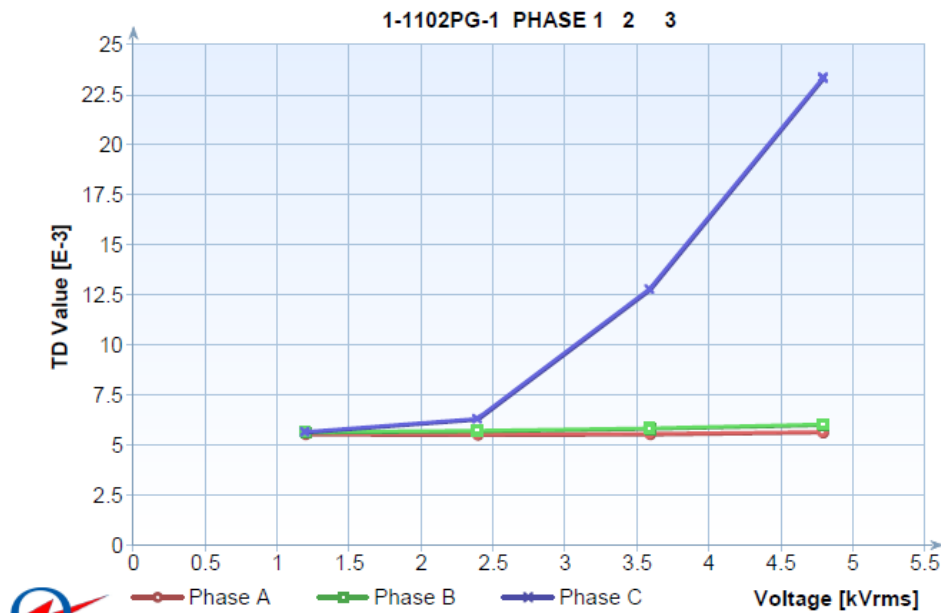
Figure 4-3
Tan δ results for an RCP motor showing a degraded C phase

This circuit had no splices, but it did contain terminations at the cable ends and on either side of a containment electrical penetration. In a case like this, the first step would be to visually inspect the penetrations for signs of overheating, partial discharge, or water intrusion. It can be seen in Figure 4-4 that the C phase was visually found to be overheating.

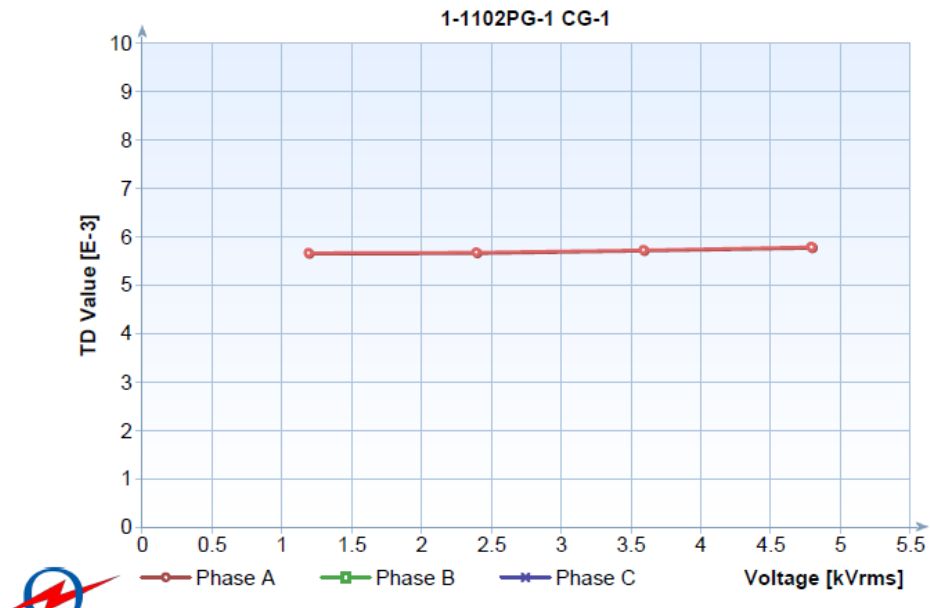
Figure 4-5
Post-repair testing for a reactor coolant pump motor showing the C phase. Only the C phase was retested so the data appear under the A phase.

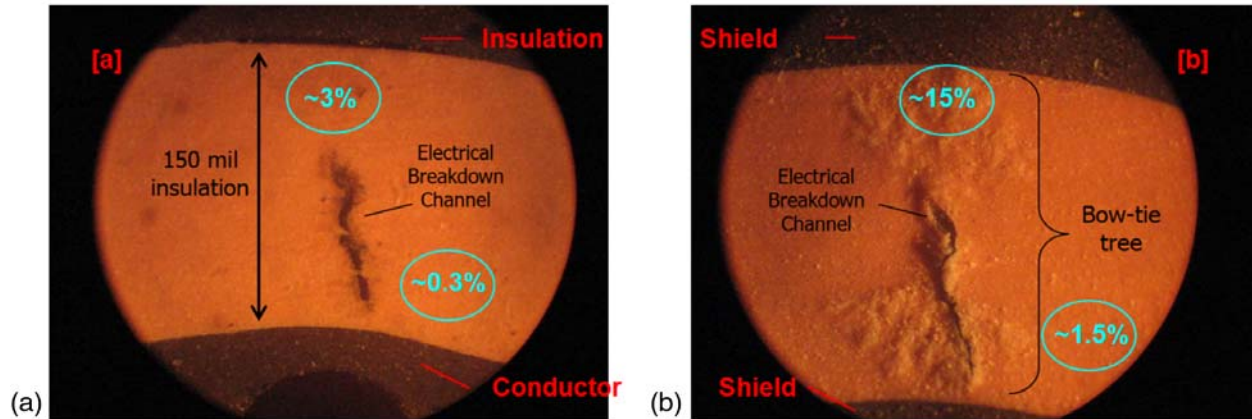
Forensic research [5, 8] was performed on two of the four pink EPR insulation issues identified in Table 3-2. In both cases, the degraded insulation was isolated forensically in the lab. The isolated sections' level of degradation was determined by the results of reduced ac breakdown strength of the degraded area compared with the surrounding insulation. In the first case [5], the resultant breakdown destroyed any evidence to be able to confirm the presence of water treeing. In the second case [7], the breakdown area was minimal, and the image [b] in Figure 5-2 shows the bow-tie water tree. The tree spans nearly all of the insulation from conductor shield to insulation shield.

Figure 5-2
[a] A wafer containing the breakdown channel of the degraded insulation, [b] the degraded area and large bow-tie water tree that has been "developed" by soaking the wafer in water

The issues of these two cables resulted in the cables being removed from the plant, based on tan δ results for all three criteria. The laboratory cable ac breakdown test showed that the insulation strength was much less for the degraded areas (4.6 V/V_0 and 2.5 V/V_0) than the surrounding "good" insulation (12 V/V_0 to 17 V/V_0). It is surmised that tan δ will equate to degraded ac breakdown strength similar to black EPR, but insufficient data points have been obtained from the two forensic reports to provide a correlation graph like the one shown for black EPR in Figure 4-6.

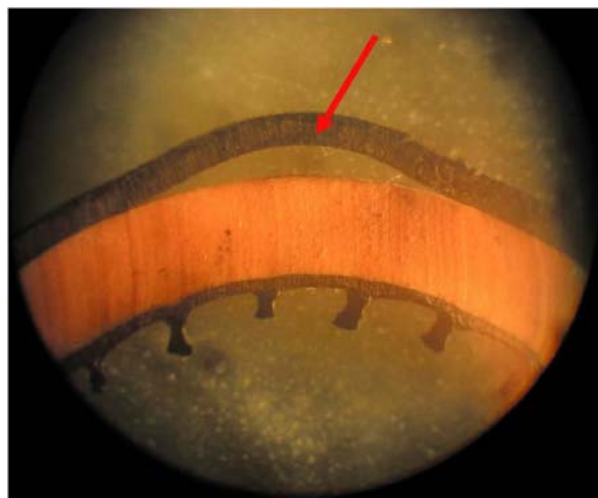
This EPRI research [8] identified that this jacket/shield-to-insulation adhesion has been compromised by water trapped at the interface that has created a water-filled pocket shown in Figure 6-3.

Figure 6-3
Arrow shows the insulation shield lifted off the insulation surface by trapped water

This delamination pocket creates stress between the insulation and insulation shield, and subsequently partial discharging occurs. The energy released by this partial discharge disintegrates the EPR at the surface as seen as the white areas in Figure 6-4, reducing the overall dielectric strength of the remaining insulation by as much as 50%.

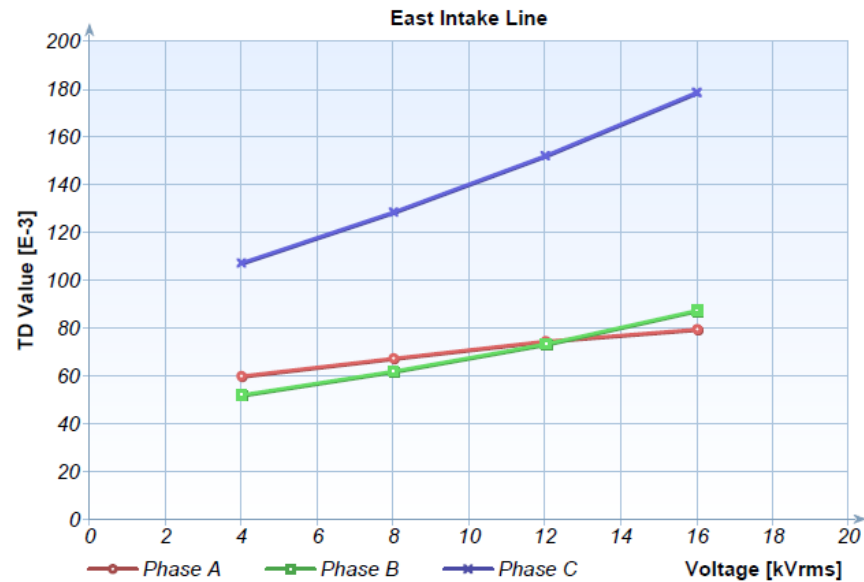
Figure 7-3
Example of "action required" brown EPR with suspected bad splices

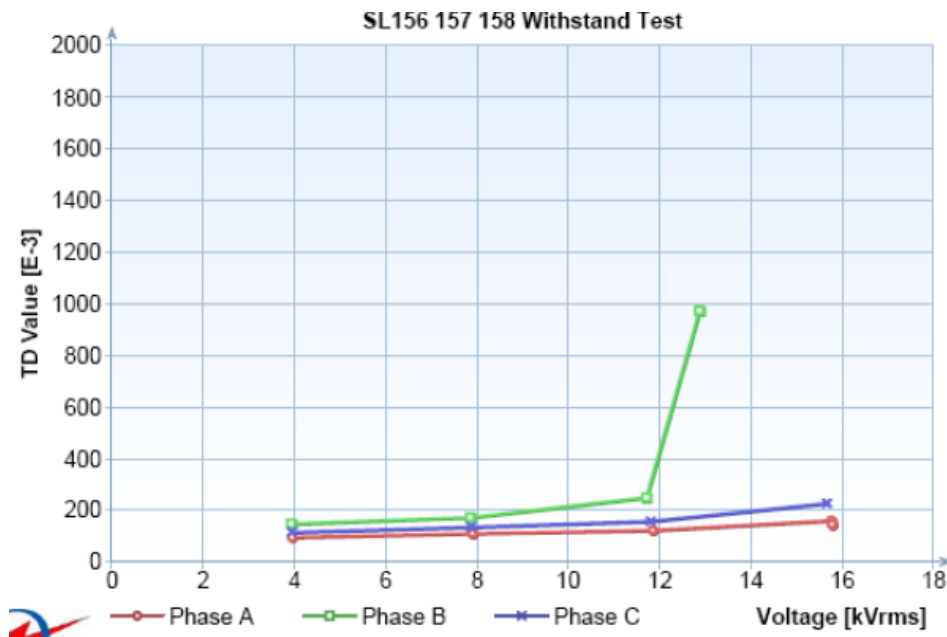
The test data shown in Figure 7-4 identified a degraded splice. The cable failed during a monitored withstand test. It is presumed that this cable would have failed in service due to the degraded splice. When the splice was opened, it was found that the zinc tape used for the metallic insulation shield had turned to zinc oxide powder. This created a non-continuous shield. The heat shrink splice could be seen visibly to have a poor shrink on one end that would have allowed water ingress into the splice. It is surmised that the electrical stress combined with water resulted in the deterioration of the zinc into the zinc oxide that is visible in Figure 7-5.

Figure 7-4
One documented case where a cable failed during a monitored withstand test

Figure 7-5
Splice with a poor heat shrink being opened and exposing the degraded zinc metallic insulation shield

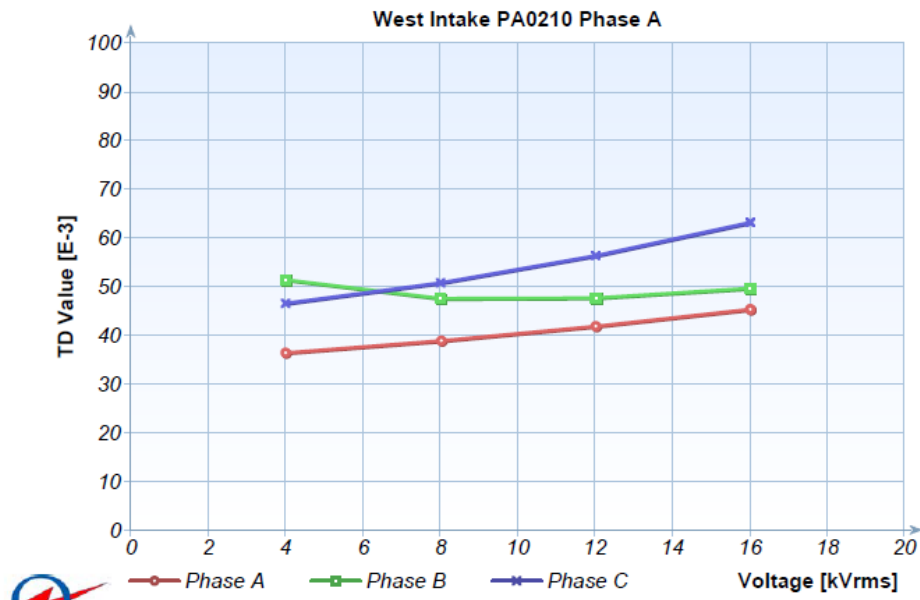
Figure 9-3
Standard deviation shows termination degradation

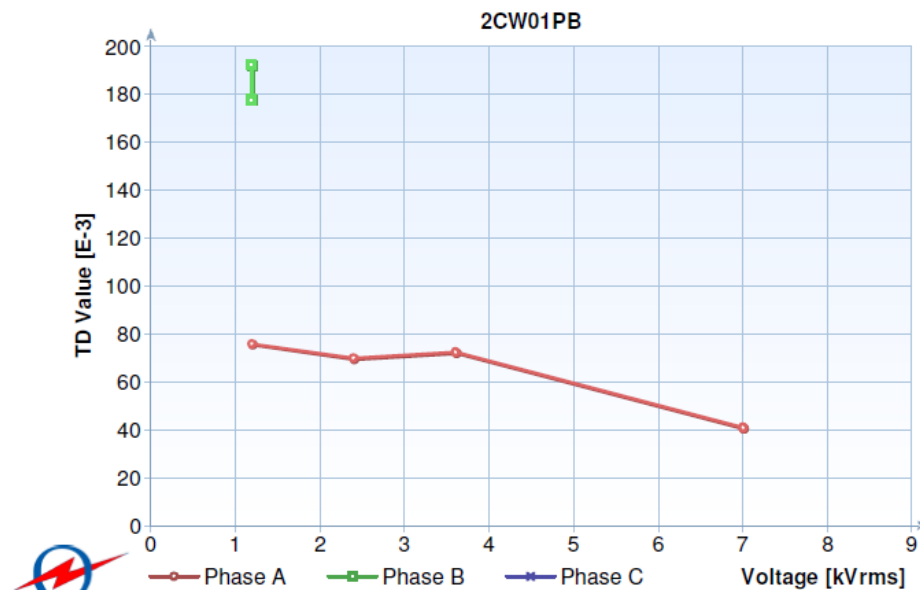
Figure 9-6
Tan δ test with negative delta tan δ identified bad splice

Investigation targeted the terminations first, but the retest results were unchanged. The splices on all three phases were replaced, and the circuit was retested (Figure 9-7). The splices were forensically evaluated. The splice was not degraded, but the metallic shield was found to be discontinuous across the splice. The cable splice was reconfigured, and the cable subsequently tested almost like a new cable of this type.

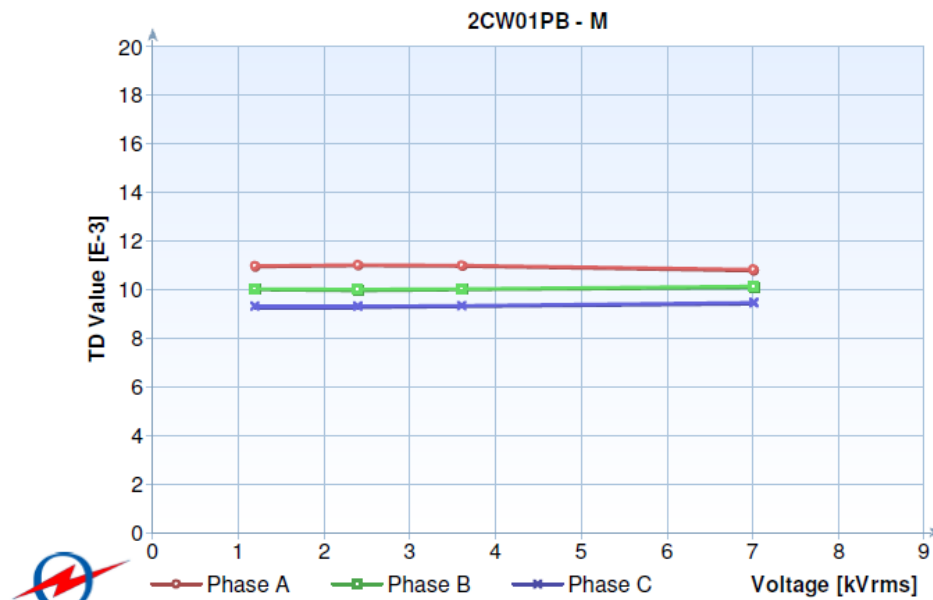
Figure 9-7
Cable with initial negative delta tan δ post-splice replacement results

Investigation into any test results with negative delta tan δ is recommended. Regardless of whether the cable contains splices, it is almost always easiest to confirm the termination condition first and then investigate the splice.
