EPRI

2023 White Paper

Transformer Bushing Failure Investigation

High-Voltage Oil-Impregnated Paper Bushing Reliability, Operational, and Safety Concerns

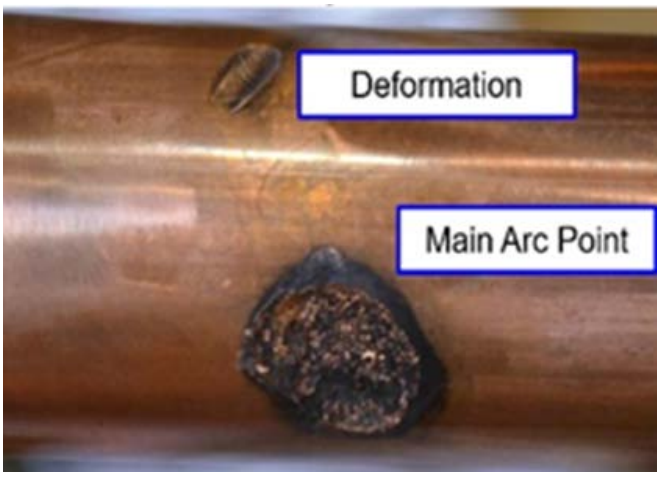
Figure 8. B-Main Arc Point of 230 kV with Copper Center Conductor

No other evidence of arcing was noted along the center conductor as shown in Figures 7 and 8. Examination of the H2 bushing capacitance stud and the cover displayed

The working hypothesis is that the paper layers found at the two locations of the condenser core are sliced off from the lower end to form the lower taper that was inadvertently wound in during the lower end winding process. Given the location of these strips in the direct vicinity of the main failure point, the presence of these errant paper strips may have played a role in the failure. In the layers of paper nearest the center conductor, a second area of torn paper and carbon was noted above apparent arc strike marks or deformation almost the size of a golf ball in the copper of the center conductor near the main arc point (roughly 2 in. [51 mm] away circumferentially) as shown in Figure 8.

Examination of the bare center conductor shows mechanical deformation in this area, a raised edge of approximately 1/8 in. (3.2 mm). There does not appear to be melting of the copper in this area that would be indicative of arcing. The upper and lower ends of the center conductor were also examined for any evidence of overheating. Any discoloration observed was consistent with the fire that followed the failure and not long-term overheating.

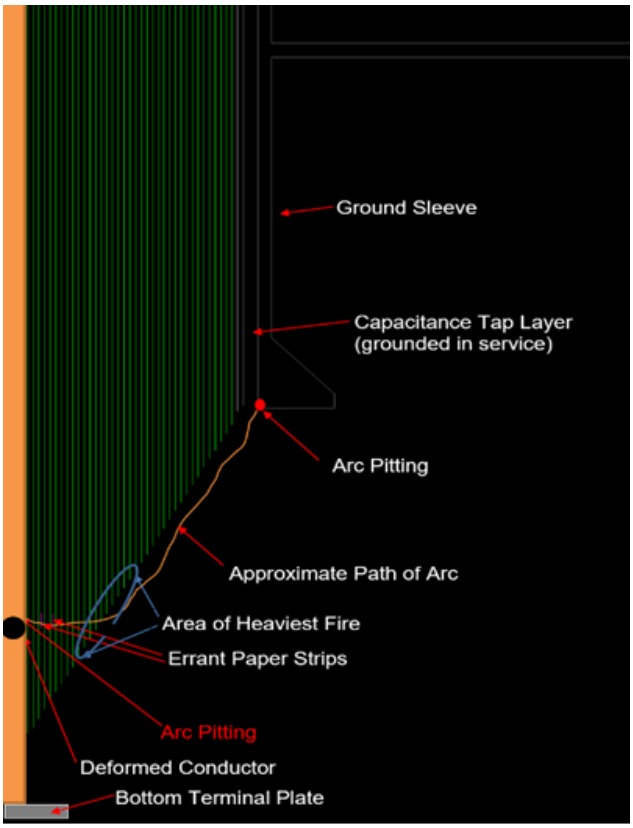
Figure 9. Illustration of Diagram of Lower End of H2 Bushing Depicting Key Findings from Forensic Examination

The key findings from the forensic examination of the H2 bushing remnants are depicted schematically in Figure 9. This figure illustrates the main arc points on the center conductor and shows the approximate path of the electrical failure to the ground sleeve. Note that the path of the arc extends outward from the center conductor and then up through the oil gap between the lower taper of the condenser core and the lower porcelain, up to the lower capacitor edge of the ground sleeve bypassing the grounded capacitance tap layer.

In discussing potential failure causes, the initial conversation included the possibility of a failure external to the bushing (perhaps in the active part) such as the transformer main tank or environmental external conditions. The known arc termination points inside the bushing reveal a dielectric failure toward the lower end of the insulated condenser core. The only termination along the center conductor was located 400 mm (15.74 in.) from the lower end of the center conductor and beneath 13–15 conductive layers of the insulation or roughly 1/3 of the total radial build of the solid insulation shown in Figure 9.

To summarize, the following hypotheses explain what was observed. The initial failure was most likely internal to the H2 bushing, flashing from the center conductor approximately 15.74 in. (400 mm) from the lower end, arcing outward through the layers of paper insulation and conductive ink, then traveling through the oil gap between the condenser core and lower porcelain up to the ground sleeve.

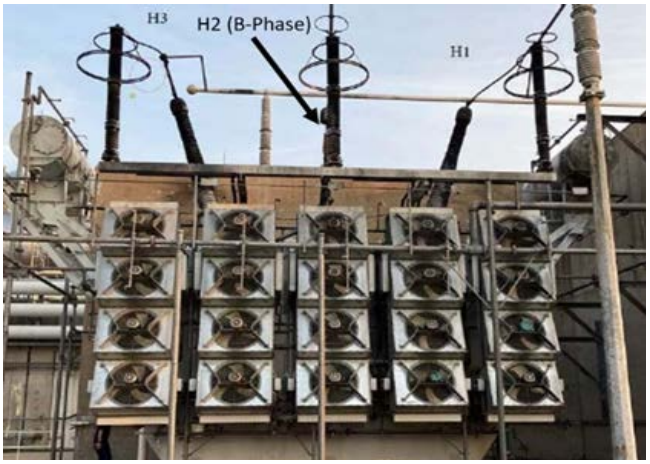
Figure 12. Image of H2 Bushing Catastrophic Failure

In this case study, the transformer bushing failure led to a reactor trip and fire on the GSU transformer. The fire ignited the B-phase high-voltage bushing as illustrated in Figure 12. During the initial inspection of the B-phase HV bushing, arc strike damage was discovered on the bushings, grading rings, and surrounding structures.

The bushing in Case #2 had metal foil for the voltage tap connection. Along with the adjacent insulation paper burn marks, creases were discovered during the unwinding of remanent paper layers in the H2 bushing similar to the Case #1 assessment. This is most likely the initiating point that led to the failure condition.

Metal foil for the voltage tap connection along with the adjacent insulation paper burn marks and creases were discovered during the unwinding of remanent paper layers in the H2 bushing. As a result of this assessment, the team concluded that this is most likely the initiating point that resulted in the catastrophic bushing failure.

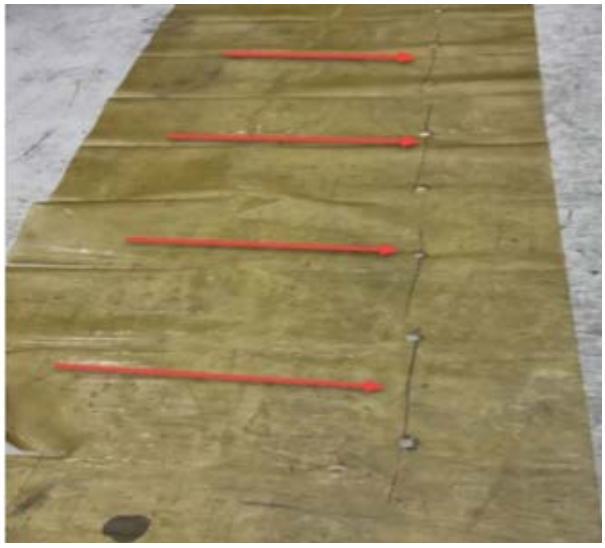
Figure 16. Punctured Insulation Because of Leakage Path Overcomes the Dielectric Strength

Some ink layers had small gaps where the ink was not wholly applied. There was no evidence of PD (breakdown) activity in these areas; however, for a bushing to perform successfully over many years, the insulation must remain effective both in composition and design shape and is the critical factor in the bushing's survival.

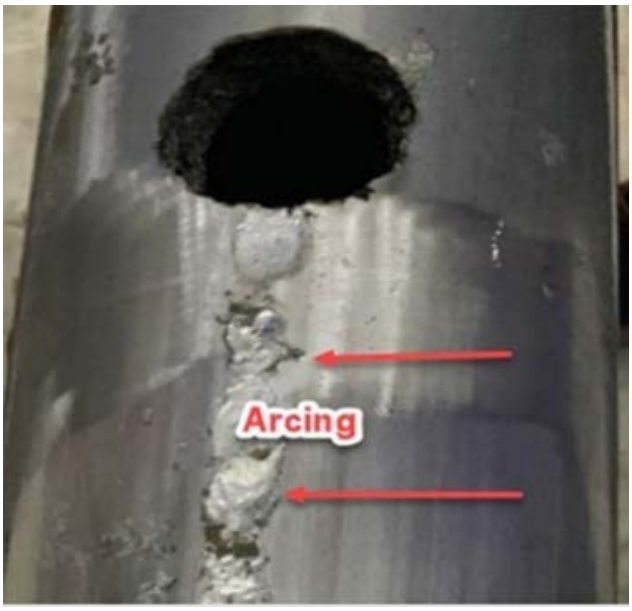
Figure 17. Illustration of Punctured Conductor with Signs of Arcing and Burning

In general, HV bushings are designed to withstand the high electrical field force or stress produced in the insulation when any grounded conditions occur. As the strength of the electrical field increases (electrical force), leakage paths may develop within the insulation as shown in Figure 16 along the red arrows. If the energy of the leakage path overcomes the dielectric strength of the insulation, it may puncture the insulation and allow the electrical energy to conduct to the nearest grounded material, causing burning and arcing as shown in Figure 17.

The root cause team concluded that the most probable cause of the 345-kV bushing failure was the presence of one or more manufacturing defects related to printing ink. The vendor investigation team believes that the improperly designed ink layers initiated the electrical event, resulting in an electrical discharge. This discharge continued until pressure was generated, which shattered the remaining kraft paper around the condenser—creating an arc with enough energy to cause overpressure and ultimately leading to a catastrophic failure of the HV bushing.

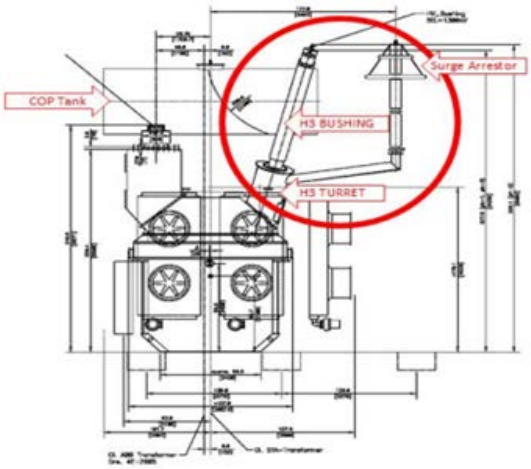
Figure 18. Illustration of A-Phase HV Bushing and Mounting in a Turret with a Surge Arrestor

In this case, the transformer was equipped with 345-kV bushings. This station automatically scrammed on the GSU transformers phase-to-ground fault and fire. Figure 18 shows the A-phase HV bushing that suffered catastrophic damage.

The team concluded that this failure was a sudden, unanticipated, catastrophic HV bushing failure because of an unknown material issue attributable to manufacturing and/or design issues by the original equipment manufacturer (OEM).

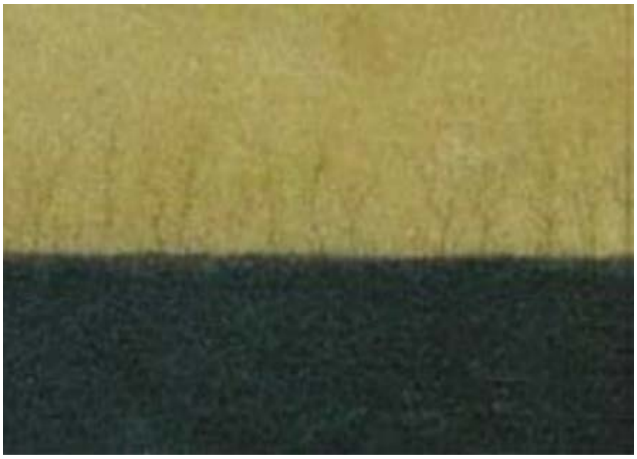
Figure 19. Image of Bushing Failure "Trees Trace" with Signs of Copper Sulfide Migration

A bushing OEM publication suggests that metal migration and semi-conductive copper sulfide migration in oil led to surface contamination of bushing insulation. Stress from this contamination is considered a causal factor for bushings insulation degradation as shown in Figure 19.

The bushing manufacturer believes that copper is migrating from the copper center conductor and creating copper trees within the paper structure. Based on this position, the bushing OEM believes that bushings with aluminum center conductors would not be susceptible to the failure mechanism (electrical treeing). This is an area that requires additional research to better understand metal migration and to determine what metal(s) are susceptible to this degradation.

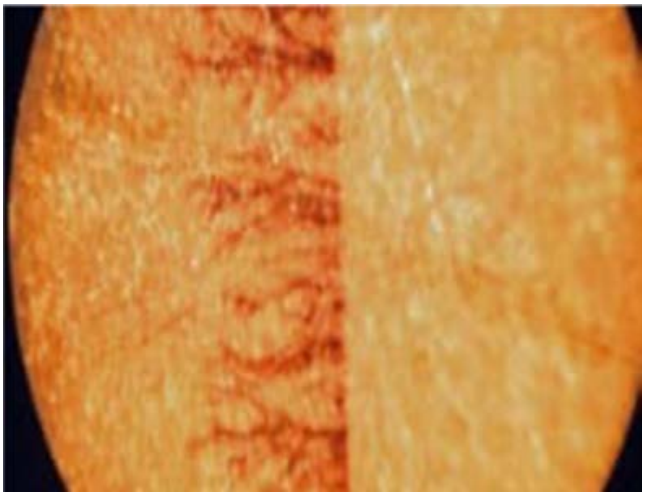
Figure 20. Image of Copper Migration Witnessed on Oil Bushings Equipped with Copper Conductor

It appears that electrical treeing was caused by the manufacturing/design of the foil edges. The foil edges were cut with a device similar to a standard office paper cutter. This results in "sharp" edges that do not control the electrical stresses at the foil/paper interface, as shown in Figure 20.
