Review of Type IV Cracking in Piping Welds

TR-108971

Final Report, October 1997

Prepared by
Tordonato Energy Consultants, Inc.
4156 South Creek Road
Chattanooga, TN 37406

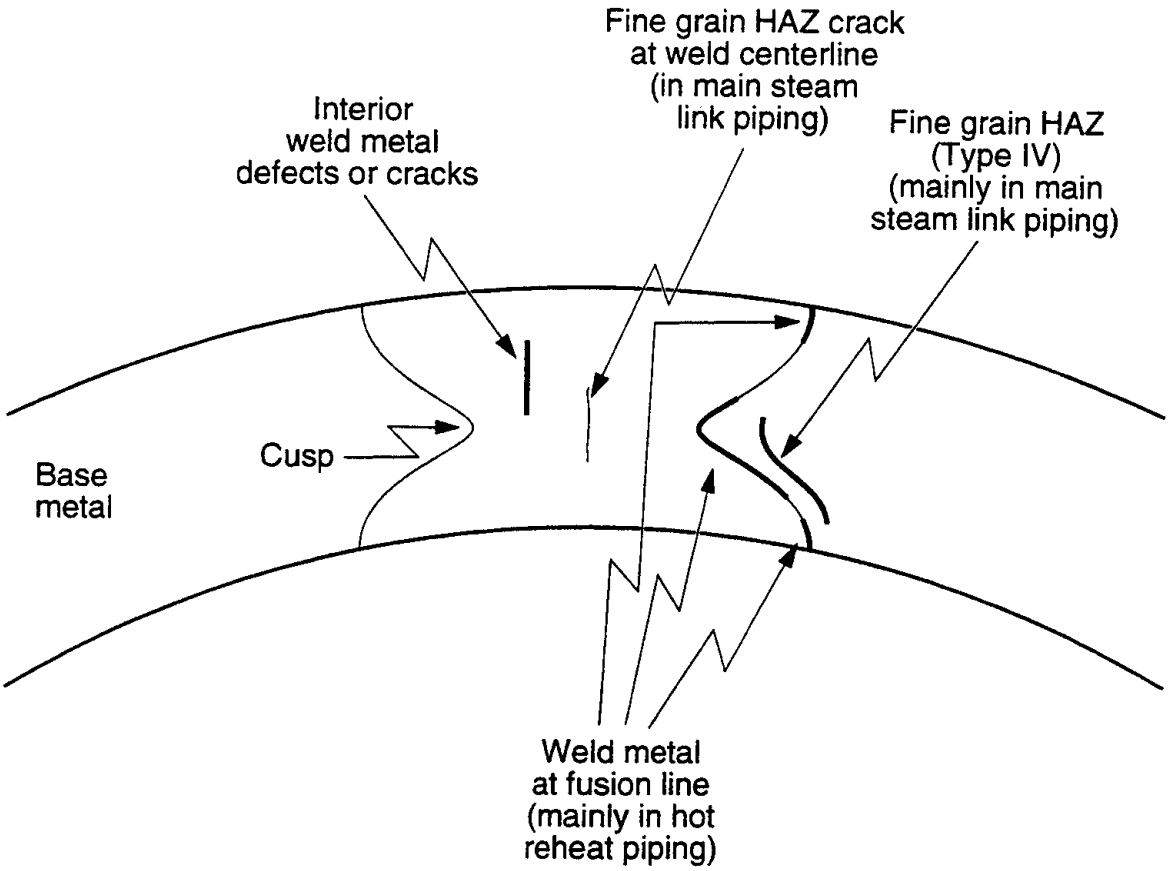
Figure 3-2
Schematic Illustration of Primary Cracking/Damage Locations Found in High Energy Piping Longitudinal Seam Weldments (Foulds et al., 1996)

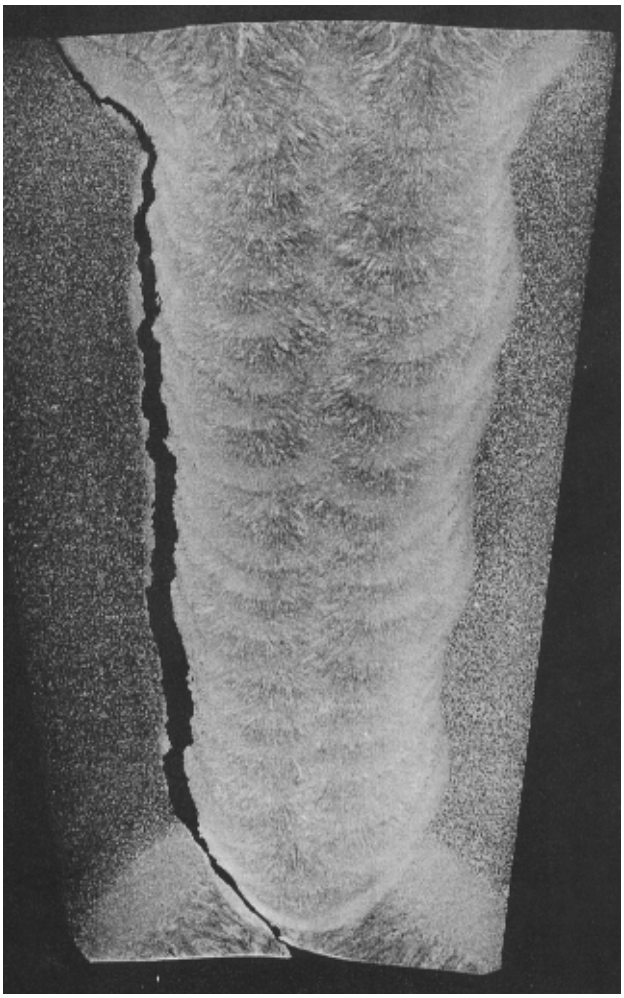
The fracture was a fishmouth opening approximately 8 inches (200 mm) wide at its maximum with a length of 8 feet (2.5 m). It was reported that approximately one to two minutes elapsed between the initial detection of a steam leak to the final rupture. Although the unit suffered significant structural damage as a result of the failure, no injuries were reported. The failed weld was at the 12:00 O'clock position in the "B" steam line. Because of the location of the weld seam and hanger problems in the early 80's, system stresses were cited as a possible contributing factor in the failure. The fracture path was through the fine-grained/intercritical region of the HAZ. A macroview near the center of the fracture is shown in Figure 3-3.

Figure 3-3
Cross Section of 1-1/4Cr-1/2Mo Main Steam Line Longitudinal Seam Weld Failure Showing Type IV Failure Mechanism After 203,000 hours (Rinaca, 1996)
