# technical brief

## Pool Shocking—"Fun in the Sun" Can Be a Shocking Event

*Power Quality Information Services and Support Target*

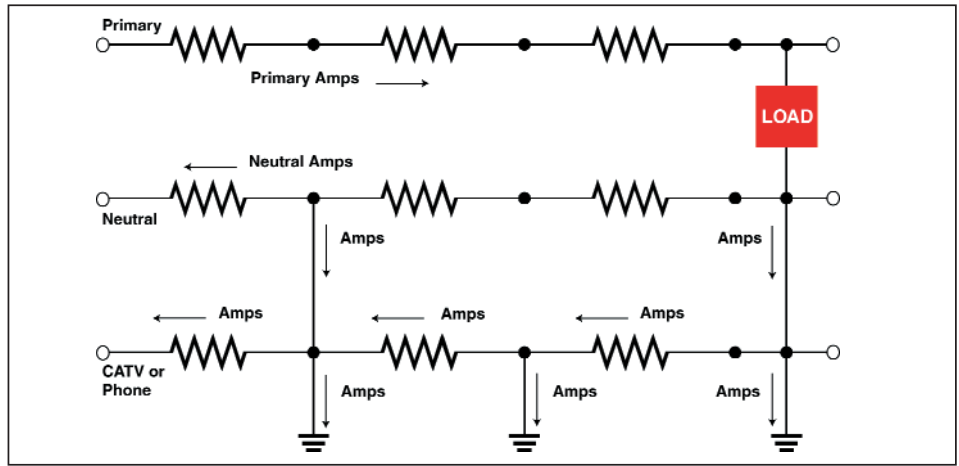
*High Impedance Neutral Path*—A high impedance neutral path will create excessive voltage drop along the neutral conductor. This voltage drop will appear as a potential difference between the neutral/grounding system and earth. Any metallic objects effectively bonded to the system neutral will consequently be at a higher potential than the surrounding earth.

When evaluating the system neutral path, it is important to recognize that the return current path for system load is comprised of more than just the system neutral conductor. Investigations need to consider all parallel paths back to the source transformer. The following can be

Figure 3. Single-phase circuit with parallel paths for the system neutral.

parallel paths back to the source, as shown in Figure 3.
