Dry Cask Storage Characterization Project

Interim Progress Report – June 2000

1000157

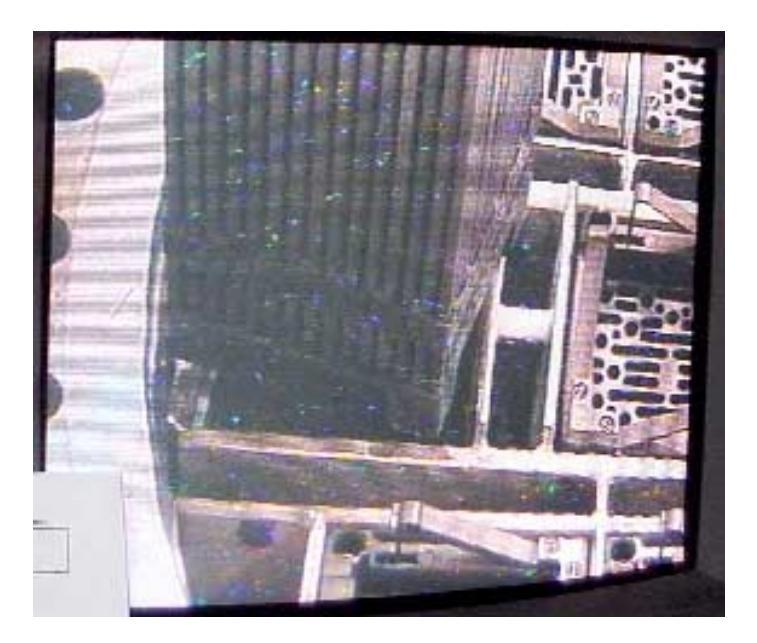
Fig 2-3. Fuel assembly being lifted

Table 2 provides the fuel assembly weight and the force required to start lifting each assembly out of the V-21 cask. The lifting force measurements indicate little 'sticking' of the assemblies during removal suggesting that no significant bowing of the assemblies or development of corrosion products causing adherence to the cask floor occurred.

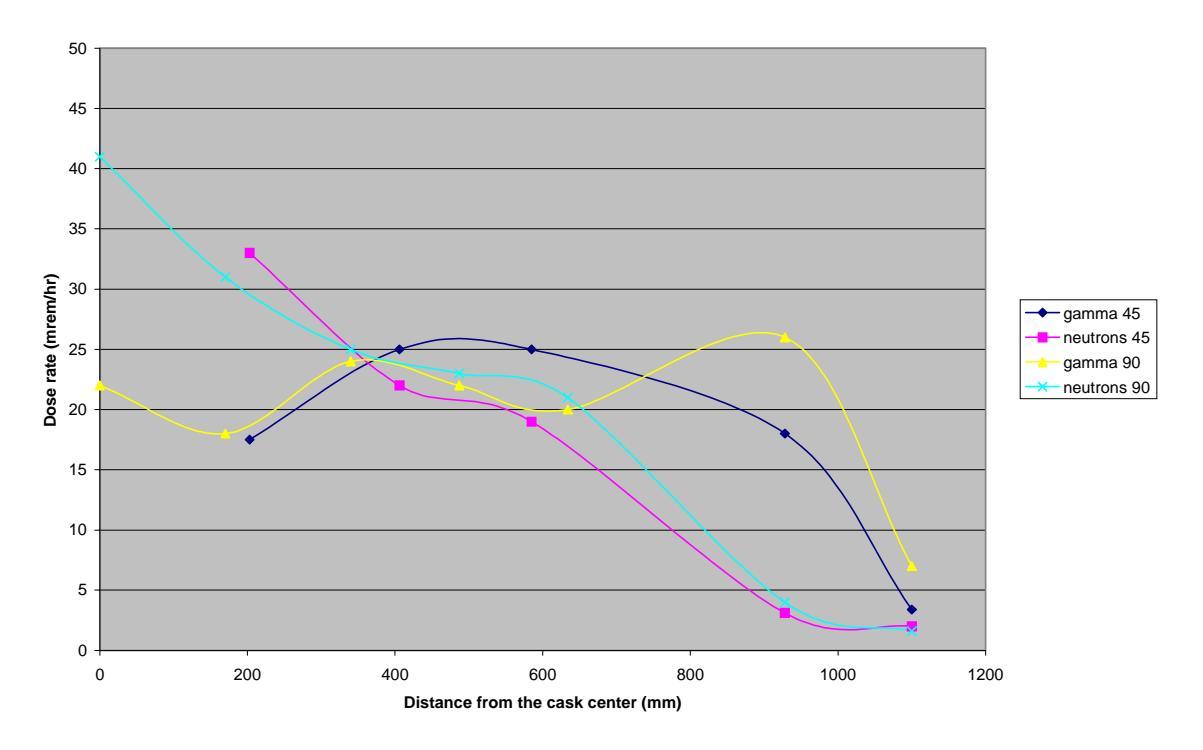
Fig. 3-1. BOTTOM Dose rates 1985 (Dosimeter TLD and TED)

Figure 3-1 and 3-2 show the dose rates measured on the bottom of the cask in 1985 and in 1999, depending on the distance to the center of the cask.

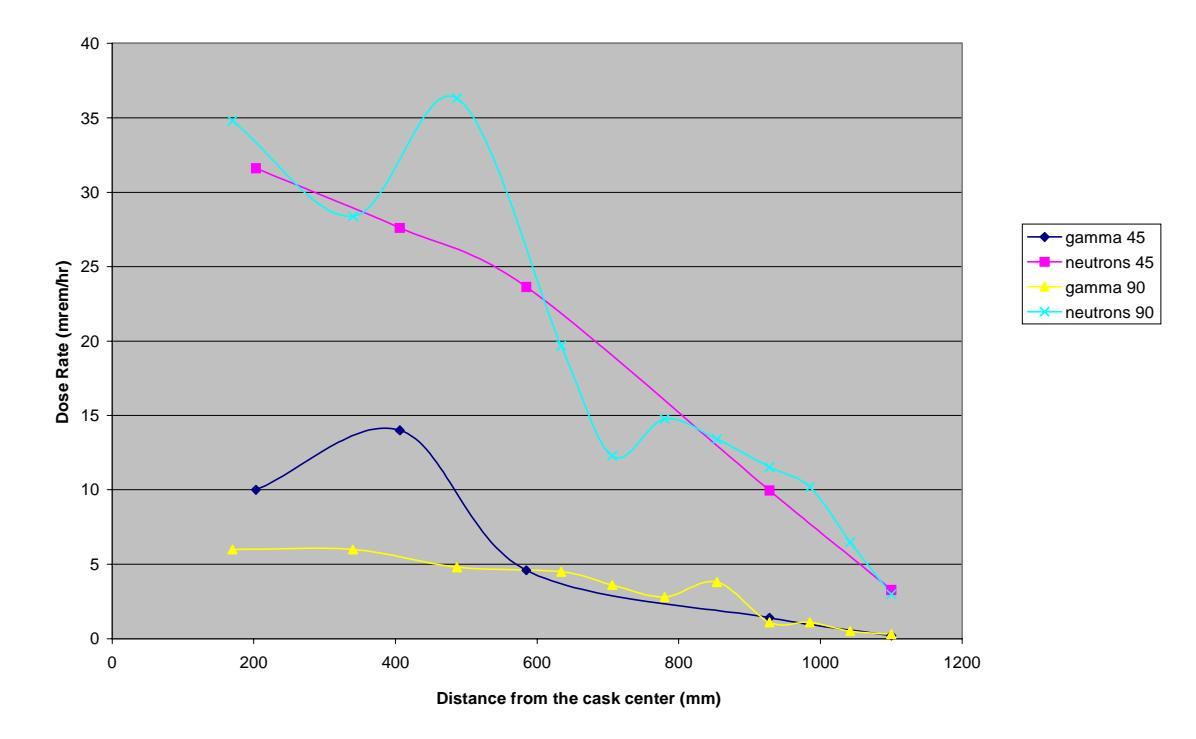
Fig. 3-6. TOP Dose rates 1999 (Dosimete, TLD and TED)

Figure 3-5 and 3-6 show the dose rates measured on the top of the cask in 1985 and in 1999, depending on the distance to the center of the cask.
