# **Dry Cask Storage Characterization Project**

*Interim Progress Report – June 2000*

**1000157**

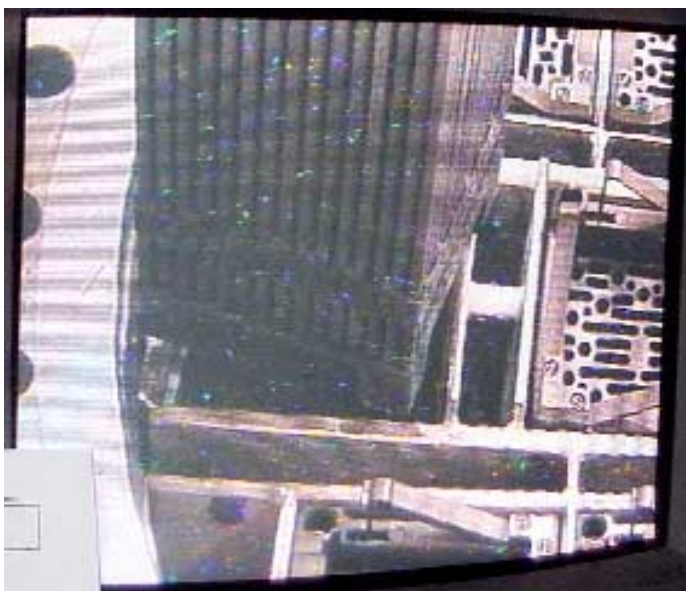
**Fig 2-3. Fuel assembly being lifted**

Table 2 provides the fuel assembly weight and the force required to start lifting each assembly out of the V-21 cask. The lifting force measurements indicate little ‘sticking’ of the assemblies during removal suggesting that no significant bowing of the assemblies or development of corrosion products causing adherence to the cask floor occurred.
