Materials Reliability Program Evaluation of the Effect of Weld Repairs on Dissimilar Metal Butt Welds (MRP-114)

Technical Report

1009559

Final Report, September 2004

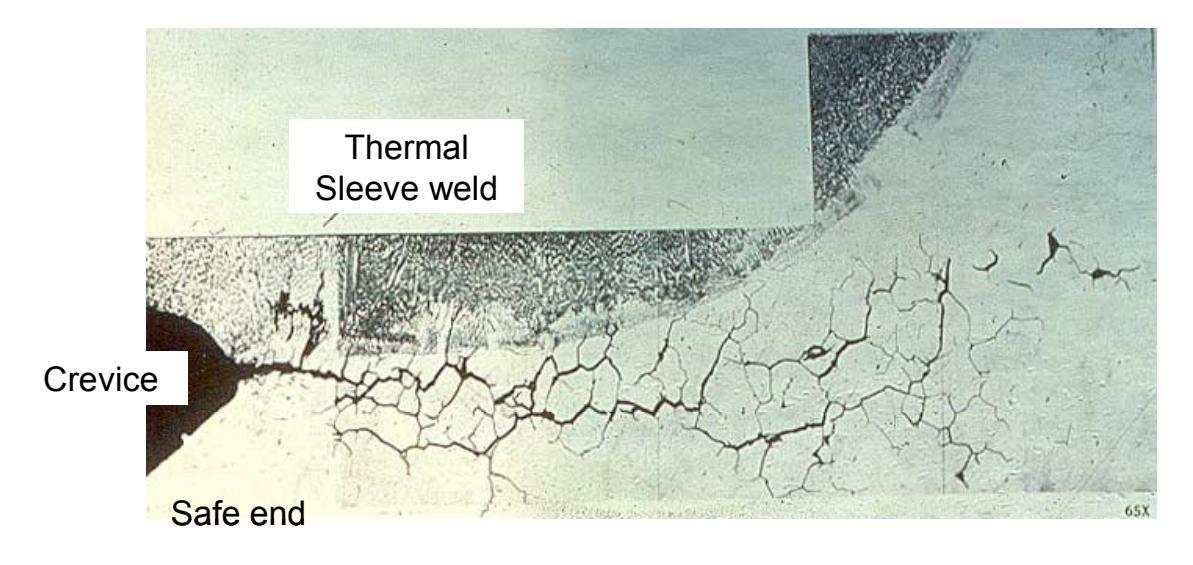
Figure 4-2 Schematic of the Circumferential IGSCC at Duane Arnold

The cracked DAEC safe-end was destructively examined at the Southwest Research Institute (SWRi) [5]. Results from metallographic examination indicated that the mode of cracking was IGSCC and existed 360 degrees around some of the safe end as sketched in Figure 4-2 based on a figure from Reference 5. General Electric Nuclear Energy (GENE) performed an independent evaluation and agreed with the SWRi evaluation [5]. The results of the examination yield several causal factors for the IGSCC at DAEC:

- The design of the safe-end was deficient for the intended application in that an electrochemical crevice was created where the thermal sleeve was attached to the safe-end with a partial penetration weld, Figures 4-2 and 4-3. The presence of a crevice results in premature IGSCC initiation in even high purity BWR-type environments [7]. When detrimental impurities such as sulfate and/or chloride are present, the detrimental effects of crevices are intensified. A discussion of the effect of crevices on IGSCC propensities are provided in the DAEC report and summarized in Figure III.B.2-9 [8] and in Figure 4-4 in this report. Small specimen test results for creviced and uncreviced Alloy 600 are shown in Figure III.B.2-4 of the DAEC report as updated in Figure 4-5 in this report.

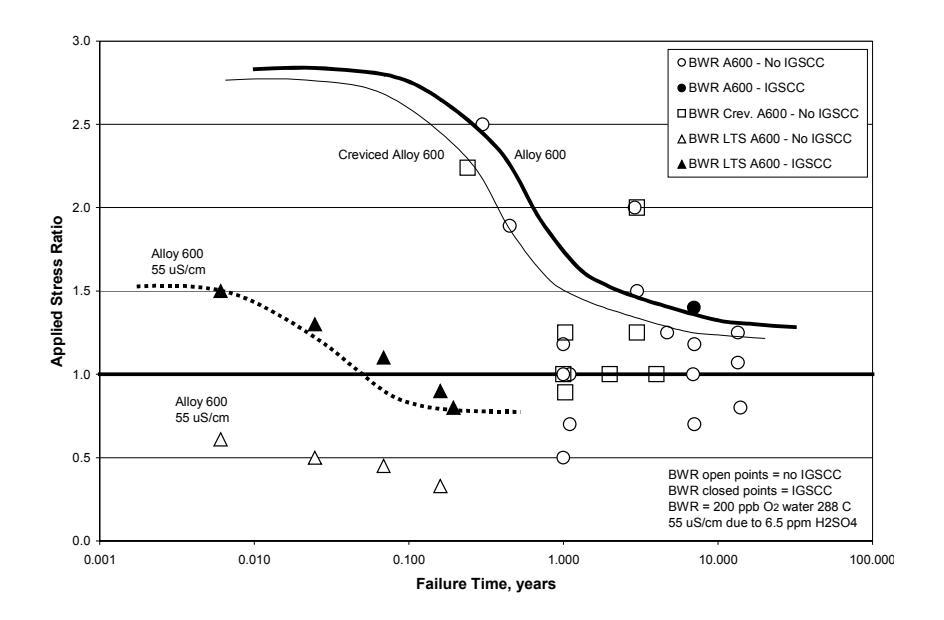
Figure 4-5 Effect of Crevices on IGSCC of Alloy 600 in BWR Environments [8]¹

¹ The general shape of the Alloy 600 time-to-failure curves are based on sensitized stainless steel data where the uncreviced Alloy 600 curve is pinned by the single pressurized tube result. Since creviced Alloy 600 would be expected to crack after shorter exposures periods, the creviced curve is sketched to the left of the uncreviced curve.

IGSCC tests of uncreviced Alloy 600 in a BWR environment have shown that high tensile stresses are needed for crack initiation. In fact, <u>no</u> uncreviced Alloy 600 component has suffered IGSCC in the BWR. The only uncreviced Alloy 600 IGSCC identified in an operating BWR occurred on a pressurized tube test specimen that had a 90% through-wall crack after seven years of exposure at an applied stress ratio of 1.4. (See the solid point pinning the uncreviced Alloy 600 IGSCC curve in Figure 4-5.)

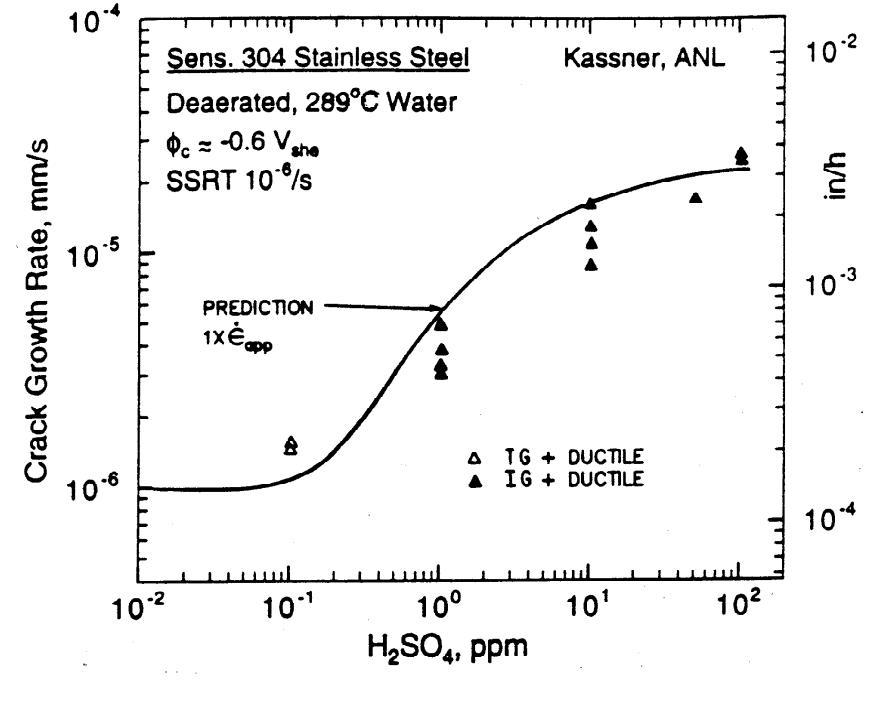
Figure 4-6 Effect of Sulfate on Crack Propagation Rates in Deaerated Water [12]

- As noted above, sulfate accelerates IGSCC initiation and propagation [7-9]. Unfortunately, approximately 800 pounds of resin was inadvertently dumped into the DAEC pressure vessel during start-up in 1975 [10]. Although the system was cleaned up as best as possible at the

time, any residual resin degrades into sulfate with irradiation. Sulfur was clearly identified in the crack tip of the cracked safe-end.
