Manhole Event Mitigation Strategies

Explosion Testing of Manhole Covers with Pressure Relief Mechanisms

1012305

Technical Update, December 2006

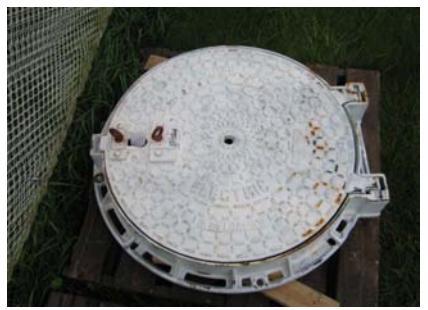
Figure 2-3 Cover #3 – Hinged Saint Gobain solid, white with Stabiloc locking mechanism

Test results suggest that the hinged cover approach requires further development as pressure relief was insufficient to prevent dislodgement of the entire cover frame. Hence, the results of this test are to a large extent inconclusive as to the capabilities of hinged covers to provide pressure relief. It is recommended to revisit this issue and re-design the attachment system of the frame to the roof slab, as this would further explore the possible advantages of hinged cover.

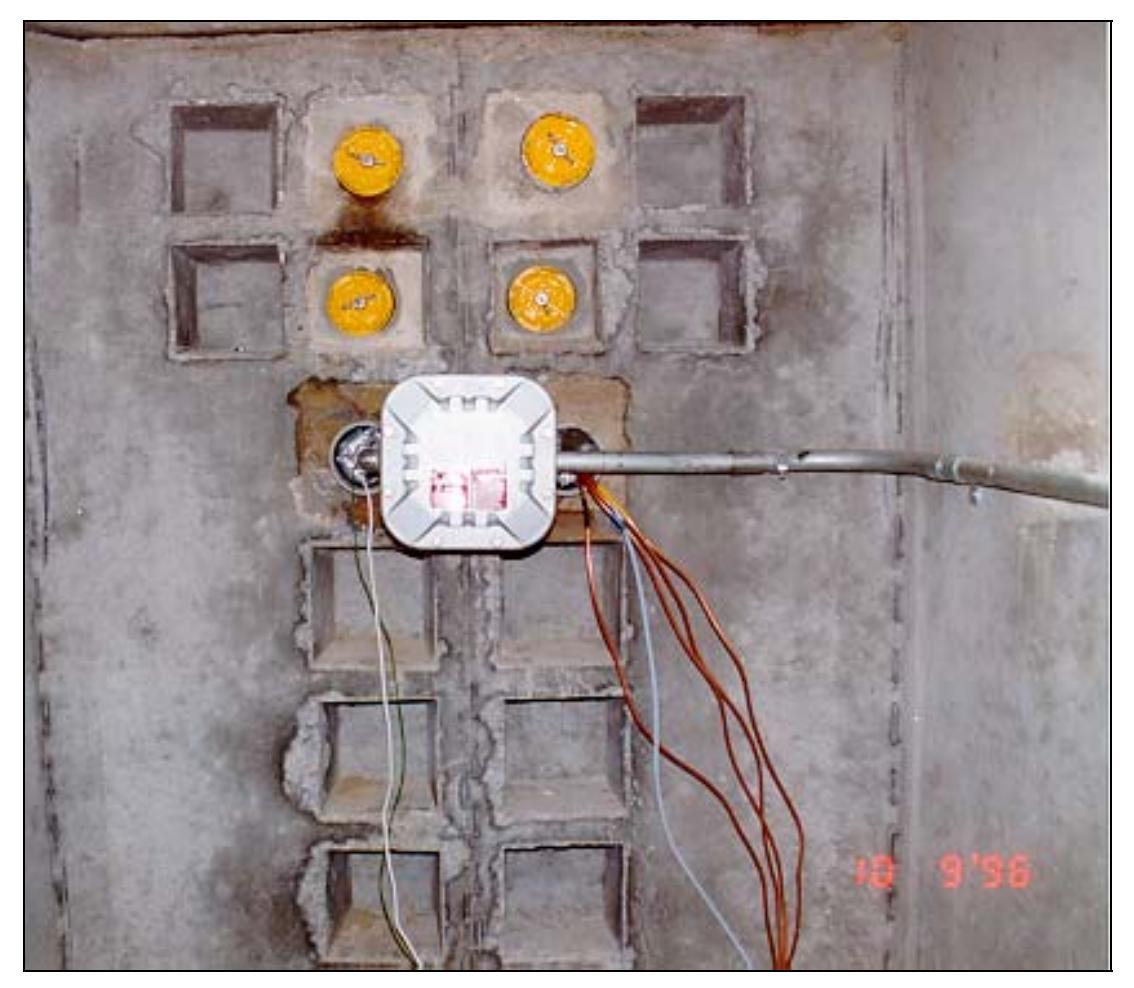
Figure 3-1 Photograph of the East Wall of the M11 Manhole Showing the Feed Tubes Entering the Manhole

Pressure and temperature sensors were placed in explosion-proof boxes mounted on each internal wall of the M11 manhole. Gas injection tubing and all instrumentation cables are brought into the M11 manhole through underground ducts at the East wall of the manhole. The ignition source is located on the floor approximately in the center of the M11 manhole, and a mixing fan is located at the South-East corner. Figure 3-1 shows the East wall with the sensor box, gas injections tubing, and instrumentation cables.
