# Examination of Heat Recovery Steam Generator Plants

*Case Studies of Remote Visual Inspection Techniques*

1014197

Technical Update, March 2008

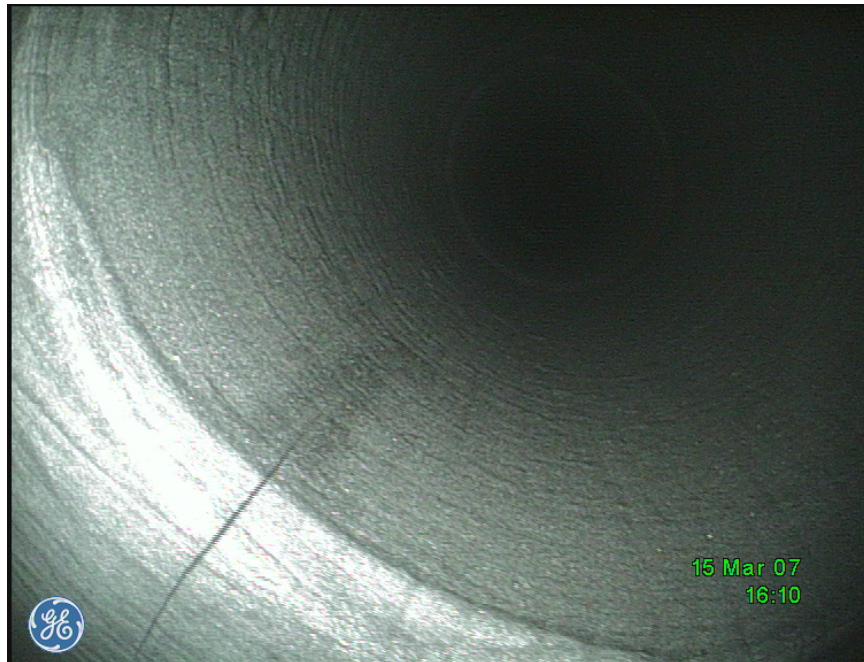
**Figure 3-1**  
**Initial Entry into a Cleaned Header**  
(The header surface shows signs of service but has been recently cleaned and is free of debris.)

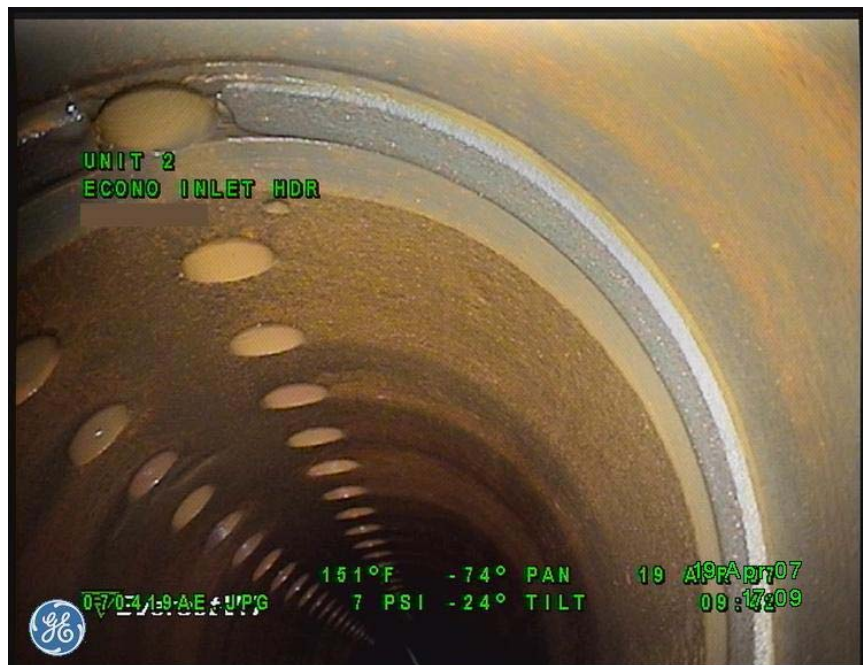
**Figure 3-9**  
Clean Header Condition Can Be Documented with RVI

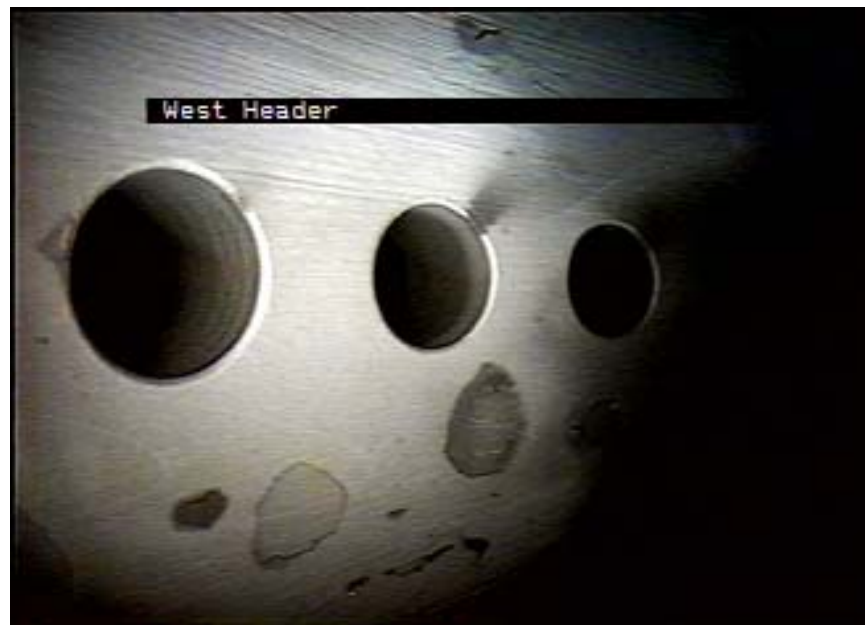
**Figure 3-14**  
**Header Penetrations with No Cracking as Documented by RVI**

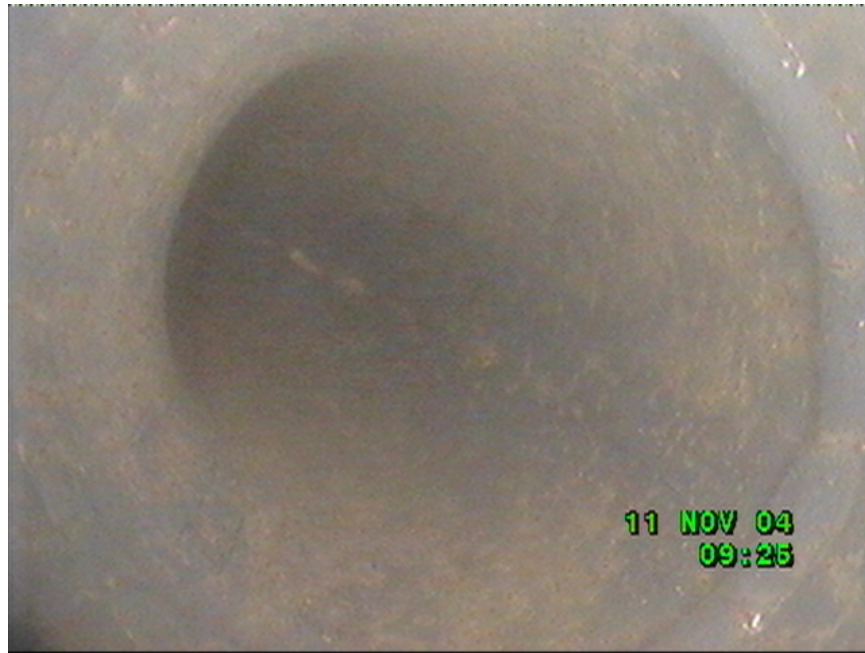
**Figure 5-1**  
**RVI Image of a “Good” Economizer Tube Two Weeks After Shutdown**  
**(The tube has a “normal” coating of high-temperature oxide.)**

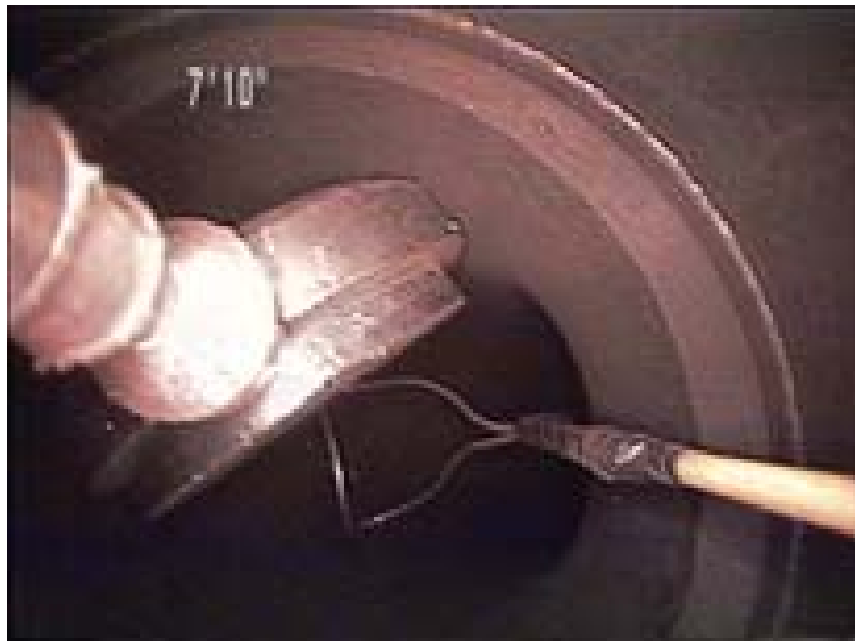
One example of a foreign object removed from HRSGs is a blanking plate that had fallen in an 8-in. (203-mm) diameter line. The retrieval involved locating the plate (as seen in the RVI image shown in Figure 11-1) and removing it using a snare as seen in the image in Figure 11-2. Another more typical instance of foreign object retrieval is the removal of a bolt with the use of a claw, as seen in the RVI image shown in Figure 11-3.

**Figure 11-1**  
**Location and Positioning of a Retrieval Tool for a Blanking Plate Using RVI to Assist the Operation**

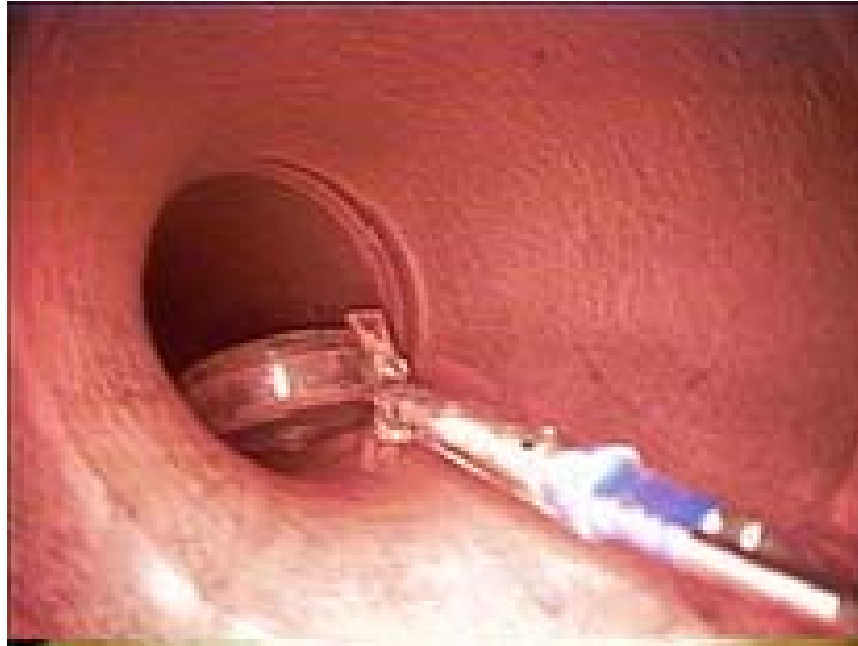
**Figure 11-2**  
**Removal of a Blanking Plate with a Snare Using RVI**

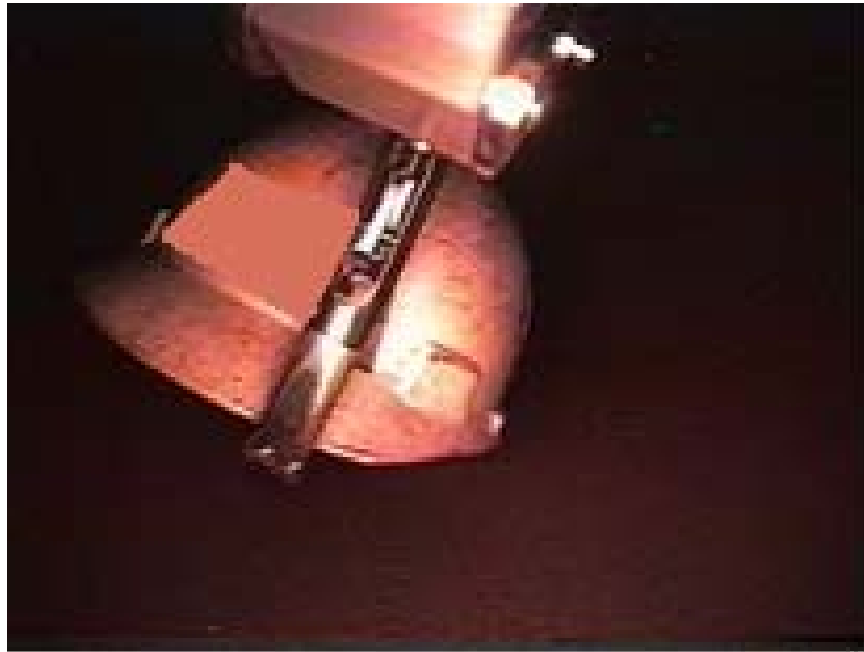
One of the more unusual retrievals was that of a hardhat found in a downcomer line, as seen in the RVI image shown in Figure 11-4. This retrieval was accomplished with the use of a clamp-type

**Figure 11-4**  
**Location and Removal of a Hardhat from a Downcomer Line with a Clamp**
