# **Assessment and Testing of High-Pressure Fluid-Filled (HPFF) Cables**

*New York Power Authority Niagara Power Project*

Technical Update Report, March 2007

**Power Delivery Consultants, Inc.**

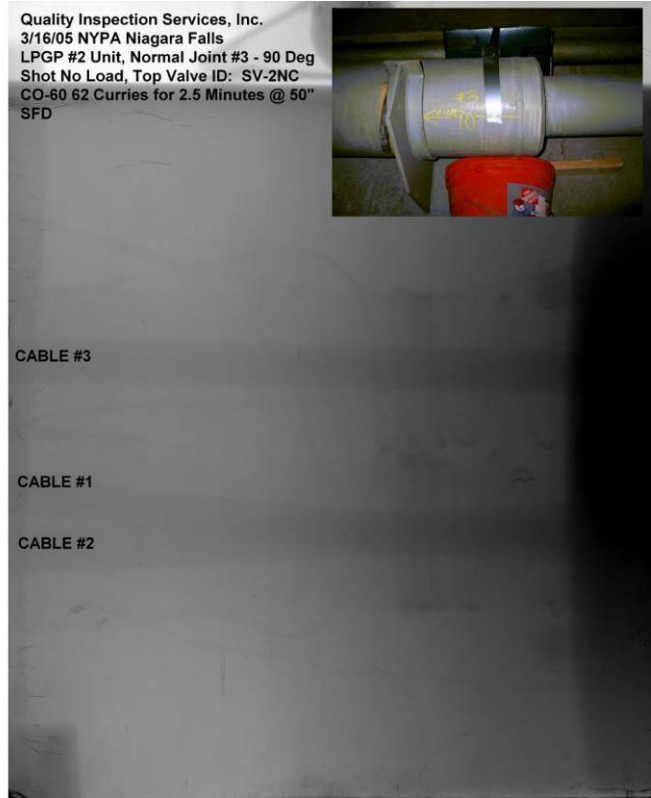
**Figure 4-14**  
LPGP #2 230 kV HPFF, Normal Joint Casing, Location #3

The cables should be gradually bent in the areas where there are transitions between the end of the casing and the end of the joint or spider. This appeared to be the case for all locations except for the LPGP #2 joint casing at location #1 (See Figure 4-15) and the trifurcator casing #3 (See Figure 4-17).

A comparison of Figures 4-15 and 4-16 show that a significant amount of bending occurs in the cables at one end of the LPGP#2 normal joint casing when the operating condition goes from no load to normal load condition. PDC recommends repeating the under load radiographic inspection for four LPGP 230 kV normal joints when the corresponding hydro motor/generator units are operating at full load (motoring) to determine if there is significant cable bending in the joint casing.

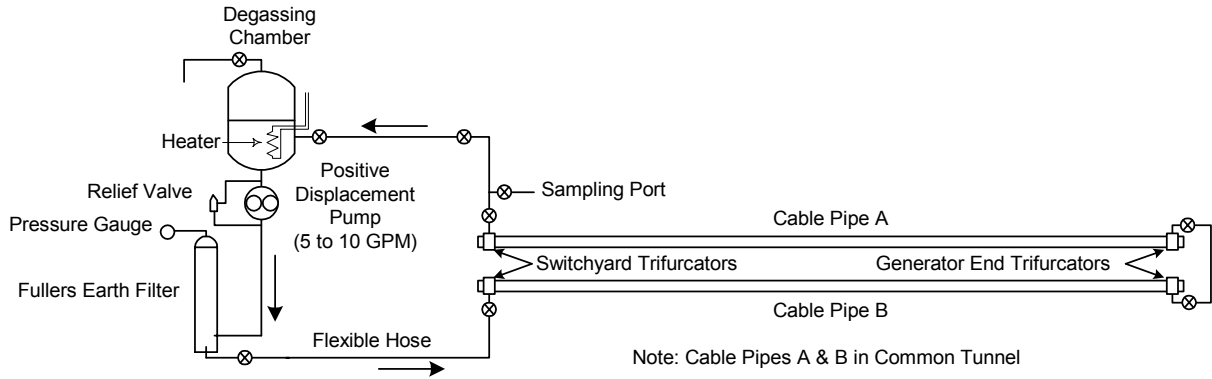
**Figure 5-1**  
**Hydraulic schematic of pipe fluid treating equipment**

The RMPP pipe fluid 100 °C dissipation factor values ranged from slightly less than 1% to 2% (See Tables 4-9 through 4-12). IEEE Standard 1406 recommends that actions be taken to reduce the pipe dielectric fluid dissipation factor when it exceeds 0.6%. Many utilities have used a Fullers Earth filter to reduce the dissipation factor of HPFF dielectric fluid when it exceeds recommended levels. PDC recommends heating (40 °C to 60 °C) and circulating the pipe fluid for the RMPP HPFF cable systems through a Fullers Earth filter to improve the dissipation factor when the units are out of service for routing maintenance. This dielectric fluid treatment could be accomplished by interconnecting two the pipes for HPFF circuits in a common tunnel as shown in Figure 5-1.

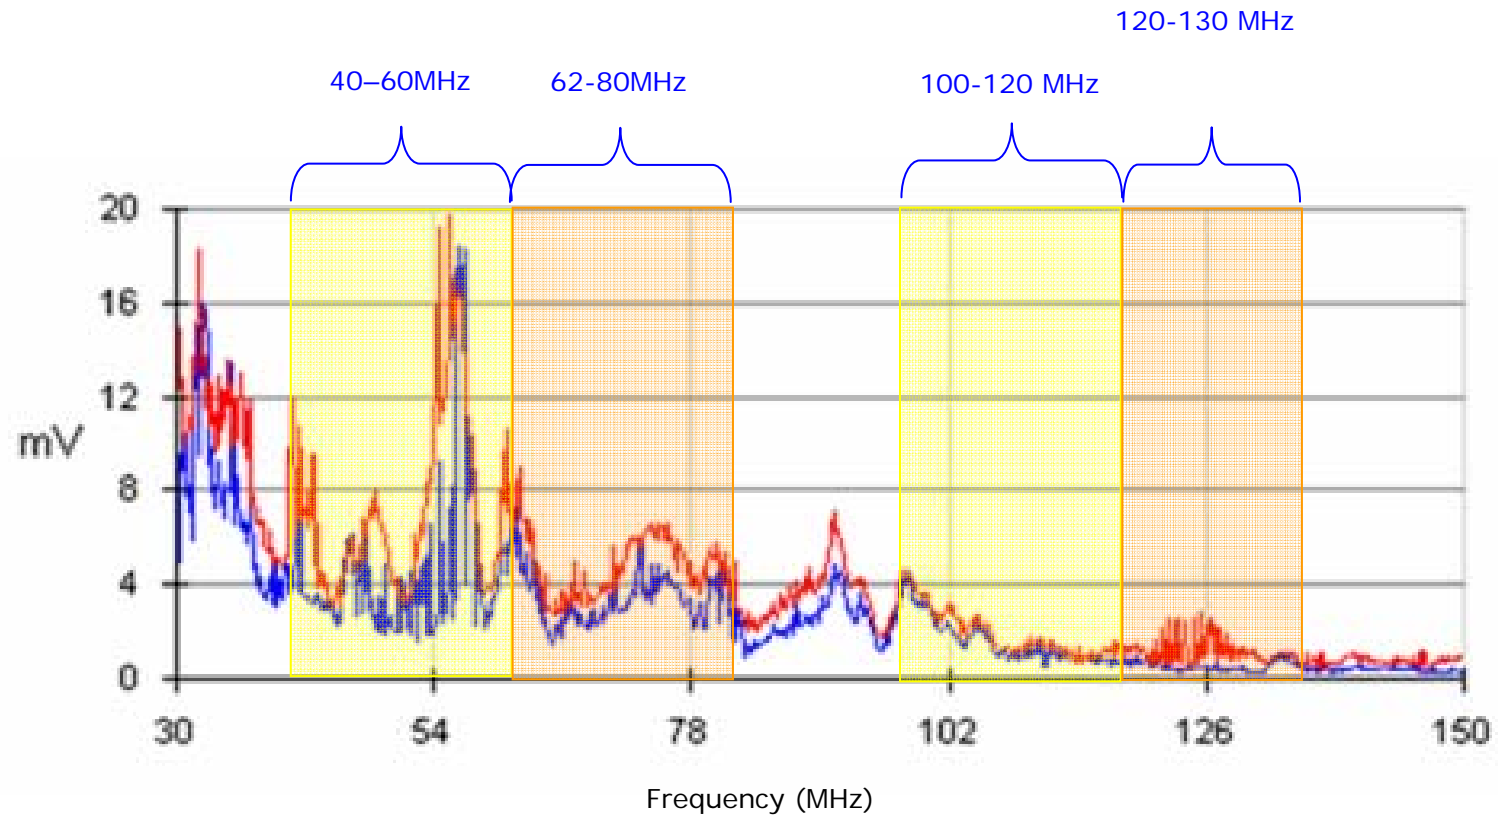
Low frequency data indicates decreasing total signal intensity at increasing distance from terminations for signals showing the signature of substation noise. The trend line in Figure 3 shows this distance effect. This in an indication that signals in this specific frequency belong to substation noise from air gap discharge activity external to the cable and/or cable terminations. Signals attributable to the cable insulation are shown at points 13 ft and 22 ft from the edge of the trifurcator. These signals are small in intensity and characterized with a low repetition and therefore not of immediate concern. Trending of these signals is recommended before action is taken.

**Figure 3:** Typical frequency scan from a test point at the R. Moses end of feeder #9 showing frequency windows where integration of total signal was carried out as a function of distance from trifurcator

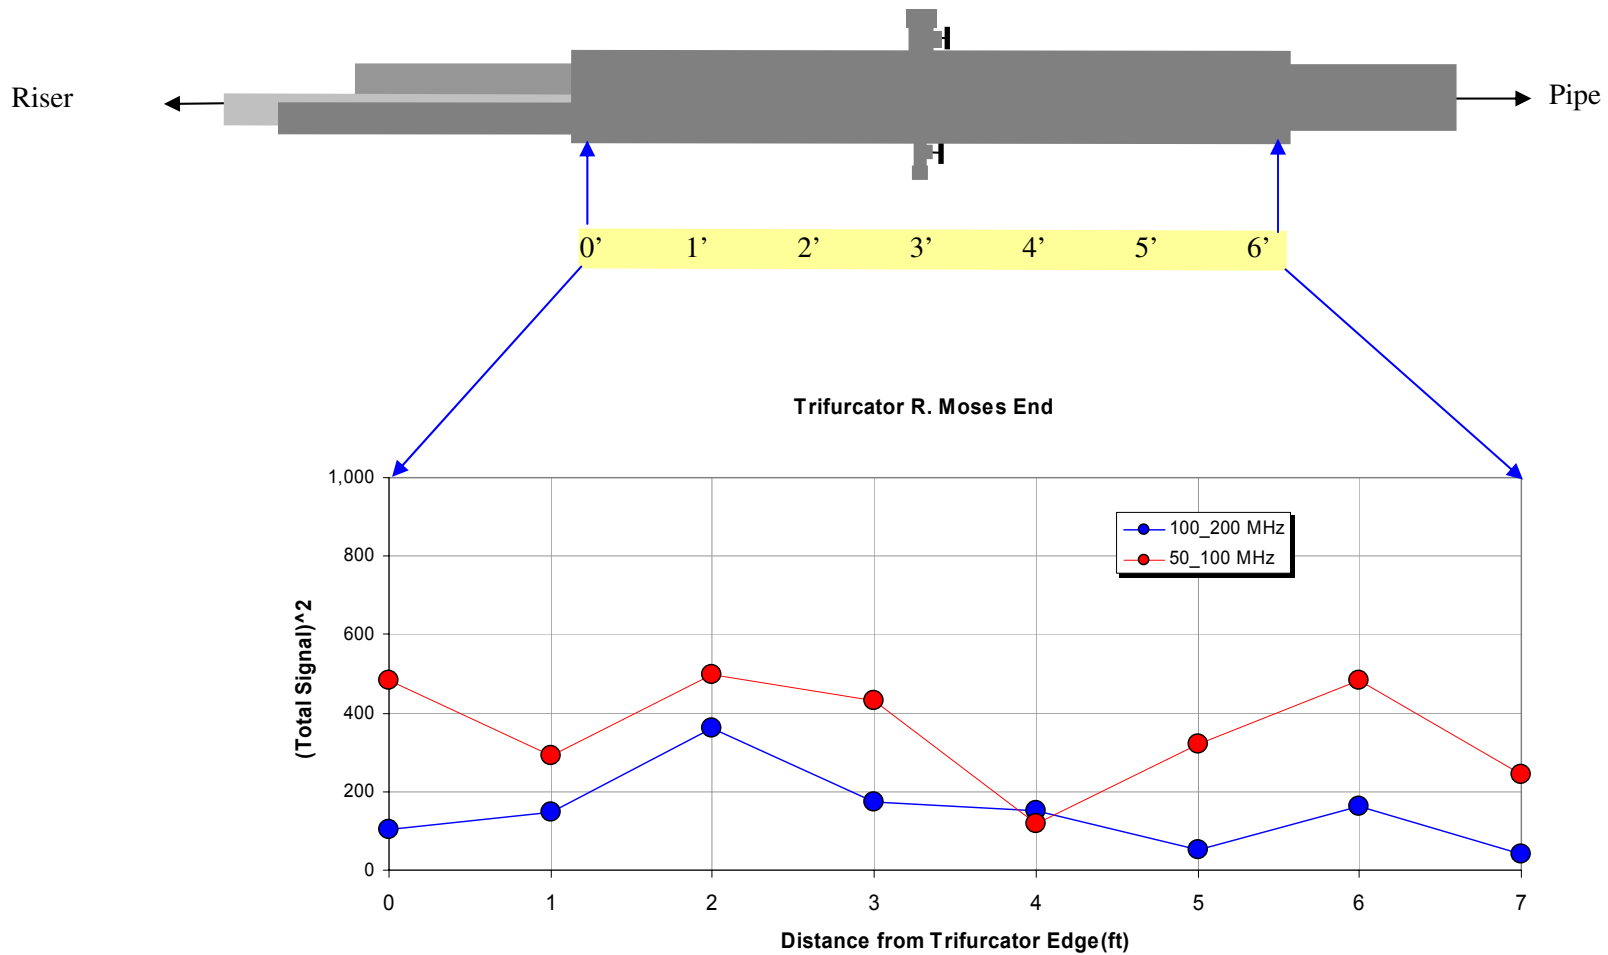
**Figure 8:** Diagram showing Feeder #9 trifurcator, R. Moses end, location of test points and data for two wide frequency ranges, 100 to 200 MHz and 50 to 100 MHz.

The data for this trifurcator is shown in Figure 8. Measurements were made directly over the trifurcator casing with a large diameter sensor at one foot intervals. The signals observed along the trifurcator correspond to substation noises with no specific peaks indicating the lack of any discharge sources inside the trifurcator.

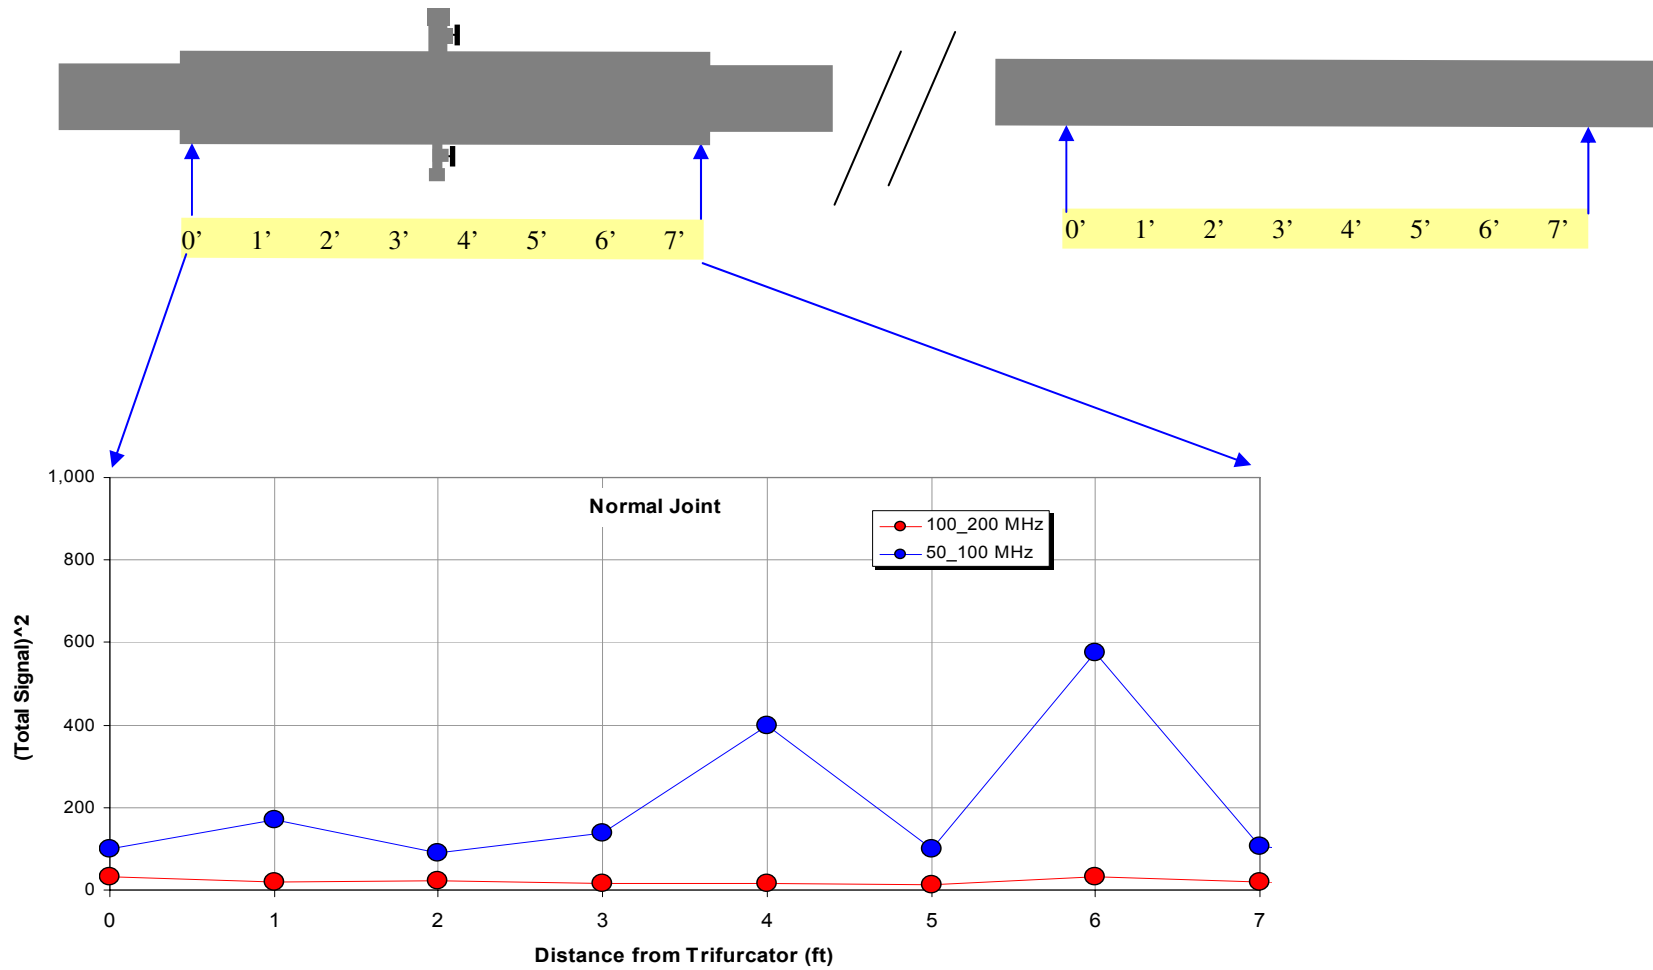
**Figure 9:** Diagram showing Feeder #9 data from a normal joint pipe. The two traces show the square of the total signal for 50 to 100 MHz and 100 to 200 MHz

Data from the normal joint are shown in Figure 9. The two traces in Figure 9 which corresponds to a much broader bandwidth of 100 to 200 MHz and 50 to 100 MHz show no signals. It should be noted that frequency range selected in to calculate the data in this joint and in the pipe sections that follow are much wider than those selected in the previous part of this report and cannot be compared. The total signal intensity observed in the normal joint is exceedingly small.

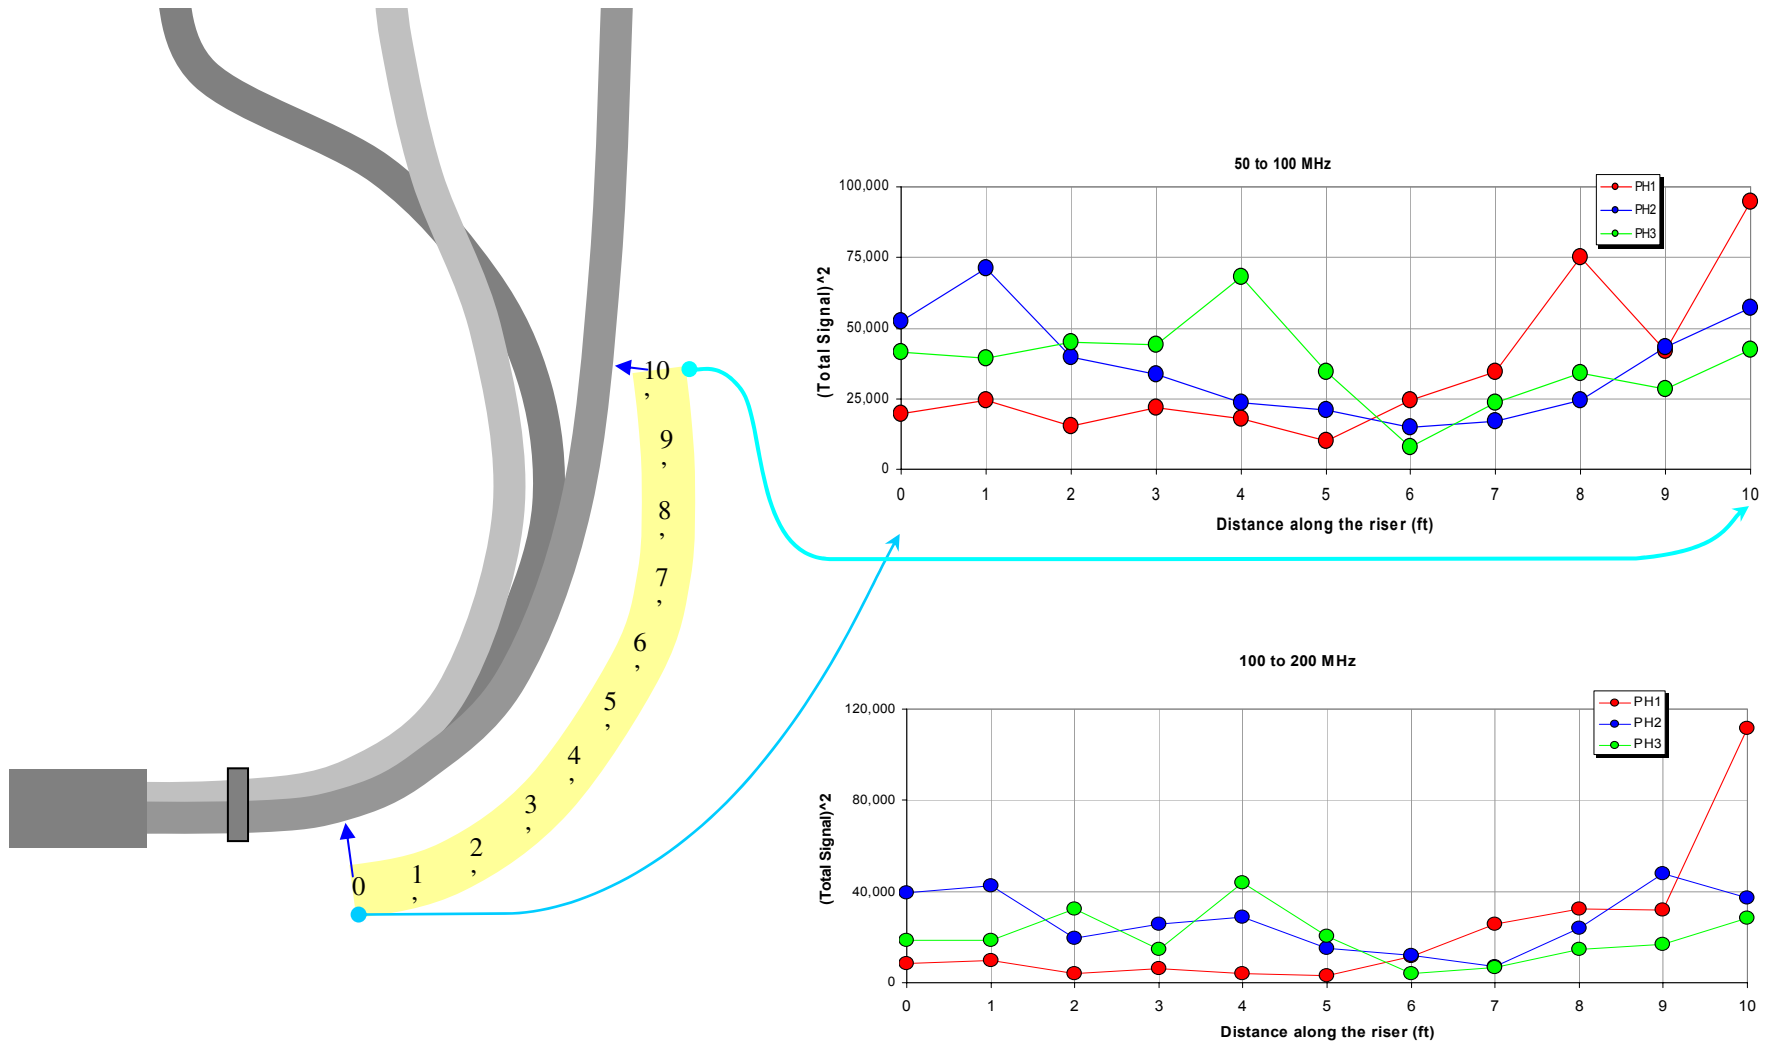
**Figure 12:** The square of the total signal as a function of location along the 10' section of riser pipe from feeder #9 at generation end of the cable at two different frequency windows.
