Distribution Conductor Burndown Test Results

Small Bare and Large Covered Conductor

Technical Update, December 2009

Electric Power Research Institute (EPRI)

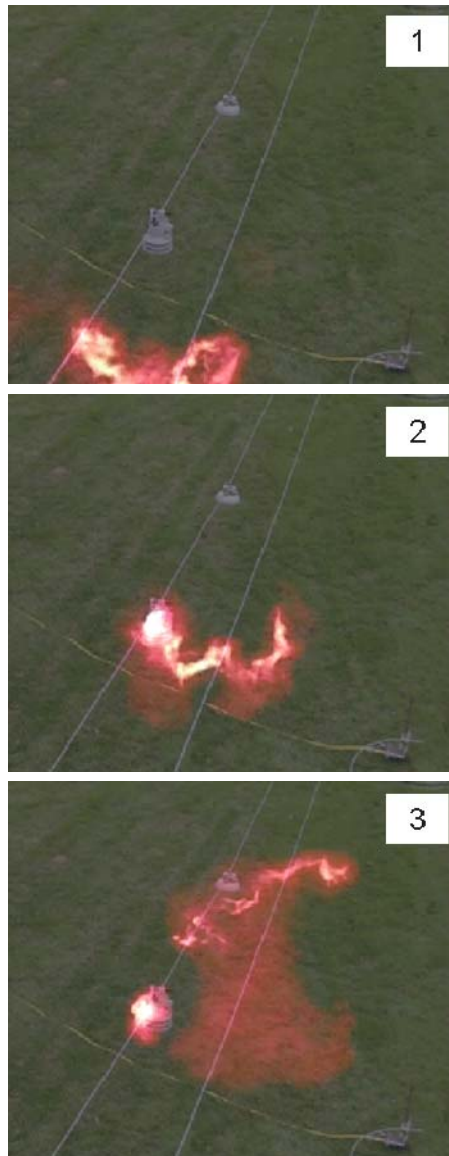
Figure 4-21
Arc Motoring Down the Test Line

Figure 4-21 shows an example of one arc attachment test. The images in Figure 4-21 are taken from a 3000 frame-per-second digital video recording of the test. An IR pass filter is used to isolate the arc channel, as discussed in Section 3, Test Setup and Methods, and then a static background image is overlaid on the video frames to produce these images.

- *Frame 1* – The arc is motoring toward the vice-top polymer insulator.
- *Frame 2* – The arc slows down and lingers at the vice-top, injecting more heat into the conductor at this location than at others where it moves swiftly past.
- *Frame 3* – The arc has motored past the vice-top insulator, but the damage is already done. The conductor begins to separate at the vice-top insulator, creating a second arc.

From the images in Figure 4-21, it appears that the arc is not attached to the conductor on the right side of the images. This is because the static background image is taken before the test begins. Once the arc is ignited, the fault current flowing in the conductors pushes them apart, making the arc to appear to be terminating in the air.

- *Polymer vice-top insulator* – The polymer vice-top insulator was attached to the bare #4 ACSR conductor, with the vice jaws clamped around the line per a typical installation. This test was repeated twice. During the first test, shown in Figure 4-21, the arc did not anchor at the insulator, but its motion down the line did slow considerably. Post-test inspection revealed that the conductor inside the jaws of the vice-top insulator had suffered significant damage (Figure 4-22). The test line was lightly tensioned during this test, and it is believed that the conductor would have fully separated had the line been under tension loading typical of field conditions. The other test conductor also incurred some “bird caging” damage as a result of the arc slowing down (Figure 4-23).

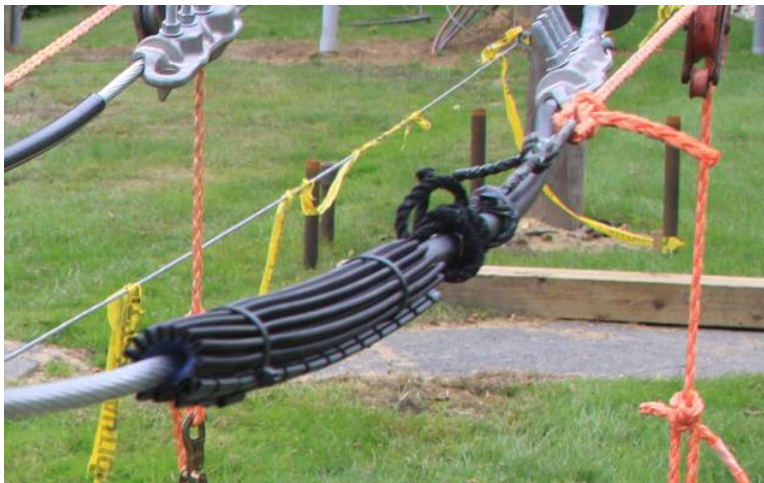
Figure 4-35
Gel Wrap Installed on a 336.4-kcmil (170.5-mm²) Aluminum Conductor Prior to a Burndown Test

Some utilities have begun using gel wraps to cover automatic splices in covered conductors on overhead systems. They are used in this manner to prevent arc initiation at the bare section of line associated with automatic splices. Two tests were made to examine what happens when a motoring arc encounters a gel wrap (no attempt was made to examine the ability of the gel wrap
